Subject: Pavement Condition Assessment Report

Scope Notes for Section 79070000

FPN 454209-1

SR 44 from W of Ridgwood Ave. to N Boundary Ave.

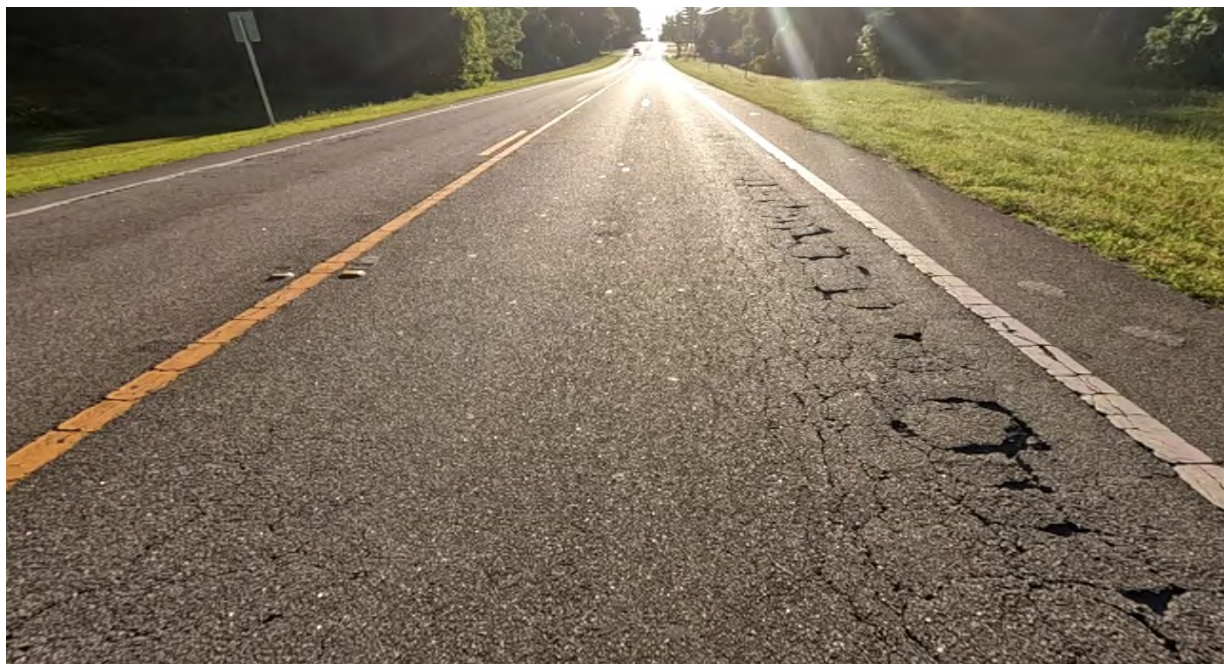
In the R1 travel lane, alligator cracking with asphalt pop-outs was observed from approximate MP 2.856 to MP 3.200 and near MP 3.867. Severe rutting was found near MP 3.708 and 3.773.

Photo 1: SR 44 Eastbound, R1 near MP 2.856. A view of alligator cracking with asphalt pop-outs.

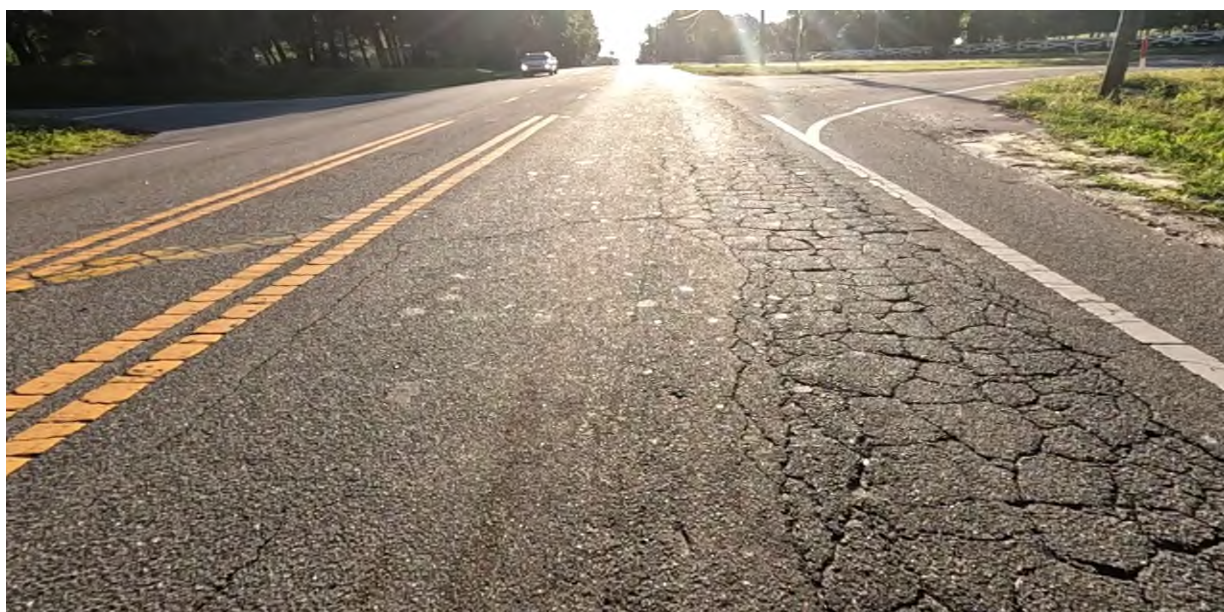
Photo 2: SR 44 Eastbound, R1 near MP 3.108. A view of severe alligator cracking.

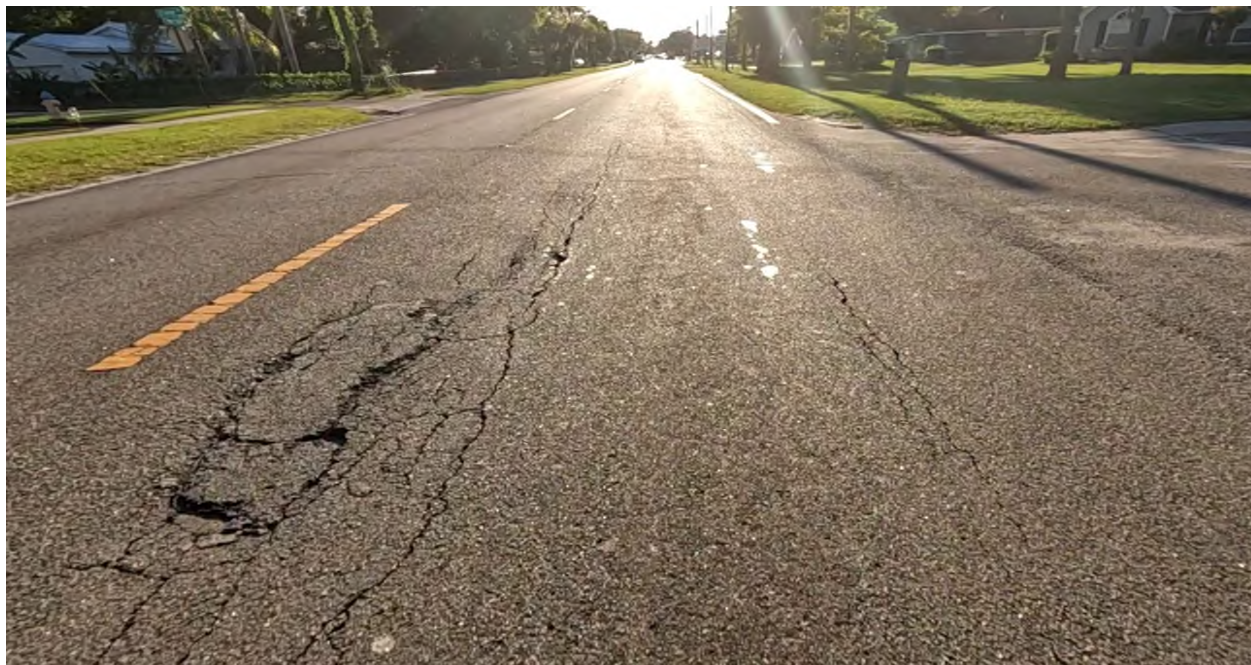
Photo 3: SR 44 Eastbound, R1 near MP 3.708. A view of longitudinal cracking with severe rutting / depression.

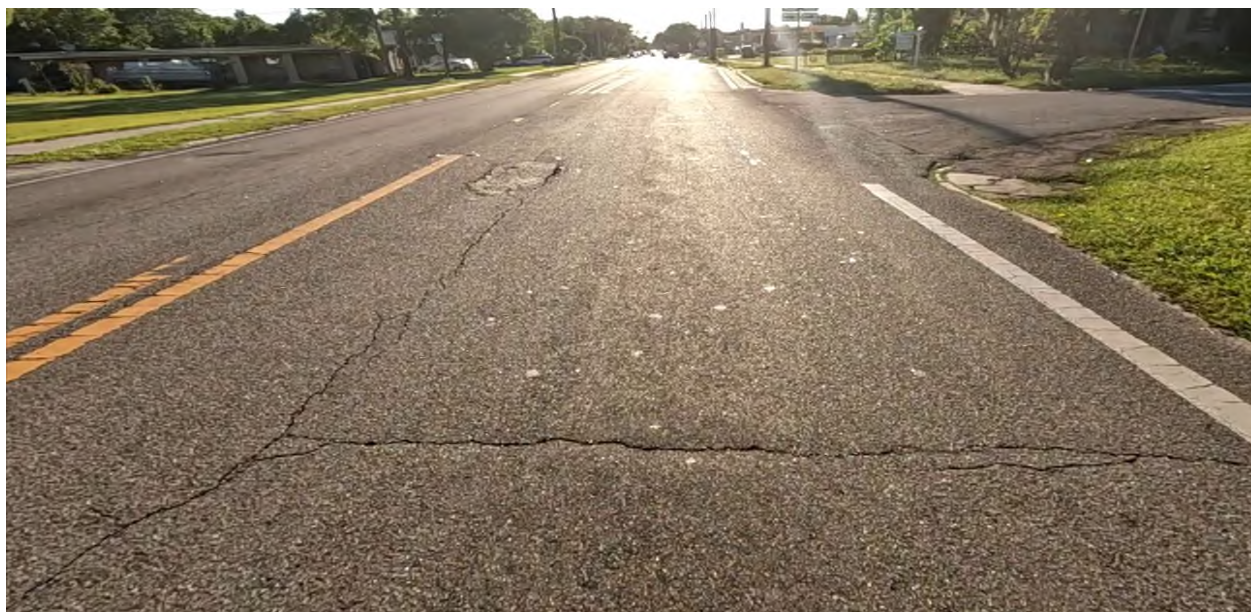
Photo 4: SR 44 Eastbound, R1 near MP 3.773. A view of longitudinal and transverse cracking.

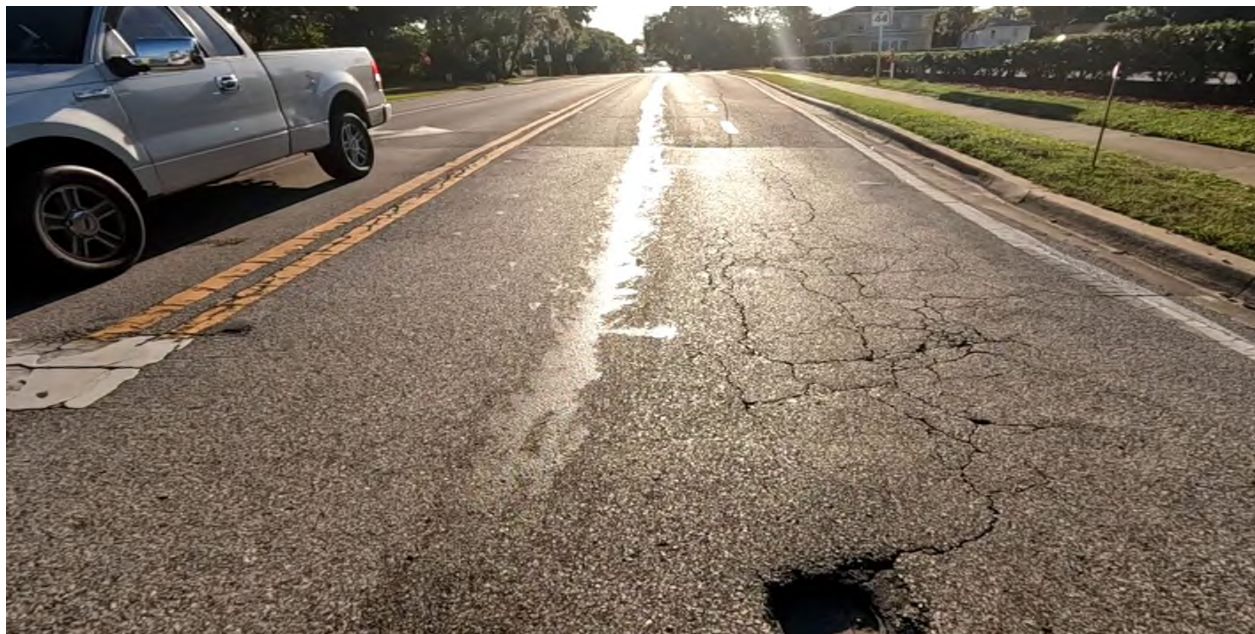
Photo 5: SR 44 Eastbound, R1 near MP 3.867. A view of alligator cracking near utility access cover.

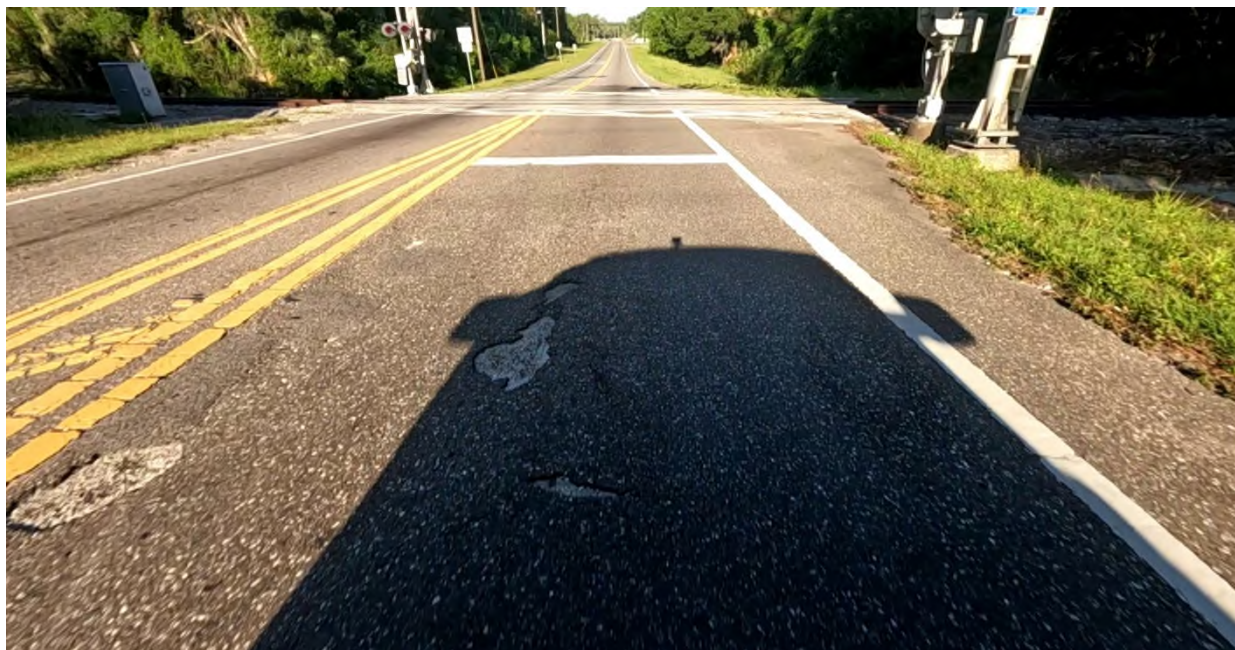
Photo 6: SR 44 Westbound, L1 near MP 3.074. A view of wearing of friction course and delamination near railroad crossing.

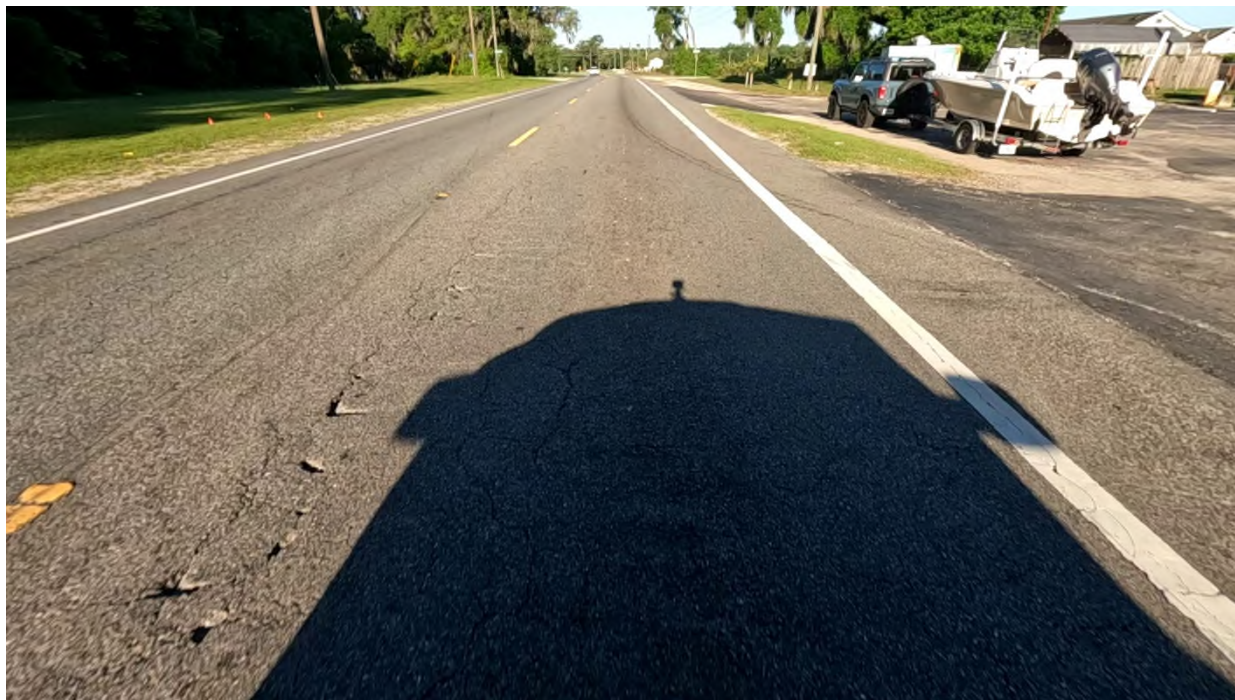
Photo 7: SR 44 Westbound, L1 near MP 2.900. A view of light to moderate branch cracking with asphalt pop-outs.

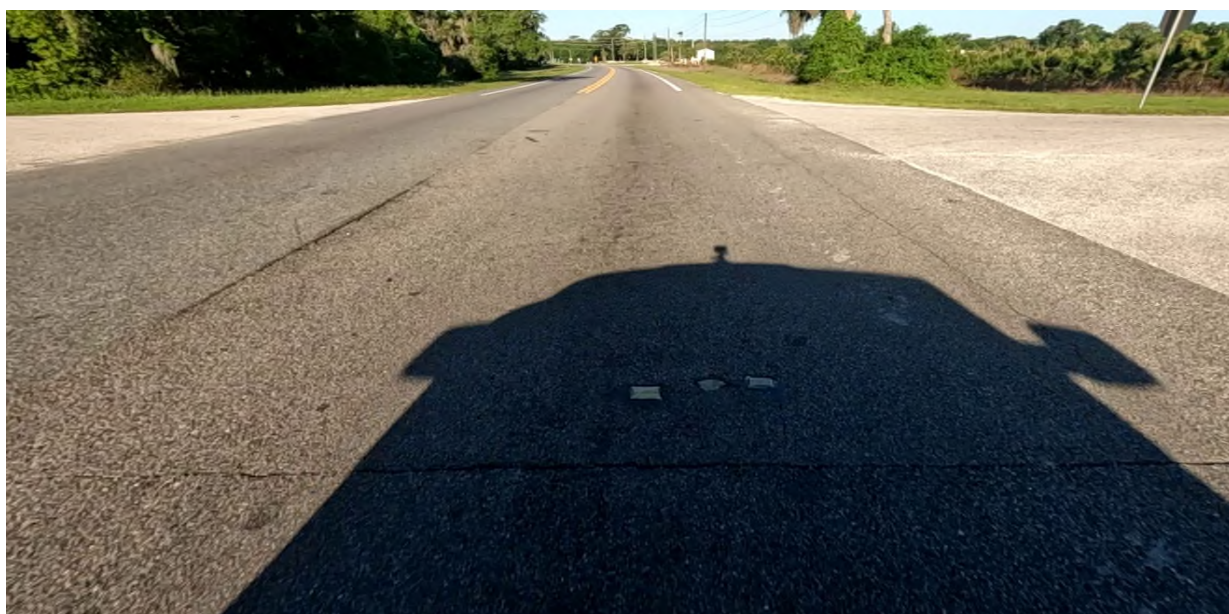
In the L1 travel lane, alligator cracking with asphalt pop-outs was observed from approximate MP 2.856 to MP 2.900. Pavement joint separation with between the R1 and L1 travel lanes found near MP 2.856 (SR 44 and N Ridgwood Ave. intersection).

Photo 8: SR 44 Westbound, L1 near MP 2.856. A view transverse cracking and joint separation.
