**FLORIDA DEPARTMENT OF TRANSPORTATION**  
**BRIDGE MANAGEMENT SYSTEM**  
**Inspection/CIDR Report with PDF attachment(s)**  
(TRAFFIC SIGNAL MAST ARM INSPECTION REPORT)

Structure ID: 70M130

INSPECTION DATE: 11/1/2021 ZZGC

| BY: FIT Engineering | STRUCTURE NAME: US-1 at Knox McRae Drive |

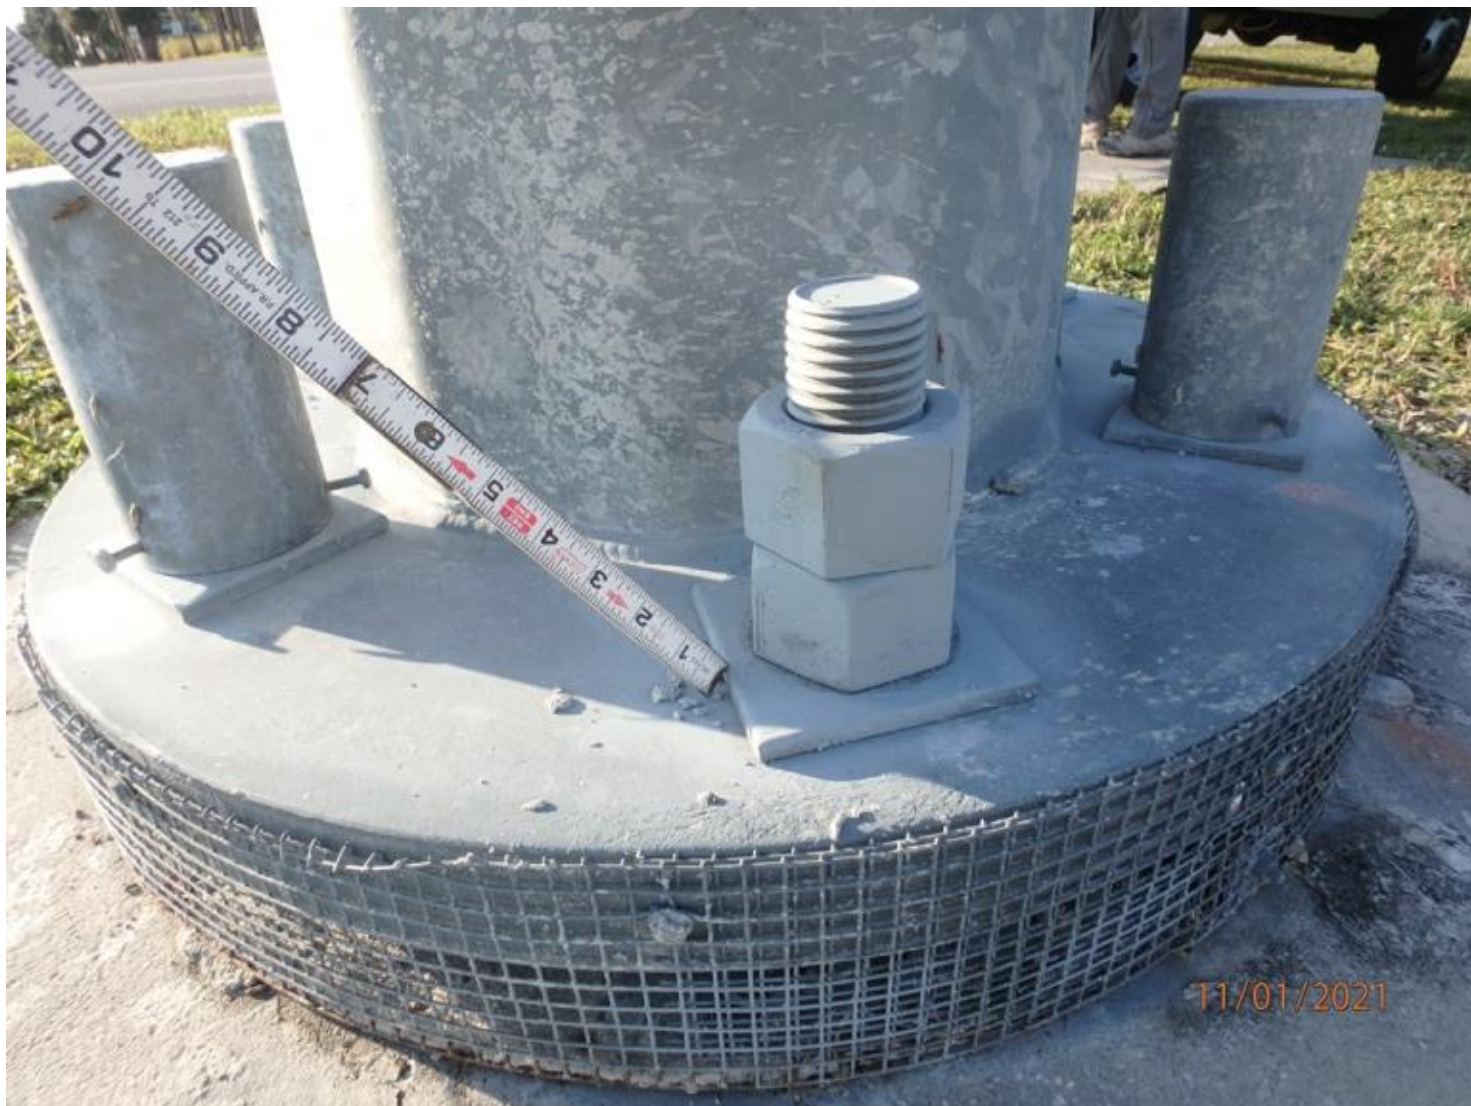
**Photo 1**

F2 - One of 6 anchor bolts is missing a cover. Refer to Photo 1.

Element 8480 / Foundation – Missing anchor bolt cover at F2

F2 - Replace the missing anchor bolt cover with one that has a minimum inside diameter of 3 1/2 in. and is at least 7 in. tall and properly secure. P=3

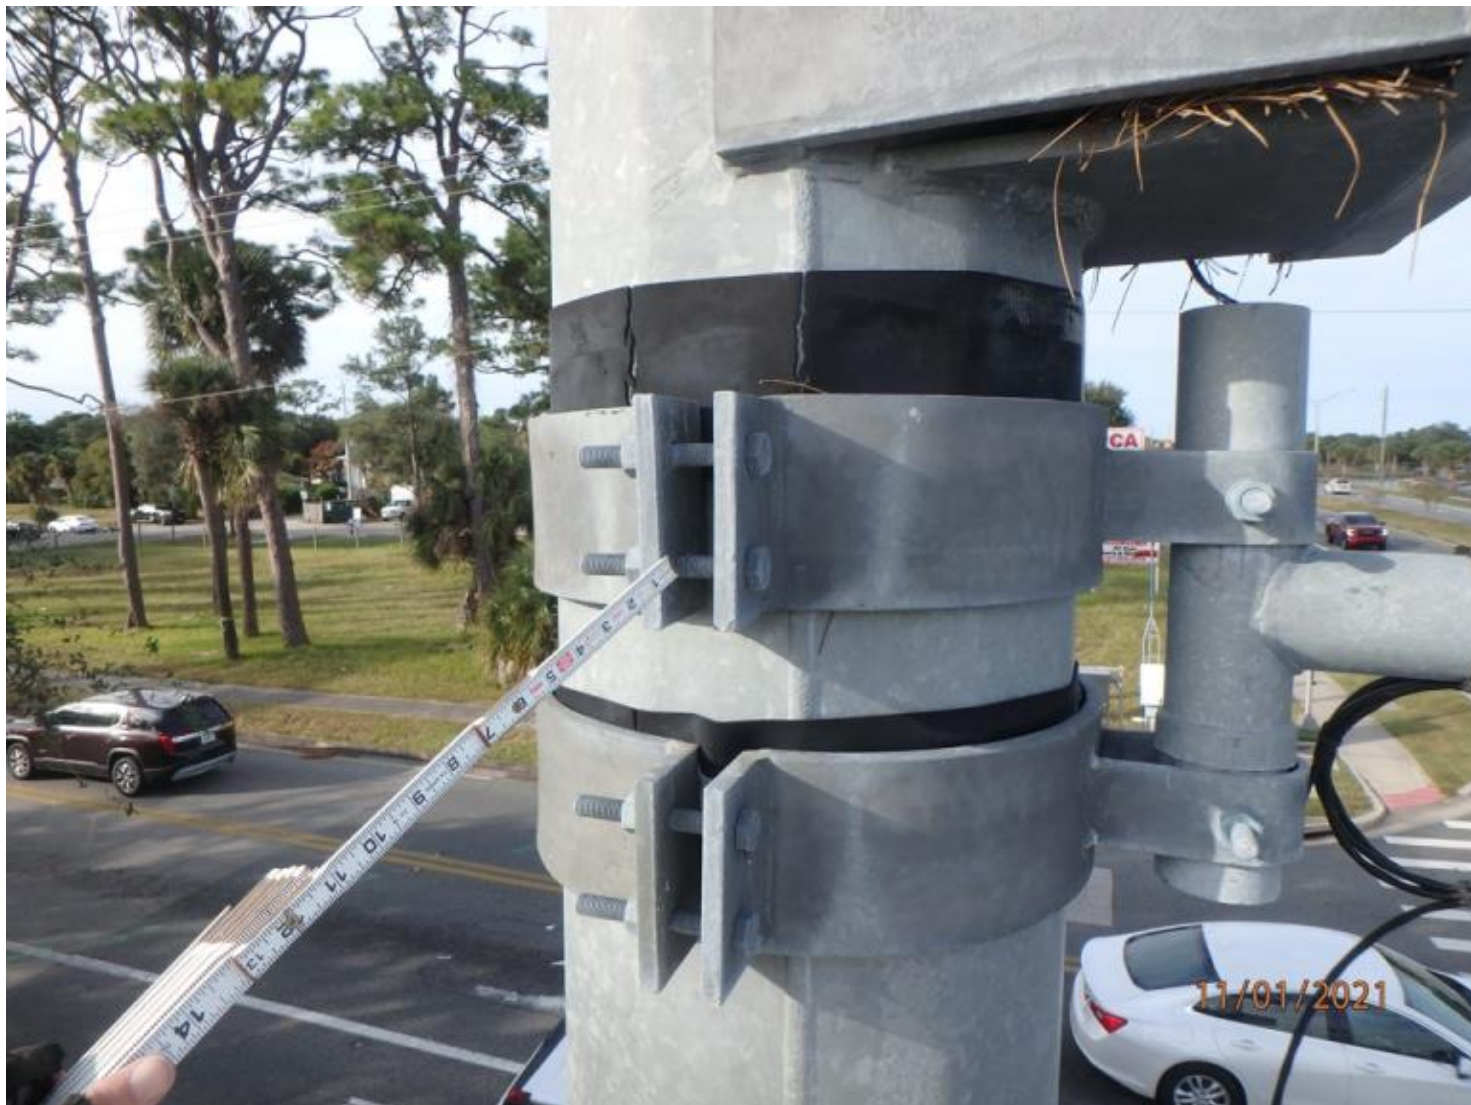
**Photo 2**

V1 - The street sign bracket appears to have slipped based on the neoprene pad being displaced; the bolts are tight. Refer to Photo 2.

Element 8481 / Vertical – Displaced neoprene pad for the street sign bracket at V1

V1 - Reposition the street sign brackets and neoprene pads. P=3

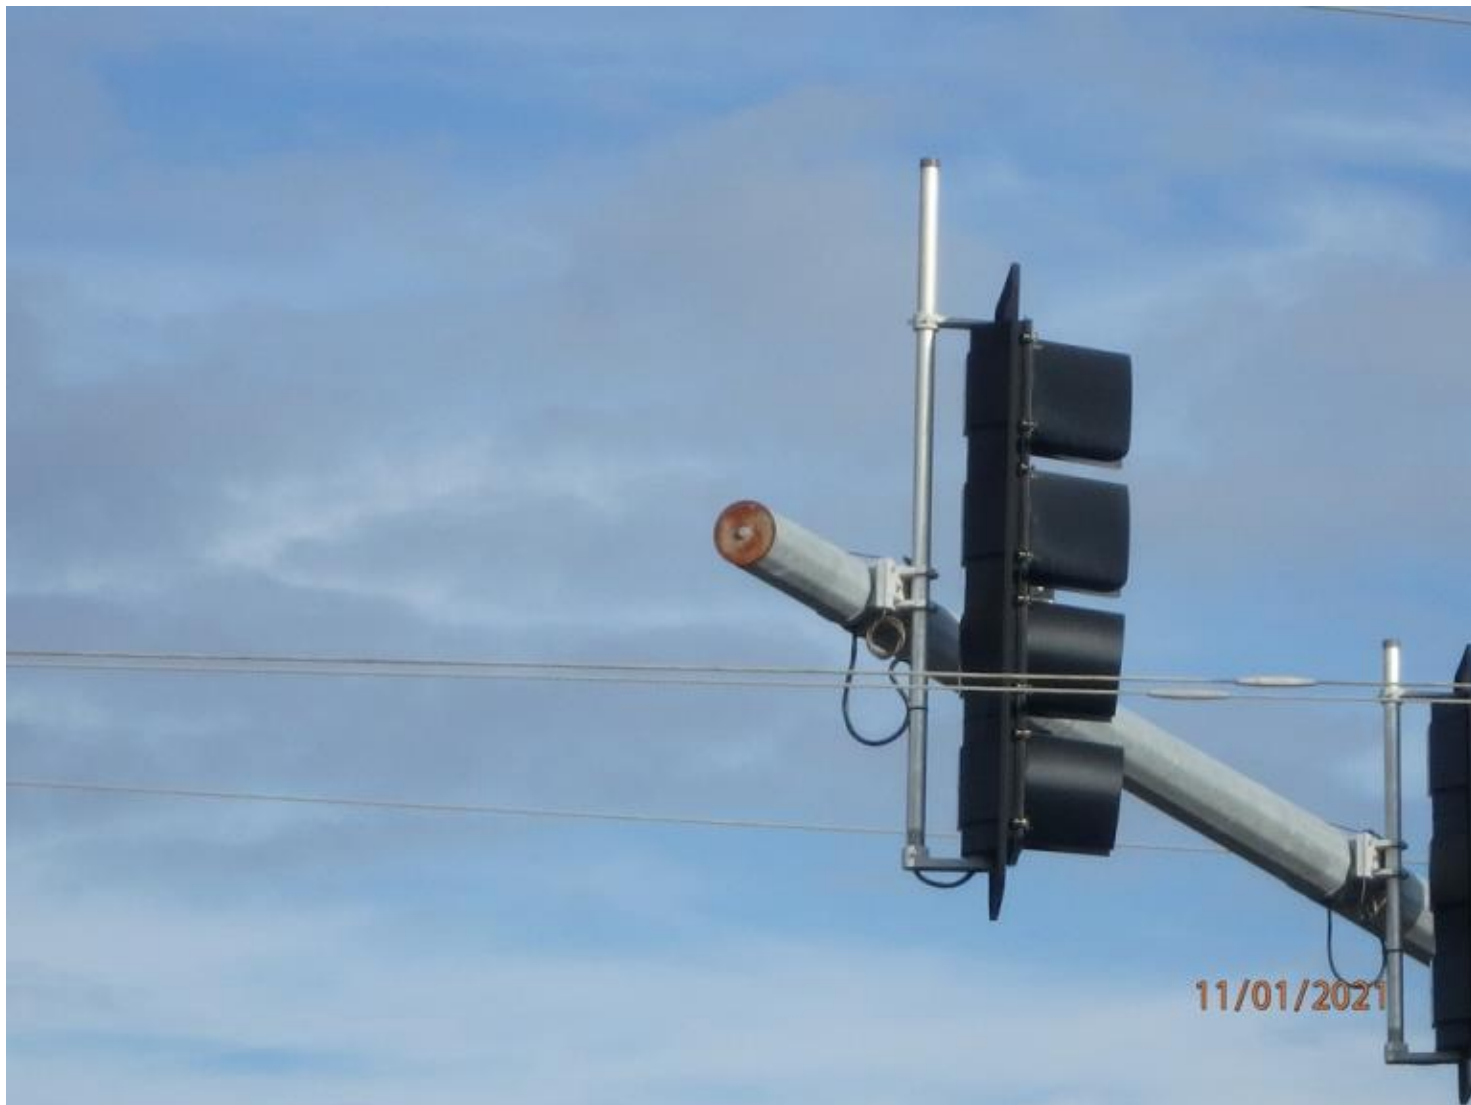
**Photo 3**

V2/H2 - The horizontal arm end cap has light to moderate surface corrosion. Refer to Photo 3. (1 EA)

V2/H2 - The galvanic coating on the horizontal arm end cap is failing, allowing corrosion to form. Refer to Photo 3. (1 SF)

Element 8484 / Horizontal – Surface corrosion on the horizontal arm end cap at V2/H2

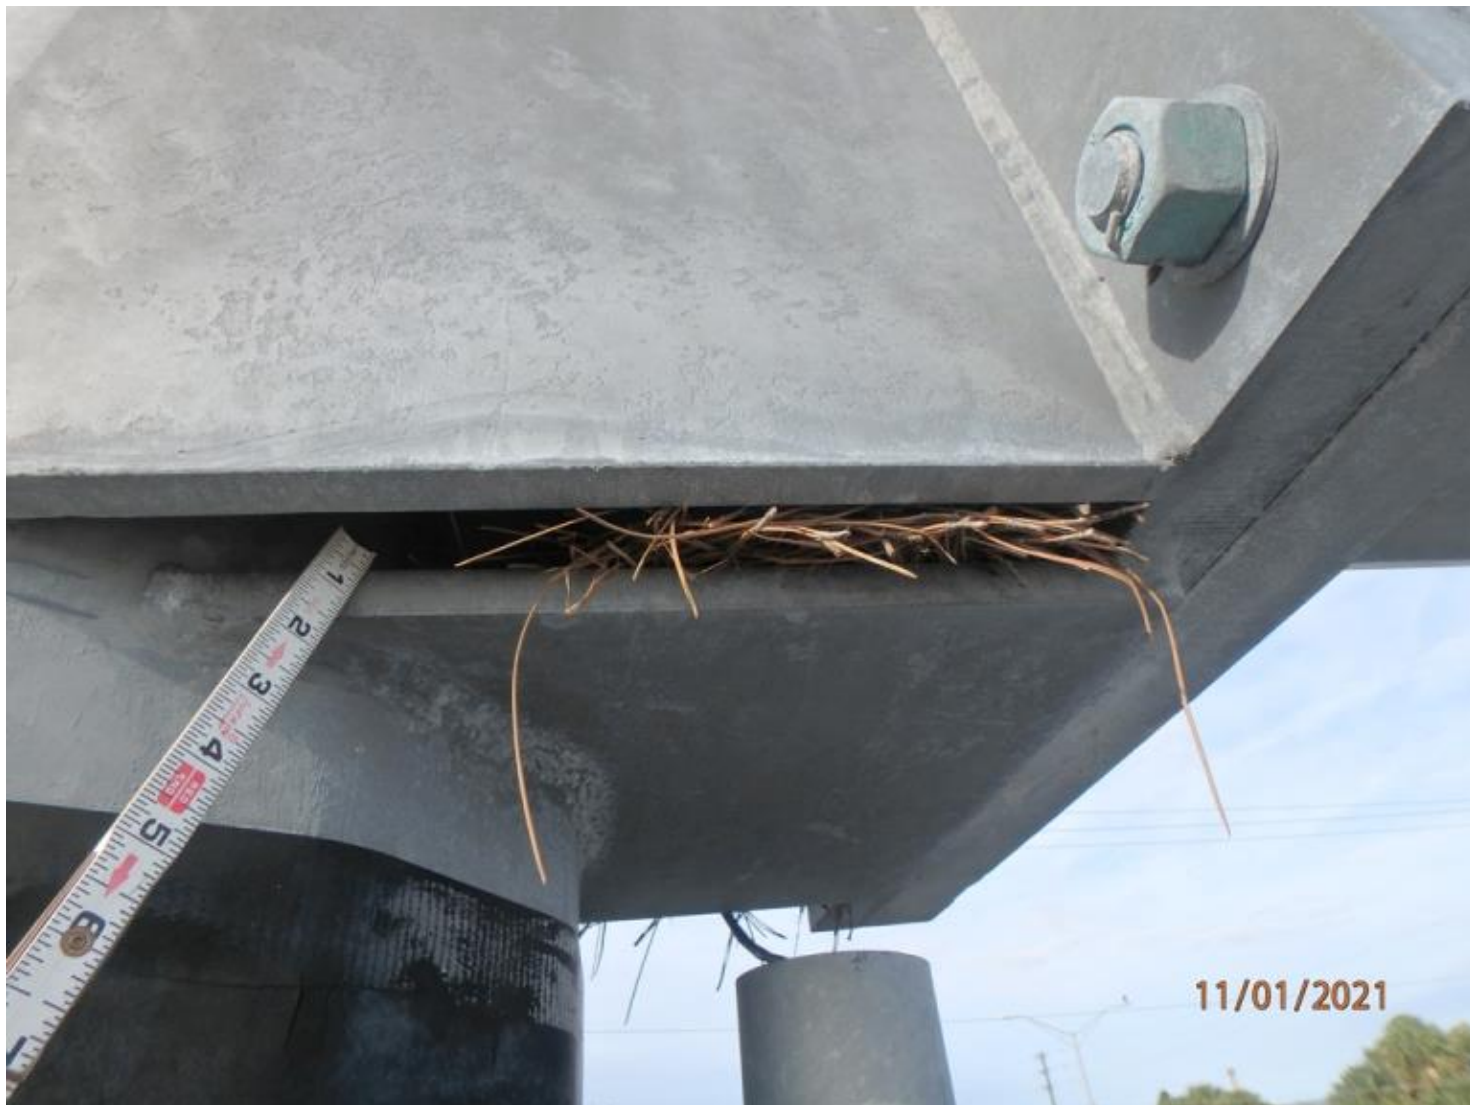
**Photo 4**

V1/H1 - A bird nest is present between the moment connection support plates and in the horizontal arm, visible through the drain hole near the moment connection. Refer to Photos 4 and 5.

Element 8484 / Horizontal – Bird nest between the moment connection plates at V1/H1

V1/H1 - Remove the bird nest from between the moment connection support plates and from the horizontal arm near the MC and install screening. P=3

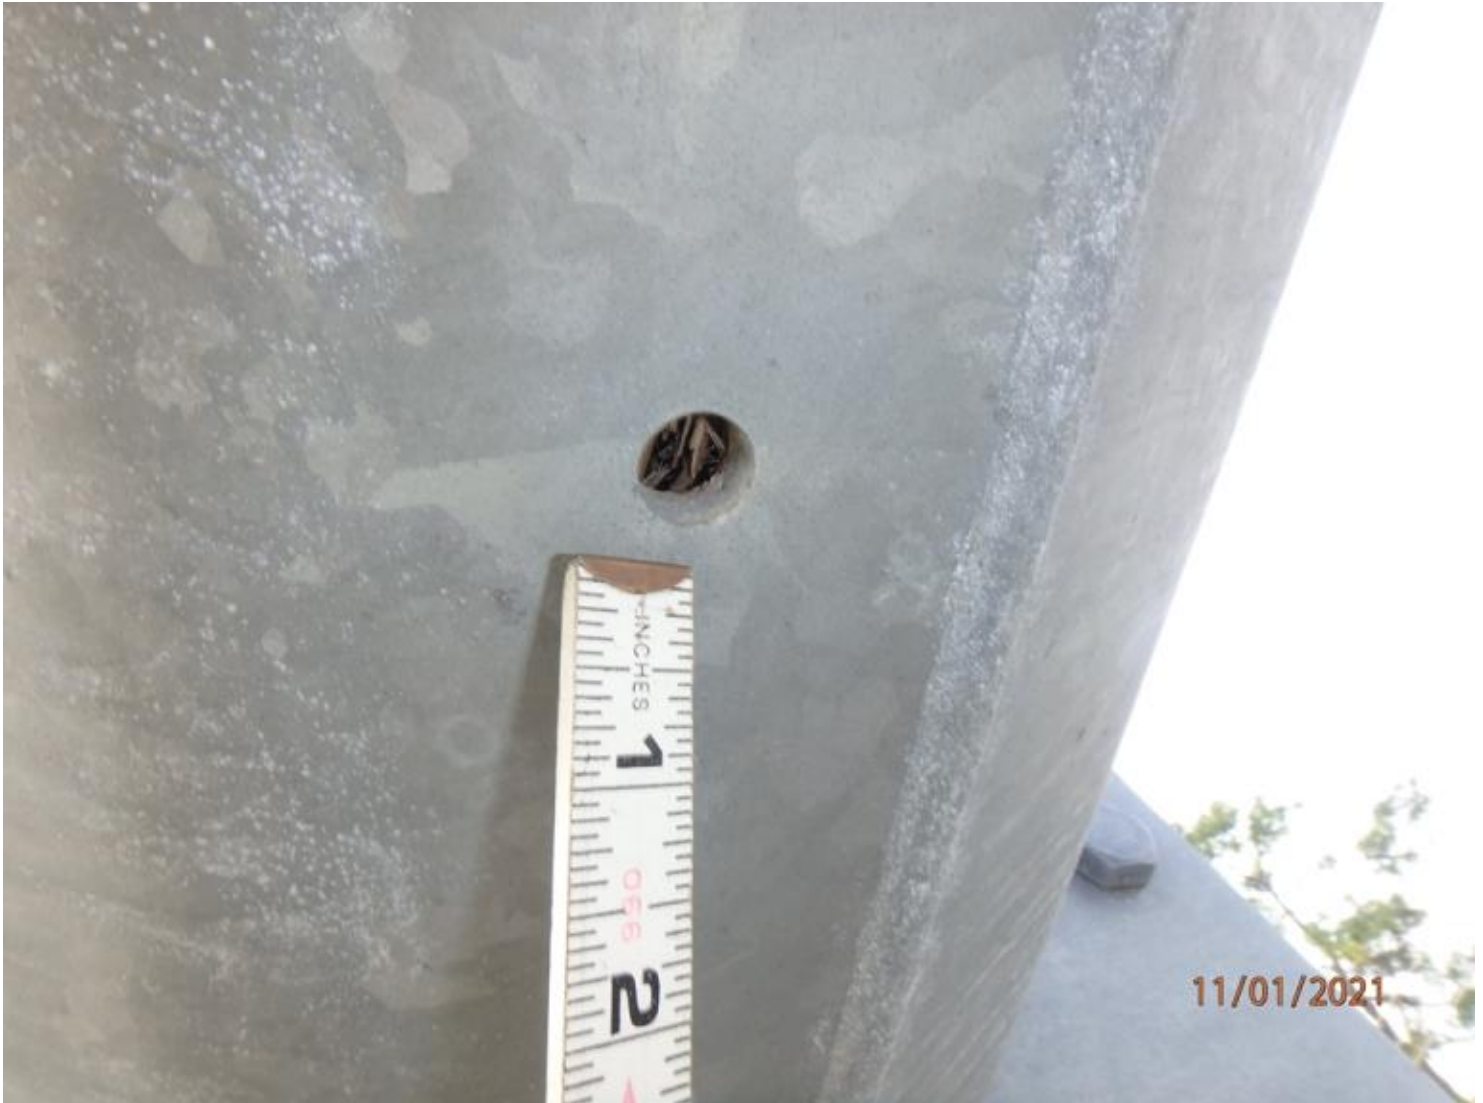
**Photo 5**

Element 8484 / Horizontal – Bird nest inside the horizontal arm at V1/H1
