**FLORIDA DEPARTMENT OF TRANSPORTATION**  
**BRIDGE MANAGEMENT SYSTEM**  
**Inspection/CIDR Report with PDF attachment(s)**  
(TRAFFIC SIGNAL MAST ARM INSPECTION REPORT)

Structure ID: 70M131

INSPECTION DATE: 11/1/2021 BBLN

| BY: FIT Engineering | STRUCTURE NAME: US-1 at Olmstead Drive |

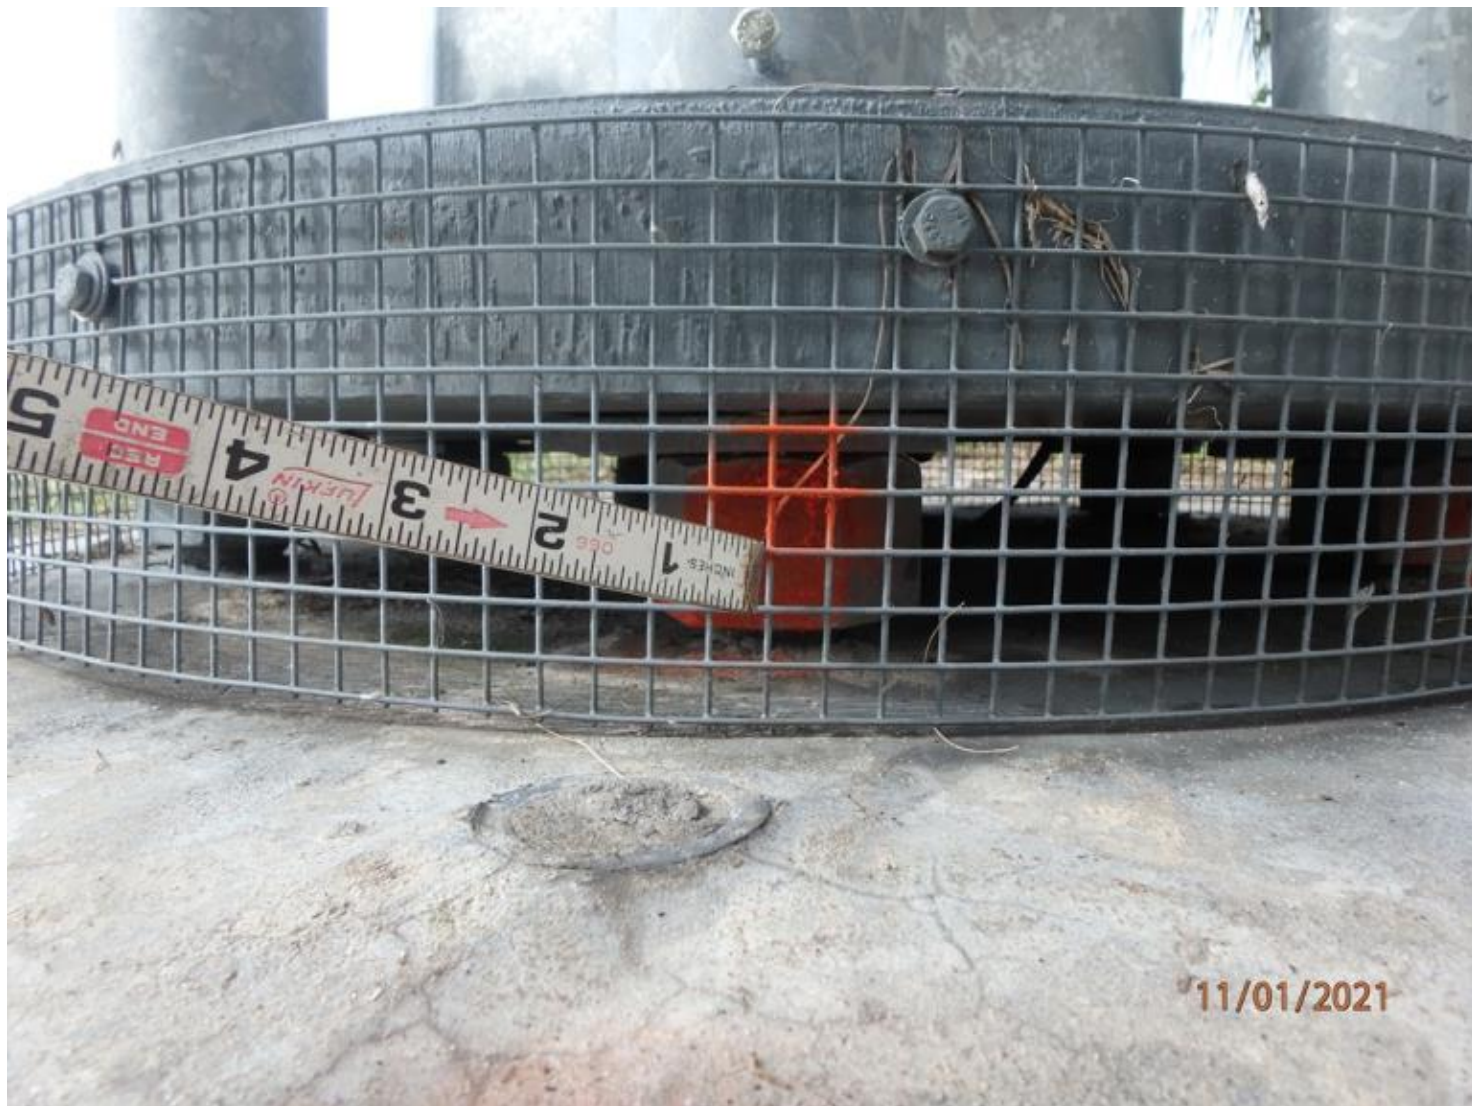
**Photo 1**

F2 - The leveling nuts for Anchor Bolts 1 and 2 are loose, as indicated by washer movement when struck with a hammer. Refer to Photo 1. (1 EA)

The NBI rating for Item 60 Substructure was lowered from an 8 - Very Good to a 5 - Fair due to loose leveling nuts at F2.

Element 8480 / Foundation – Typical loose leveling nut at F2

F2 - Tighten the loose leveling nuts for Anchor Bolts 1 and 2. P=3

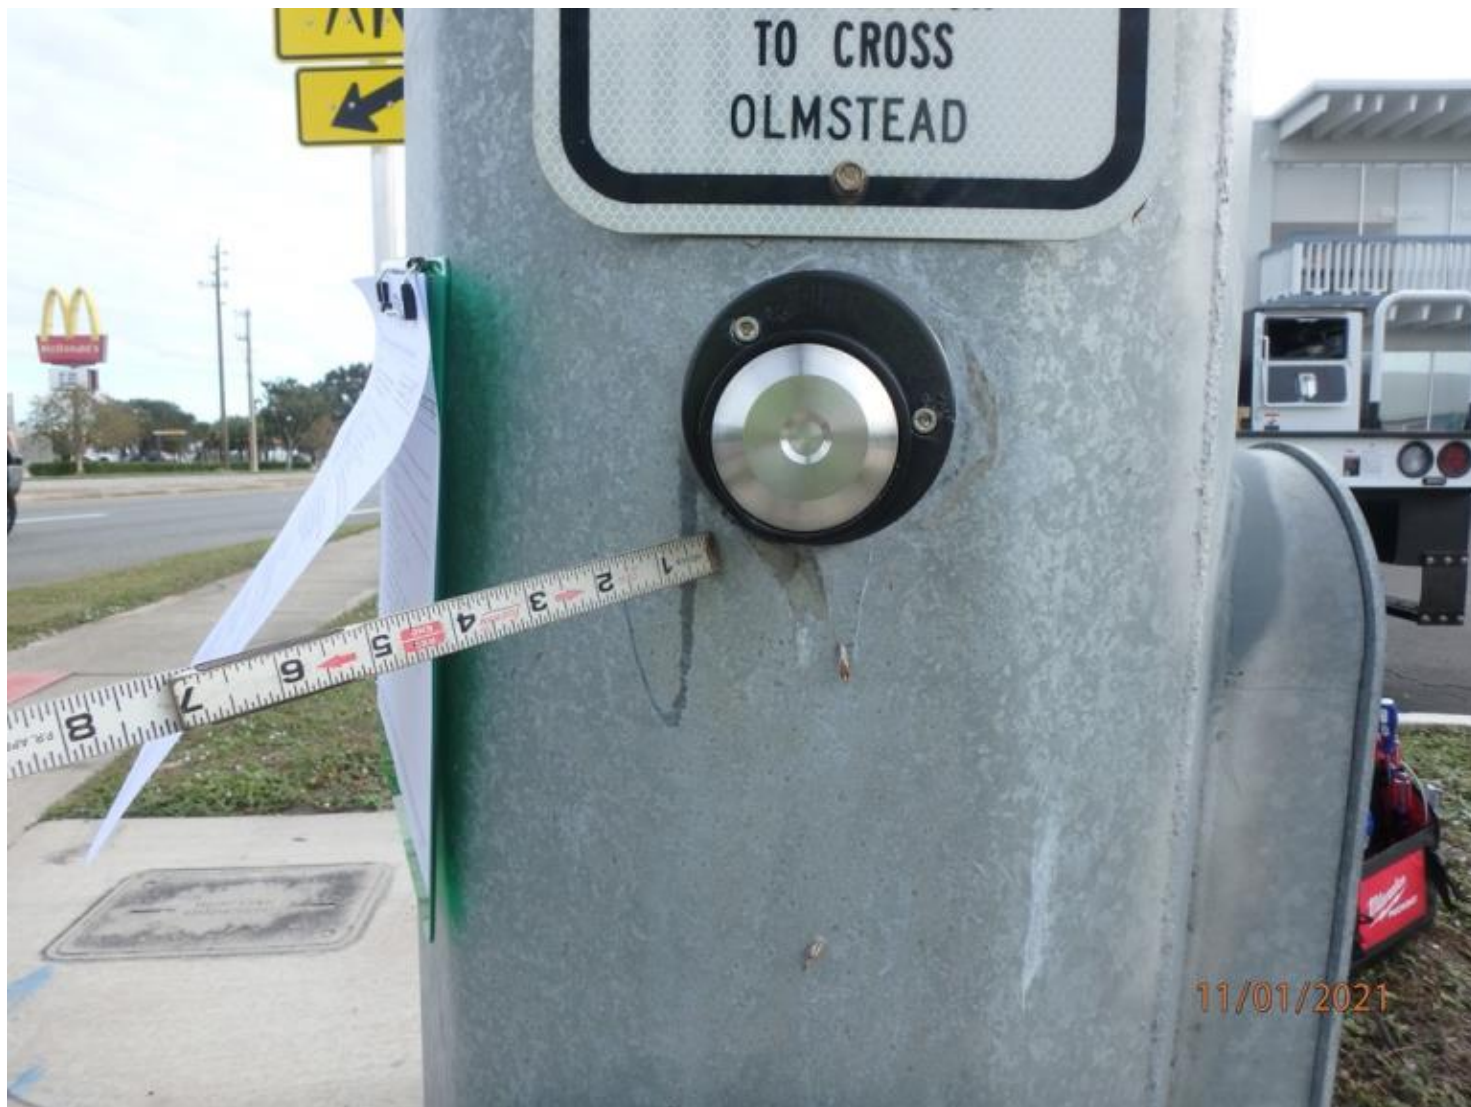
Photo 2

V1 - The pedestrian crosswalk button is not secure on the pole and can be rotated indicating a broken or missing bottom bolt. Refer to Photo 2.

Element 8481 / Vertical – Unsecured pedestrian crosswalk button at V1

V1 - Secure the pedestrian crosswalk signal button on the pole. P=3

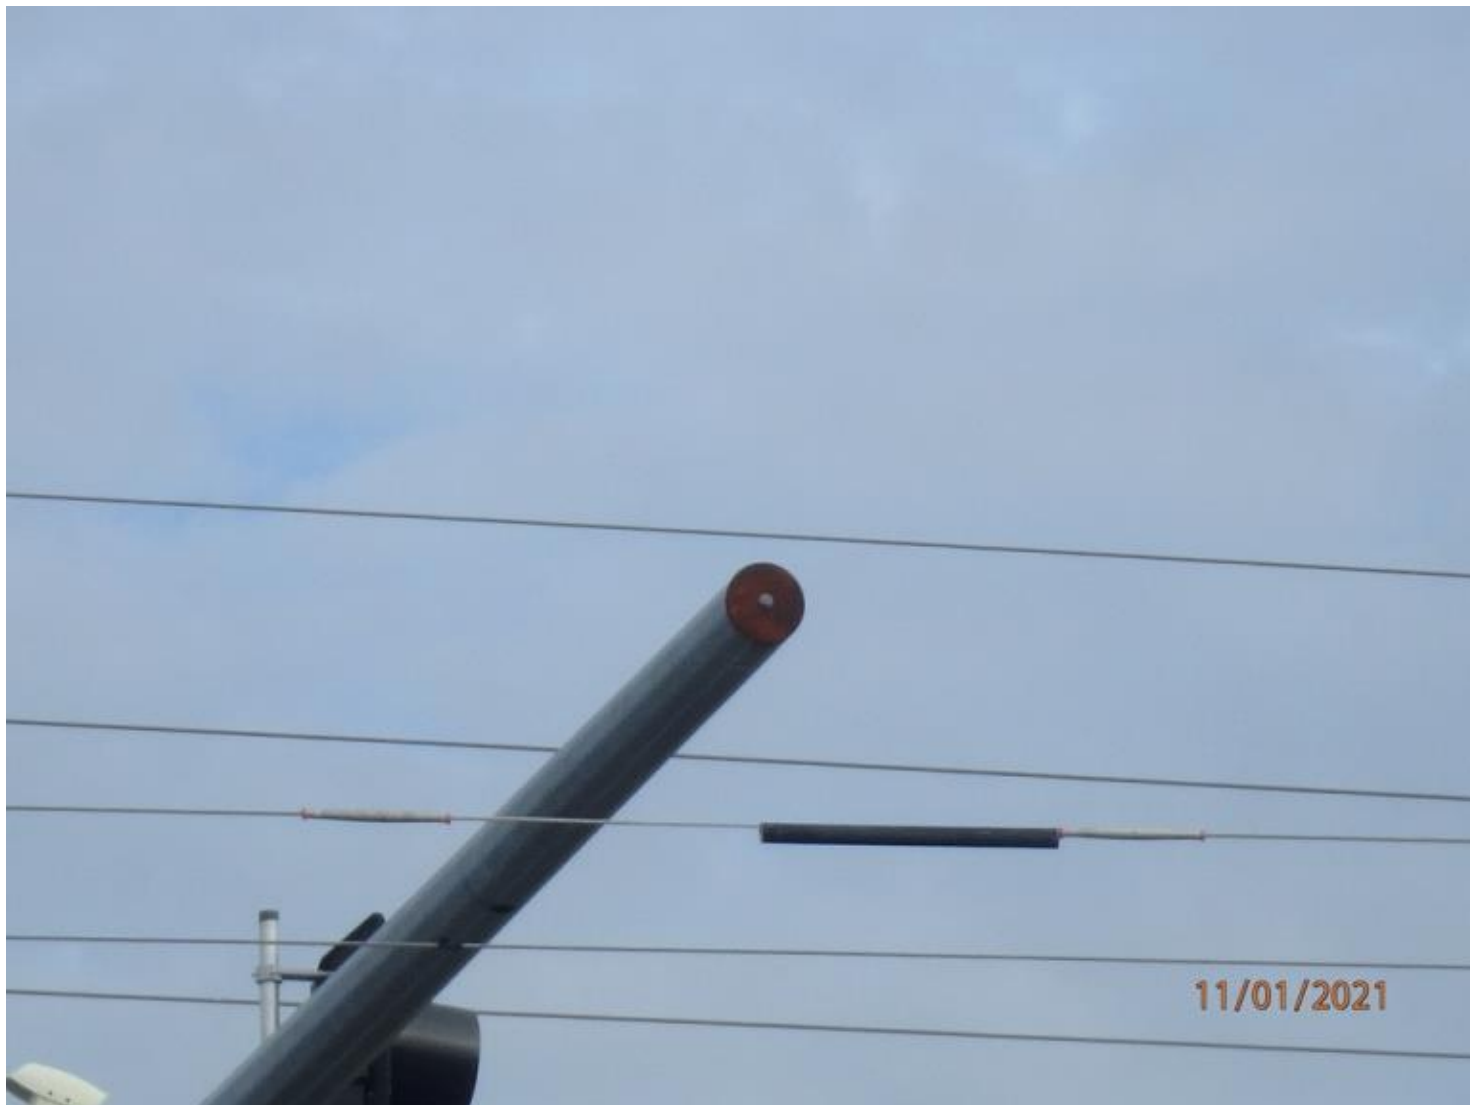
**Photo 3**

V1/H1, V1/H2, V2/H3 and V2/H4 - The horizontal arm end cap has light to moderate surface corrosion at each location. Refer to Photo 3. (4 EA)

8518/4      New Comment:  
CS4 3440:  
V1/H1, V1/H2, V2/H3 and V2/H4 - The galvanic coating on the horizontal arm end cap is failing, allowing corrosion to form at each location. Refer to Photo 3. (4 SF)

Element 8484 / Horizontal – Surface corrosion on the horizontal arm end cap at V2/H3; typical at all four horizontal arms

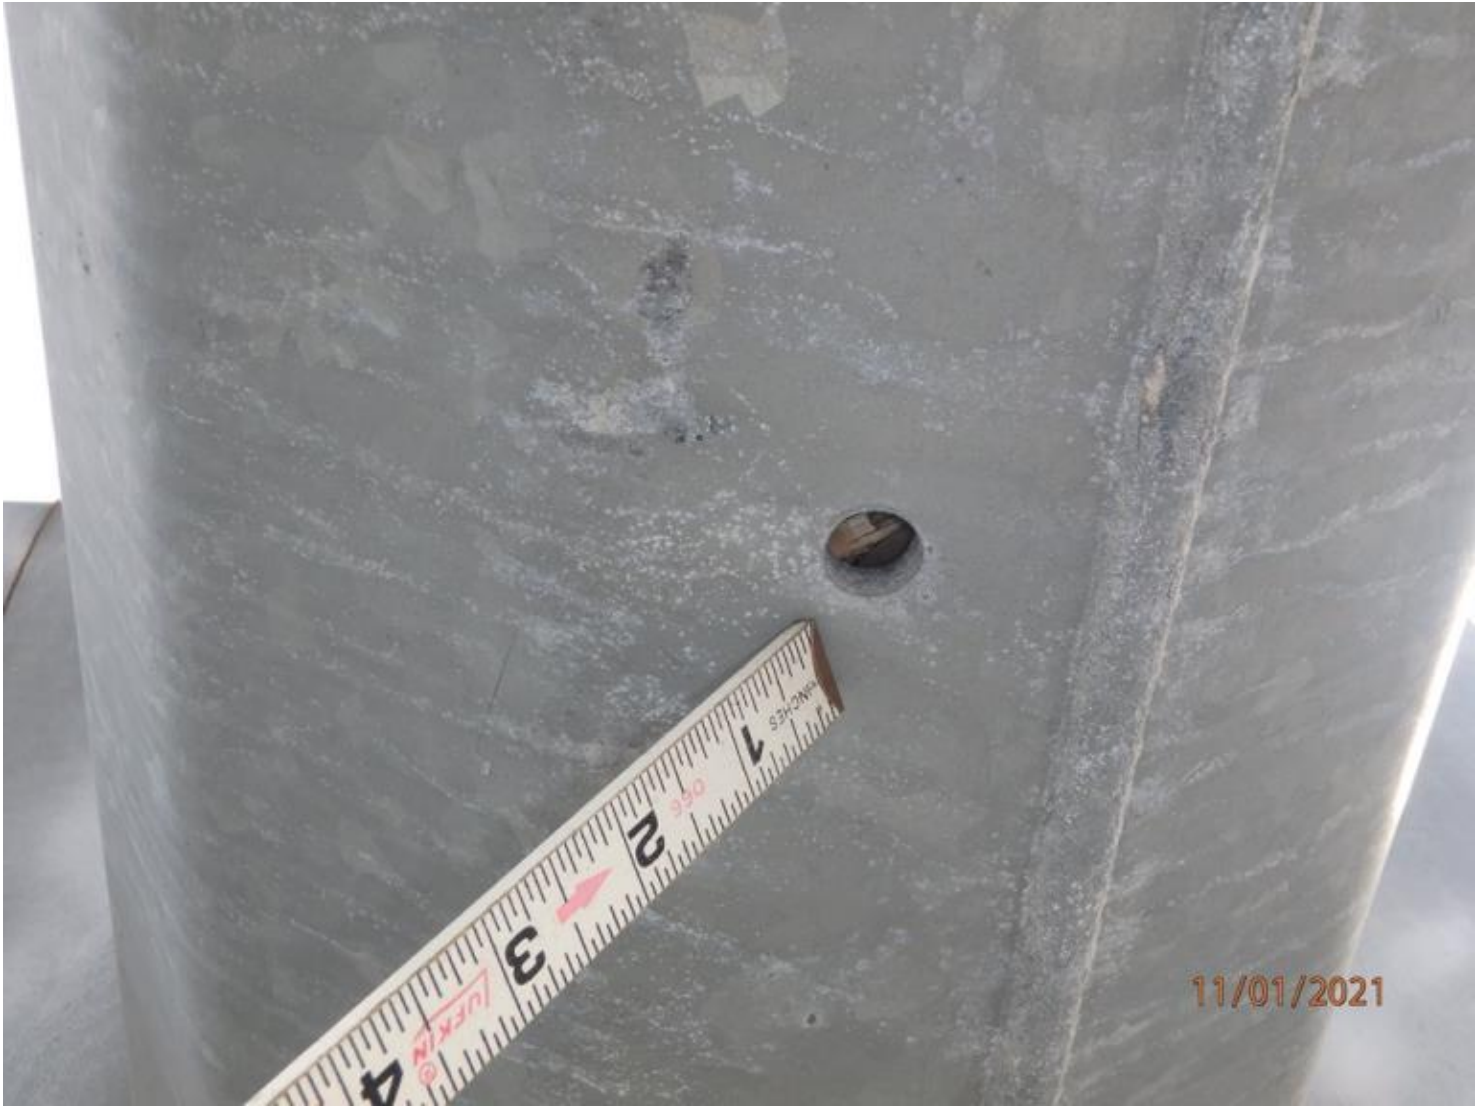
**Photo 4**

V1/H2 - A bird nest is present in the horizontal arm, visible through the drain hole near the moment connection; however, screening is in-place. Refer to Photo 4.

Element 8484 / Horizontal – Bird nest inside the horizontal arm at V1/H2

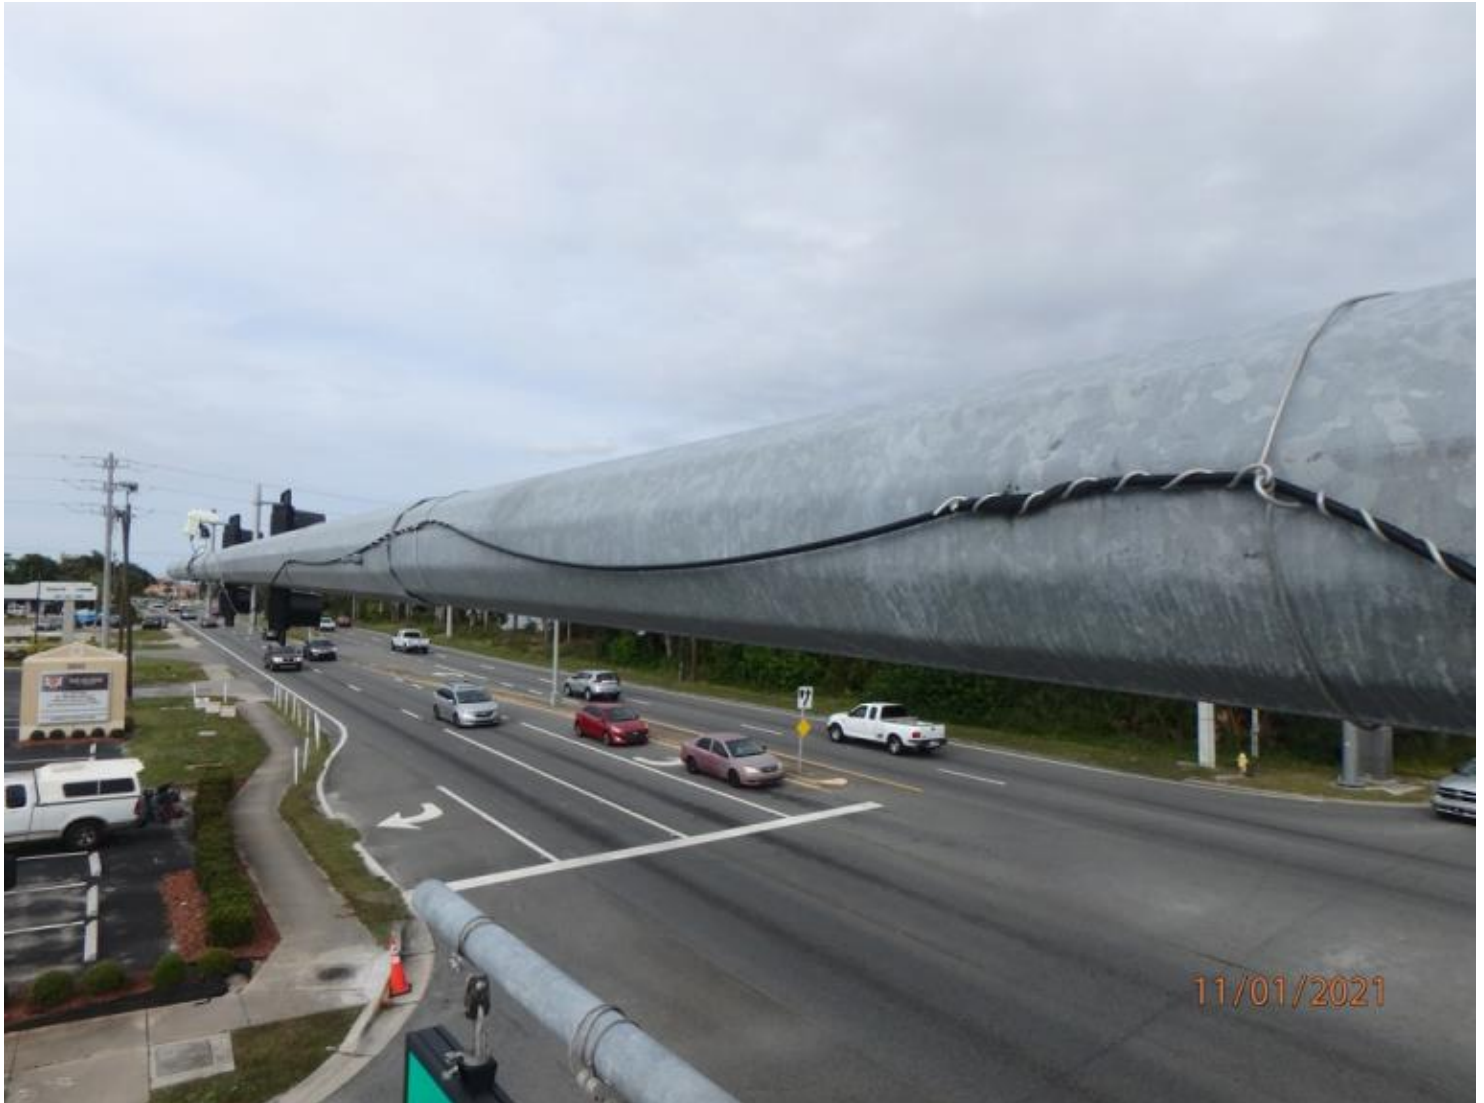
**Photo 5**

V1/H2 - The wiring for the camera is running outside of the horizontal arm. Refer to Photo

Element 8484 / Horizontal – Camera wiring running outside the horizontal arm at V1/H2

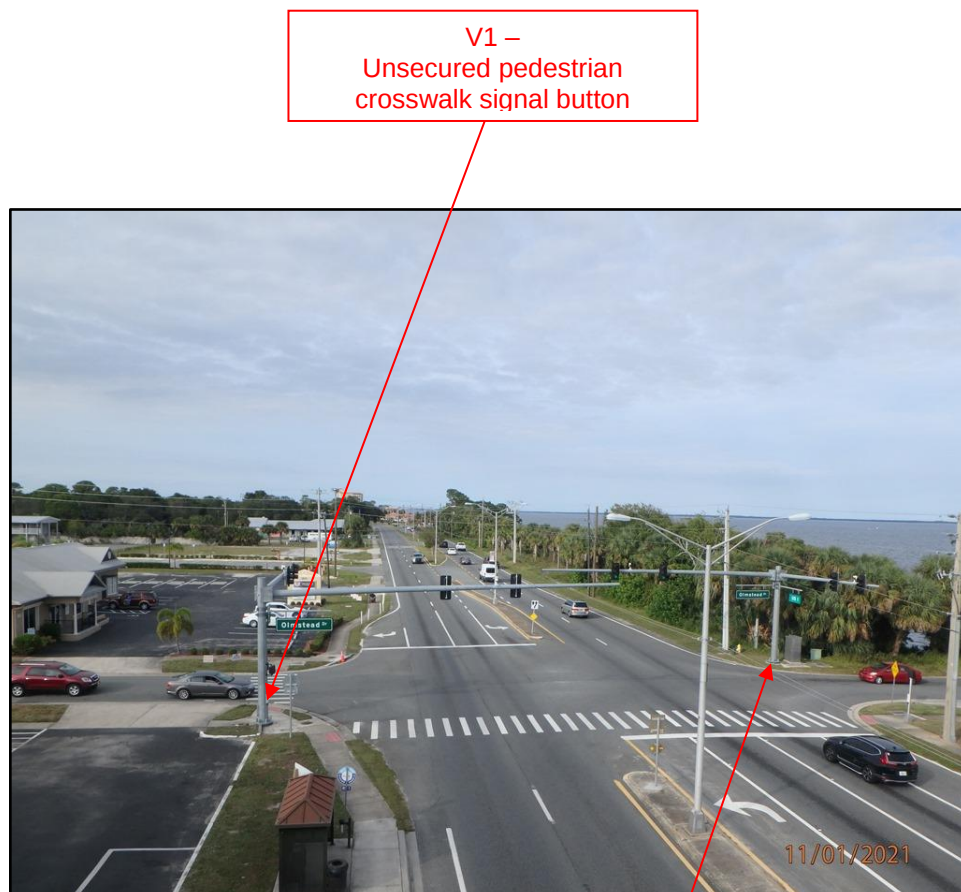
Deficiency Location Photo

F2 –  
Loose leveling nuts
