**FLORIDA DEPARTMENT OF TRANSPORTATION**  
**BRIDGE MANAGEMENT SYSTEM**  
**Inspection/CIDR Report with PDF attachment(s)**  
(TRAFFIC SIGNAL MAST ARM INSPECTION REPORT)

Structure ID: 70M132

INSPECTION DATE: 11/1/2021 EGID

| BY: FIT Engineering | STRUCTURE NAME: US-1 at Country Club Drive |

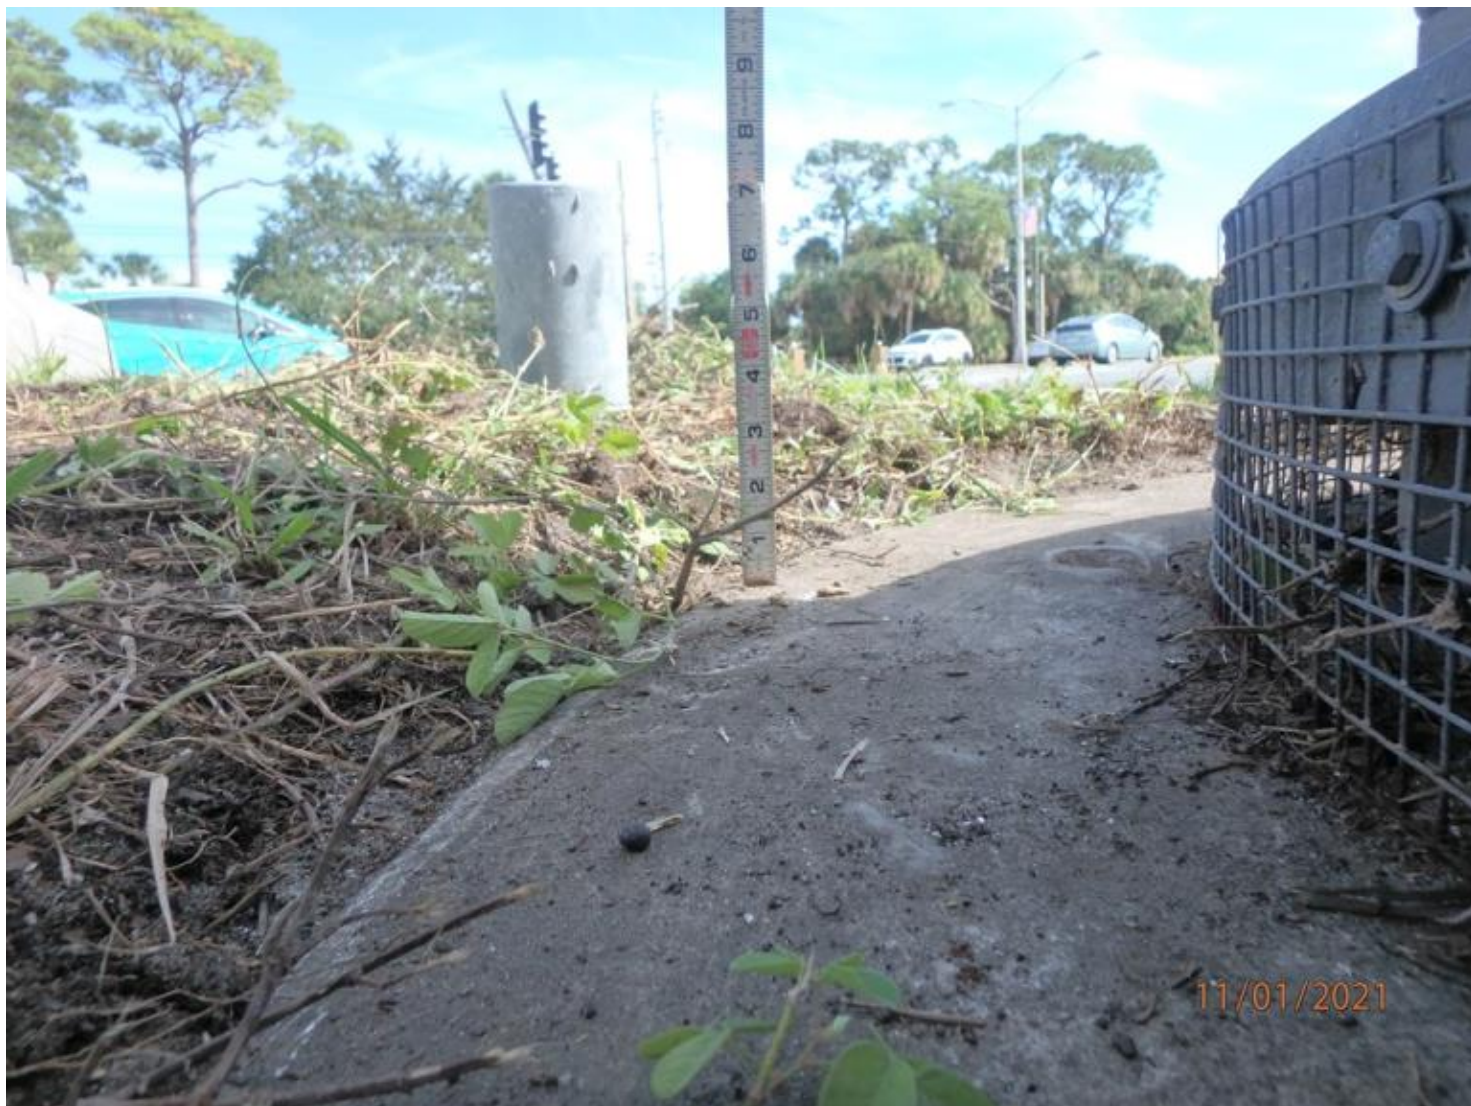
**Photo 1**

F2 - The foundation is 4 in. below grade. Refer to Photo 1.

Element 8480 / Foundation – Foundation below grade at F2

F2 - Re-grade or install shoring around the foundation. P=3

F2 - Regrade area around foundation. - Not completed.

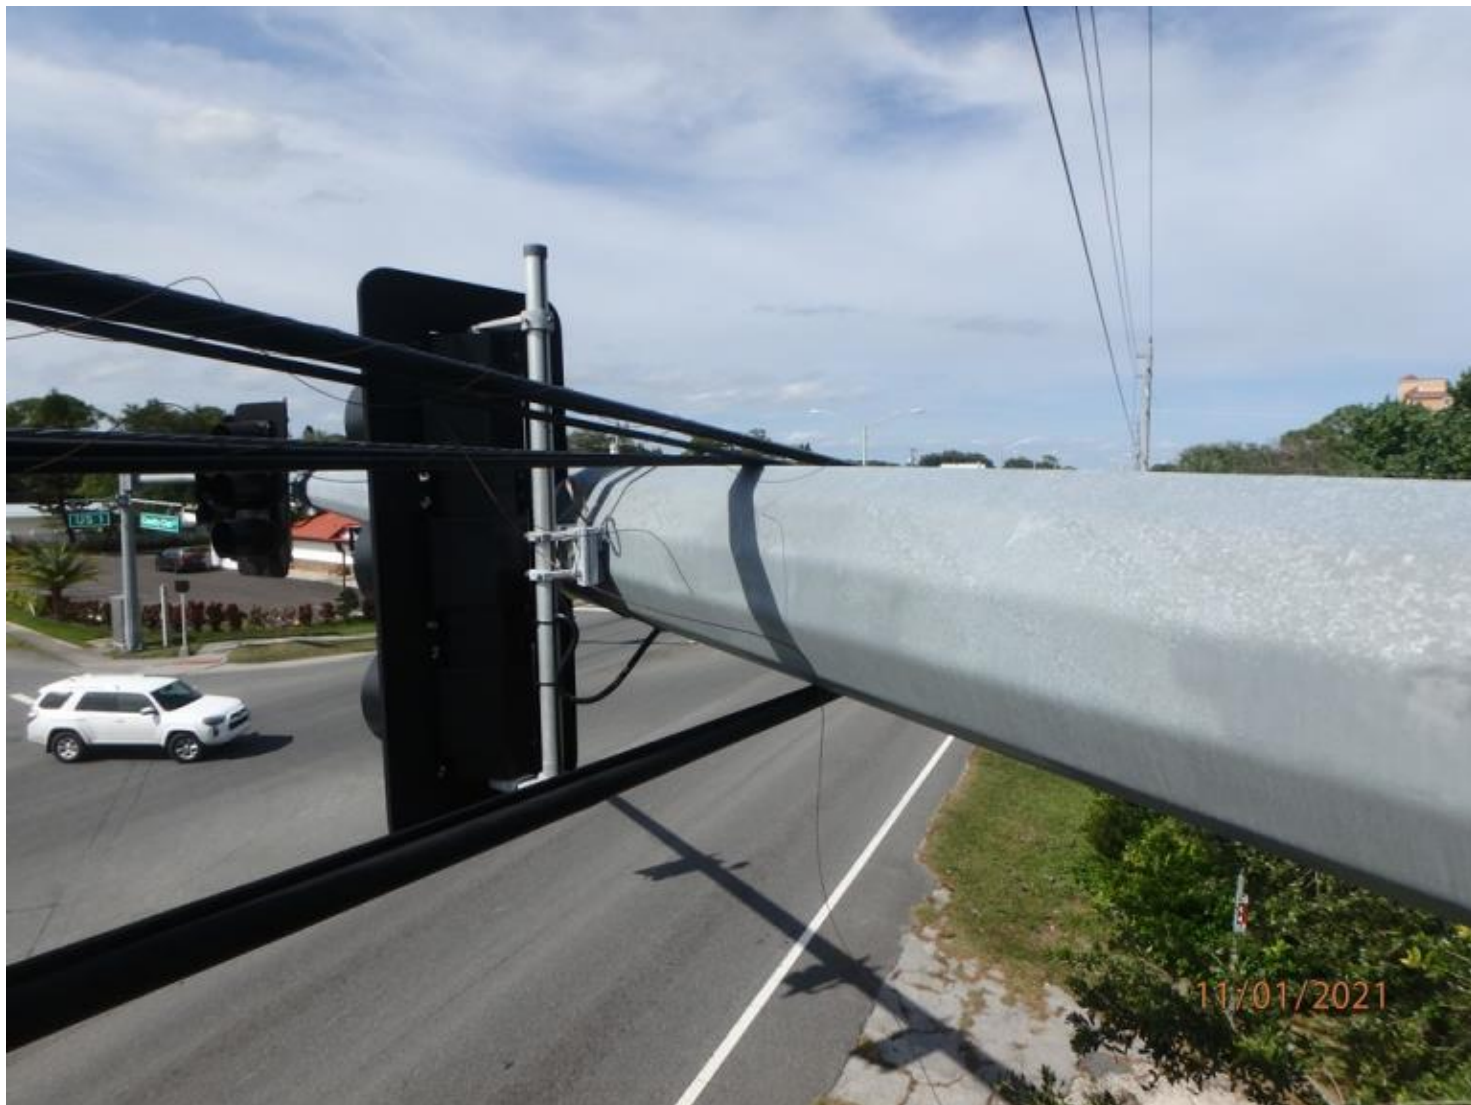
**Photo 2**

V1/H1 - Utility cables are rubbing on the top and bottom of the horizontal arm. Refer to Photo 2.

Element 8484 / Horizontal – Utility cables rubbing the top and bottom of the horizontal arm at V1/H1

V1/H1 - Sleeve or relocate the utility cables to eliminate contact with the horizontal arm. P=3

V1/H1 - Sleeve the utility lines to prevent damage. - Not completed.

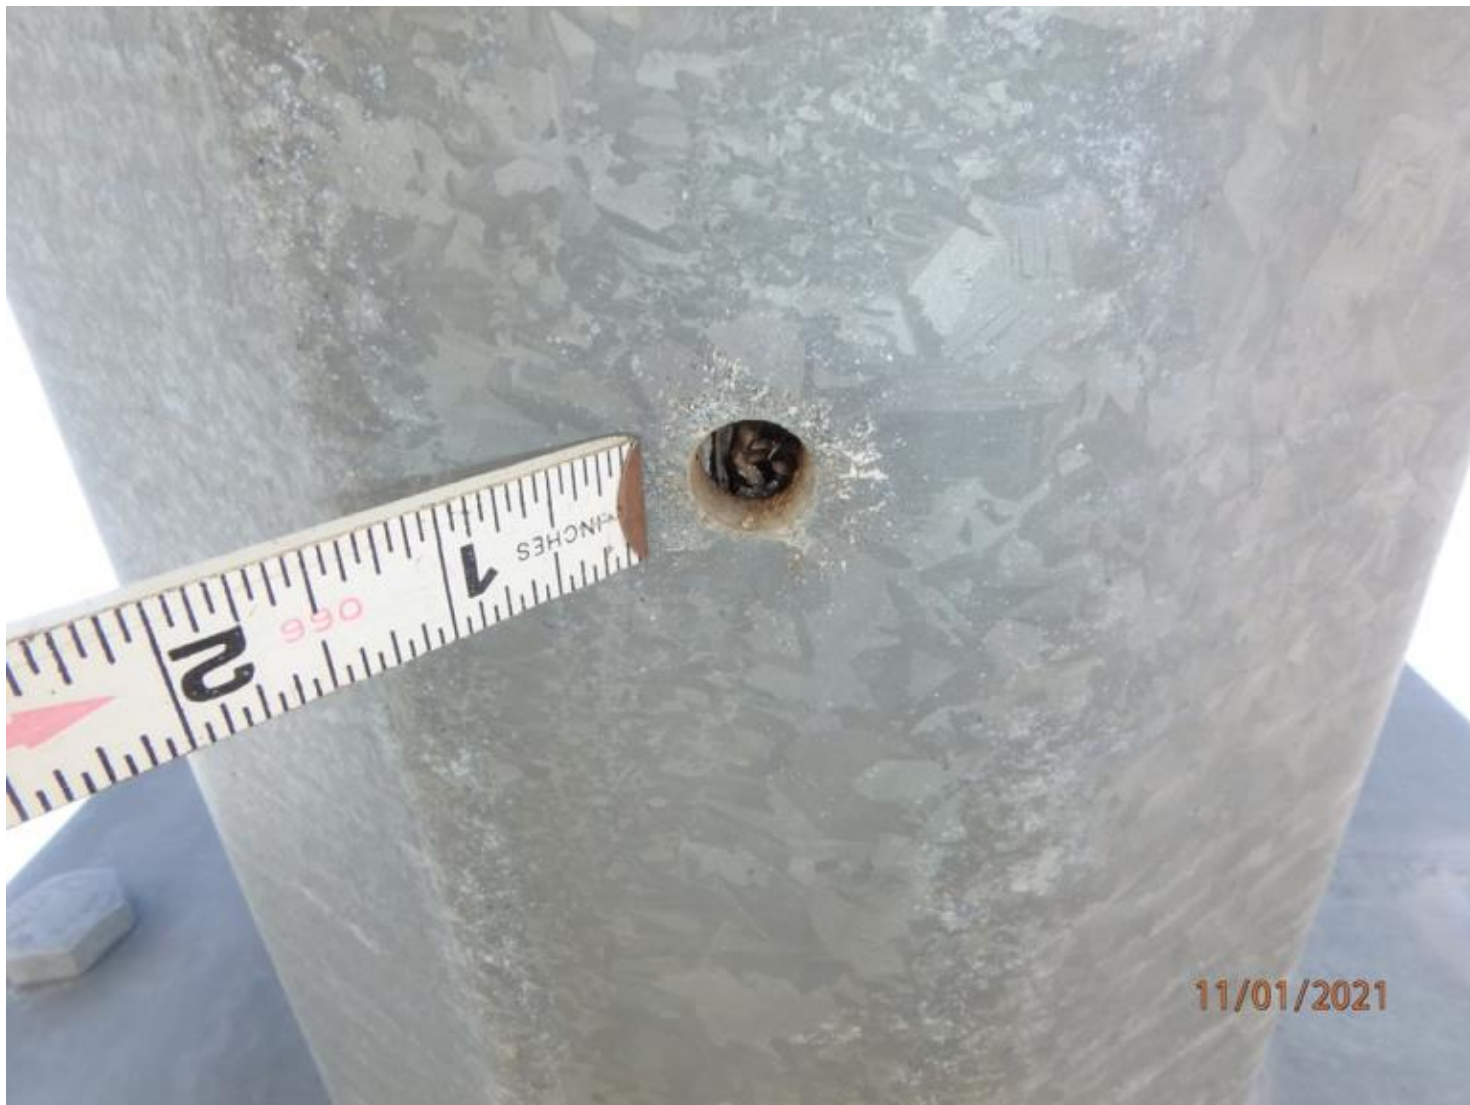
**Photo 3**

V2/H2 - A bird nest is present in the horizontal arm, visible through the drain hole near the moment connection. Refer to Photo 3.

Element 8484 / Horizontal – Bird nest inside the horizontal arm at V2/H2

V2/H2 - Remove the bird nest from the horizontal arm near the moment connection and install screening. P=3

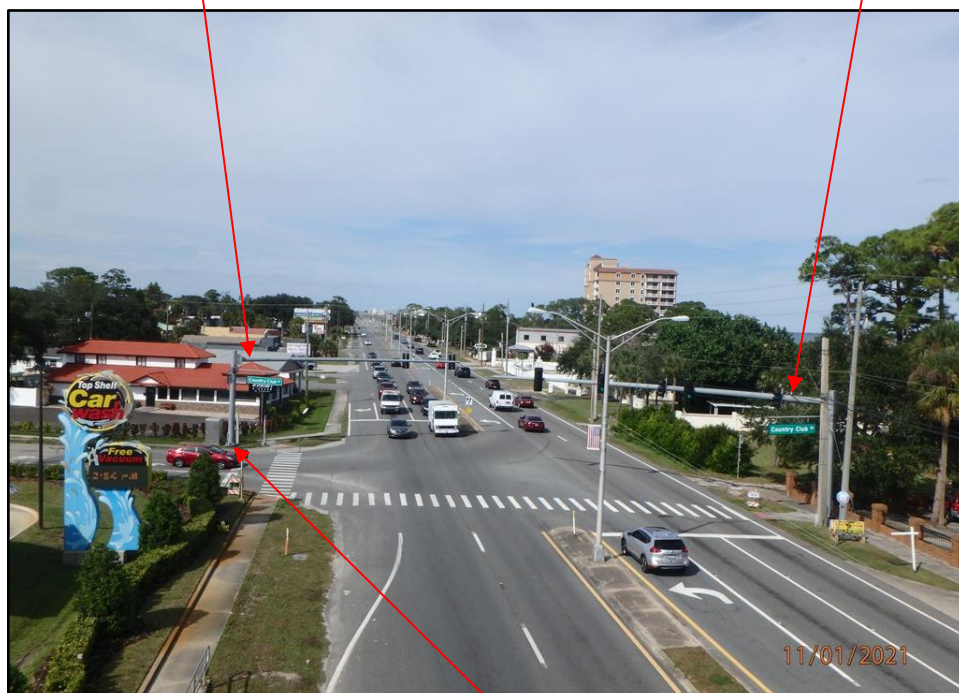
Deficiency Location Photo

V2/H2 –  
Bird nest inside horizontal arm

V1/H1 –  
Utility cables rubbing  
the horizontal arm

F2 –  
Foundation  
below grade
