**FLORIDA DEPARTMENT OF TRANSPORTATION**  
**BRIDGE MANAGEMENT SYSTEM**  
**Inspection/CIDR Report with PDF attachment(s)**  
(TRAFFIC SIGNAL MAST ARM INSPECTION REPORT)

Structure ID: 70M080

INSPECTION DATE: 3/18/2026 HHXN

| BY: | Ayres Associates | STRUCTURE NAME: | US-1 (Washington Ave.) at SR-50 (Cheney Highway) |

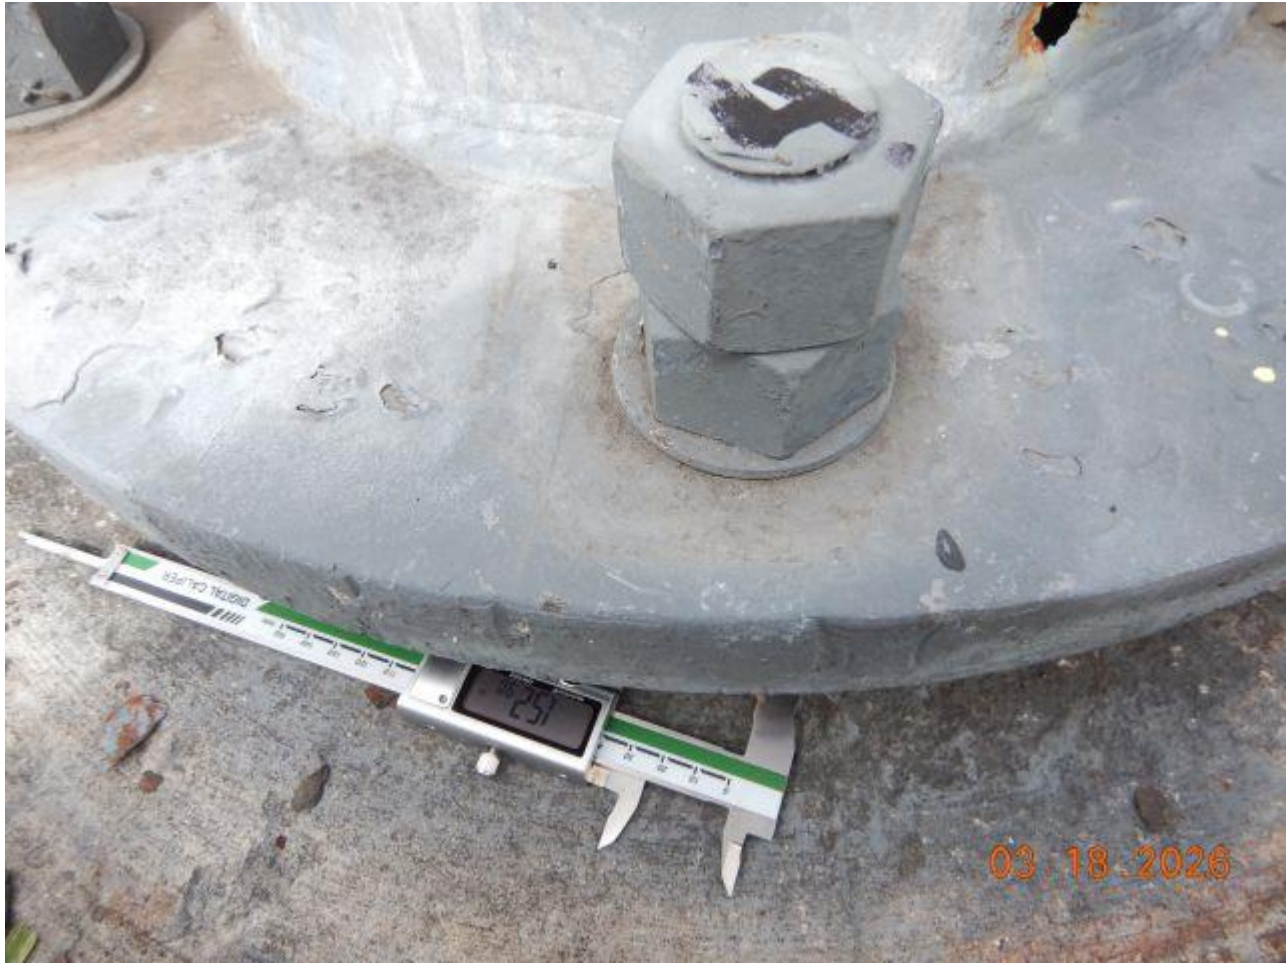
**Photo 1: Element 8480 / Mast Arm Foundation**

F1 - The anchor bolt leveling nuts below the base plate have heavy corrosion with up to 29% section loss (previously noted as 25%). Original average nut outside diameter = 2.13 in. & minimum remaining nut diameter at Anchor Bolt #4 is 1.52 in. (previously noted as 1.60 in. at AB #1). INCREASE. Refer to Photos 1 and 2. REPAIR. (1 EA)

F1 - Overview of anchor bolt #4 leveling nut below base plate remaining nut cross section measurement with caliber.

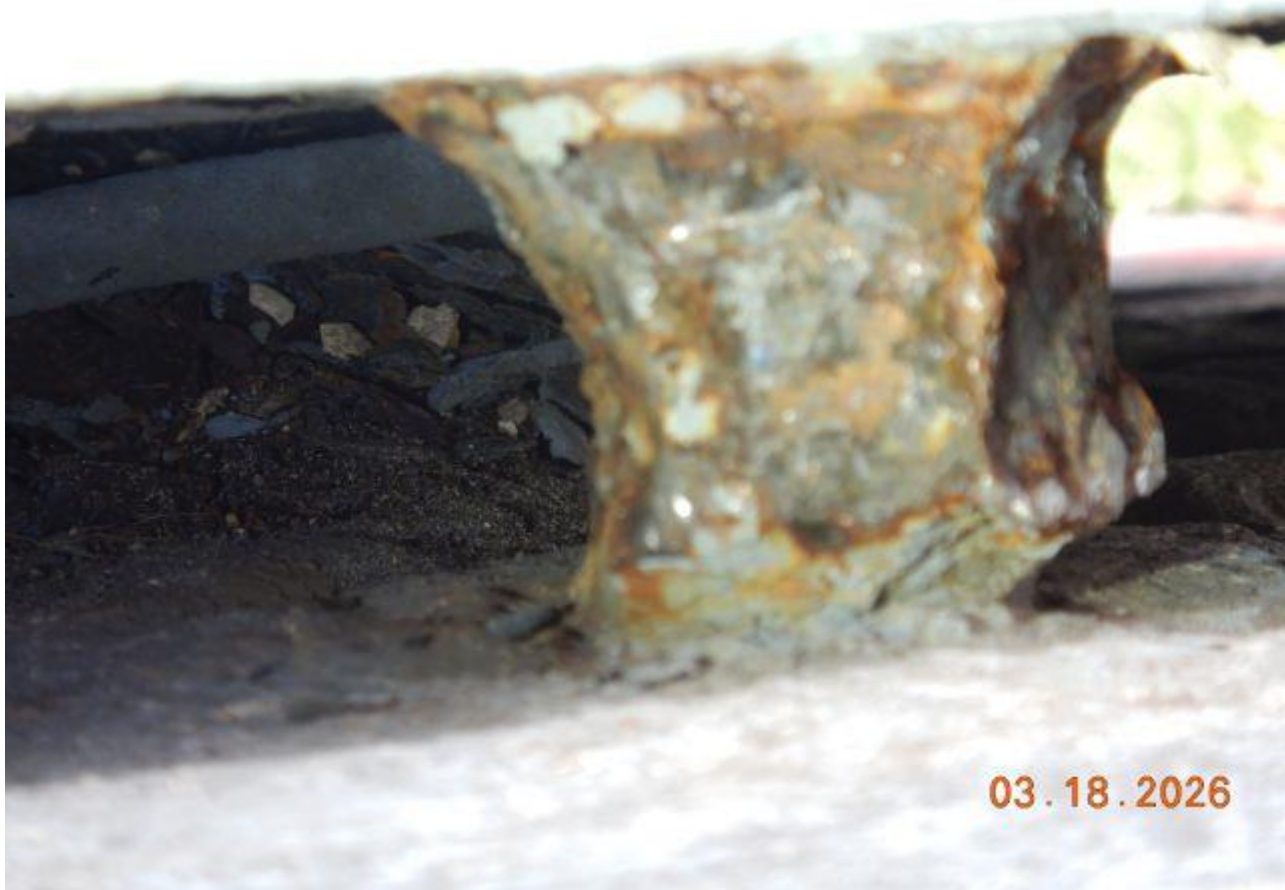
**Photo 2: Element 8480 / Mast Arm Foundation**

F1 - Close-up of typical anchor bolt leveling nut below base plate with corrosion & section loss (AB #4 shown).

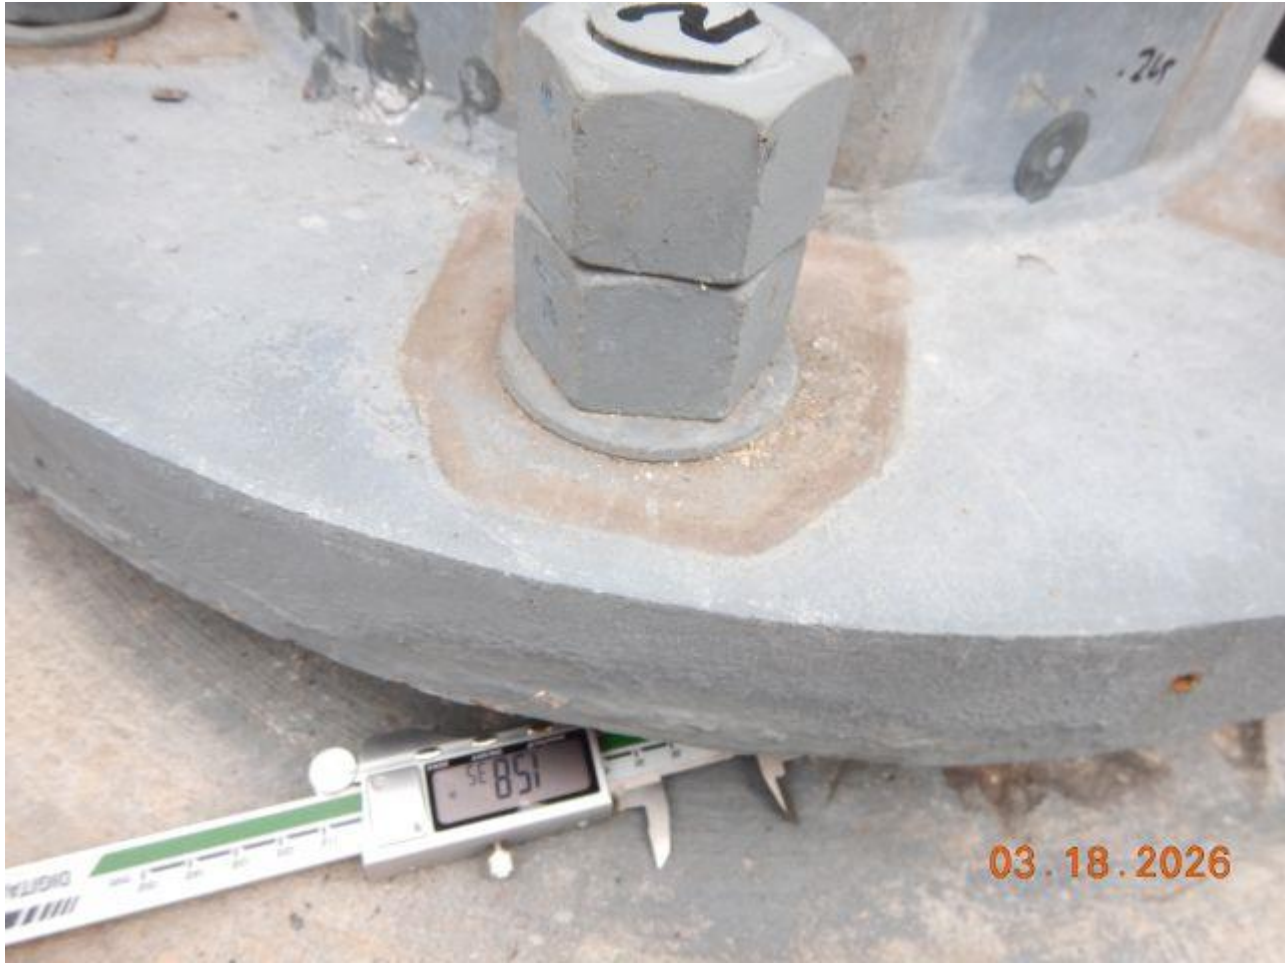
**Photo 3: Element 8480 / Mast Arm Foundation**

F2 - The anchor bolt leveling nuts below the base plate have heavy corrosion with up to 26% section loss (previously noted as 22%). Original average nut outside diameter = 2.13 in. & minimum remaining nut diameter at Anchor Bolt #2 is 1.58 in. (previously noted as 1.67 in.). INCREASE. Refer to Photos 3 and 4. REPAIR. (1 EA)

F2 - Overview of anchor bolt #2 leveling nut below base plate remaining nut cross section measurement with caliber.

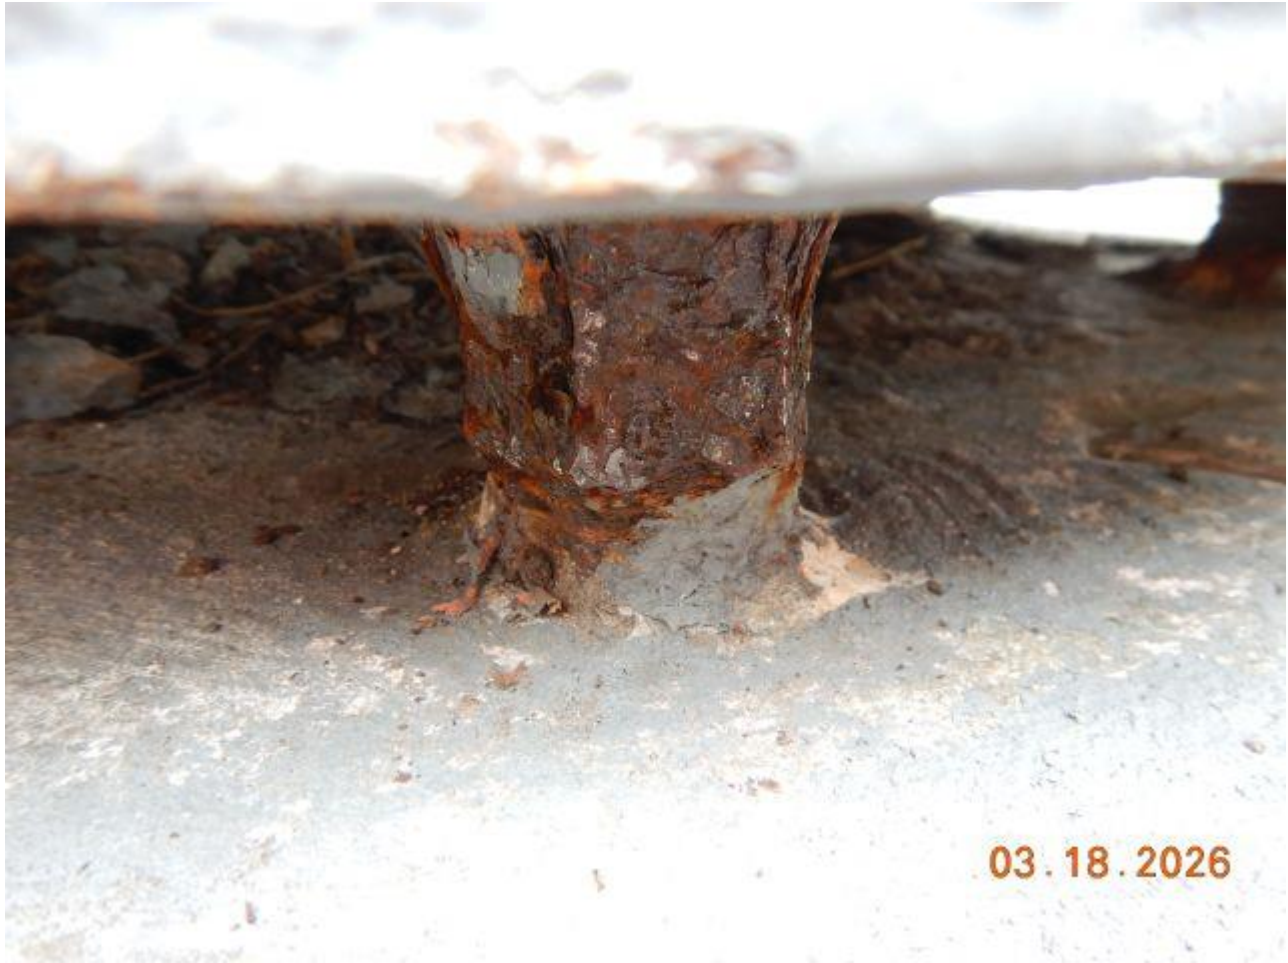
**Photo 4: Element 8480 / Mast Arm Foundation**

F2 - Close-up of typical anchor bolt leveling nut below base plate with corrosion & section loss (AB #2 shown).

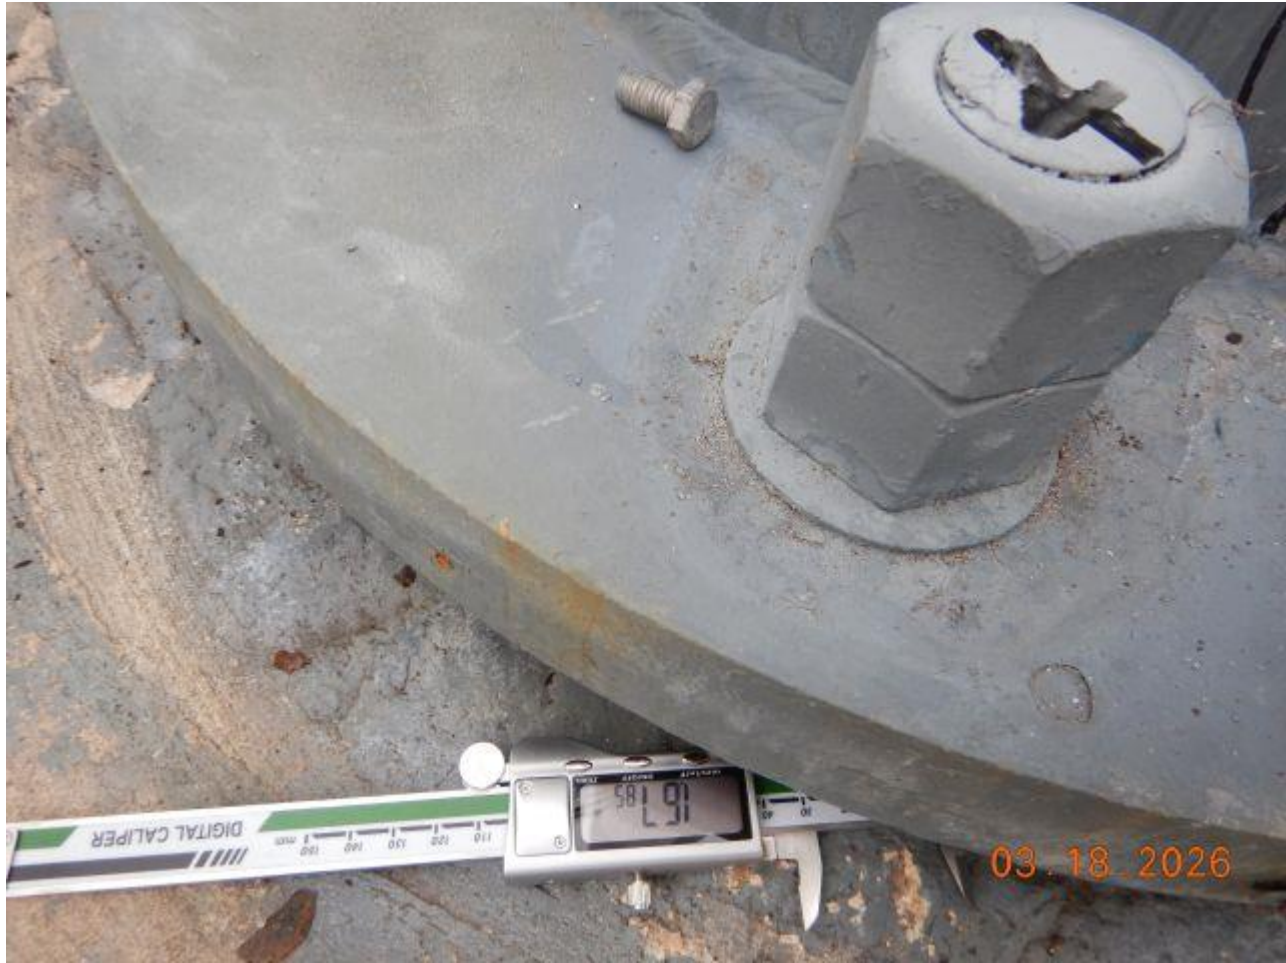
**Photo 5: Element 8480 / Mast Arm Foundation**

F3 - The anchor bolt leveling nuts below the base plate have heavy corrosion with up to 22% section loss. Original average nut outside diameter = 2.13 in. & minimum remaining nut diameter at Anchor Bolt #4 is 1.67 in. NO CHANGE. Refer to Photos 5 and 6. REPAIR. (1 EA)

F3 - Overview of anchor bolt #4 leveling nut below base plate remaining nut cross section measurement with caliper.

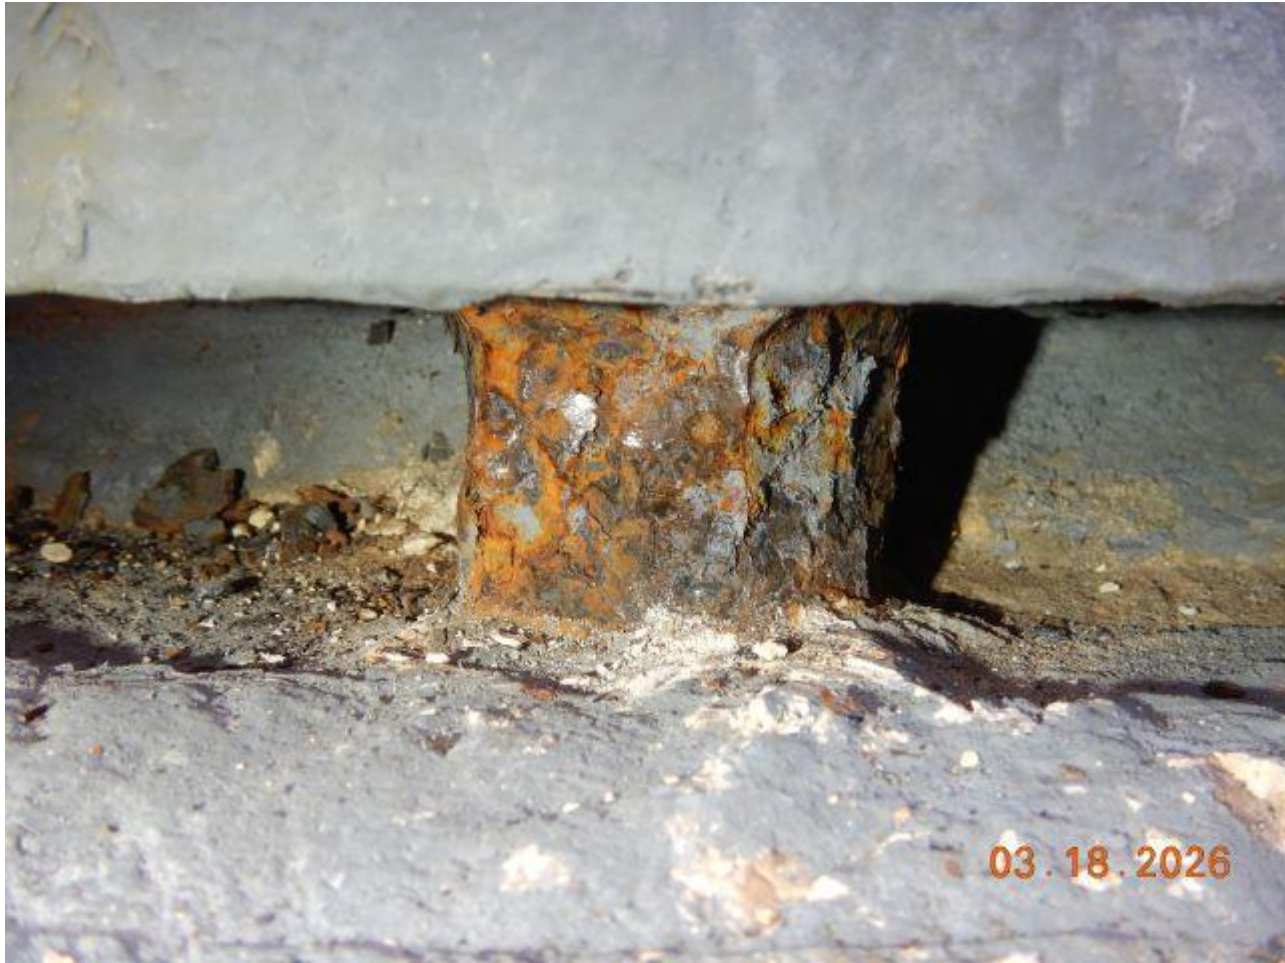
**Photo 6: Element 8480 / Mast Arm Foundation**

F3 - Close-up of typical anchor bolt leveling nut below base plate with corrosion & section loss (AB #4 shown).

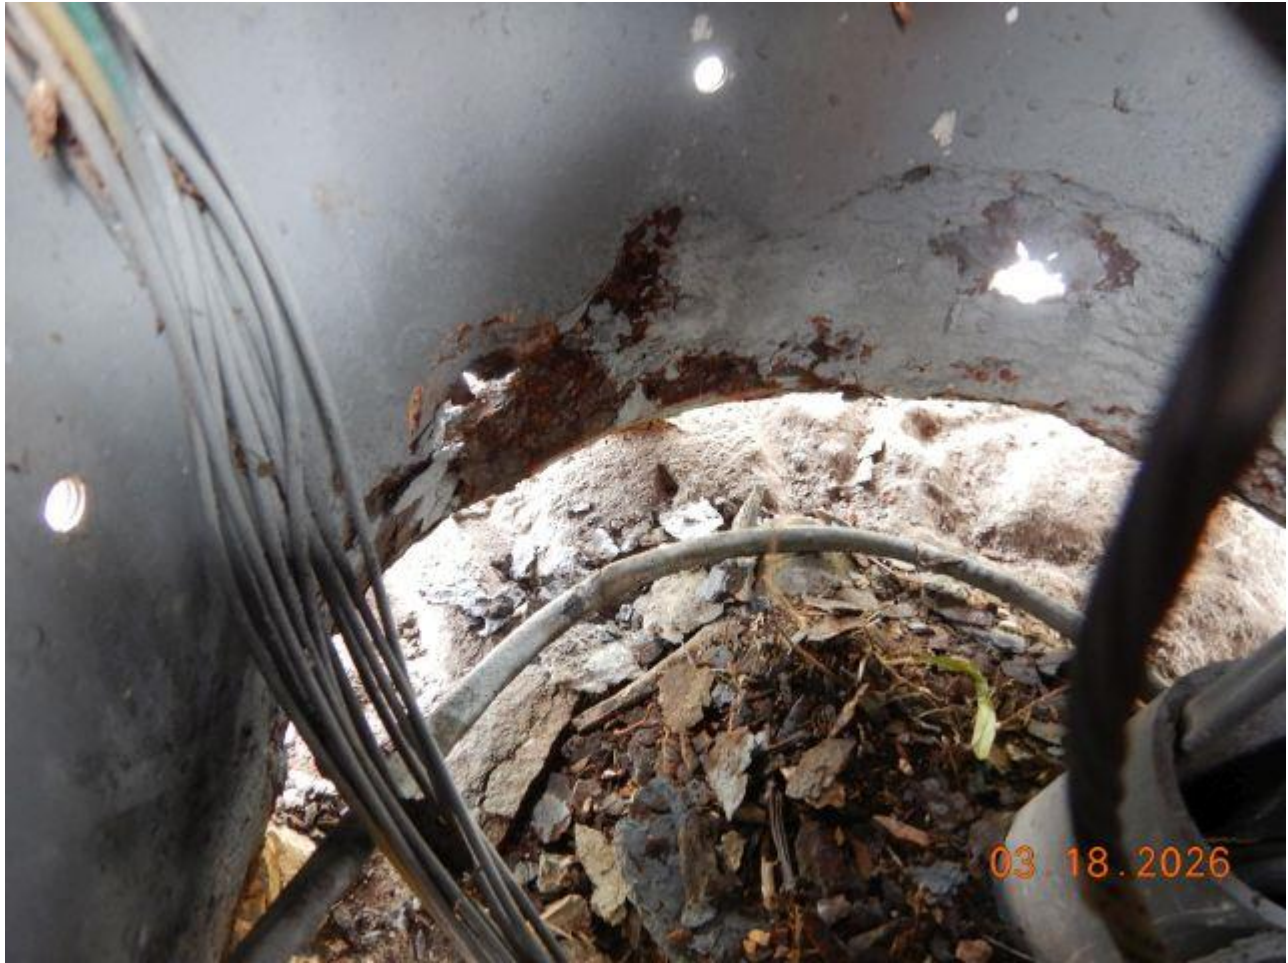
**Photo 7: Element 8481 / Mast Arm Vertical**

V1 - The interior of the pole has heavy to severe corrosion extending up +/- 5 in. high from the base plate and extending up to 22 in. wide around the column interior from Anchor Bolt #2 to Anchor Bolt #5 with up to 62% section loss. Original thickness = 0.265. & minimum remaining thickness = 0.100 in. (previously noted as 0.104 in.) behind Anchor Bolts #3 and #4.

Additionally, there are (2) holes on the east quadrant with 100% section loss 1 1/4 in. long x 1/2 in. high (previously 1 in. L) between Anchor Bolts #2 and #3 and 1 1/4 in. diameter (previously noted as 1 in.) between Anchor Bolts #3 & #4, both just above the base plate. INCREASE. Refer to Photos 7 thru 9. REPAIR. (1 EA)

V1 - Column interior view of corrosion and section loss holes.

V1 V2 and V3 - Replace all TSMAs within 3 months. The structures have not been replaced since the 12/2025 Interim Inspection.

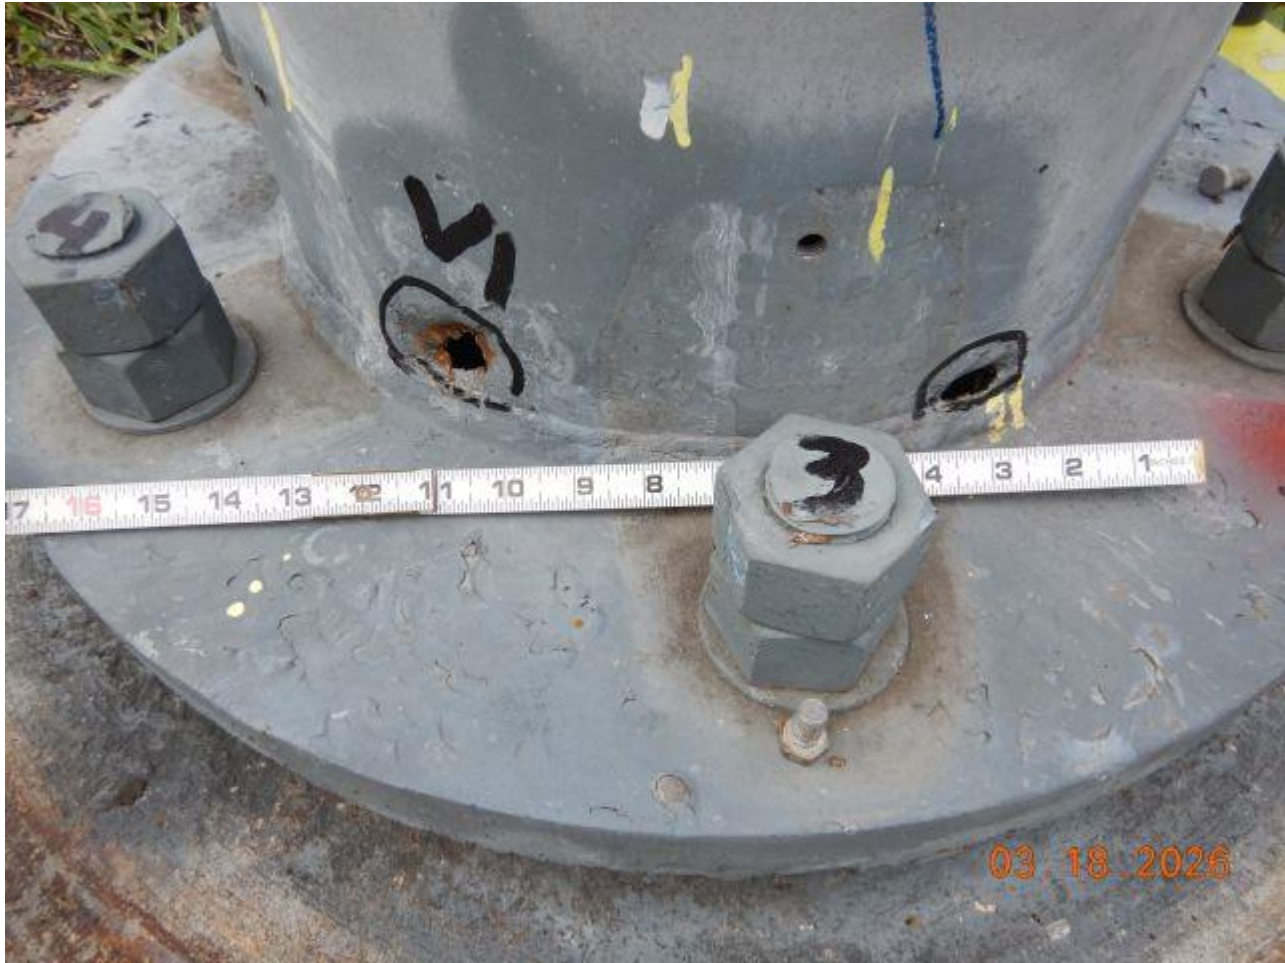
**Photo 8: Element 8481 / Mast Arm Vertical**

V1 - Column exterior view of corrosion and section loss holes.

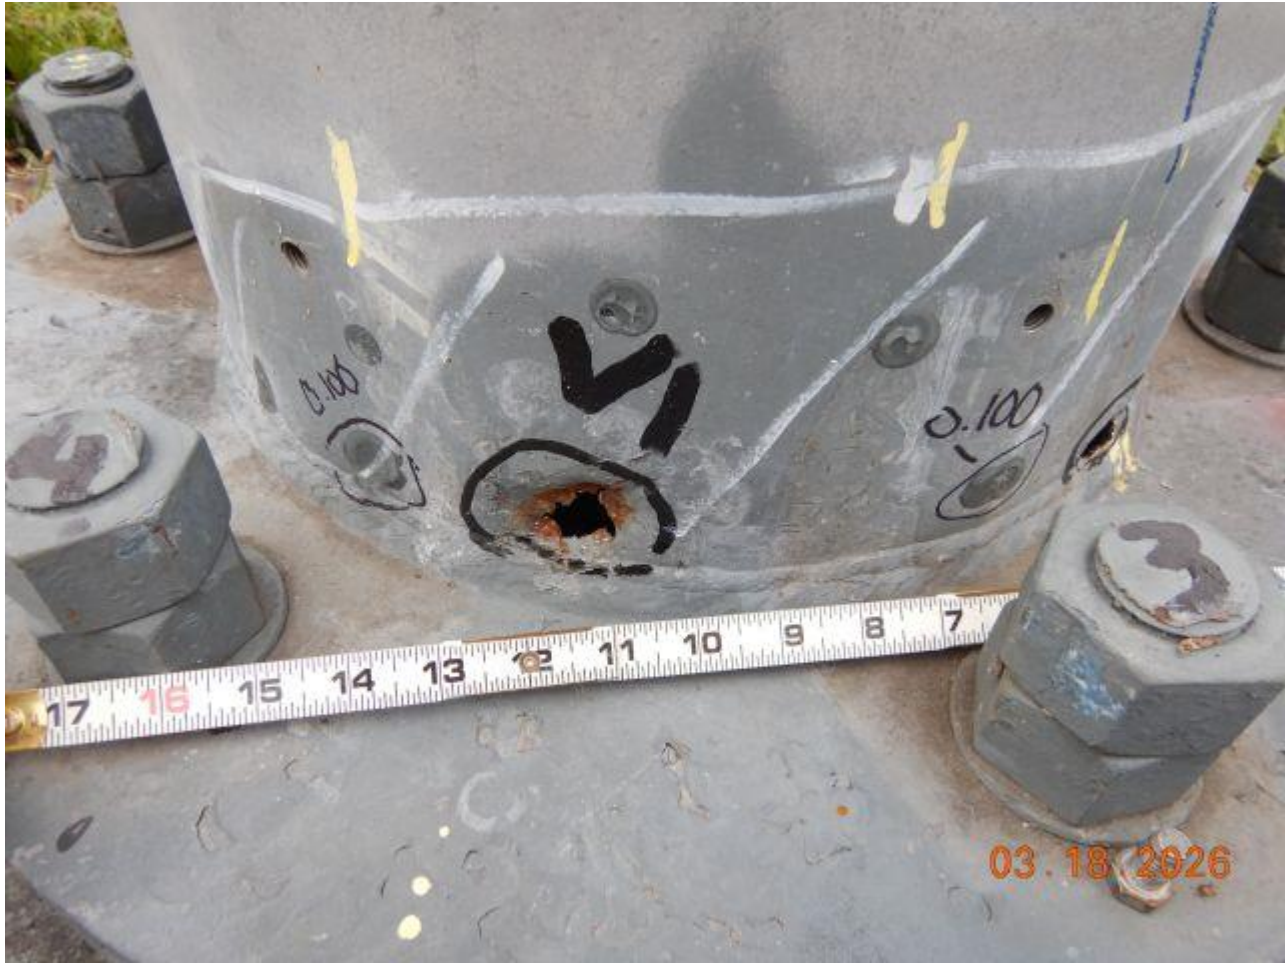
**Photo 9: Element 8481 / Mast Arm Vertical**

V1 - Column exterior view of section loss holes with D-meter remaining thickness readings behind anchor bolts #3 & 4.

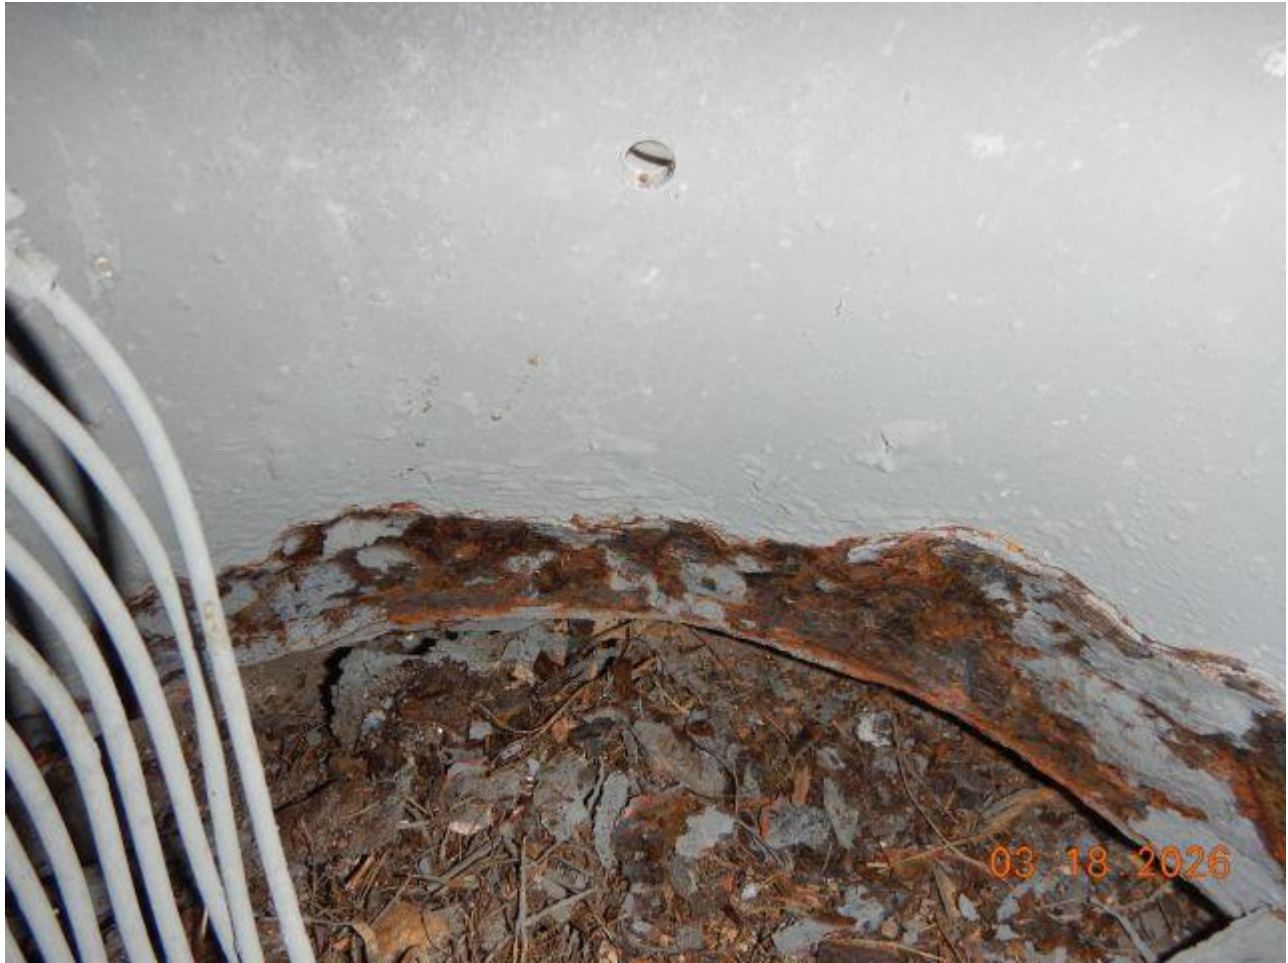
**Photo 10: Element 8481 / Mast Arm Vertical**

V2 - The interior of the pole has moderate to heavy laminating corrosion extending up +/- 3 in. from the base plate and extending around the entirety of the pole interior with up to 60% section loss. Original thickness = 0.265 in. and minimum remaining thickness = 0.105 in. between Anchor Bolts #4 and #5 taken just above the base plate. The bottom 2 in. of the vertical within the base plate has 100% section loss between Anchor Bolts #2 and #3 and the remaining has heavy corrosion and section loss along the bottom column to base plate weld. INCREASE. Refer to Photos 10 thru 13. REPAIR. (1 EA)

V2 - Column interior view of corrosion and section loss.

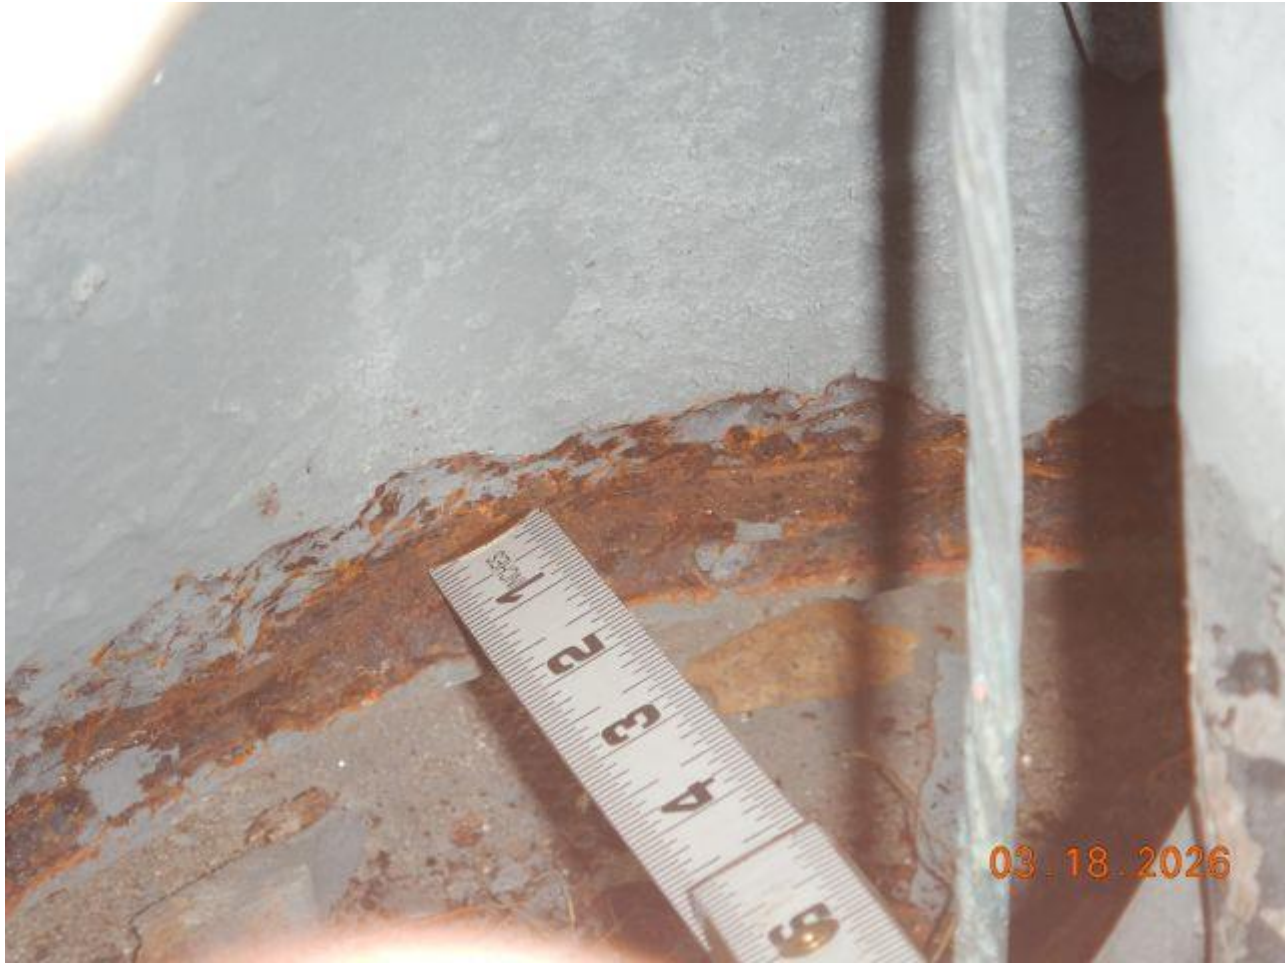
**Photo 11: Element 8481 / Mast Arm Vertical**

V2 - Column interior view of corrosion with up to 100% section loss in bottom 2 in. between anchor bolts #3 & 4.

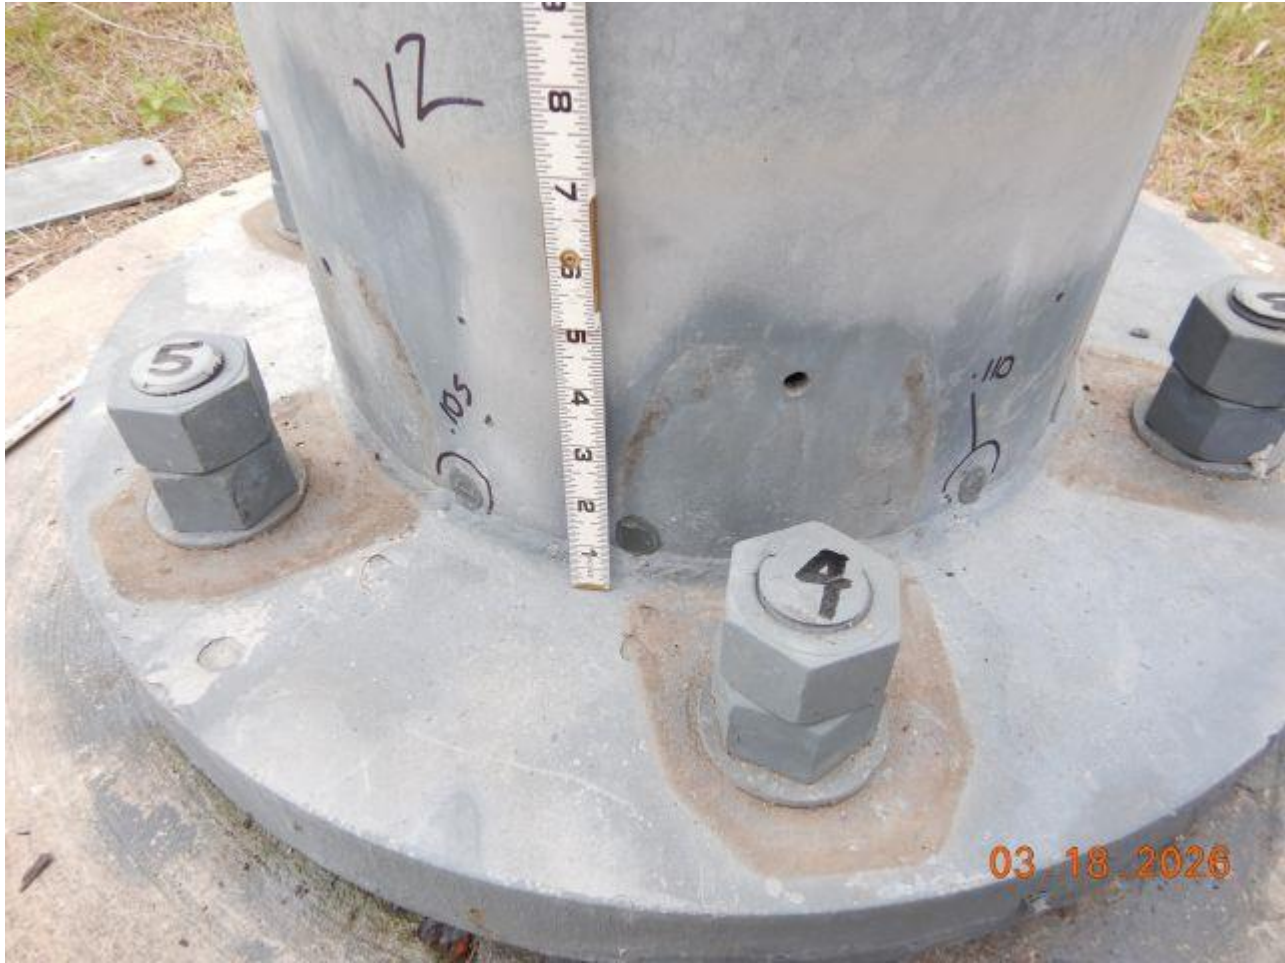
**Photo 12: Element 8481 / Mast Arm Vertical**

V2 - Column exterior view of section loss D-meter remaining thickness readings between anchor bolts #3 thru 5.

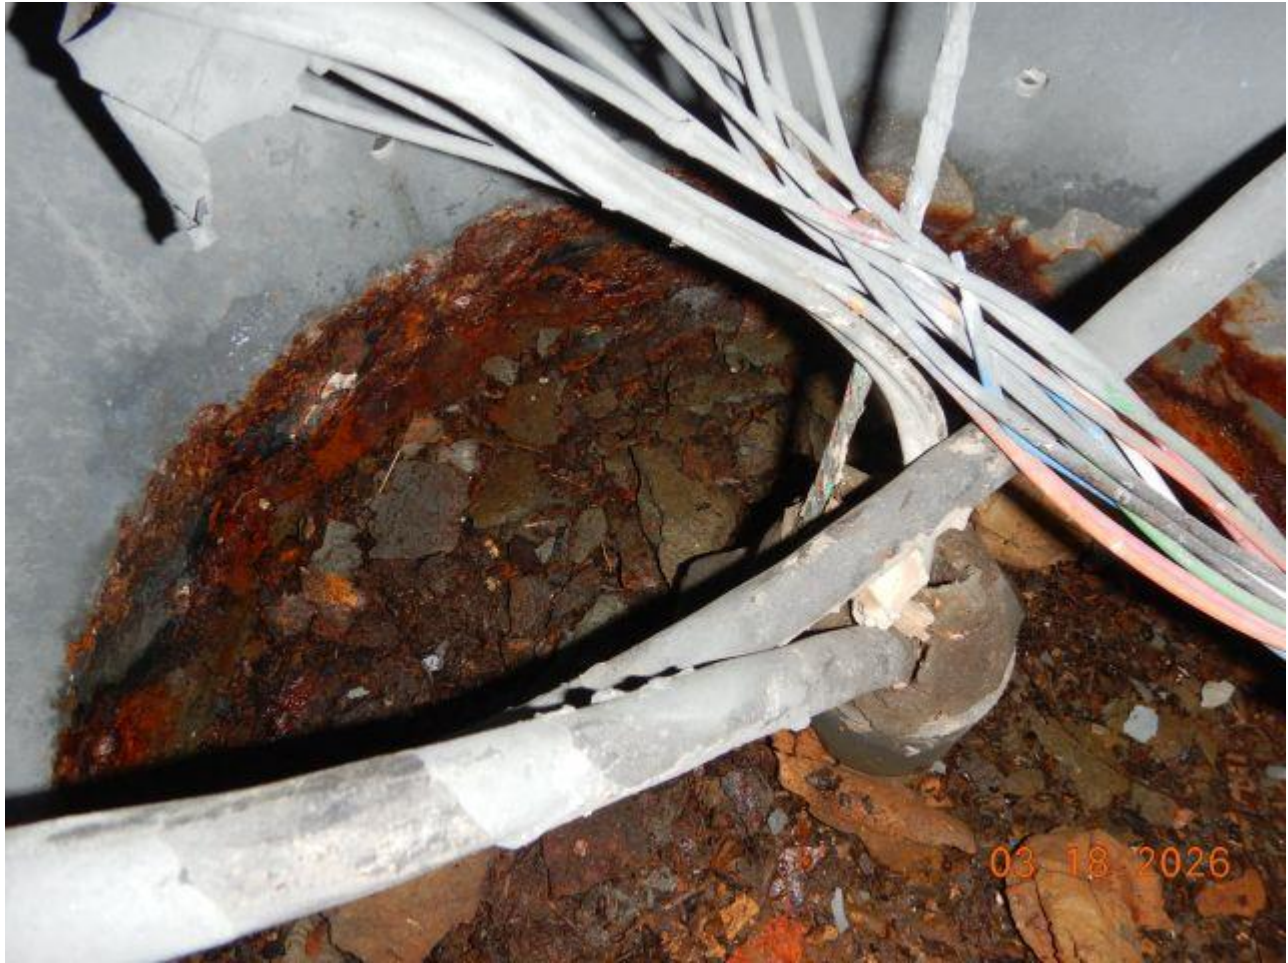
**Photo 13: Element 8481 / Mast Arm Vertical**

V3 - The interior of the pole has heavy to severe corrosion extending up +/- 4 in. from the base plate and extending around the entirety of the pole with up to 63% section loss. Original thickness = 0.265 in. & minimum remaining thickness = 0.098 in. behind Anchor Bolt #4.

Additionally, there are (4) areas of 100% section loss between Anchor Bolts #2 and #4 (starting from Anchor Bolt #2). The sizes of the holes have increased with the overall area measuring 12 in. L x 1 in. H and should be treated as having 100% section loss. Hole sizes are as follows: INCREASE. Refer to Photos 13 and 14. REPAIR. (1 EA)

V3 - Column interior view of corrosion and section loss holes.

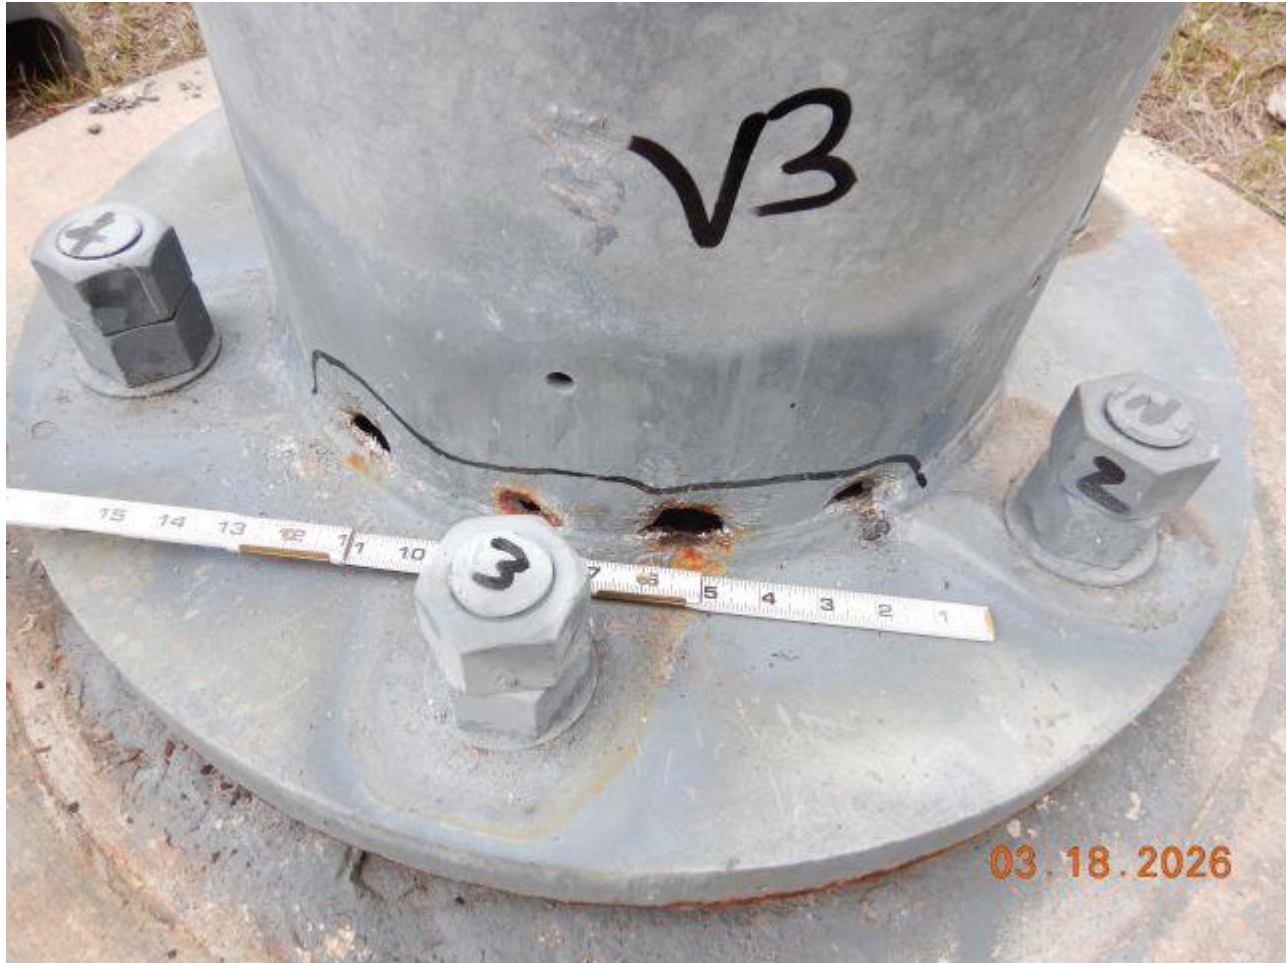
**Photo 14: Element 8481 / Mast Arm Vertical**

- 1 in. L x 1/2 in. H (previously noted as 1/4 in. dia.)
- 1 3/4 in. L x 3/4 in. H (previously noted as 1 1/4 in. L x 1/2 in. H)
- 3/4 in. L x 1/2 in. H (previously noted as 1/2 in. L x 3/16 in. H)
- 1 1/4 in. L x 1/2 in. H (previously noted as 1 in. L)

V3 - Column exterior view of (4) section loss holes between anchor bolts #2 thru 4.

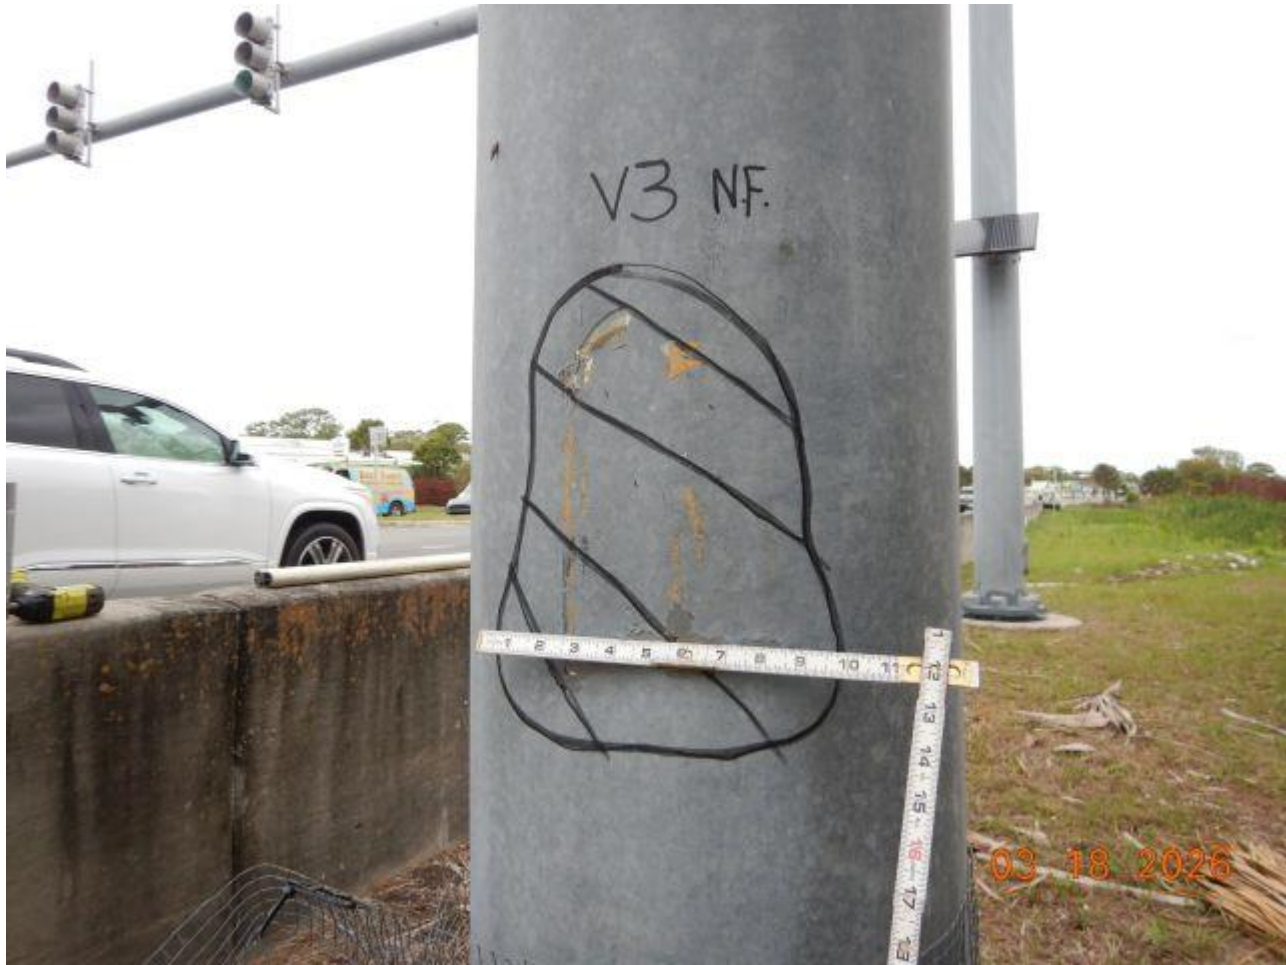
**Photo 15: Element 8481 / Mast Arm Vertical**

V3 - Impact related dent on south quadrant 28 in. above the base plate.

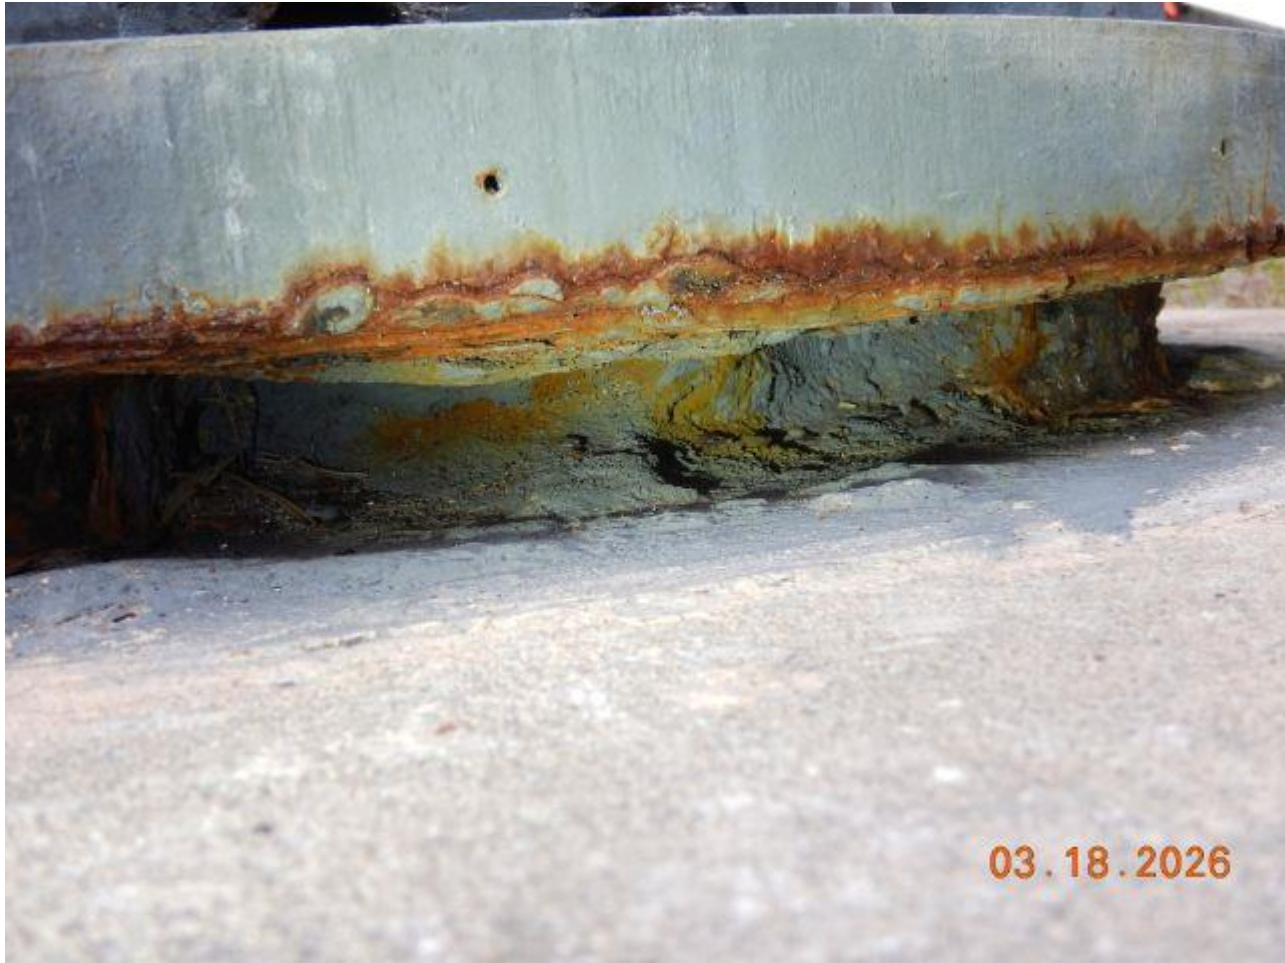
**Photo 16: Element 8481 / Mast Arm Vertical**

V1, V2 and V3 - The base plate underside and vertical face have areas of moderate to heavy laminating corrosion and pitting up to 1/8 in. at each location. NO CHANGE. Refer to Photo

F1, F2 & F3 - Typical base plate underside and vertical face corrosion and section loss.

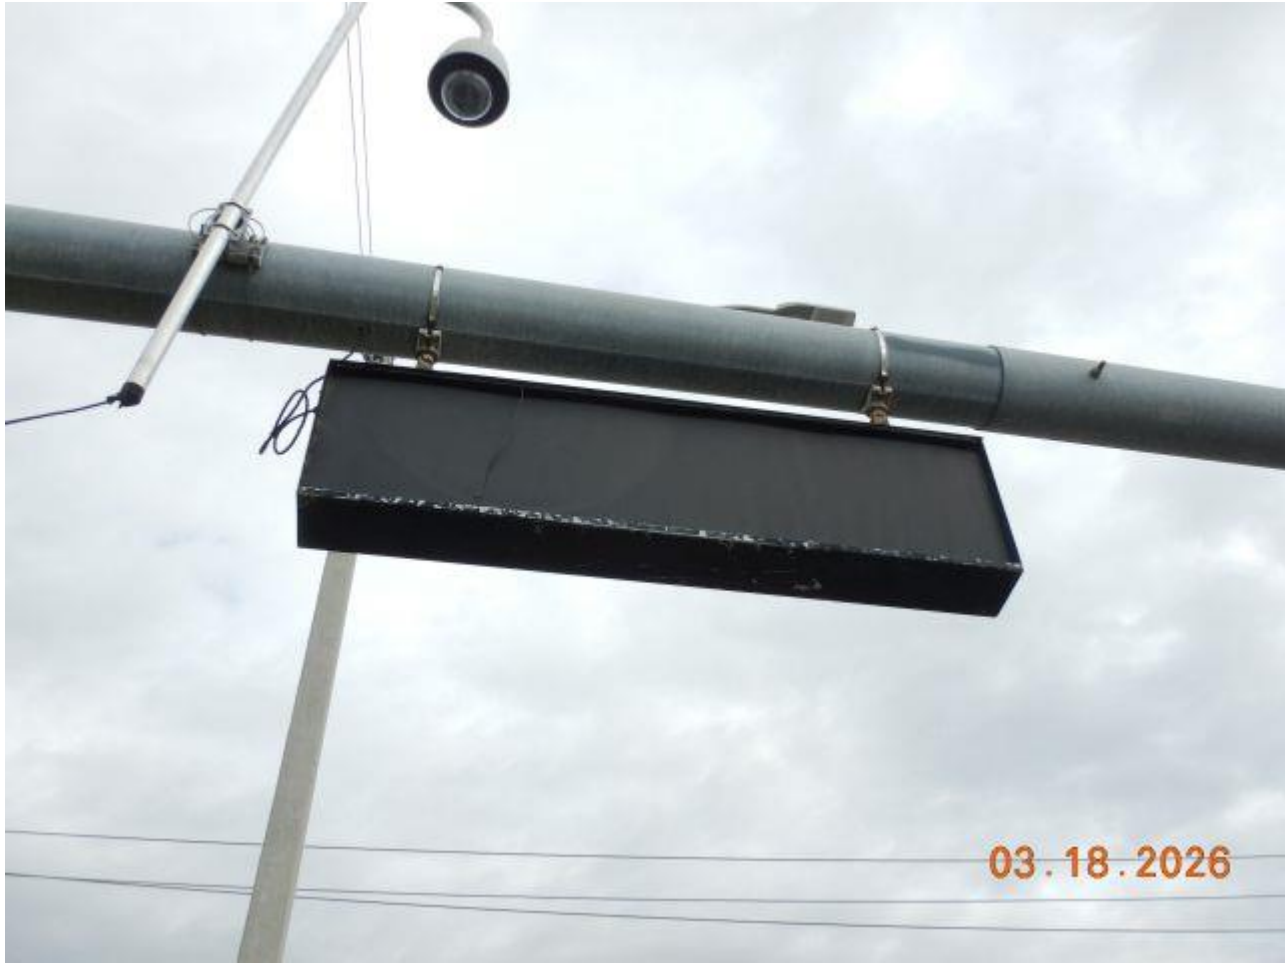
**Photo 18: Element 8484 / Mast Arm Horizontal**

V1/H1 - The street sign is missing the facing on the south side. - NO CHANGE. Refer to Photo 18.

V1/H1 Missing street sign facing on south side.

REPAIR RECOMMENDATION:  
None.
