**FLORIDA DEPARTMENT OF TRANSPORTATION**  
**BRIDGE MANAGEMENT SYSTEM**  
**Inspection/CIDR Report with PDF attachment(s)**  
(TRAFFIC SIGNAL MAST ARM INSPECTION REPORT)

Structure ID: 70M080

INSPECTION DATE: 3/18/2026 HHXN

| BY: | Ayres Associates | STRUCTURE NAME: | US-1 (Washington Ave.) at SR-50 (Cheney Highway) |

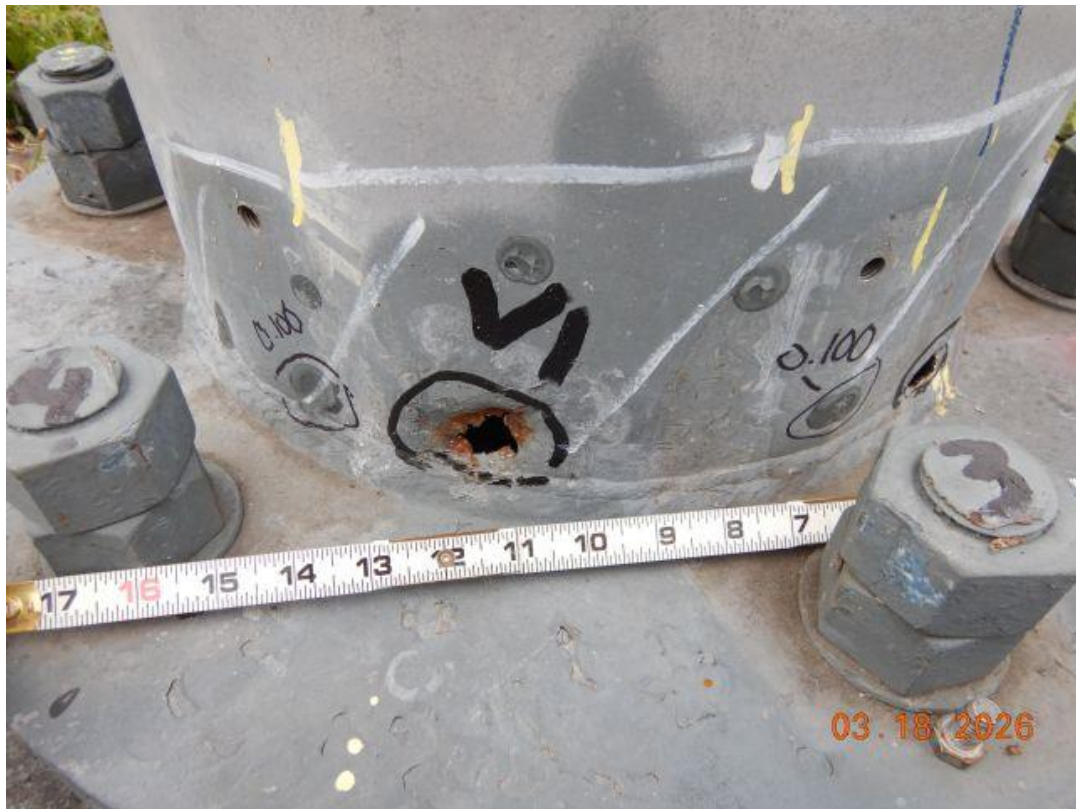
V1 - The interior of the pole has heavy to severe corrosion extending up approximately 5 in. from the base plate and extending up to 22 in. wide around the east quadrant of the vertical with up to 62% section loss. Original thickness = 0.265. & minimum remaining thickness = 0.100 in. at circumferential distance 20 in. starting from Anchor Bolt #1. Additionally, there is an area of 100% section loss with a 1¼ in. diameter (previously 1 in.) hole on the east quadrant of the pole just above the base plate and a hole 1¼ in. long x 1/2 in. high (previously 1 in. x ½ in.) between Anchor Bolts #2 and #3. - INCREASE. Refer to Photos 1 and 2.

Photo 1: V1– View of holes due to corrosion and thickness readings

**Recommendation:** Remove Verticals V1, V2 and V3 within 1 month of the date of this advisory. Install temporary traffic signals until a permanent replacement is designed and constructed.

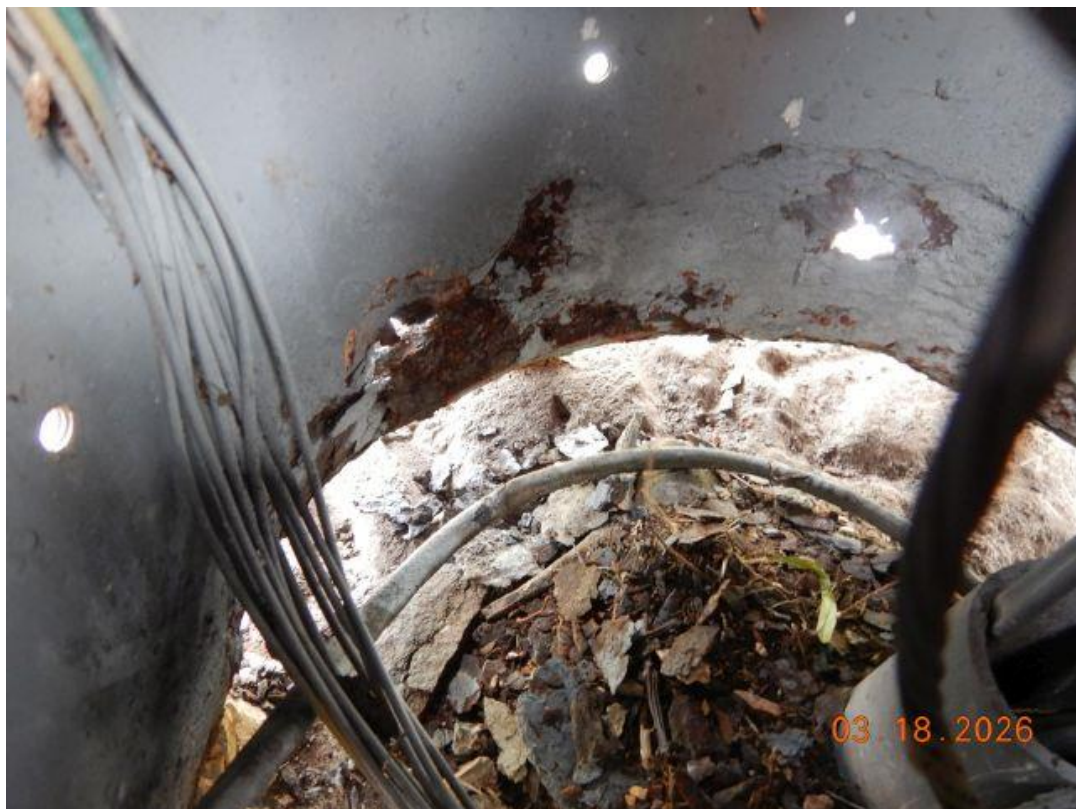
Photo 2: V1 – View of holes due to corrosion and corrosion at base plate of vertical interior

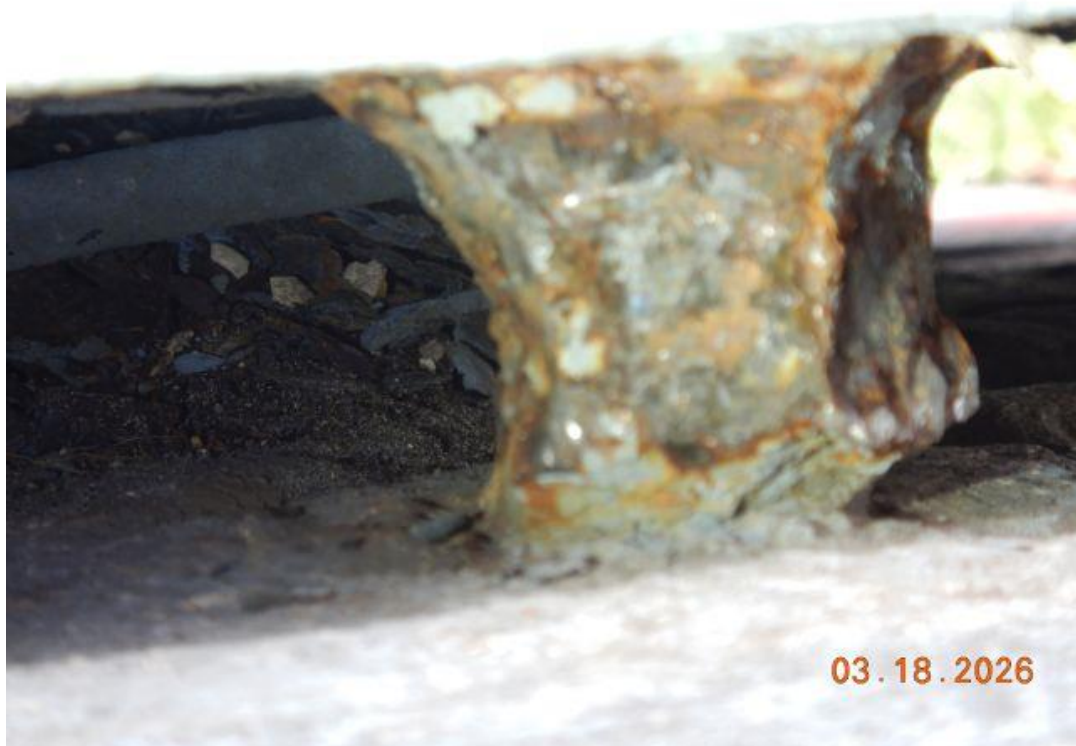
F1 - The anchor bolt leveling nuts have heavy corrosion with up to 29% section loss. Original nut outside diameter = 2.13 in. Minimum remaining nut diameter at Anchor Bolt #1 is 1.52 in. - INCREASE. Refer to Photo 3.

Photo 3: F1 – View of corrosion on anchor bolts and leveling nuts beneath base plate

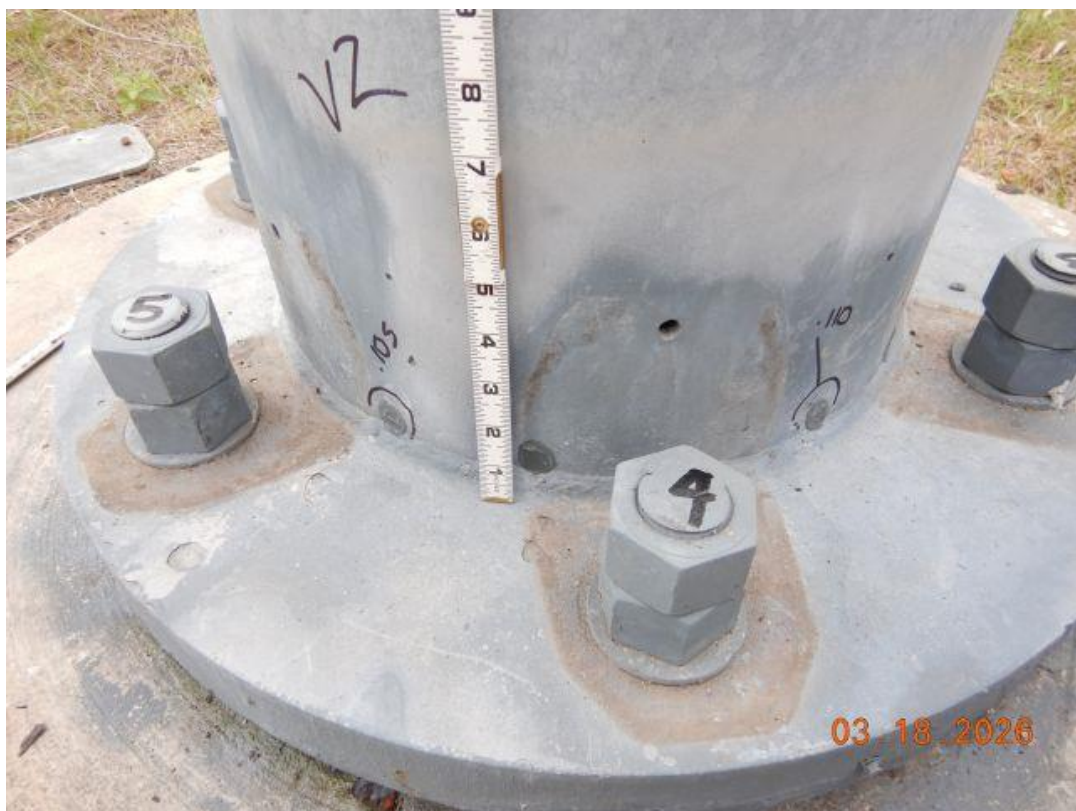
V2 - The interior of the pole has moderate to heavy laminating corrosion extending up approximately 3 in. from the base plate and extending around the entirety of the pole with up to 60% section loss. Original thickness = 0.265. & minimum remaining thickness = 0.105 in. between Anchor Bolts #4 and #5. The bottom 2 in. of the vertical within the baseplate has 100% section loss between Anchor Bolts 2 & 3 and the

Photo 4: V2 – View of exterior of vertical and thickness readings

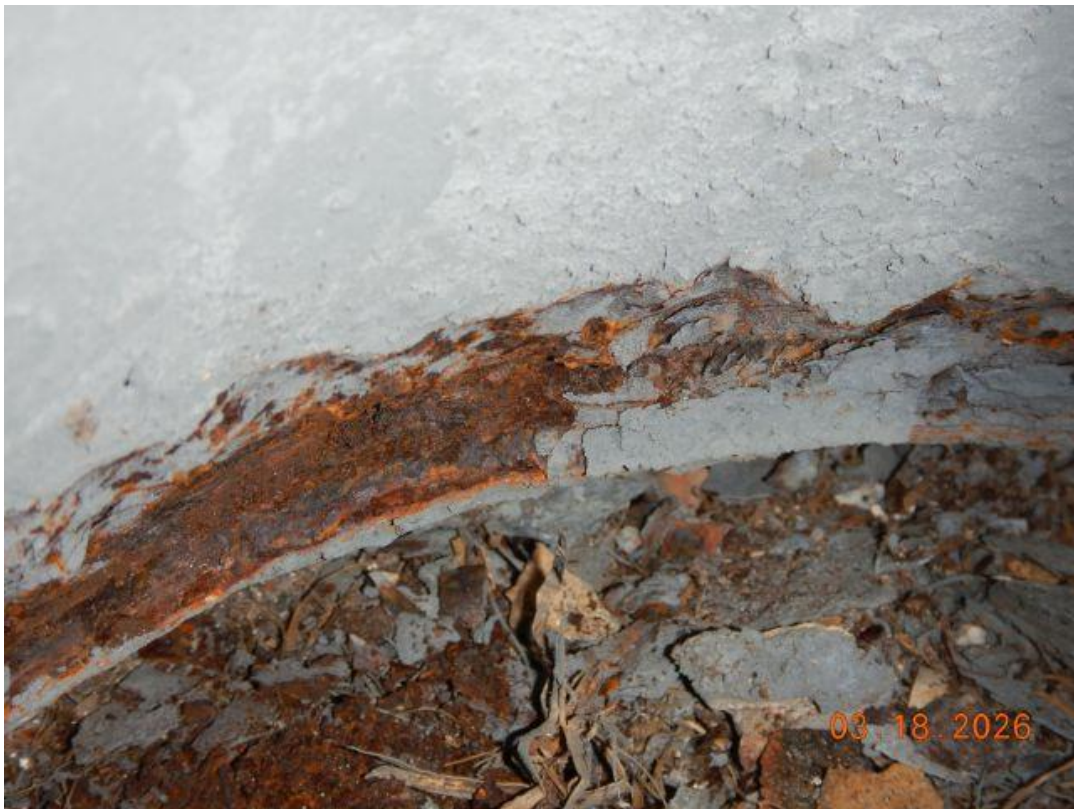
remaining has heavy corrosion and section loss along the bottom weld within the vertical. - INCREASE. Refer to Photos 4 thru 6.

Photo 5: V2 – View of corrosion and section loss at base plate of vertical interior

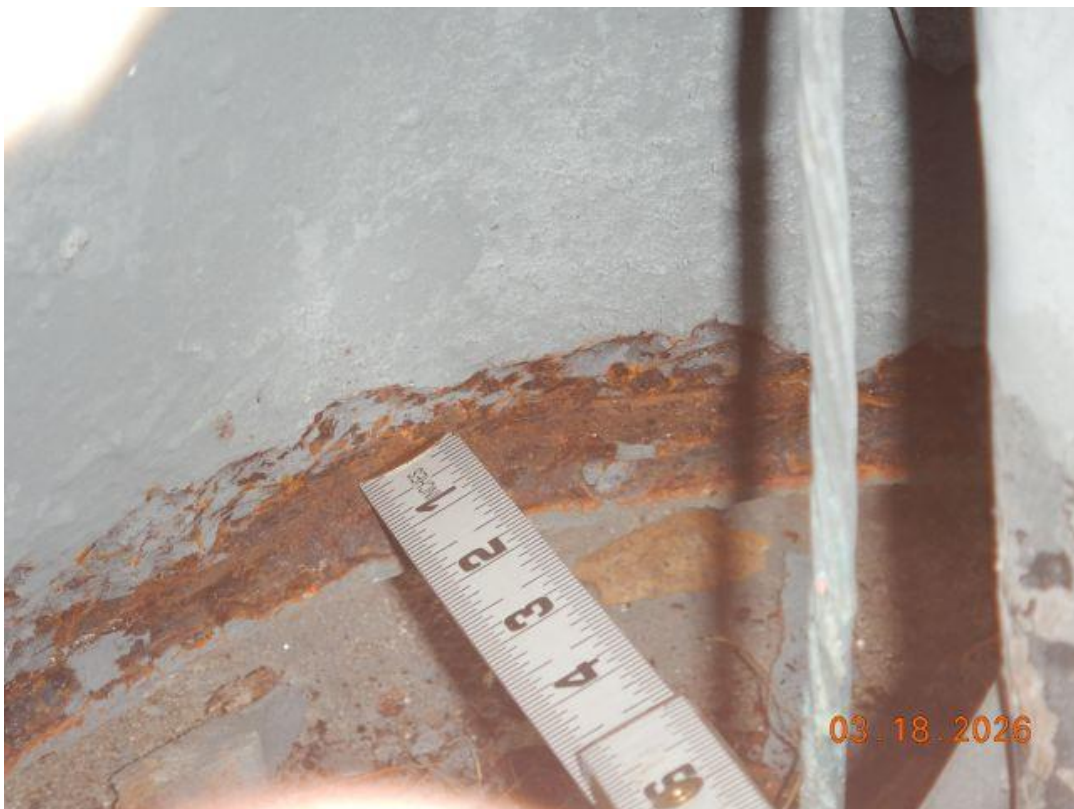
Photo 6: V2 – View of corrosion and section loss at base plate on vertical interior

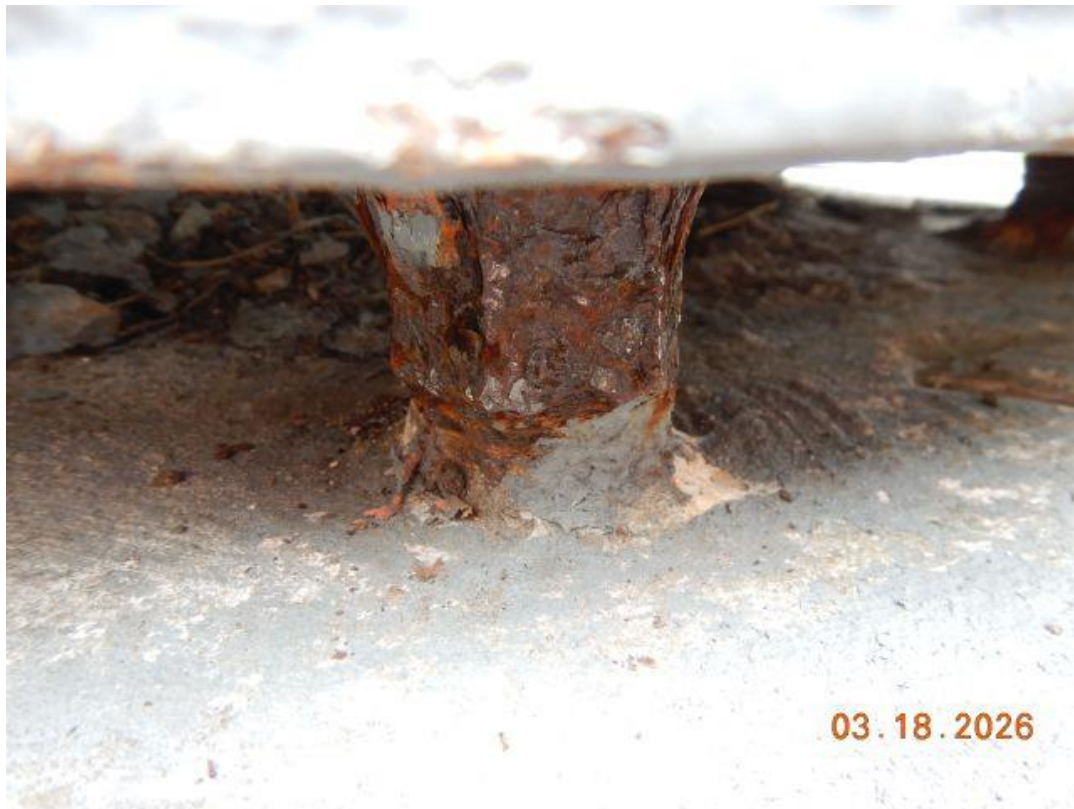
F2 - The anchor bolt leveling nuts have heavy corrosion with up to 26% section loss. Original nut outside diameter = 2.13 in. Minimum remaining nut diameter at Anchor Bolt 2 is 1.58 in. - INCREASE. Refer to Photo 7.

Photo 7: F2 – View of corrosion on anchor bolts and leveling nuts beneath base plate

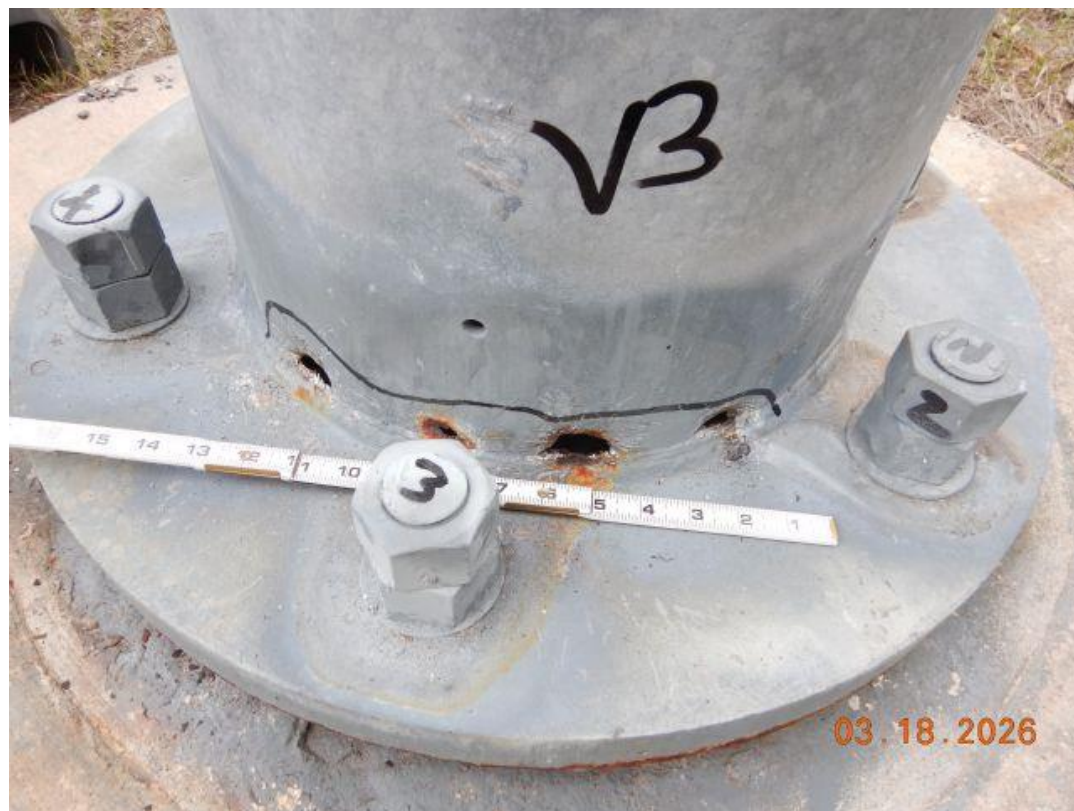
V3 - The interior of the pole has heavy to severe corrosion extending up approximately 4 in. from the base plate and extending around the entirety of the pole with up to 63% section loss. Original thickness = 0.265 in. & minimum remaining thickness = 0.098 in. at circumferential distance 16 in. starting from Anchor Bolt #1. Additionally, there are (4) areas of 100% section loss between Anchor Bolts #2 and #4 (starting from Anchor Bolt #2). The sizes of the holes have increased and an area 12 in. L x 1 in. H area should be treated as having 100% section loss. Holes sizes are as follows – 1 in. L x ½ in. H (previously ¼ in. diameter), 1¾ in. L x ¾ in. H (previously 1¼ in. L x ½ in. H), ¾ in. L x ½ in. H (previously ½ in. L x 3/16 in. H) and 1¼ in. L x ½ in. H (previously 1 in. L x ½ in. H). - INCREASE. Refer to Photos 8 thru 10.

Photo 8: V3 – View of holes due to corrosion on vertical exterior

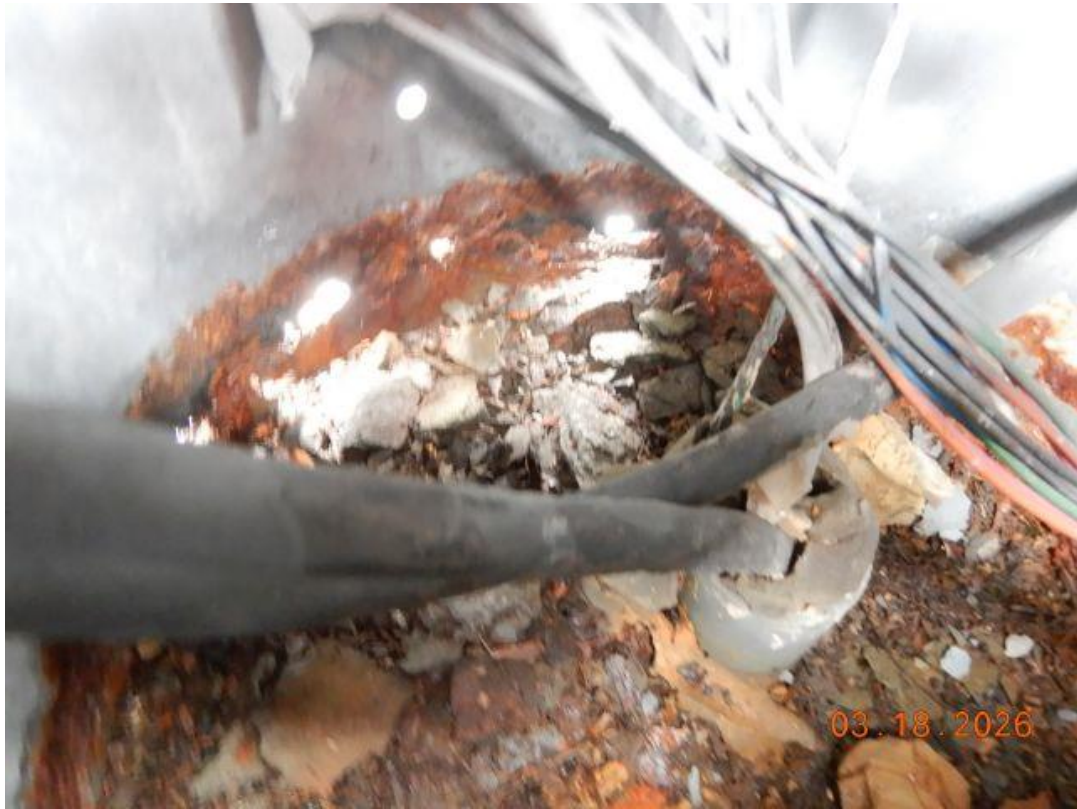
Photo 9: V3 – View of holes due to corrosion and corrosion at base plate of vertical interior

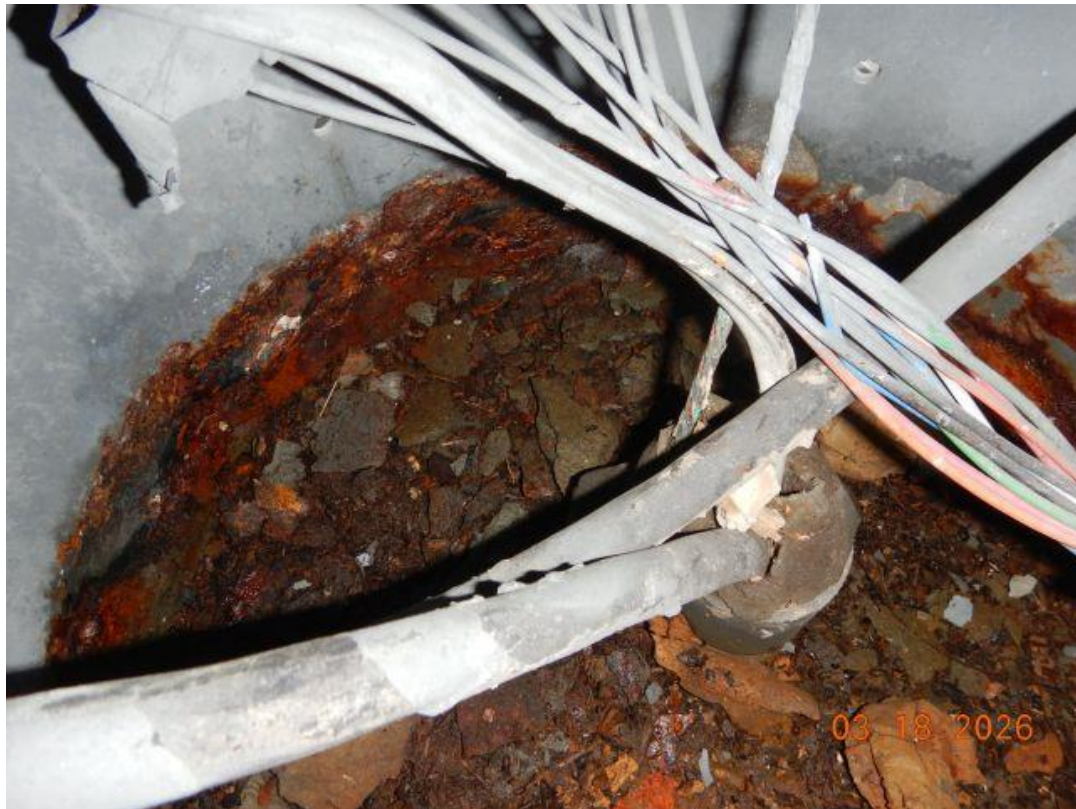
Photo 10: V3 – View of holes due to corrosion and corrosion at base plate of vertical interior

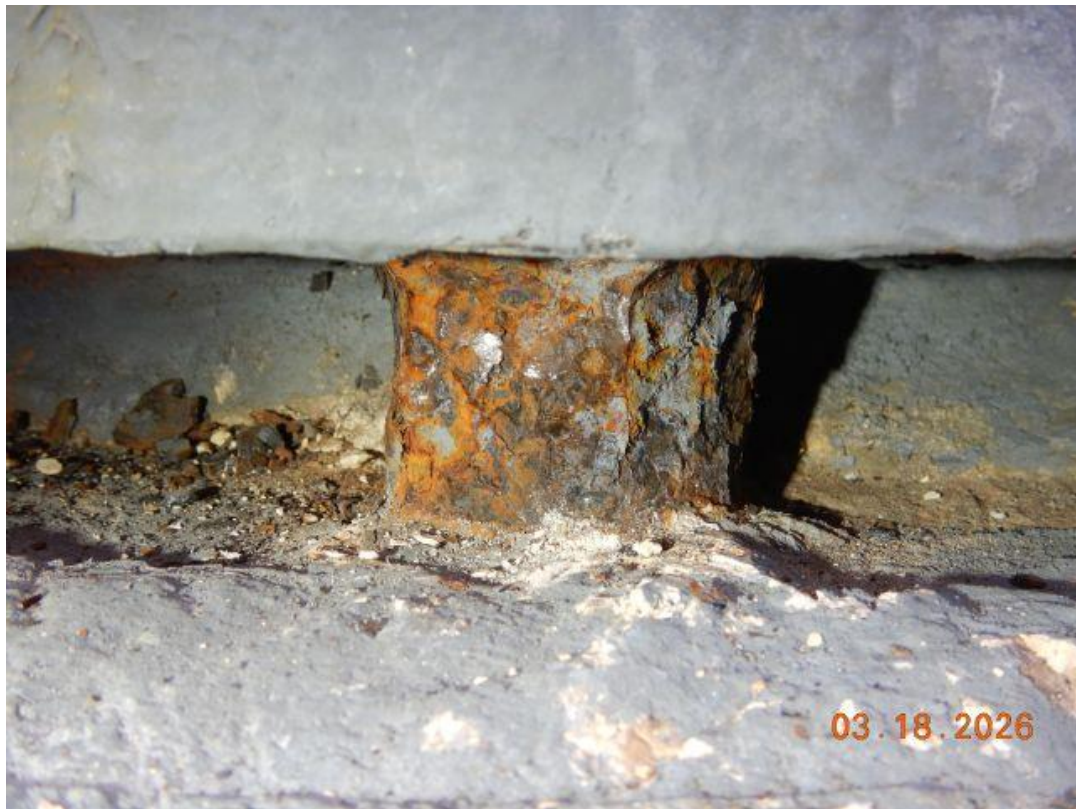
F3 - The anchor bolt leveling nuts have heavy corrosion with up to 22% section loss. Original nut outside diameter = 2.13 in. Minimum remaining nut diameter at Anchor Bolt 4 is 1.67 in. - NO CHANGE. Refer to Photo 11.

Photo 11: F3 – View of corrosion on anchor bolts and leveling nuts beneath base plate
