**FLORIDA DEPARTMENT OF TRANSPORTATION**  
**BRIDGE MANAGEMENT SYSTEM**  
**Inspection/CIDR Report**  
(TRAFFIC SIGNAL MAST ARM INSPECTION REPORT)

Structure ID: 70M081

INSPECTION DATE: 3/18/2026 BTGR

| BY: | Ayres Associates | STRUCTURE NAME: | US-1 (Washington Ave.) at Harrison St |

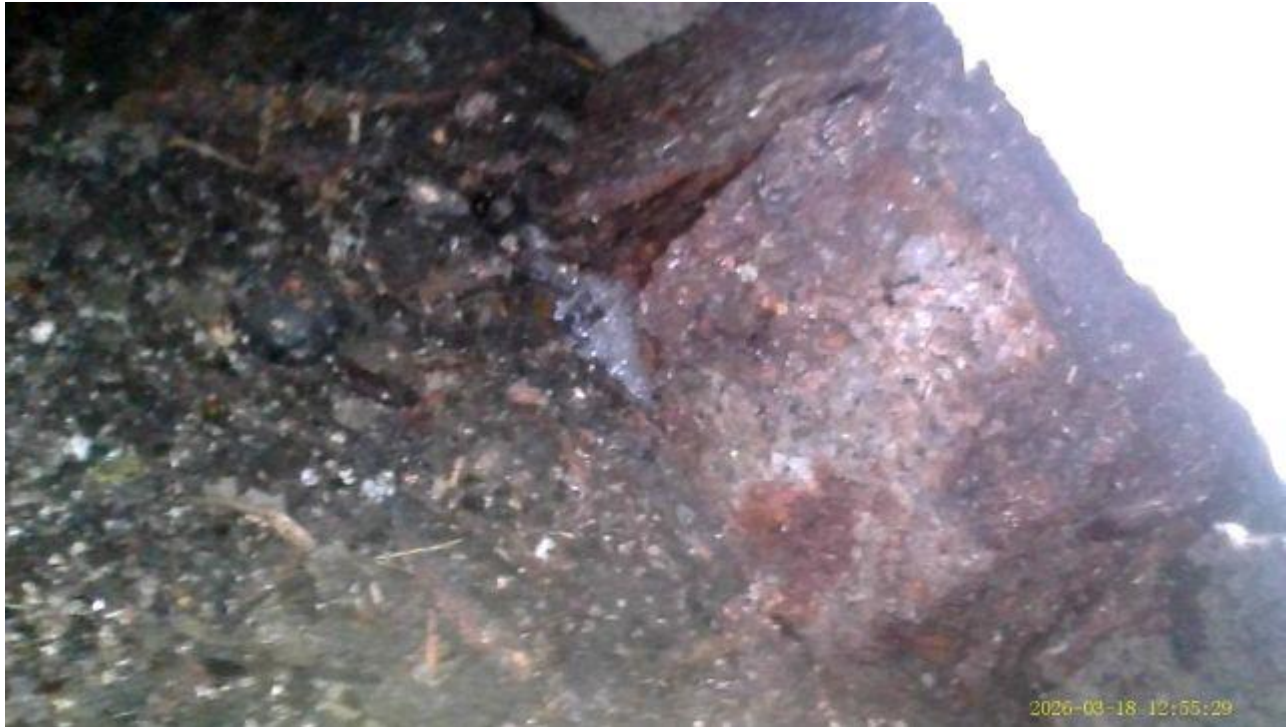
**Photo 1: Element 8480 / Mast Arm Foundation**

F1 and F2 - The grout rings are hollow sounding and have cracking with moderate to heavy efflorescence built up around the base of the grout pad and the anchor bolt threads, leveling nuts and washers below the base plate have moderate to heavy flaking corrosion and potential section loss viewed with a borescope inserted thru the terminal compartment access (previously no corrosion or efflorescence noted). INCREASE. Refer to Photos 1 and 2. REPAIR. (2 EA)

NBI Item (60) Substructure rating is coded a 5 - Fair due to excessive anchor bolt stand-off distance at Foundation F2 and heavy corrosion on the anchor bolts & leveling nuts below the base plate with potential section loss at the F1 & F2 Foundations.

F1 - Typical heavy anchor bolt leveling nut and washer corrosion below base plate.

| CONDITION<br>STATE | | | PRIORITY |
|---|---|---|---|
| F1 & F2 - Remove grout rings, clean & paint bolts & install wire screens per FDOT Spec. 649-8. | | | |

F1 & F2 - Remove grout rings, clean & paint bolts & install wire screens per FDOT Spec. 649-8.

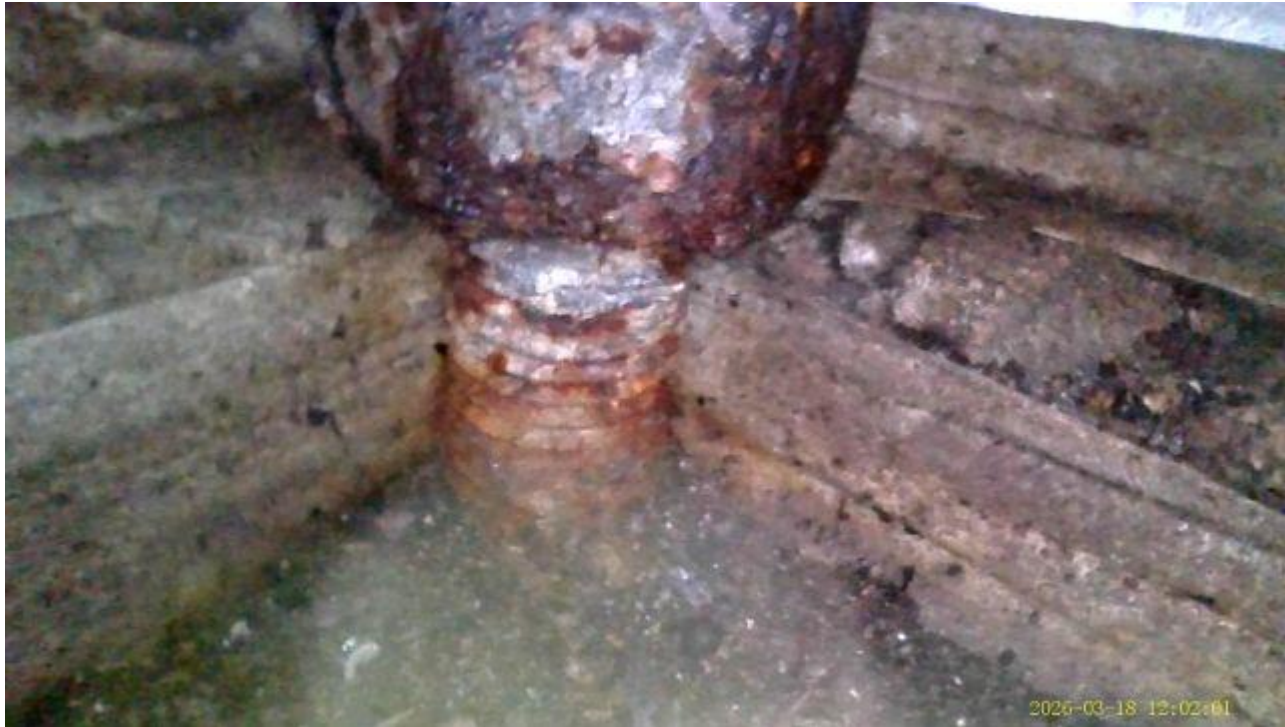
**Photo 2: Element 8480 / Mast Arm Foundation**

F2 - Typical moderate to heavy anchor bolt thread, leveling nut and washer corrosion below base plate.

F1 & F2 - Remove grout rings, clean & paint bolts & install wire screens per FDOT Spec. 649-8.

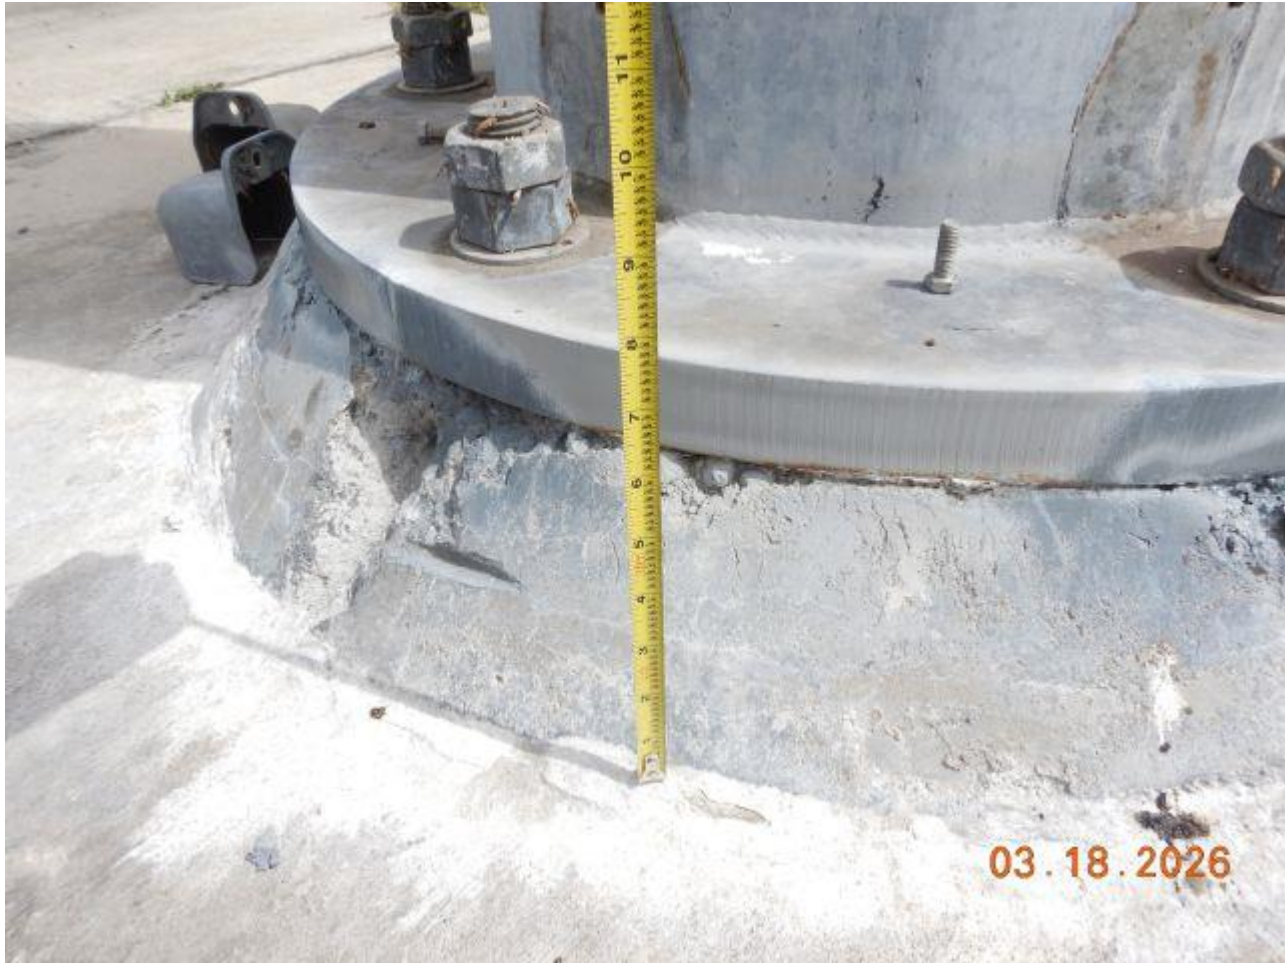
**Photo 3: Element 8480 / Mast Arm Foundation**

F2 - The anchor bolt stand-off distance is greater than the diameter of the anchor bolt. Bolt diameter = 1 1/2 in. & average estimated stand-off distance = 2 7/8 in. NO CHANGE. Refer to Photo 3. REPAIR.

Average Estimated Stand-Off Distance: F1 = 5/8 in.; F2 = 2 7/8 in.

F2 - Excess anchor bolt stand-off distance.

F1 & F2 - Remove grout rings, clean & paint bolts & install wire screens per FDOT Spec. 649-8.

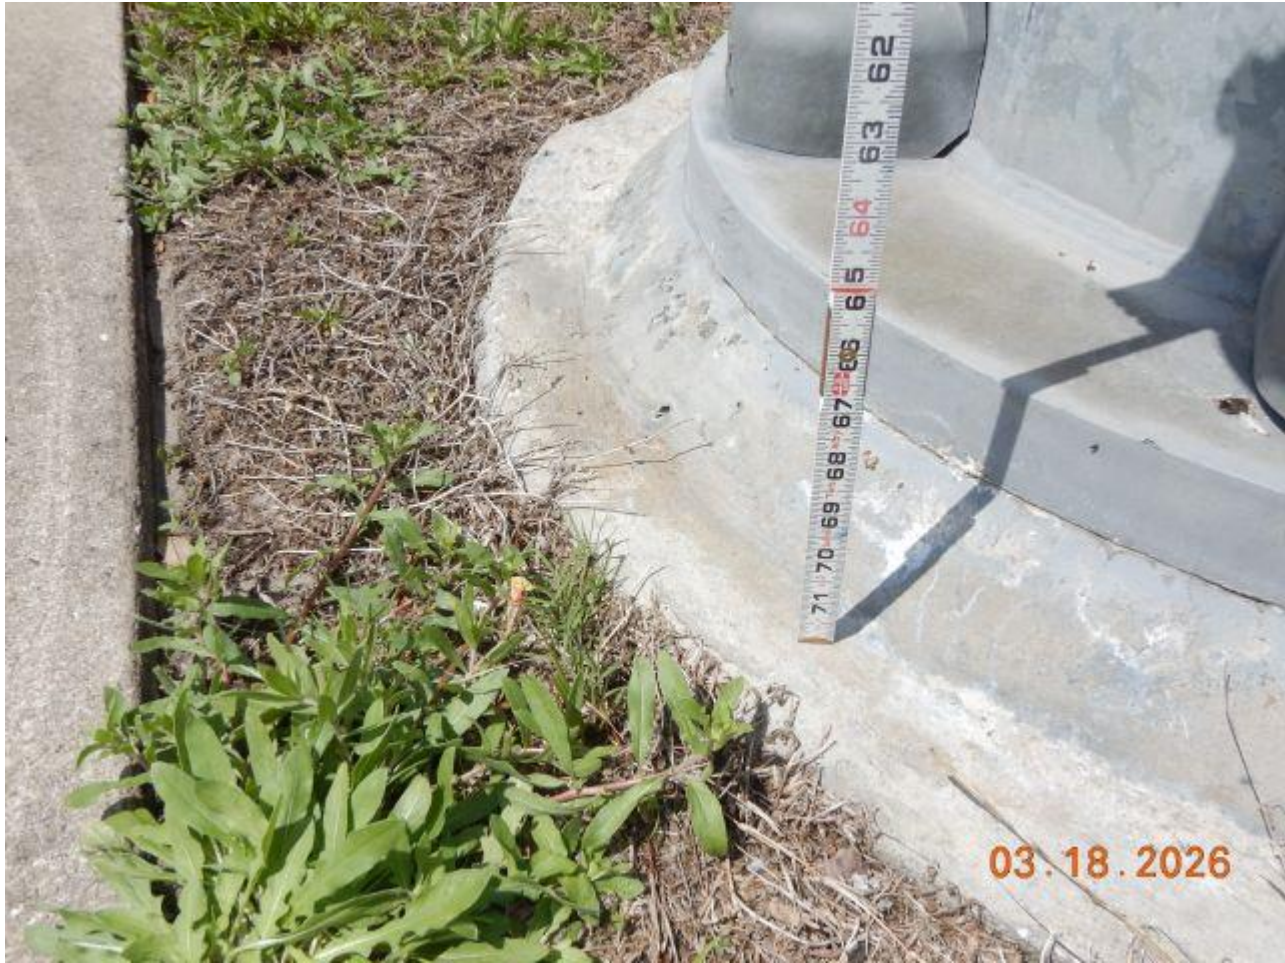
**Photo 4: Element 8480 / Mast Arm Foundation**

F1 - The grout ring is missing a drain hole. NEW. Refer to Photo 4. REPAIR.

F1 - Grout ring missing the drain hole.

F1 & F2 - Remove grout rings, clean & paint bolts & install wire screens per FDOT Spec. 649-8.

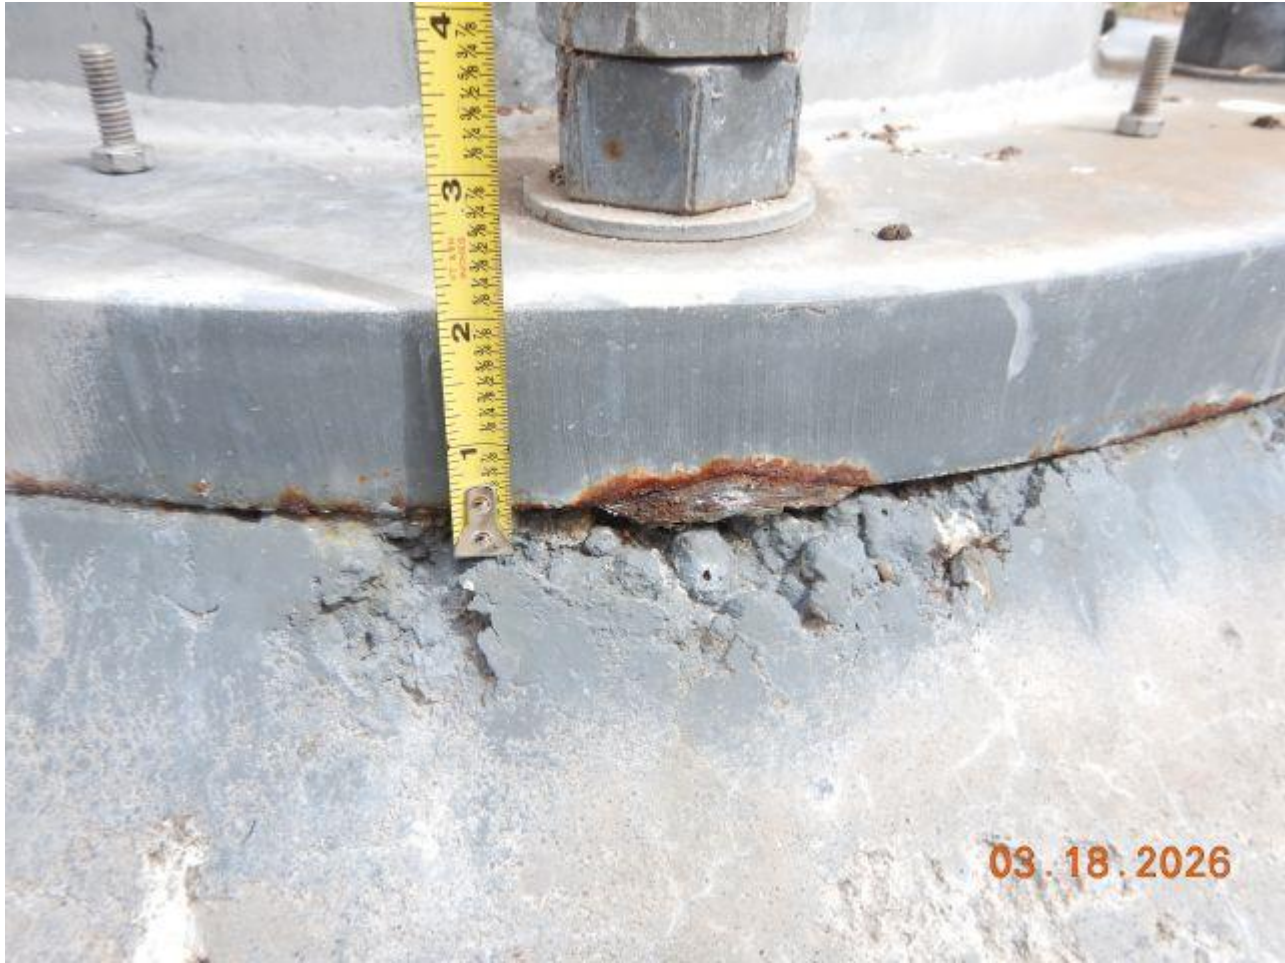
**Photo 5: Element 8481 / Mast Arm Vertical**

V2 - The column base plate bottom outside edge has intermittent corrosion and pack rust at the grout pad interface. NEW. Refer to Photo 5. REPAIR. (1 EA)

8518/4 CS4 (3440):  
V2 - Failed, no protection of underlying metal on areas of base plate with corrosion. (1SF)

V2 - Typical corrosion around column base plate bottom outside edge at the grout pad interface.

F1 & F2 - Remove grout rings, clean & paint bolts & install wire screens per FDOT Spec. 649-8.

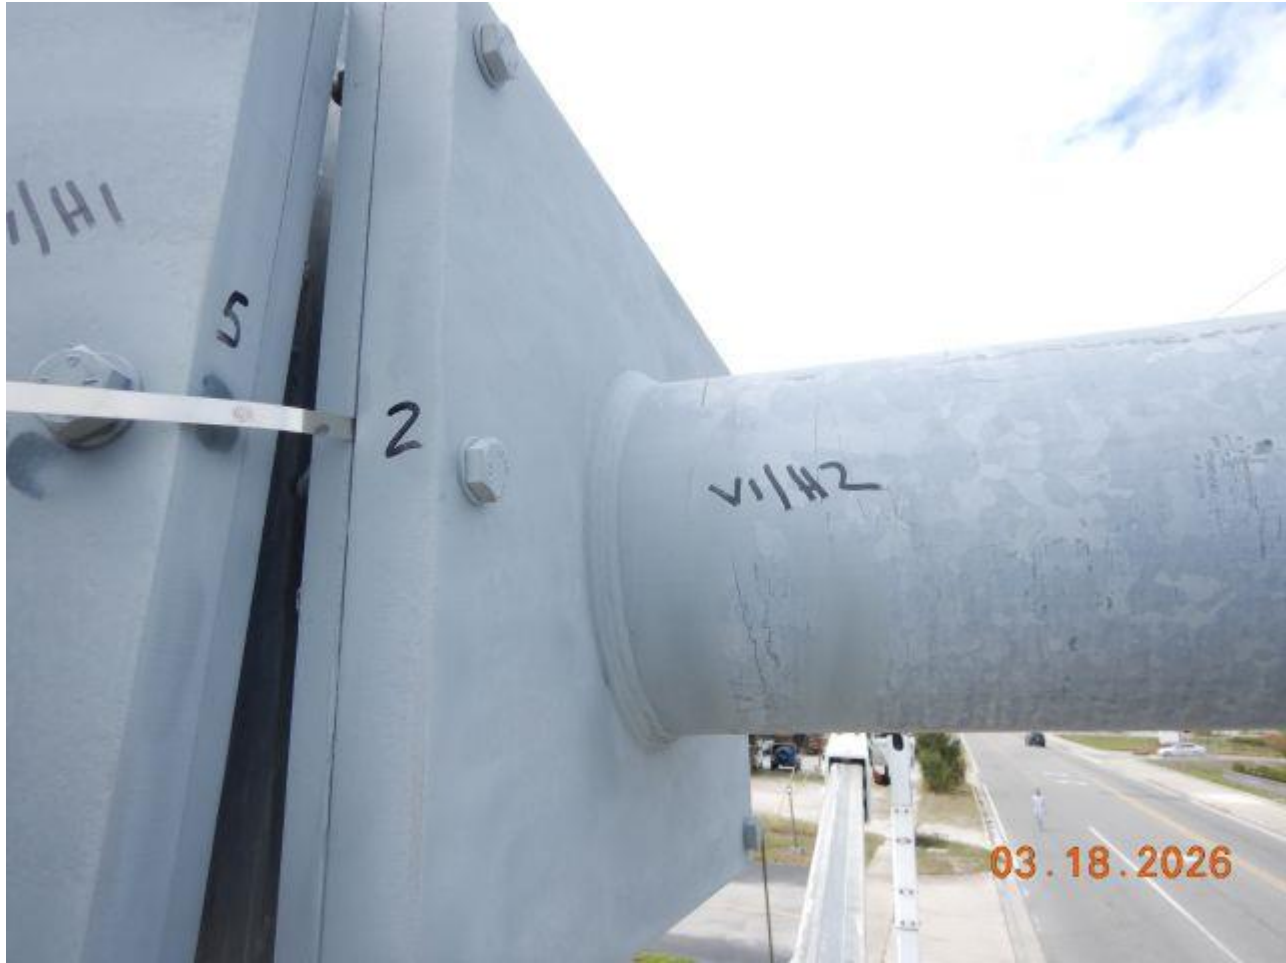
**Photo 6: Element 8484 / Mast Arm Horizontal**

V1/H2 - The moment connection has gap up to a 0.020 in. wide between the plates at Bolt #2, but all bolts are tight. NEW. Refer to Photo 6. (1 EA)

V1/H2 - Moment connection gap between plates at Bolt #2.

REPAIR RECOMMENDATION:  
None.

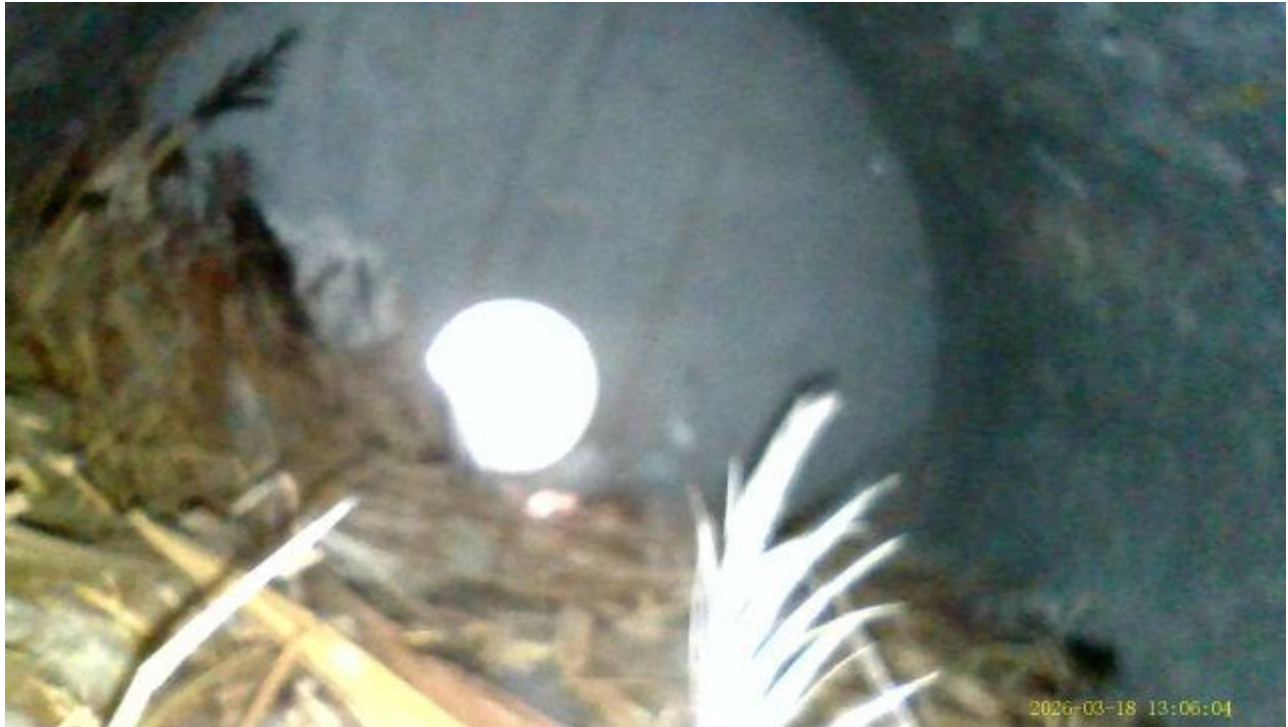
**Photo 7: Element 8484 / Mast Arm Horizontal**

V1/H1, V2/H2, V3/H3 and V4/H4 - There is a heavy accumulation of bird nesting material inside the horizontal arm interiors at the moment connections viewed with a borescope inserted thru the arm drain holes. No corrosion could be seen thru the nesting material and D-meter readings at 3 in., 12 in. & 24 in. from the moment connection taken at the 5, 6 and 7 o'clock positions did not indicate any reduction in section at this time. NEW. Refer to Photos 7 thru 10.

V1/H1 - Heavy bird nesting material inside horizontal arm near the moment connection.

| CONDITION<br>STATE | | | PRIORITY |
|---|---|---|---|
| V1H1 V1H2 V2H3 and V2H4 - Install screening at moment connection plates. | | | |

V1H1 V1H2 V2H3 and V2H4 - Install screening at moment connection plates.

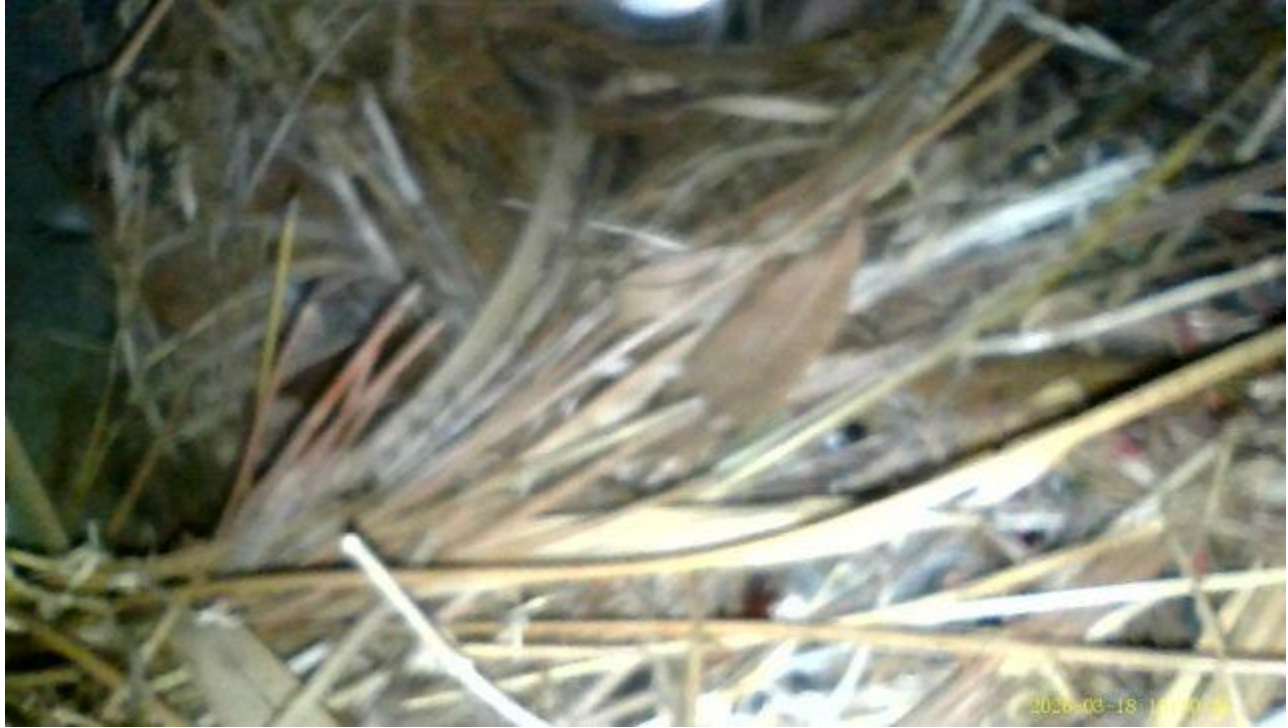
**Photo 8: Element 8484 / Mast Arm Horizontal**

V2/H2 - Heavy bird nesting material inside horizontal arm near the moment connection.

V1H1 V1H2 V2H3 and V2H4 - Install screening at moment connection plates.

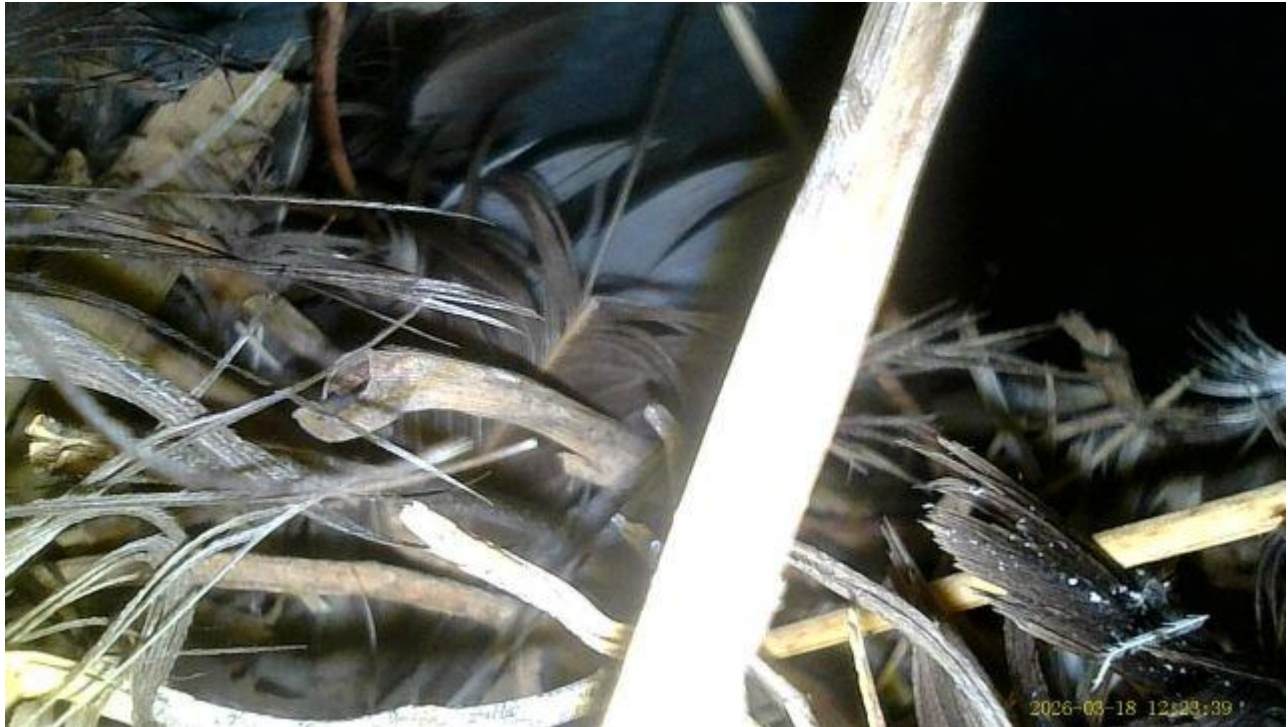
**Photo 10: Element 8484 / Mast Arm Horizontal**

V4/H4 - Heavy bird nesting material inside horizontal arm near the moment connection.

V1H1 V1H2 V2H3 and V2H4 - Install screening at moment connection plates.
