**FLORIDA DEPARTMENT OF TRANSPORTATION**  
**BRIDGE MANAGEMENT SYSTEM**  
**Inspection/CIDR Report**  
(TRAFFIC SIGNAL MAST ARM INSPECTION REPORT)

Structure ID: 70M083

INSPECTION DATE: 3/18/2026 HBPD

| BY: | Ayres Associates | STRUCTURE NAME: | US-1 (Washington Ave.) at S. Terrier Trl |

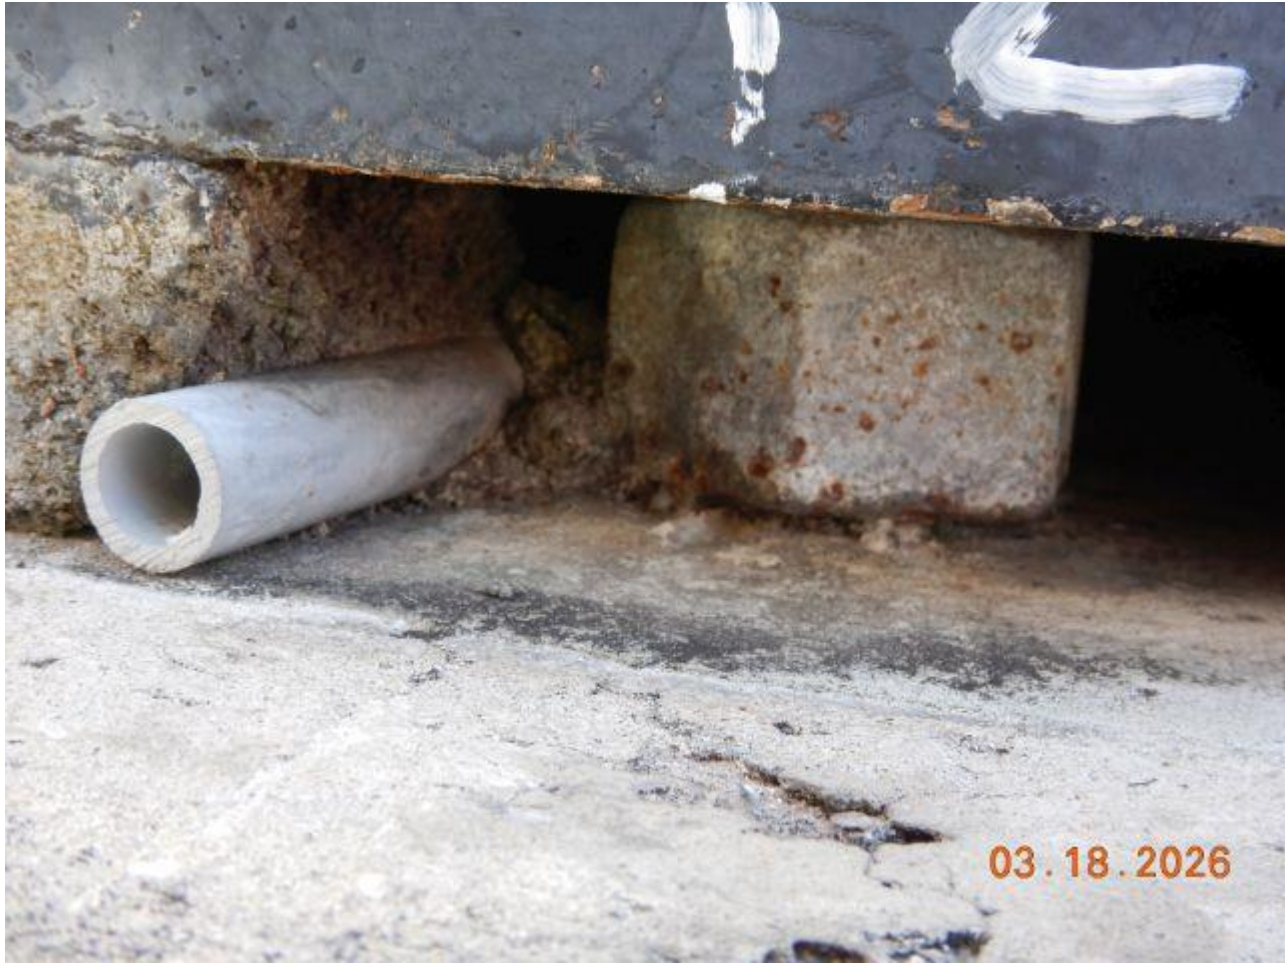
**Photo 1: Element 8480 / Mast Arm Foundation**

F2, F3 and F4 - The anchor bolts and leveling nuts below the base plate have light corrosion viewed thru the spalled grout rings. NO CHANGE. Refer to Photos 1, 2 & 3. (3 EA) REPAIR.

F2, F3 and F4 - All anchor bolts leveling nuts are missing the washer below the base plate. NEW. Refer to Photos 1, 2 & 3.

F2 - Typical anchor bolt leveling nut with light spotty corrosion & missing washers below the base plate.

F1, F2, F3 & F4 - Remove remaining grout pad. Clean / paint all corrosion and tighten any loose leveling nuts. Install structural grout pad in accordance with FDOT Spec. 649-7. No repairs have been made since the 2021 inspection.

F2 F3 & F4 - Remove grout pad, paint anchor bolts & leveling nuts & install wire screen Per Spec. 649-8.

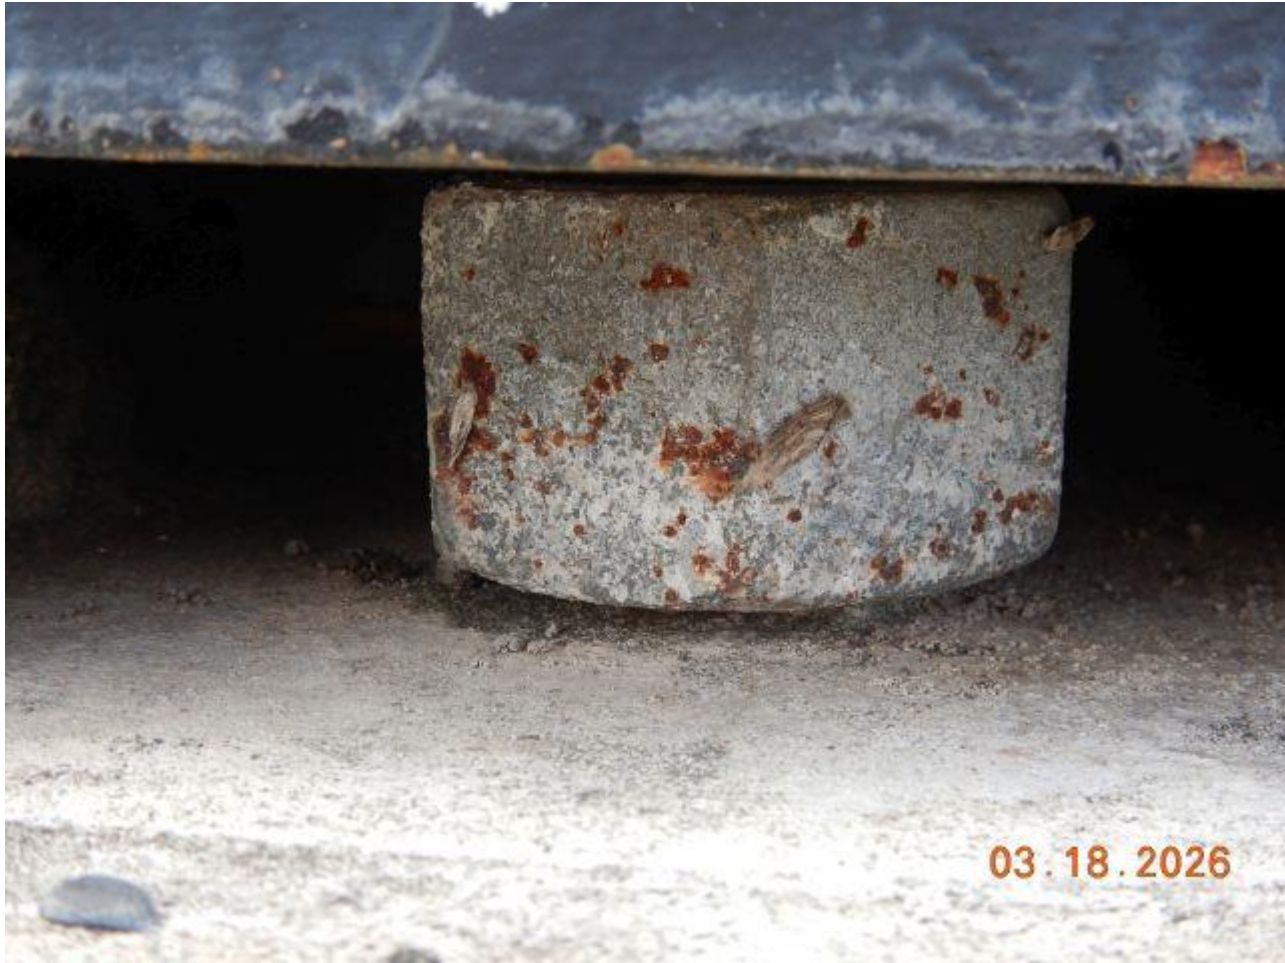
**Photo 2: Element 8480 / Mast Arm Foundation**

F3 - Typical anchor bolt leveling nut with light spotty corrosion & missing washers below the base plate.

F2 F3 & F4 - Remove grout pad, paint anchor bolts & leveling nuts & install wire screen Per Spec. 649-8.

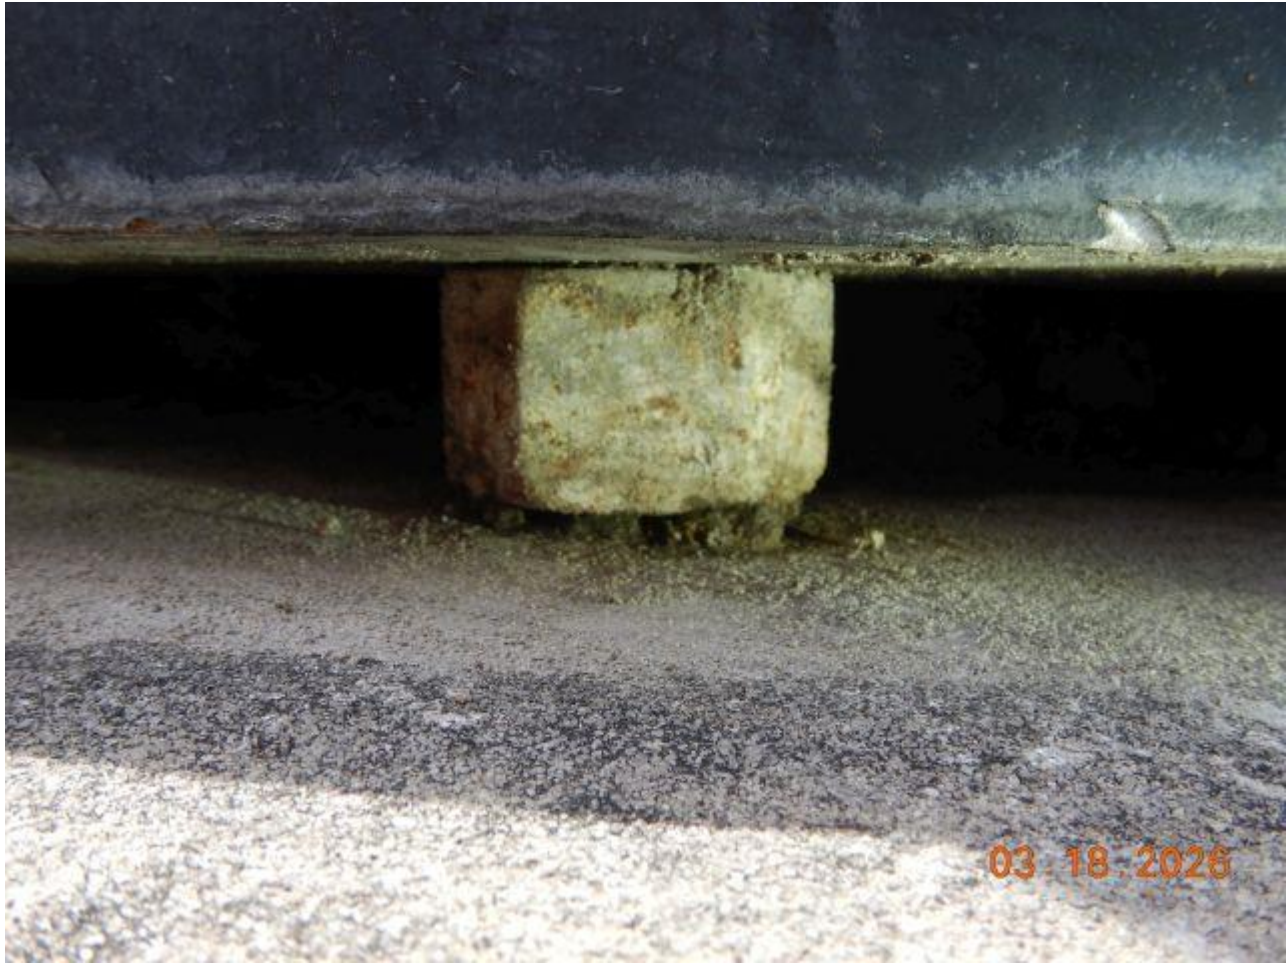
**Photo 3: Element 8480 / Mast Arm Foundation**

F4 - Typical anchor bolt leveling nut with light spotty corrosion & missing washers below the base plate.

F2 F3 & F4 - Remove grout pad, paint anchor bolts & leveling nuts & install wire screen Per Spec. 649-8.

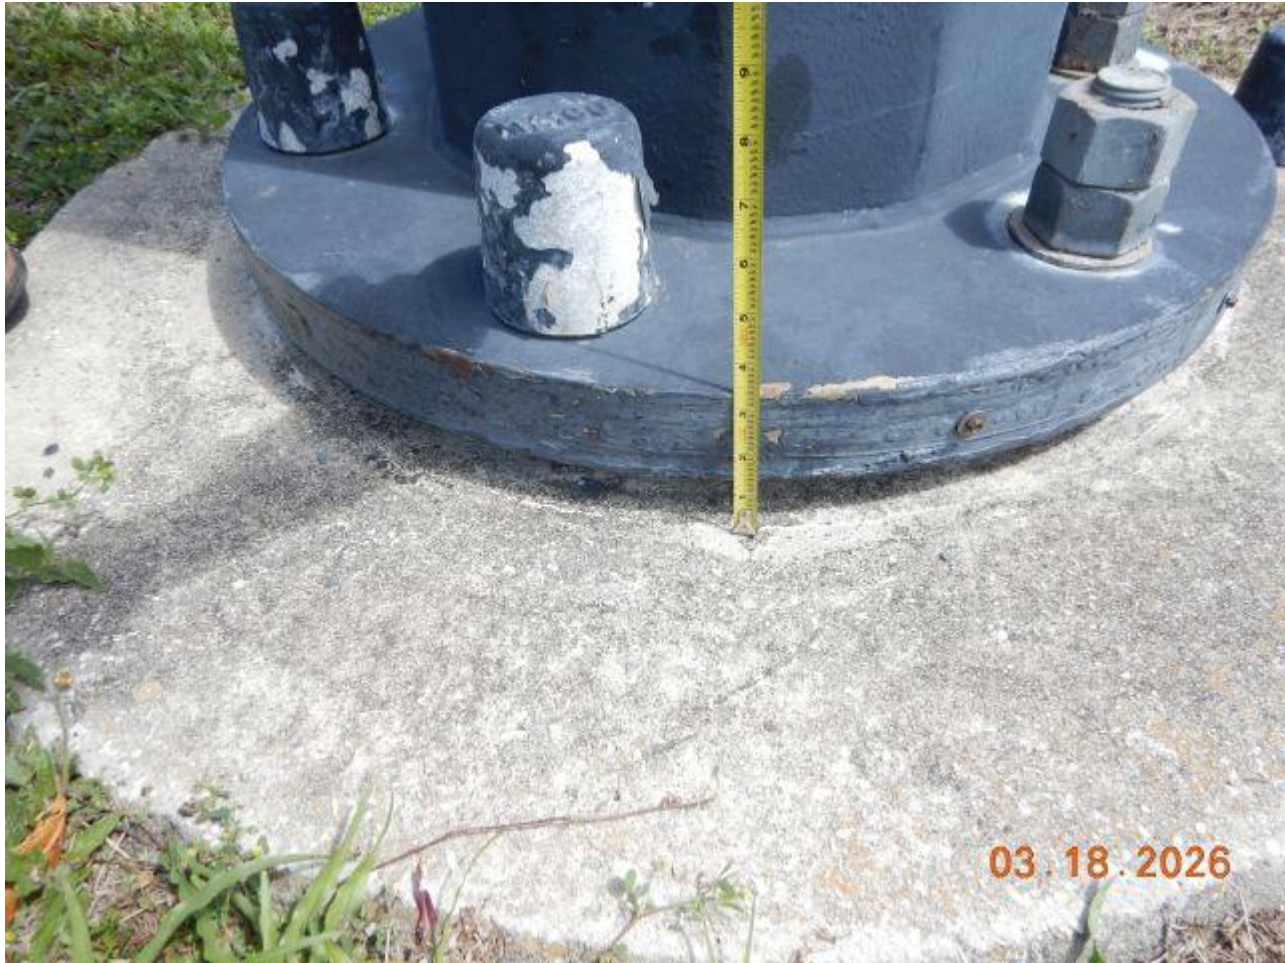
**Photo 4: Element 8480 / Mast Arm Foundation**

F1 - The wire screen is missing below the base plate (previously noted as damaged). INCREASE. Refer to Photo 4. REPAIR.

F1 - Missing wire screen below base plate.

F1 - Replace the missing wire screen per FDOT Spec. 649-8.

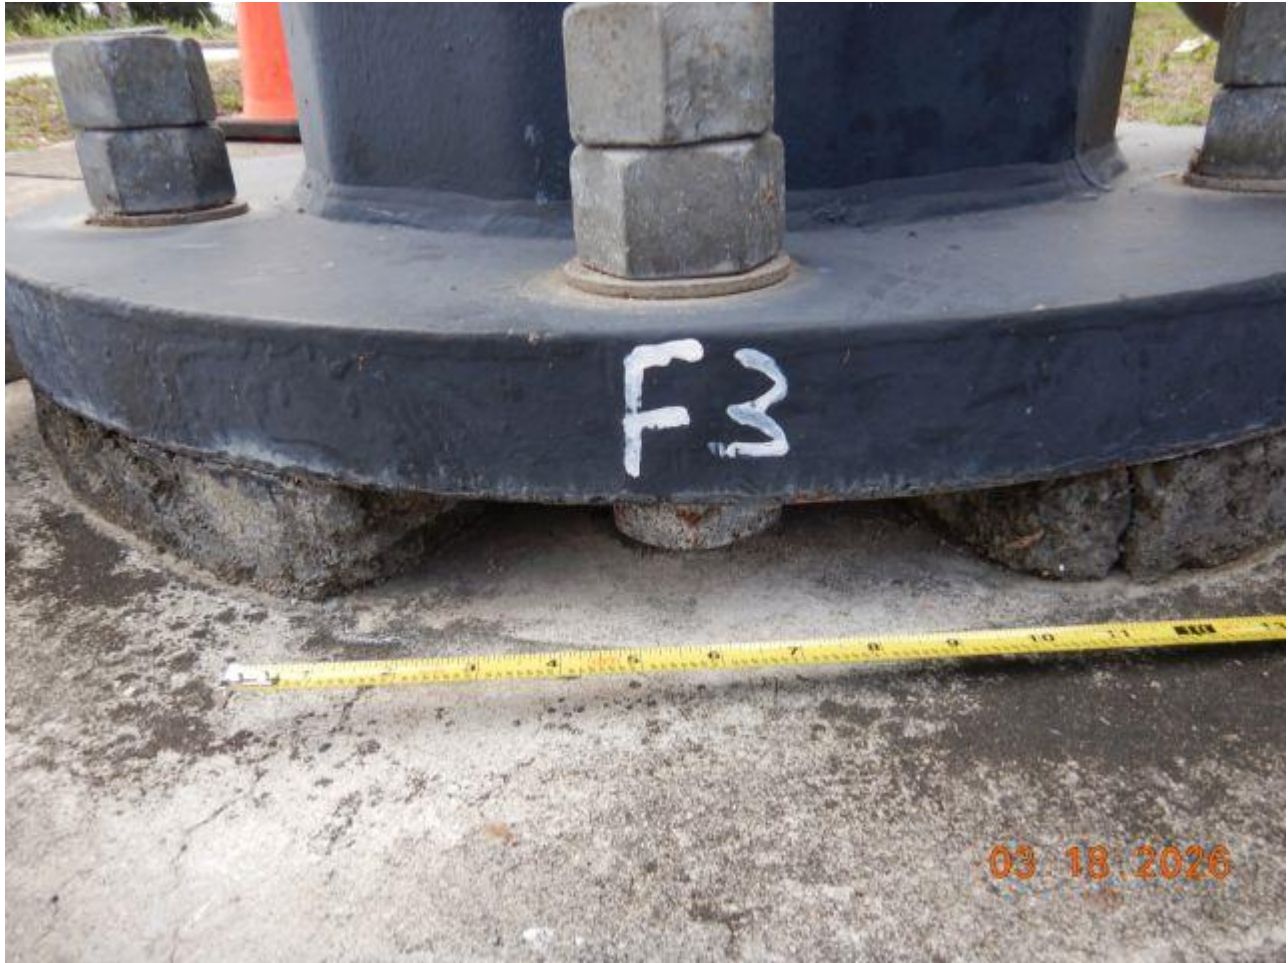
**Photo 5: Element 8480 / Mast Arm Foundation**

F2, F3 and F4 - The grout rings are soft / hollow sounding and were previously partially removed by the inspectors. NO CHANGE. Refer to Photo 5. REPAIR.

F2 F3 & F4 - Typical partially removed grout ring (F3 shown).

F2 F3 & F4 - Remove grout pad, paint anchor bolts & leveling nuts & install wire screen Per Spec. 649-8.

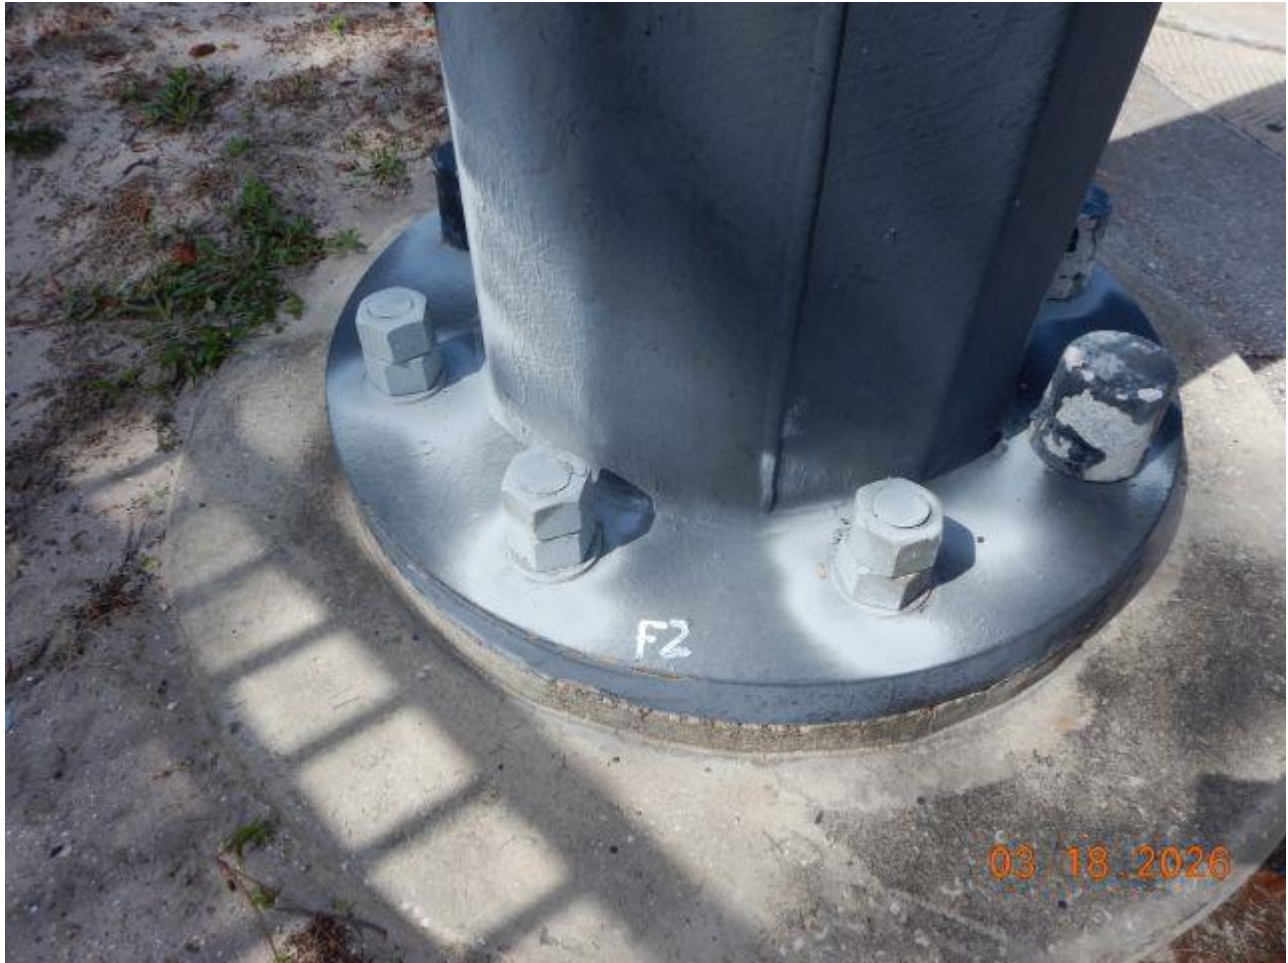
**Photo 6: Element 8480 / Mast Arm Foundation**

F2 - (3) of (8) anchor bolt covers (AB #1, 7 & 8) are missing. NEW. Refer to Photo 6. REPAIR.

F2 - Missing anchor bolt covers (AB #1, 7 & 8).

F2 and F3 - Replace the missing anchor bolt covers.

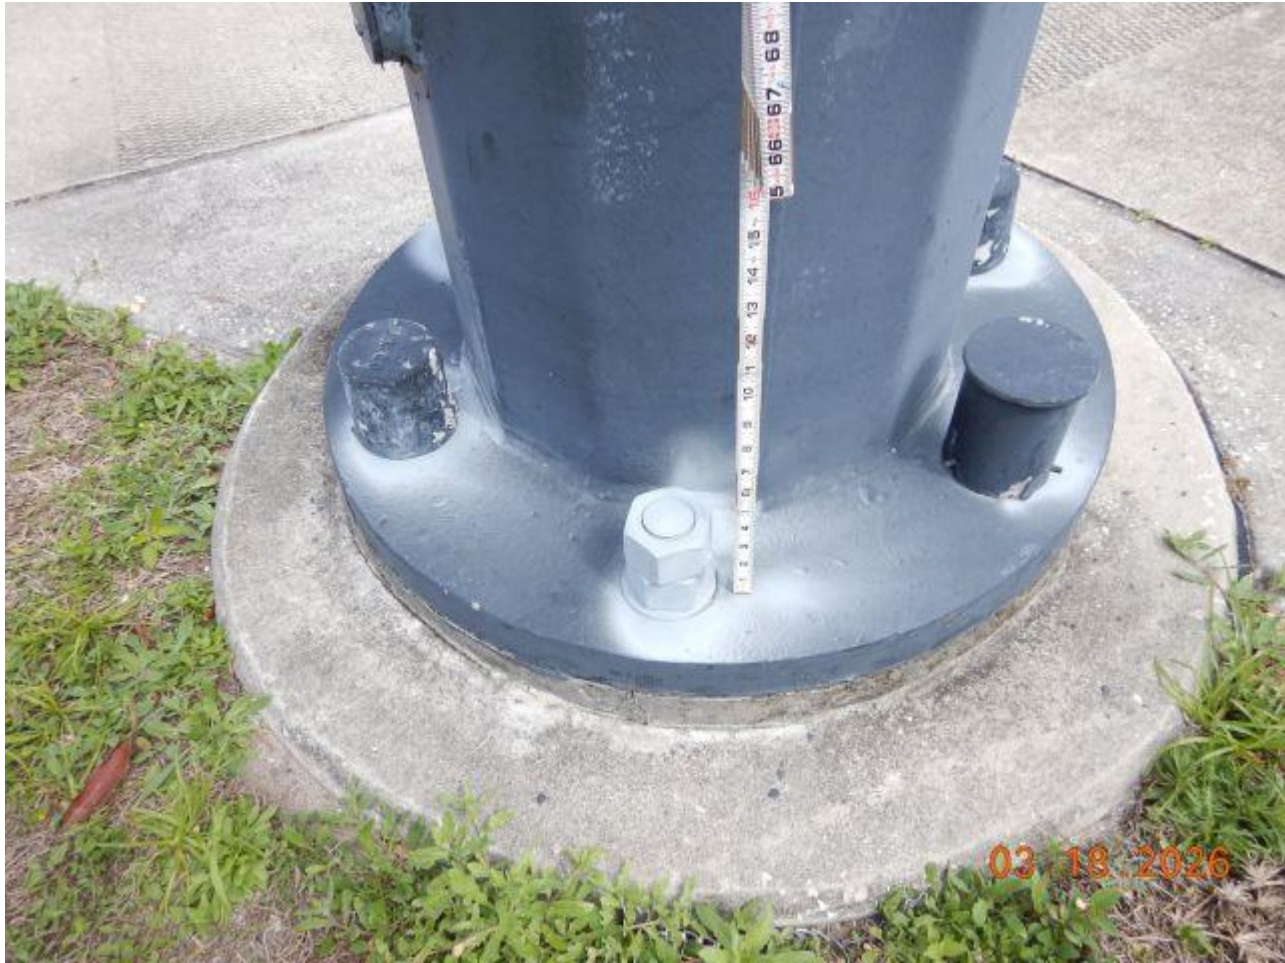
**Photo 7: Element 8480 / Mast Arm Foundation**

F3 - (1) of (6) anchor bolt covers (AB #6) is missing. NEW. Refer to Photo 7. REPAIR.

F3 - Missing anchor bolt cover (AB #6).

F2 and F3 - Replace the missing anchor bolt covers.

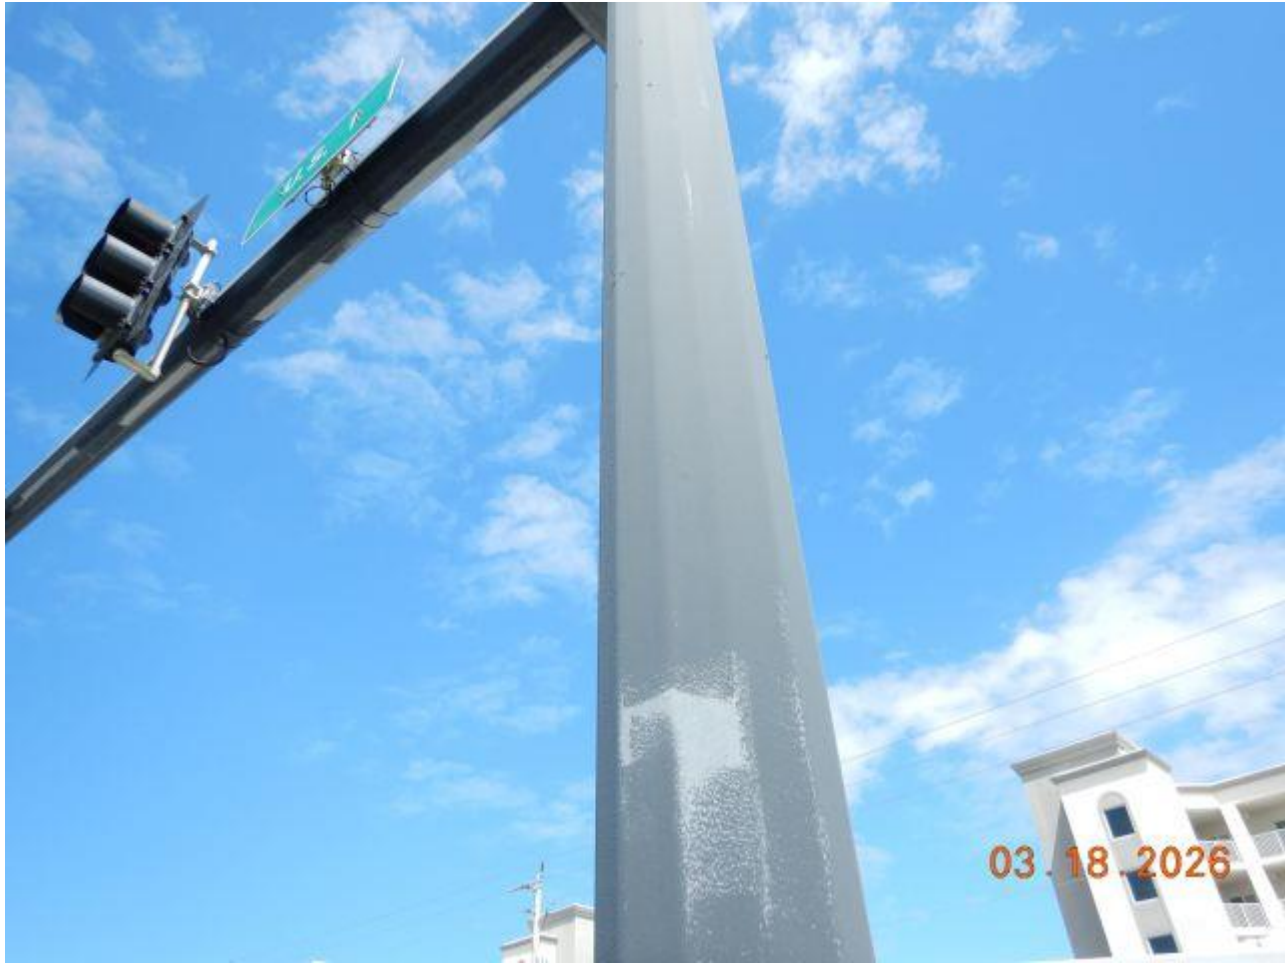
**Photo 8: Element 8481 / Mast Arm Vertical**

V1, V2, V3 and V4 - The vertical column paint is chalky and faded. NO CHANGE. Refer to Photo 8. REPAIR.

V1 V2 V3 & V4 - Typical chalky and faded vertical column paint.

V1, V2, V3 and V4 - Clean and paint the verticals as needed. The Verticals have not been painted since the 2021 Inspection.

V1 V2 V3 & V4 - Clean and paint the verticals columns.

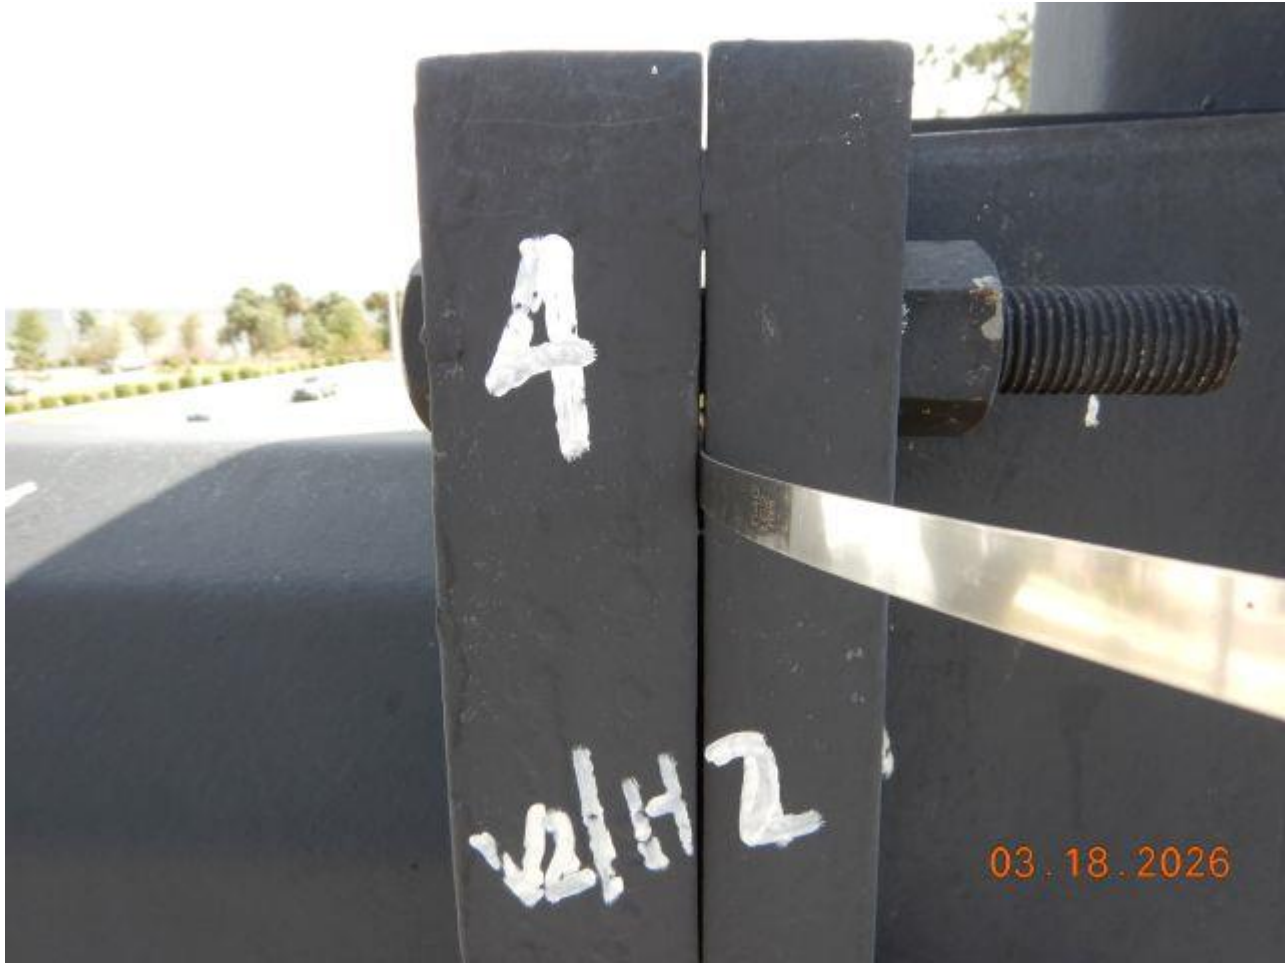
**Photo 9: Element 8484 / Mast Arm Horizontal**

V2/H2 - The moment connection has gap up to a 0.0625 in. wide between the plates exposing the shoulders of Bolts #1 and #4 (top bolts), but all bolts are tight. NO CHANGE. Refer to Photo 9. (1 EA)

V2/H2 - Moment connection gap between plates exposing the shoulders of Bolts #1 & 4.

REPAIR RECOMMENDATION:  
None.

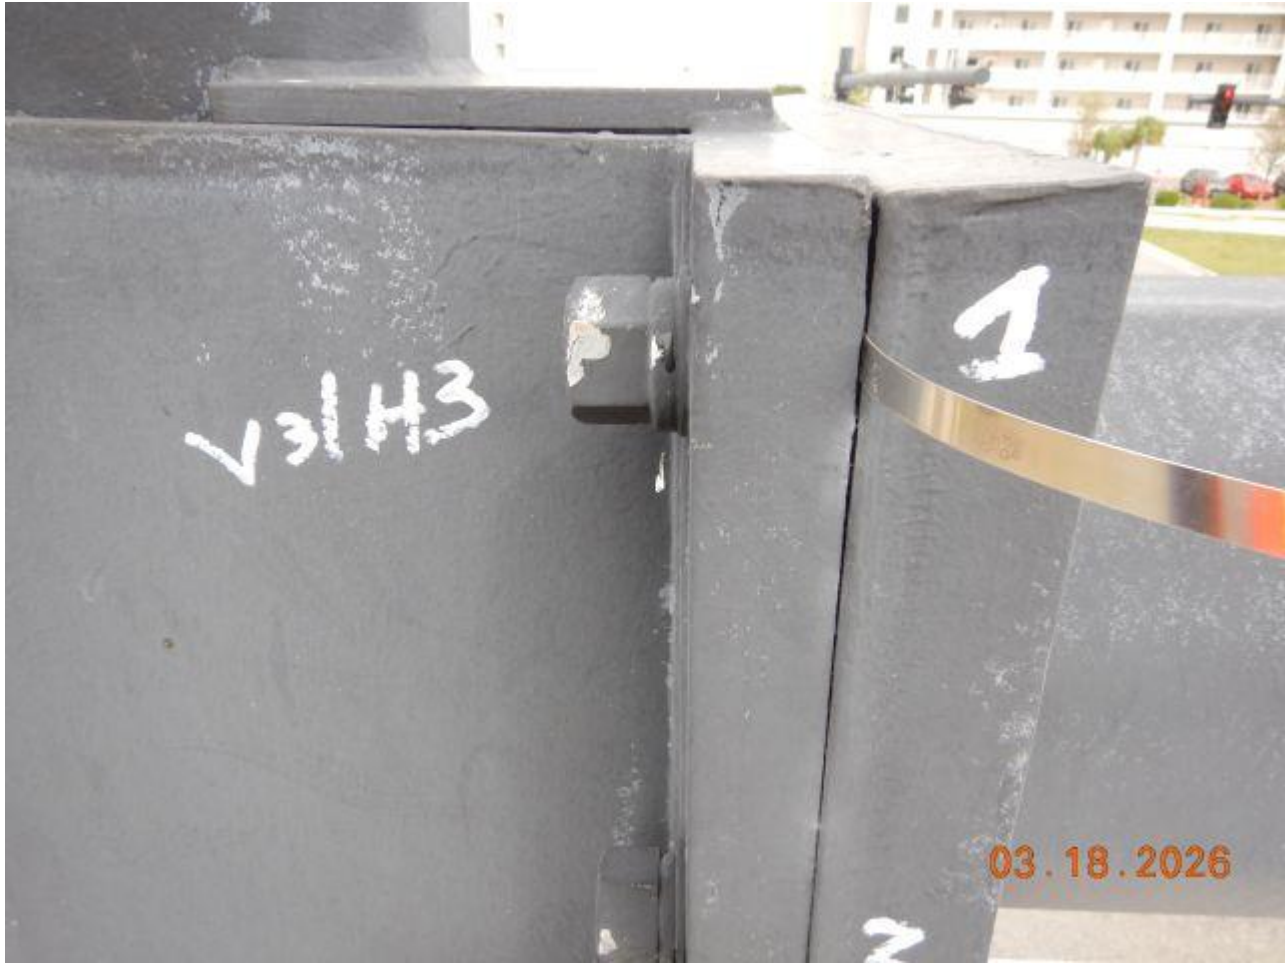
**Photo 10: Element 8484 / Mast Arm Horizontal**

V3/H3 - The moment connection has gap up to 0.025 in. wide between the plates exposing the shoulders of Bolts #1 and #4, but all bolts are tight. NO CHANGE. Refer to Photo 10. (1 EA)

V3/H3 - Moment connection gap between plates slightly exposing bolt #1.

REPAIR RECOMMENDATION:  
None.

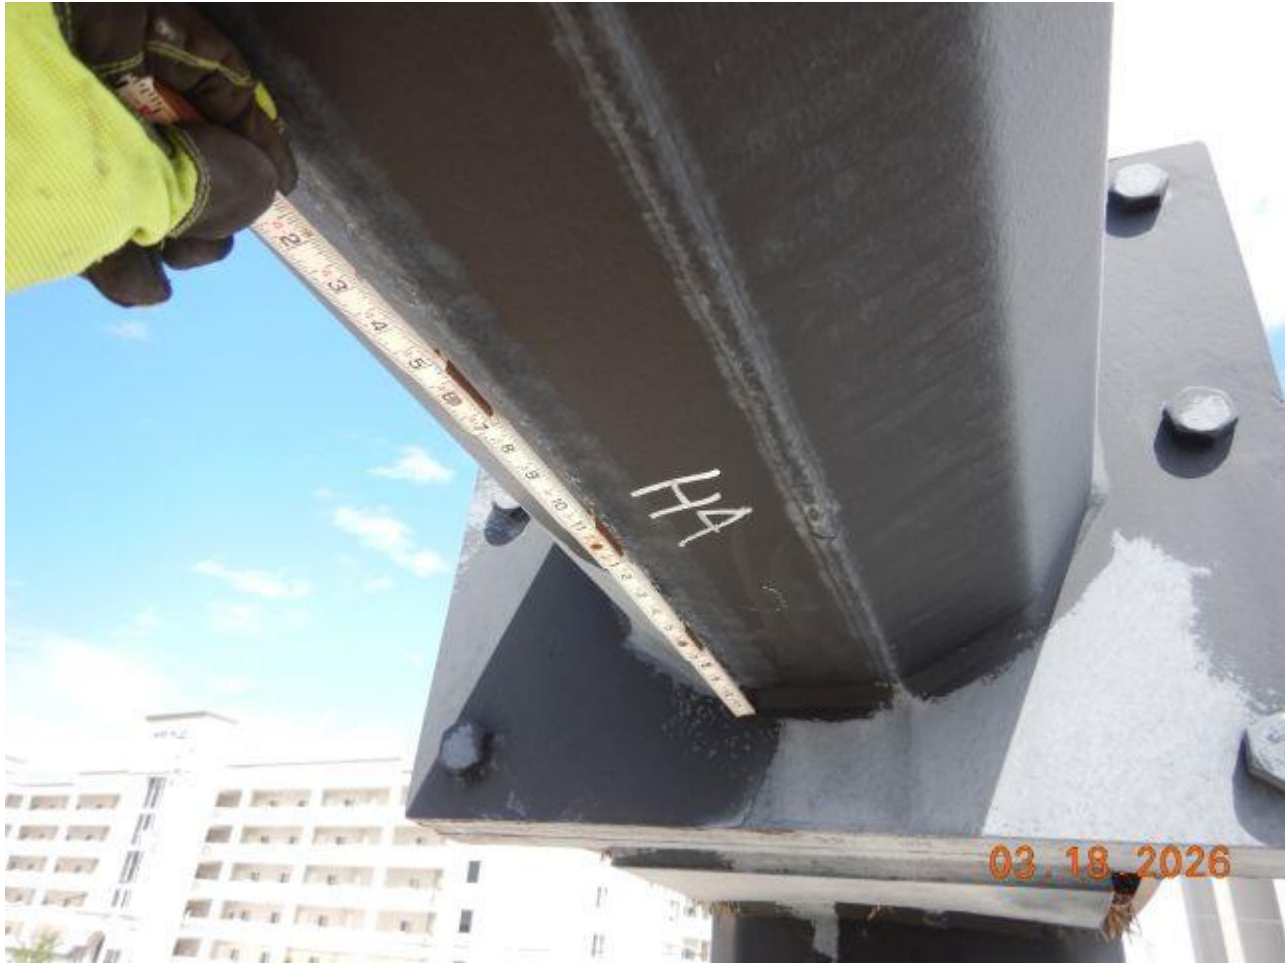
**Photo 11: Element 8484 / Mast Arm Horizontal**

V1/H1, V2/H2, V3/H3 & V4/H4 - The horizontal arms are missing the drain hole in the bottom near the moment connections. NEW. Refer to Photo 11. REPAIR.

V1/H1, V2/H2, V3/H3, & V4/H4 - Typical missing drain hole in bottom of the horizontal arm.

H1 H2 H3 & H4 - Install 0.50 in. dia. drain hole in arm underside 1 ft. from MC per Index 649-031.

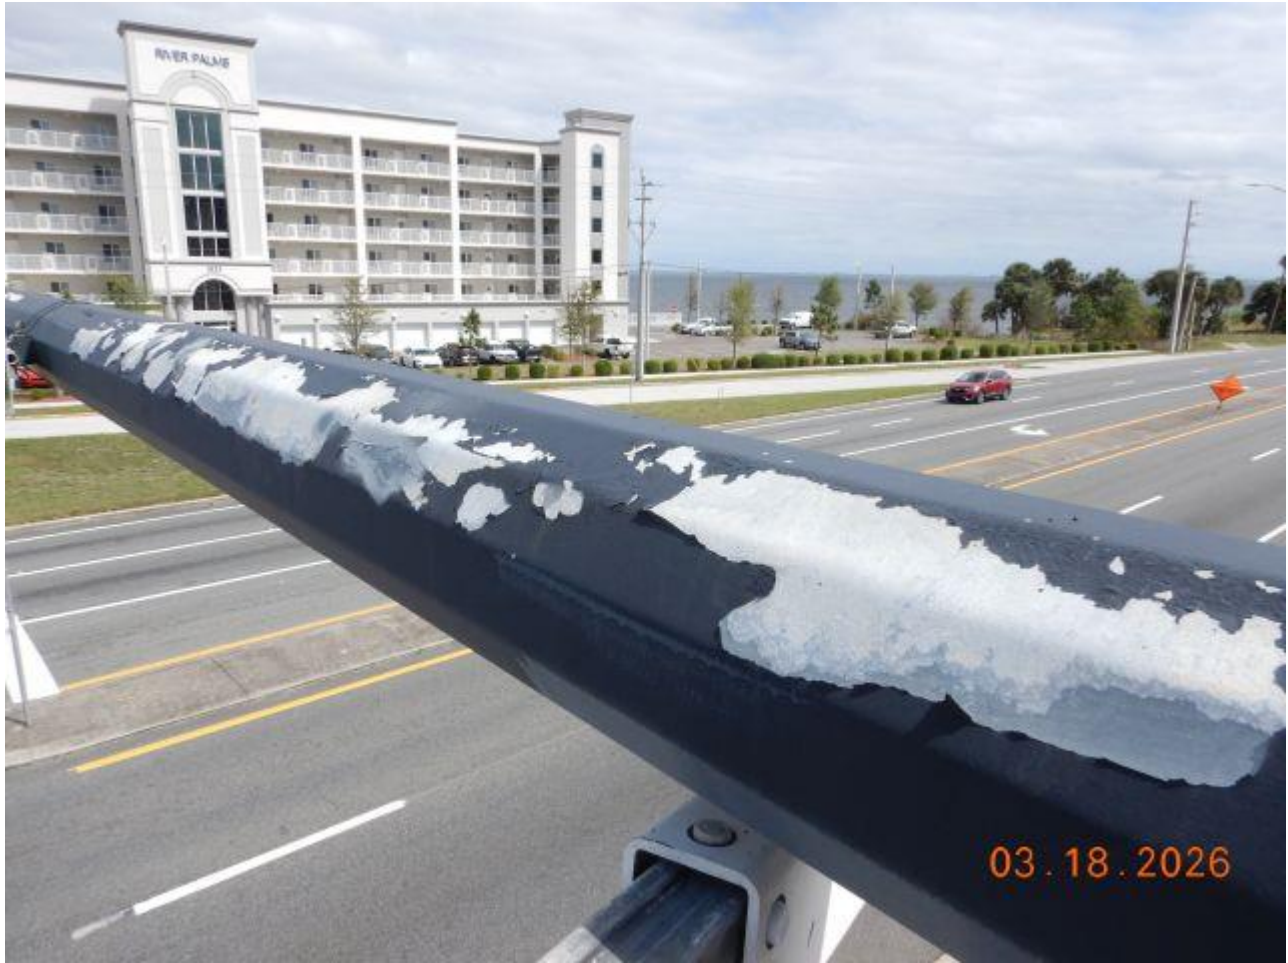
**Photo 12: Element 8484 / Mast Arm Horizontal**

V1/H1, V2/H2, V3/H3 & V4/H4 - The horizontal paint is chalky / faded and peeling in areas exposing the galvanizing below. NO CHANGE. Refer to Photo 12. REPAIR.

V1/H1 V2/H2 V3/H3 and V4/H4 - Typical chalky / faded and peeling horizontal arm paint (H2 shown).

V1/H1, V2/H2, V3/H3 & V4/H4 - Clean and spot paint the horizontal arms are needed. The horizontals have not been painted since the 2021 Inspection.

| CONDITION<br>STATE | | | PRIORITY |
|---|---|---|---|
| V1H1 V2H2 V3H3 & V4H4 - Clean and paint the horizontals arms. | | | |

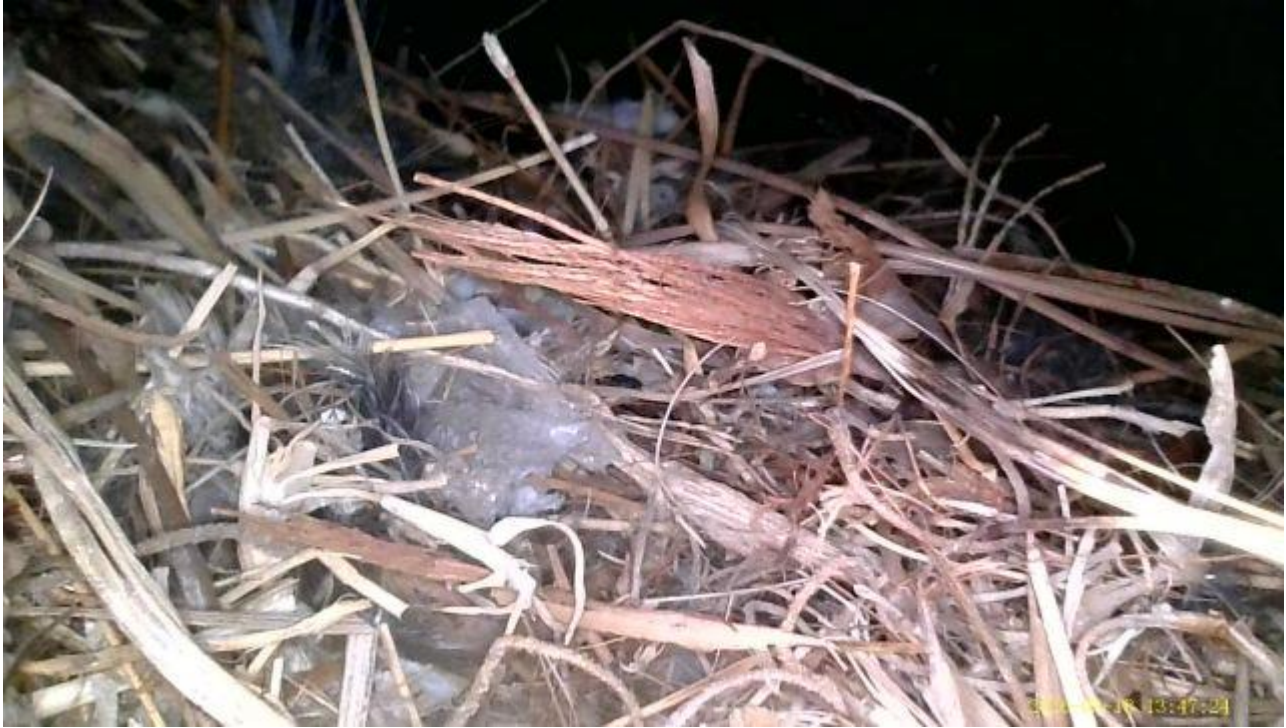
**Photo 13: Element 8484 / Mast Arm Horizontal**

V1/H1, V2/H2, V3/H3 & V4/H4 - The horizontal arm interiors have a heavy accumulation of bird nesting material viewed with a borescope thru the moment connection plate signal wire holes. D-meter readings at 3 in., 12 in. & 24 in. from the moment connection taken at the 5, 6 and 7 o'clock positions did not indicate any reduction in section at this time. NEW. Refer to Photo 13.

V1/H1 V2/H2 V3/H3 and V4/H4 - Typical bird nesting material inside horizontal arm near the moment connection (H1 shown).

REPAIR RECOMMENDATION:  
None.

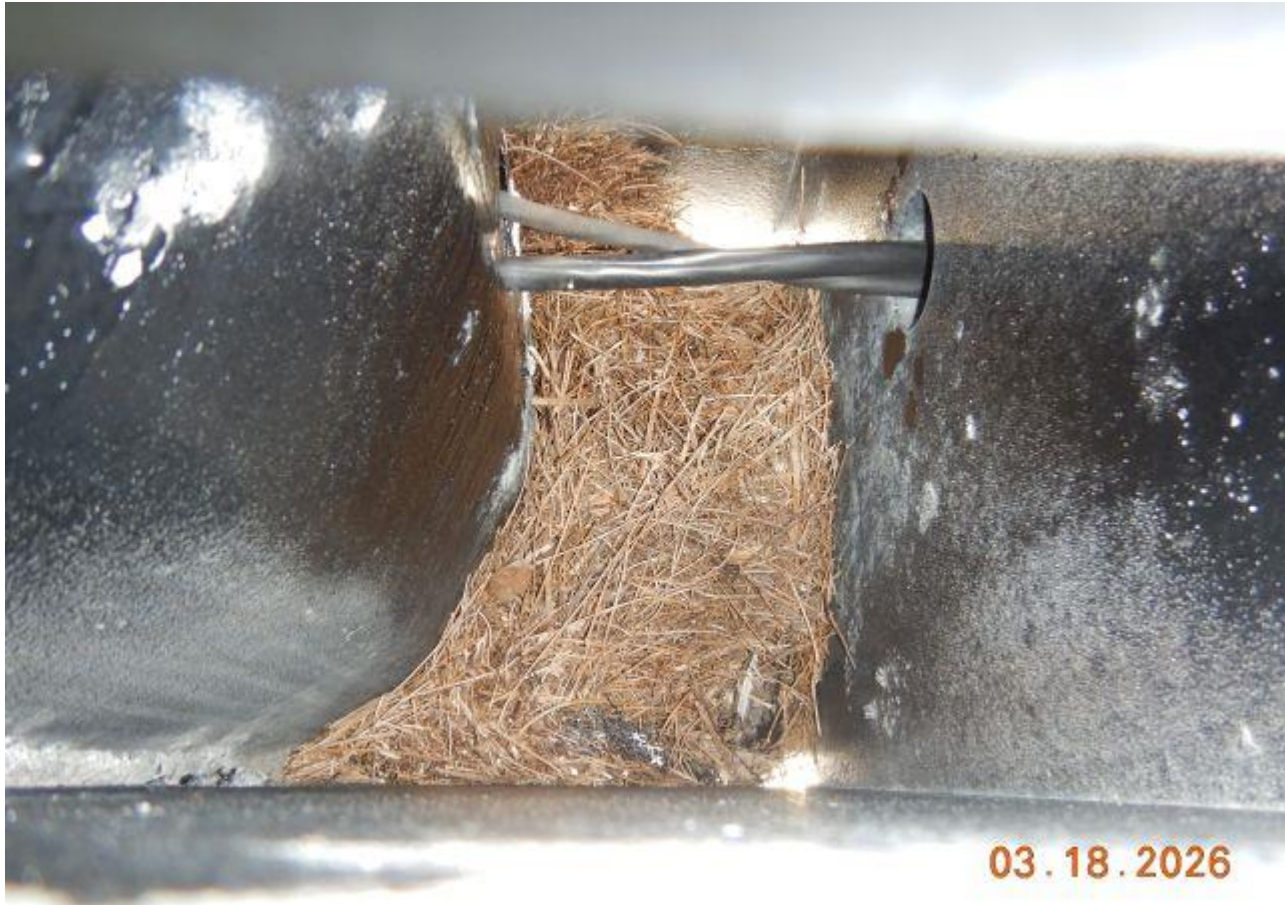
**Photo 14: Element 8484 / Mast Arm Horizontal**

V3/H3 & V4/H4 - There are bird nests present between the moment connection plates. NO CHANGE. Refer to Photo 14. REPAIR.

V3/H3 & V4/H4 - Typical bird nest between moment connection plates.

V1/H1, V2/H2, V3/H3 & V4/H4 - Remove birds nest from moment connection plates. Bird nests at V1/H1 and V2/H2 are no longer present. V3/H3 and V4/H4 bird nests have not been removed since the 2021 Inspection or are re-occurring.

| CONDITION<br>STATE | | | PRIORITY |
|---|---|---|---|
| V3H3 & V4H4 - Remove bird nests from moment connection plates & install screening. | | | |
