**FLORIDA DEPARTMENT OF TRANSPORTATION**  
**BRIDGE MANAGEMENT SYSTEM**  
**Inspection/CIDR Report**  
(TRAFFIC SIGNAL MAST ARM INSPECTION REPORT)

Structure ID: 70M084

| BY: | Ayres Associates | STRUCTURE NAME: | US-1 (Washington Ave.) at Grace St |

TYPE OF INSPECTION: Regular NBI

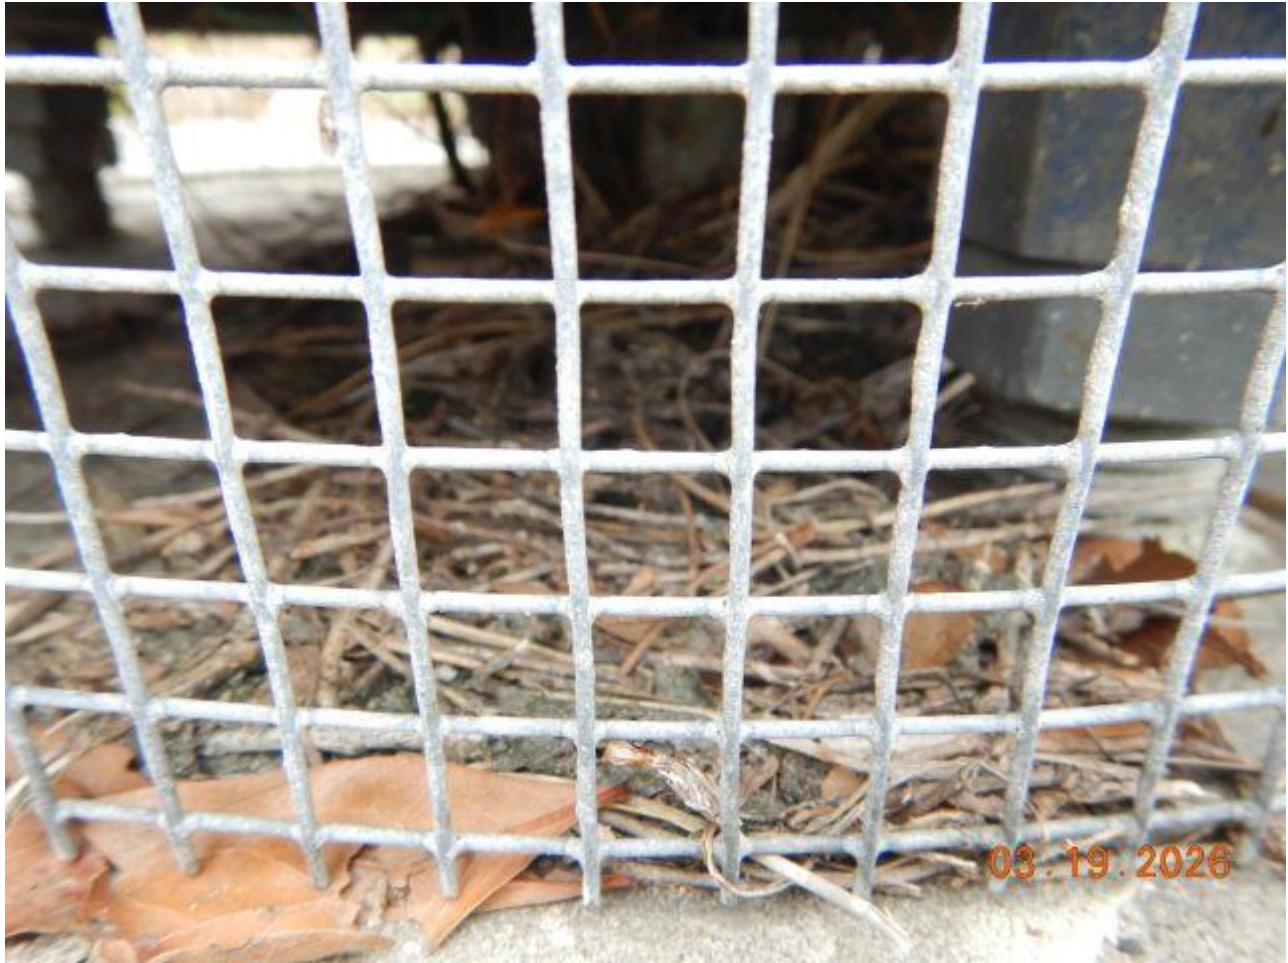
**Photo 1: Element 8480 / Mast Arm Foundation**

F1 - Clean the dirt and debris below the base plate and replace the vermin guard in accordance with FDOT Spec 649-6. No repairs have been performed.

F1 - Debris and vermin nesting material below base plate.

| CONDITION<br>STATE | | | PRIORITY |
|---|---|---|---|
| F1 - Remove debris and vermin nesting material from below base plate. | | | |

F1 - Remove debris and vermin nesting material from below base plate.

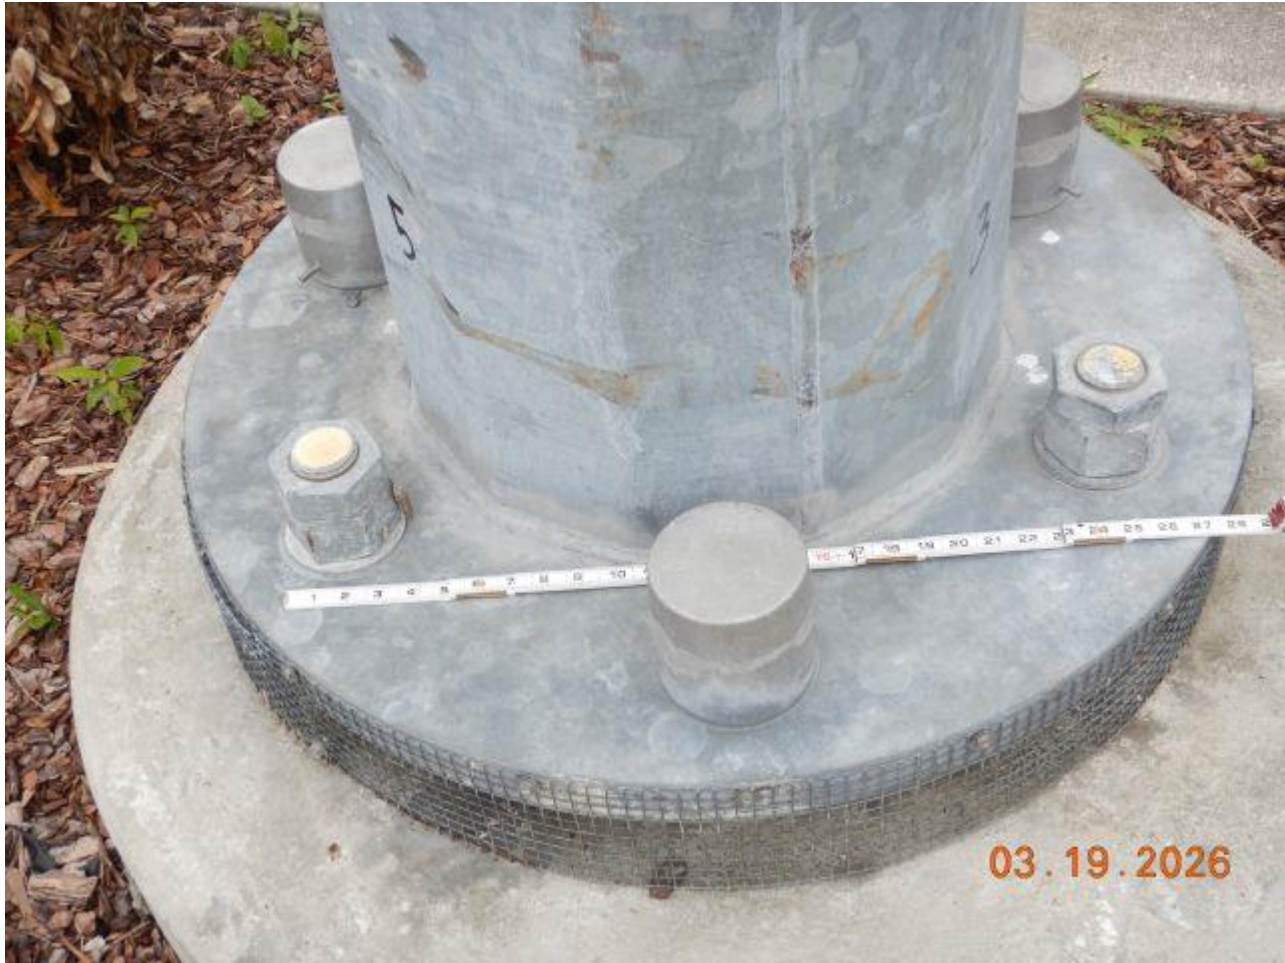
**Photo 2: Element 8480 / Mast Arm Foundation**

F2 - Missing anchor bolt covers (AB #3 & 5).

| CONDITION<br>STATE | | | PRIORITY |
|---|---|---|---|
| F2 - Replace the 2 missing anchor bolt covers. | | | |

F2 - Replace the 2 missing anchor bolt covers.

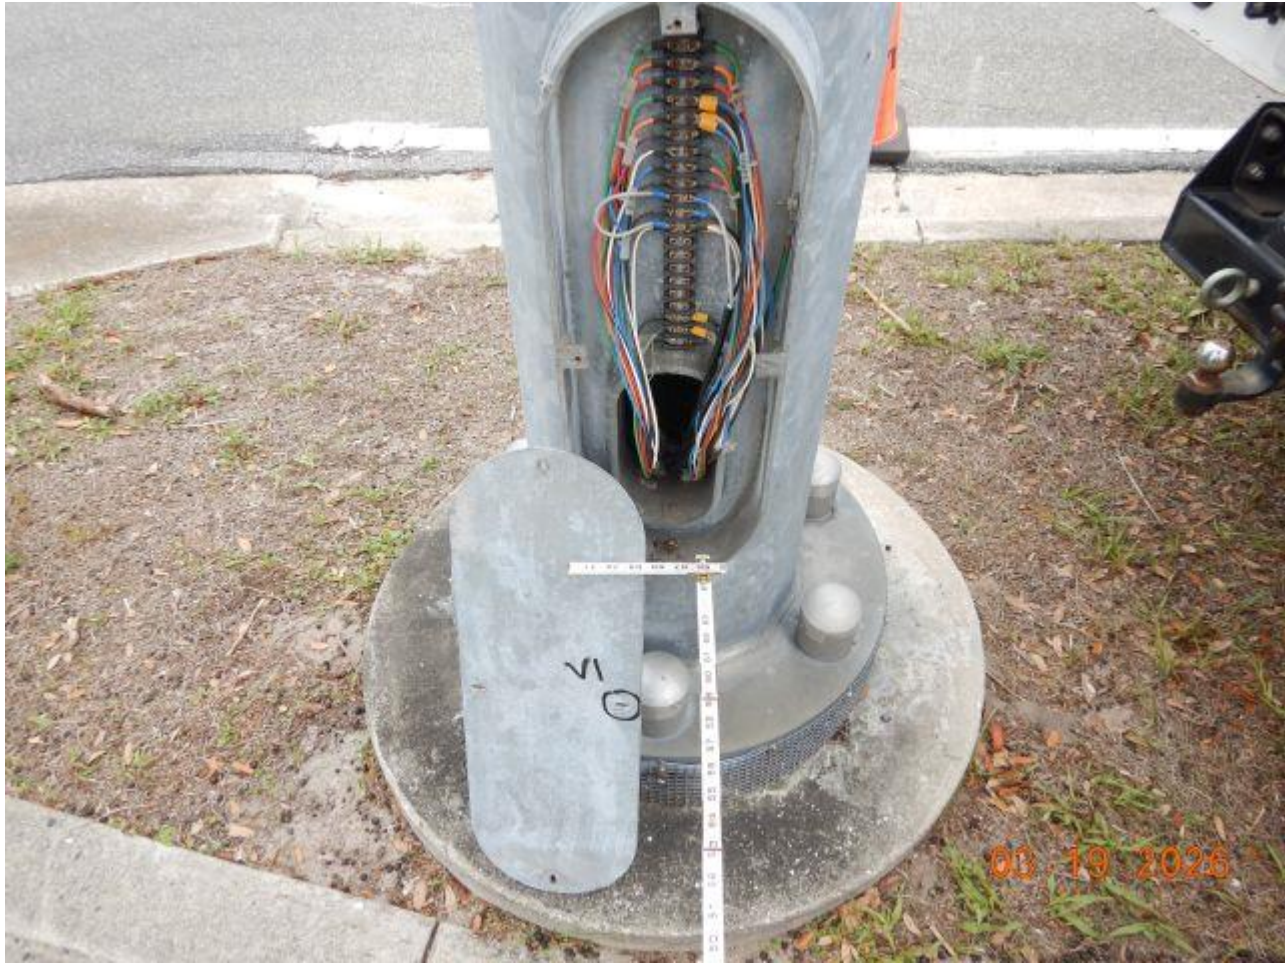
**Photo 3: Element 8481 / Mast Arm Vertical**

V1, V2 and V3 - The terminal compartment covers are missing the weatherproof gaskets. NEW. Refer to Photo 3. REPAIR.

V1 V2 & V3 - Typical terminal compartment cover missing the weatherproof gasket.

| CONDITION<br>STATE | | | PRIORITY |
|---|---|---|---|
| V1 V2 & V3 - Install weatherproof gasket for terminal compartment cover per FDOT Index 649-031. | | | |

V1 V2 & V3 - Install weatherproof gasket for terminal compartment cover per FDOT Index 649-031.

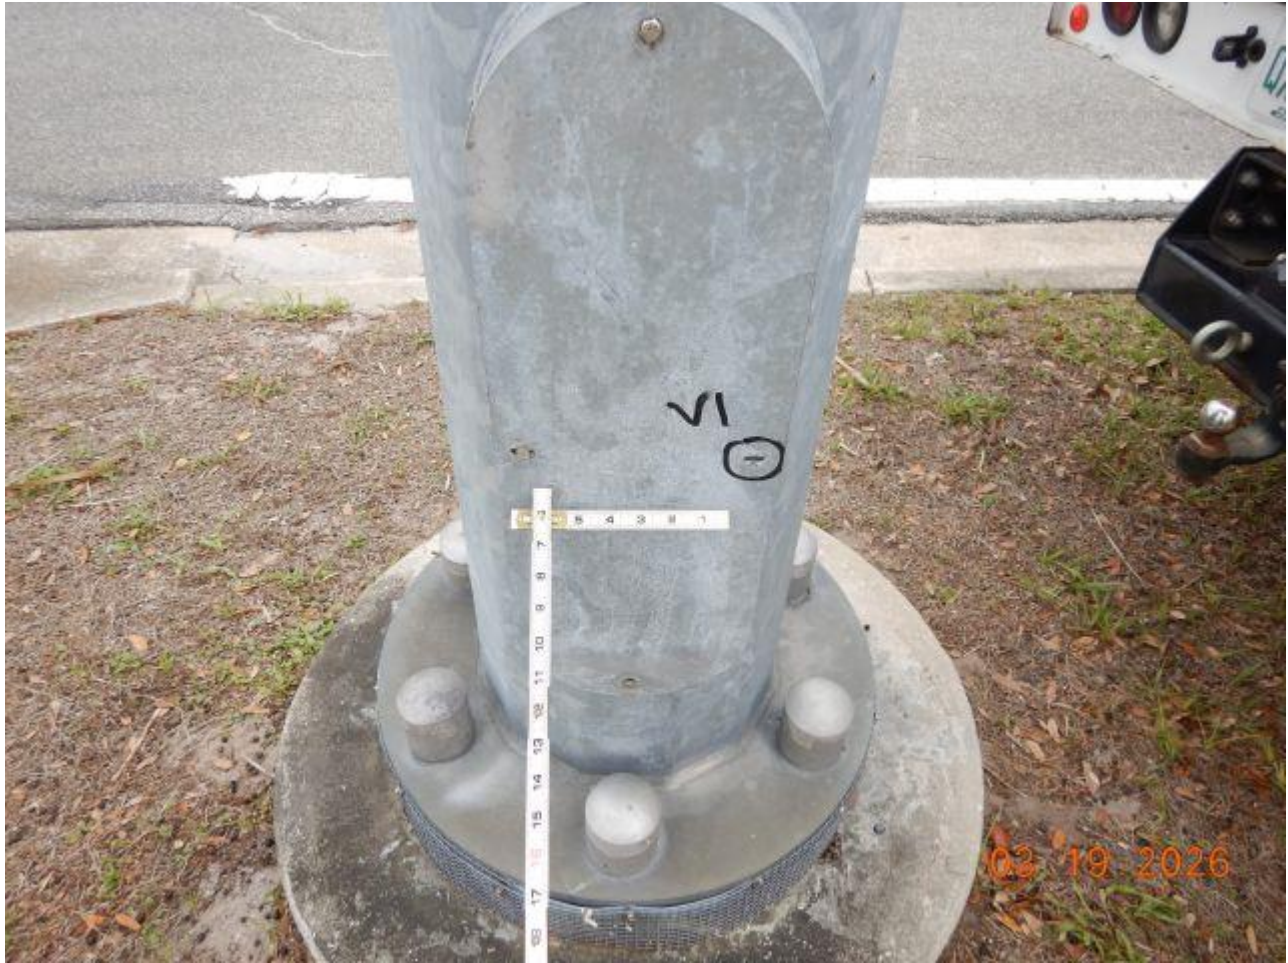
**Photo 4: Element 8481 / Mast Arm Vertical**

V1 - The terminal compartment cover has (1) of (4) bolts sheared off, but cover is secure. NEW. Refer to Photo 4.

V1 - Compartment cover with sheared attachment bolt.

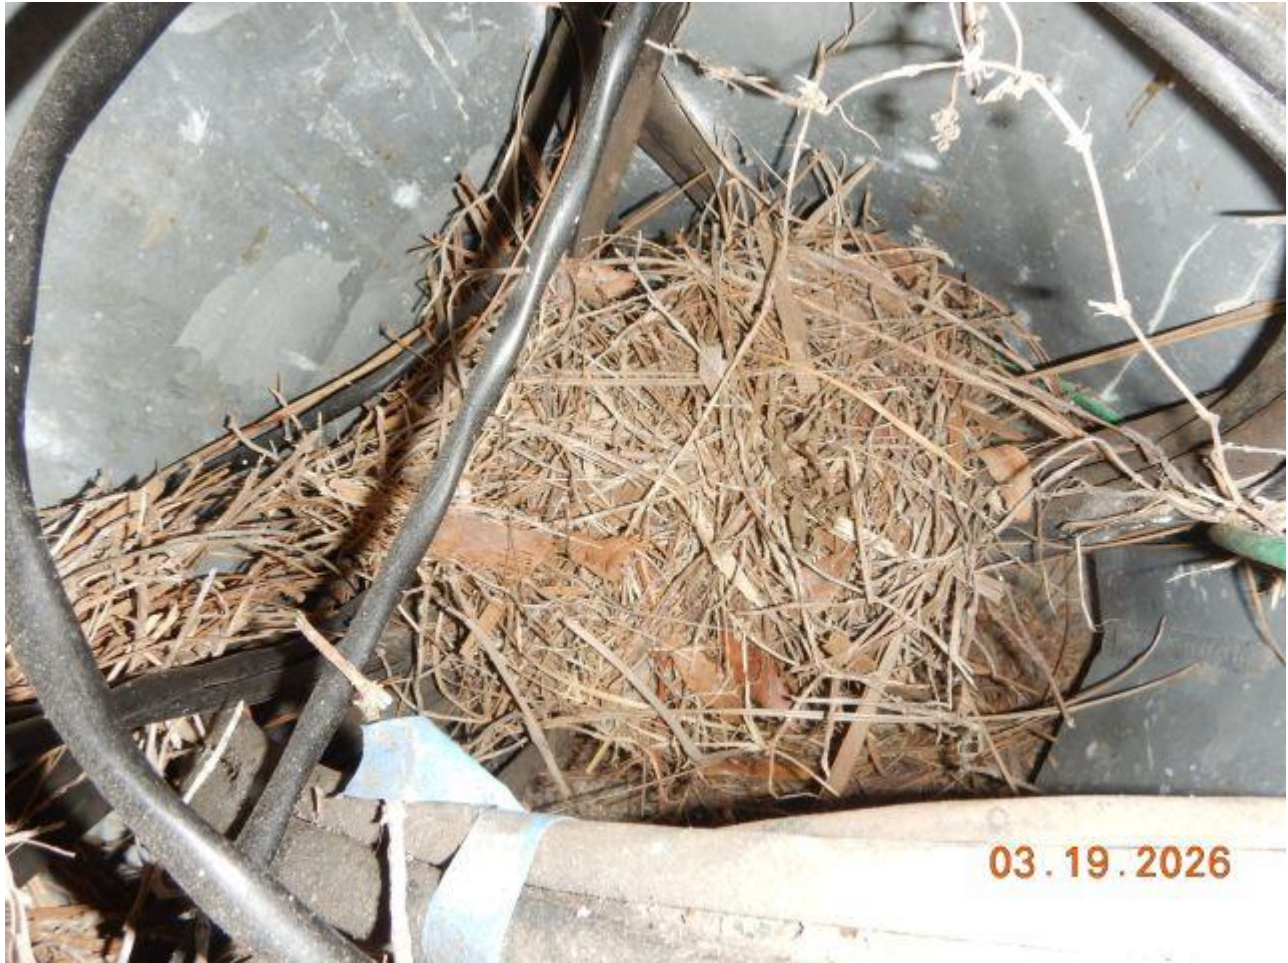
**Photo 5: Element 8481 / Mast Arm Vertical**

V1 - There is a heavy accumulation of nesting debris within the vertical at the terminal compartment. NEW. Refer to Photo 5. REPAIR.

V1 - Heavy accumulation of vermin nesting material within column at the terminal compartment.

| CONDITION<br>STATE | | | PRIORITY |
|---|---|---|---|
| V1 - Remove vermin nesting material from within column at the terminal compartment. | | | |

V1 - Remove vermin nesting material from within column at the terminal compartment.

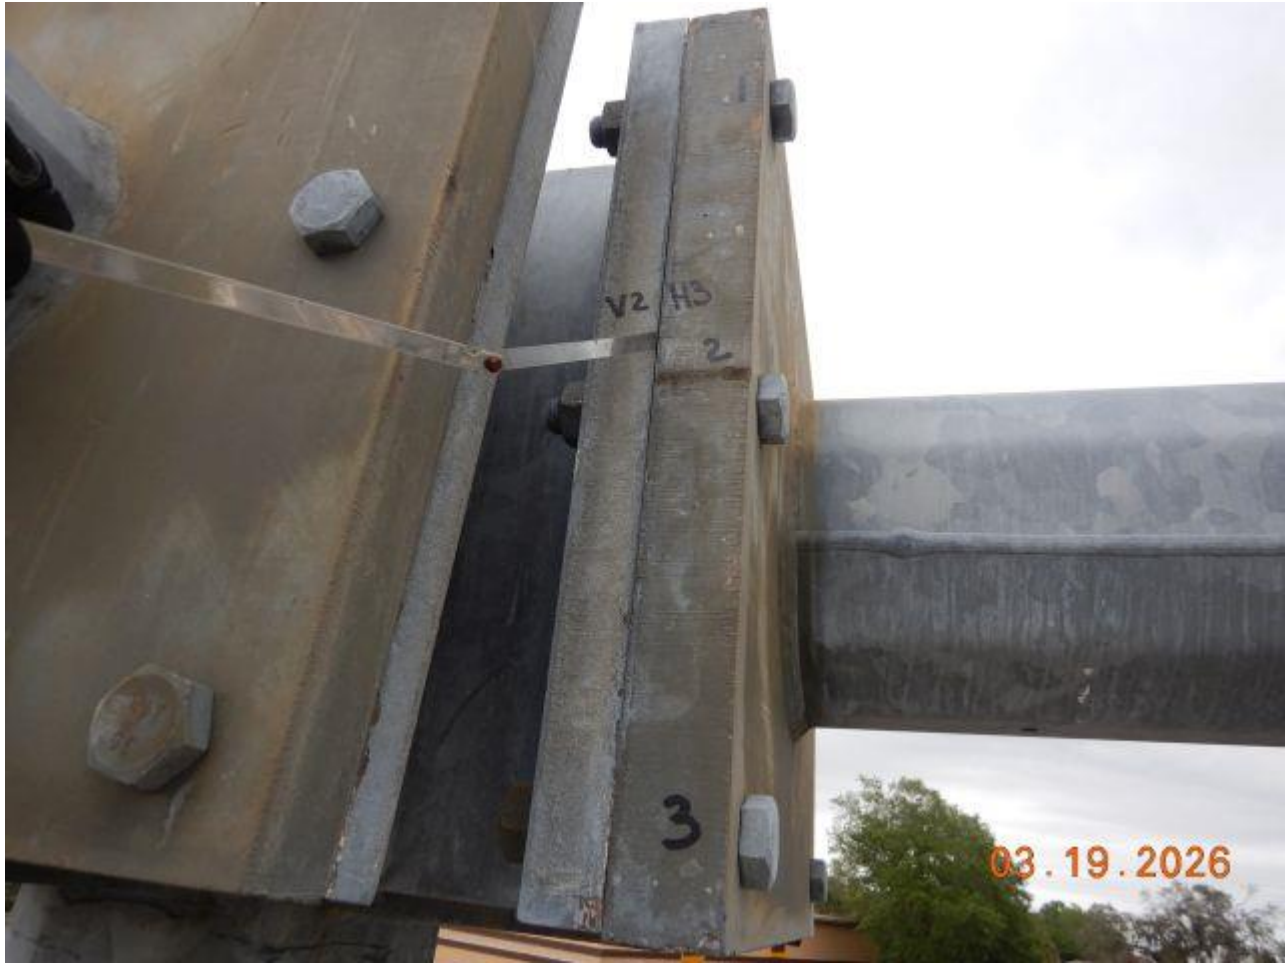
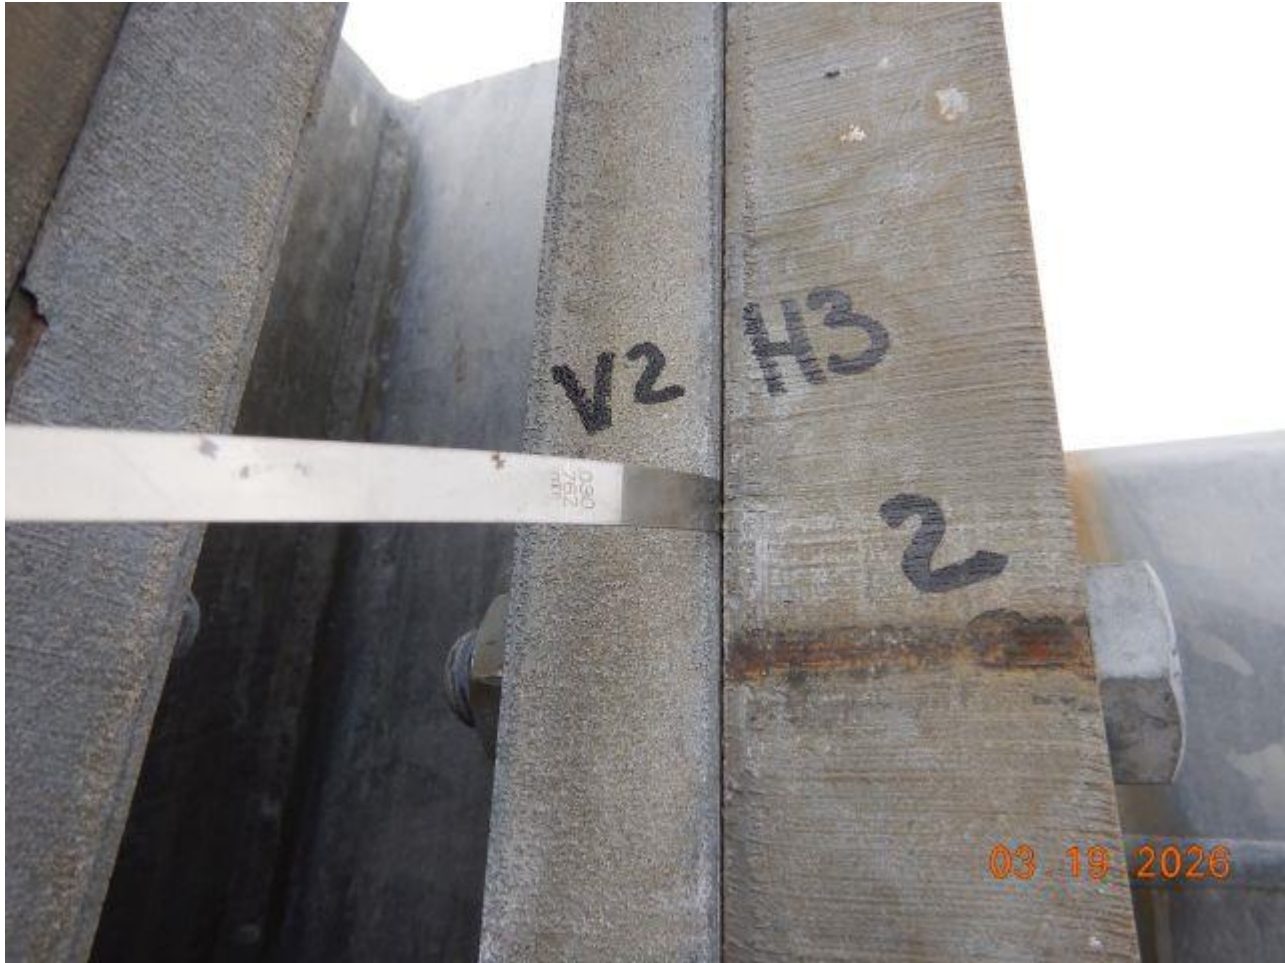
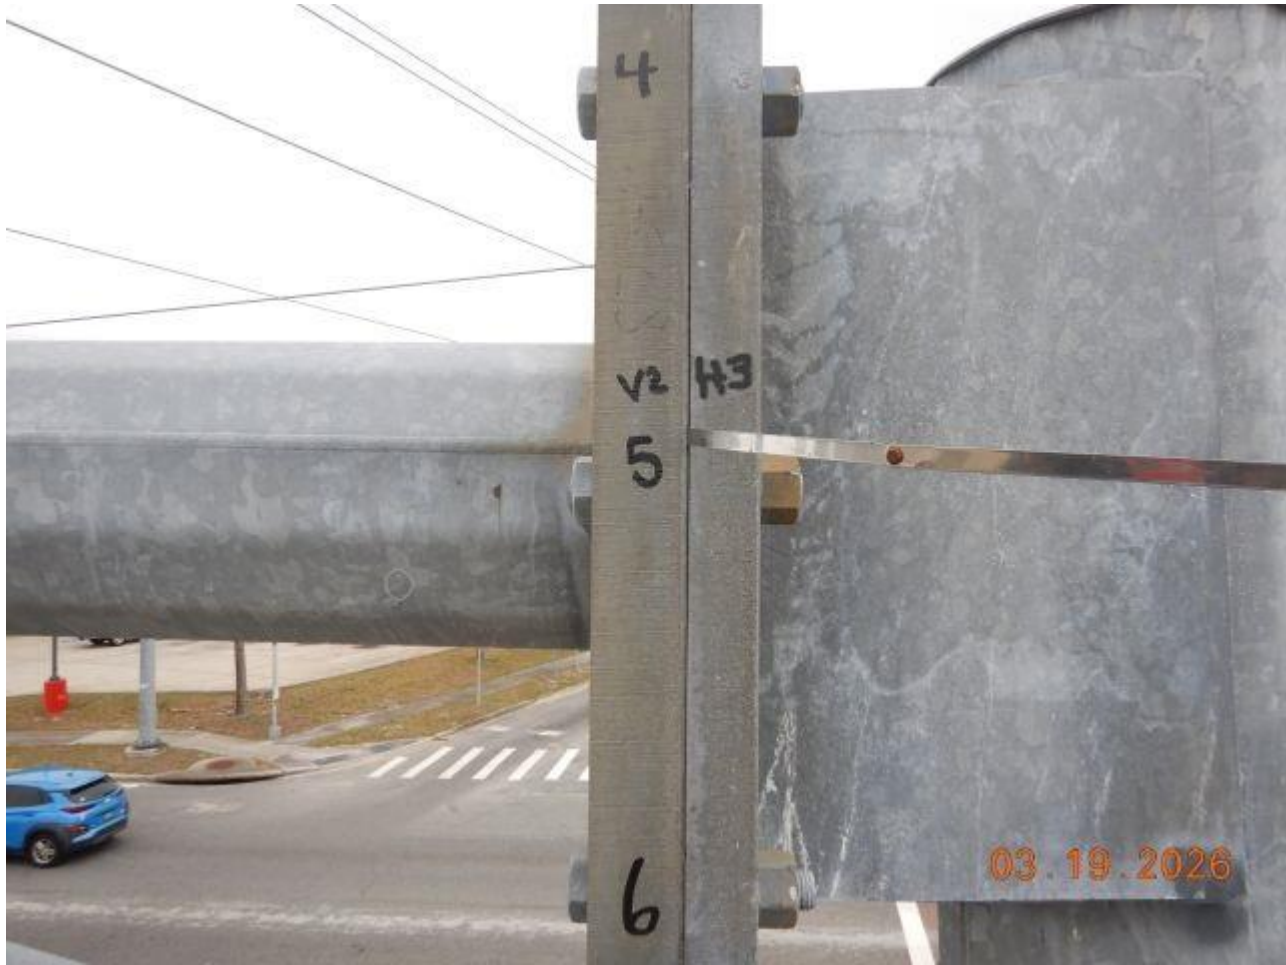
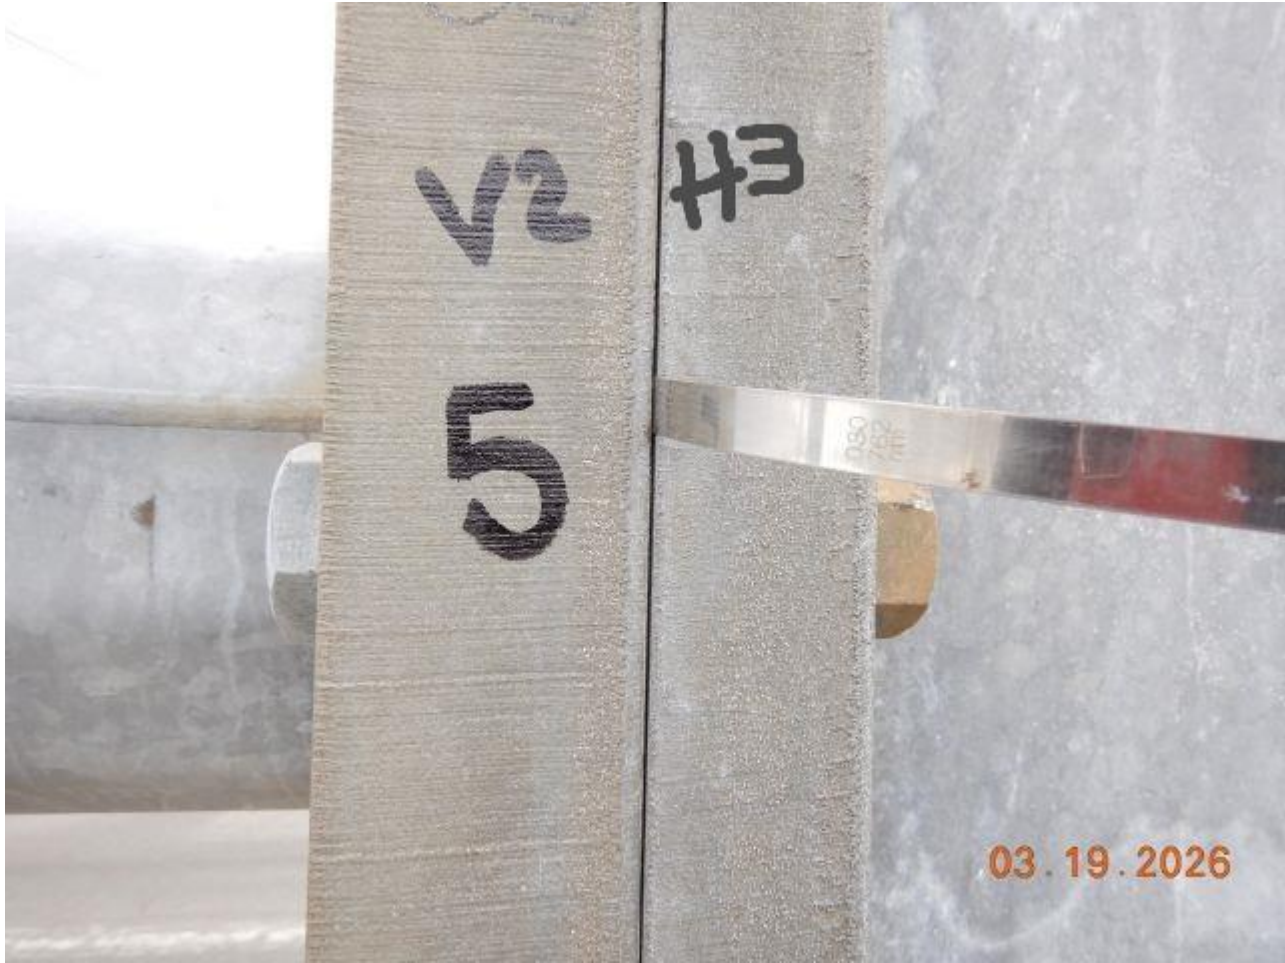
V2/H3 - The moment connection has a 1/32 in. gap between the plates at Bolts #2 and #5, but all bolts are tight. NEW. Refer to Photos 6 thru 9. (1 EA)

V2/H3 - Overview of slight moment connection gap between plates at Bolt #2.

V2/H3 - Close-up of slight moment connection gap between plates at Bolt #2.

V2/H3 - Overview of slight moment connection gap between plates at Bolt #5.

V2/H3 - Close-up of slight moment connection gap between plates at Bolt #5.

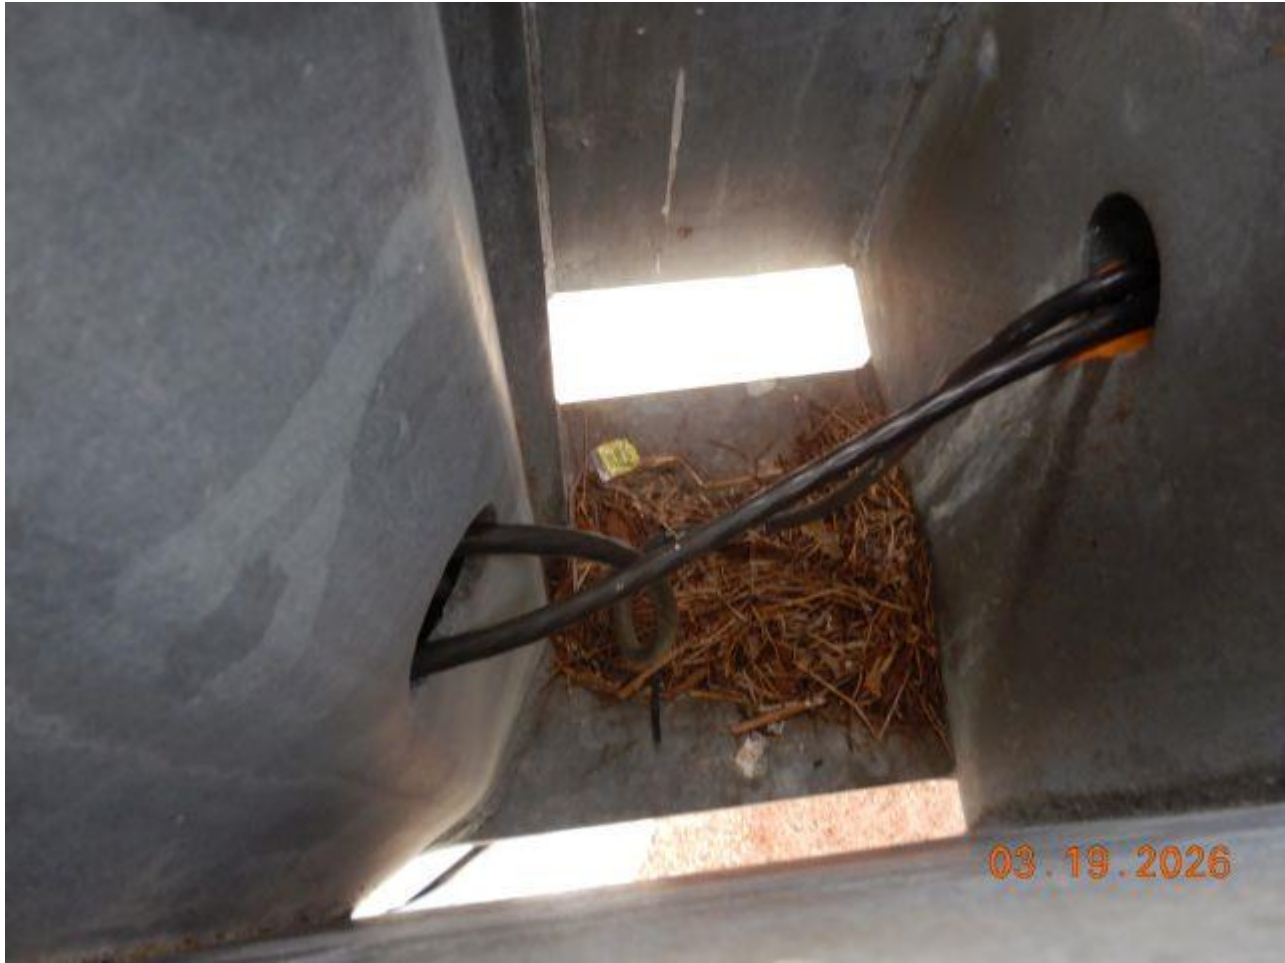
**Photo 11: Element 8484 / Mast Arm Horizontal**

V2/H2 - There is a bird nest between the moment connection plates. NEW. Refer to Photo 11. REPAIR.

V2/H2 - Bird nest between moment connection plates.

| CONDITION<br>STATE | | | PRIORITY |
|---|---|---|---|
| Remove bird nests from H2 moment connection plates & install screening at H1 H2 H3 & H4. | | | |

Remove bird nests from H2 moment connection plates & install screening at H1 H2 H3 & H4.

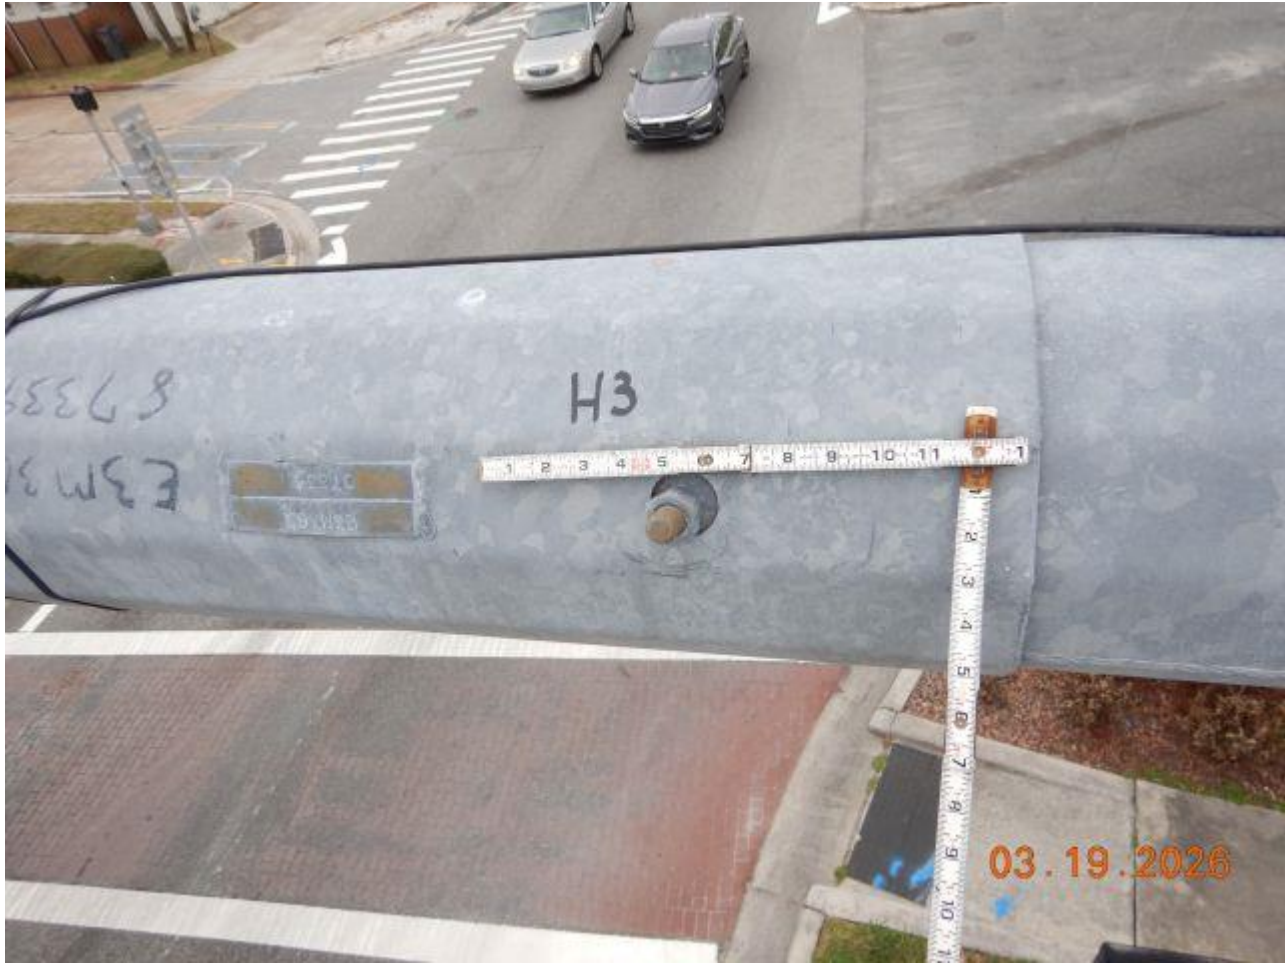
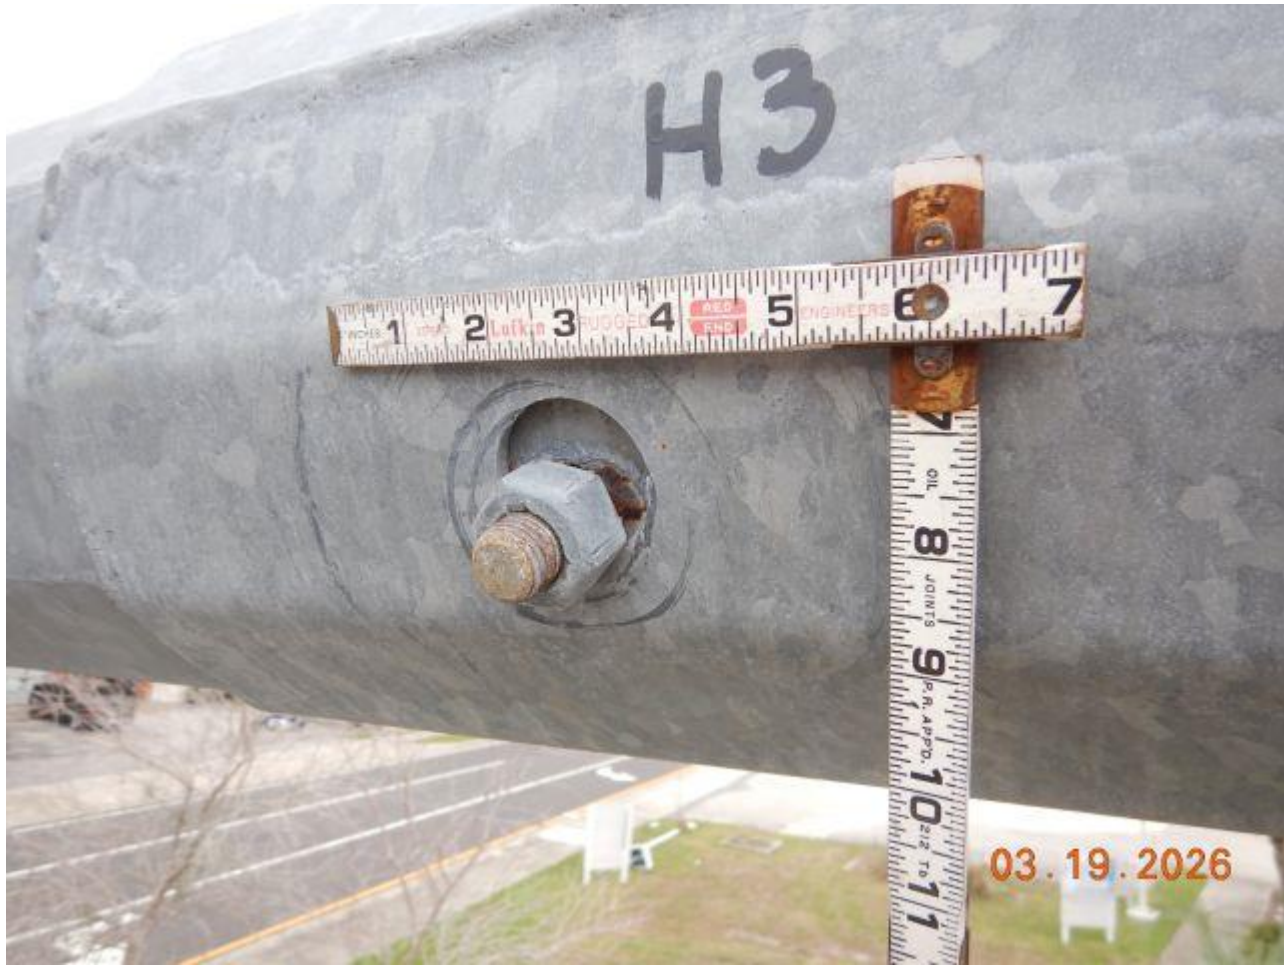
V2/H2, V2/H3 and V3/H4 - The mast arm splice bolts are missing washers and the holes are oversized, therefore the bolts have none or little clamping affect. NEW. Refer to Photos 12 and 13. REPAIR.

V2H2 V2H3 and V3H4 - Overview of typical mast arm splice bolt missing the washer and oversized hole.

V2H2 V2H3 and V3H4 - Close-up of typical mast arm splice bolt missing the washer and oversized hole.

| CONDITION<br>STATE | | | PRIORITY |
|---|---|---|---|
| V2H2 V2H3 and V3H4 - Install flat washers on the mast arm splice bolts. | | | |

V2H2 V2H3 and V3H4 - Install flat washers on the mast arm splice bolts.
