**FLORIDA DEPARTMENT OF TRANSPORTATION**  
**BRIDGE MANAGEMENT SYSTEM**  
**Inspection/CIDR Report**  
(TRAFFIC SIGNAL MAST ARM INSPECTION REPORT)

Structure ID: 70M085

| BY: | Ayres Associates | STRUCTURE NAME: | US-1 SB at SR-405 |

TYPE OF INSPECTION: Regular NBI

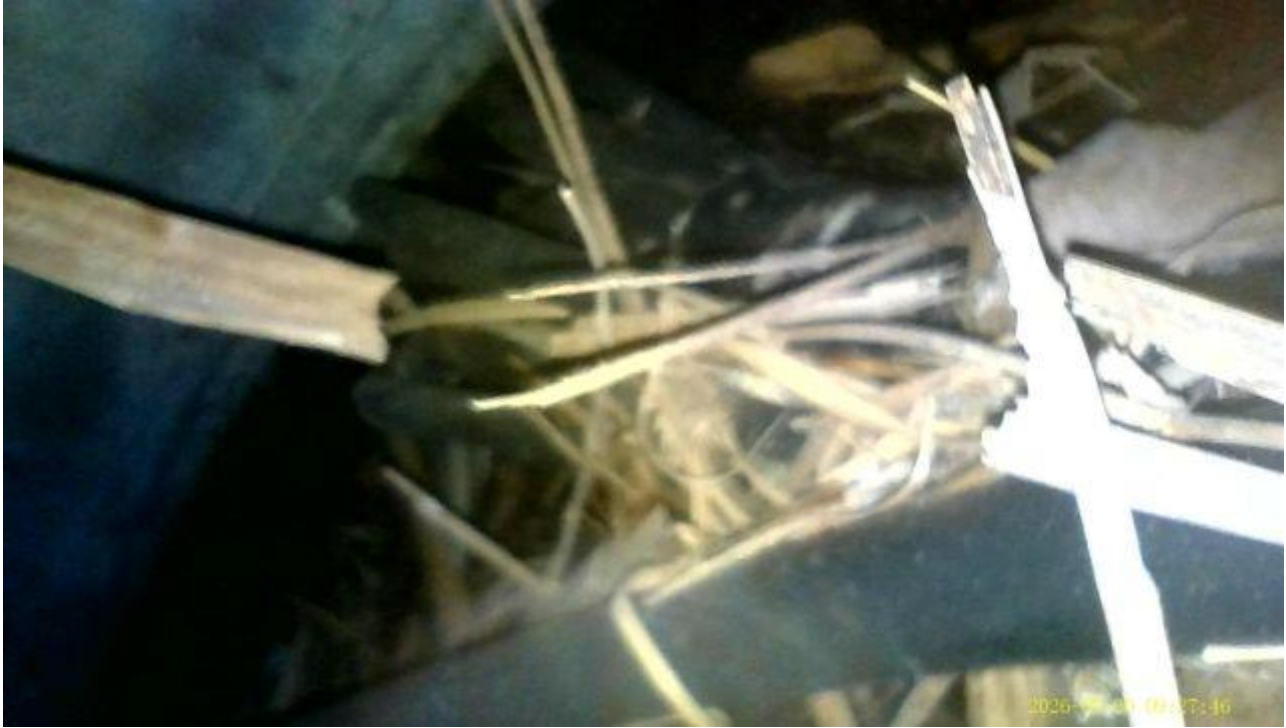
**Photo 1: Element 8480 / Mast Arm Foundation**

F1 - There is a heavy accumulation of debris and moisture below the base plate around the anchor bolts viewed with a borescope thru the terminal compartment. The anchor bolts and leveling nuts could not be directly viewed thru the debris. NEW. Refer to Photo 1. REPAIR.

F1 - Debris and moisture below base plate.

| CONDITION<br>STATE | | | PRIORITY |
|---|---|---|---|
| F1 - Remove grout ring paint anchor bolts & leveling nuts & install wire screen per FDOT Spec.649-8. | | | |

F1 - Remove grout ring paint anchor bolts & leveling nuts & install wire screen per FDOT Spec.649-8.

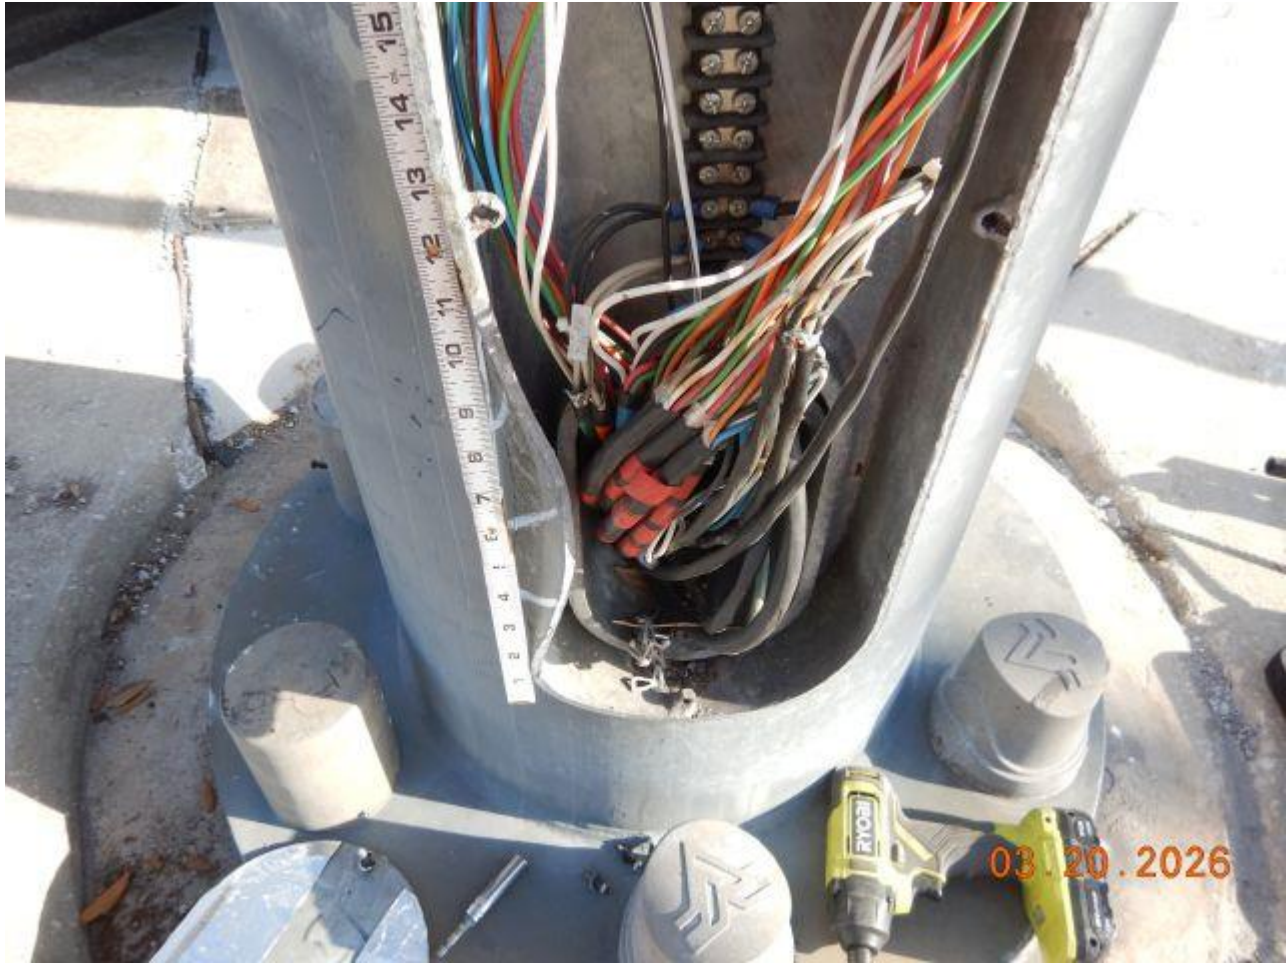
**Photo 2: Element 8481 / Mast Arm Vertical**

V1 - The compartment access flange has impact damage on the west side 12 in. H x 3 in. W with 1 in. of distortion. NO CHANGE. Refer to Photos 2 & 3. (1 EA) REPAIR

V1 - Overview compartment access flange with impact damage.

| CONDITION<br>STATE | | | PRIORITY |
|---|---|---|---|
| V1 - Repair the column compartment access flange. | | | |

V1 - Repair the column compartment access flange.

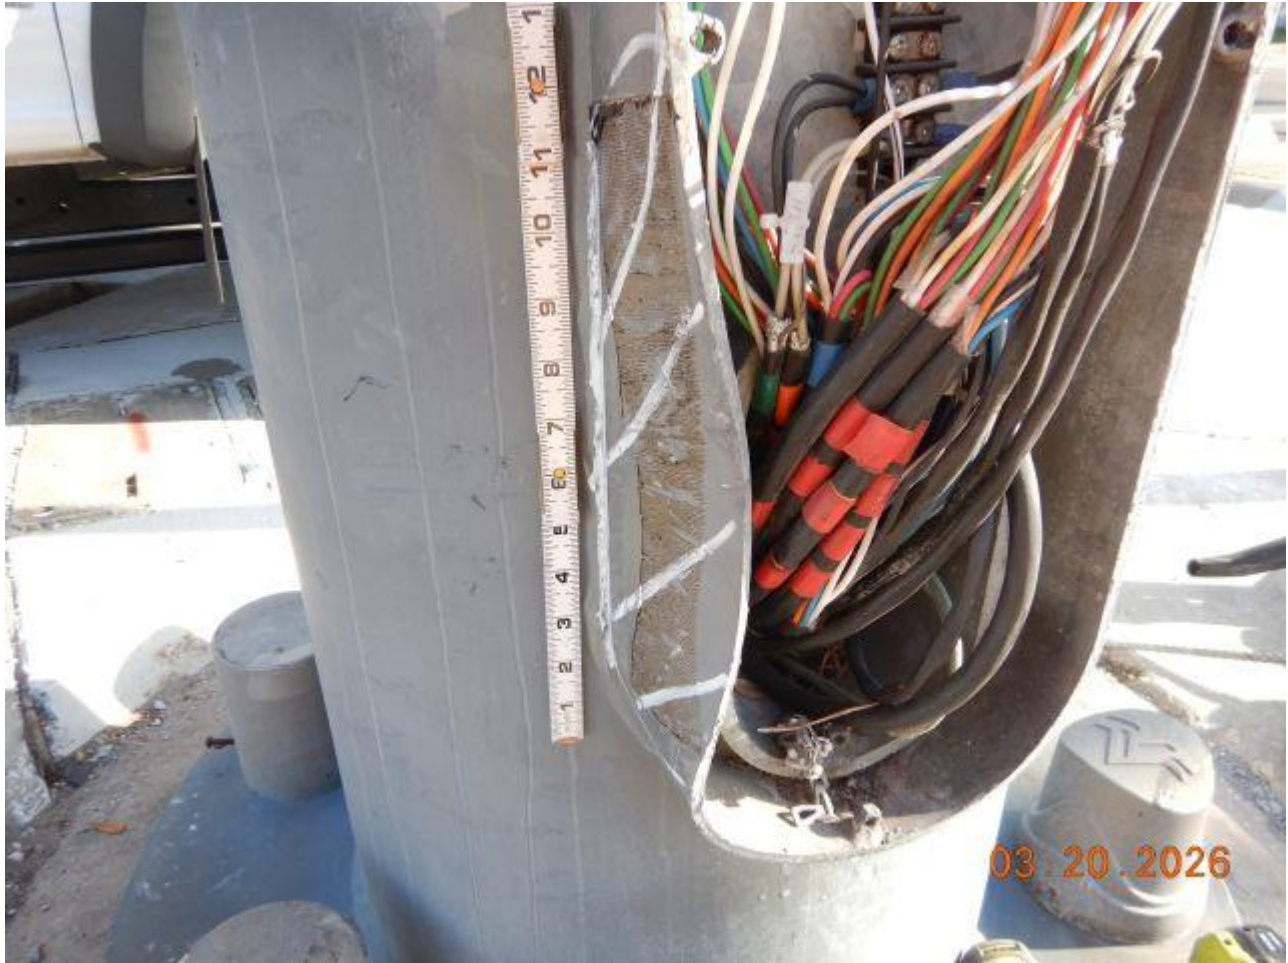
**Photo 3: Element 8481 / Mast Arm Vertical**

V1 - Close-up of compartment access flange with impact damage.

V1 - Repair the column compartment access flange.

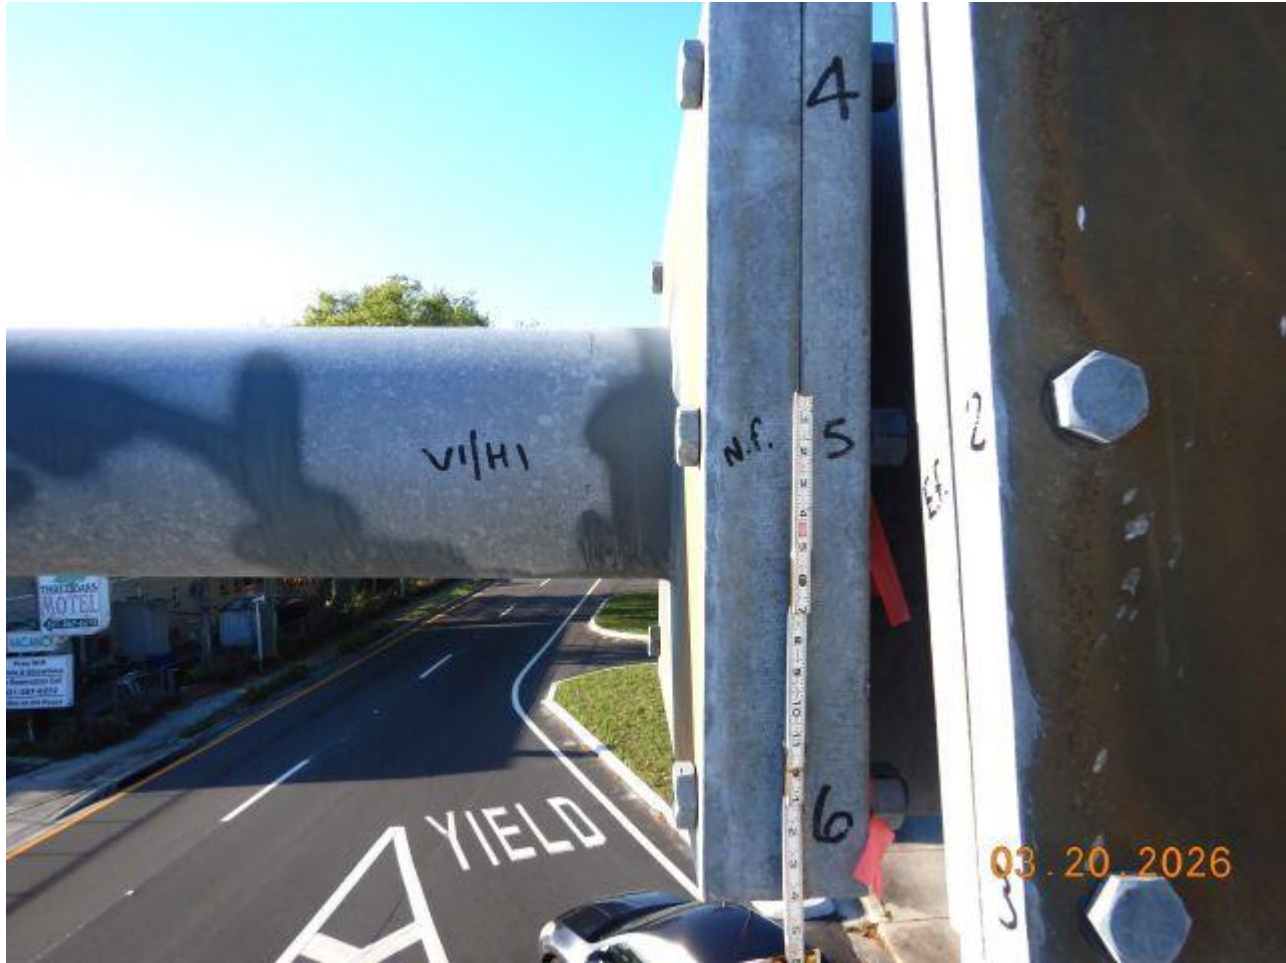
**Photo 4: Element 8484 / Mast Arm Horizontal**

V1/H1 - Moment Connection Bolts #5 & #6 are loose. NO CHANGE. Refer to Photos 4 & 5. (1 EA) REPAIR.

V1/H1 - Overview of loose moment connection bolts #5 & 6 and gap between plates.

| CONDITION<br>STATE | | | PRIORITY |
|---|---|---|---|
| V1H1 - Replace moment connection bolts #5 & 6 with new A325 bolts 7 in. L x 1.0 in. Dia. | | | |

V1/H1 - Replace moment connection bolts #5 & 6 with new A325 bolts 7 in. L x 1.0 in. Dia.

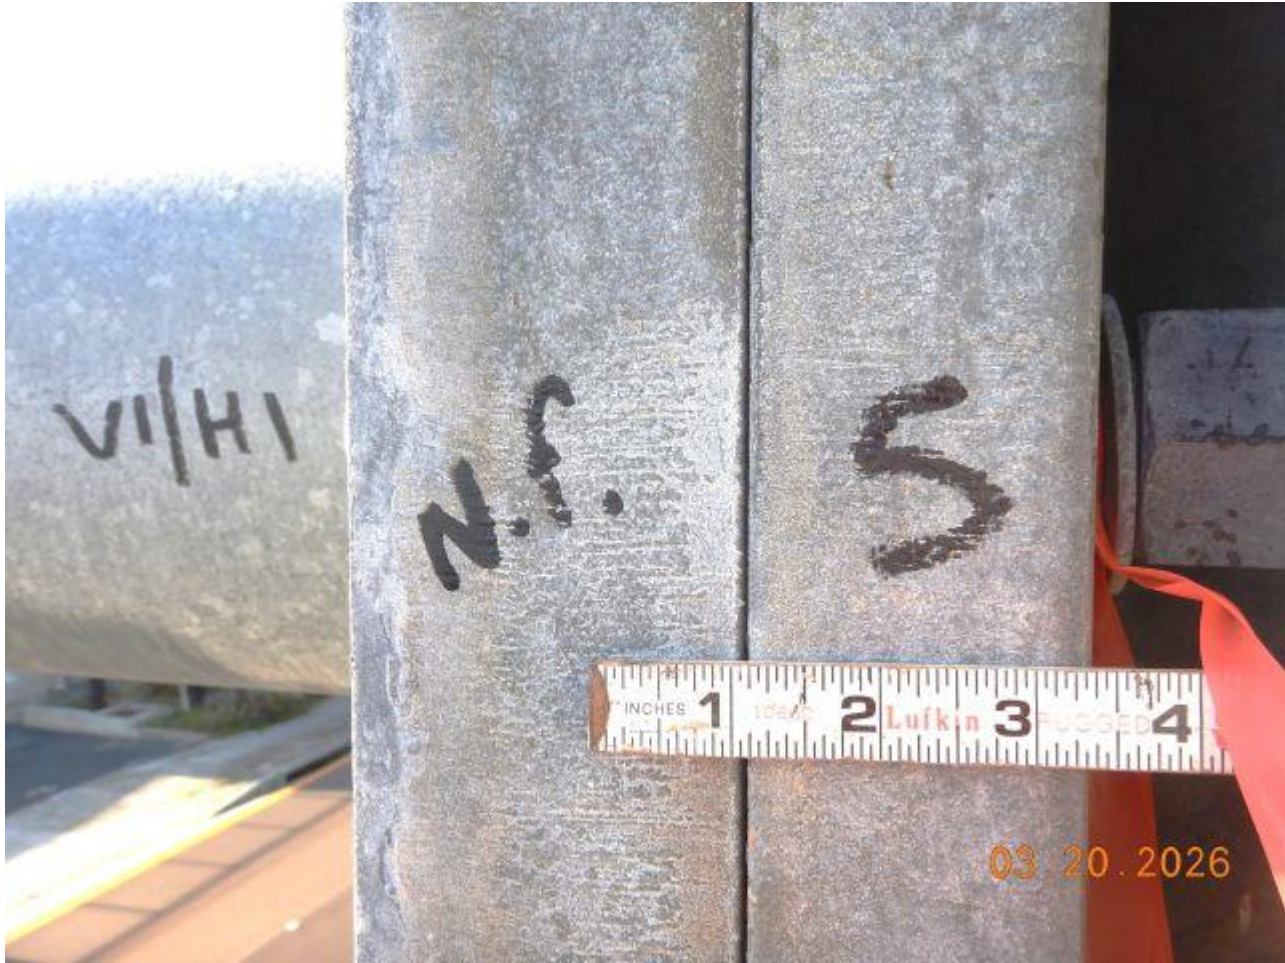
**Photo 5: Element 8484 / Mast Arm Horizontal**

V1/H1 - The moment connection has a gap up to 1/16 in. wide between the plates at Bolts #5 and #6 (previously Bolt #6 only). INCREASE. Refer to Photo 5. REPAIR.

V1/H1 - Close-up of loose moment connection bolt and gap between plates.

V1H1 - Replace moment connection bolts #5 & 6 with new A325 bolts 7 in. L x 1.0 in. Dia.

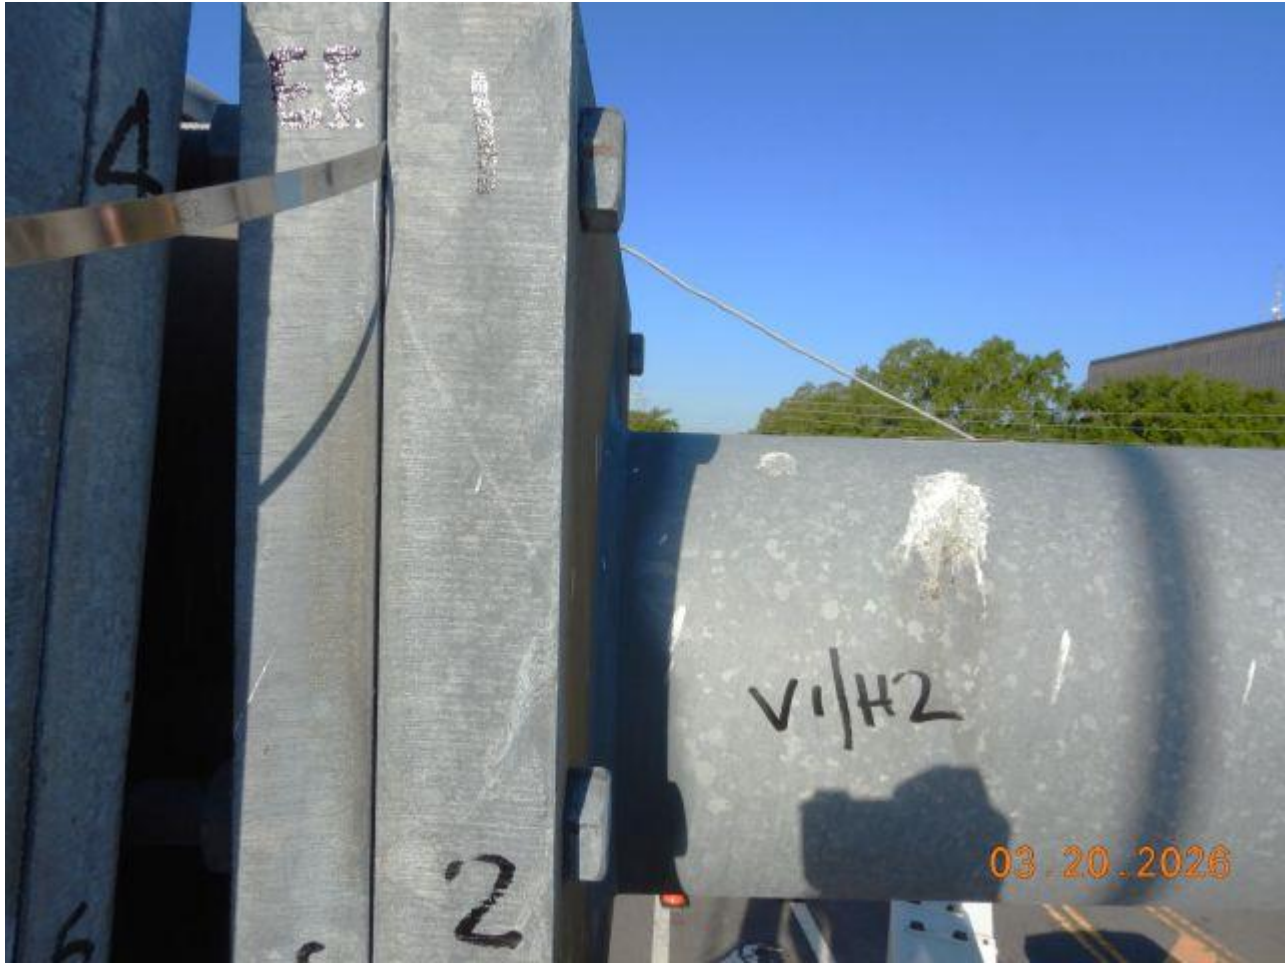
**Photo 6: Element 8484 / Mast Arm Horizontal**

V1/H2 - The moment connection has a gap up to 1/16 in. wide between the plates at Bolts #1 and #2 (previously noted at Bolt #1 only), but all bolts are tight. INCREASE. Refer to Photo 6. (1 EA)

V1/H2 - Overview of moment connection gap between plates at Bolts #1 and #2.

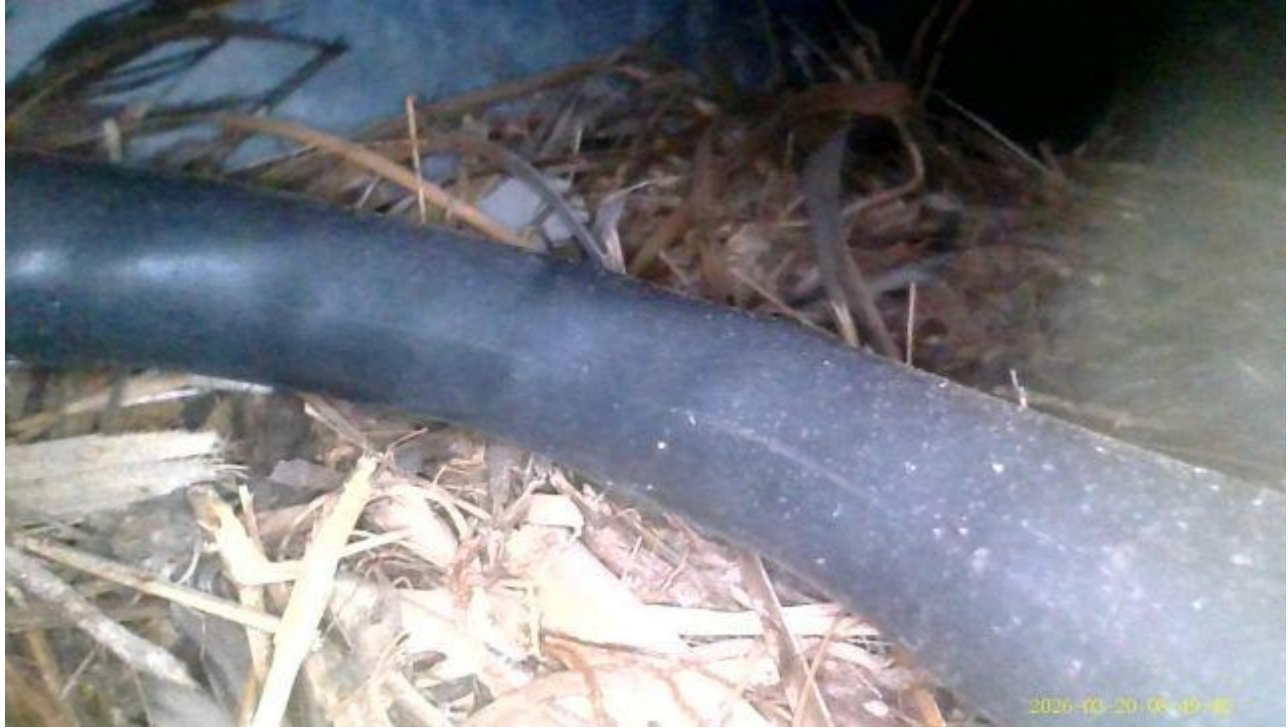
**Photo 7: Element 8484 / Mast Arm Horizontal**

V1/H1 - The horizontal arm interior has a heavy accumulation of bird nesting material viewed with a borescope thru the arm drain hole. D-meter readings at 3 in., 12 in. & 24 in. from the moment connection taken at the 5, 6 and 7 o'clock positions did not indicate any reduction in section at this time. NEW. Refer to Photo 7. REPAIR.

V1/H1 - Bird nesting material inside horizontal arm interior.

| CONDITION<br>STATE | | | PRIORITY |
|---|---|---|---|
| V1H1 & V1H2 - Install screening to prevent bird nesting in the arms & moment connection plates. | | | |

V1H1 & V1H2 - Install screening to prevent bird nesting in the arms & moment connection plates.
