**FLORIDA DEPARTMENT OF TRANSPORTATION**  
**BRIDGE MANAGEMENT SYSTEM**  
**Inspection/CIDR Report**  
(TRAFFIC SIGNAL MAST ARM INSPECTION REPORT)

Structure ID: 70M086

| BY: | Ayres Associates | STRUCTURE NAME: | US-1 (Washington Ave.) NB at SR-405 (South St.) |

TYPE OF INSPECTION: Regular NBI

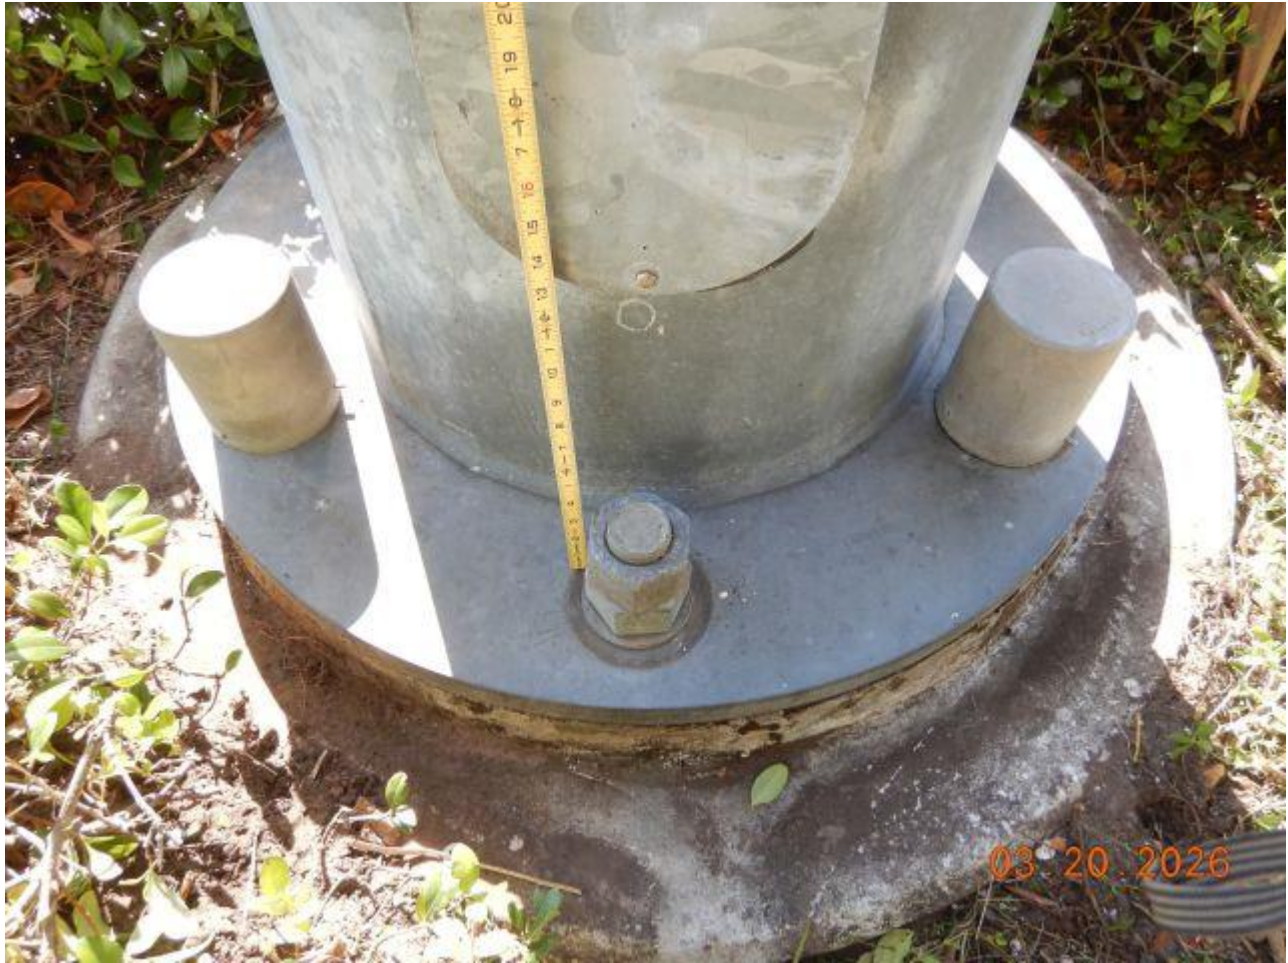
**Photo 1: Element 8480 / Mast Arm Foundation**

F1 - (1) of (6) anchor bolt covers is missing (AB#1). NEW. Refer to Photo 1. REPAIR.

F1 - Missing anchor bolt cover (AB#1).

| CONDITION<br>STATE | | | PRIORITY |
|---|---|---|---|
| F1 - Replace missing anchor bolt cover. | | | |

F1 - Replace the missing anchor bolt cover.

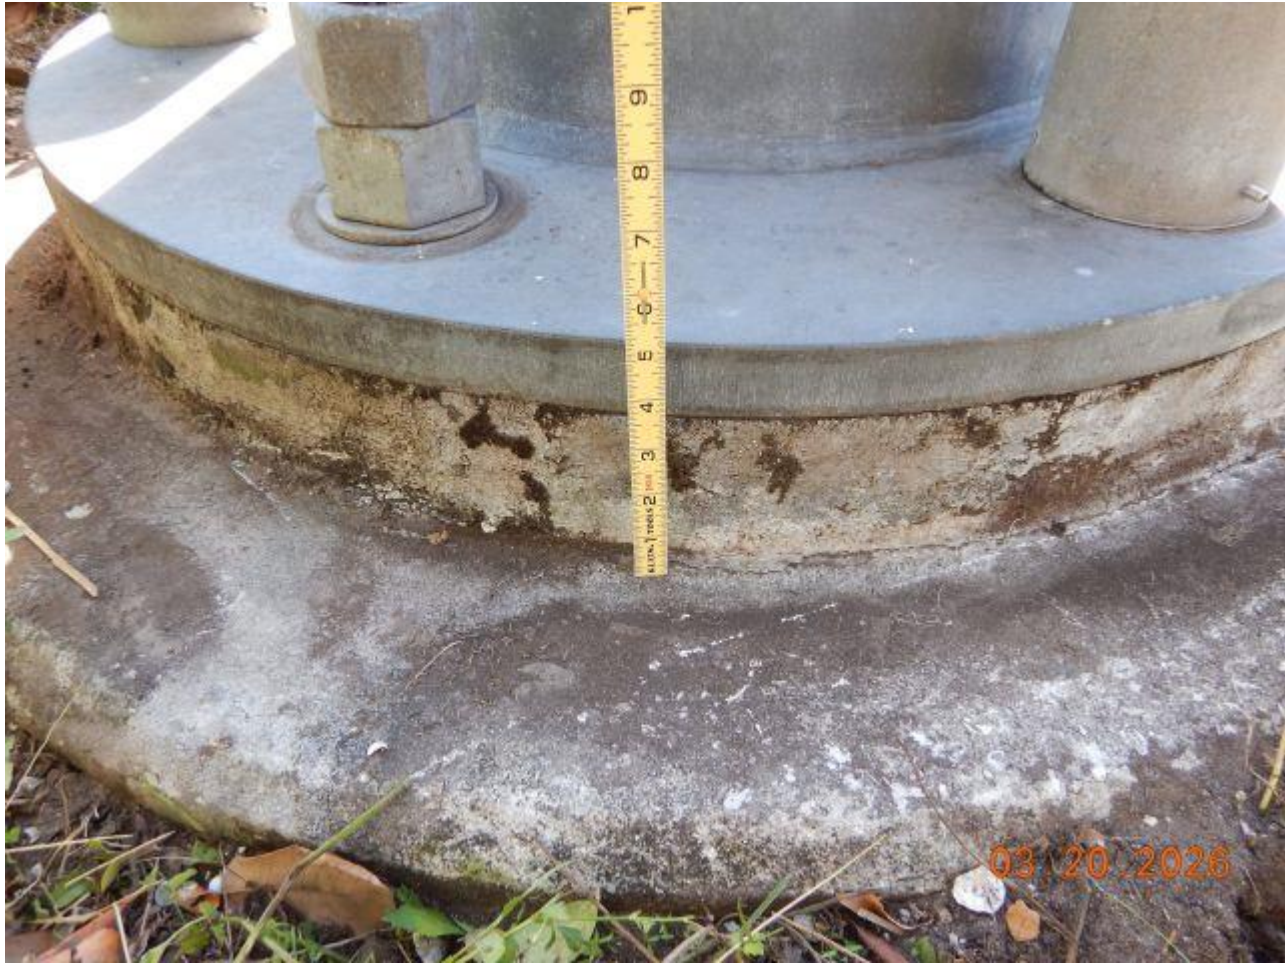
**Photo 2: Element 8480 / Mast Arm Foundation**

F1 - The grout ring is missing a drain hole. NEW. Refer to Photo 2. REPAIR.

F1 - Grout ring missing drain hole.

| CONDITION<br>STATE | | | PRIORITY |
|---|---|---|---|
| F1 - Remove grout ring paint anchor bolts & leveling nuts & install wire screen per FDOT Spec.649-8. | | | |

F1 - Remove grout ring paint anchor bolts & leveling nuts & install wire screen per FDOT Spec.649-8.

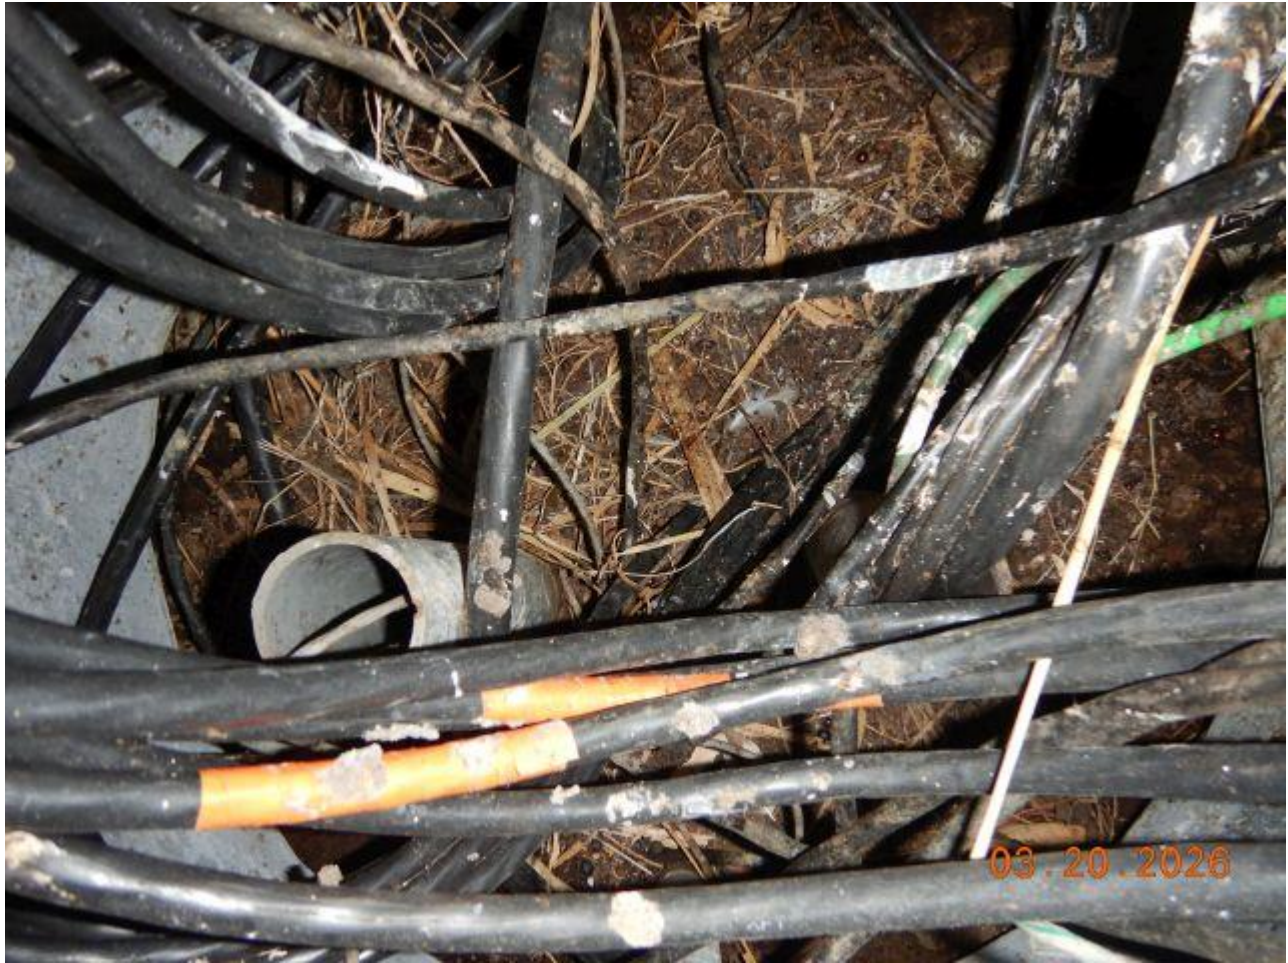
**Photo 3: Element 8480 / Mast Arm Foundation**

F1 - There is a heavy accumulation of dirt and nesting material inside the column and below the base plate around the anchor bolts viewed with a borescope thru the terminal compartment. The anchor bolts and leveling nuts could not be directly viewed thru the debris. NEW. Refer to Photo 3. REPAIR.

F1 - Dirt, debris & nesting material inside column and below base plate.

F1 - Remove grout ring paint anchor bolts & leveling nuts & install wire screen per FDOT Spec.649-8.

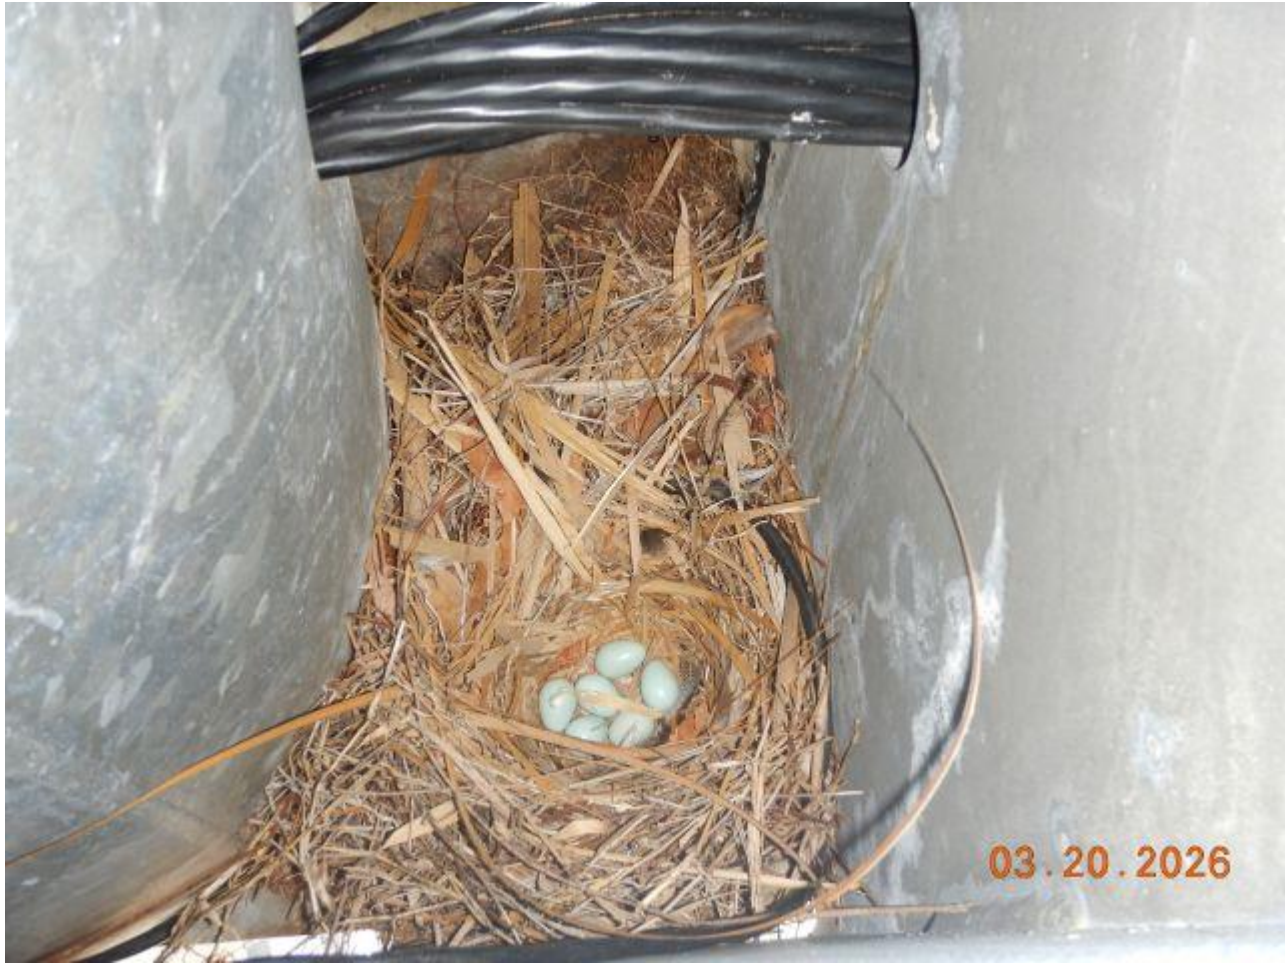
**Photo 4: Element 8484 / Mast Arm Horizontal**

V1/H1 - There is a bird nest between the moment connection plates. NO CHANGE. Refer to Photo 4. REPAIR.

V1/H1 - Remove the bird nest between the moment connection plates. The bird nest has not been removed since the 2021 Inspection or is re-occurring.

V1/H1 - Typical bird nest between moment connection plates.

| CONDITION<br>STATE | | | PRIORITY |
|---|---|---|---|
| V1H1 - Remove bird nests from moment connection plates & install screening. | | | |

V1H1 - Remove bird nests from moment connection plates & install screening.
