**FLORIDA DEPARTMENT OF TRANSPORTATION**  
**BRIDGE MANAGEMENT SYSTEM**  
**Inspection/CIDR Report**  
(TRAFFIC SIGNAL MAST ARM INSPECTION REPORT)

Structure ID: 70M087

| BY: | Ayres Associates | STRUCTURE NAME: | US-1 (Washington Ave.) NB at Main St |

TYPE OF INSPECTION: Regular NBI

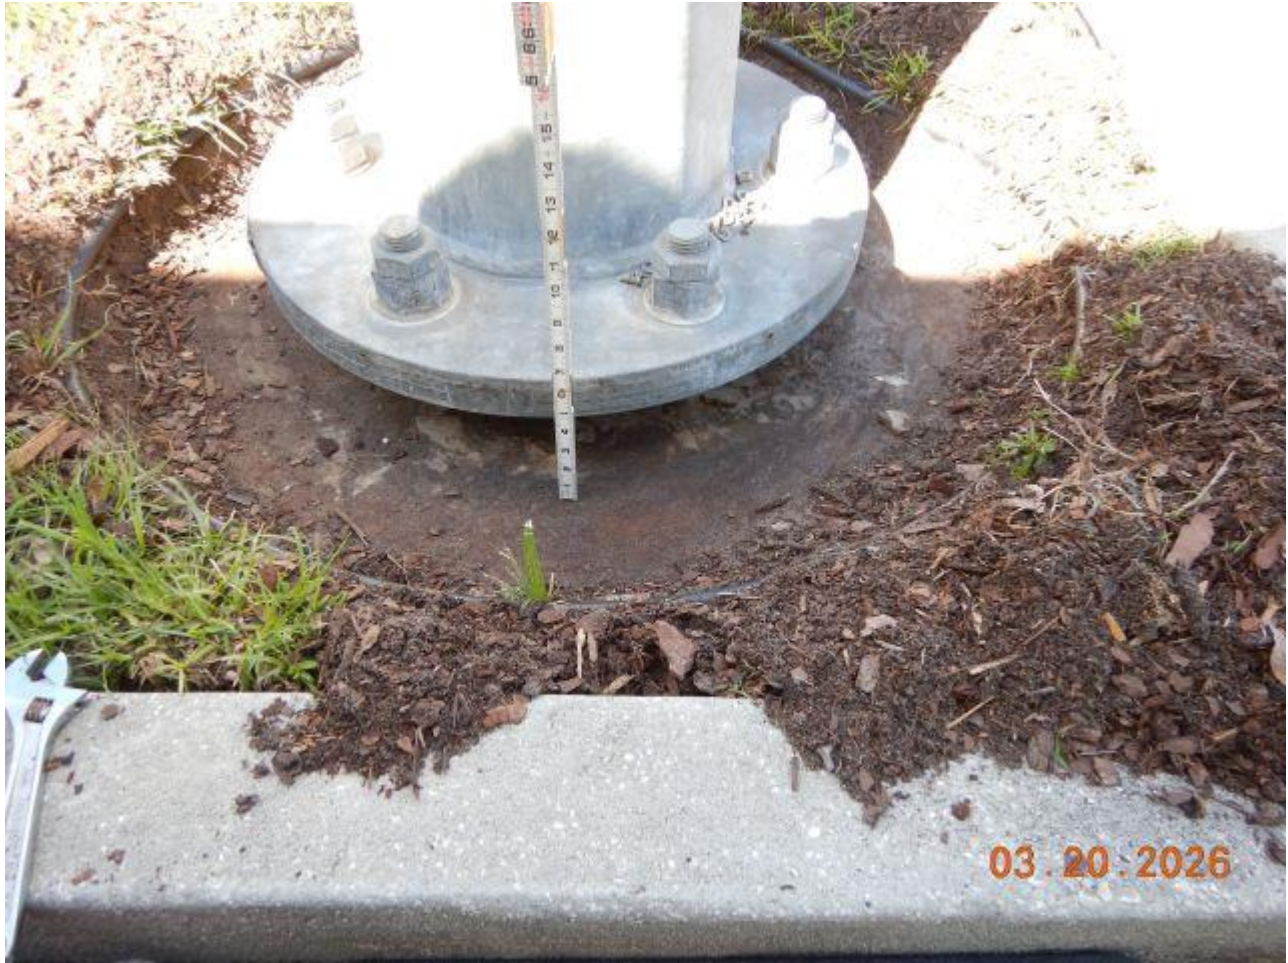
**Photo 1: Element 8480 / Mast Arm Foundation**

F1 - The foundation is up to 4 in. below grade and within a landscaping ring that is filled with mulch around the foundation. Heavy dirt below the base plate was removed and light corrosion on the anchor bolt threads and leveling nuts were cleaned & painted by the inspectors. NEW. Refer to Photo's 1 & 2.

F1 - Foundation below grade and within a landscape area filled with mulch.

REPAIR RECOMMENDATION:  
None.

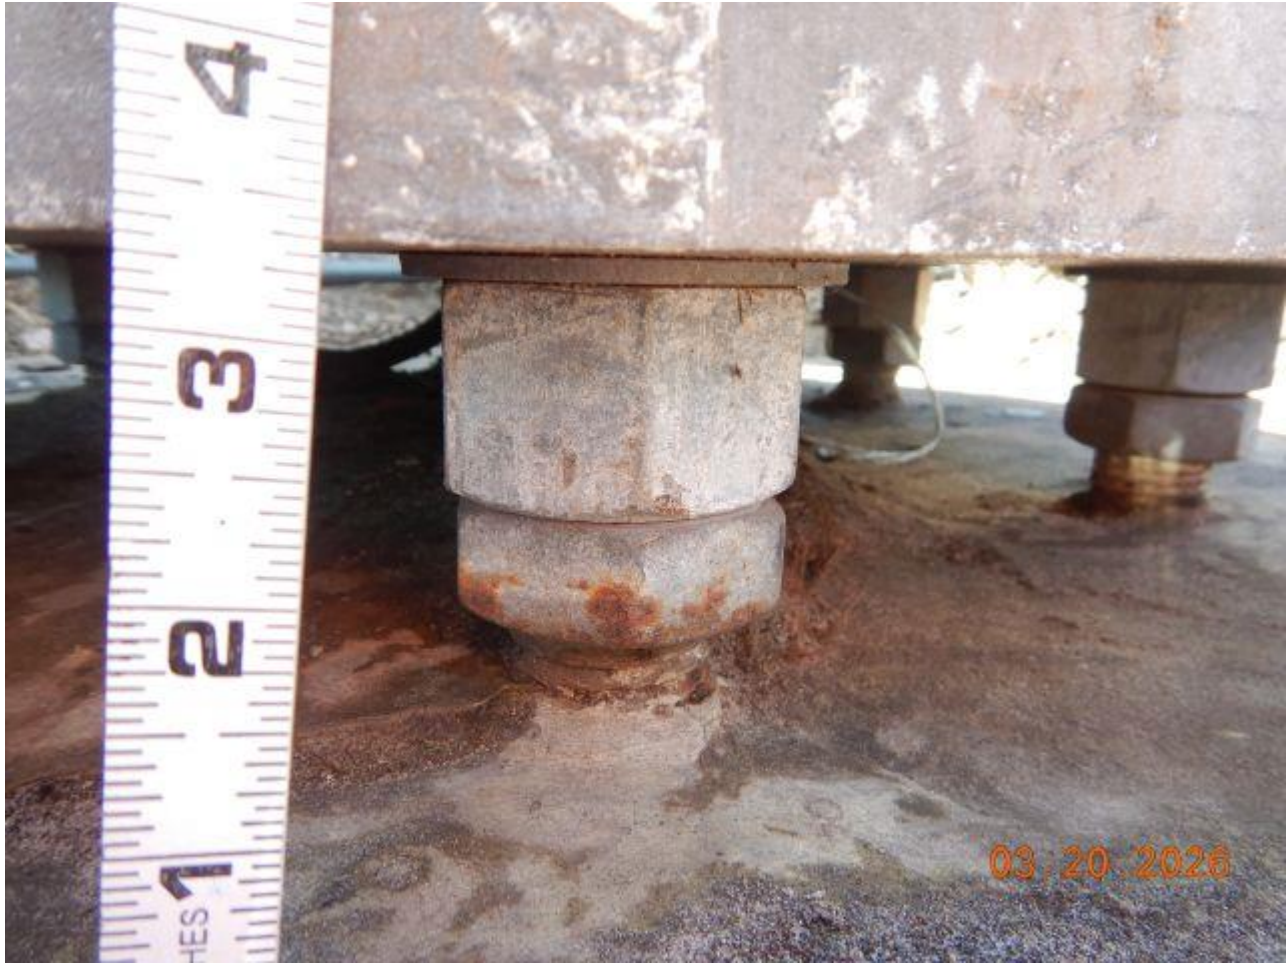
**Photo 2: Element 8480 / Mast Arm Foundation**

F1 - Typical light corrosion on anchor bolt threads & leveling nuts below the base plate prior to being cleaned & painted by the inspectors.

F1 and F2 - The wire screens below the base plate were removed by the inspectors and heavy dirt & debris removed, all anchor bolts & leveling inspected then clean & painted before re-installing the wire screens.

REPAIR RECOMMENDATION:  
None.

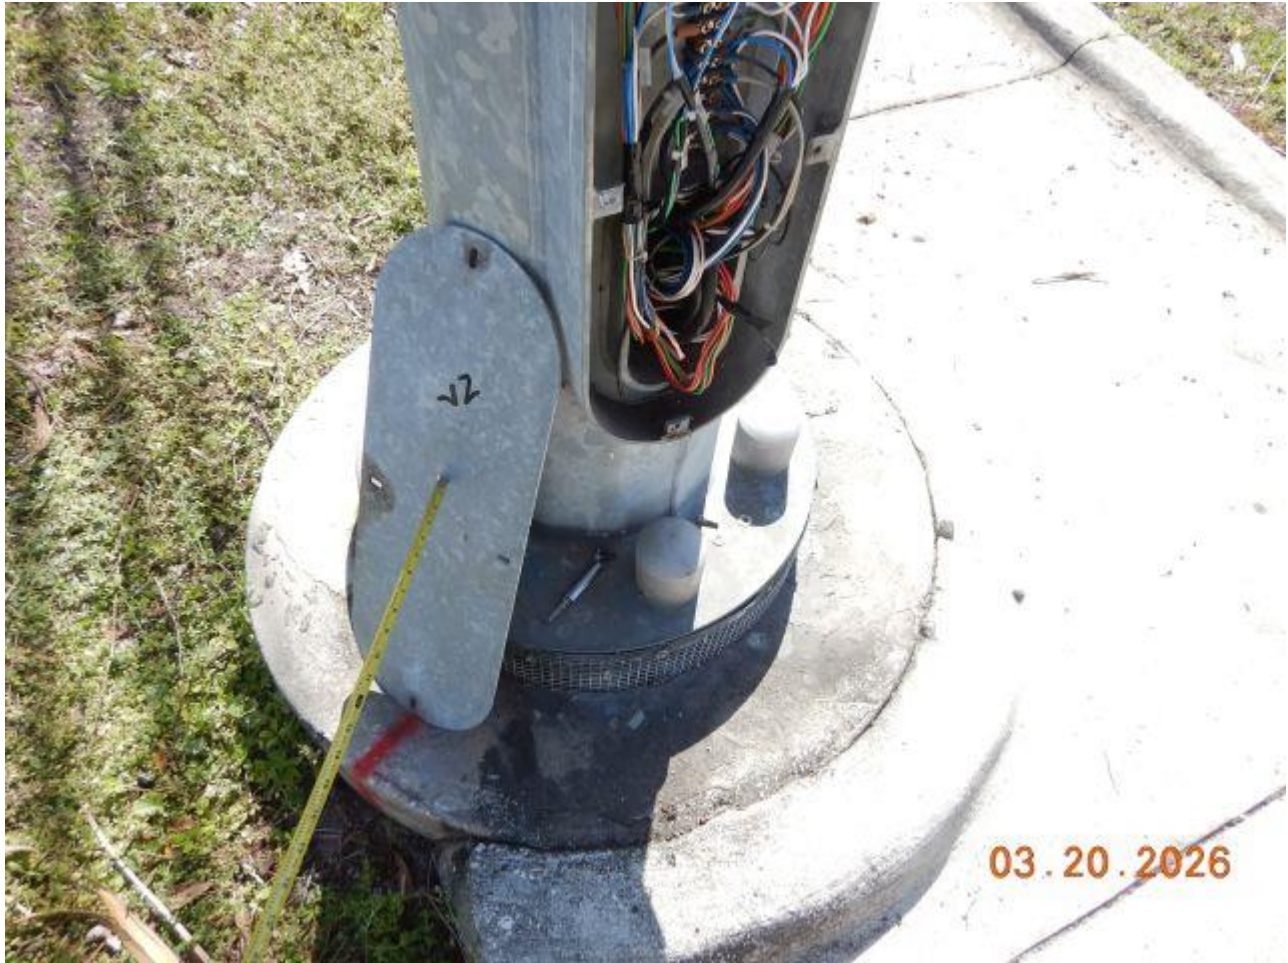
**Photo 2: Element 8481 / Mast Arm Vertical**

V1 and V2 - The terminal compartment covers are missing the weatherproof gaskets. NO CHANGE. Refer to Photo 2. REPAIR.

V1 & V2 - Install missing compartment cover gasket and fastener. Missing gaskets and bolts have not been installed since the 2021 Inspection.

V1 & V2 - Typical terminal compartment cover missing the weatherproof gasket (V2 Shown).

| CONDITION<br>STATE | | PRIORITY |
|---|---|---|
| WORK ORDER RECOMMENDATION:<br>V1 & V2 - Install weatherproof gasket for terminal compartment cover per FDOT Index 649-031. | | |

V1 & V2 - Install weatherproof gasket for terminal compartment cover per FDOT Index 649-031.

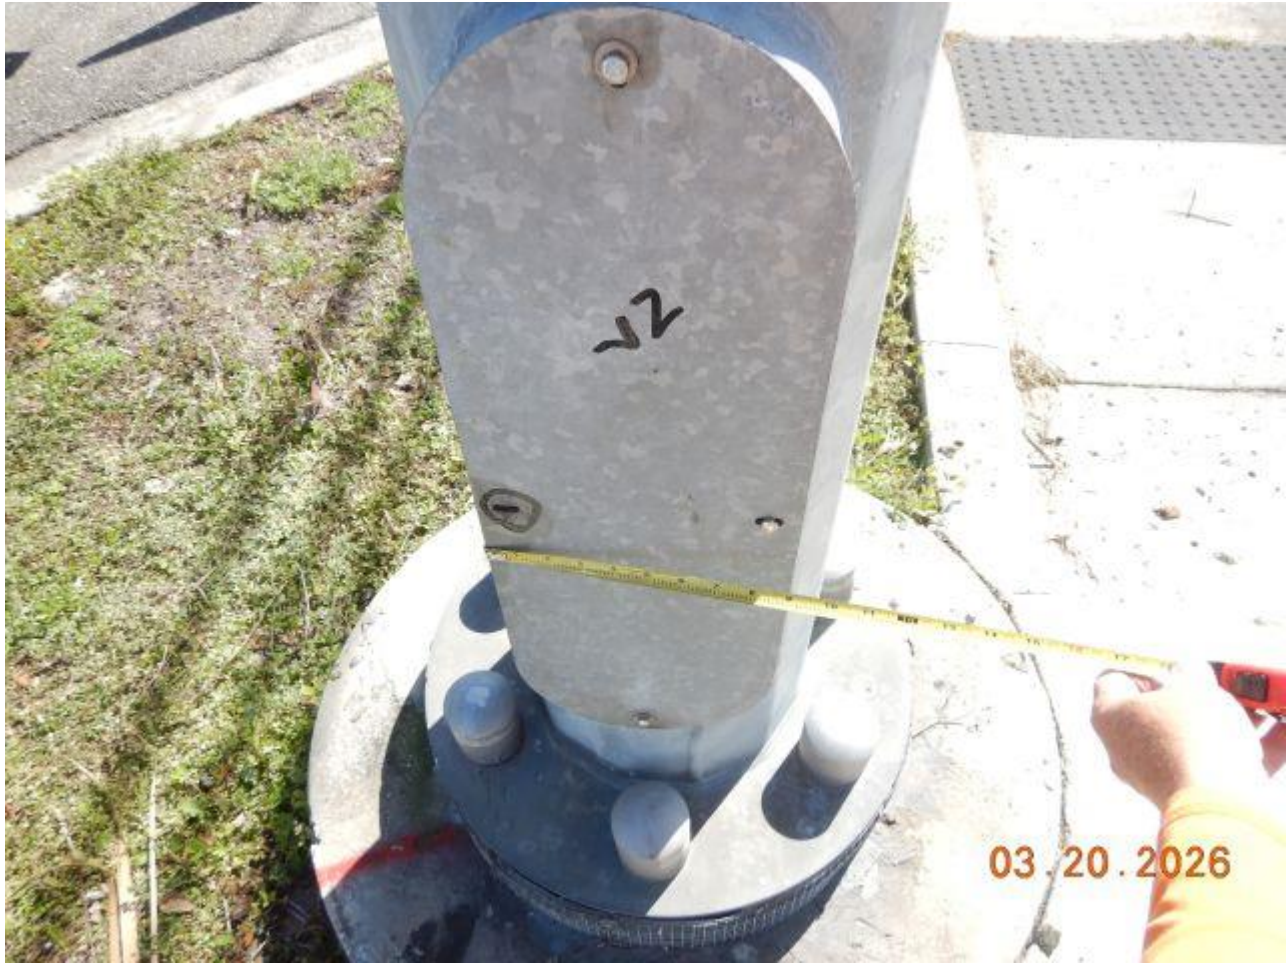
**Photo 3: Element 8481 / Mast Arm Vertical**

V2 - The terminal compartment cover has (1) of (4) bolts sheared off, but the cover is secure. NO CHANGE. Refer to Photo 3.

V2 - Install missing compartment cover fastener. Fastener has not been replaced since the 2021 Inspection or is re-occurring.

V2 - Sheared terminal compartment cover attachment bolt.

REPAIR RECOMMENDATION:  
None.

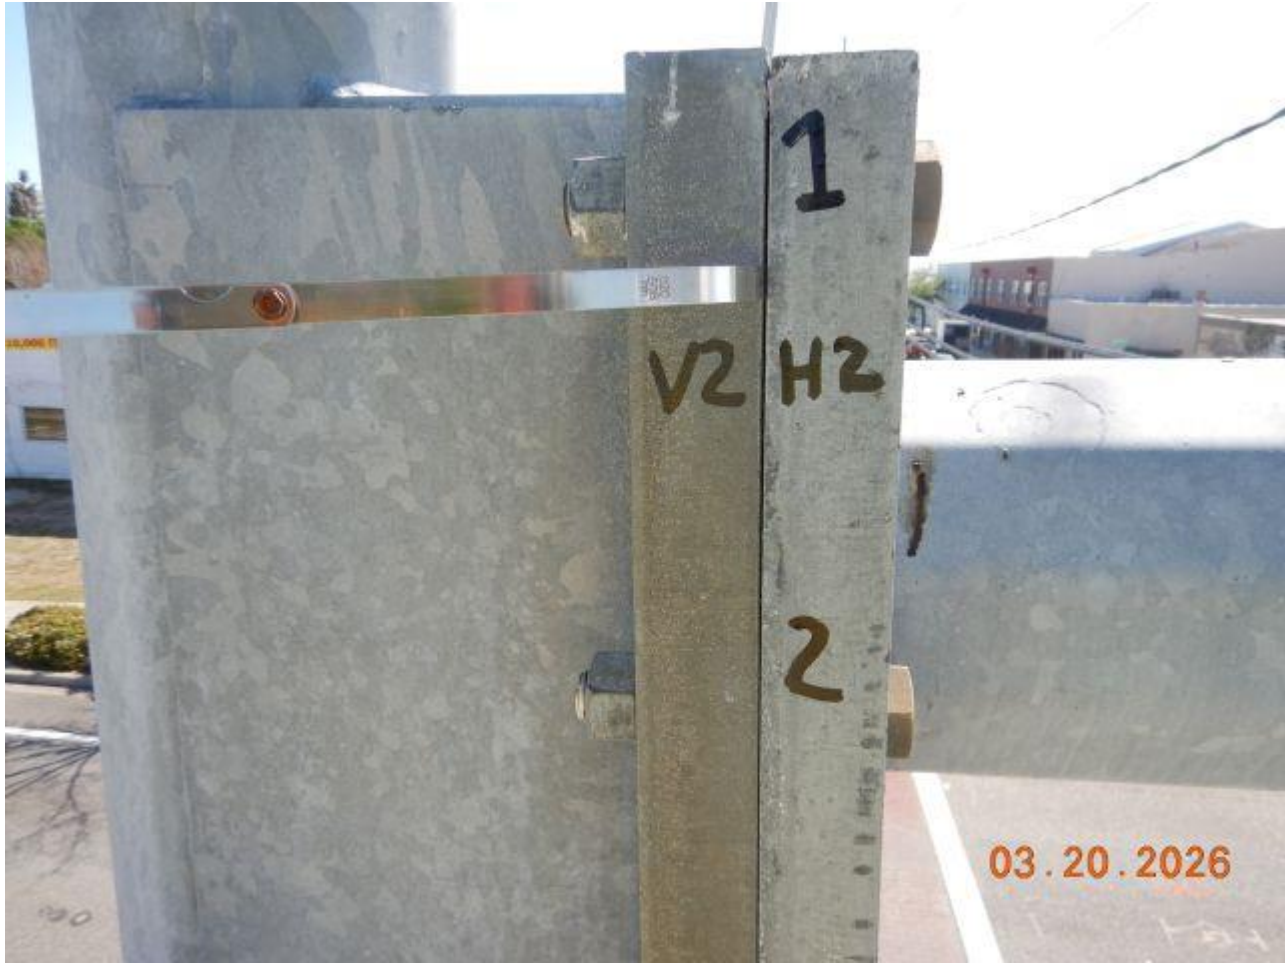
**Photo 4: Element 8484 / Mast Arm Horizontal**

V2/H2 - The moment connection has a gap up to 0.020 in. wide between the plates at Bolt #1, but all bolts are tight. NEW. Refer to Photos 4 and 5. (1 EA)

V2/H2 - Overview of moment connection with slight gap between plates at Bolt #1.

REPAIR RECOMMENDATION:  
None.

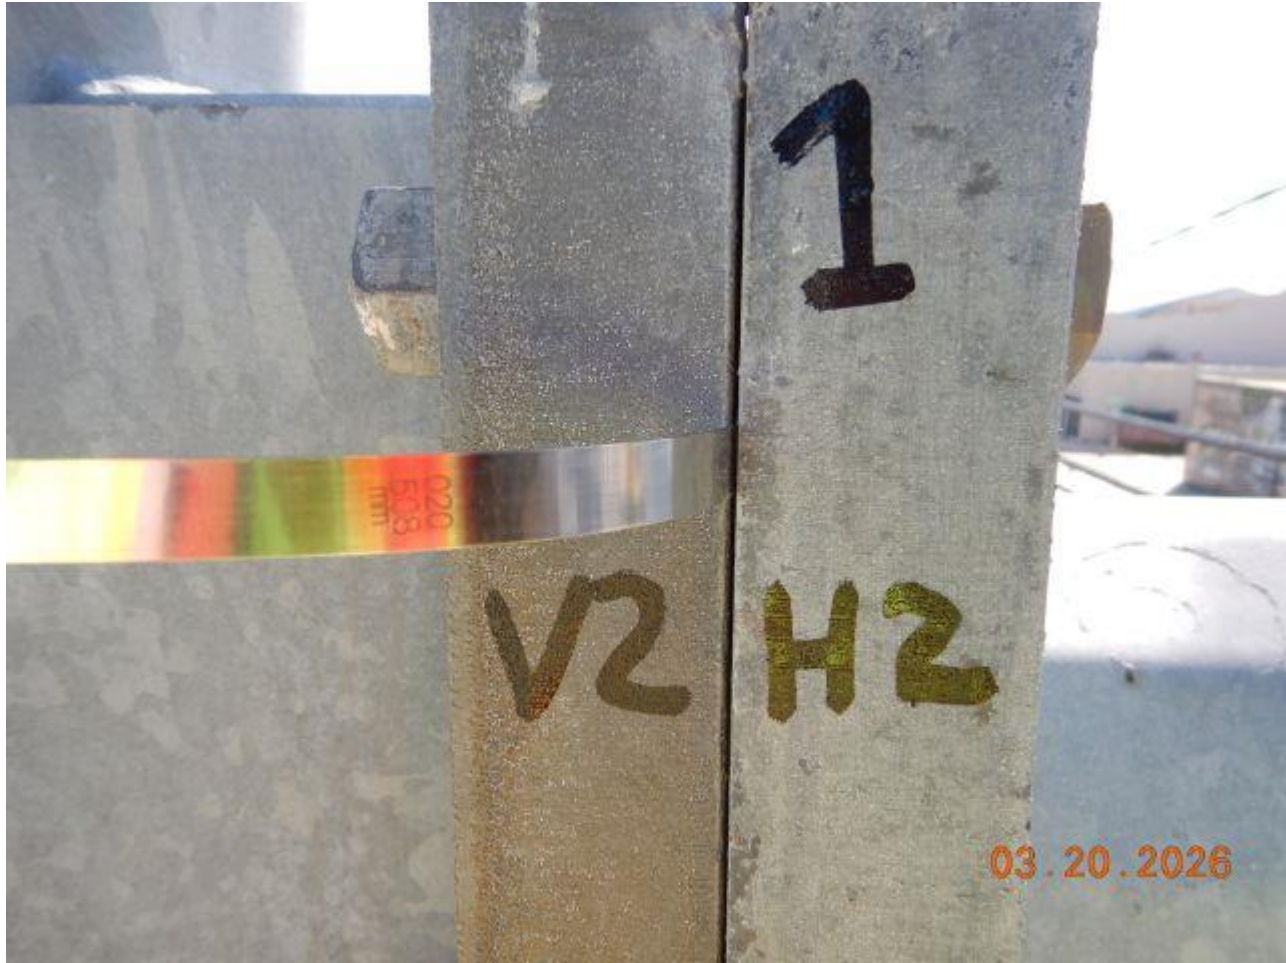
**Photo 5: Element 8484 / Mast Arm Horizontal**

V2/H2 - Close-up of moment connection with slight gap between plates at Bolt #1.

REPAIR RECOMMENDATION:  
None.

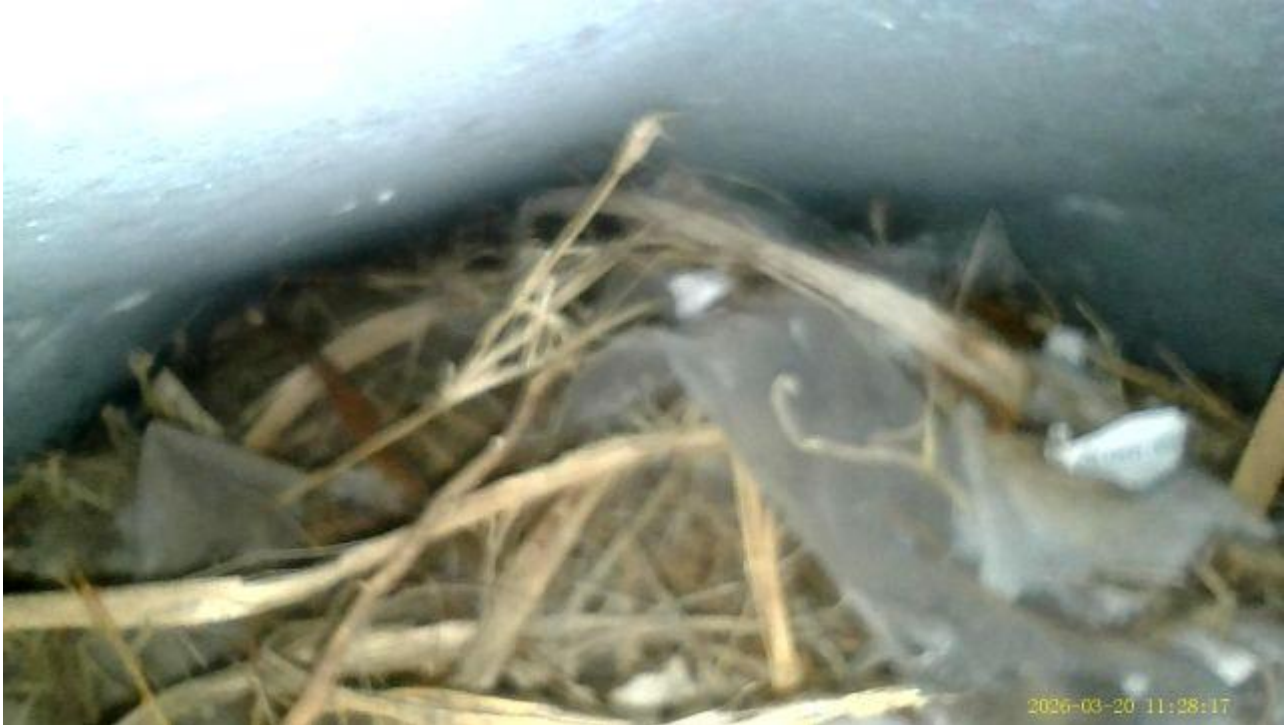
**Photo 6: Element 8484 / Mast Arm Horizontal**

V1/H1, V2/H2 and V2/H3 - The horizontal arm interiors have a heavy accumulation of bird nesting material viewed with a borescope thru the drain hole. D-meter readings at 3 in., 12 in. & 24 in. from the moment connection taken at the 5, 6 and 7 o'clock positions did not indicate any reduction in section at this time. NEW. Refer to Photos 6, 7 & 8. REPAIR.

V1/H1 - Heavy bird nesting material inside horizontal arm interior.

| CONDITION<br>STATE | | PRIORITY |
|---|---|---|
| WORK ORDER RECOMMENDATION:<br>Remove bird nests from H1 moment connection plates & install screening at H1 H2 H3. | | |

Remove bird nests from H1 moment connection plates & install screening at H1 H2 H3.

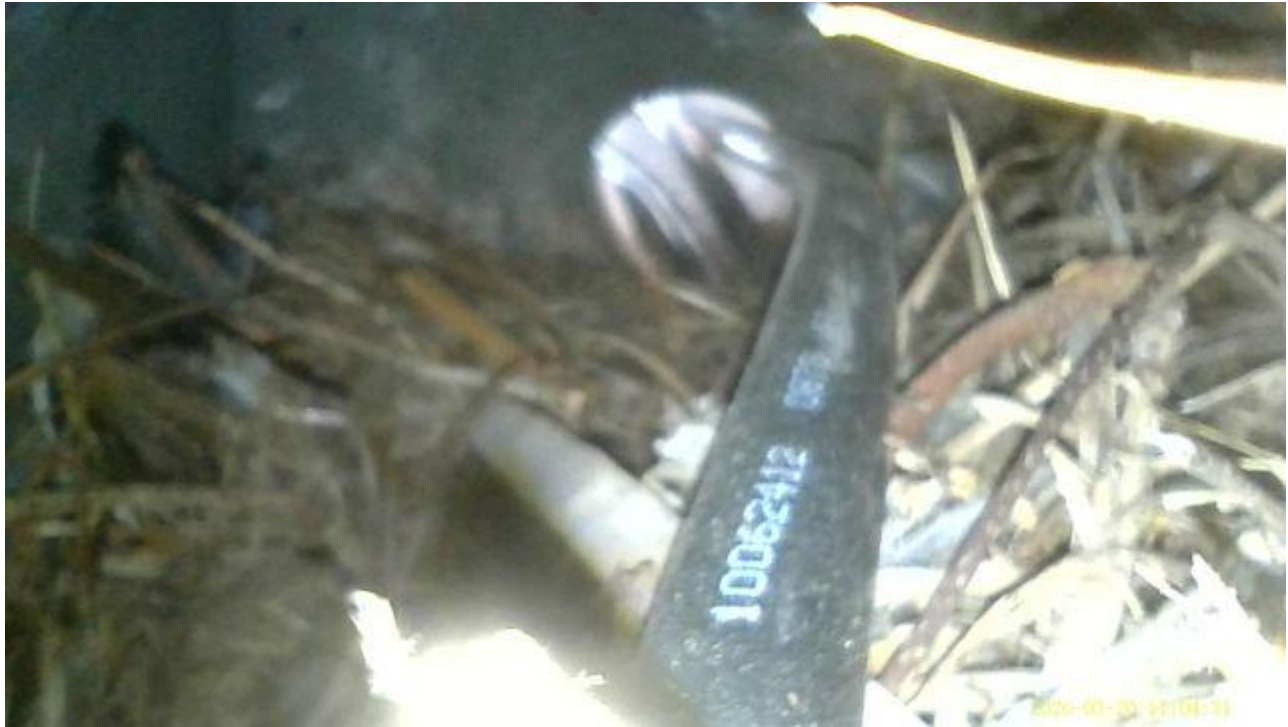
**Photo 7: Element 8484 / Mast Arm Horizontal**

V2/H2 - Heavy bird nesting material inside horizontal arm interior.

Remove bird nests from H1 moment connection plates & install screening at H1 H2 H3.

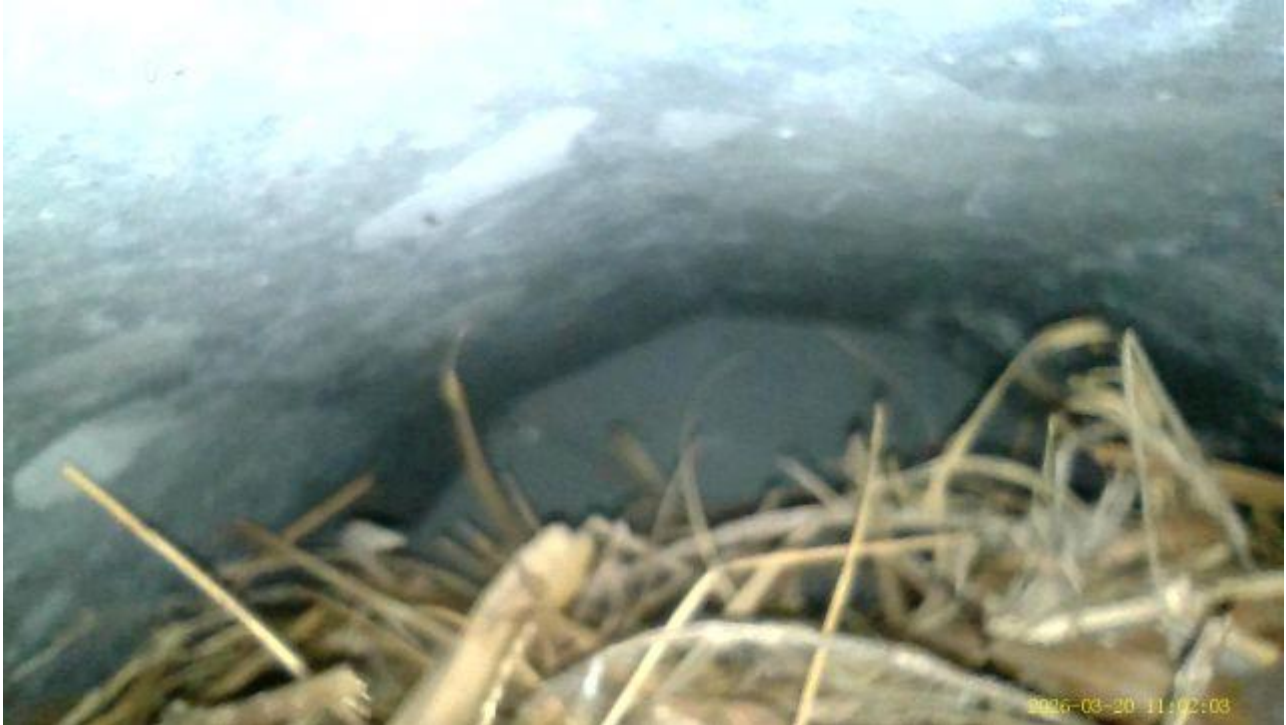
**Photo 8: Element 8484 / Mast Arm Horizontal**

V3/H3 - Heavy bird nesting material inside horizontal arm interior.

Remove bird nests from H1 moment connection plates & install screening at H1 H2 H3.

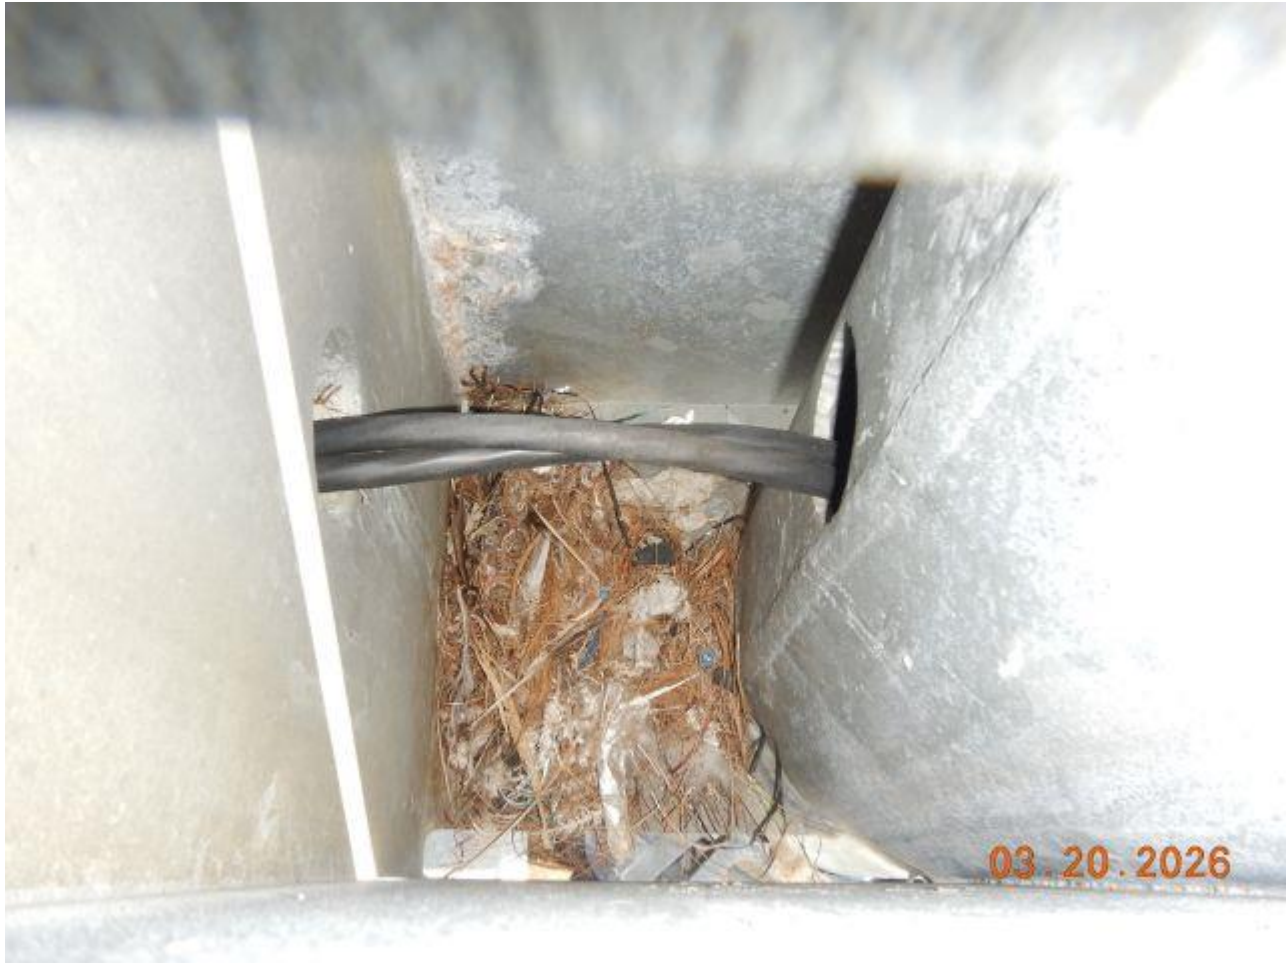
**Photo 9: Element 8484 / Mast Arm Horizontal**

V1/H1 - There is a bird nest between the moment connection plates. Refer to Photo 9. REPAIR.

V1/H1 - Bird nest between moment connection plates.

Remove bird nests from H1 moment connection plates & install screening at H1 H2 H3.
