**FLORIDA DEPARTMENT OF TRANSPORTATION**  
**BRIDGE MANAGEMENT SYSTEM**  
**Inspection/CIDR Report**  
(TRAFFIC SIGNAL MAST ARM INSPECTION REPORT)

Structure ID: 70M093

| BY: | Ayres Associates | STRUCTURE NAME: | US-1 (Hopkins Ave) SB at SR-406 (Garden St.) |

TYPE OF INSPECTION: Regular NBI

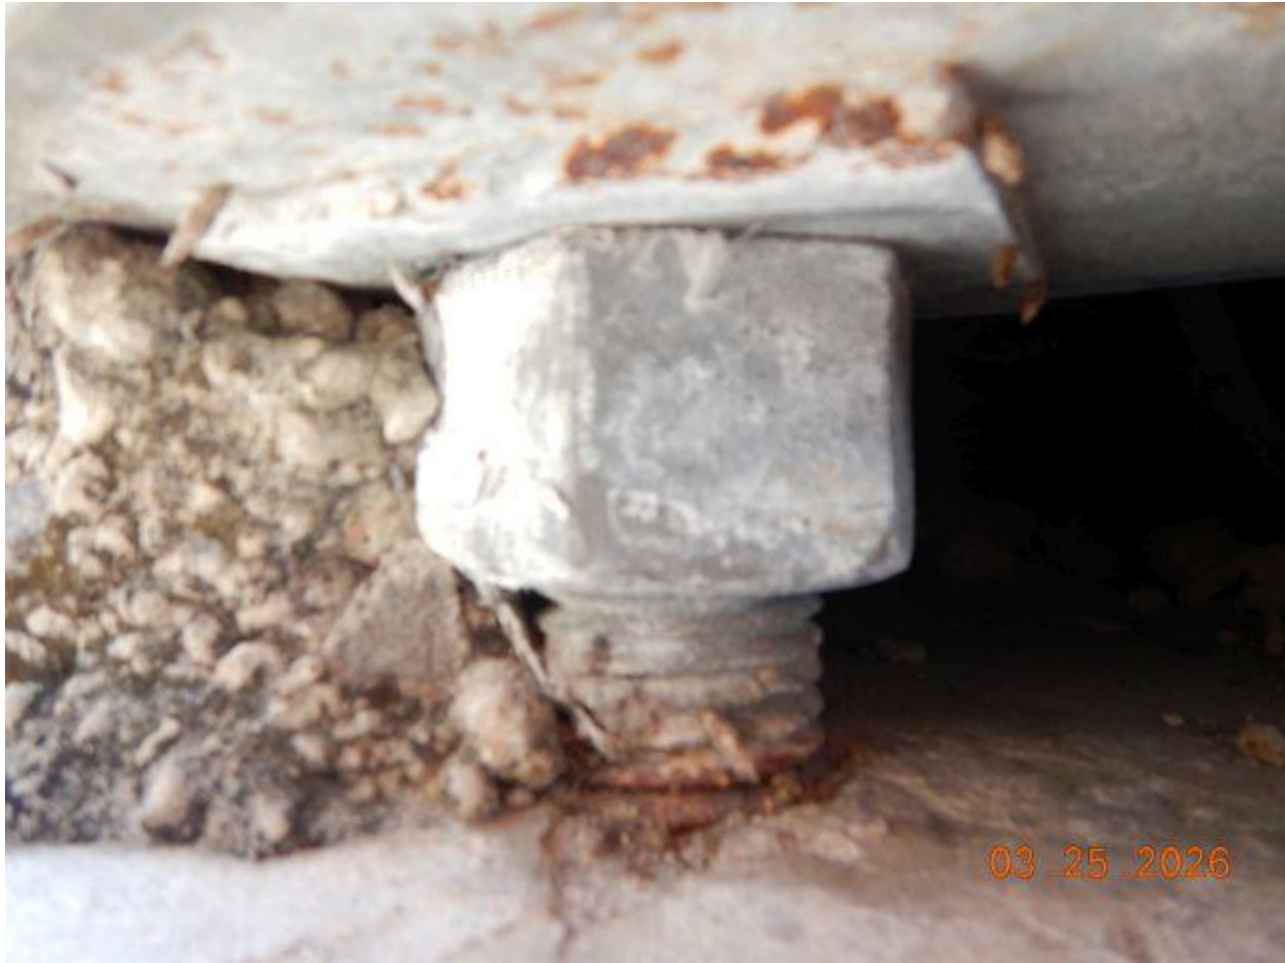
**Photo 1 - Element 8480 / Mast Arm Foundation**

F2 - Anchor bolt threads, leveling nuts and washers below the base plate have light to moderate corrosion visible where the grout ring was partially removed. NEW. Refer to Photo 1. (1 EA) REPAIR.

F2 - Light to moderate anchor bolt thread, leveling nut & washer corrosion below the base plate visible where grout pad was partially removed.

F2 - Remove remaining grout pad. Clean / paint all corrosion and tighten any loose leveling nuts. Install structural grout pad in accordance with FDOT Spec. 649-7. No repairs have been made since the 2021 inspection.

| CONDITION<br>STATE | | | PRIORITY |
|---|---|---|---|
| F2 - Remove grout ring clean & paint anchor bolts & install wire screen per FDOT Spec 649-8. | | | |

F2 - Remove grout ring clean & paint anchor bolts & install wire screen per FDOT Spec 649-8.

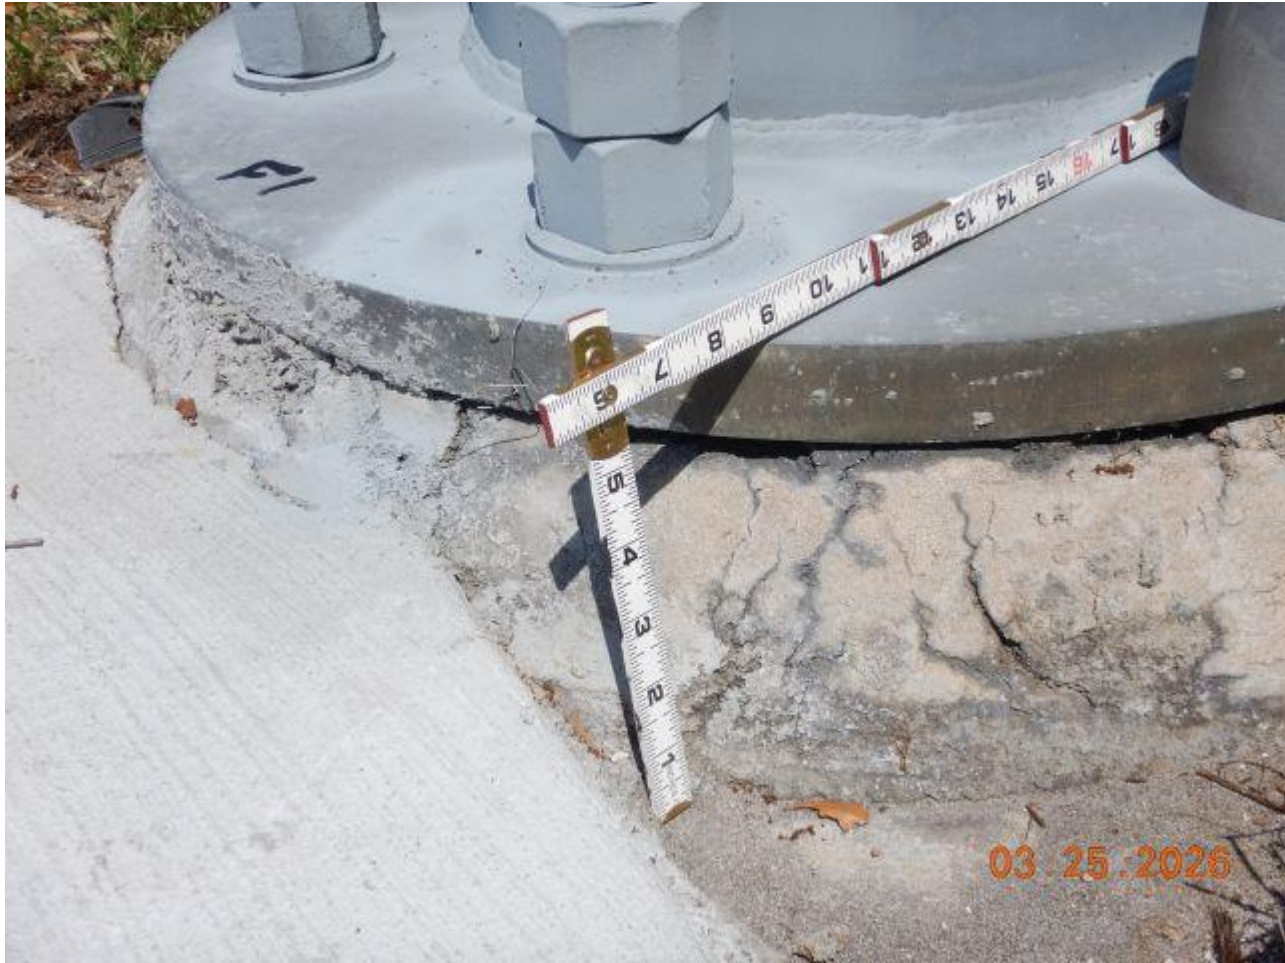
**Photo 2 - Element 8480 / Mast Arm Foundation**

F1 - The anchor bolt stand-off distance is slightly greater than the diameter of the anchor bolts. Bolt diameter = 1 3/4 in. and average estimated stand-off distance = 2 in. Per DMS Memorandum 15-03, this structure was built before 2008 and has an arm length less than 60 ft., therefore, no repair is necessary at this time. NO CHANGE. Refer to Photo 2.

The NBI Item (60) - Substructure is coded 5 - Fair due to the F1 foundation anchor bolt stand-off distance exceeding 1 bolt diameter.

F1 - Average estimated anchor bolt stand-off distance slightly exceeded.

WORK ORDER RECOMMENDATION:  
None.

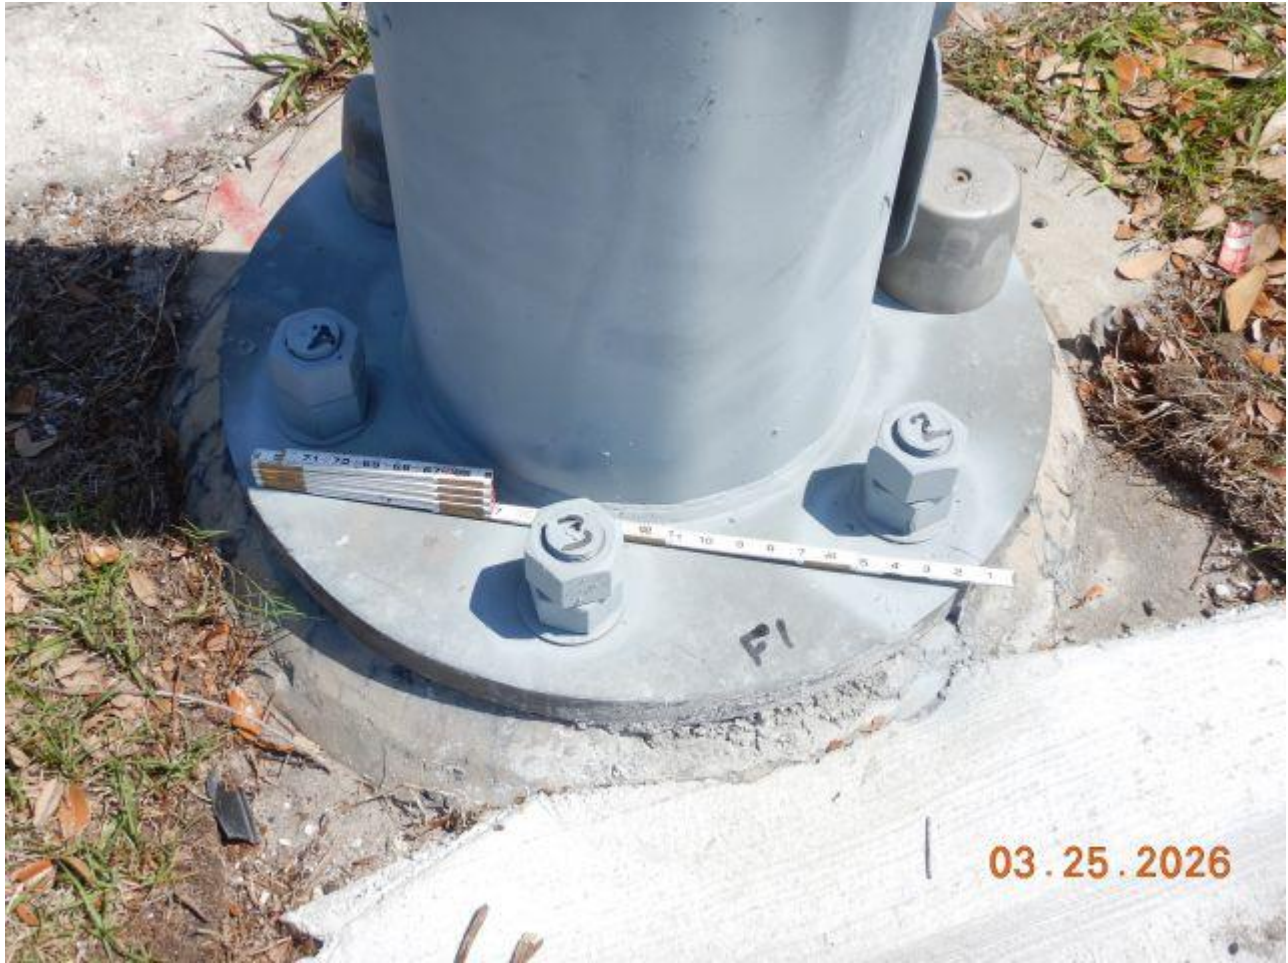
**Photo 3 - Element 8480 / Mast Arm Foundation**

F1 - (3) of (6) anchor bolt covers (AB #2, 3 & 4) are missing. NEW. Refer to Photo 3. REPAIR.

F1 - (3) of (6) anchor bolt covers missing (AB #2, 3 & 4).

| CONDITION<br>STATE | | | PRIORITY |
|---|---|---|---|
| F1 - Install the (3) missing anchor bolt covers. | | | |

F1 - Install the (3) missing anchor bolt covers.

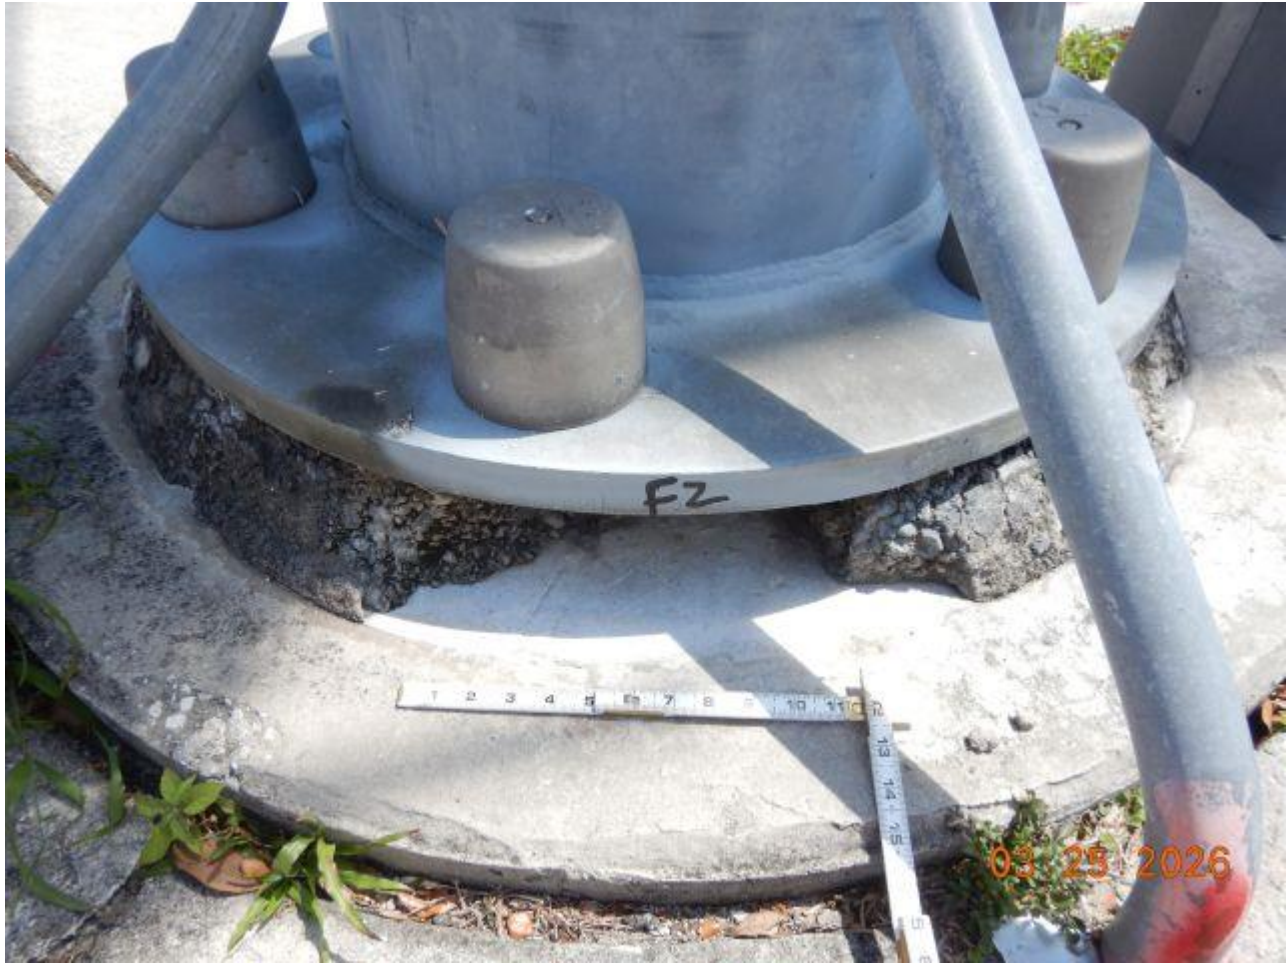
**Photo 5 - Element 8480 / Mast Arm Foundation**

F2 - The grout pad is rough, honeycombing, has minor vertical cracking and was previously partially removed between anchor bolts #5 and 6. NO CHANGE. Refer to Photos 5. REPAIR.

F2 - Grout ring partially removed between anchor bolts # 5 & 6.

F2 - Remove grout ring clean & paint anchor bolts & install wire screen per FDOT Spec 649-8.

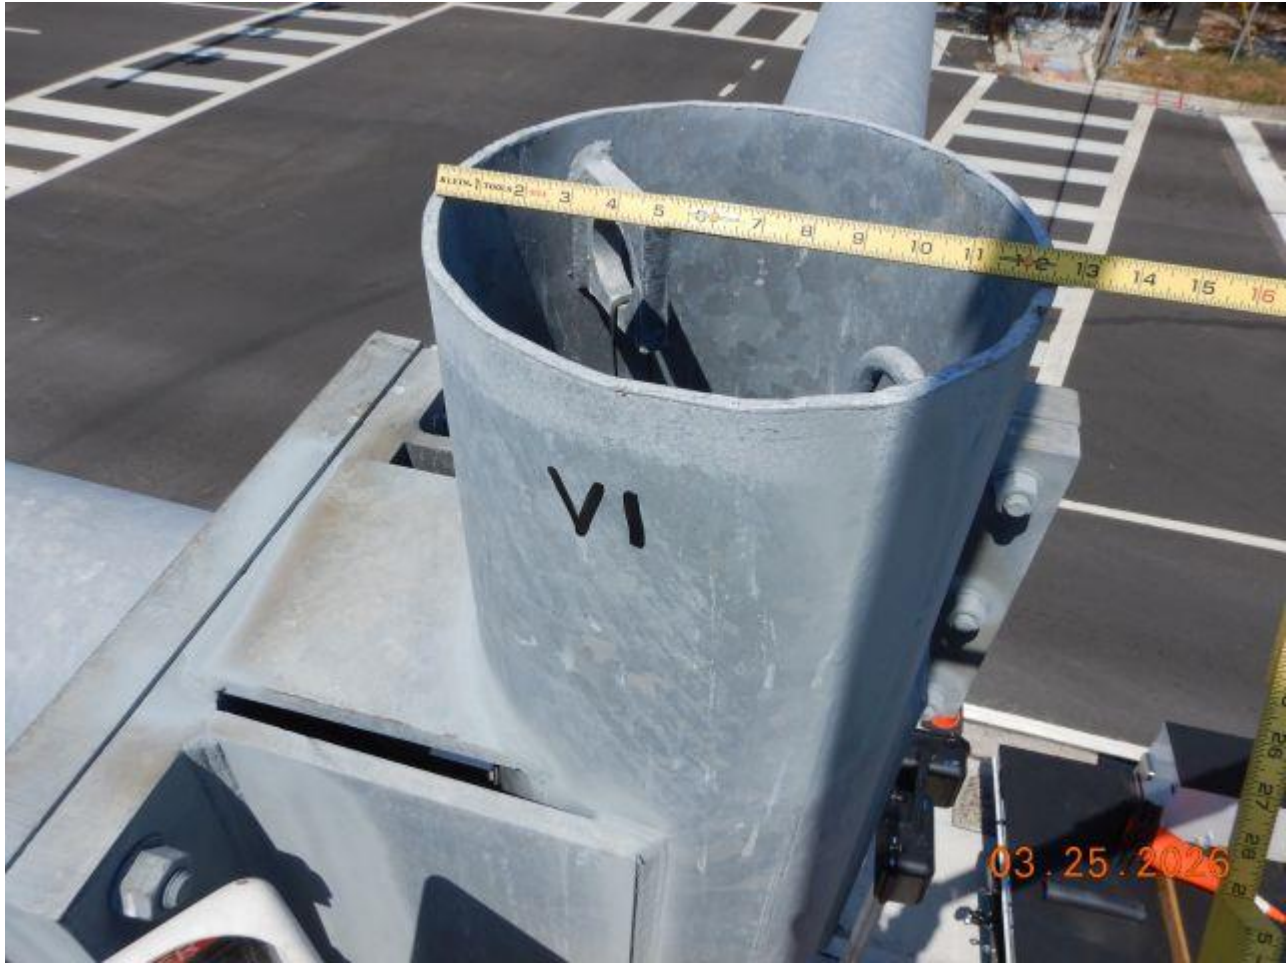
**Photo 6 - Element 8481 / Mast Arm Vertical**

V1 - The column cap is missing. NEW. Refer to Photo 6. REPAIR.

V1 - Missing column cap.

| CONDITION<br>STATE | | | PRIORITY |
|---|---|---|---|
| V1 - Install a 13 in. diameter column cap. | | | |

WORK ORDER RECOMMENDATION:  
V1 - Install a 13 in. diameter column cap.

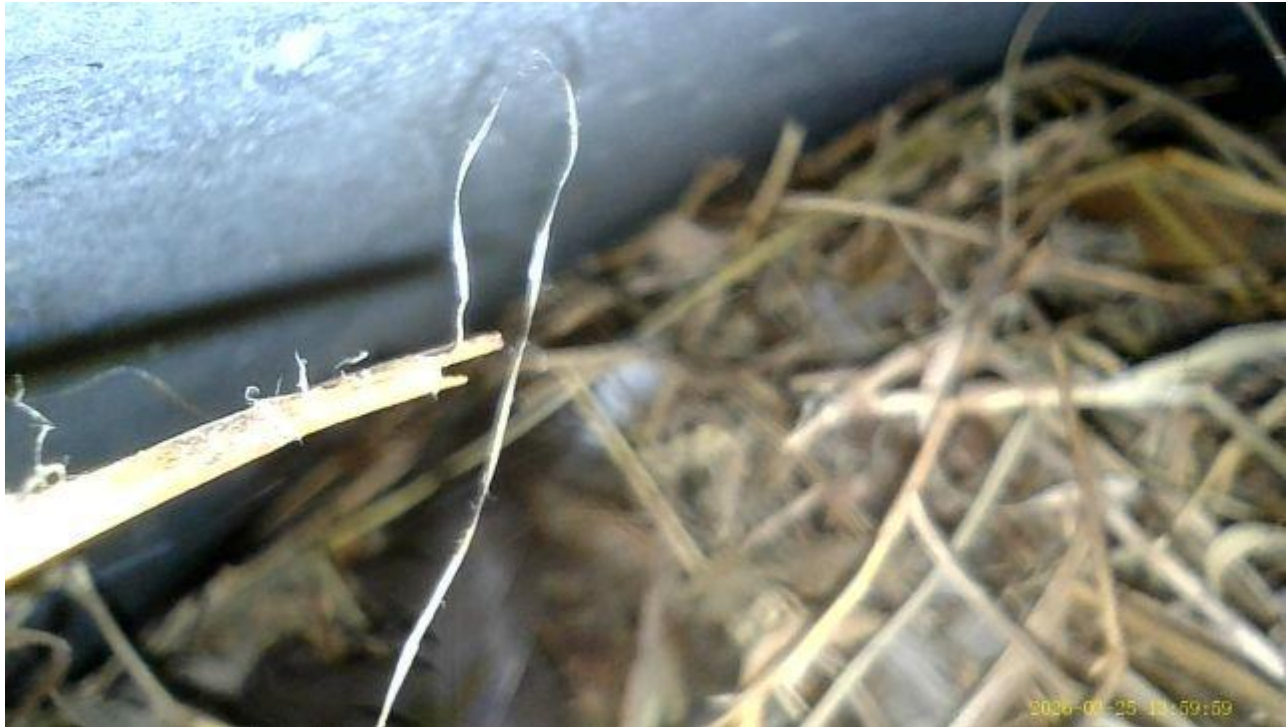
**Photo 7 - Element 8484 / Mast Arm Horizontal**

V1/H1, V1/H2, V2/H3 - There is a moderate too heavy accumulation of bird nesting material inside the horizontal arm interiors at the moment connections viewed with a borescope

inserted thru the arm drain holes. No corrosion could be seen thru the nesting material and D-meter readings at 3 in., 12 in. & 24 in. from the moment connection taken at the 5, 6 and 7 o'clock positions did not indicate any reduction in section at this time. NEW. Refer to Photos 7 thru 9. REPAIR

V1/H1 - Typical bird nesting material inside horizontal arm near the moment connection.

H1 H2 & H3 - Install screening at the moment connection plates to prevent nesting in arms.

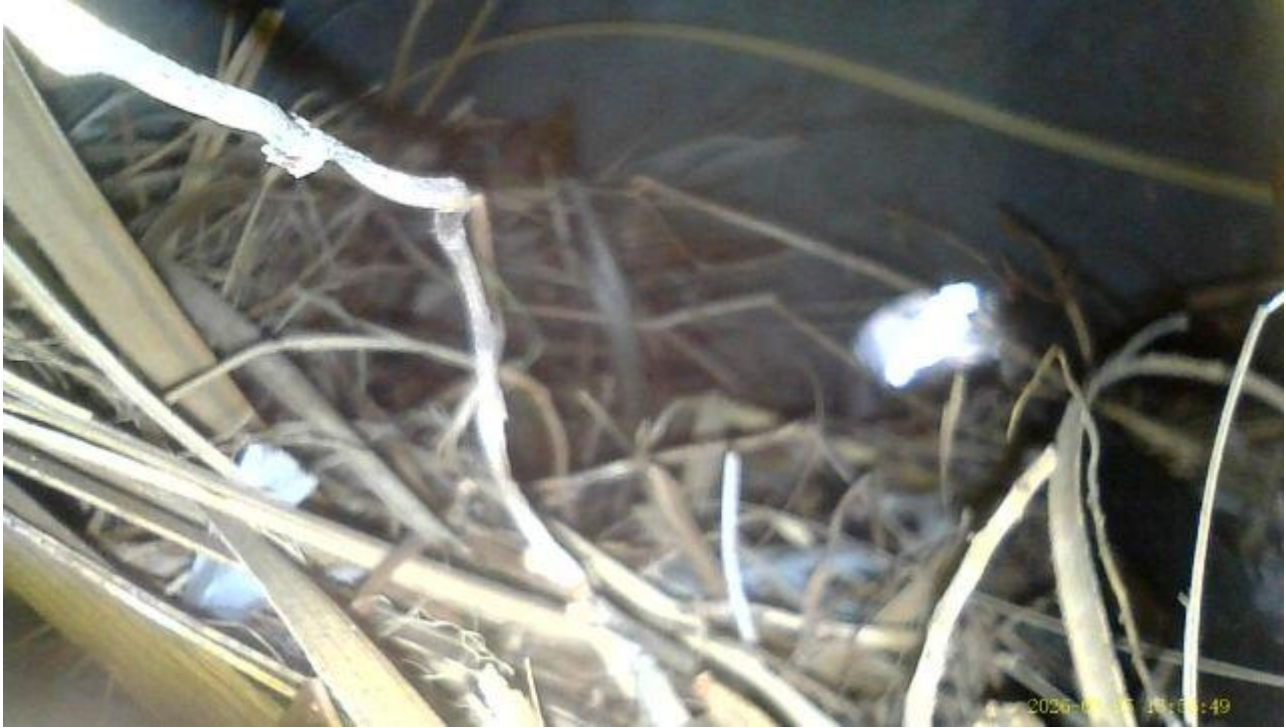
**Photo 8 - Element 8484 / Mast Arm Horizontal**

V1/H2 - Typical bird nesting material inside horizontal arm near the moment connection.

H1 H2 & H3 - Install screening at the moment connection plates to prevent nesting in arms.

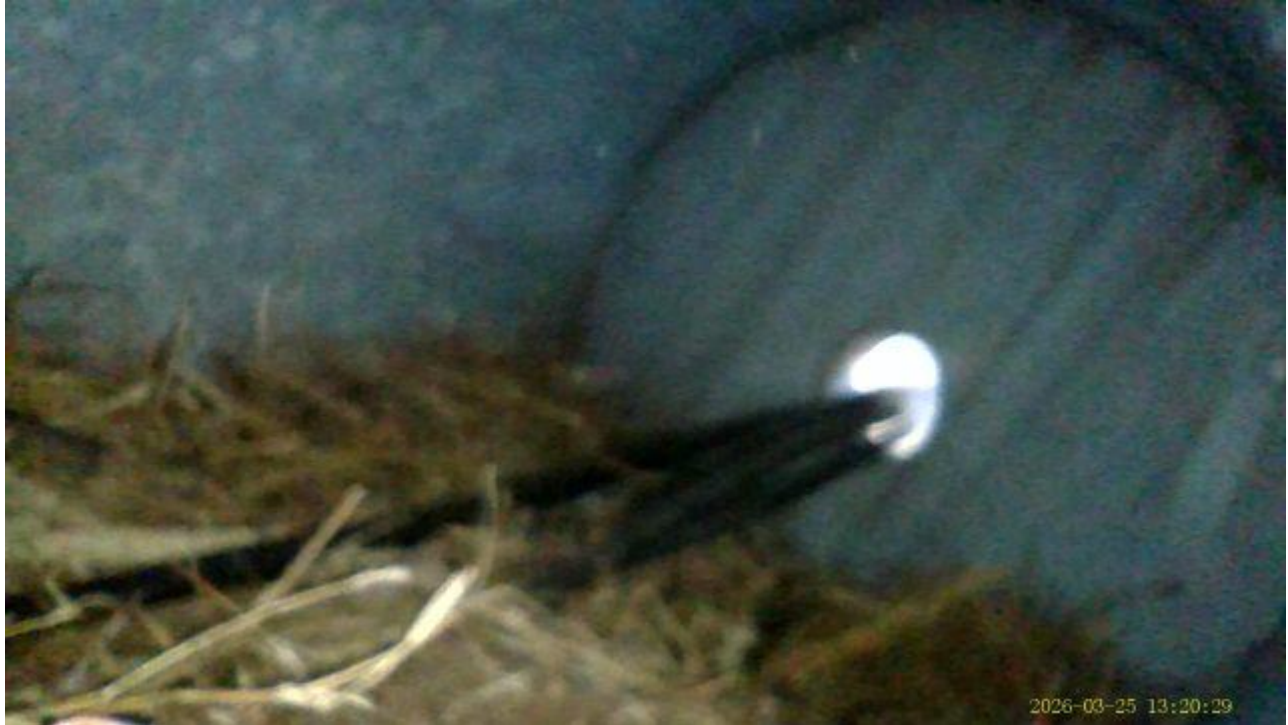
**Photo 9 - Element 8484 / Mast Arm Horizontal**

V2/H3 - Typical bird nesting material inside horizontal arm near the moment connection.

H1 H2 & H3 - Install screening at the moment connection plates to prevent nesting in arms.

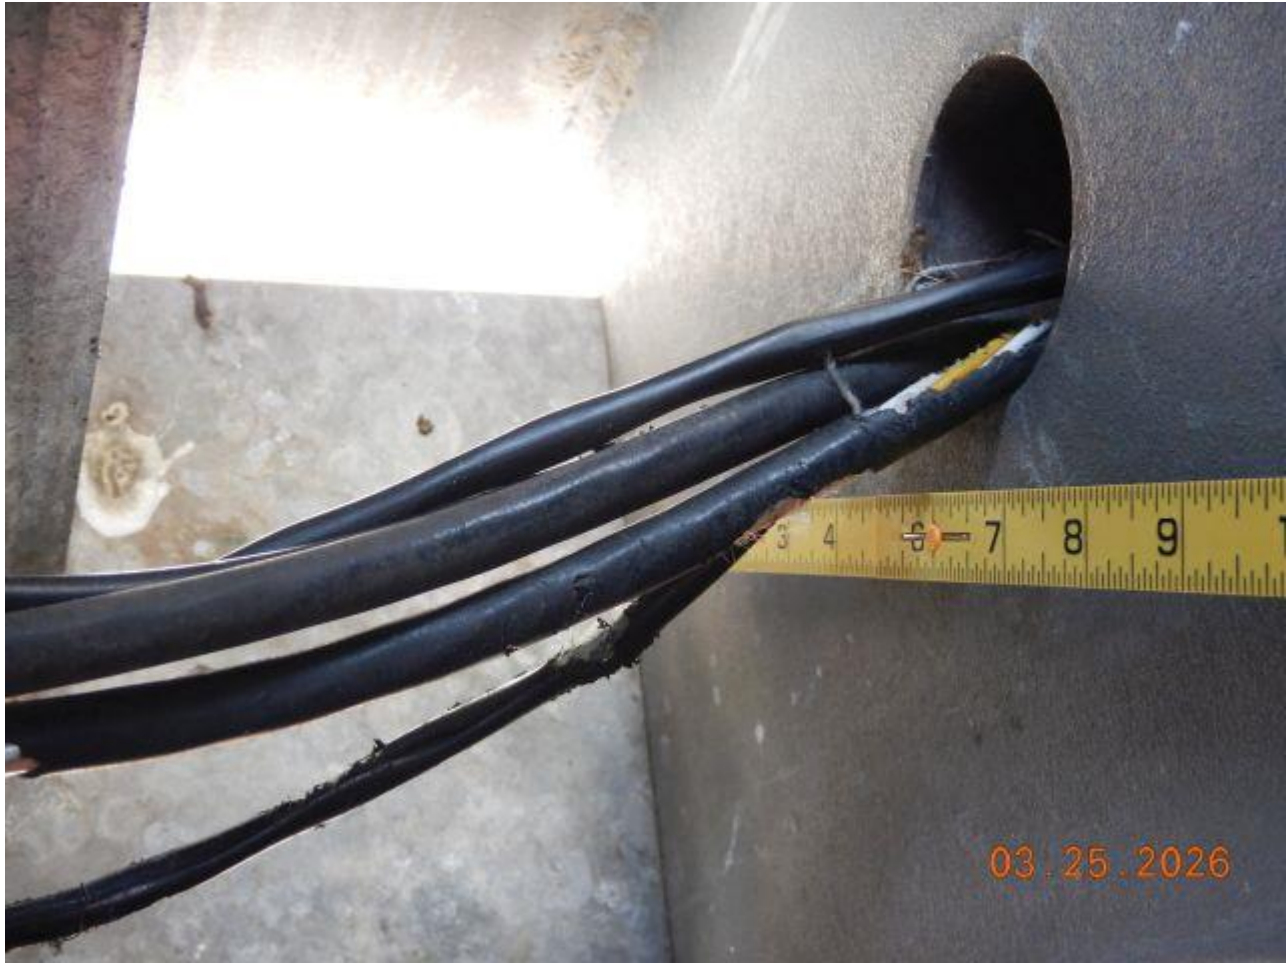
**Photo 10 - Element 8484 / Mast Arm Horizontal**

V1/H2 - The signal wiring inside the moment connection plates outer protective sheathing is chewed / damaged exposing the internal wires. NEW. Refer to Photo 10. REPAIR

V1/H2 - Signal wiring outer protective sheathing is damaged exposing individual wires inside.

| CONDITION<br>STATE | | | PRIORITY |
|---|---|---|---|
| V1/H2 - Repair damaged signal wiring within moment connection plates. | | | |

V1/H2 - Repair damaged signal wiring within moment connection plates.

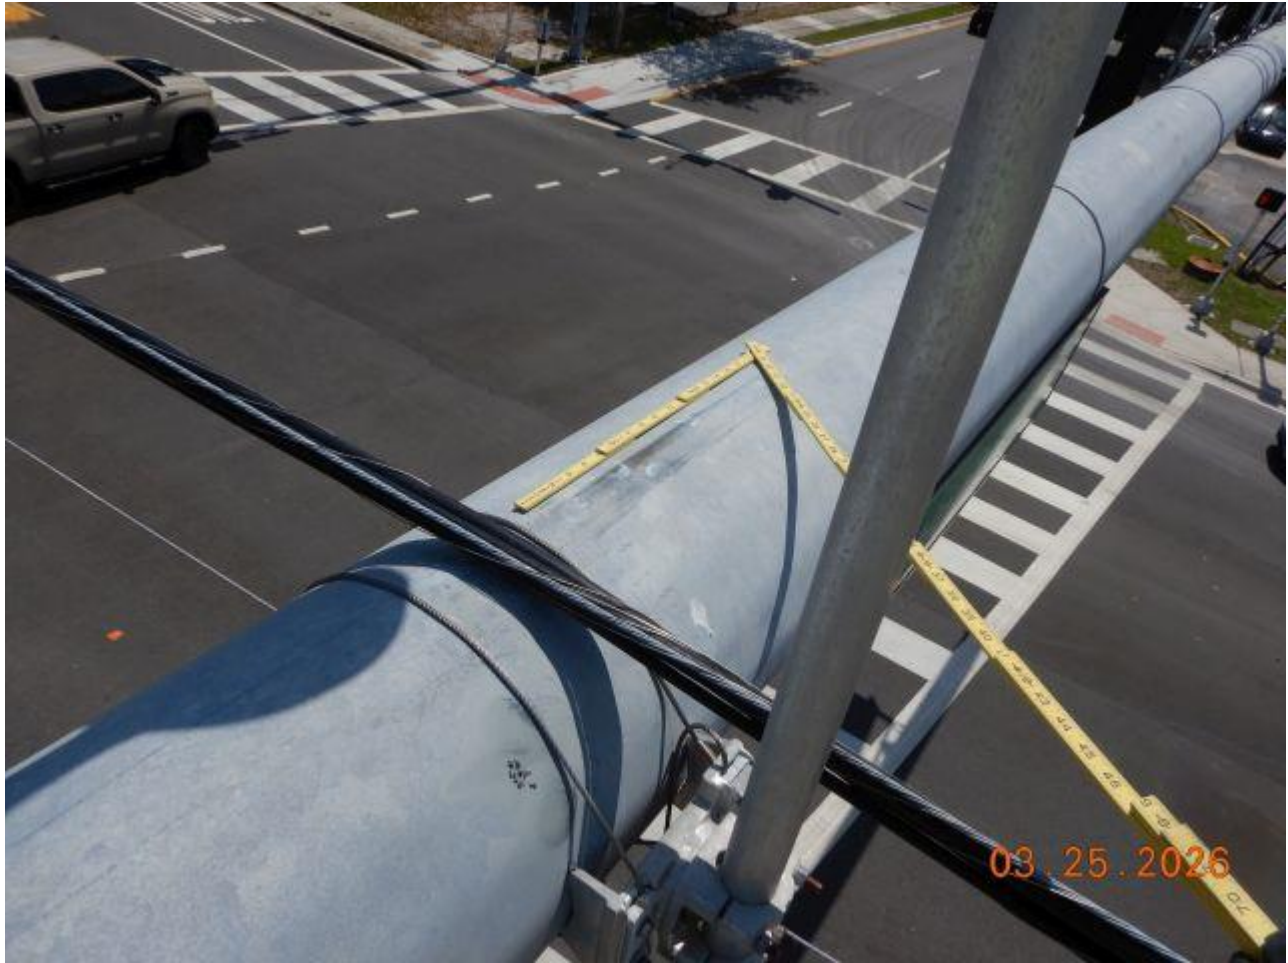
**Photo 11 - Element 8484 / Mast Arm Horizontal**

V2/ H3 - There is a utility wire resting on the top of the horizontal arm causing abrasions to the protective coating and there is another wire hanging just below the bottom of the arm. NO CHANGE. Refer to Photo 11.

V2/H3 - Utility cable in contact with topside of arm & damaging the protective coating.

V2/H3 - Sleeve or relocate the utility wire in contact with horizontal. No repairs have been made since the 2021 inspection.

| CONDITION<br>STATE | | | PRIORITY |
|---|---|---|---|
| V2/H3 - Sleeve or re-locate utility cable. | | | |

V2/H3 - Sleeve or re-locate utility cable.
