**FLORIDA DEPARTMENT OF TRANSPORTATION**  
**BRIDGE MANAGEMENT SYSTEM**  
**Inspection/CIDR Report**  
(TRAFFIC SIGNAL MAST ARM INSPECTION REPORT)

**Structure ID: 70M094**  
**DISTRICT: D5 - Deland**

| BY: Ayres Associates | STRUCTURE NAME: US-1 (Hopkins Ave.) SB at Main St |

TYPE OF INSPECTION: Regular NBI

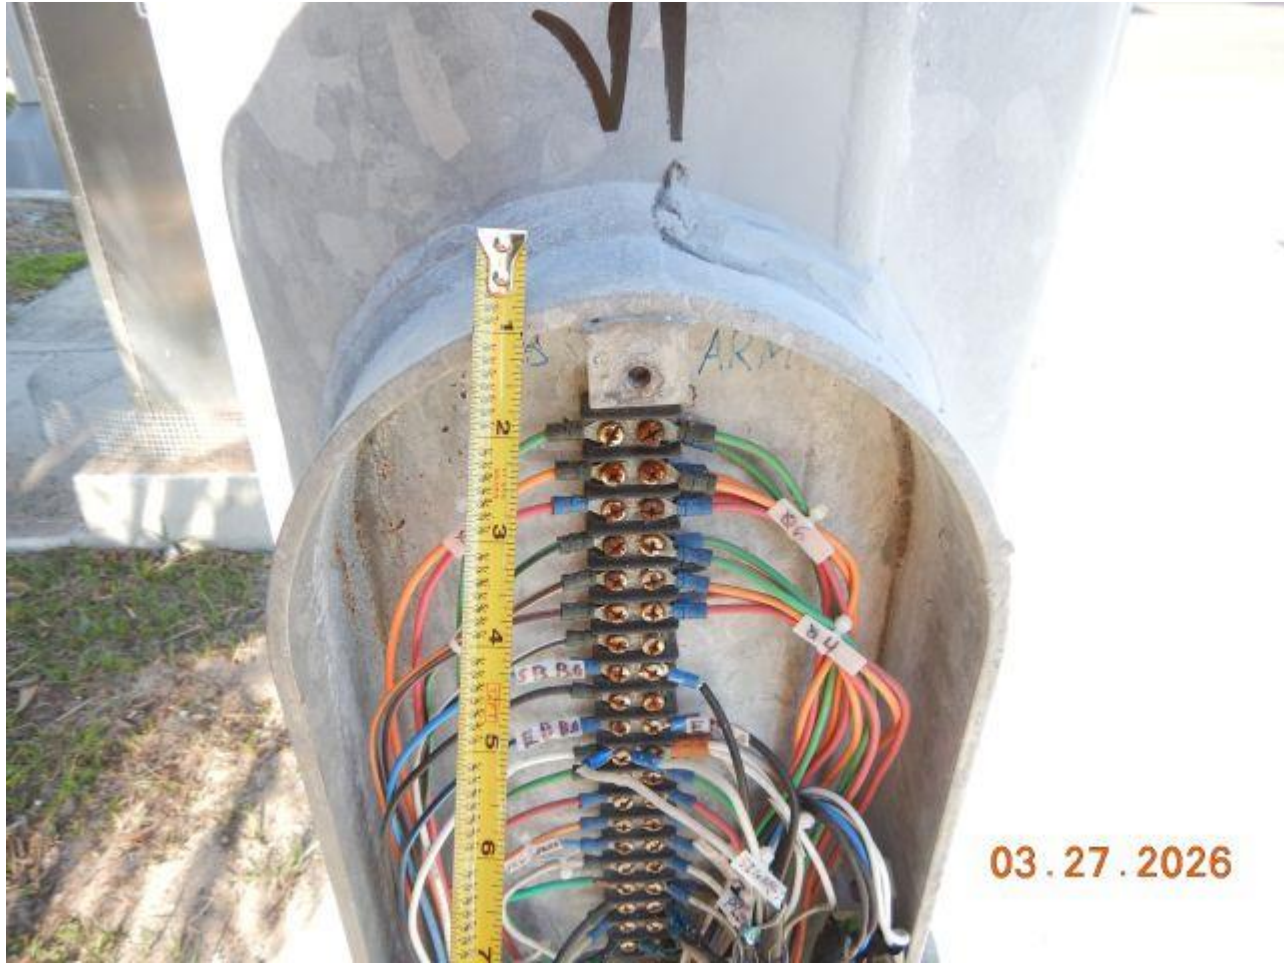
**Photo 1 - Element 8481 Mast Arm Vertical**

V1 - The electrical terminal strip screws are corroded inside the compartment cover access. NO CHANGE. Refer to Photo 1. REPAIR

V1 - Corroded terminal strip screws

V1 - Replace corroded terminal strip screws as needed. No repairs have been made since the 2021 inspection.

| CONDITION<br>STATE | | | PRIORITY |
|---|---|---|---|
| V1 - Clean & protect terminal strip screws. | | | |

V1 - Clean & protect terminal strip screws.

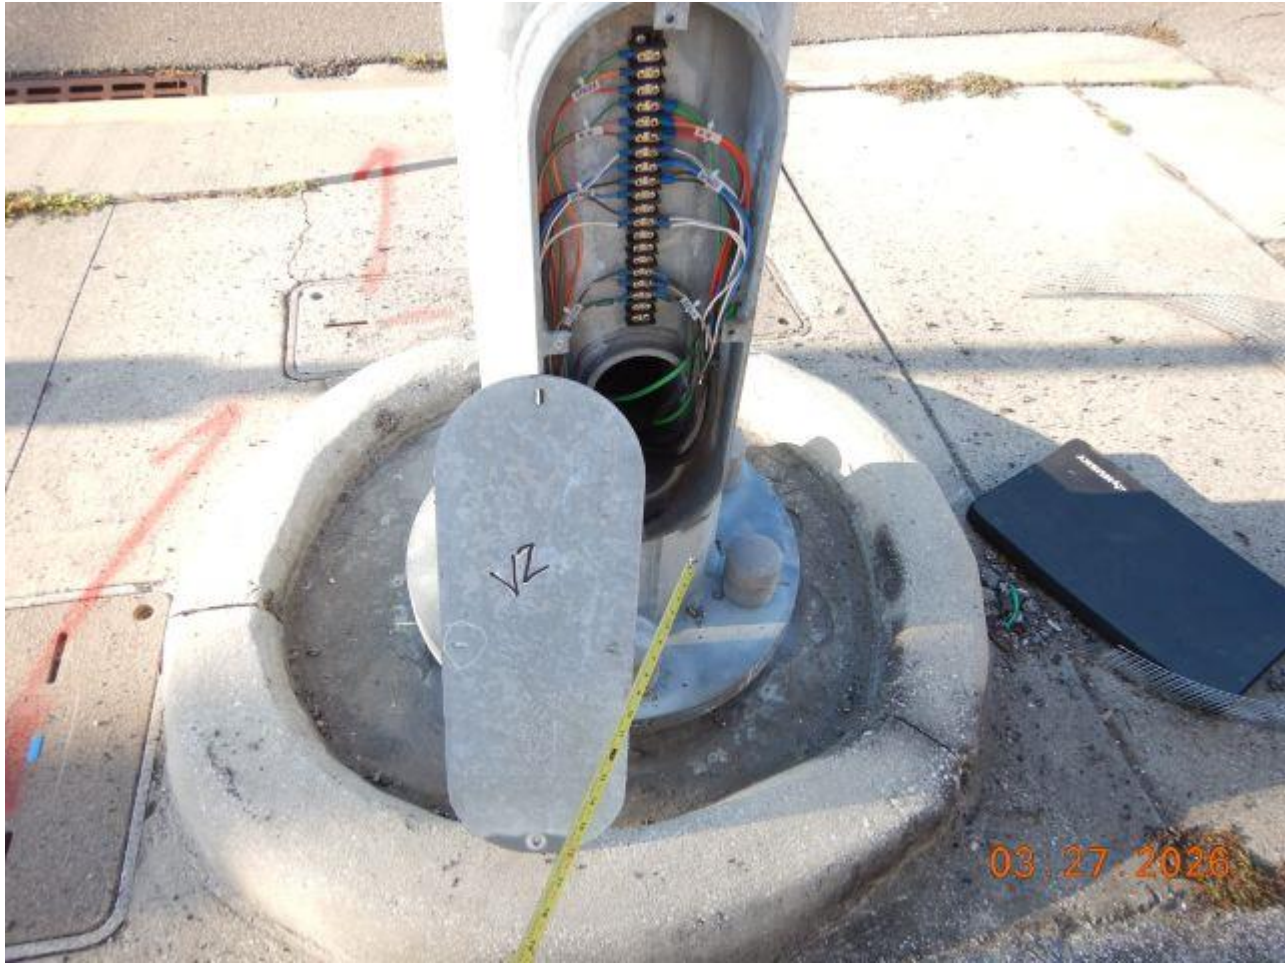
**Photo 2 - Element 8481 Mast Arm Vertical**

V1 & V2 - The compartment cover weatherproof gaskets are missing. NO CHANGE. Refer to Photo 2. REPAIR

V1 & V2 - Typical terminal compartment cover missing the weatherproof gasket.

V1 & V2 - Install compartment cover gaskets and replace compartment cover bolt as needed. No repairs have been made since the 2021 inspection.

| CONDITION<br>STATE | | | PRIORITY |
|---|---|---|---|
| V1 & V2 - Install weatherproof gasket for terminal compartment cover per FDOT Index 649-031. | | | |

V1 & V2 - Install weatherproof gasket for terminal compartment cover per FDOT Index 649-031.

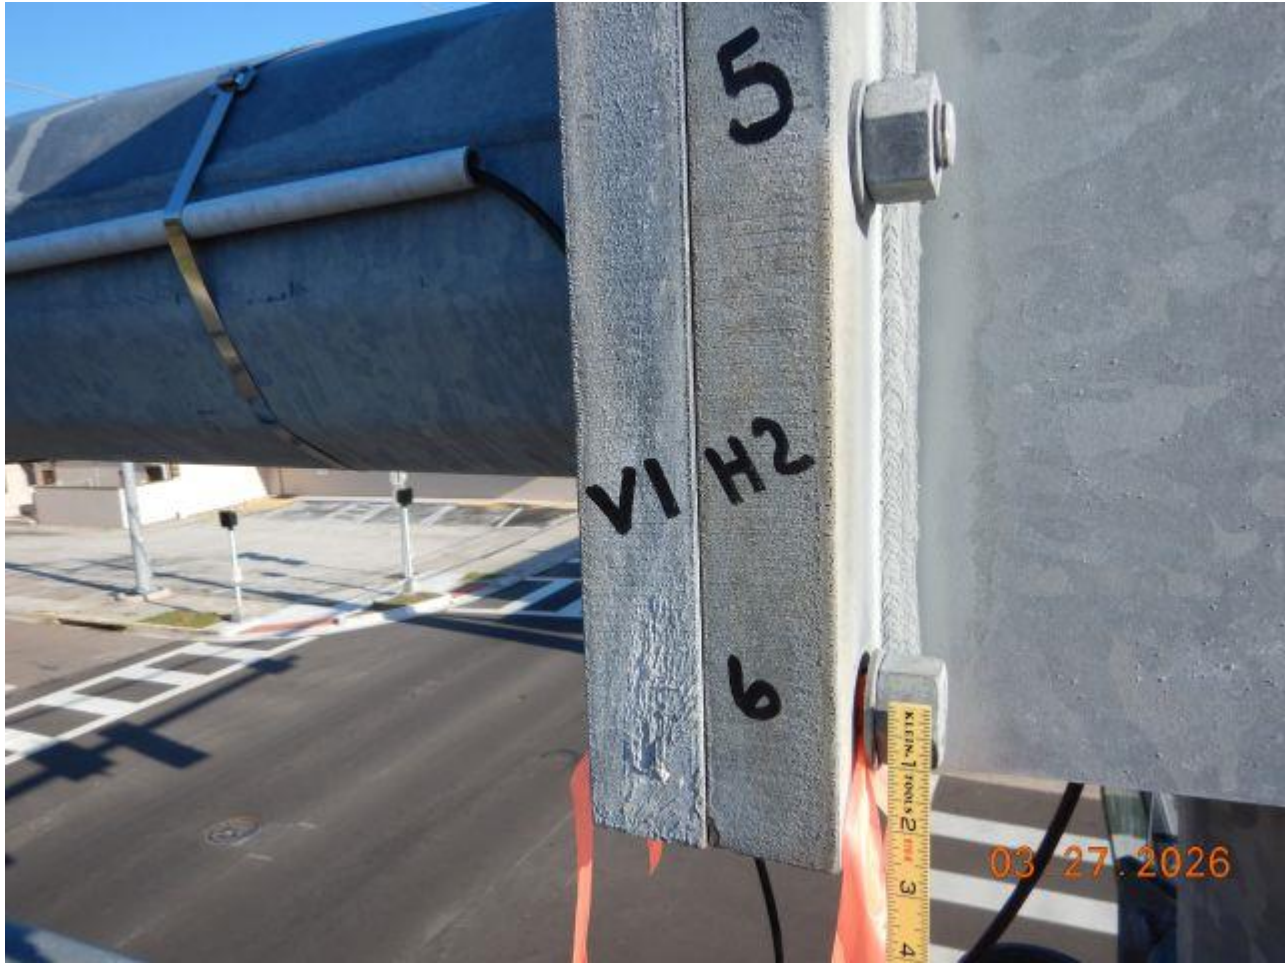
**Photo 3 - Element 8484 Mast Arm Horizontal**

V1/H2 - Moment connection bolt #6 (bottom right) is loose. NEW. Refer to Photos 3. (1 EA) REPAIR.

V1/H2 - Overview of moment connection bolt #6 loose.

| CONDITION<br>STATE | | | PRIORITY |
|---|---|---|---|
| V1H2 - Replace moment connection bolt 6 with new Galv. A325 bolt 6in L x 1in. dia. | | | |

V1H2 - Replace moment connection bolt 6 with new Galv. A325 bolt 6in L x 1in. dia.

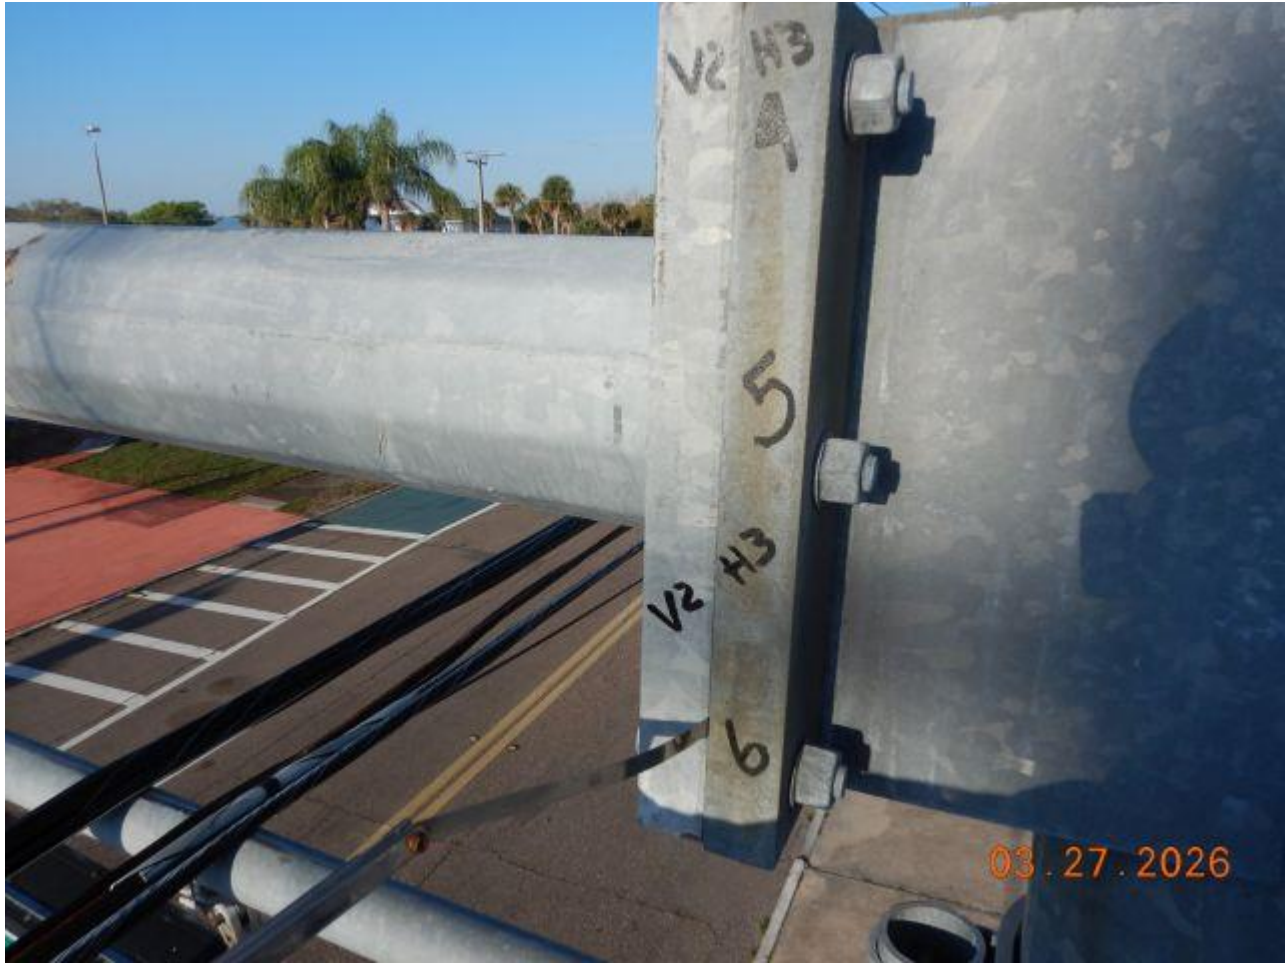
**Photo 4 - Element 8484 Mast Arm Horizontal**

V3/H3 - The moment connection has a gap up to 0.020 in. wide between the plates at bolt #6. NEW. Refer to Photo 4 & 5. (1 EA)

V2/H3 - Overview of slight gap between moment connection plates at Bolt #6.

WORK ORDER RECOMMENDATION:  
None.

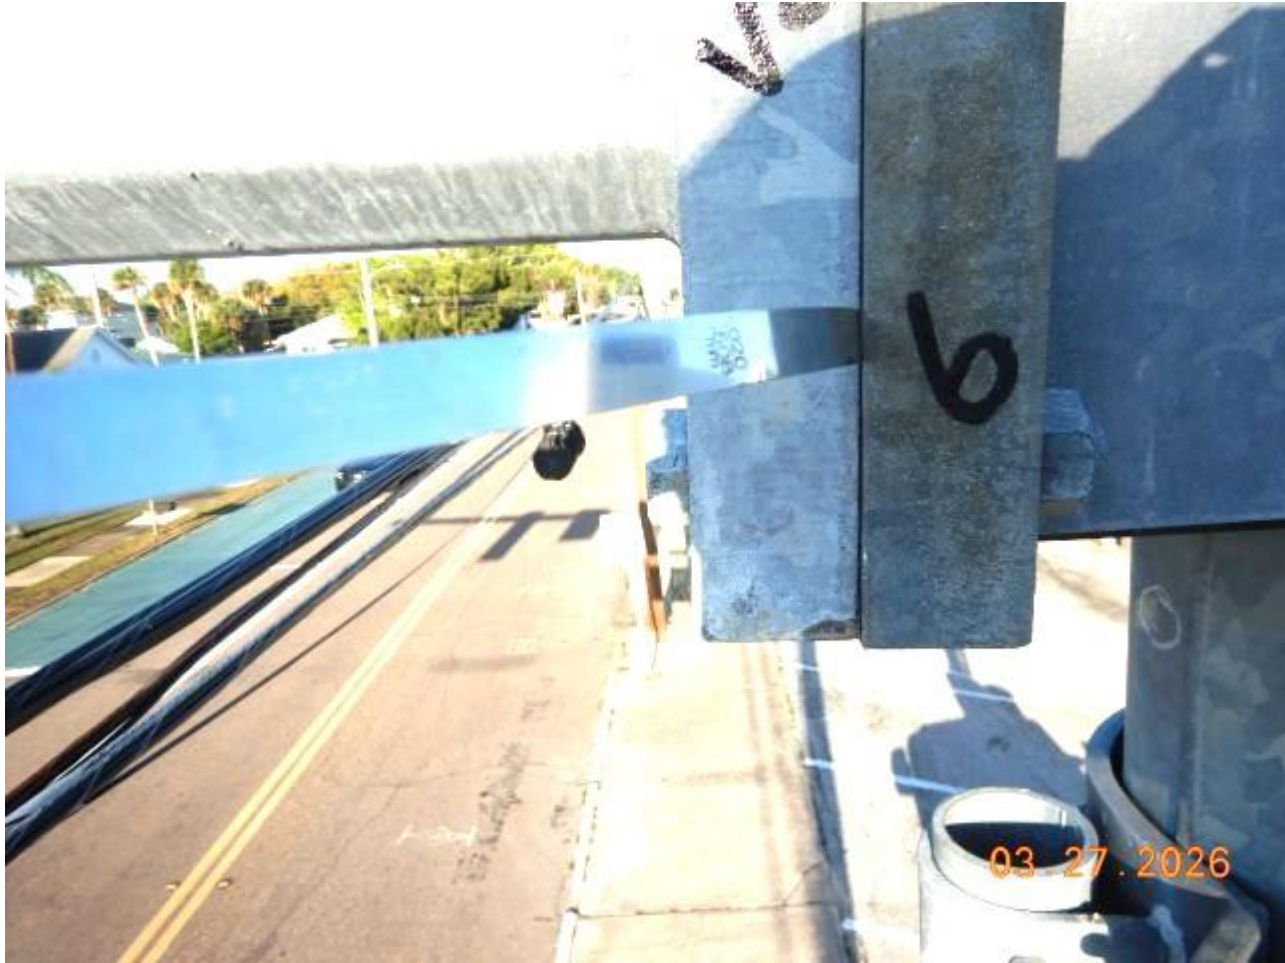
**Photo 5 - Element 8484 Mast Arm Horizontal**

V2/H3 - Close-up of slight gap between moment connection plates at Bolt #6.

WORK ORDER RECOMMENDATION:  
None.

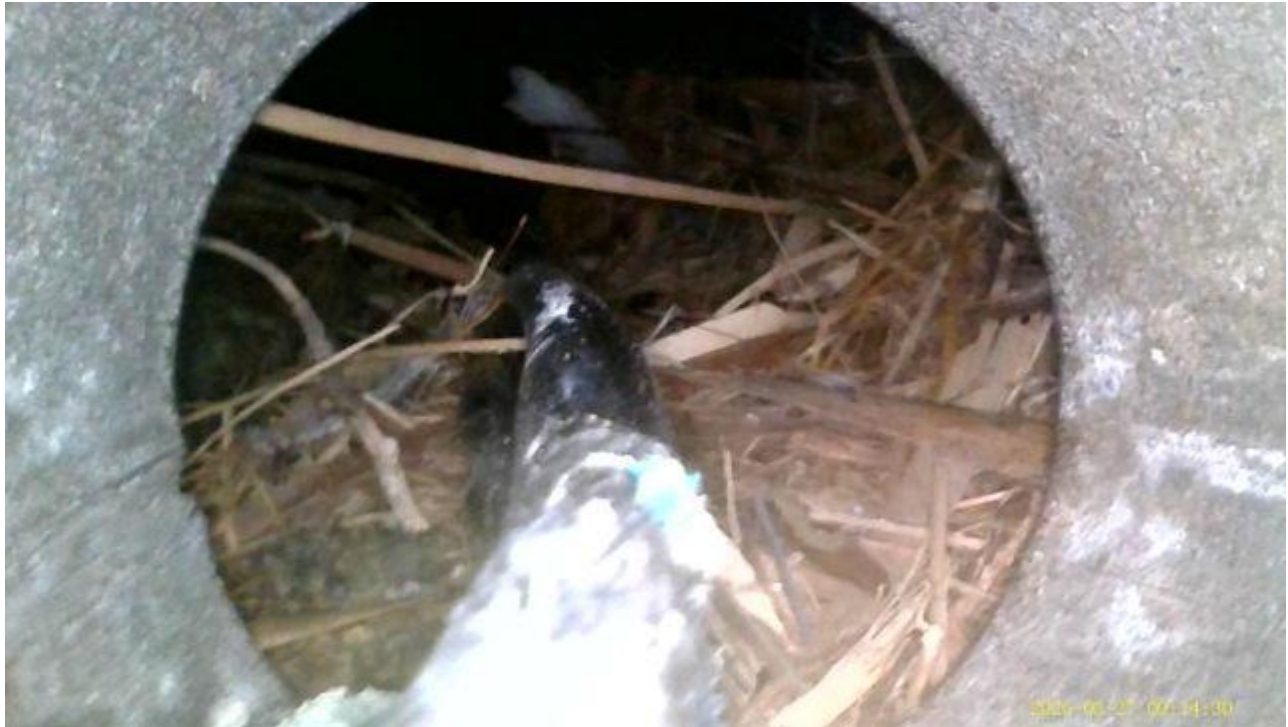
**Photo 7 - Element 8484 Mast Arm Horizontal**

V1/H1, V1/H2 & V2/H3 - There is a heavy accumulation of bird nesting material inside the horizontal arm interiors at the moment connections viewed with a borescope inserted thru the arm drain holes. No corrosion could be seen thru the nesting material and D-meter readings at 3 in., 12 in. & 24 in. from the moment connection taken at the 5, 6 and 7 o'clock positions did not indicate any reduction in section at this time. NEW. Refer to Photos 6, 7 & 8. REPAIR

V1/H2 - Typical bird nesting material inside horizontal arm near the moment connection.

| CONDITION<br>STATE | | | PRIORITY |
|---|---|---|---|
| H1 H2 & H3 - Install screening at the moment connection plates to prevent nesting in arms. | | | |

H1 H2 & H3 - Install screening at the moment connection plates to prevent nesting in arms.

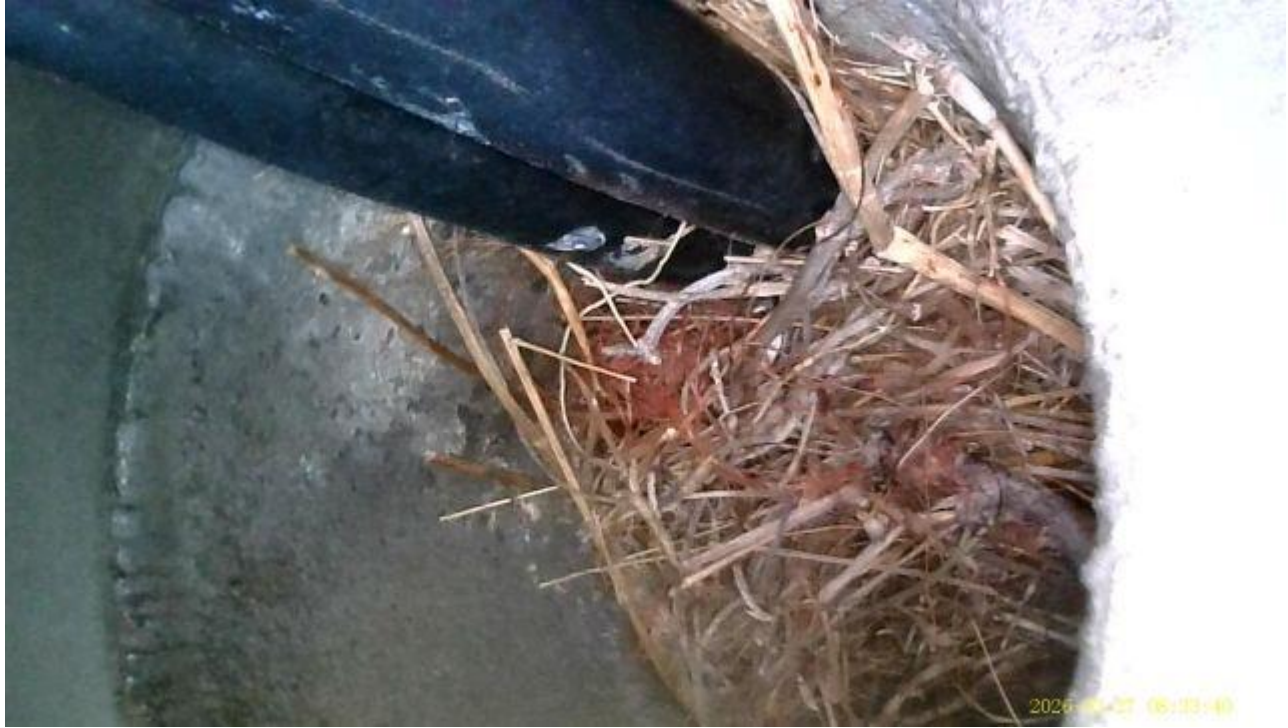
**Photo 8 - Element 8484 Mast Arm Horizontal**

V2/H3 - Typical bird nesting material inside horizontal arm near the moment connection.

H1 H2 & H3 - Install screening at the moment connection plates to prevent nesting in arms.

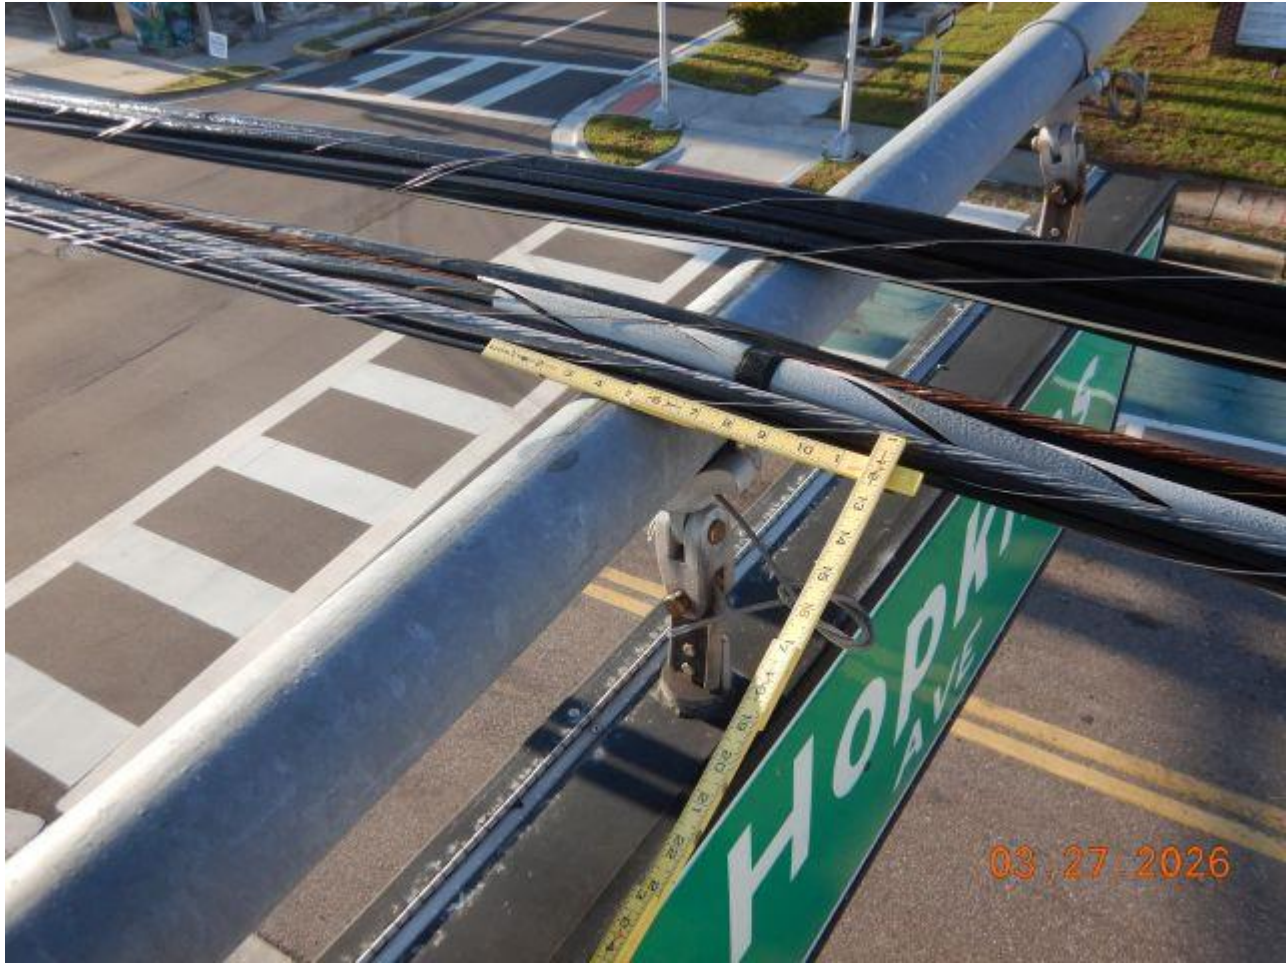
**Photo 9 - Element 8484 Mast Arm Horizontal**

V3 - There are several utility lines laying on top of the horizontal sign support bracket. NEW. Refer to Photo 9. REPAIR.

V3 - Utility wires laying on the top of the street sign support bracket.

V3 - Relocate the utility wires laying on top of the street sign support.
