**FLORIDA DEPARTMENT OF TRANSPORTATION**  
**BRIDGE MANAGEMENT SYSTEM**  
**Inspection/CIDR Report**  
(TRAFFIC SIGNAL MAST ARM INSPECTION REPORT)

Structure ID: 70M095

| BY: | Ayres Associates | STRUCTURE NAME: | US-1 (Hopkins Ave) SB at Julia St |

TYPE OF INSPECTION: Regular NBI

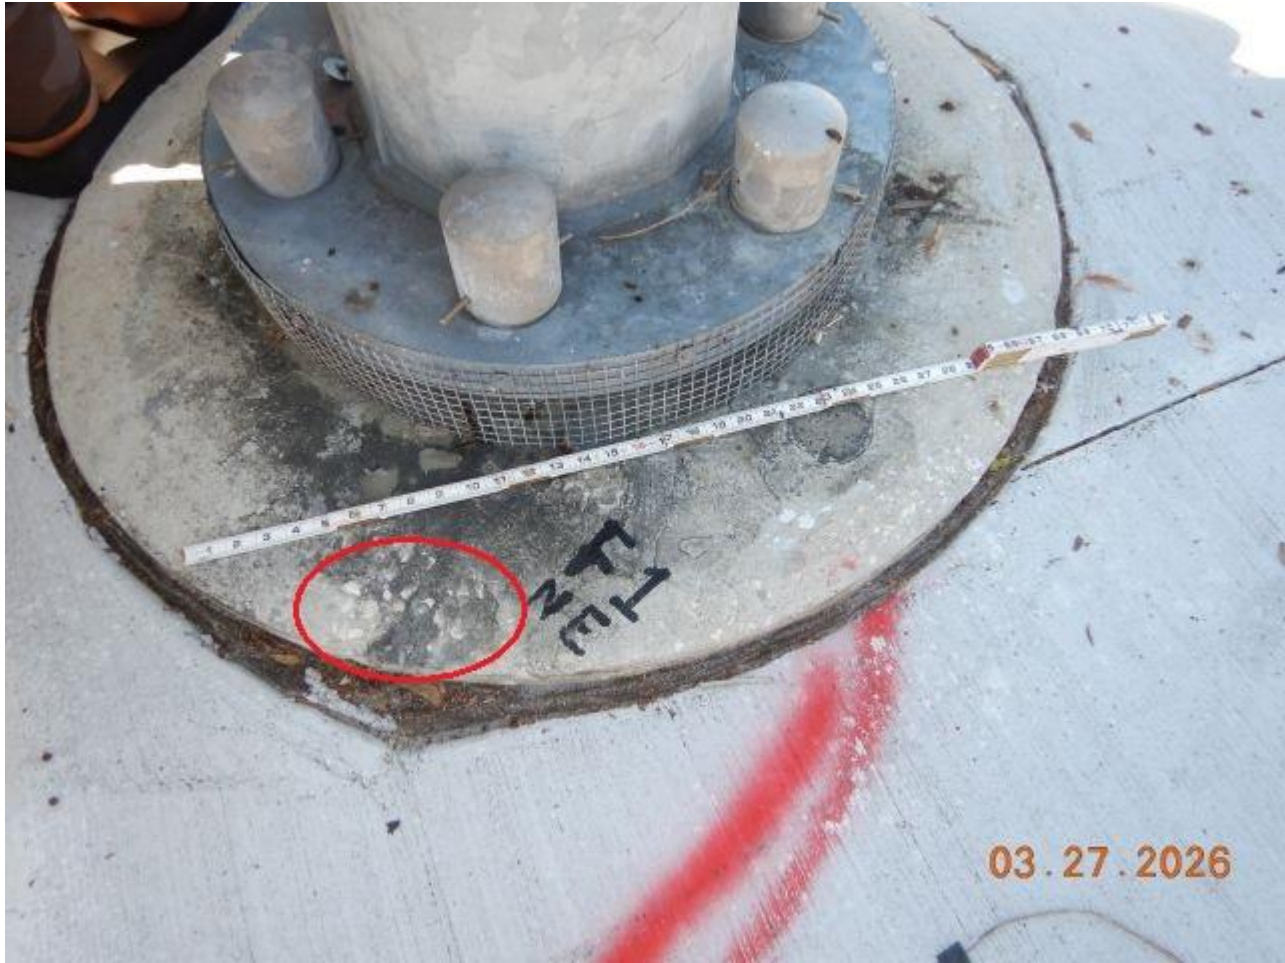
**Photo 1 - Element 8480 Mast Arm Foundation**

F1 - The top northeast edge of the foundation has a minor spall 6 in. L x 4 in. W X 1/2 in. D with no exposed steel. Refer to Photo 1. (1 EA)

F1 - Top northeast quadrant with minor spall.

REPAIR RECOMMENDATION:  
None.

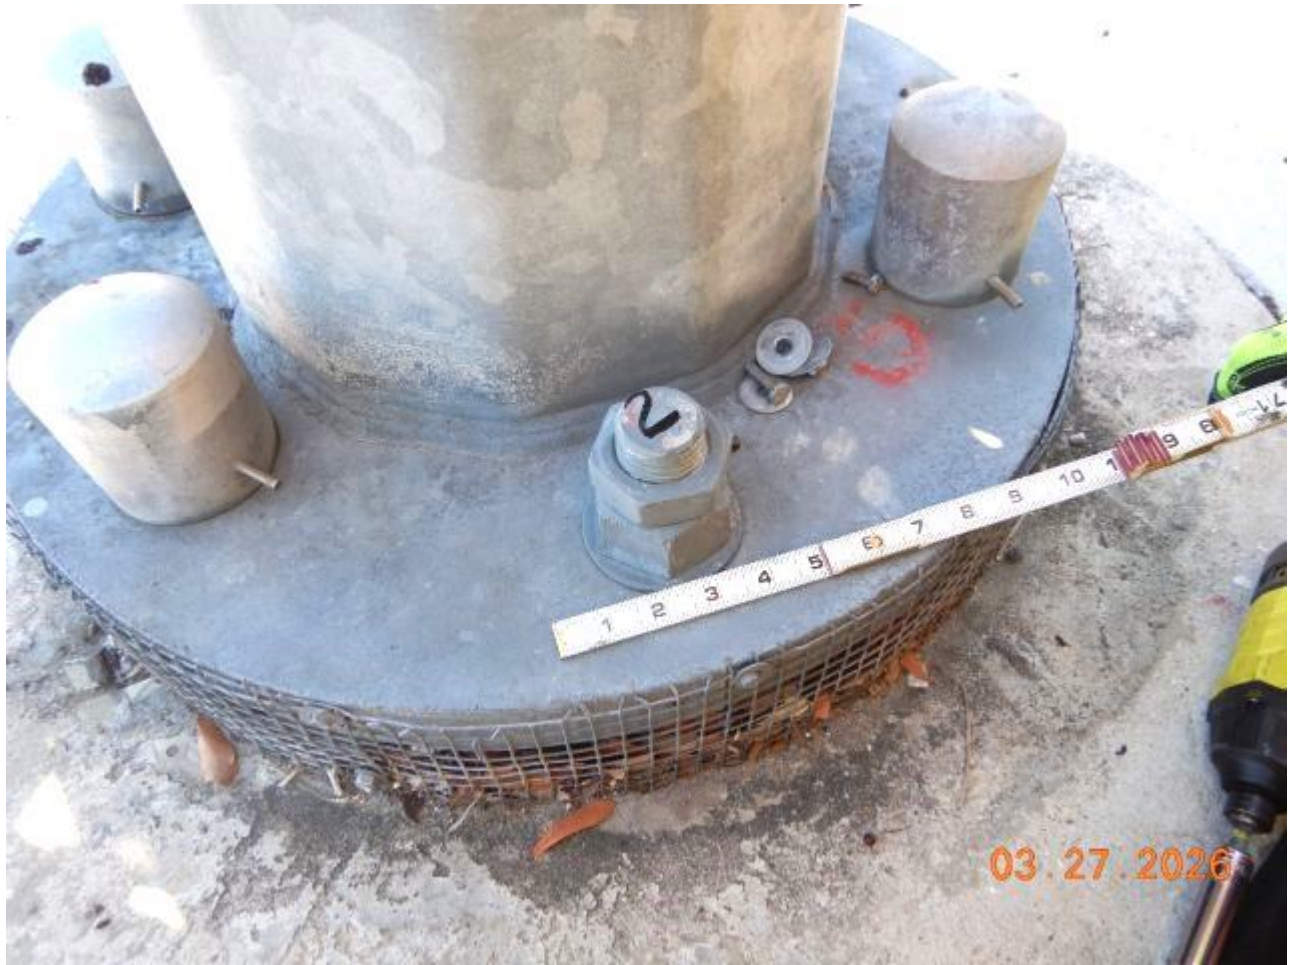
**Photo 2 - Element 8480 Mast Arm Foundation**

F1 - (1) of (6) anchor bolt covers (AB#2) is missing. NEW Refer to Photo 2. REPAIR

F2 - (1) of (6) missing anchor bolt covers (AB #2).

| CONDITION<br>STATE | PRIORITY |
|---|---|
| WORK ORDER RECOMMENDATION:<br>F2 - Install the missing anchor bolt cover. | |

F2 - Install the missing anchor bolt cover.

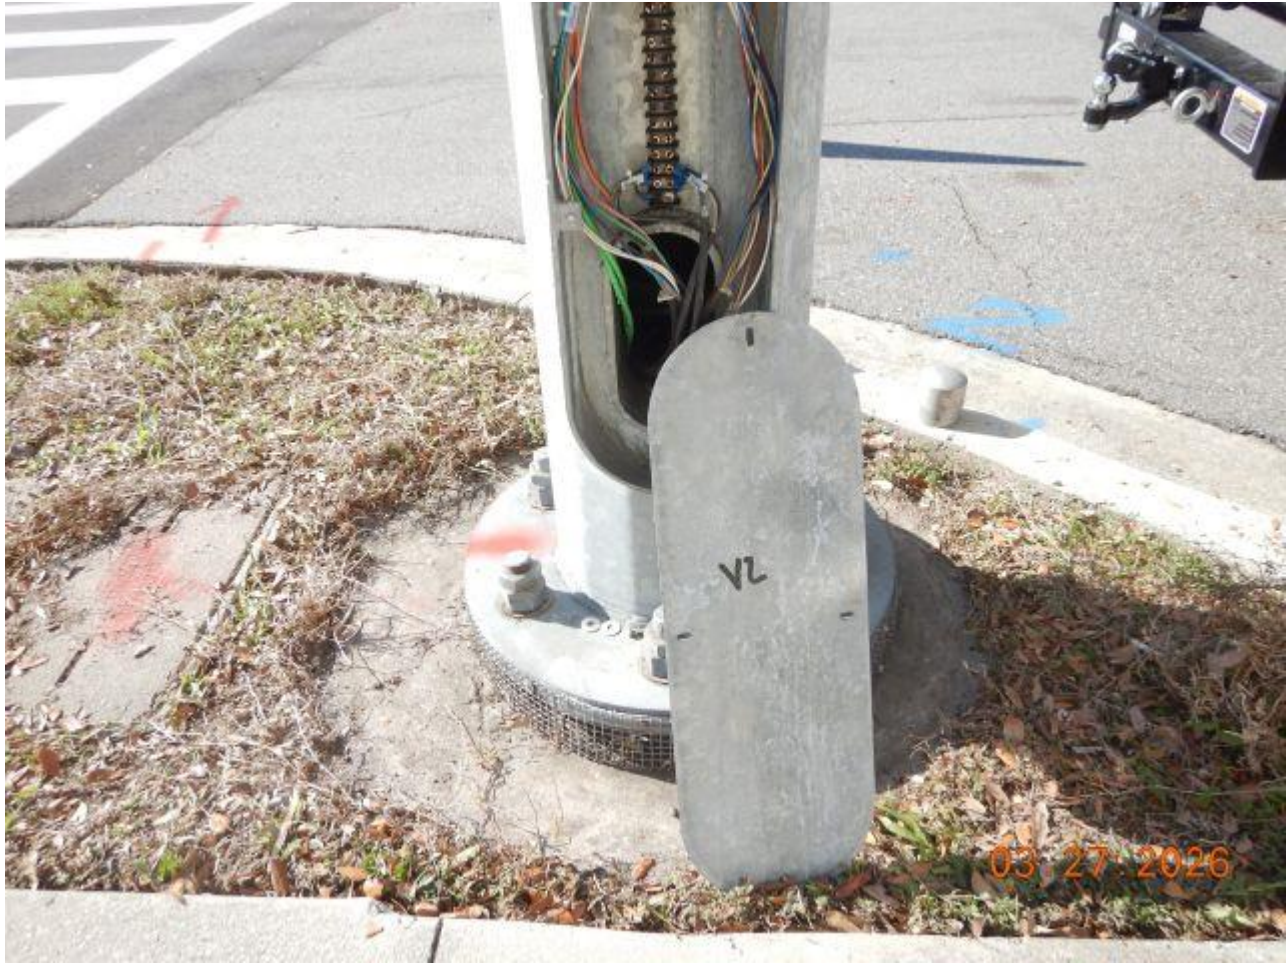
**Photo 3 - Element 8481 Mast Arm Vertical**

V1 & V2 - The compartment covers are missing the weatherproof gaskets. NO CHANGE. Refer to Photo 3. REPAIR

V1 & V2 - Install compartment cover gasket. The weatherproof gaskets have not been installed.

V1 & V2 - Typical terminal compartment cover missing the weatherproof gasket.

| CONDITION<br>STATE | PRIORITY |
|---|---|
| WORK ORDER RECOMMENDATION:<br>V1 & V2 - Install weatherproof gasket for terminal compartment cover per FDOT Index 649-031. | |

V1 & V2 - Install weatherproof gasket for terminal compartment cover per FDOT Index 649-031.

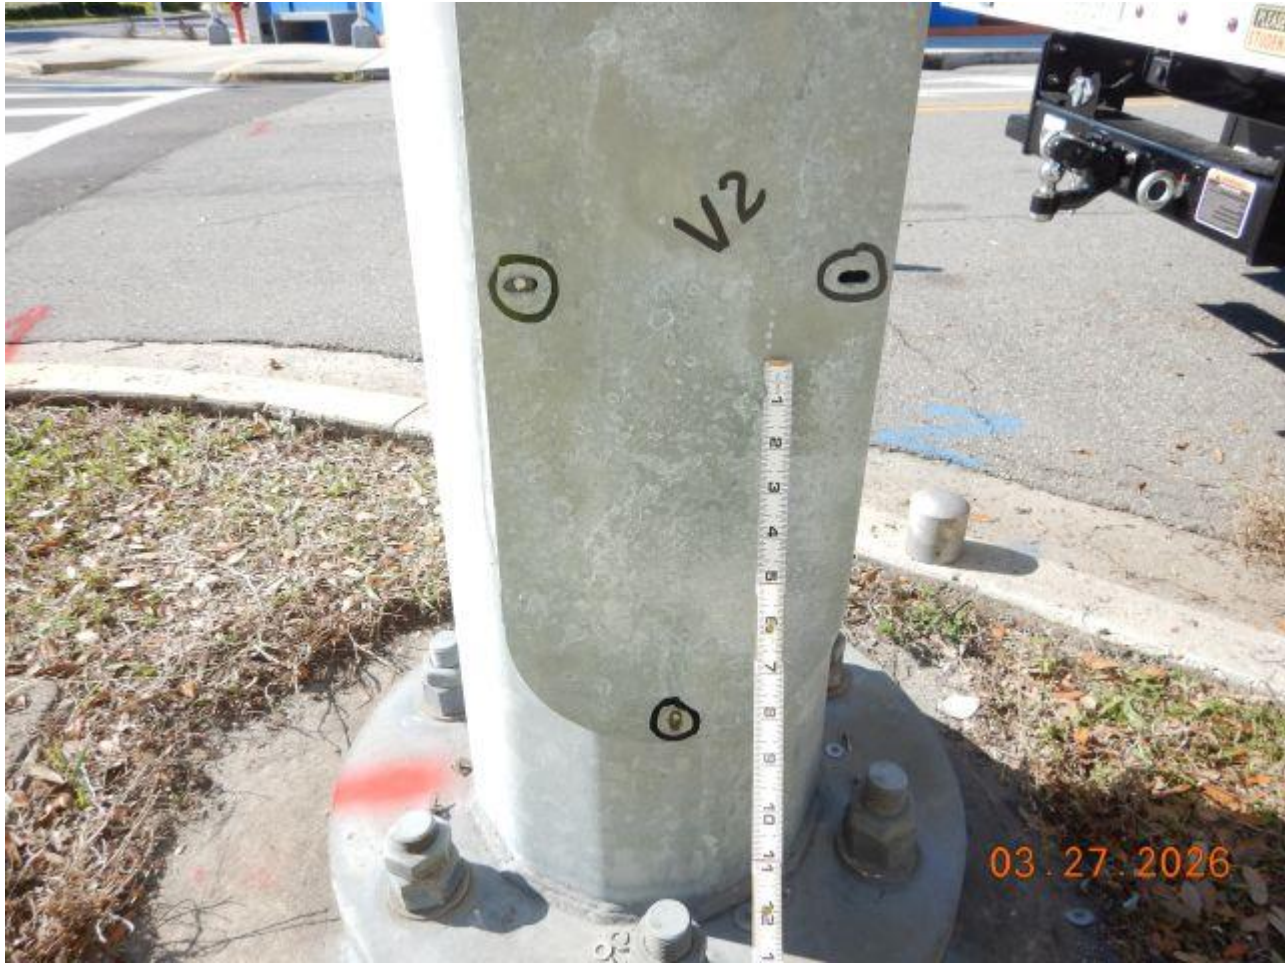
**Photo 4 - Element 8481 Mast Arm Vertical**

V2 - The compartment cover has (2) sheared bolts and (1) missing bolt due to the clip welded to the inside of the hand hole flange missing. NEW. Refer to Photo 4. REPAIR.

V2 - Compartment cover with (2) sheared bolts and (1) missing due to broken clip.

| CONDITION<br>STATE | PRIORITY |
|---|---|
| WORK ORDER RECOMMENDATION:<br>V2 - Repair & Install the compartment cover bolts. | |

V2 - Repair & Install the compartment cover bolts.

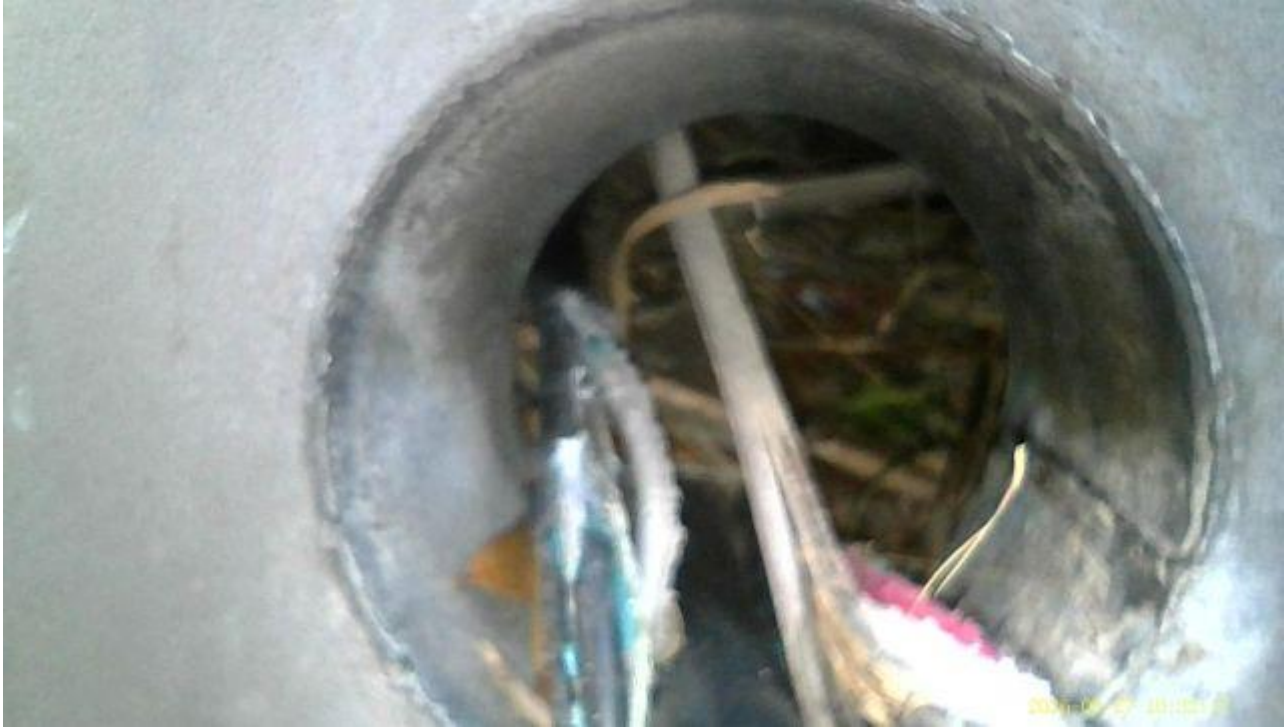
**Photo 5 - Element 8484 Mast Arm Horizontal**

V1/H1 & V2/H3 - Have heavy accumulation and V1/H2 has light accumulation of bird nesting material inside the horizontal arm interiors at the moment connections viewed with a borescope inserted thru the arm drain holes. No corrosion could be seen thru the nesting material and D-meter readings at 3 in., 12 in. & 24 in. from the moment connection taken at the 5, 6 and 7 o'clock positions did not indicate any reduction in section at this time. NEW. Refer to Photos 5, 6 & 7. REPAIR

V1/H1 - Typical bird nesting material inside horizontal arm near the moment connection.

| CONDITION<br>STATE | PRIORITY |
|---|---|
| WORK ORDER RECOMMENDATION:<br>H1 H2 & H3 - Install screening at the moment connection plates to prevent nesting in arms. | |

H1 H2 & H3 - Install screening at the moment connection plates to prevent nesting in arms.

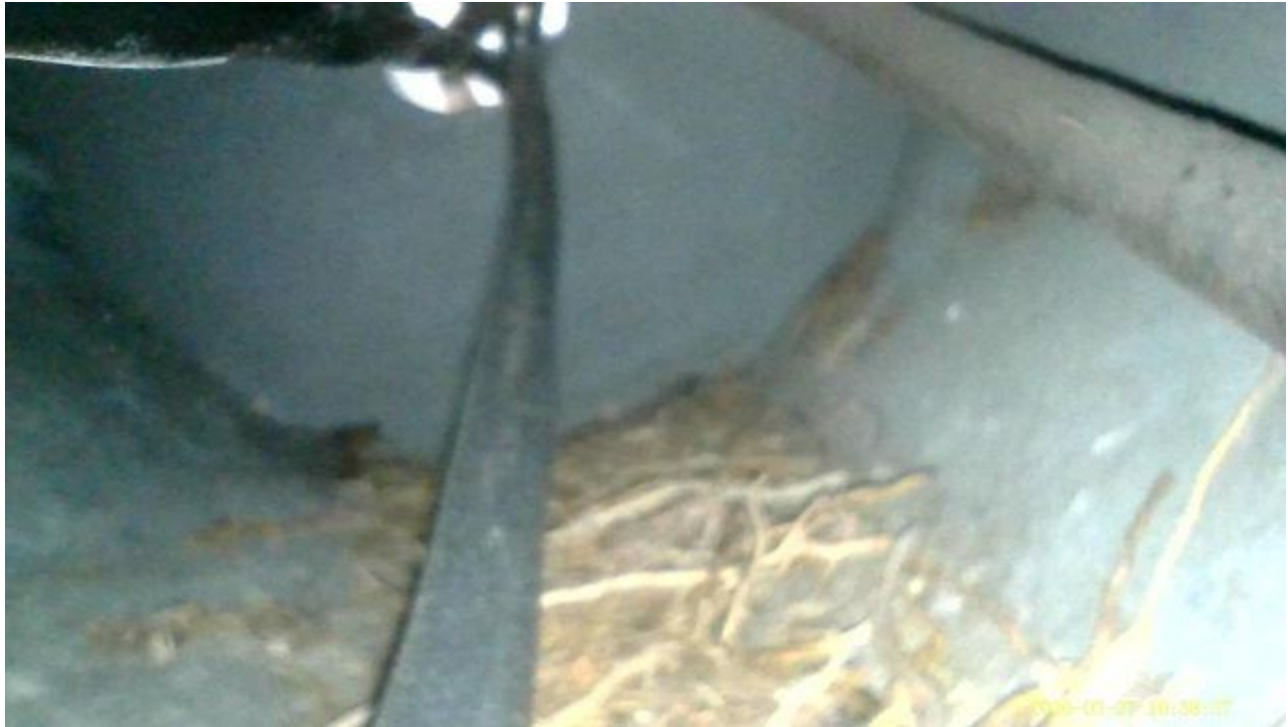
**Photo 6 - Element 8484 Mast Arm Horizontal**

V1/H2 - Typical bird nesting material inside horizontal arm near the moment connection.

H1 H2 & H3 - Install screening at the moment connection plates to prevent nesting in arms.
