**Subject:** Pavement Condition Assessment Report

The attached Pavement Condition Assessment report for SR 524, Section #70070-000, from MP 0.000 to MP 5.200 is submitted on behalf of NV5.

Scope Notes for Section 70070000

SR 524 from SR 520 to SR 528

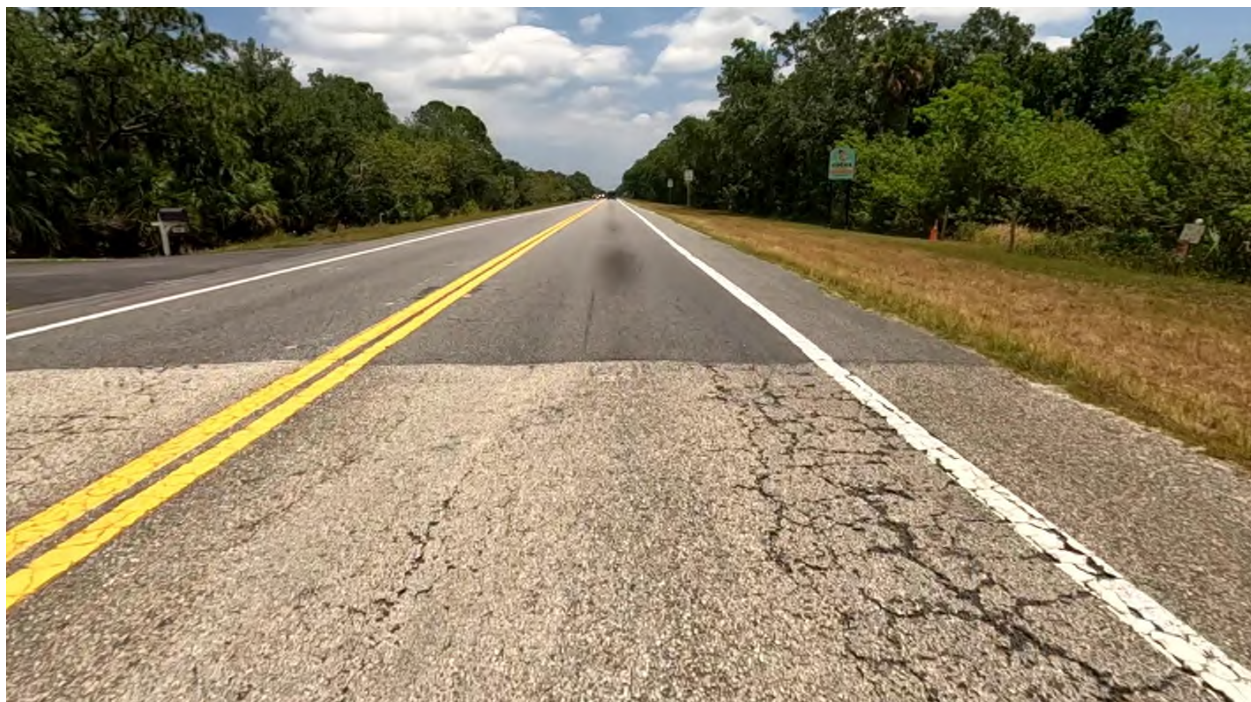
In all mainline travel lanes, longitudinal and branch cracking with light wearing of friction course was observed at random throughout the project limits. From approximate MP 0.000 to MP 0.200 in all mainline travel lanes, longitudinal cracking and alligator cracking with delamination was observed.

Photo 1: SR 524, Northbound, R1 near MP 0.200, longitudinal and alligator cracking with delamination and pavement change.

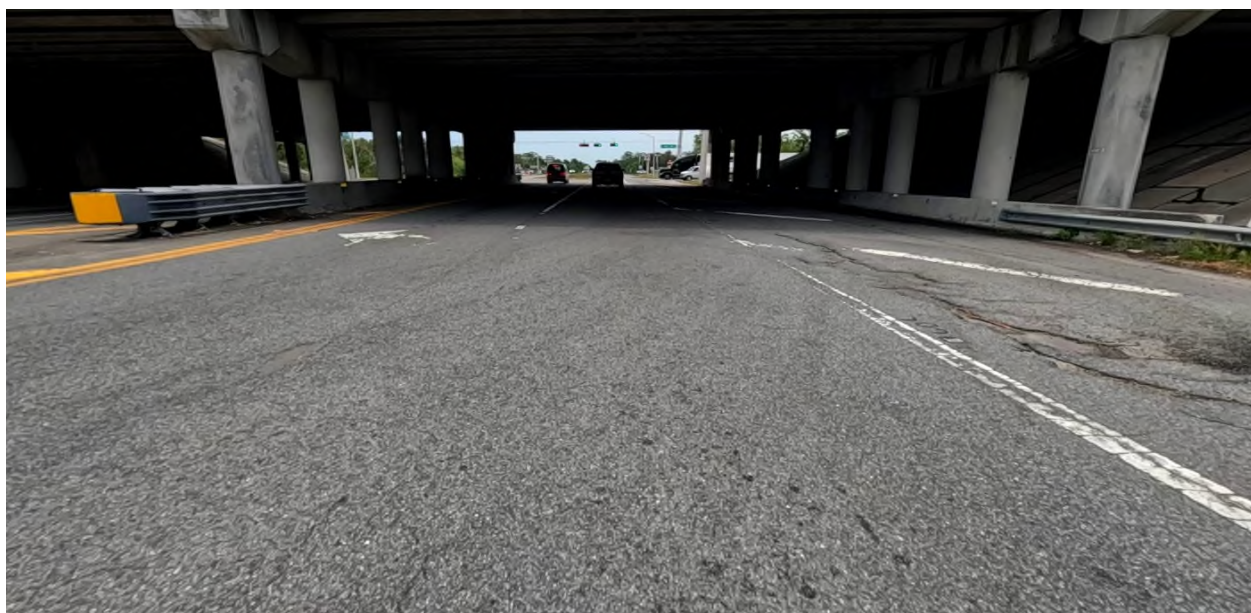
In the Northbound outside paved shoulder (OR), branch cracking, shoving, and wearing of friction course with delamination was observed near MP 1.935 (SR 524 and I-95 underpass).

Photo 2: SR 524, Northbound, R1 near MP 1.635, shoving and wearing of friction course with delamination at outside paved shoulder (OR).

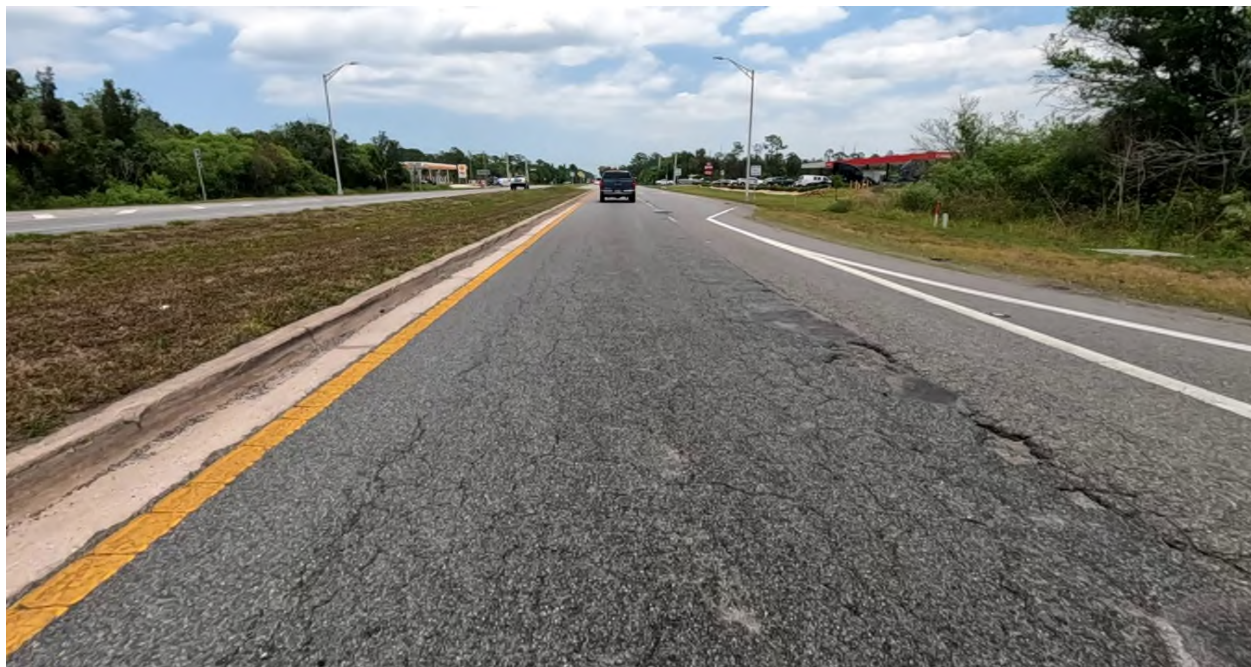
In the R1 travel lane, alligator cracking with delamination was observed near MP 1.715 (SR 524 and I-95 NB off ramp) and MP 1.836 (intersection of SR 524 and Friday Dr.).

Photo 3: SR 524, Northbound, R1 near MP 1.715, longitudinal and alligator cracking with delamination at I-95 NB Off Ramp.

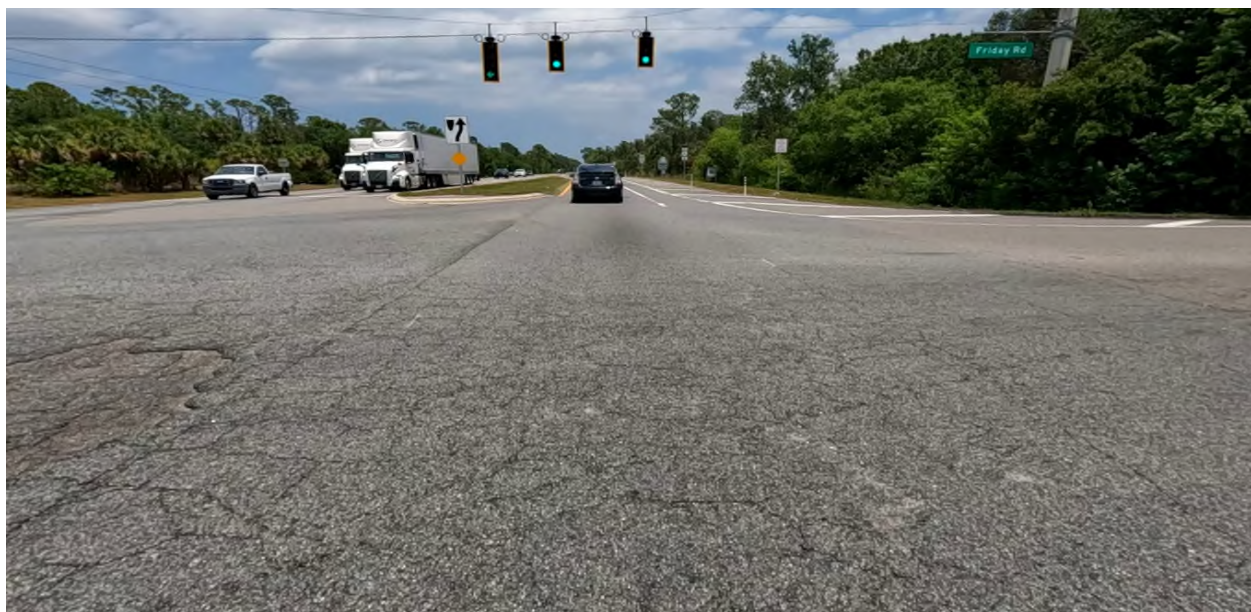
Photo 4: SR 524, Northbound, R1 near MP 1.836, longitudinal and alligator cracking with wearing of friction course and delamination at the intersection of SR 524 and Friday Dr.

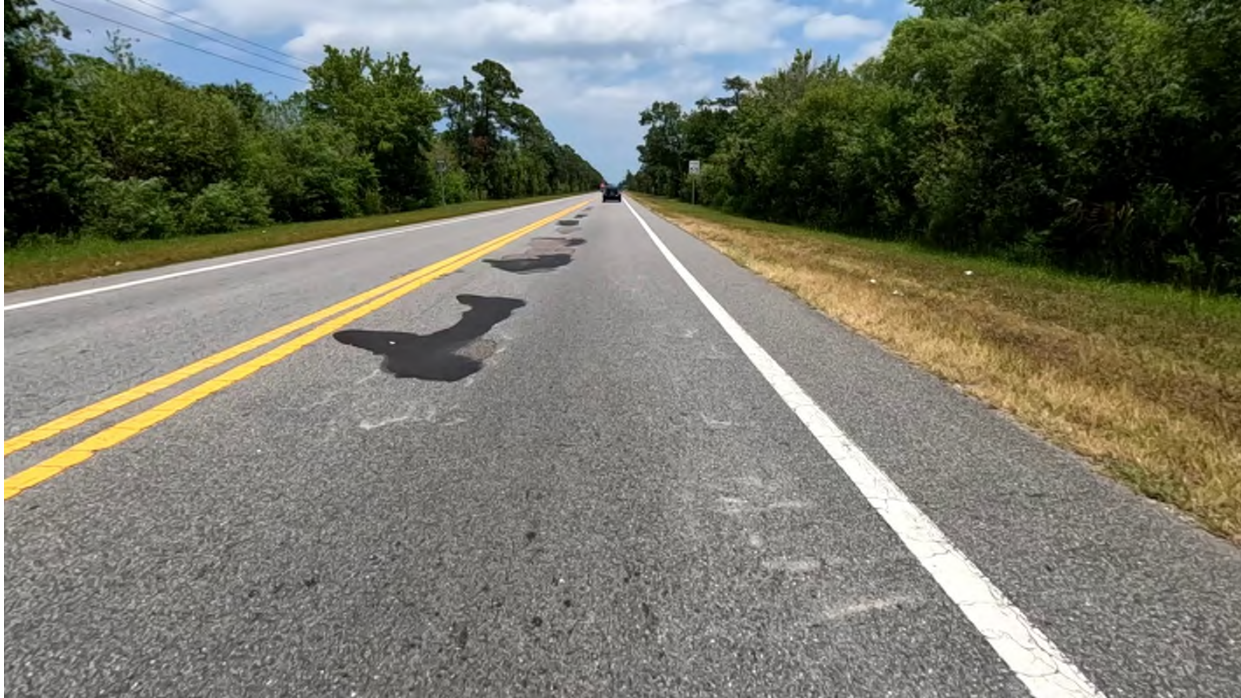
A pavement change was observed in all mainline travel lanes from approximate MP 0.000 to MP 0.200, MP 2.300 to MP 5.200. Near MP 5.072, a maintenance patch (119-ft) was observed on the SR 528 Eastbound On-Ramp. Maintenance patches were observed in all mainline travel lanes from approximate MP 1.850 to MP 1.950.

Photo 5: SR 524, Northbound, R1 near MP 1.850, maintenance patches. Note the light branch cracking with limerock pumping.

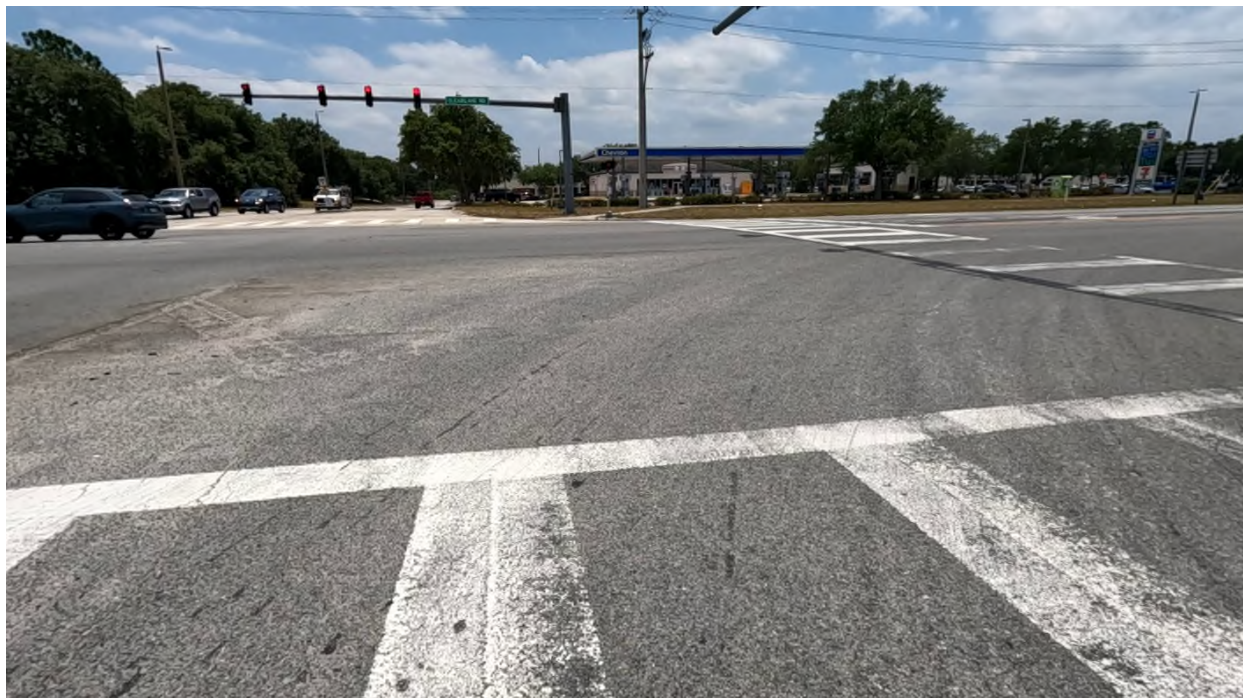
Photo 6: SR 524 Southbound, L1 near MP 5.212, wearing of friction course with delamination at the intersection of SR 524 and Industry Rd.

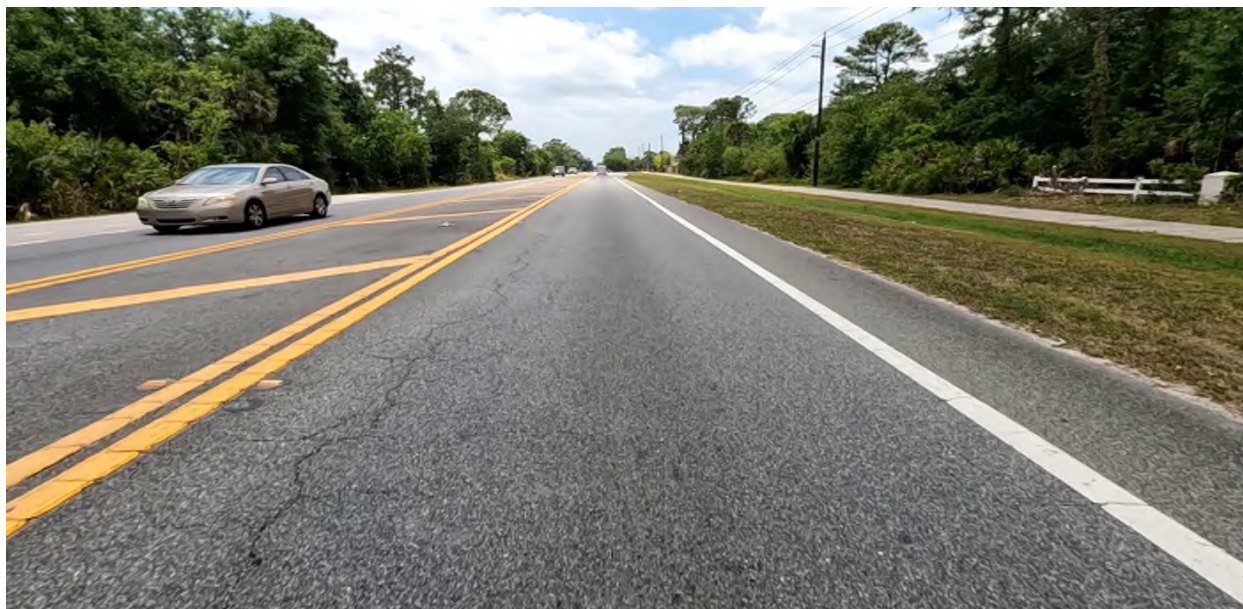
Photo 7: SR 524 Southbound, L1 near MP 2.450, longitudinal and branch cracking.

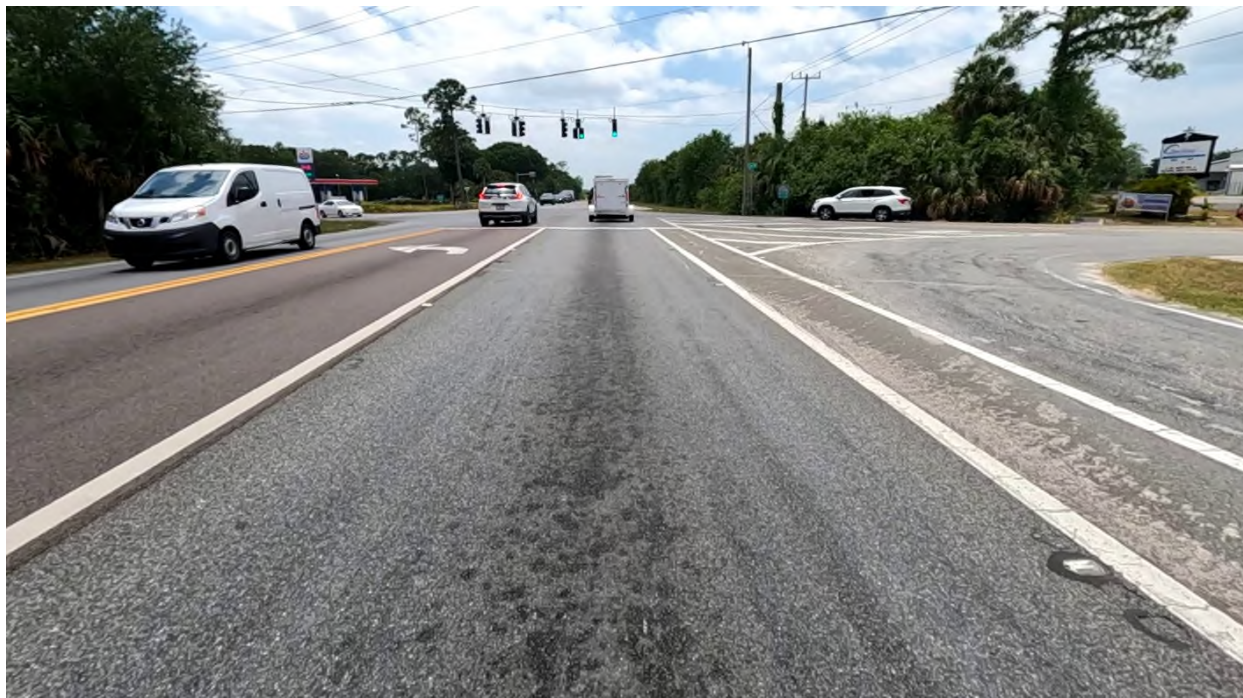
Moderate wearing of friction course with delamination was observed in the Southbound right turn lane (LRTL onto Cox Rd.) near MP 2.916. In the Southbound left turn lane (LLTL onto Cox Rd.), there was newer pavement found from approximate MP 2.900 to MP 3.000.

Photo 8: SR 524 Southbound, L1 near MP 2.916, wearing of the friction course with delamination on right turn lane (LRTL) onto Cox Rd.

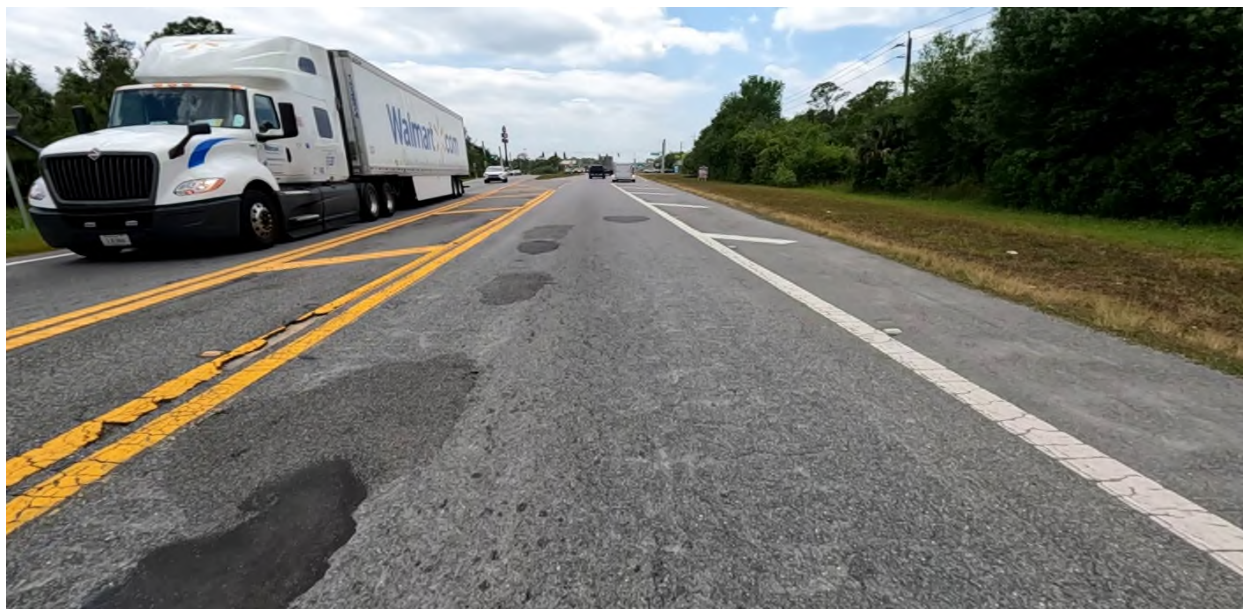
Photo 9: SR 524 Southbound, L1 near MP 1.950, branch cracking with limerock pumping and wearing of friction course with delamination. Note the multiple maintenance/pothole patches.

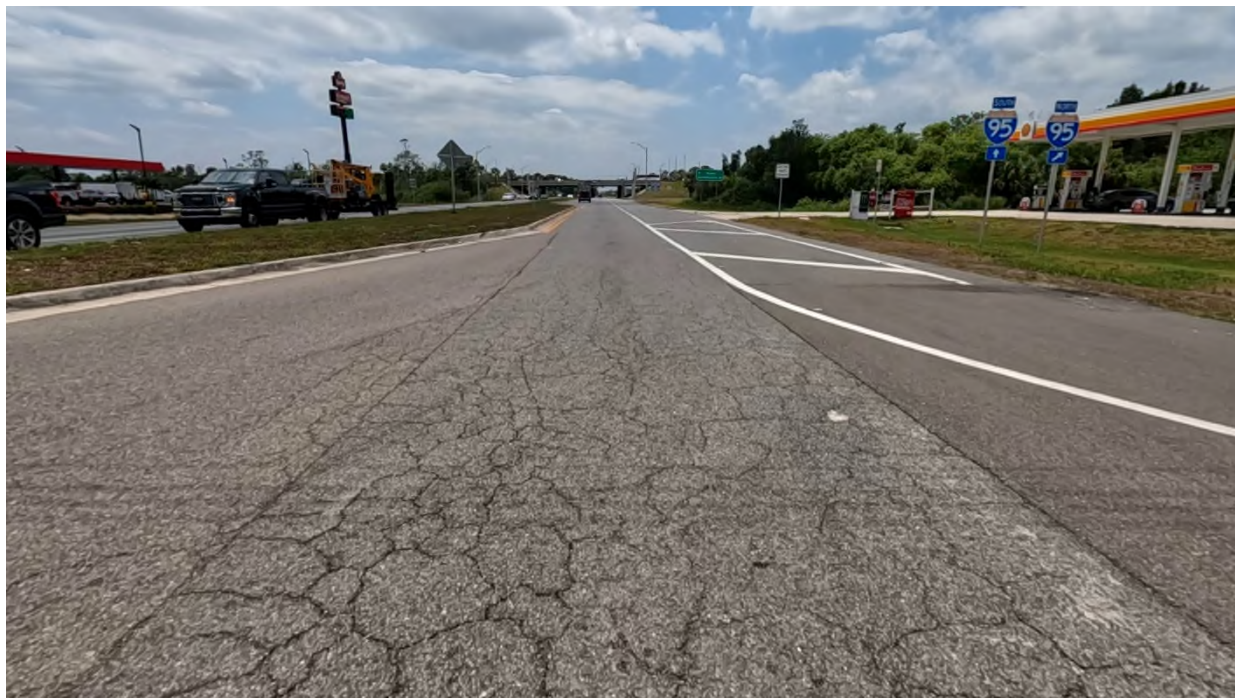
In the L1 travel lane, alligator cracking with delamination and pavement joint separation was observed near MP 1.836 (intersection of SR 524 and Friday Rd.). Light shoving and wearing of friction course was observed near MP 1.695 (intersection of SR 524 and I-95 NB To Ramp).

Photo 10: SR 524 Southbound, L1 near MP 1.836, alligator cracking and joint separation at the intersection of SR 524 and Friday Rd.

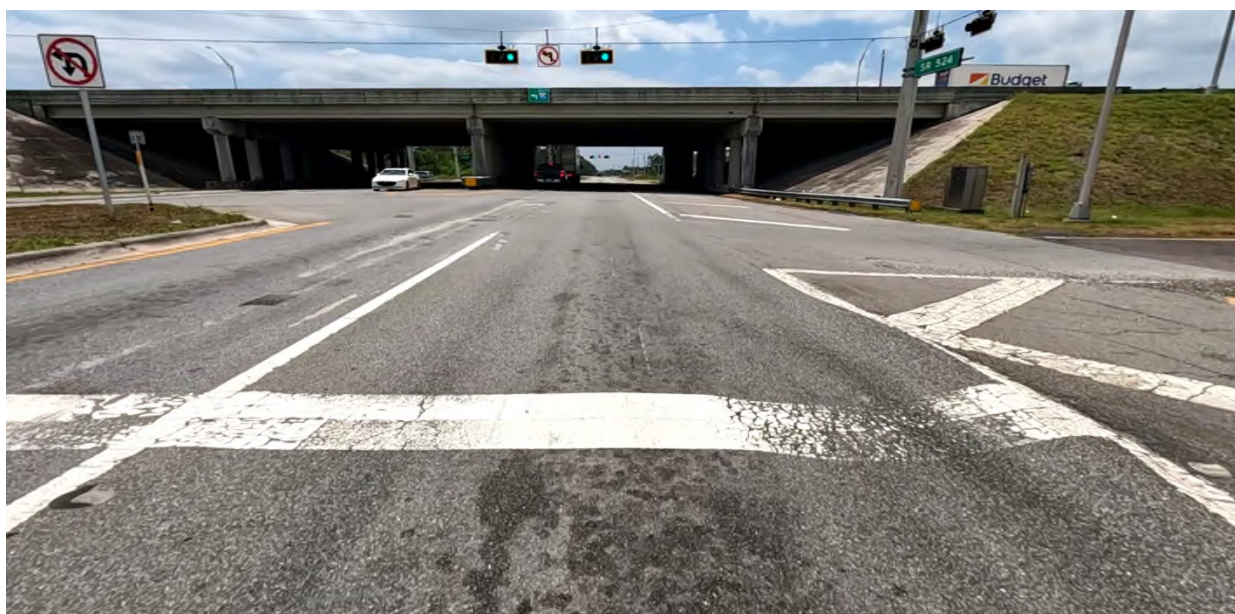
Photo 11: SR 524 Southbound, L1 near MP 1.695, shoving and wearing of friction course at I-95 NB On Ramp. Note the visible rutting in the outside wheelpath.
