**FLORIDA DEPARTMENT OF TRANSPORTATION
BRIDGE MANAGEMENT SYSTEM
Inspection/CIDR Report with PDF attachment(s)
(INTERIM INSPECTION REPORT)**

Structure ID: 75M125

BY: Ayres Associates	STRUCTURE NAME: SR-526 at Paramore Ave
OWNER: 1 State Highway Agency	YEAR BUILT: 1900
MAINTAINED BY: 4 City/Municipal Hwy Agy	SECTION NO.: 75 030 000
STRUCTURE TYPE: 3 Steel - Traffic Signal Mast Arm	MP: 0.500
LOCATION: 0.40 Mi. West of I-4	ROUTE: 00526
SERV. TYPE ON: Traffic Signal Mast Arm	FACILITY CARRIED: SR526 (Washington)
SERV. TYPE UNDER: 1 Highway	FEATURE INTERSECTED: Paramore Ave
MAST ARM CODE: 4	MAST ARM DESCRIPTION: Mast arm is outside the mast arm boundary area

TYPE OF INSPECTION: Interim

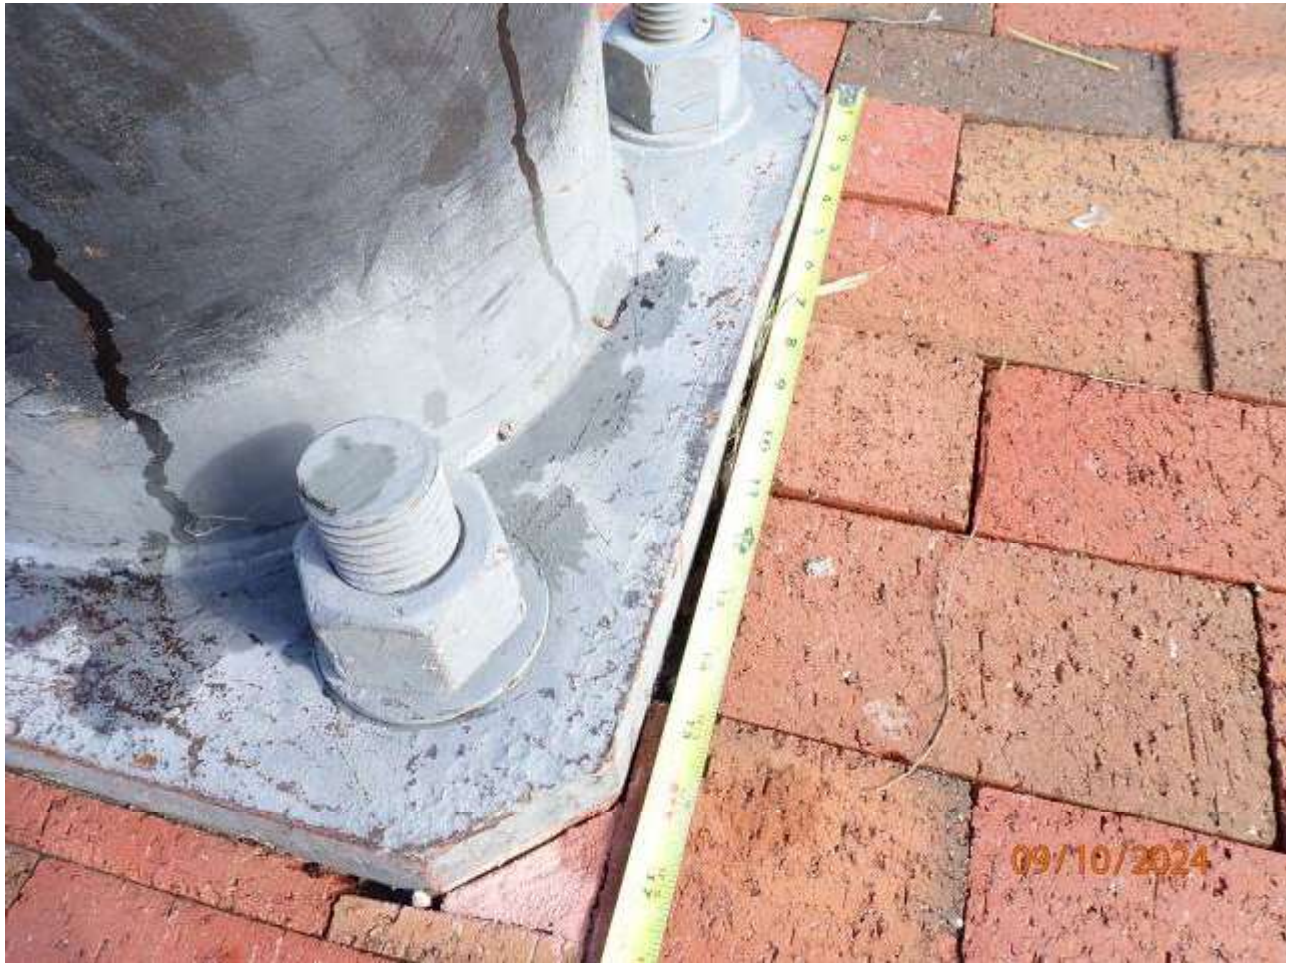
Photo 1

V1 - There are isolated areas of painted over pitting up to 1/32 in. deep on the base plate in the northeast and southeast quadrants. Refer to Photo 1. (1EA)

Element 84841 / Vertical - V1 Painted over minor pitting on base plate.

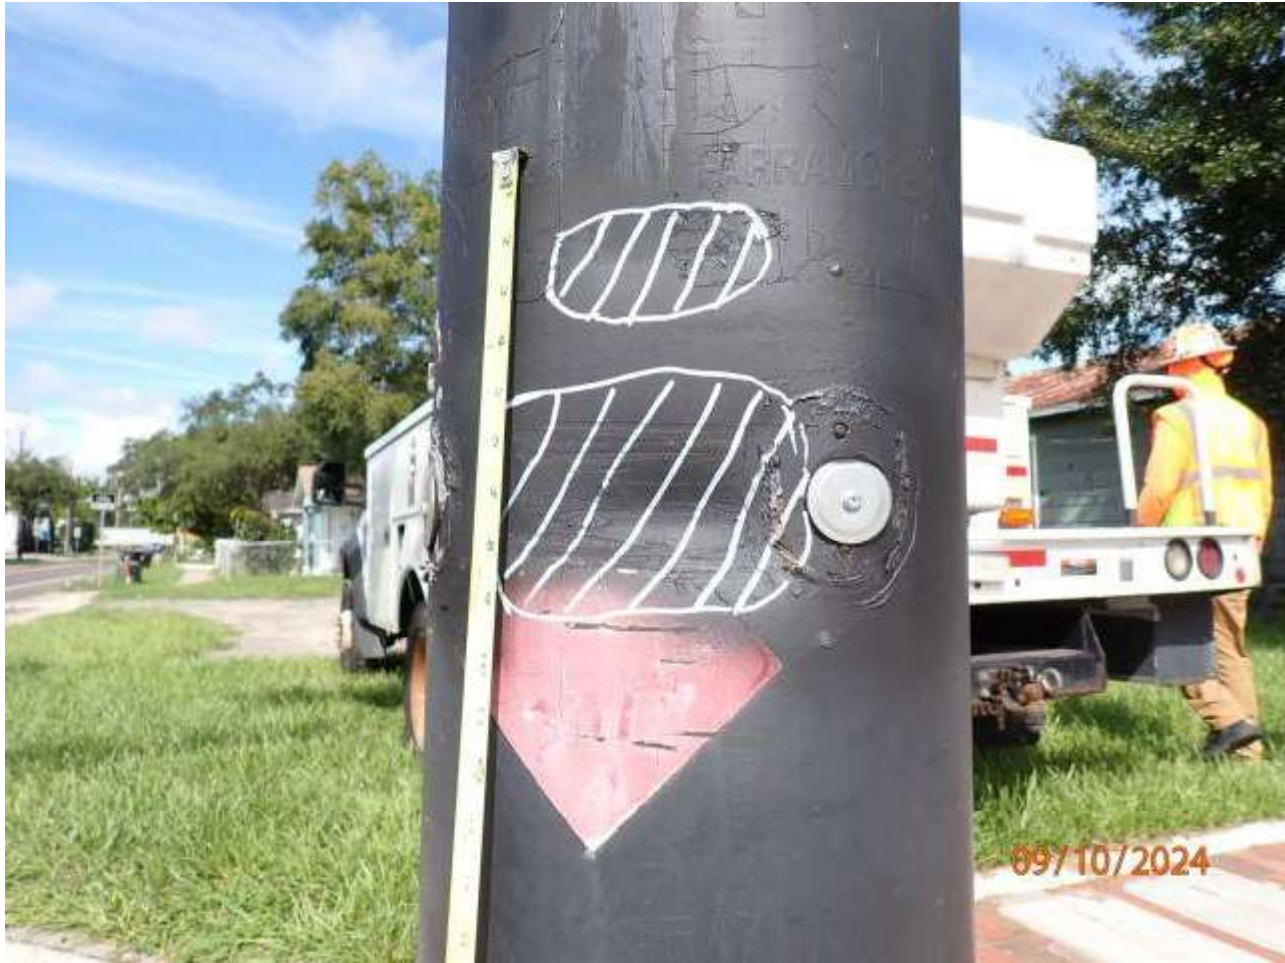
Photo 2

V2 - The vertical southeast quadrant 39 in. above the base plate has impact damage 7 in. H x 5 in. W x 7/8 in. deep. Refer to Photo 2. (1EA)

Element 8481 / Vertical - V2 Impact damage.

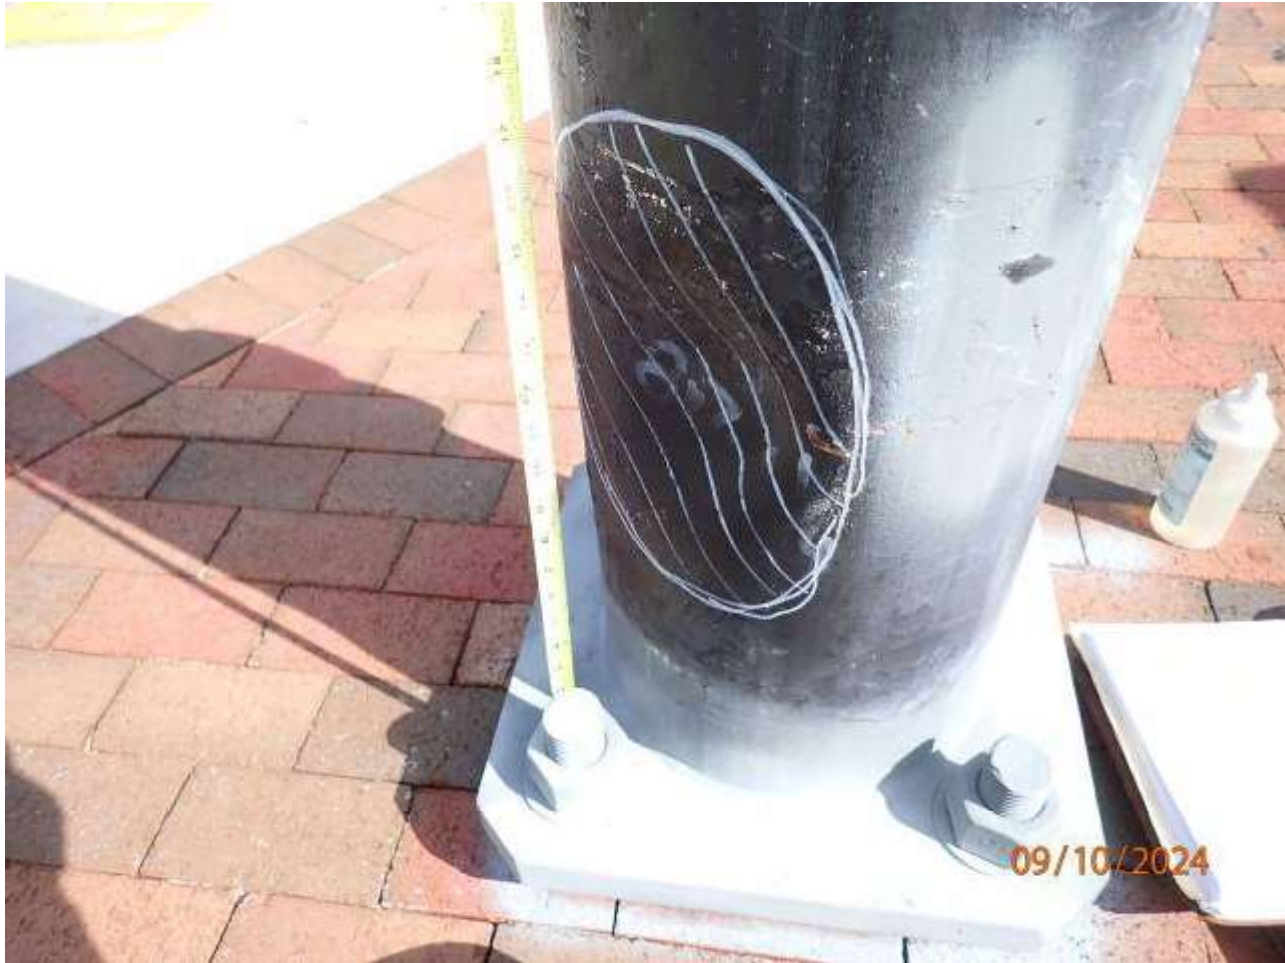
Photo 3

V3 - The vertical south face 6 in. above the base plate has impact damage 11 in. H x 8 in. W x 1 1/4 in. D. Refer to Photo 3.

Element 8481 / Vertical - V3 Impact damage.

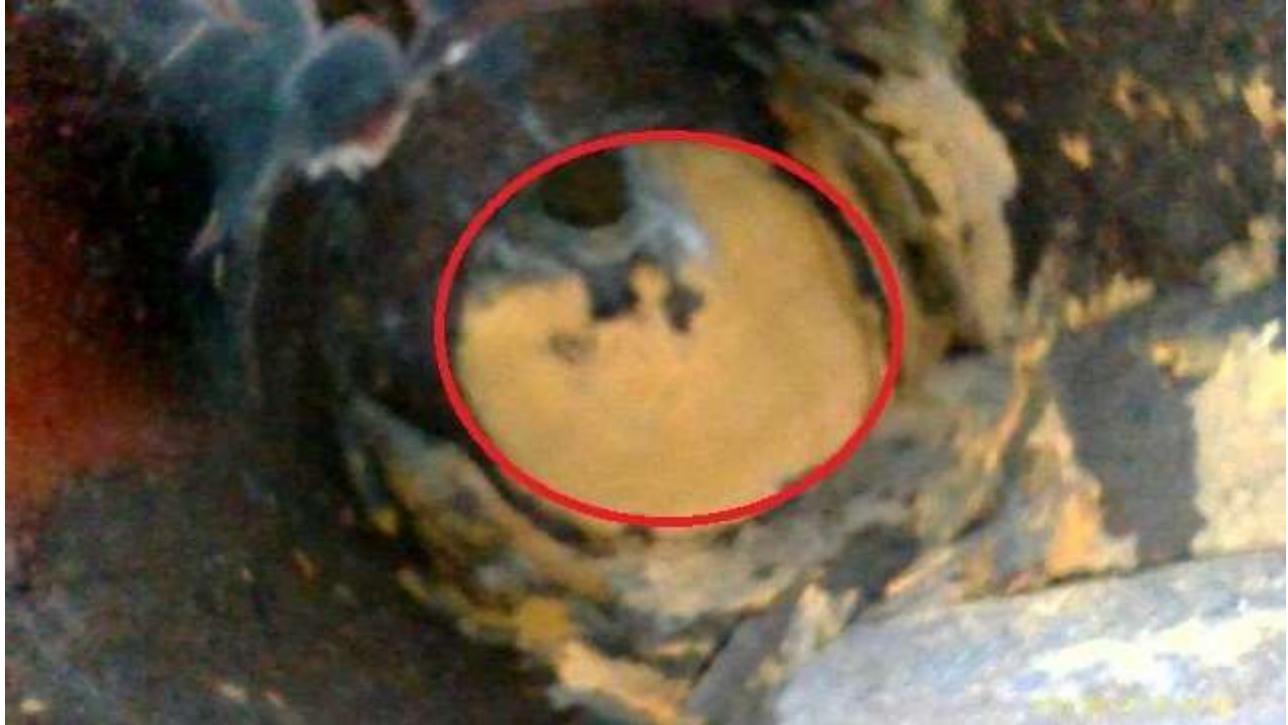
Photo 4

V3 - The vertical west face inside the horizontal arm appears to have heavy active corrosion viewed with a borescope thru the signal wiring hole in the horizontal arm underside. Area is inaccessible to measure for section loss. Refer to Photo 4. (1EA)

Element 8481 / Vertical - V3 Corrosion on west face inside horizontal arm.

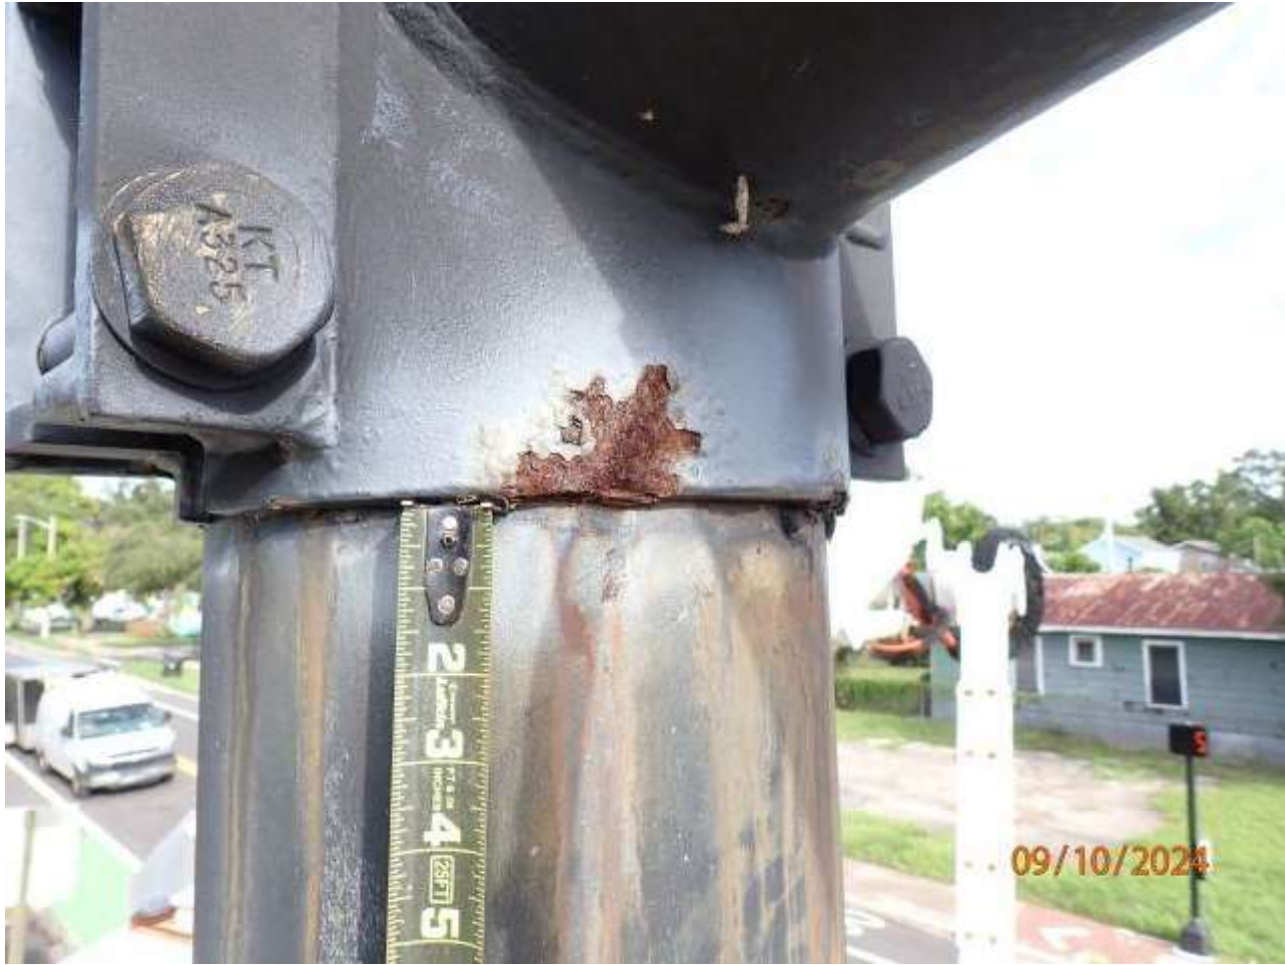
Photo 5

V1/H1, V2/H2 and V4/H4 - The moment connection collar has areas of light to moderate corrosion bleeding thru previously applied paint throughout. Refer to Photo 5.

Element 8484 / Horizontal - Typical moment connection collar corrosion.

V1/H1, V2/H2 and V4/H4 - Repair areas of corrosion on the moment connection collars at each location. - Corrosion may have been painted since the 2023 inspection but is re-occurring.

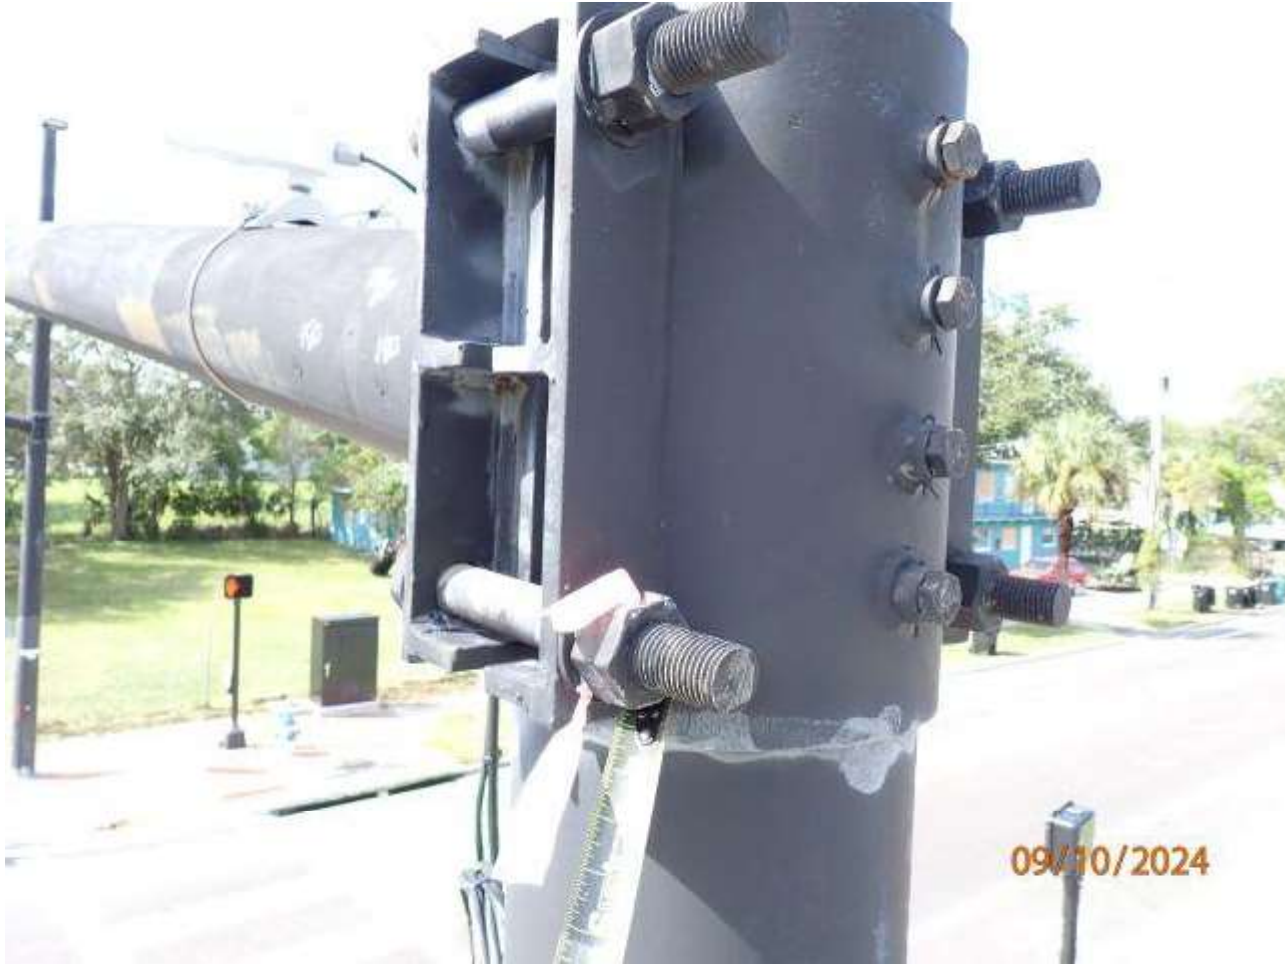
Photo 6

V2/H2 - Moment Connection Bolt #4 is loose. Refer to Photo 6.

Element 8484 / Horizontal - V2/H2 Moment Connection Bolt #4 loose.

V2/H2 - Replace loose Moment Connection Bolt #4 with new 1 1/4 in. diameter x 8 1/2 in. long galvanized A325 bolt and properly tighten per FDOT Spec. 460-5. P=3

V2/H2 - Replace the loose 9 in. L x 1 1/4 in. W bolt at the moment connection. - Bolt has not been replaced since the 2023 inspection.

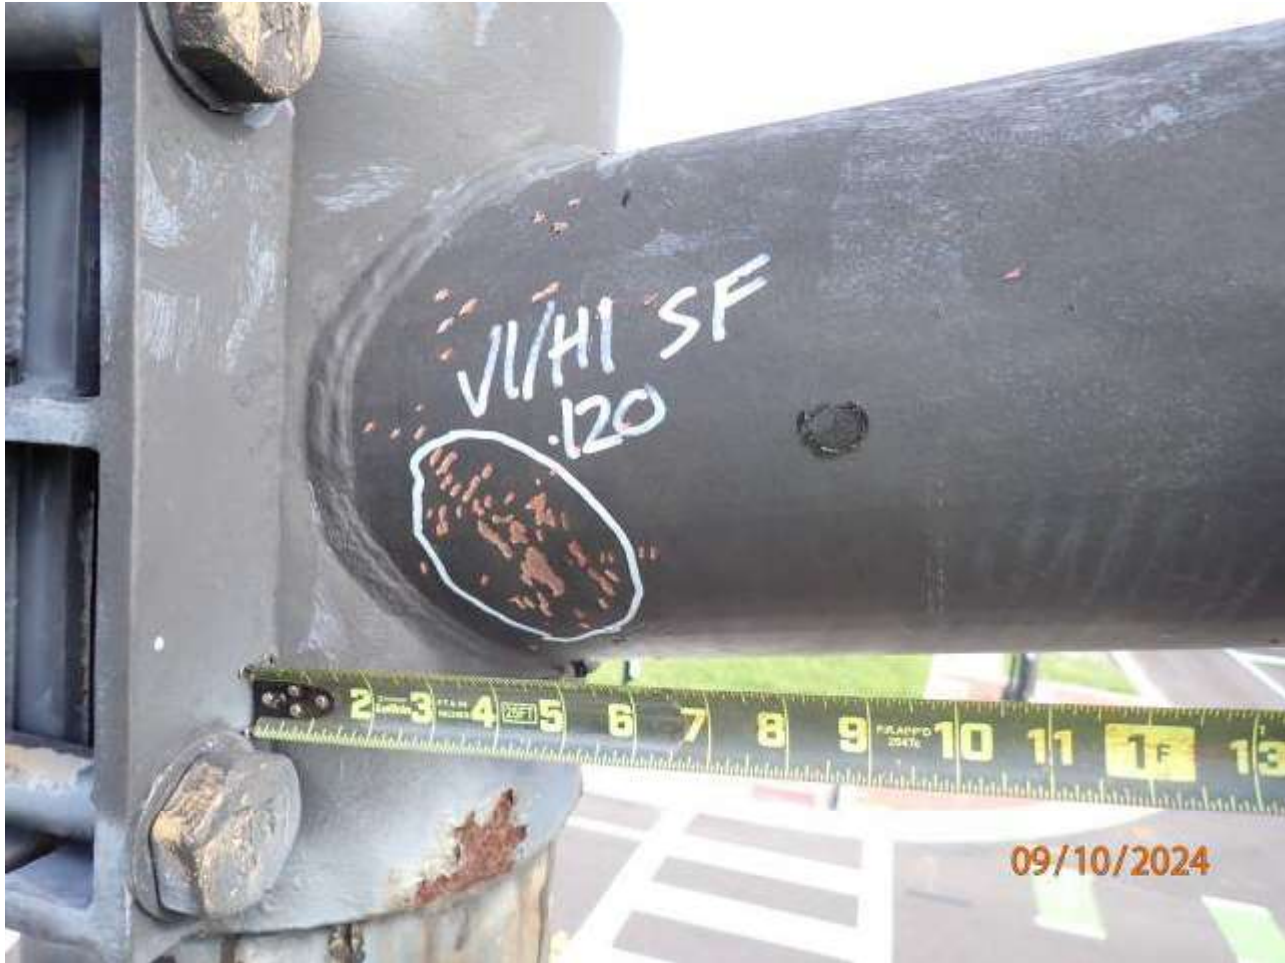
Photo 7

V1/H1 - South face of the arm at the moment connection has a small malleable area 4 in. diameter with approximately 33% section loss in this area. Original arm thickness = 0.180 in. and remaining thickness in this area = 0.120 in. Additional measurements taken at 3 ft. and 6 ft. from the moment connection on all faces of the arm were all 0.180 in. Refer to Photos 7 and 8.

Element 8484 / Horizontal - V1/H1 Malleable area on south face.

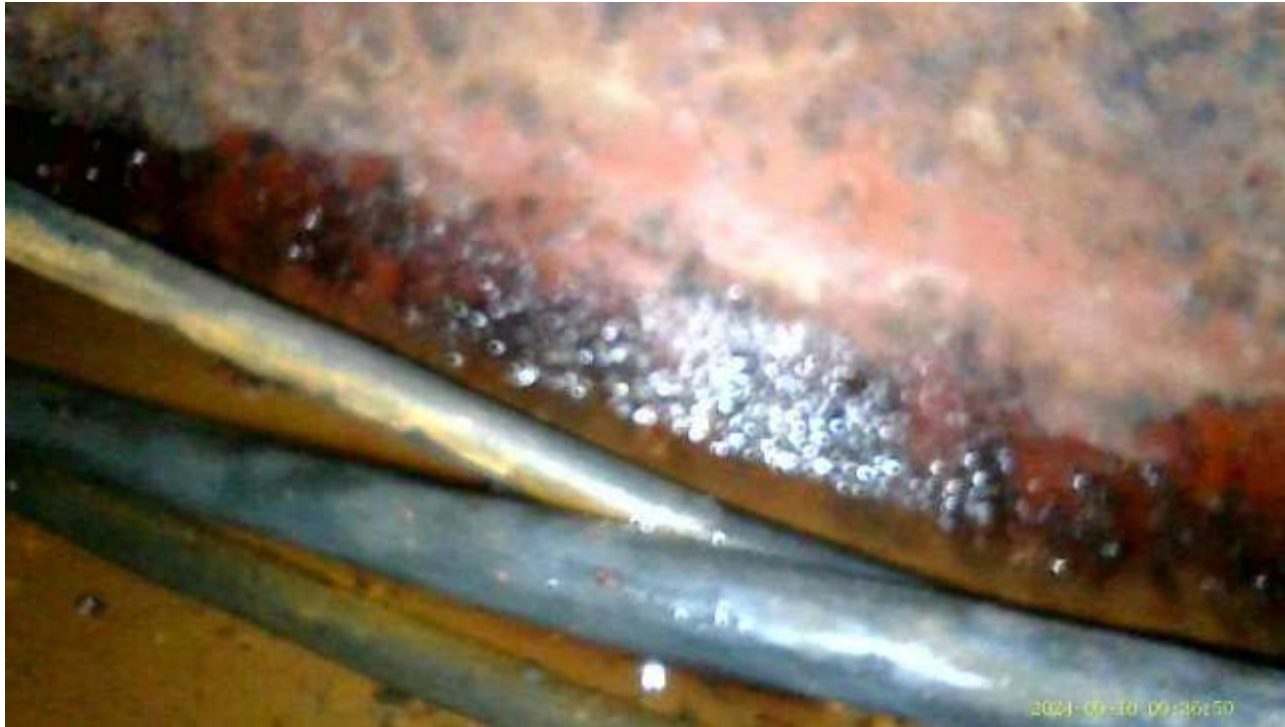
Photo 8

Element 8484 / Horizontal - V1/H1 Ponding water and corrosion on arm interior.

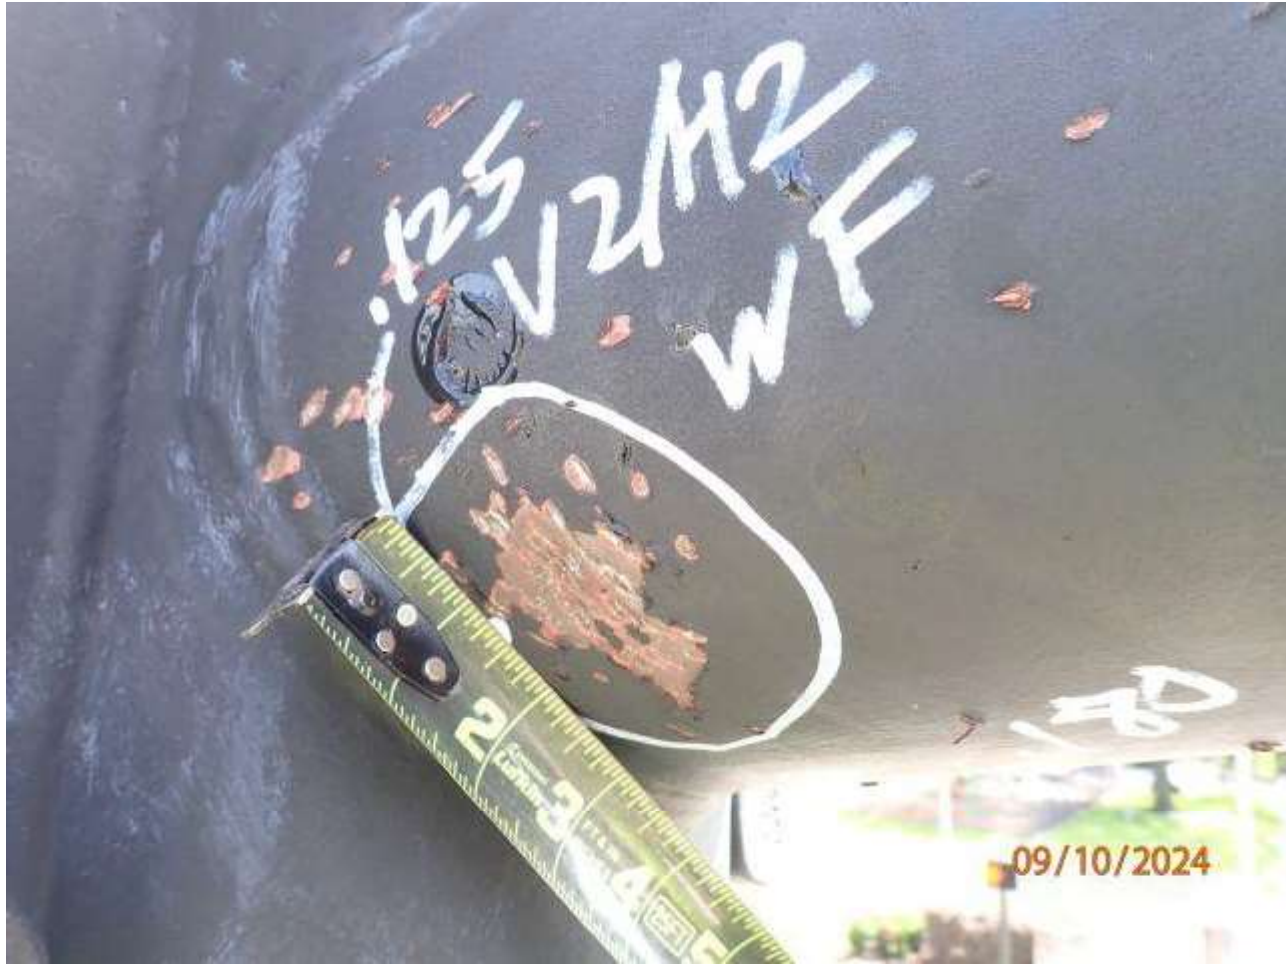
Photo 9

V2/H2 - West face of the arm at the moment connection has a small malleable area 4 in. diameter with approximately 30% section loss in this area and up to 16% section loss on the east face at the moment connection. Original arm thickness = 0.180 in. and remaining thickness on west face at malleable area = 0.125 in. and east face at the moment connection = 0.150 in. Additional measurements taken at 3 ft. and 6 ft. from the moment connection on all faces of the arm were all 0.180 in. Refer to Photos 9 and 10.

Element 8484 / Horizontal - V2/H2 Malleable area on west face of arm.

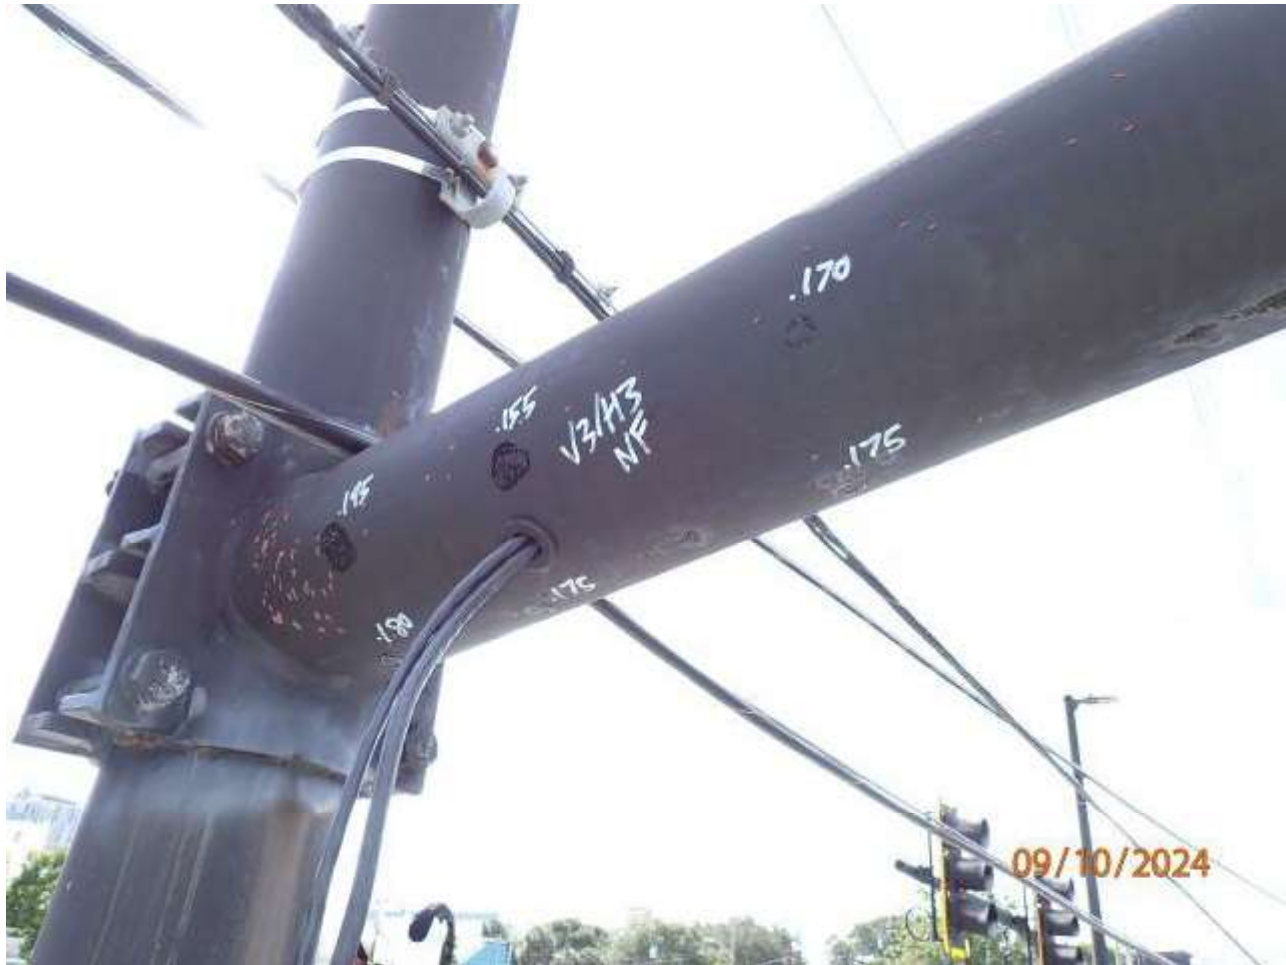
Photo 11

V3/H3 - No malleable areas were observed however thickness measurements indicate up to 20% section loss within the first 18 in. of the arm on the north and south faces. Original arm thickness = 0.180 in. and remaining thickness in first 18 in. ranges from 0.145 in. to 0.170 in. Refer to Photos 11 thru 14.

Element 8484 / Horizontal - V3/H3 Thickness measurements on north face of arm.

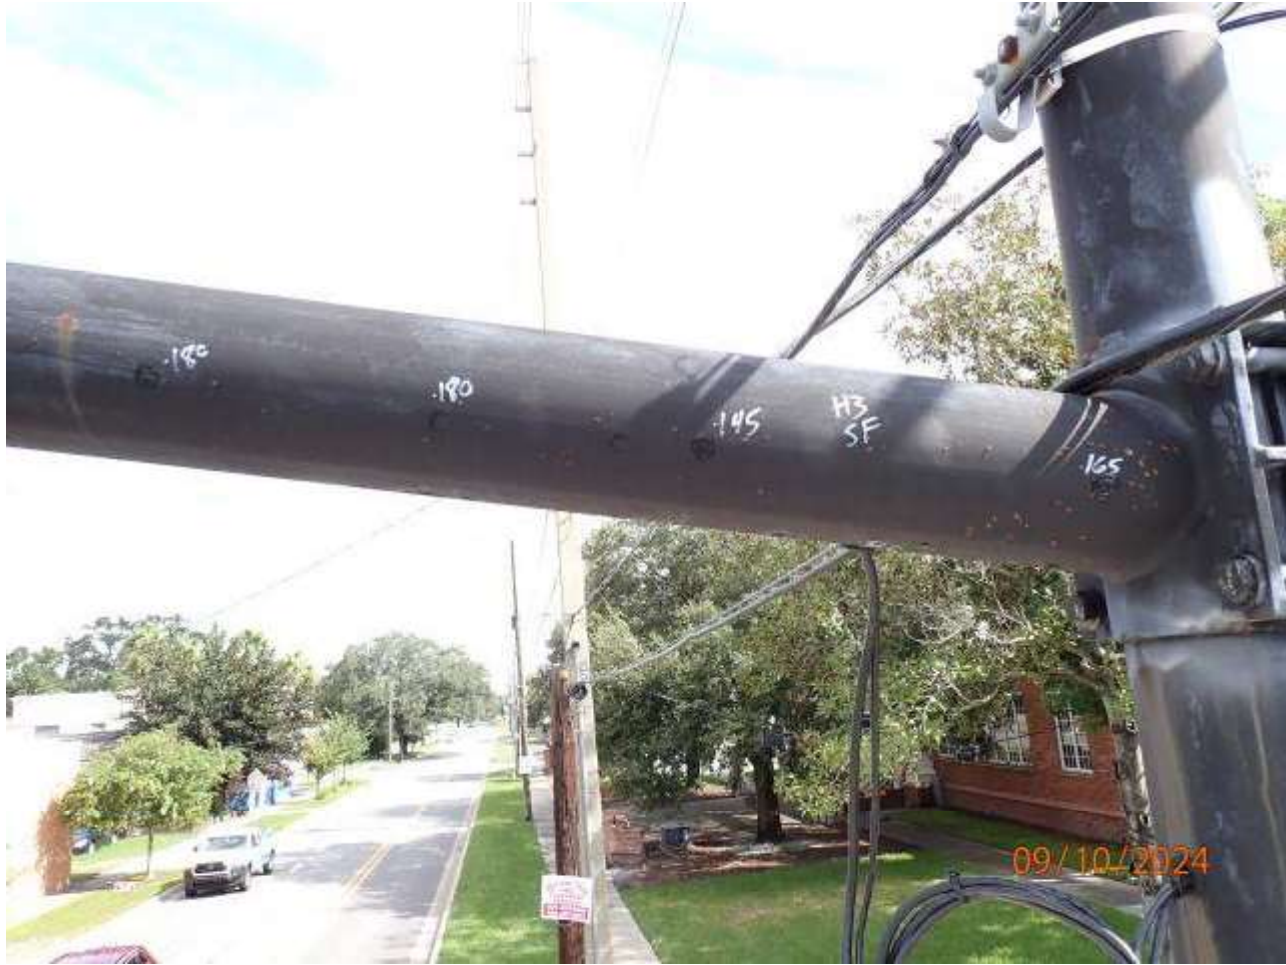
Photo 12

Element 8484 / Horizontal - V3/H3 Thickness measurements on south face of arm.

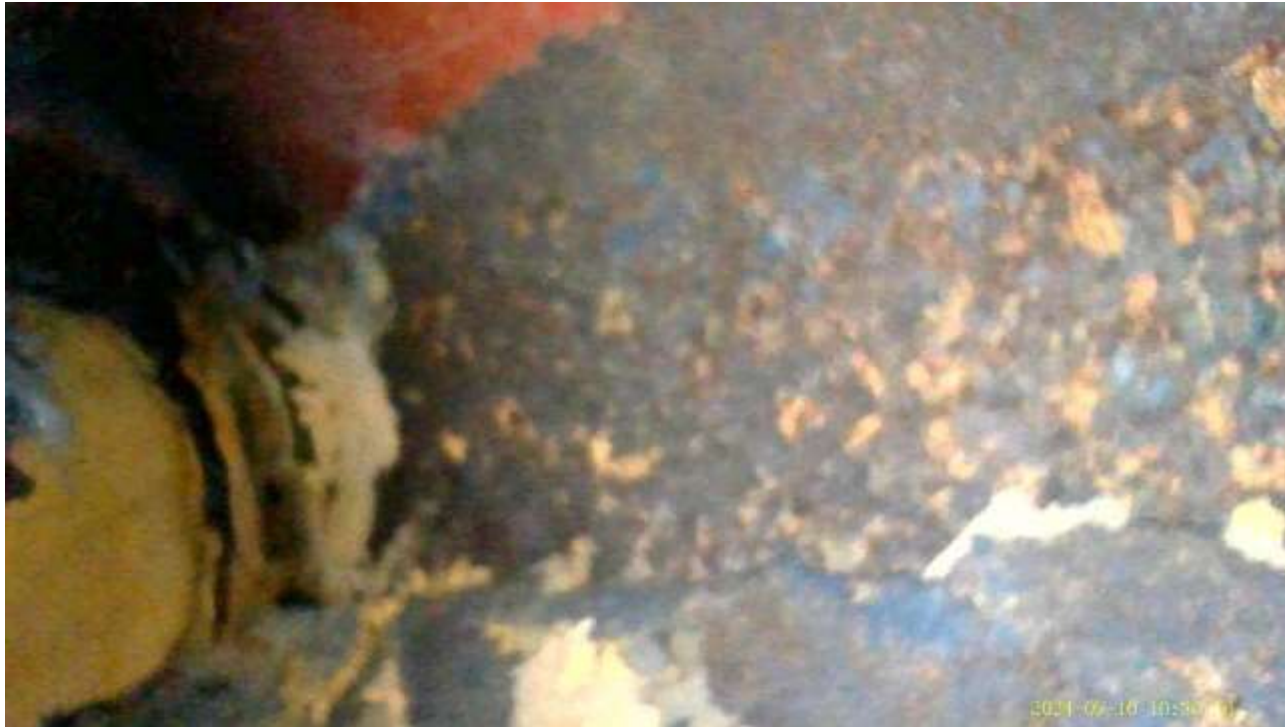
Photo 13

Element 8484 / Horizontal - V3/H3 Corrosion on arm interior.

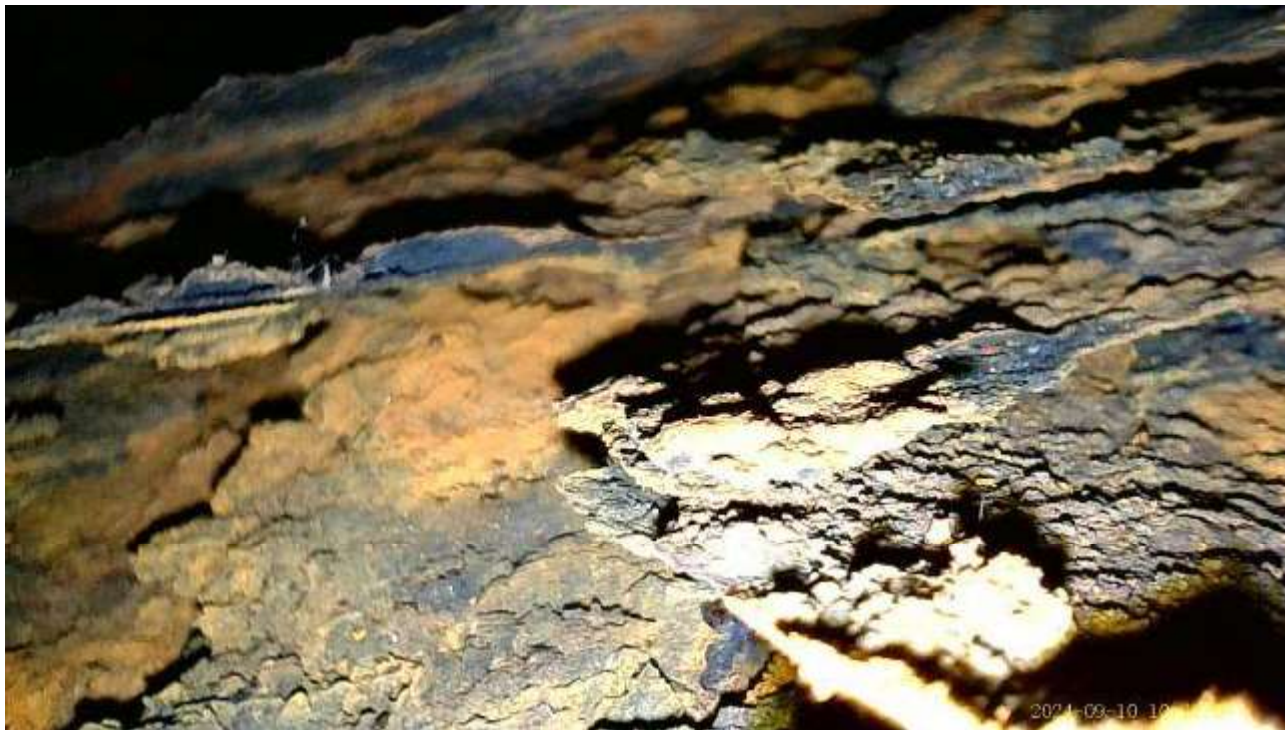
Photo 14

Element 8484 / Horizontal - V3/H3 Corrosion on arm interior.

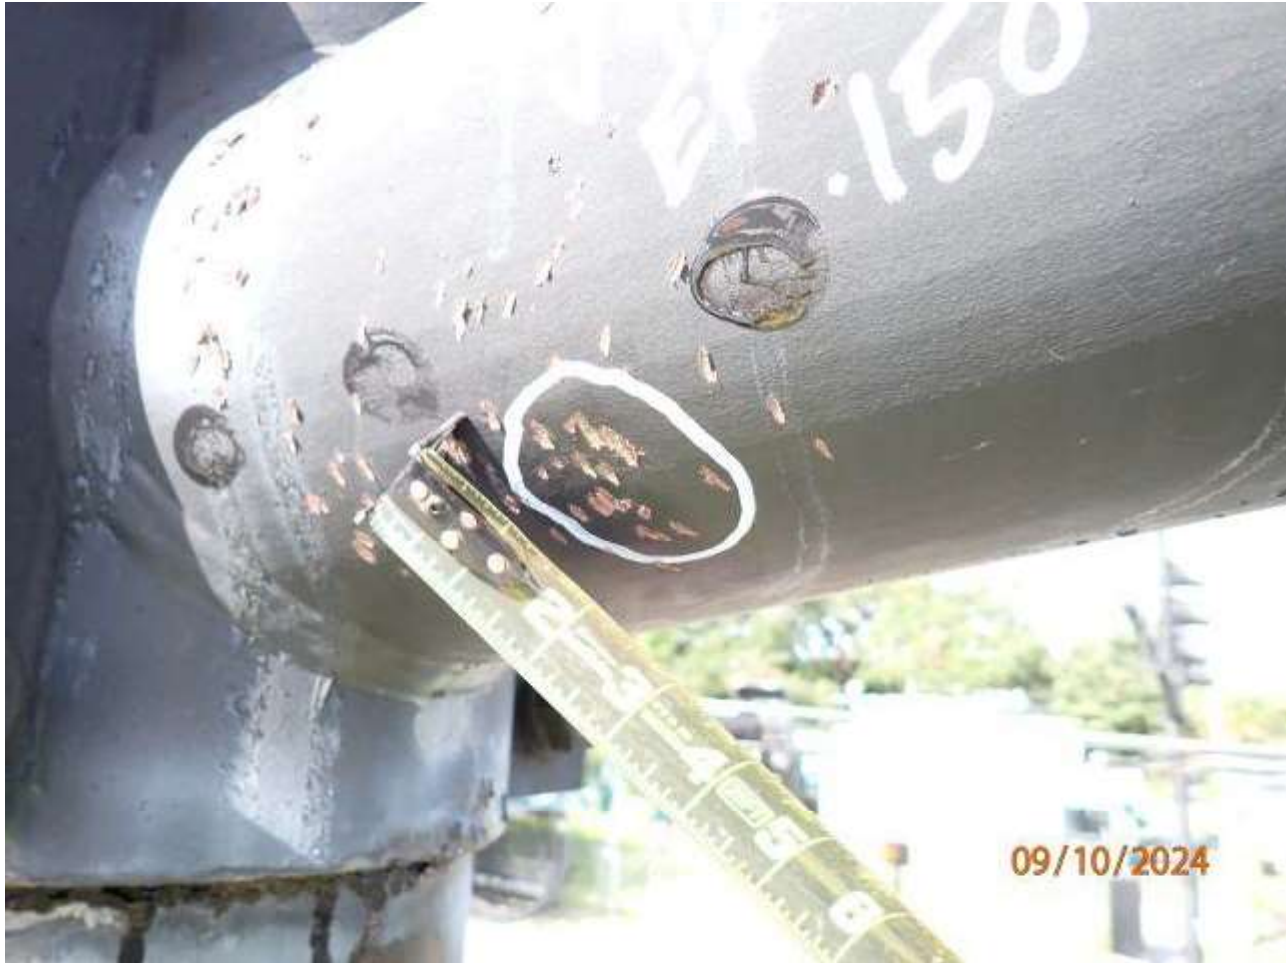
Photo 15

V4/H4 - East face of the arm at the moment connection has a small malleable area 3 in. diameter with up to 20% section loss on the east and west faces within the first 2 ft. of the arm. Original arm thickness = 0.180 in. and remaining thickness in first 2 ft. ranges from 0.145 in. to 0.150 in. Refer to Photos 15 and 16.

Element 8484 / Horizontal - V4/H4 Malleable area on east face of arm.

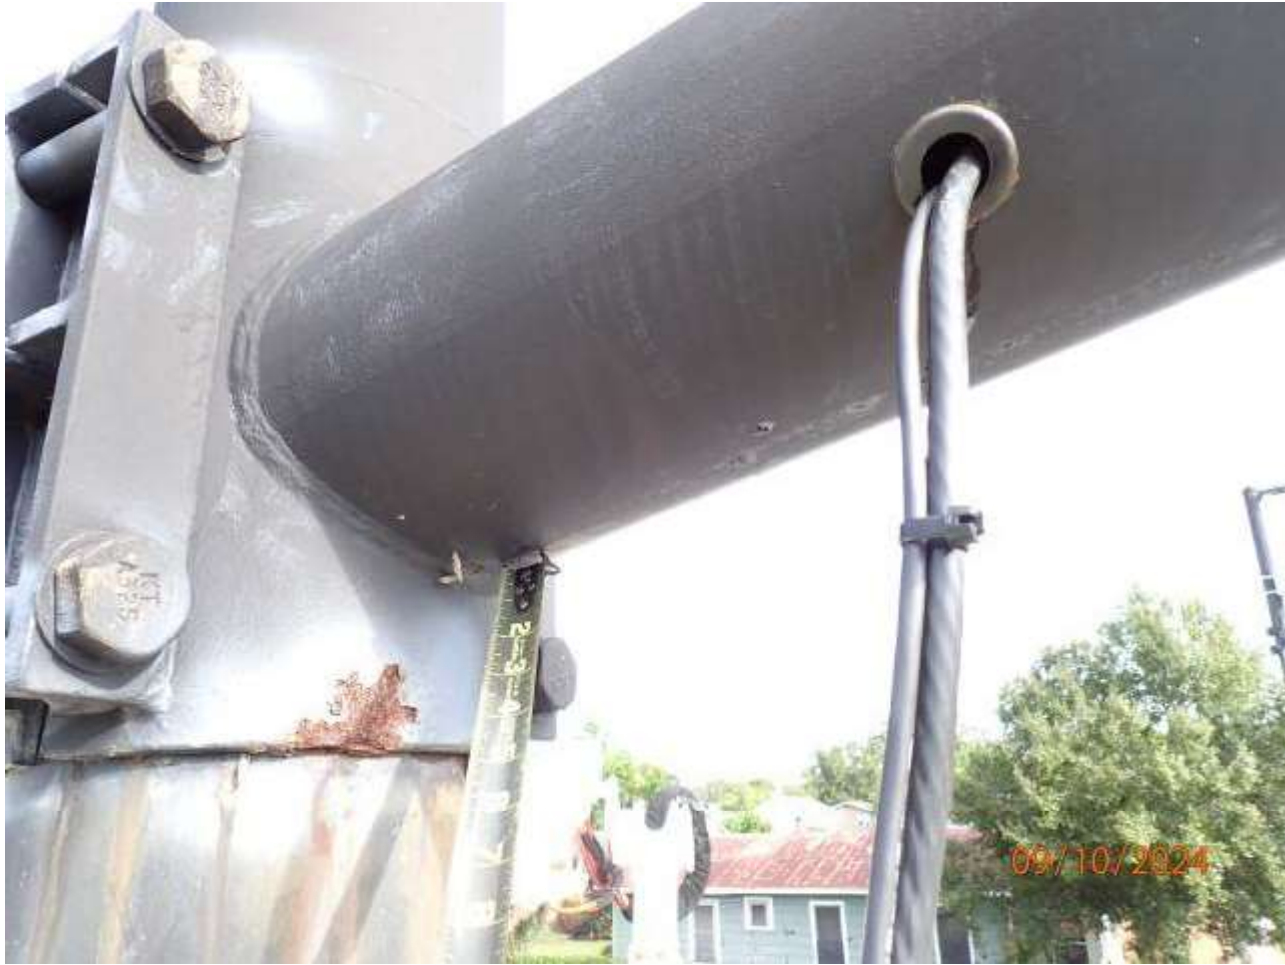
Photo 17

V1/H1, V2/H2, V3/H3 and V4/H4 - The horizontal arms are missing drain holes. Refer to Photo 17.

Element 8484 / Horizontal - Typical missing drain hole in horizontal arm.

V1/H1, V2/H2, V3/H3 and V4/H4 - Install 1/2 in. diameter drain hole in arm underside within 1 ft. of the moment connection per FDOT Standard Index 649-031 Sheet (1) of (6). P=3
