**FLORIDA DEPARTMENT OF TRANSPORTATION  
BRIDGE MANAGEMENT SYSTEM****Inspection/CIDR Report with PDF attachment(s)  
(INTERIM INSPECTION REPORT)****Structure ID: 75M112****Inspection****DISTRICT: D5 - Deland****INSPECTION DATE: 5/28/2025 BZHA**

| BY: Ayres Associates | STRUCTURE NAME: SR-552 (Curry Ford Rd.) at Dixie Belle Dr |

TYPE OF INSPECTION: Interim

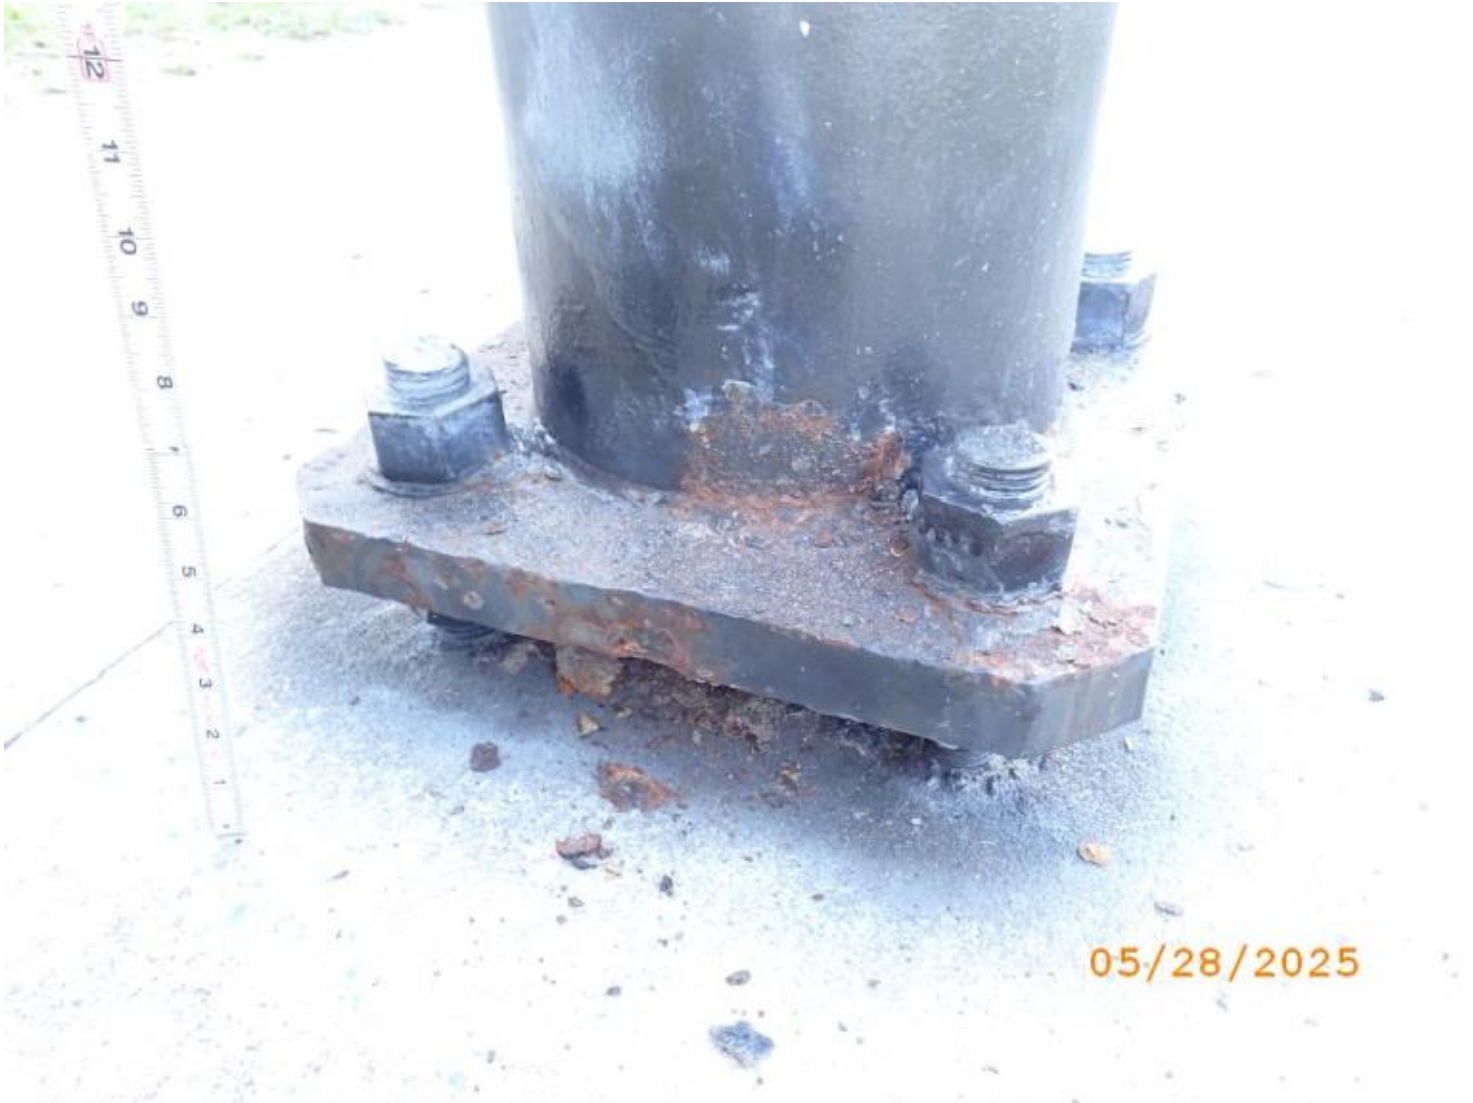
**Photo 1 - Element 8480 / Mast Arm Foundation**

F1 - All (4) anchor bolts are missing the lock nuts and are too short for installation of a half-height jam nut. NO CHANGE. Refer to Photo 1. (1EA)

NBI Item (60) Substructure rating is coded 5 - Fair due to excessive anchor bolt stand-off distance at F2 and missing anchor bolt lock nuts at both foundations.

F1 Missing anchor bolt lock nuts.

F1 - Install a self-locking nut on all 1 1/2 in. diameter anchor bolts. - Self locking nuts have not been installed since the 2023 Routine Inspection.

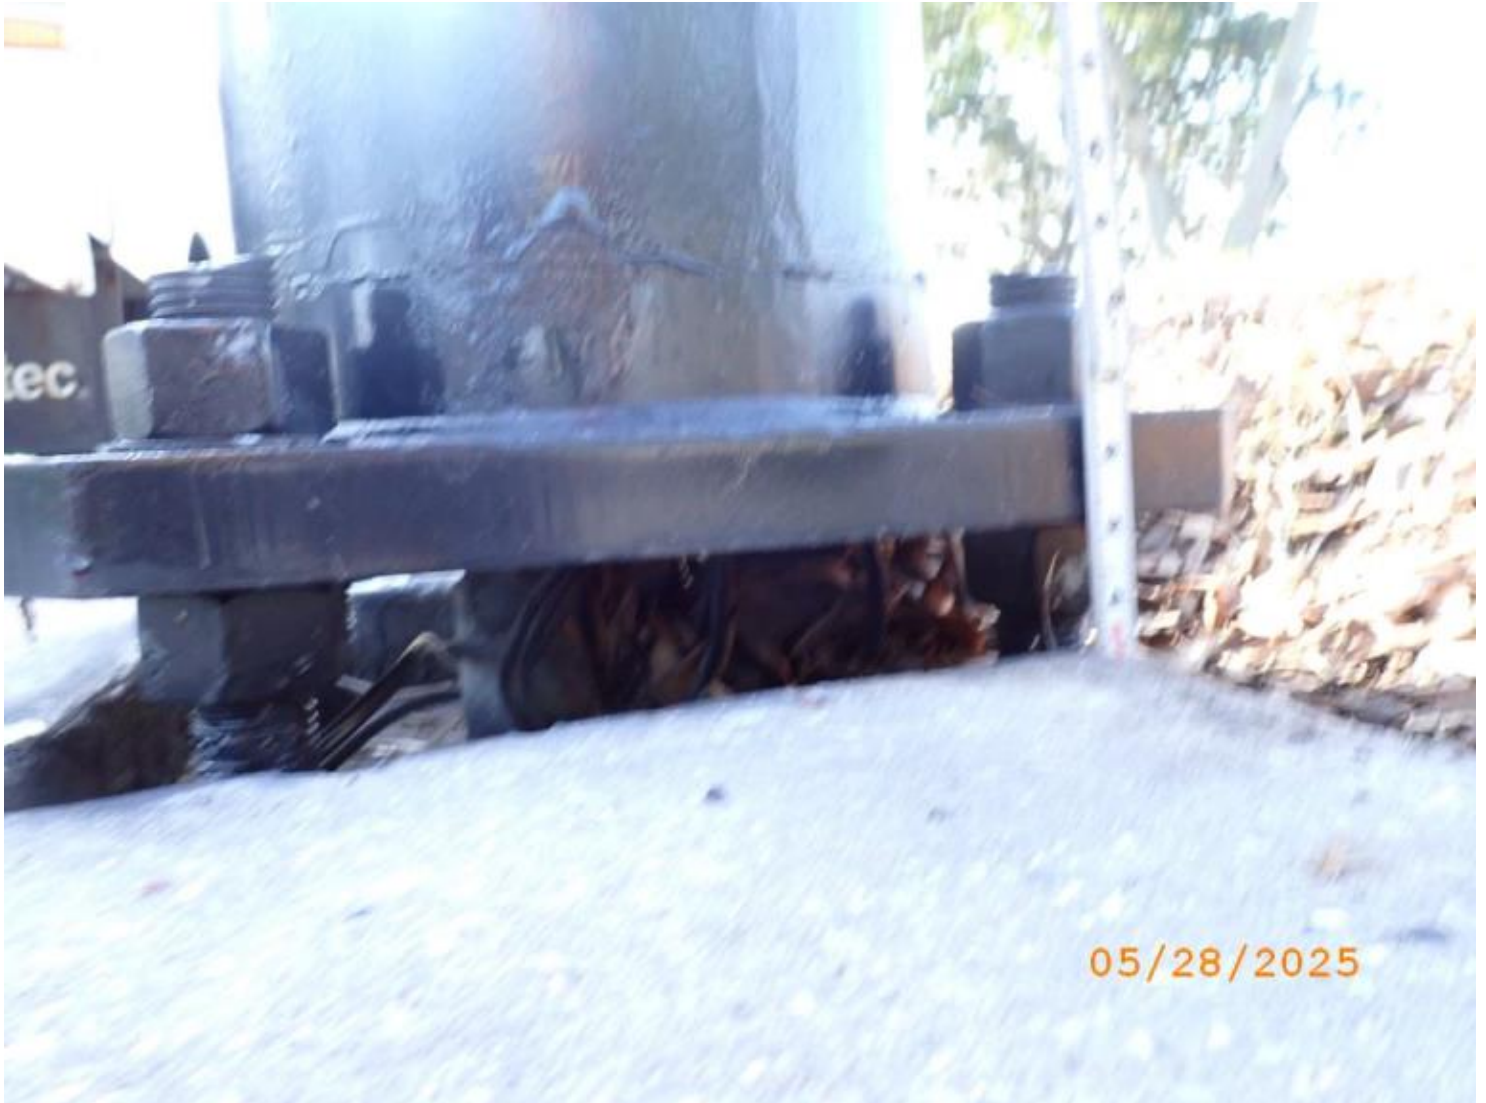
**Photo 2 - Element 8480 / Mast Arm Foundation**

F2 - All (4) anchor bolts are missing the lock nuts. Half-height or modified jam nuts can be installed. NO CHANGE. Refer to Photo 2. (1EA)

F2 - The anchor bolt stand-off distance is greater than the diameter of the anchor bolt. Bolt diameter = 1 1/2 in. and average stand-off distance = 3 3/8 in. NO CHANGE. Refer to Photo 2.

F2 Missing anchor bolt lock nuts and excessive stand-off distance.

F2 - Install a half height jam nuts on all 1 1/2 in. diameter anchor bolts. - Half height jam nuts have not been installed since the 2023 Routine Inspection.

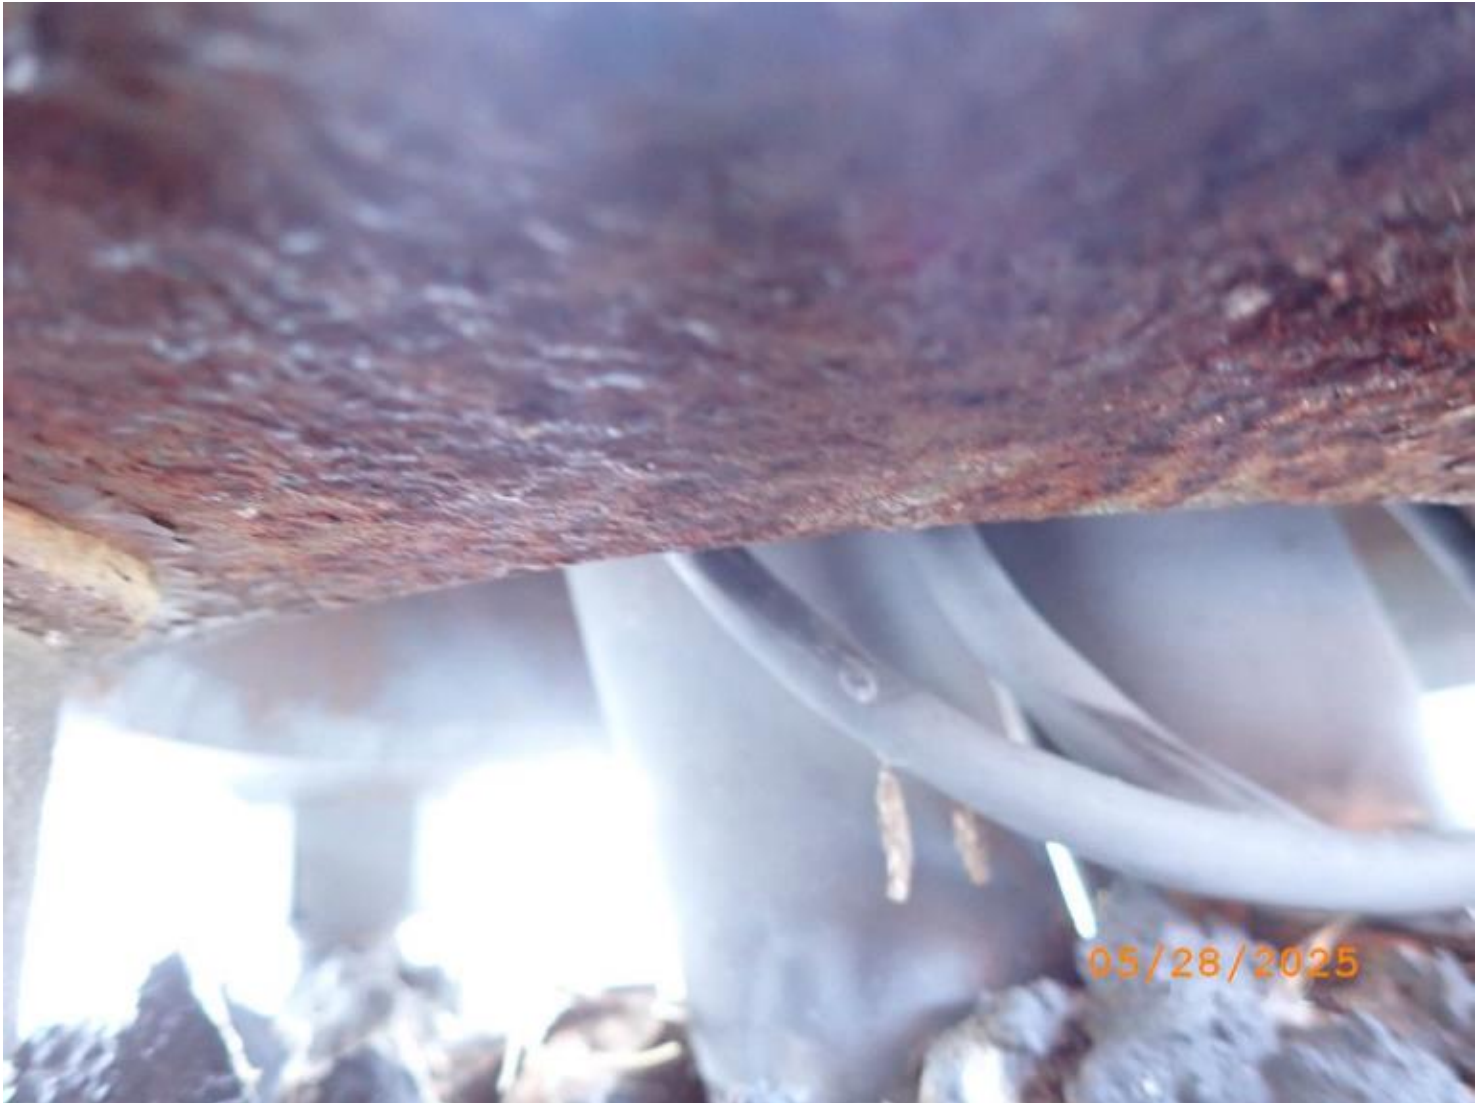
**Photo 3 - Element 8481 / Metal Mast Arm Vertical**

V1 - The column base plate has painted over moderate to heavy delaminative corrosion on all faces (top, bottom & vertical faces) with areas of pitting up to 1/8 in. deep. Original base plate thickness 1 1/2 in. Areas of corrosion bleeding thru the paint were cleaned and painted by the inspectors during the 2025 Interim Inspection. DECREASE. Refer to Photo 3 and 4. REPAIR. (1EA)

V1 Base plate underside corrosion.

V1 and V2 - Program intersection for replacement. P=3

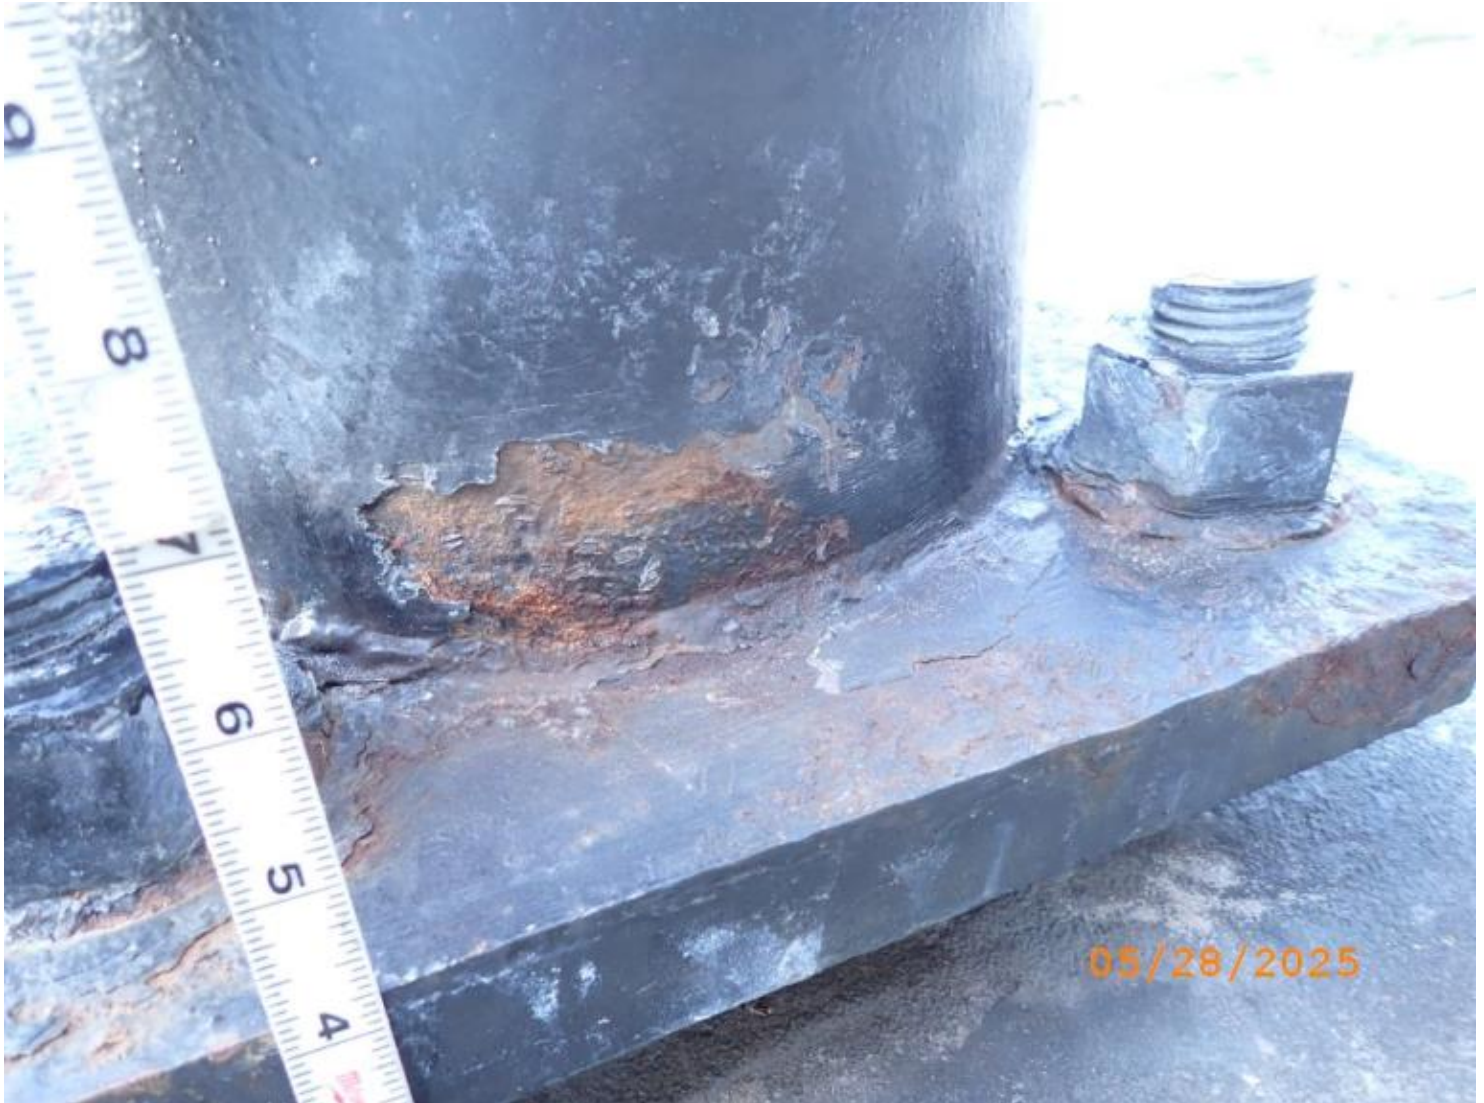
**Photo 4 - Element 8481 / Metal Mast Arm Vertical**

V1 - The bottom of the column at the base plate has painted over moderate to heavy delaminative corrosion around the full circumference x up to 3 in. high with areas of pitting up to 1/16 in. deep. Original column thickness 0.180 in. Areas of corrosion bleeding thru the paint were cleaned and painted by the inspectors during the 2025 Interim Inspection. DECREASE. Refer to Photo 4. REPAIR.

V1 Typical base plate top and vertical face corrosion and column corrosion at the base plate.

V1 and V2 - Program intersection for replacement. P=3

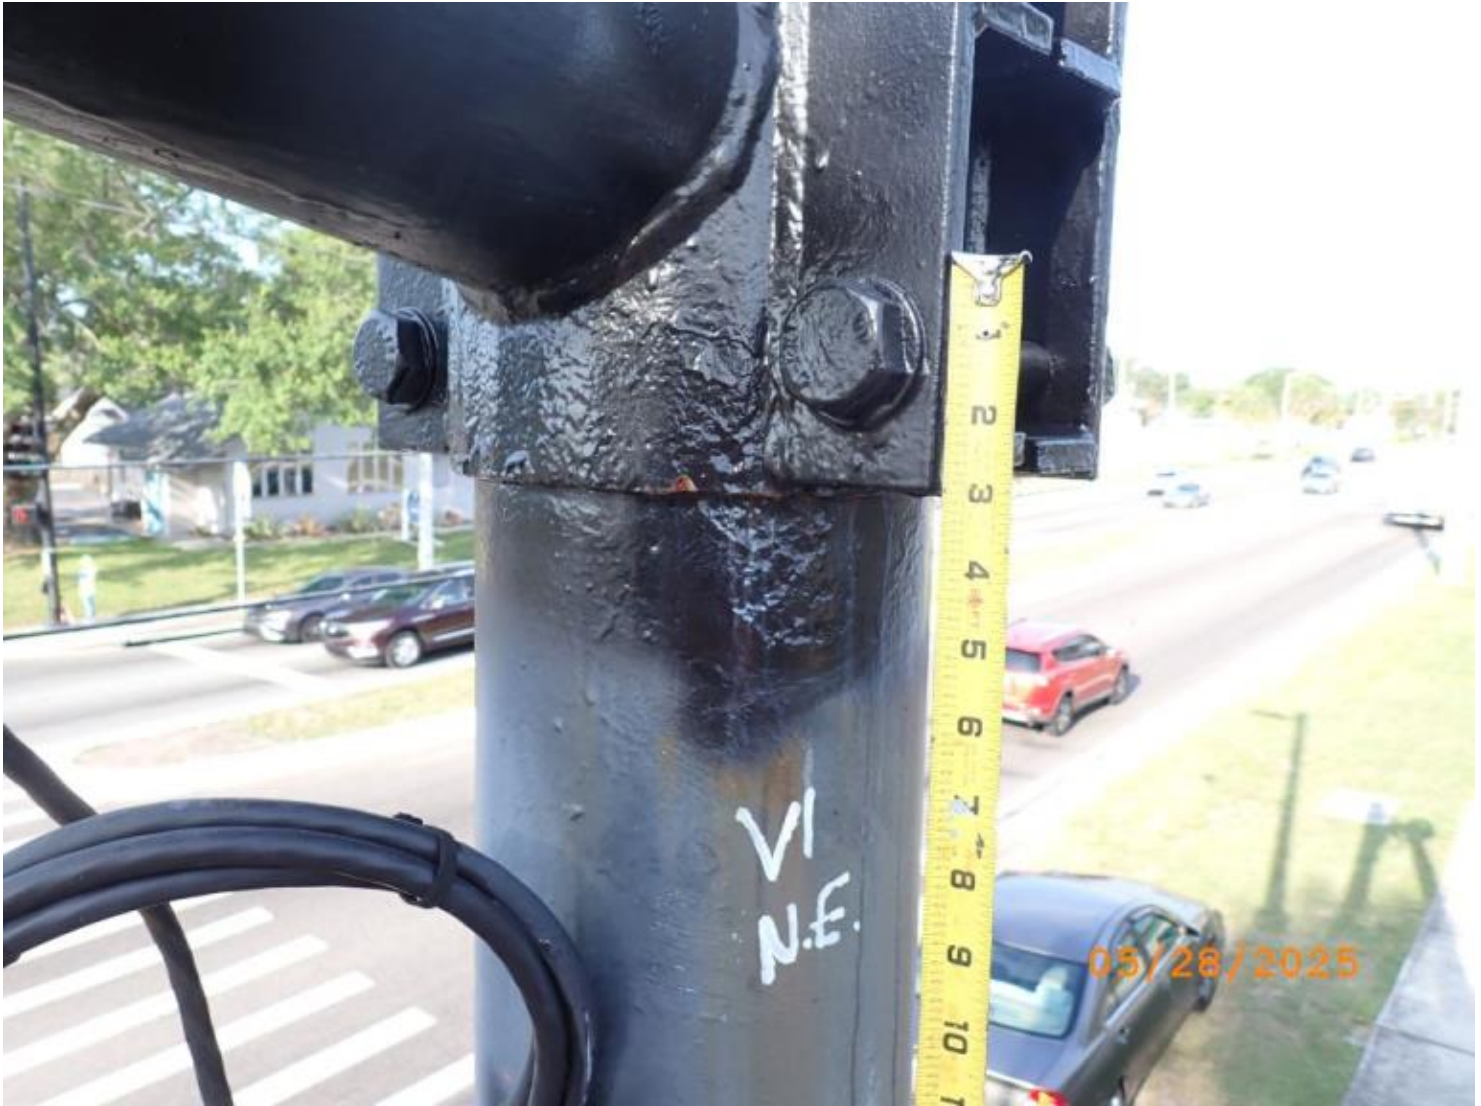
**Photo 5 - Element 8481 / Metal Mast Arm Vertical**

V1 - The northeast face of the column just below the moment connection collar has an area of painted over moderate corrosion 6 in. W x 2 in. H with pitting up to 1/16 in deep. Original column thickness 0.180 in. DECREASE. Refer to Photo 5. REPAIR.

V1 Painted over column corrosion & pitting on NE face just below moment connection collar.

V1 and V2 - Program intersection for replacement. P=3

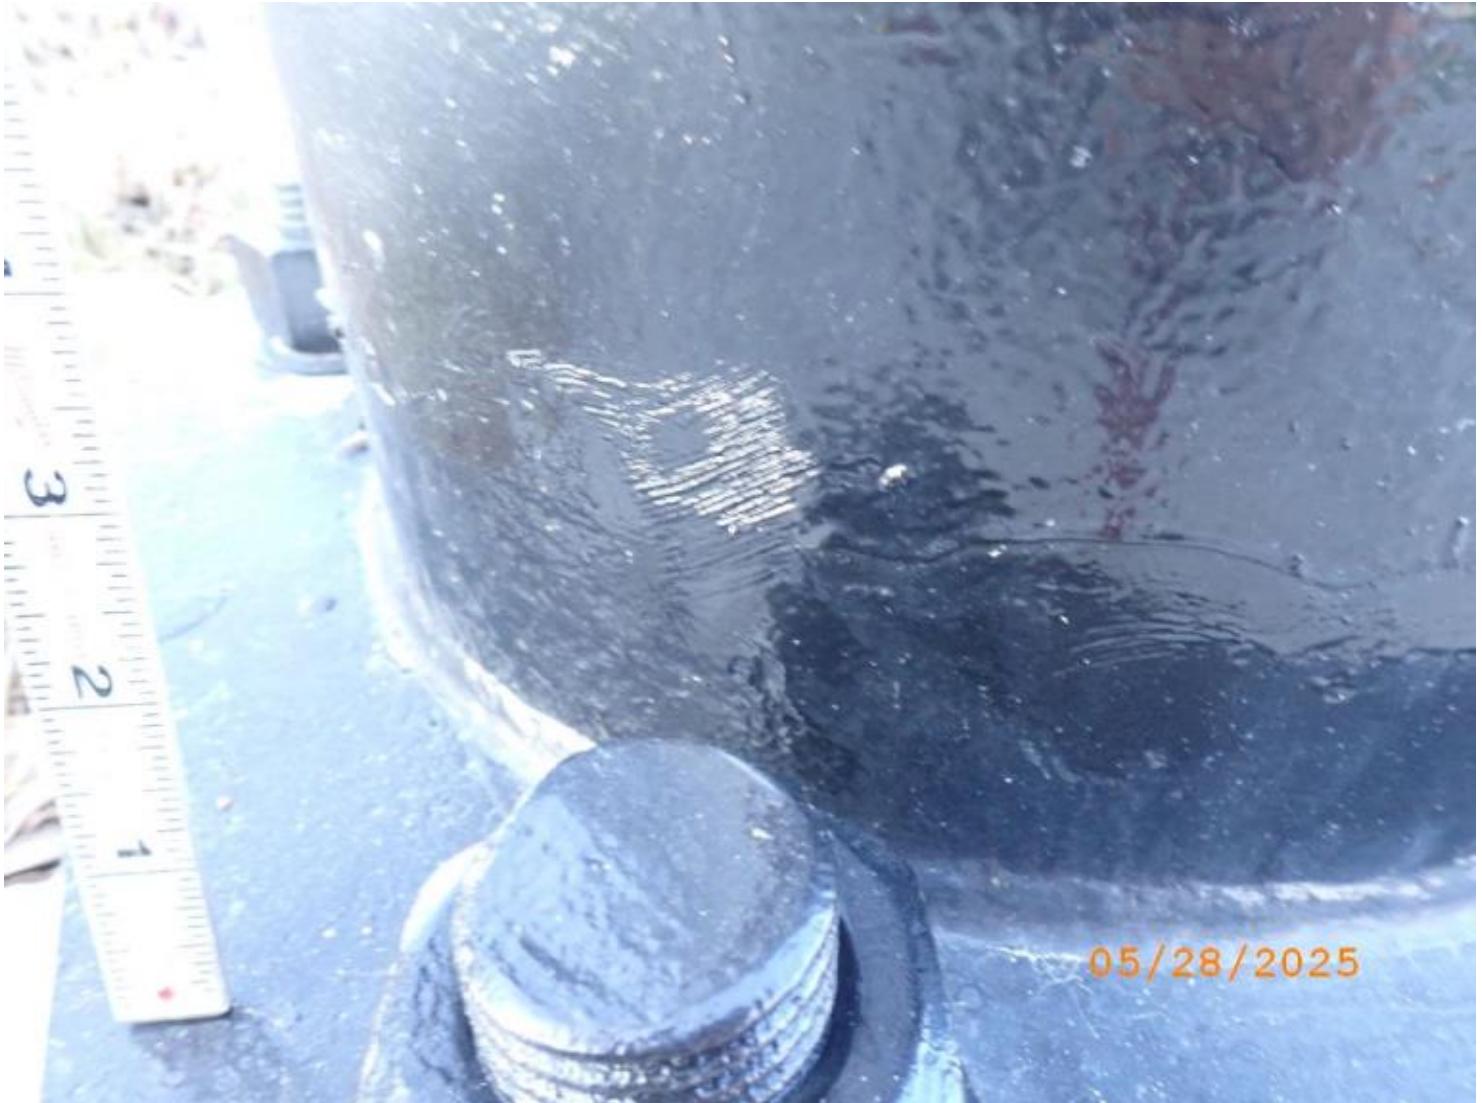
**Photo 6 - Element 8481 / Metal Mast Arm Vertical**

V2 - The bottom northeast face of the column at the base plate behind anchor bolt #3 has an area of painted over corrosion 9 in. W x up to 3 in. high with light pitting up to 1/32 in. deep. Original column thickness 0.180 in. DECREASE. Refer to Photo 6. REPAIR.

V2 Painted over column corrosion with light pitting at base plate at NE quadrant.

V1 and V2 - Program intersection for replacement. P=3

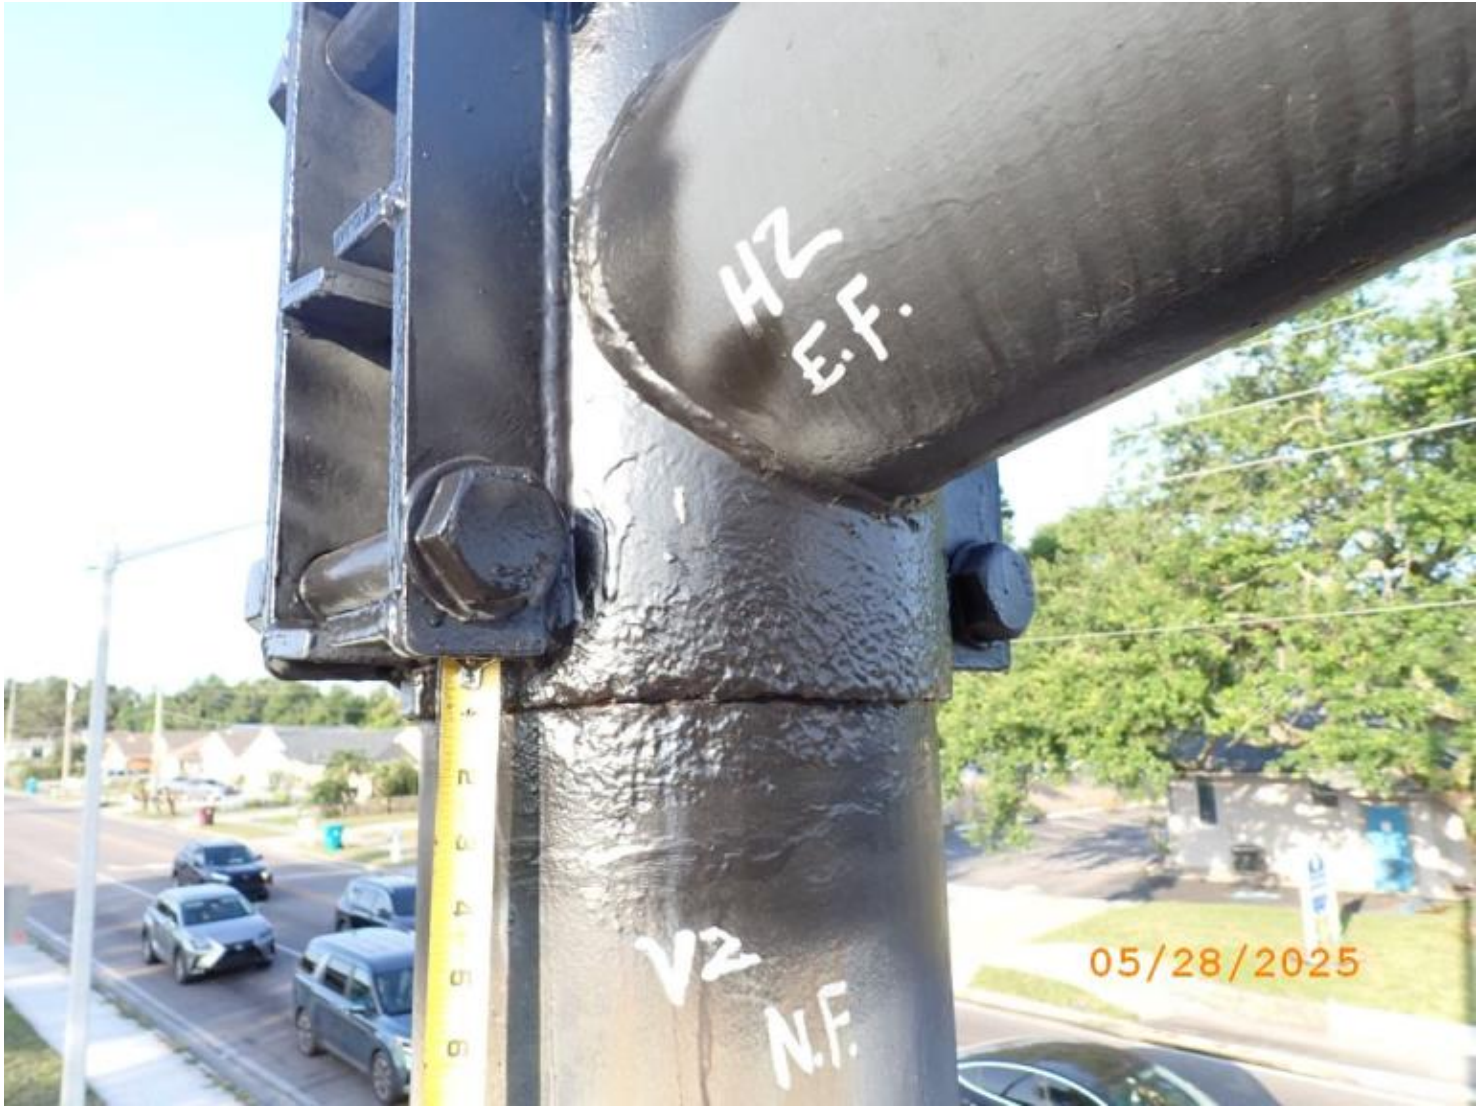
**Photo 7 - Element 8481 / Metal Mast Arm Vertical**

V2 - The north face of the column just below the moment connection collar has an area of painted over moderate corrosion 16 in. W x 2 in. H with pitting up to 1/16 in deep. Original column thickness 0.180 in. DECREASE. Refer to Photo 7. REPAIR.

V2 Overview of painted over column corrosion & pitting on north face just below moment connection collar.

V1 and V2 - Program intersection for replacement. P=3

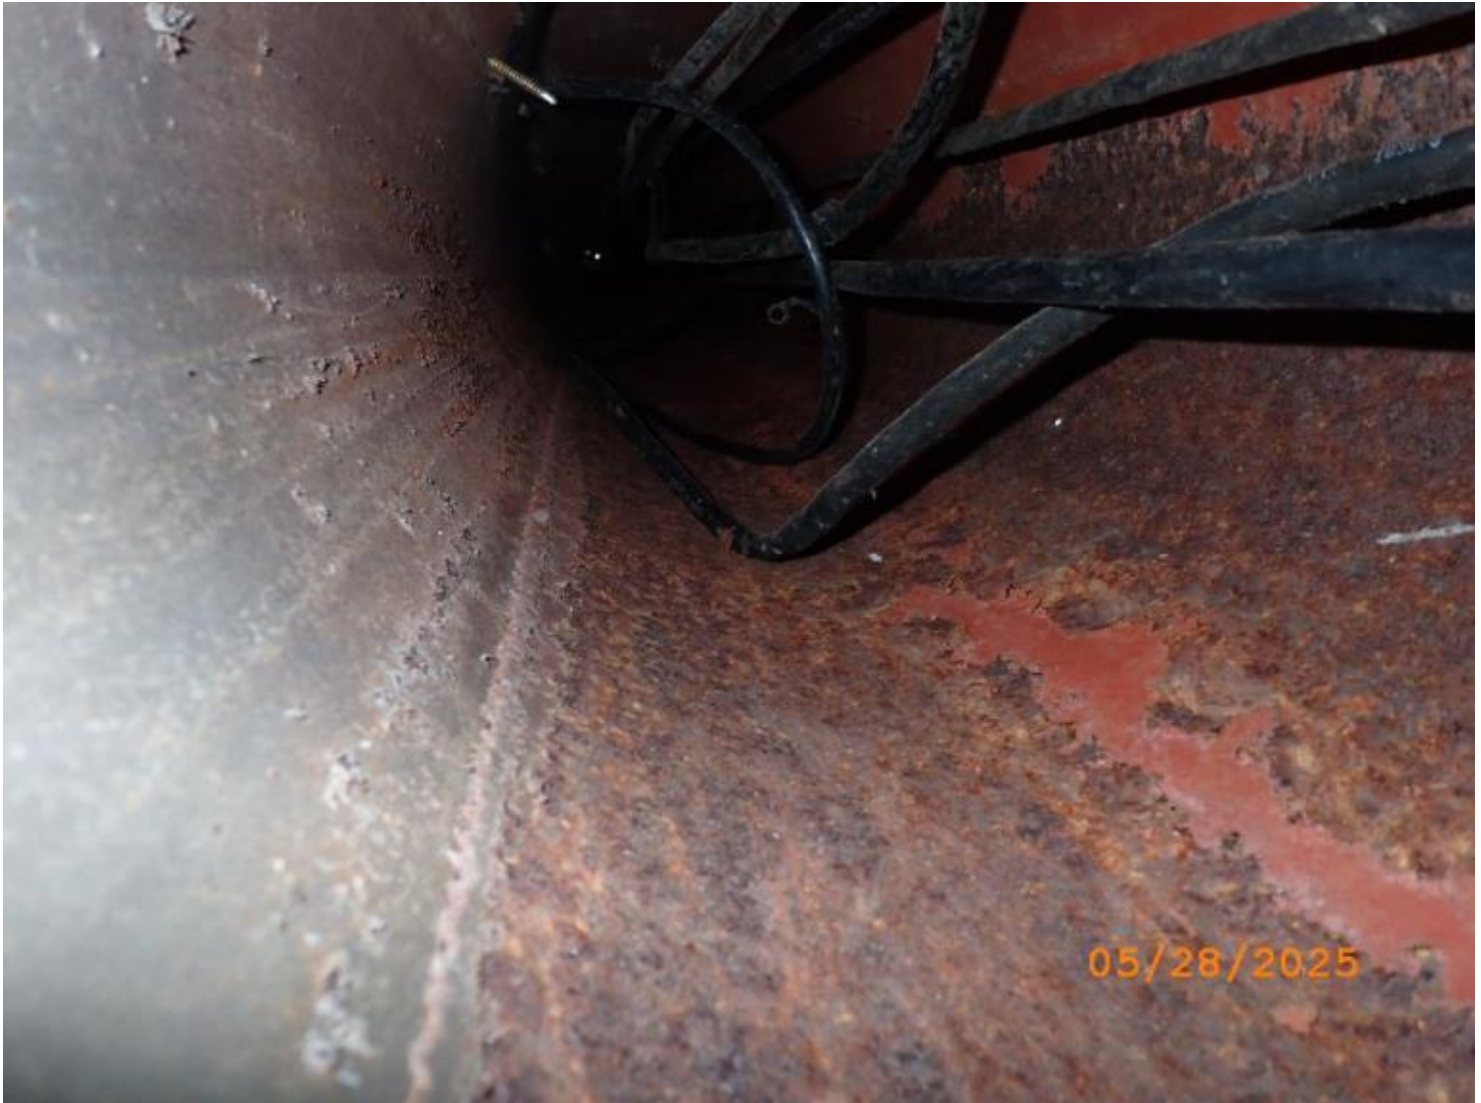
**Photo 8 - Element 8481 / Metal Mast Arm Vertical**

V1 & V2 - The column interiors have areas of light surface corrosion. NO CHANGE. Refer to Photo 8. REPAIR.

Typical column interior corrosion (V2 shown).

V1 and V2 - Program intersection for replacement. P=3

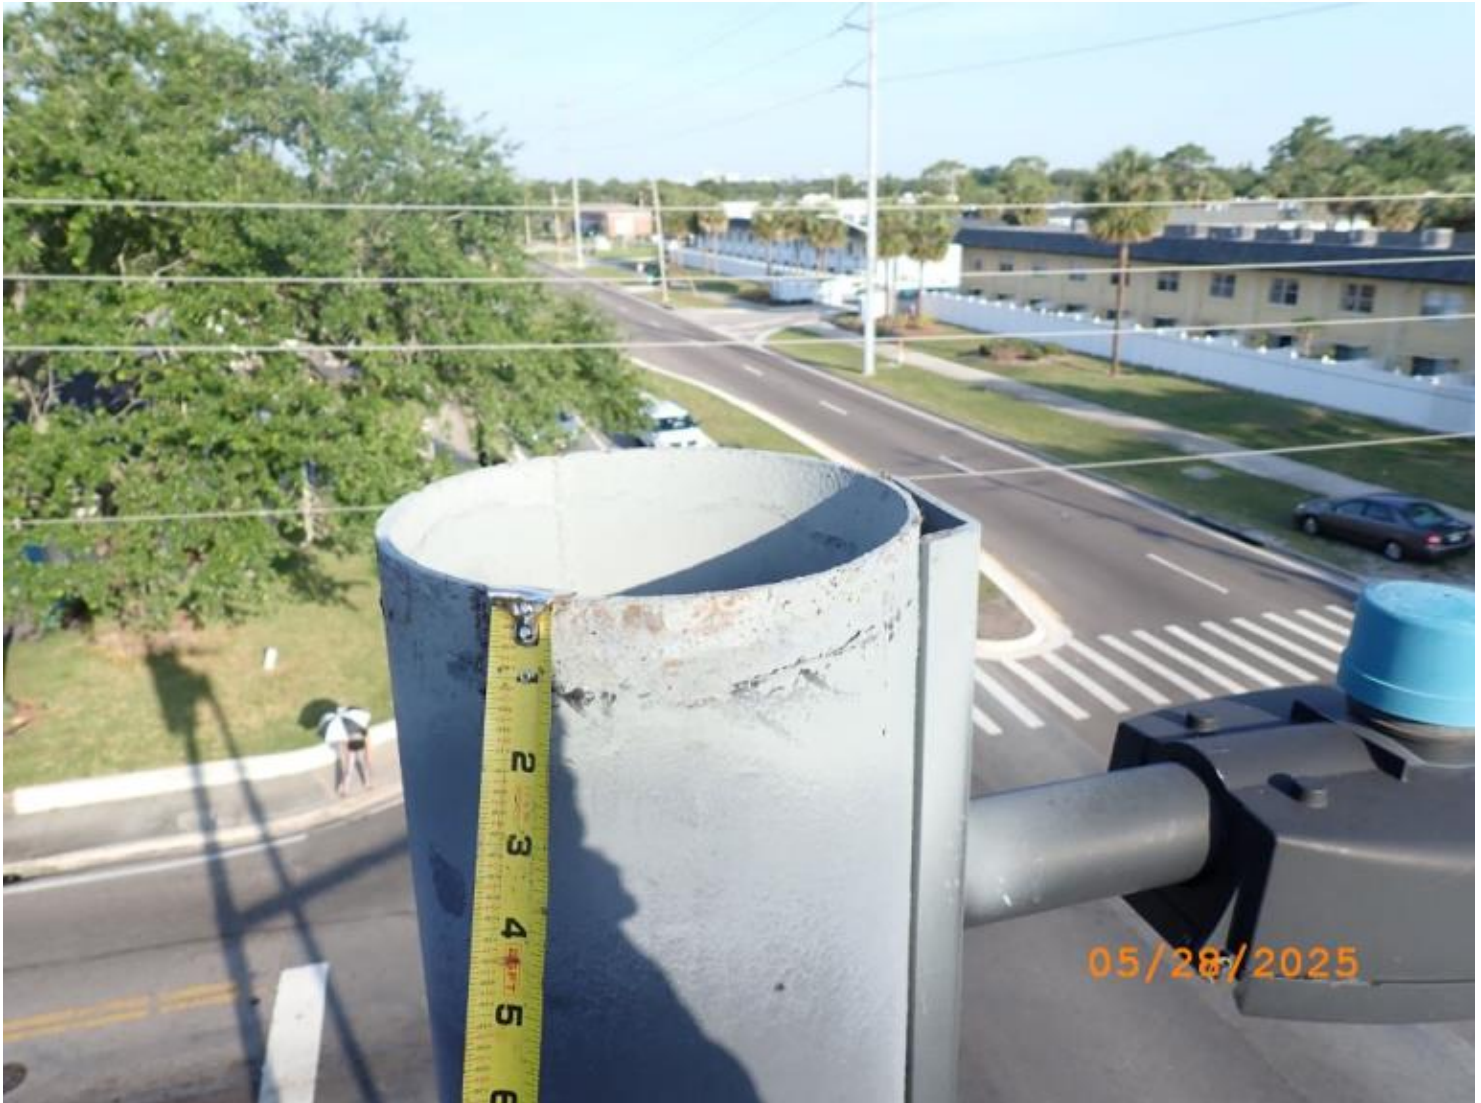
**Photo 9 - Element 8481 / Metal Mast Arm Vertical**

V1 & V2 - The top 2 in. of the columns under the column caps have painted over moderate corrosion. NO CHANGE. Refer to Photo 9. REPAIR.

Typical painted over column corrosion under the cap (V2 shown).

V1 and V2 - Program intersection for replacement. P=3

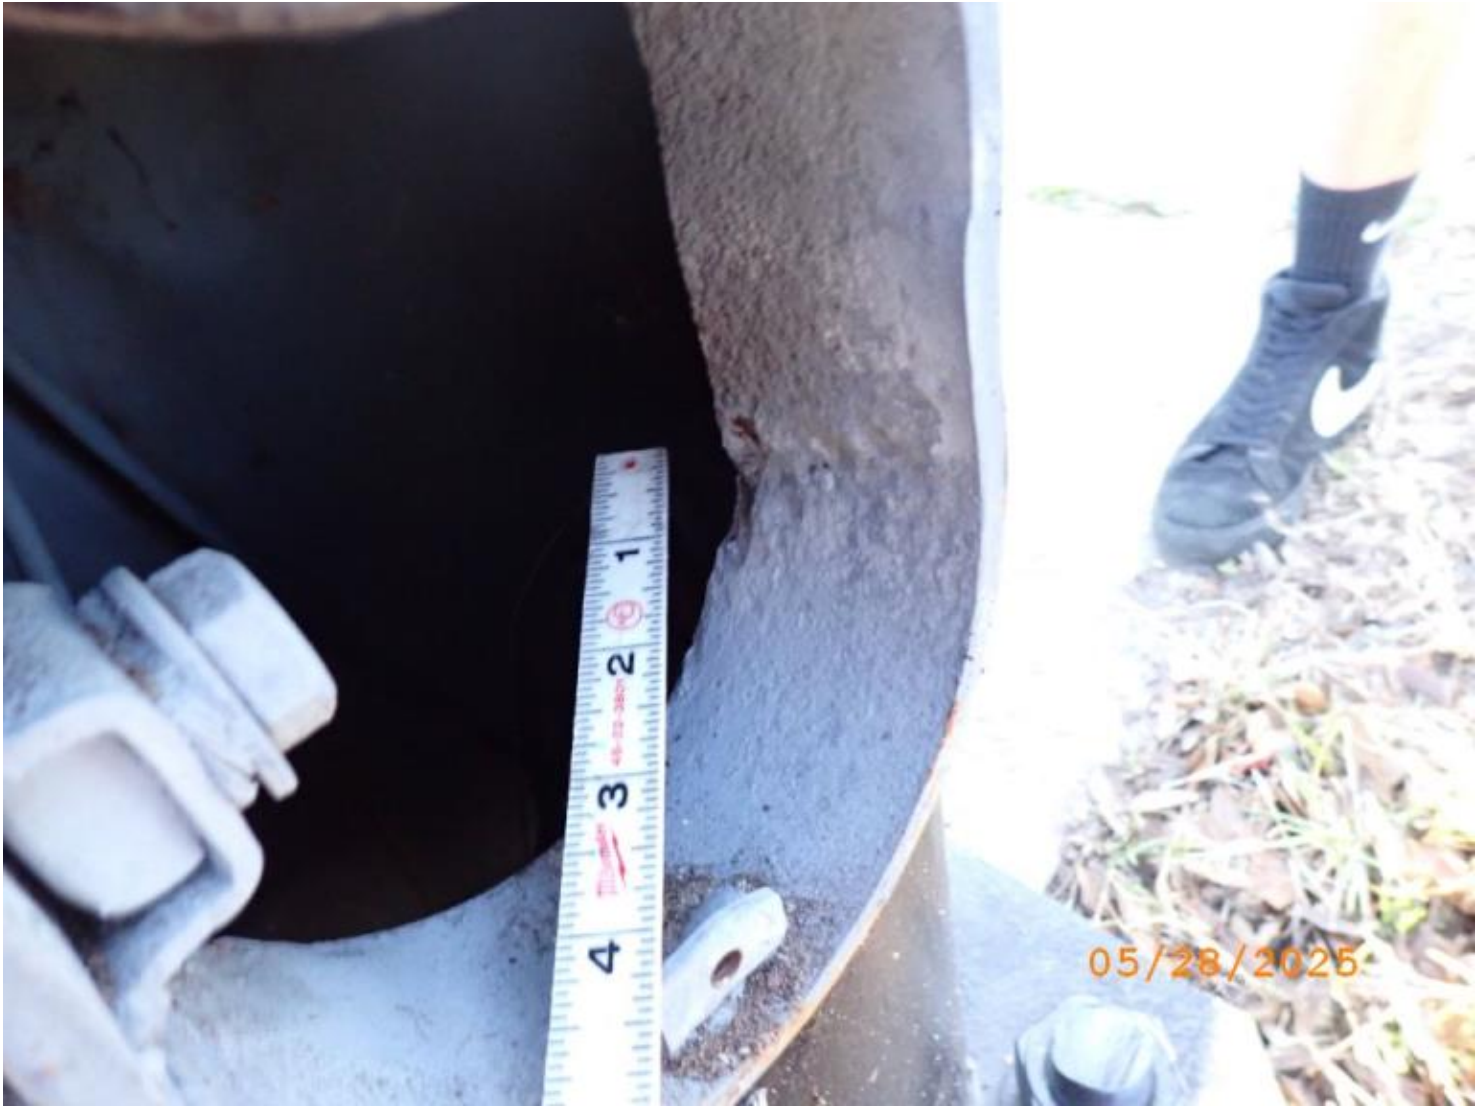
**Photo 10 - Element 8481 / Metal Mast Arm Vertical**

V1 & V2 - The hand hole access flanges have painted over moderate corrosion with areas of light pitting. NO CHANGE. Refer to Photo 10. REPAIR.

Typical column hand hole access flange with painted over corrosion & pitting (V2 shown).

V1 and V2 - Program intersection for replacement. P=3

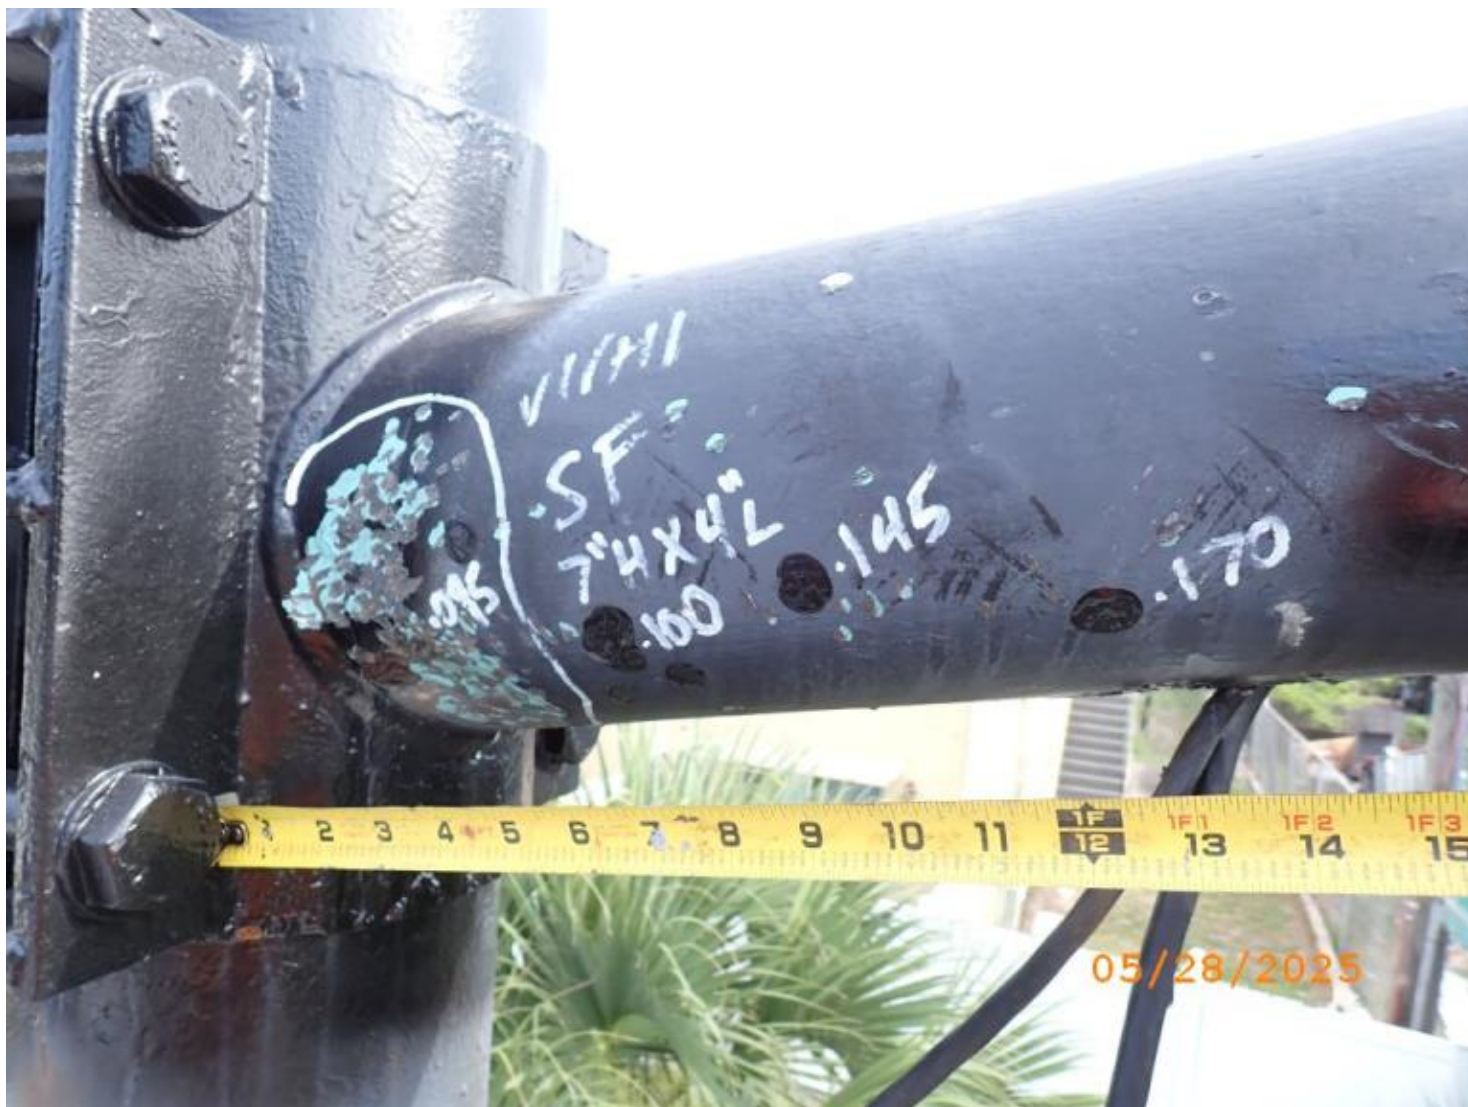
**Photo 11 - Element 8484 / Metal Mast Arm Horizontal**

V1/H1 - The horizontal arm interior has severe corrosion with flaking and section loss viewed with a borescope thru the signal wiring hole near the moment connection with the south face of the arm being slightly malleable adjacent to the moment connection 7 in. high x 4 in. long with approximately 47% section loss in this area (original arm thickness = 0.180 in. and remaining section = 0.095 in.). Section loss extends approximately 14 in. from the moment connection with thickness readings on the lower half of the arm ranging from 0.120 in. to 0.170 in. (previously noted as arm interior having heavy delaminative corrosion and pitting with the extent of any section loss unable to be determined). INCREASE. Refer to Photos 11 thru 15. REPAIR. (1EA)

V1/H1 Slightly malleable area on south face of arm and thickness readings.

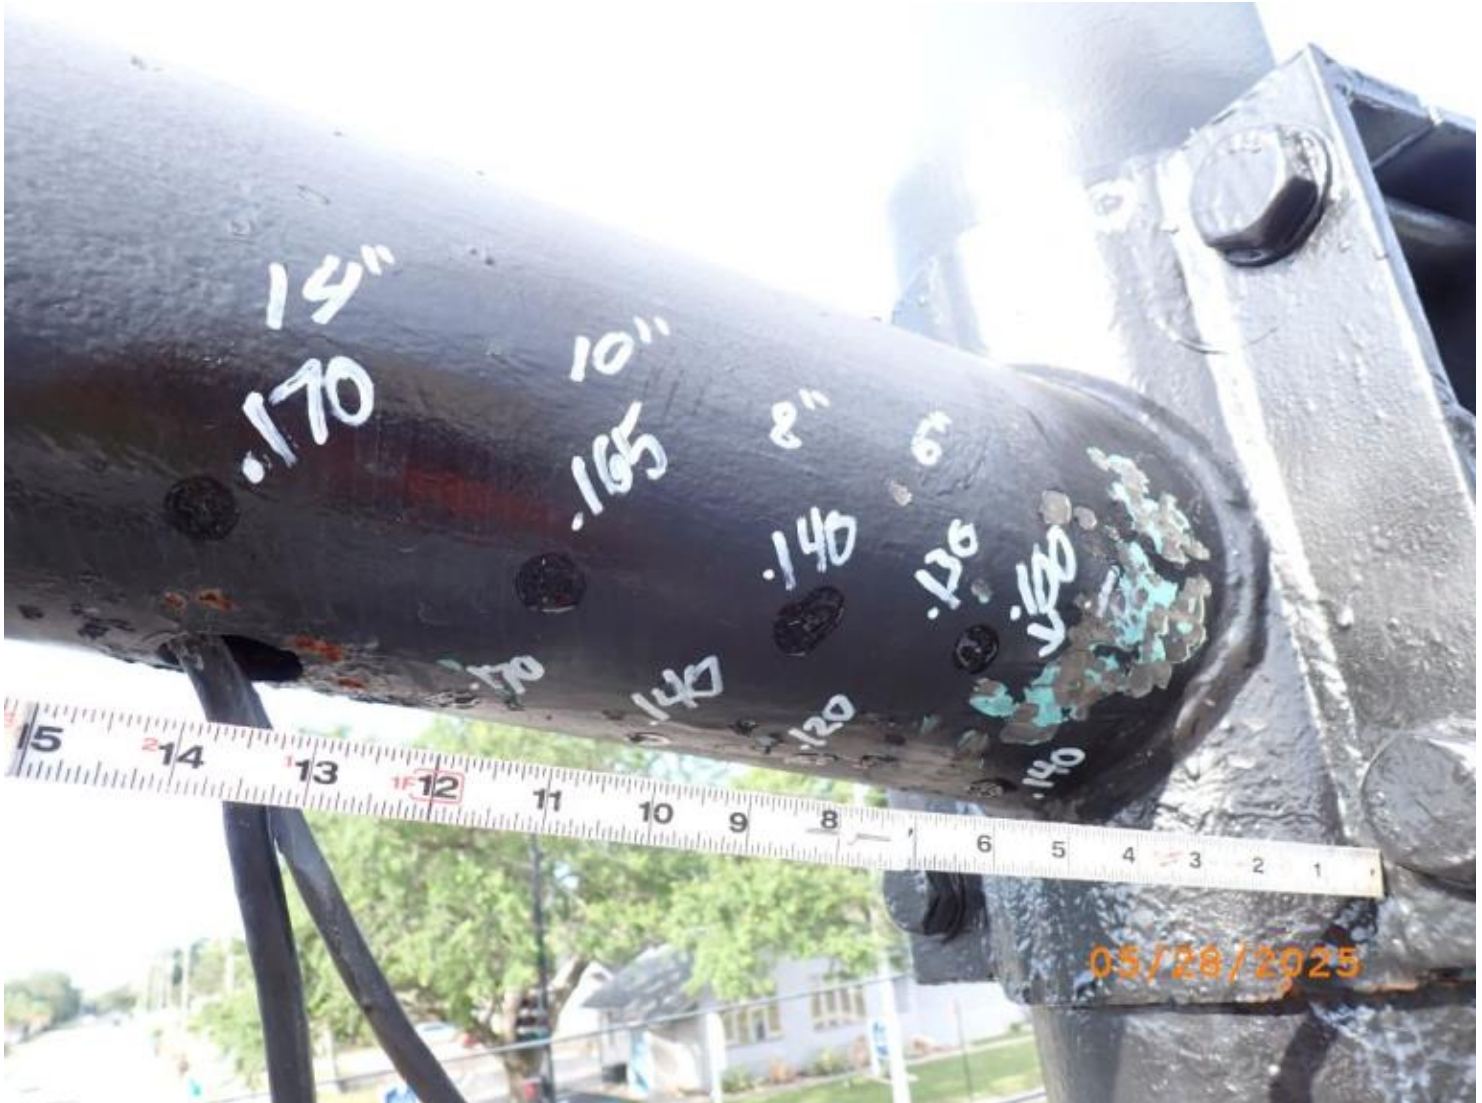
**Photo 12 - Element 8484 / Metal Mast Arm Horizontal**

V1/H1 Thickness readings on underside and north face of arm.

FDOT WORK ORDER RECOMMENDATION:  
V1/H1 - Remove arm within 6 months. P=2

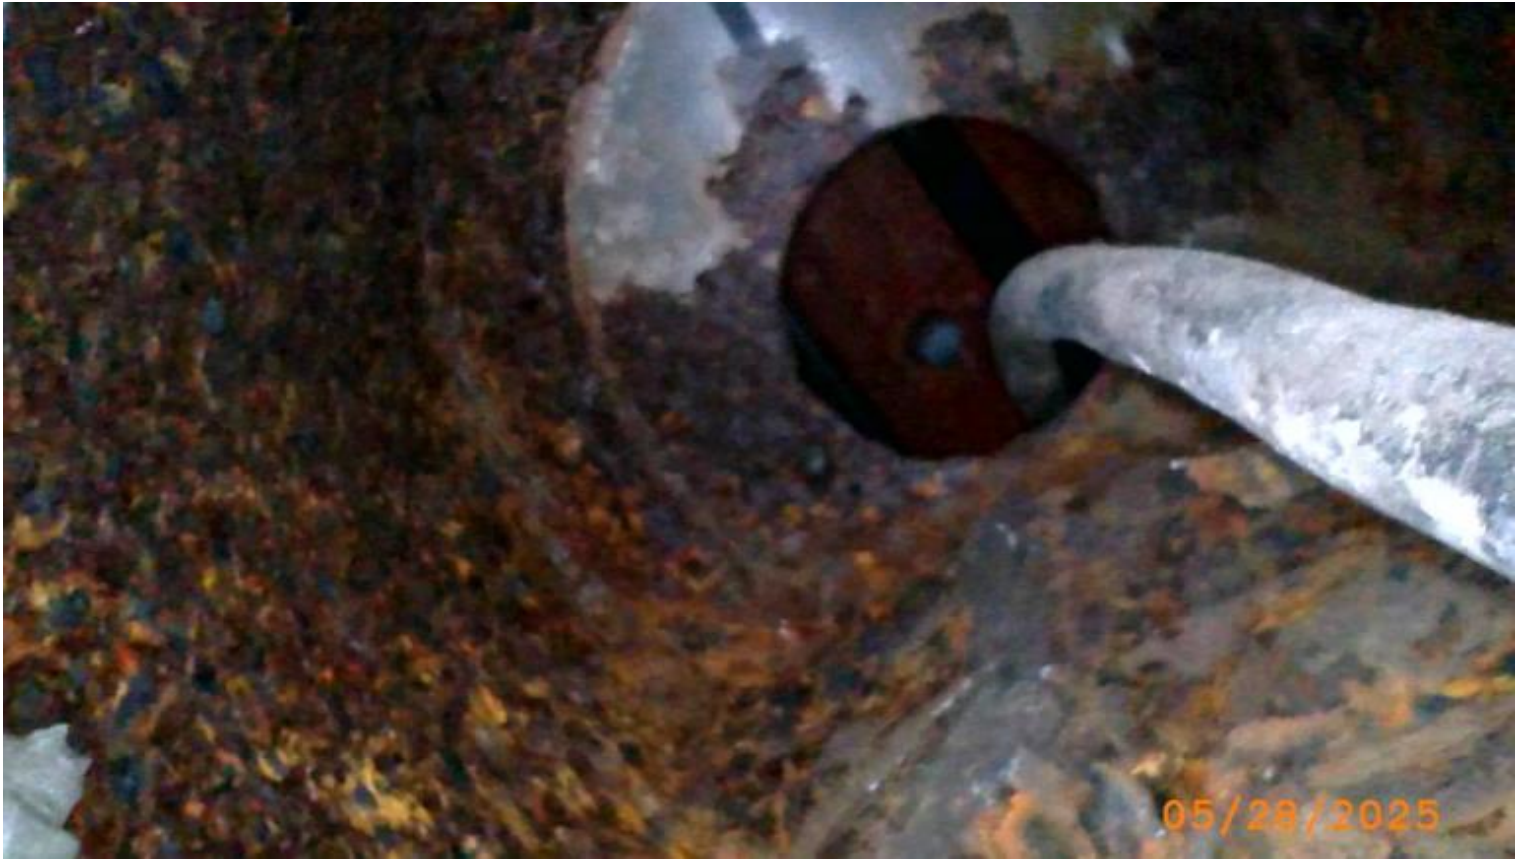
**Photo 13 - Element 8484 / Metal Mast Arm Horizontal**

V1/H1 Borescope view of corrosion on arm interior.

FDOT WORK ORDER RECOMMENDATION:  
V1/H1 - Remove arm within 6 months. P=2
