**FLORIDA DEPARTMENT OF TRANSPORTATION  
BRIDGE MANAGEMENT SYSTEM****Inspection/CIDR Report with PDF attachment(s)  
(INTERIM INSPECTION REPORT)****Structure ID: 75M112****Inspection****DISTRICT: D5 - Deland****INSPECTION DATE: 5/28/2025 BZHA**

| BY: Ayres Associates | STRUCTURE NAME: SR-552 (Curry Ford Rd.) at Dixie Belle Dr |

TYPE OF INSPECTION: Interim

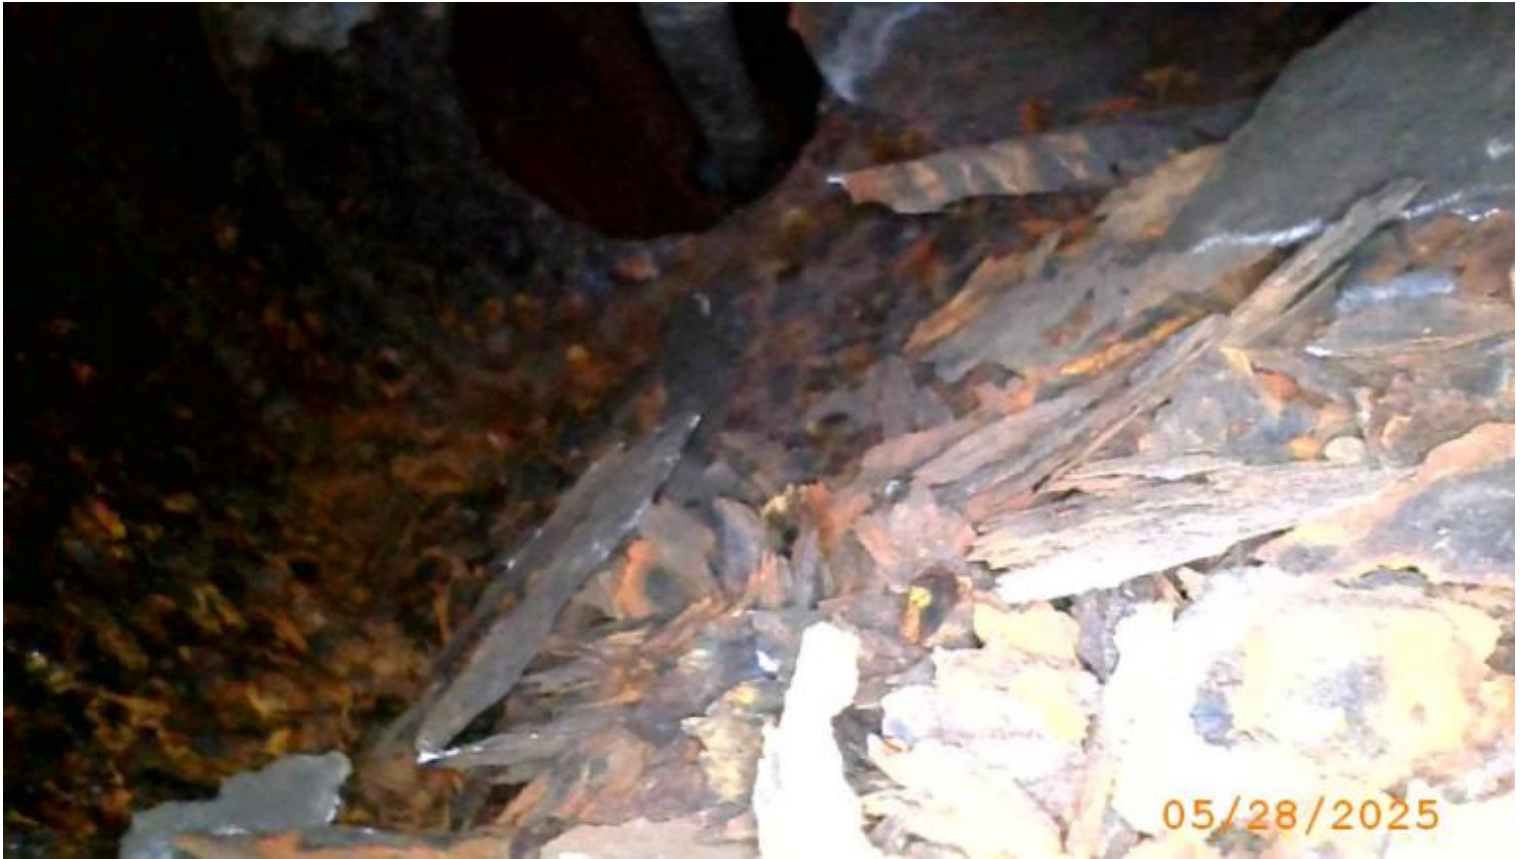
**Photo 14 - Element 8484 / Metal Mast Arm Horizontal**

V1/H1 - The horizontal arm interior has severe corrosion with flaking and section loss viewed with a borescope thru the signal wiring hole near the moment connection with the south face of the arm being slightly malleable adjacent to the moment connection 7 in. high x 4 in. long with approximately 47% section loss in this area (original arm thickness = 0.180 in. and remaining section = 0.095 in.). Section loss extends approximately 14 in. from the moment connection with thickness readings on the lower half of the arm ranging from 0.120 in. to 0.170 in. (previously noted as arm interior having heavy delaminative corrosion and pitting with the extent of any section loss unable to be determined). INCREASE. Refer to Photos 11 thru 15. REPAIR. (1EA)

V1/H1 Borescope view of corrosion on arm interior.

FDOT WORK ORDER RECOMMENDATION:  
V1/H1 - Remove arm within 6 months. P=2

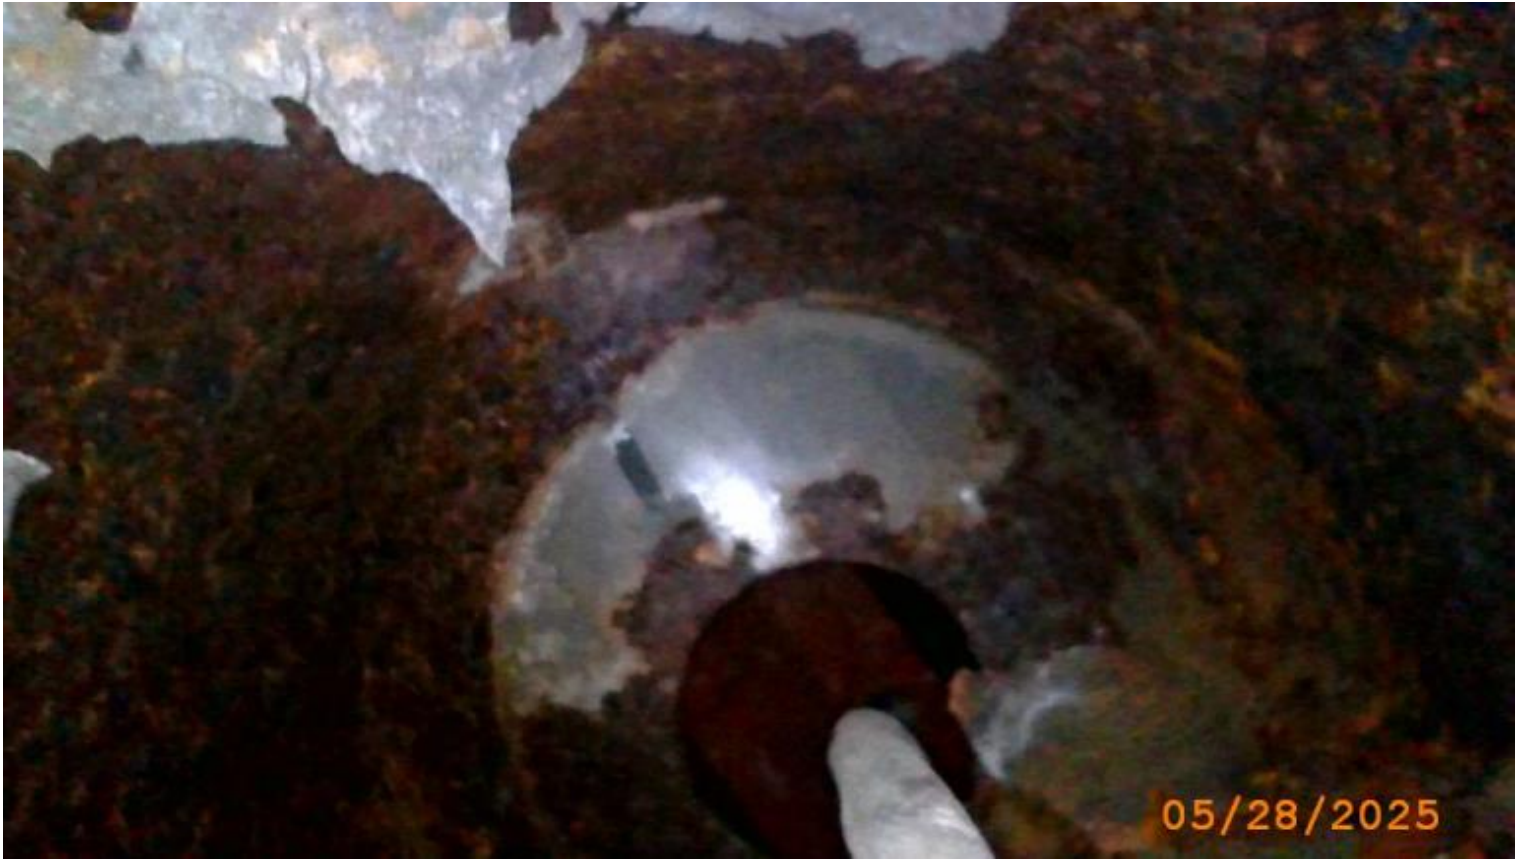
**Photo 15 - Element 8484 / Metal Mast Arm Horizontal**

V1/H1 Borescope view of corrosion on arm interior.

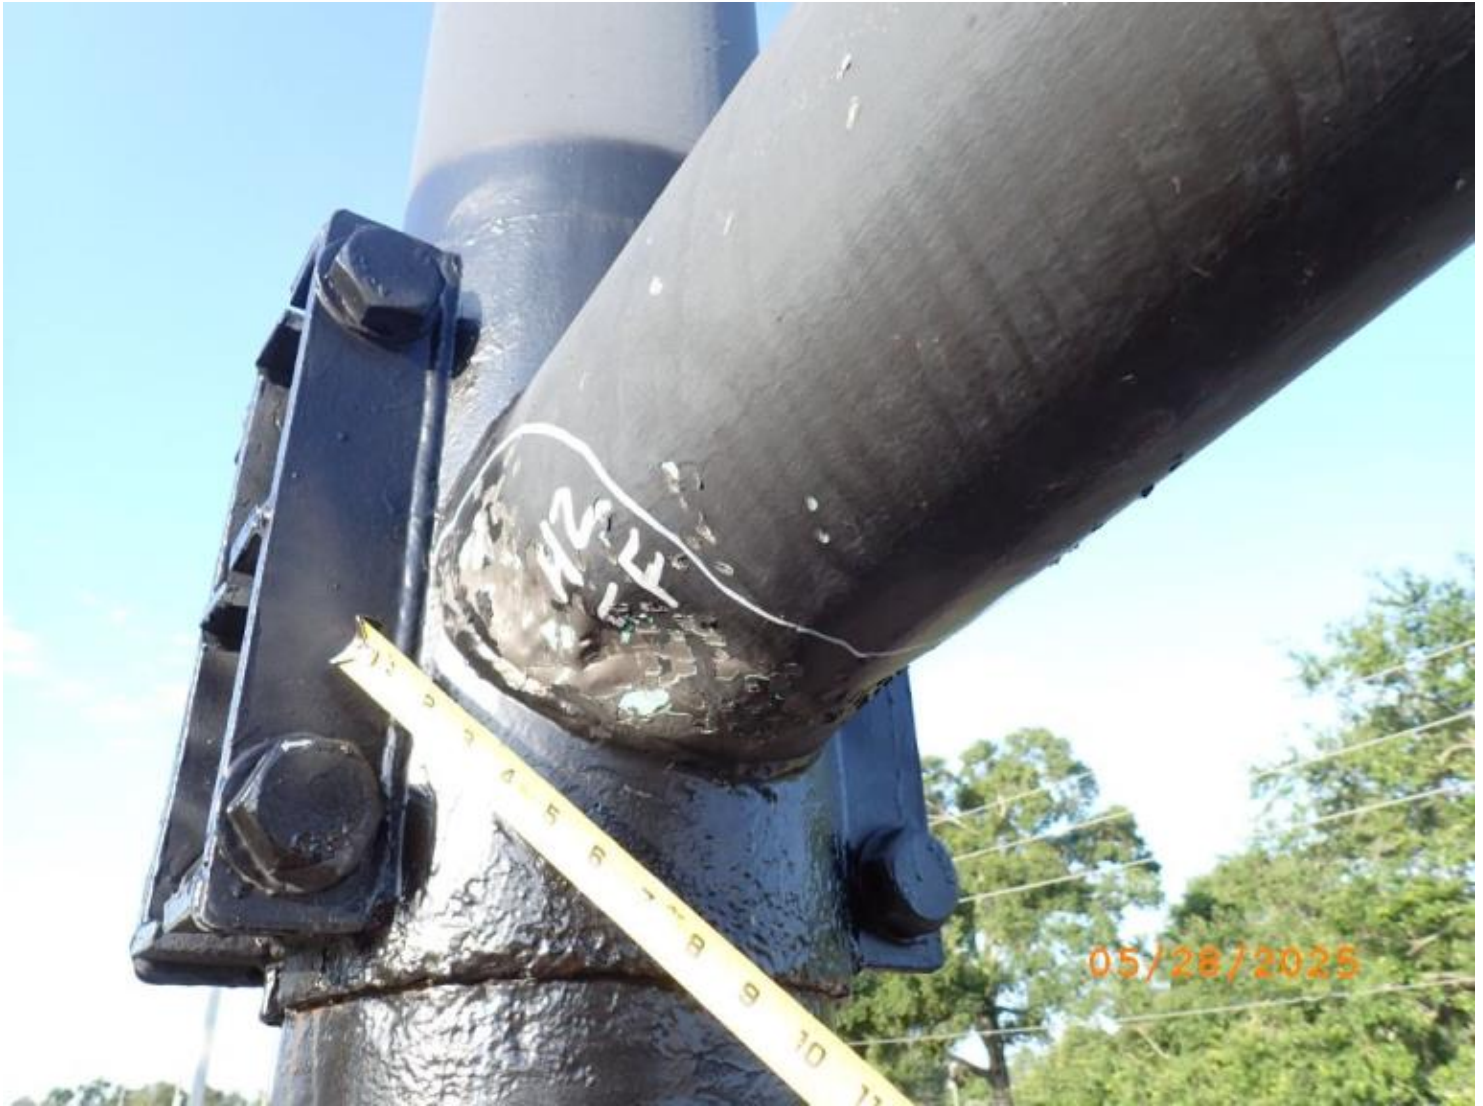
**Photo 16 - Element 8484 / Metal Mast Arm Horizontal**

V2/H2 - The bottom 180 degrees of the horizontal arm is easily malleable with a hammer for a 5 in. length adjacent to the moment connection due to severe corrosion on the arm interior with approximately 47% section loss in this area (original arm thickness = 0.180

in. and remaining section in this area was 0.095 in. on the arm underside and 0.100 in. to 0.105 in. on the east and west faces). Arm circumference = 28 in. and malleable area = 14 in. There is nowhere to insert a borescope to view the arm interior. Section loss extends approximately 24 in. from the moment connection with thickness readings taken on the lower half of the arm from 6 in. to 18 in. away from the moment connection ranging from 0.120 in. to 0.145 in. (previously noted as presumed some level of corrosion exists on the arm interior). INCREASE. Refer to Photos 16 thru 20. REPAIR. (1EA)

V2/H2 - Malleable area on underside of arm.

FDOT WORK ORDER RECOMMENDATION:  
V2/H2 - Remove arm within 1 week. P=1

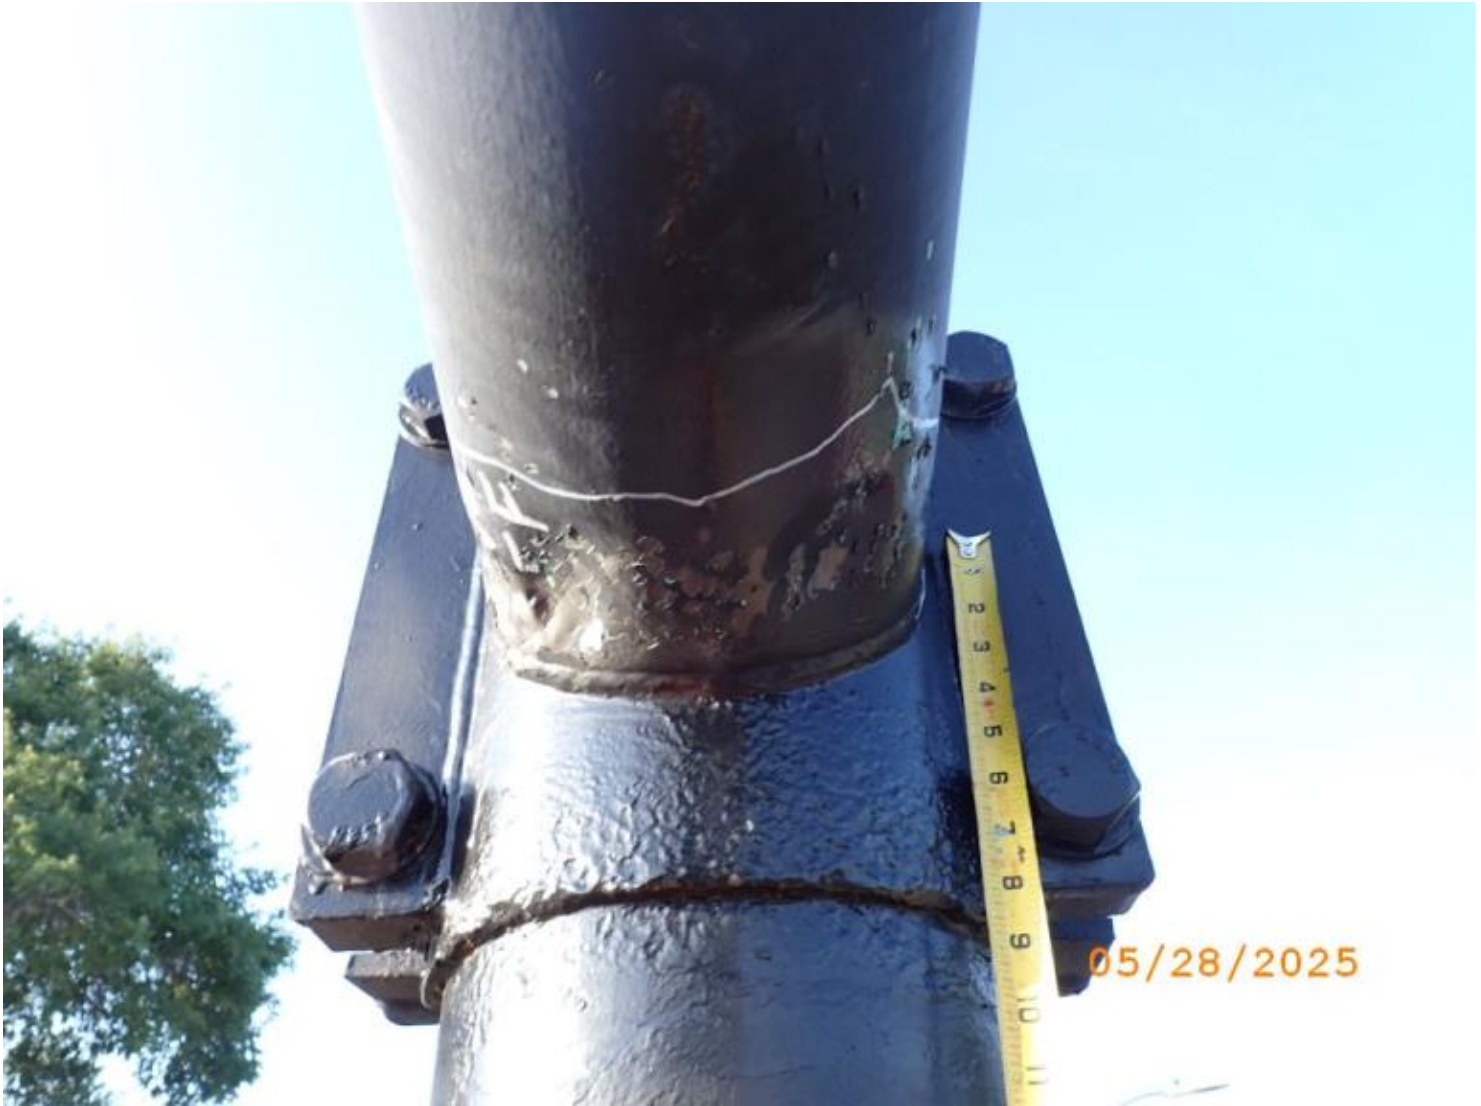
**Photo 17 - Element 8484 / Metal Mast Arm Horizontal**

V2/H2 - Malleable area on underside of arm.

FDOT WORK ORDER RECOMMENDATION:  
V2/H2 - Remove arm within 1 week. P=1

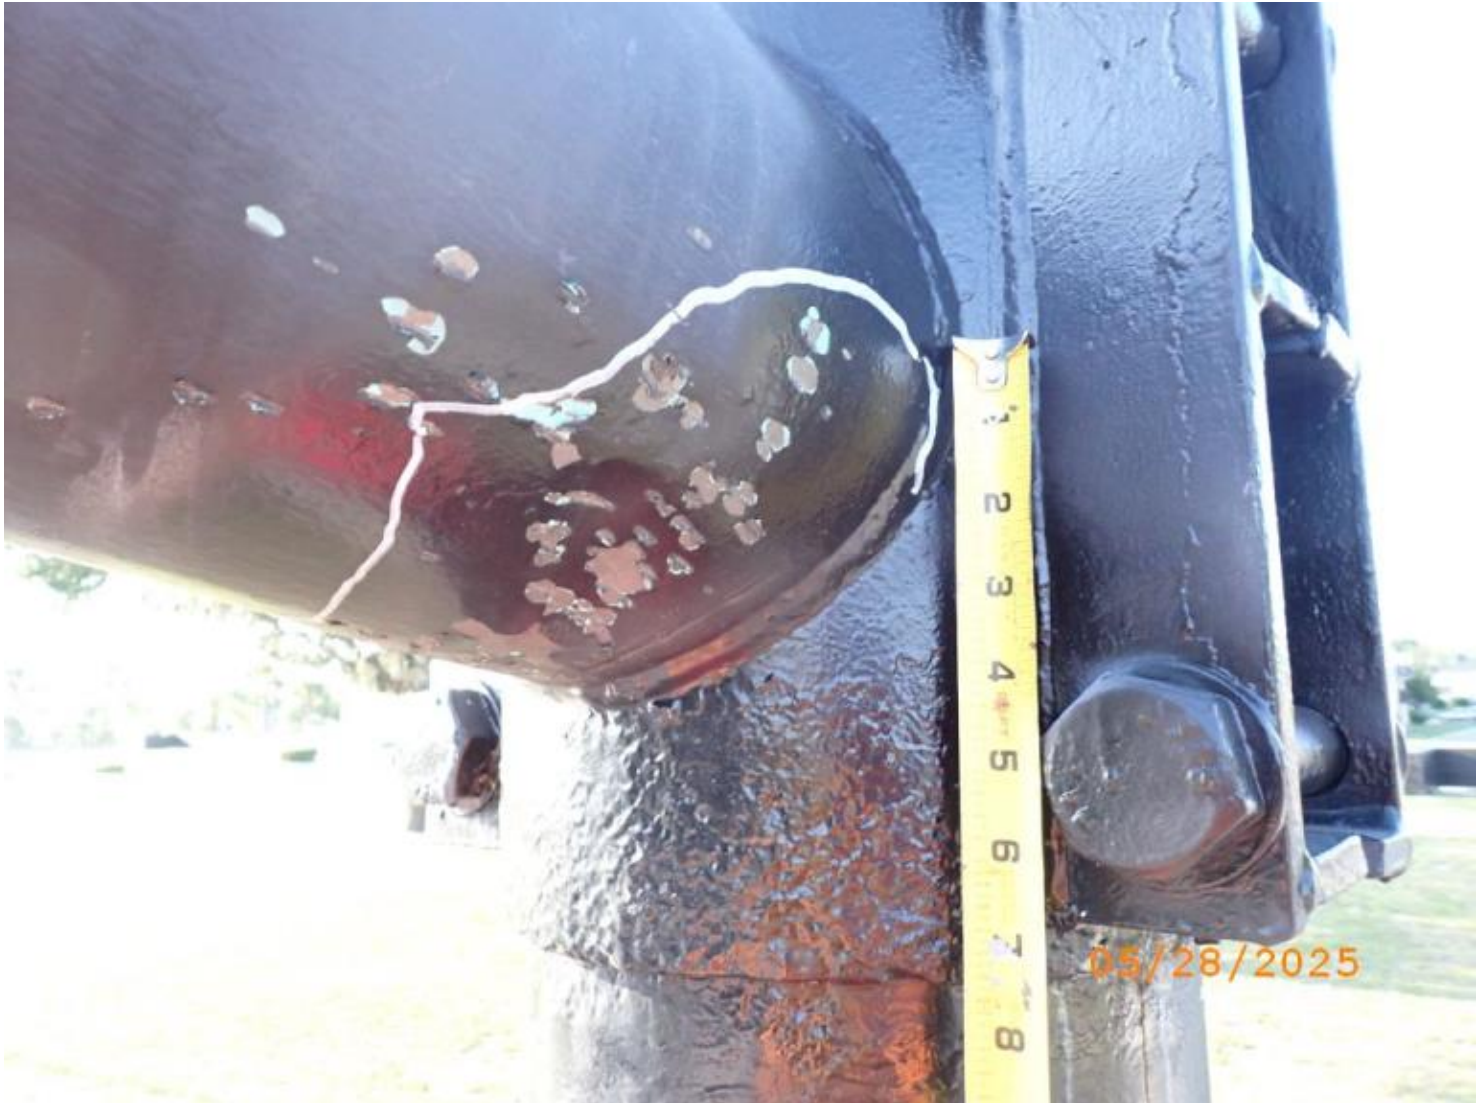
**Photo 18 - Element 8484 / Metal Mast Arm Horizontal**

V2/H2 - Malleable area on underside of arm.

FDOT WORK ORDER RECOMMENDATION:  
V2/H2 - Remove arm within 1 week. P=1

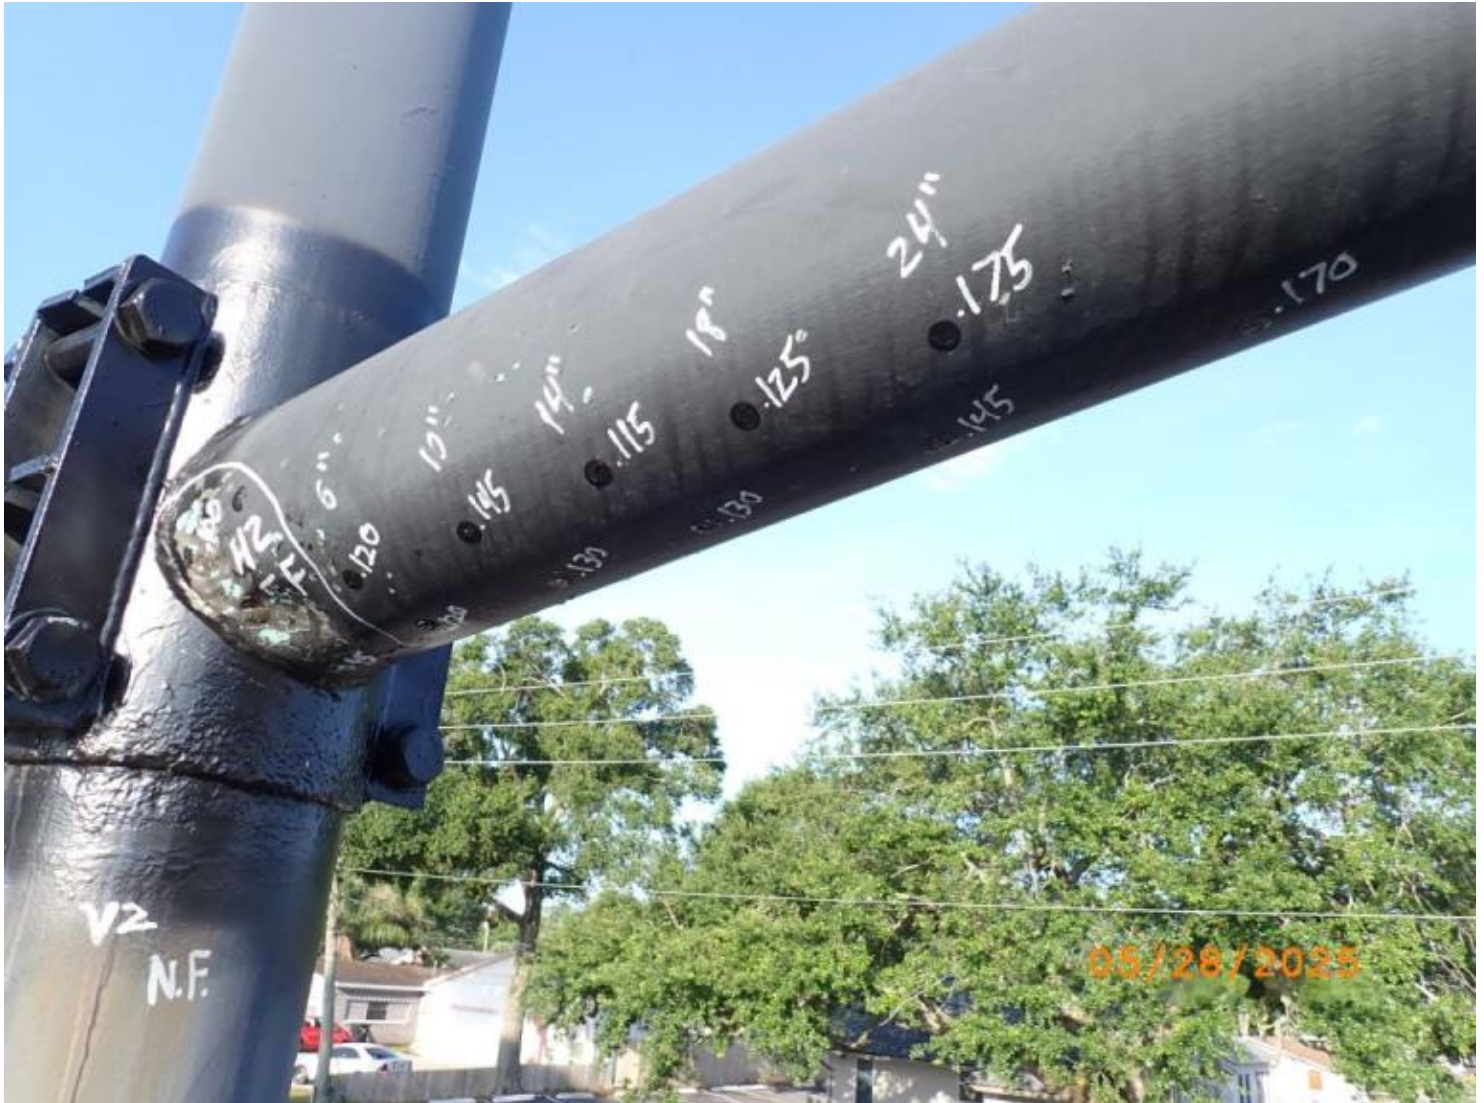
**Photo 19 - Element 8484 / Metal Mast Arm Horizontal**

V2/H2 Thickness readings on underside and east face of arm.

FDOT WORK ORDER RECOMMENDATION:  
V2/H2 - Remove arm within 1 week. P=1

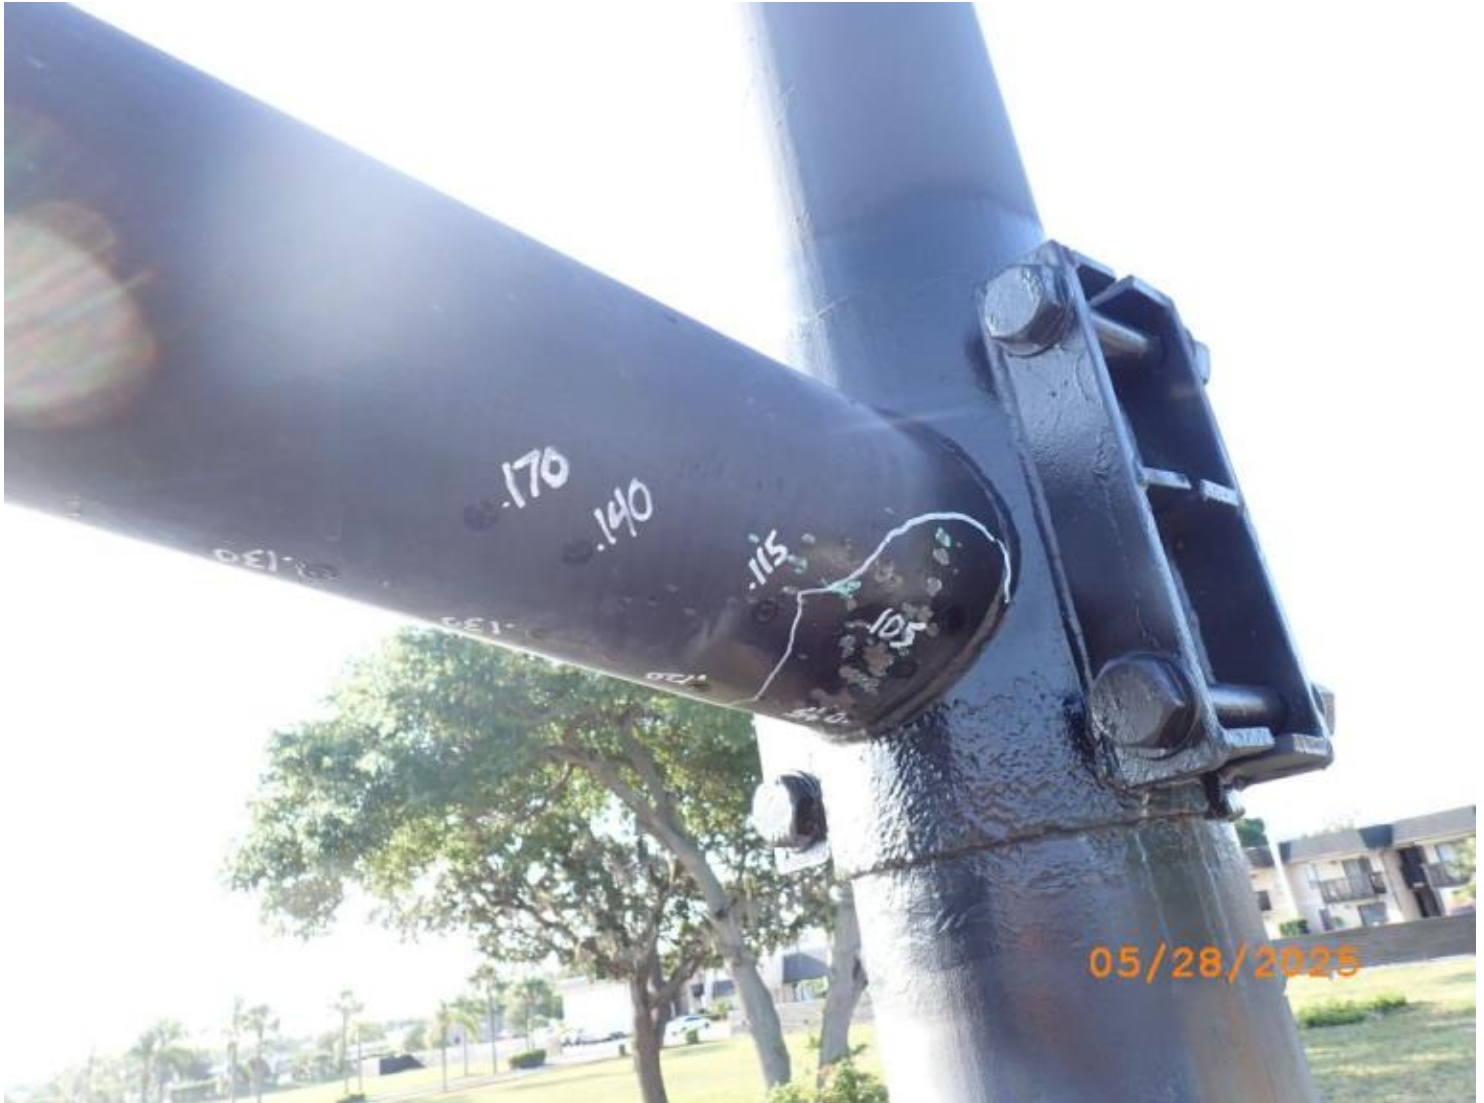
**Photo 20 - Element 8484 / Metal Mast Arm Horizontal**

V2/H2 Thickness readings on underside and west face of arm.

FDOT WORK ORDER RECOMMENDATION:  
V2/H2 - Remove arm within 1 week. P=1

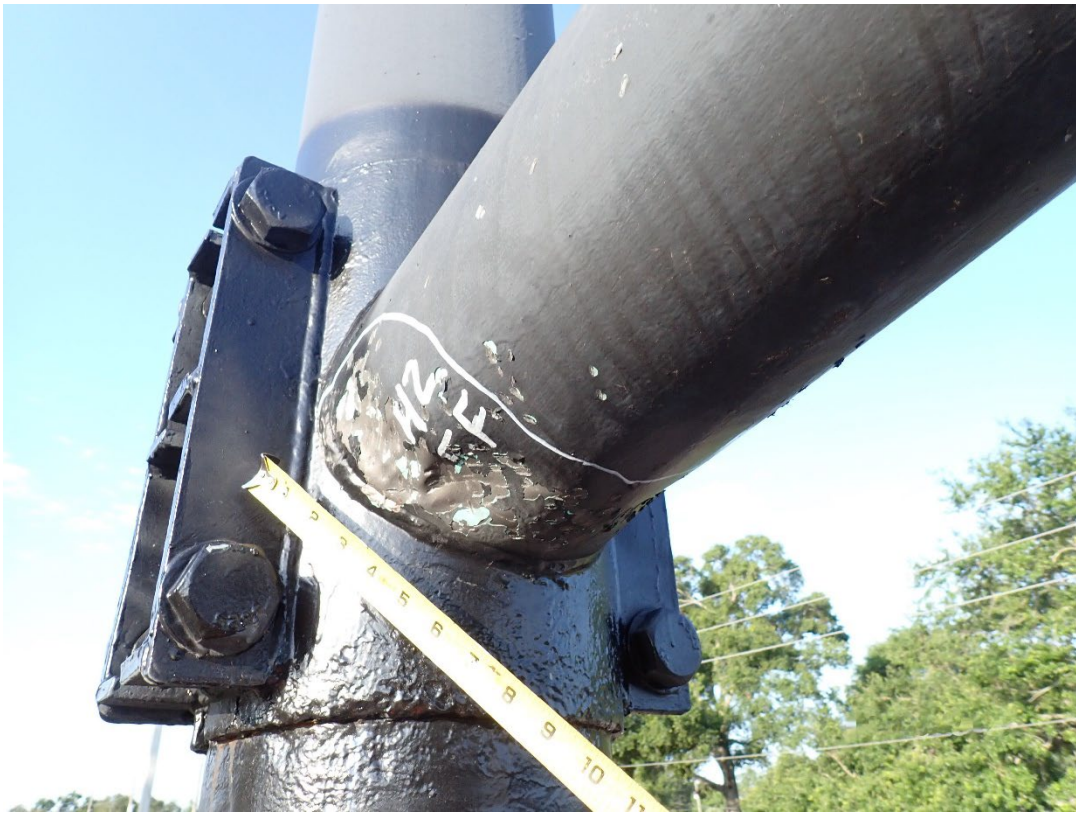
V2/H2 (arm length = 32 ft.) - The bottom 180 degrees of the horizontal arm is easily malleable with a hammer for a 5 in. length adjacent to the moment connection due to severe corrosion on the arm interior. Minimum thickness readings in this area were 0.095 in. on the arm underside and 0.100 in. to 0.105 in. on the east and west faces (original arm thickness = 0.180 in.) with approximately 47% section loss in this area. Arm circumference = 28 in. and malleable area = 14 in. There is nowhere to insert a borescope to view the arm interior. Section loss extends approximately 24 in. from the moment connection with thickness readings taken on the lower half of the arm from 6 in. to 18 in. away from the moment connection ranging from 0.120 in. to 0.145 in. Refer to Photos 1 through 5.

Photo 1: V2/H2 – Malleable area on underside of arm

**Recommendation:** Based on the severity of corrosion, section loss, and malleable areas, it is recommended that V2/H2 be removed within one week. V1/H1 should be removed within 6 months.

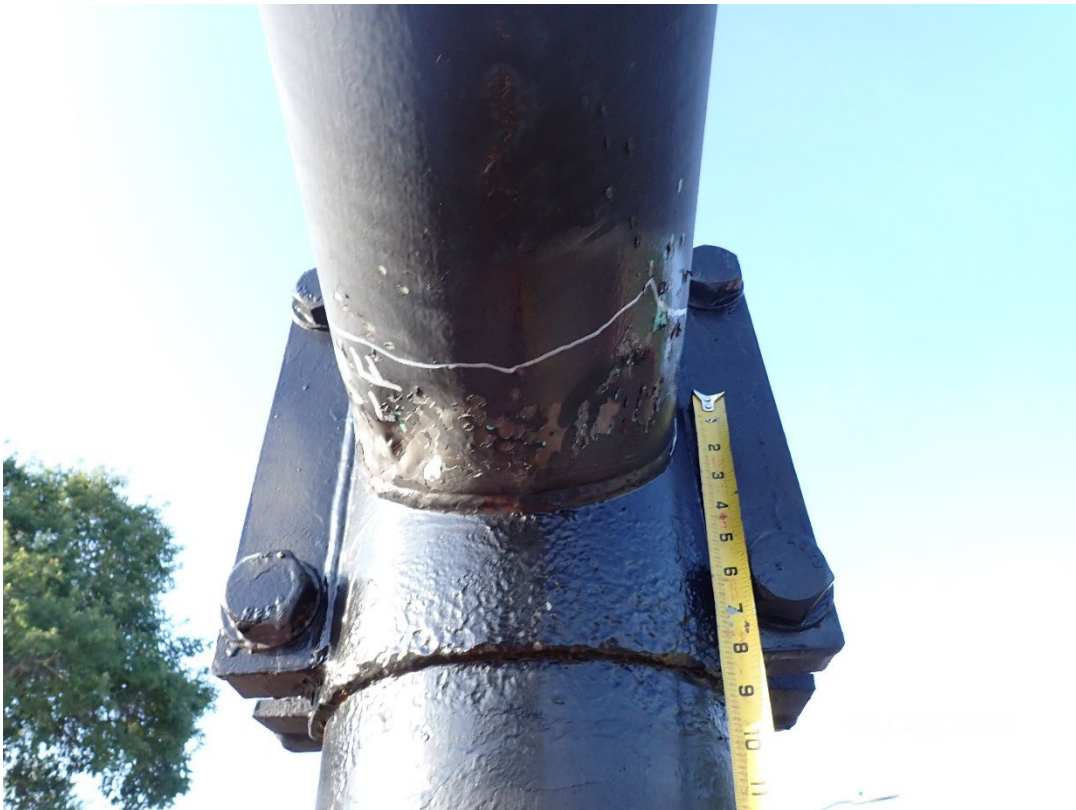
Photo 2: V2/H2 – Malleable area on underside of arm

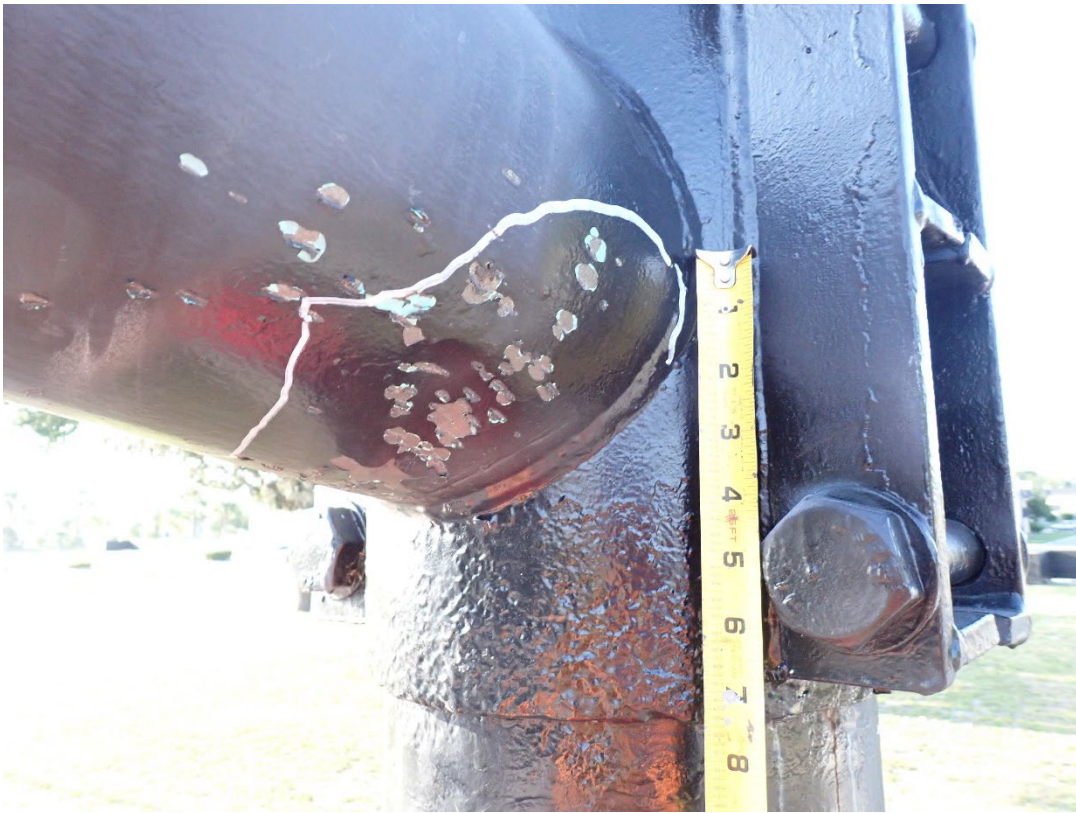
Photo 3: V2/H2 – Malleable area on underside of arm

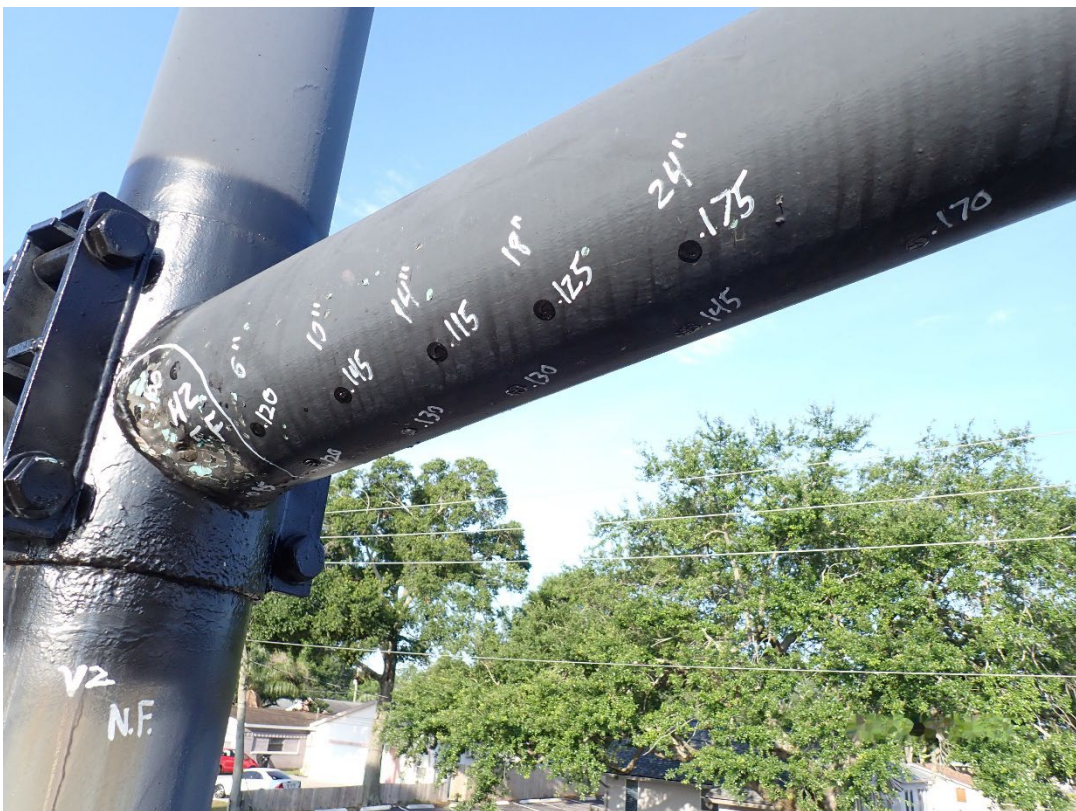
Photo 4: V2/H2 – Thickness readings on underside and east face of arm

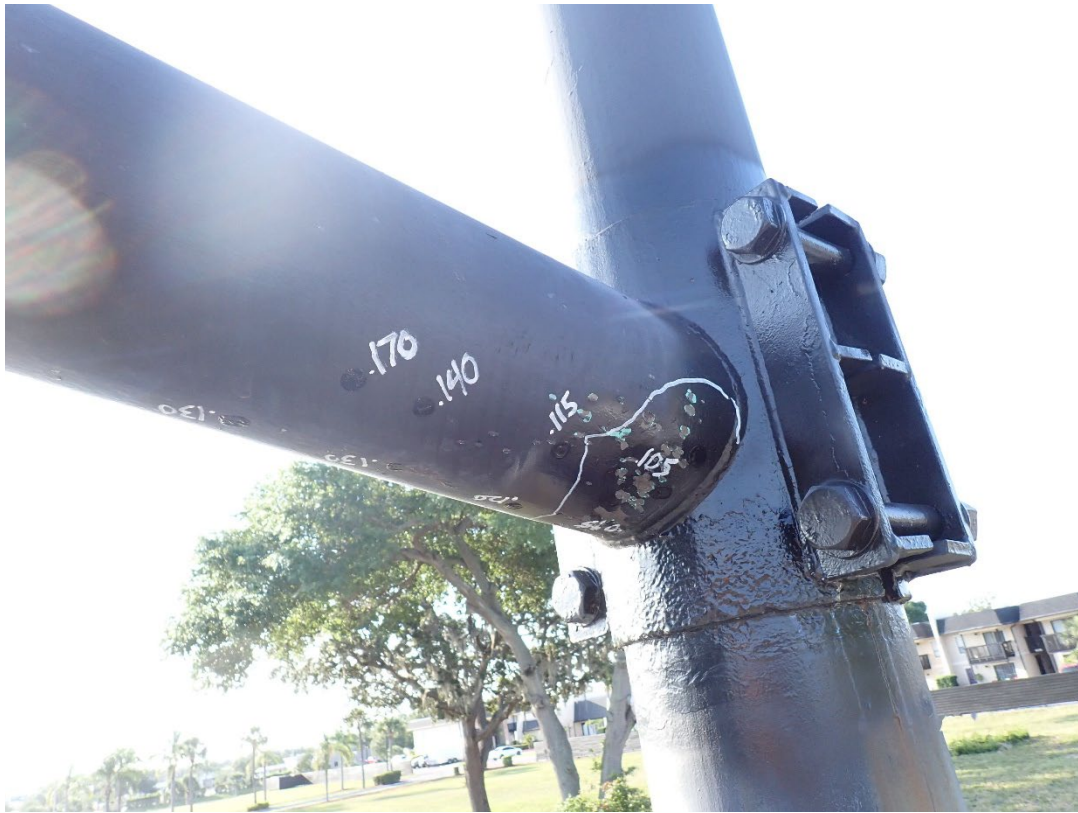
Photo 5: V2/H2 – Thickness readings on underside and west face of arm

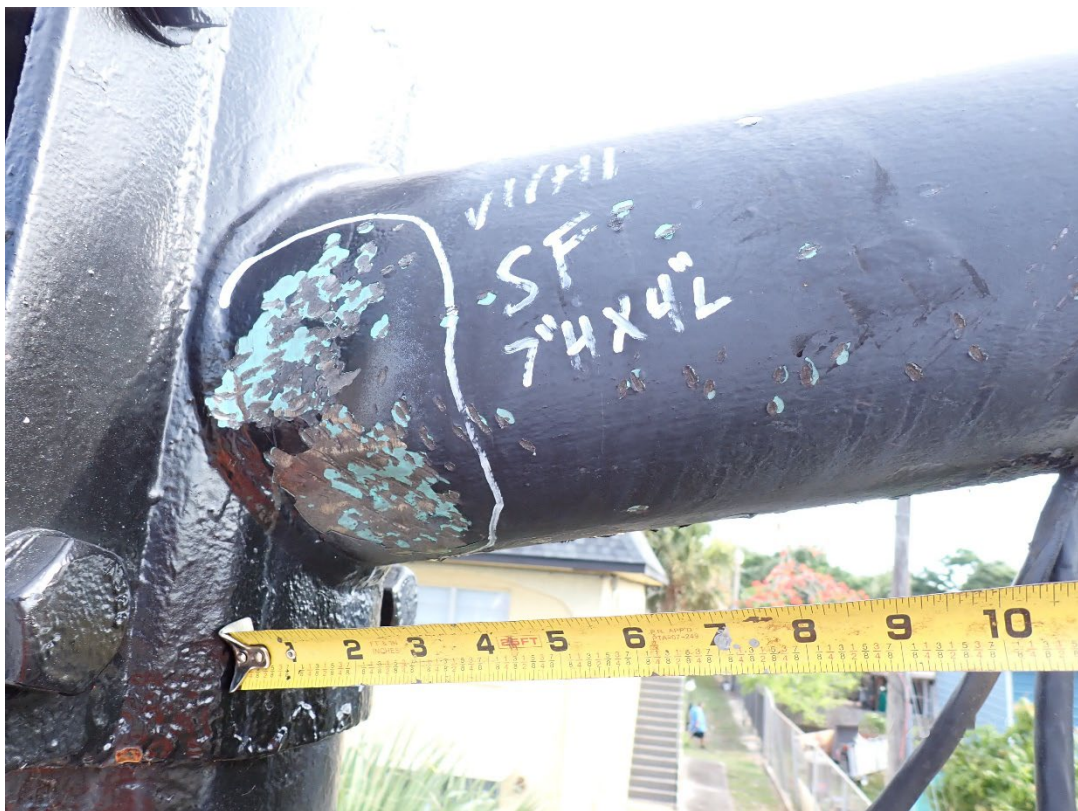
V1/H1 (arm length = 24 ft.)– The horizontal arm interior has severe corrosion with flaking and section loss viewed with a borescope thru the signal wiring hole near the moment connection. The south face of the arm has a slightly malleable area adjacent to the moment connection measuring 7 in. high x 4 in. long. Minimum thickness readings in this area were 0.095 in. (original arm thickness = 0.180 in.) with approximately 47% section loss in this area. Section loss extends approximately 14 in. from the moment connection with thickness readings on the lower half of the arm ranging from 0.120 in. to 0.170 in. Refer to Photos 6 through 11.

Photo 6: V1/H1 – Slightly malleable area on south face of arm

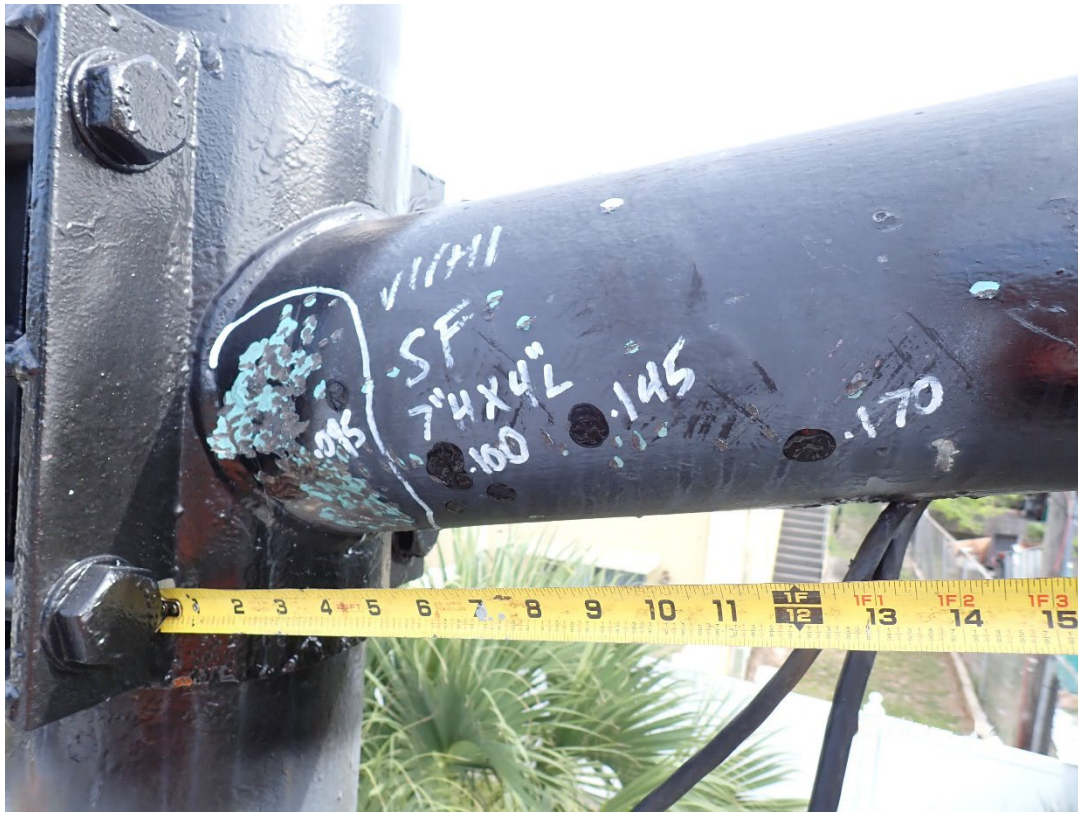
Photo 7: V1/H1 – Thickness readings on south face of arm

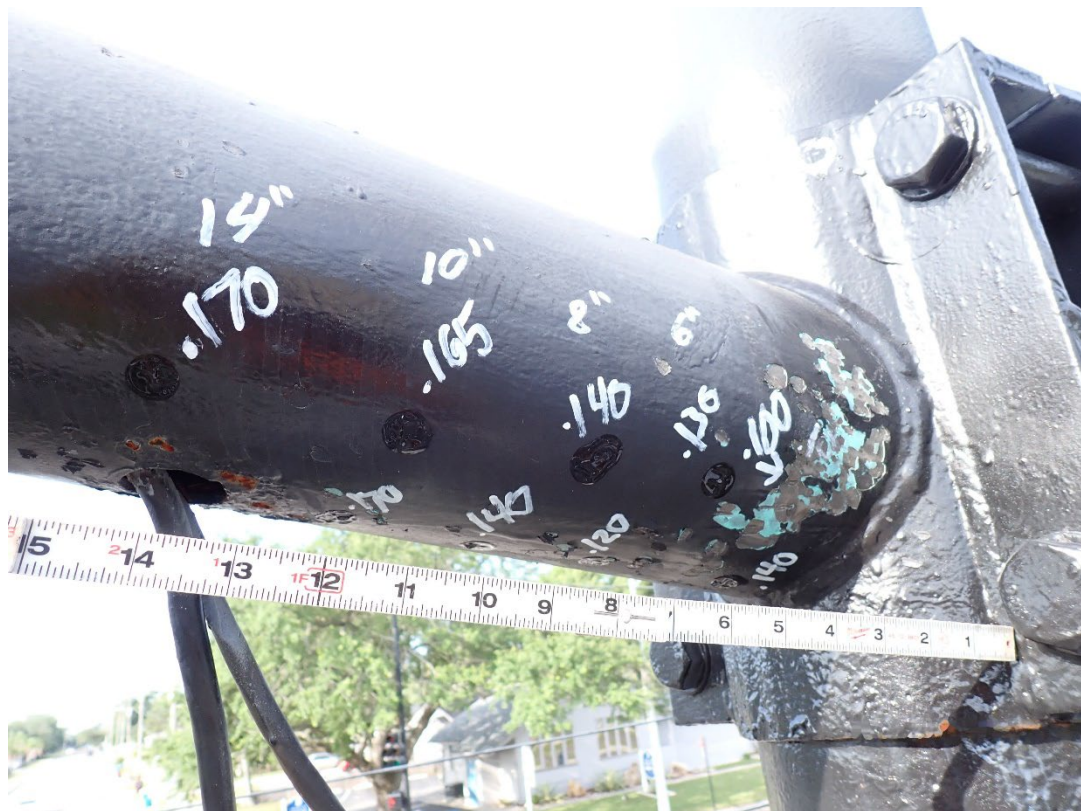
Photo 8: V1/H1 – Thickness readings on underside and north face of arm

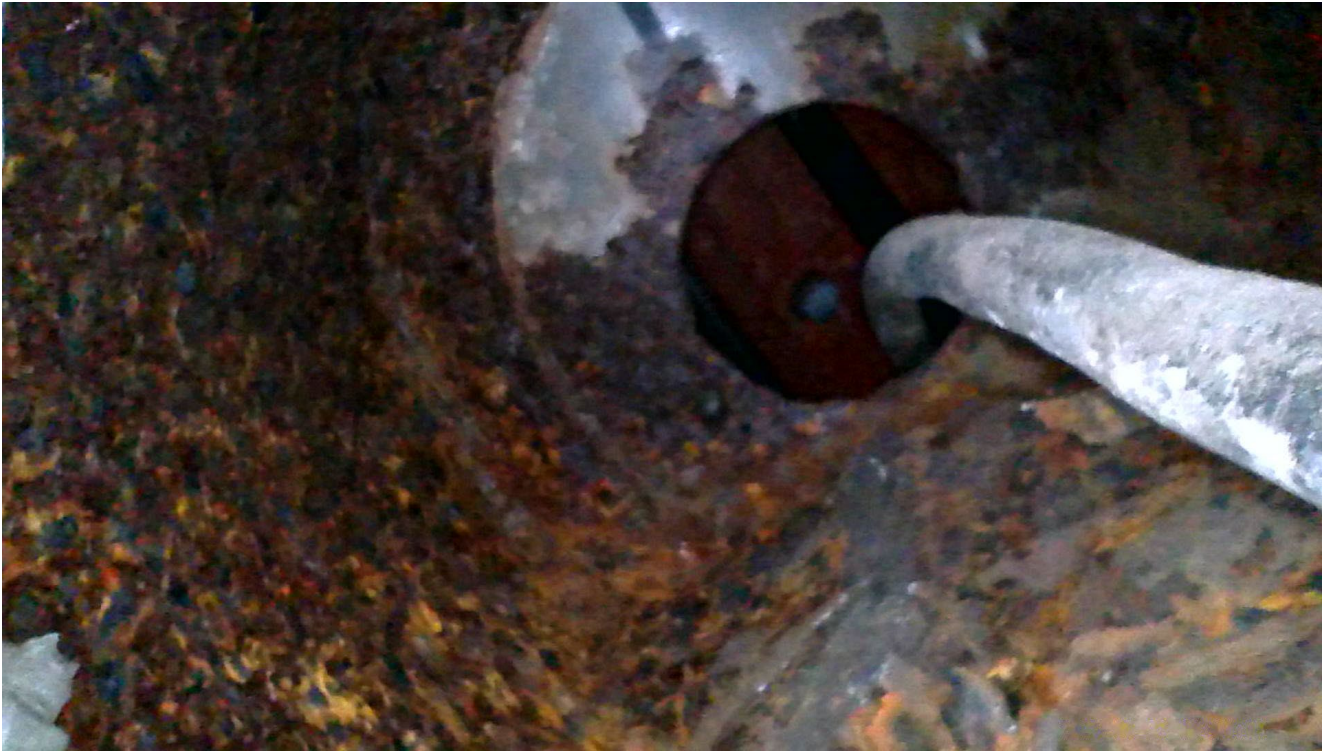
Photo 9: V1/H1 – Borescope view of corrosion on arm interior

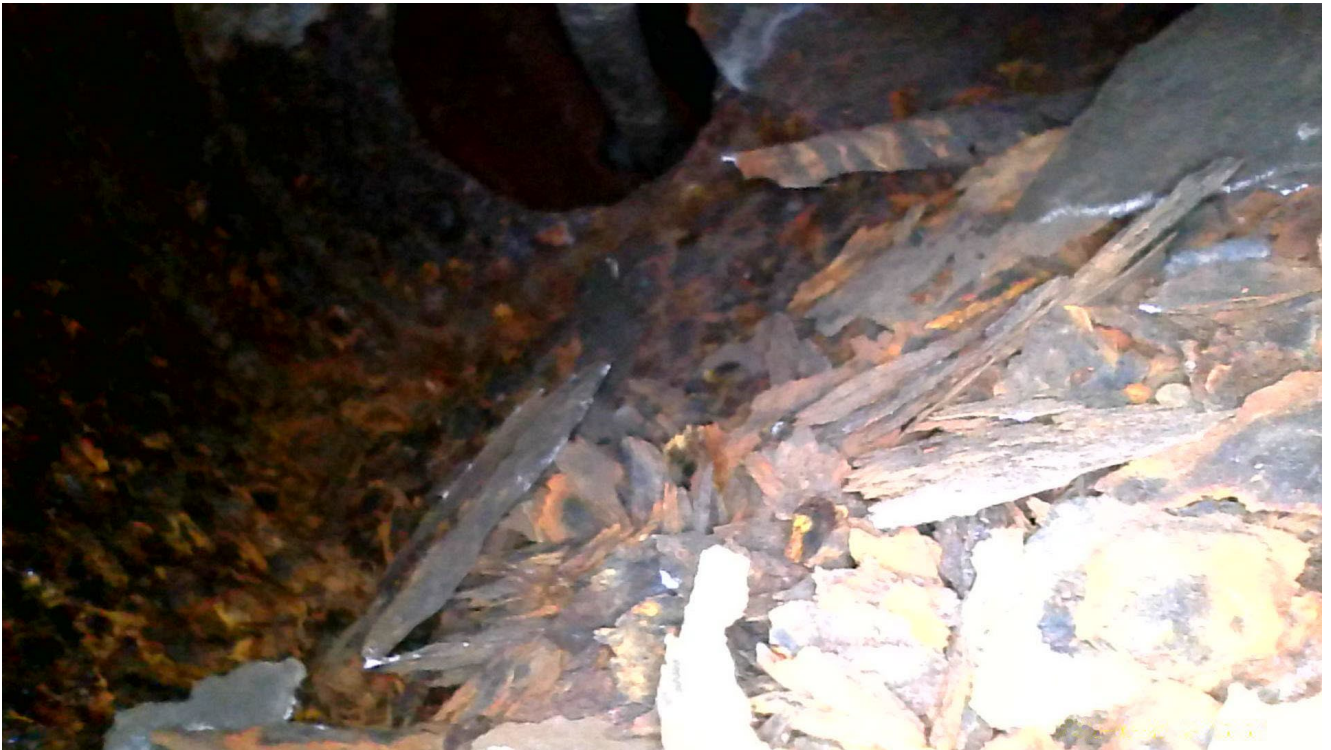
Photo 10: V1/H1 – Borescope view of corrosion on arm interior

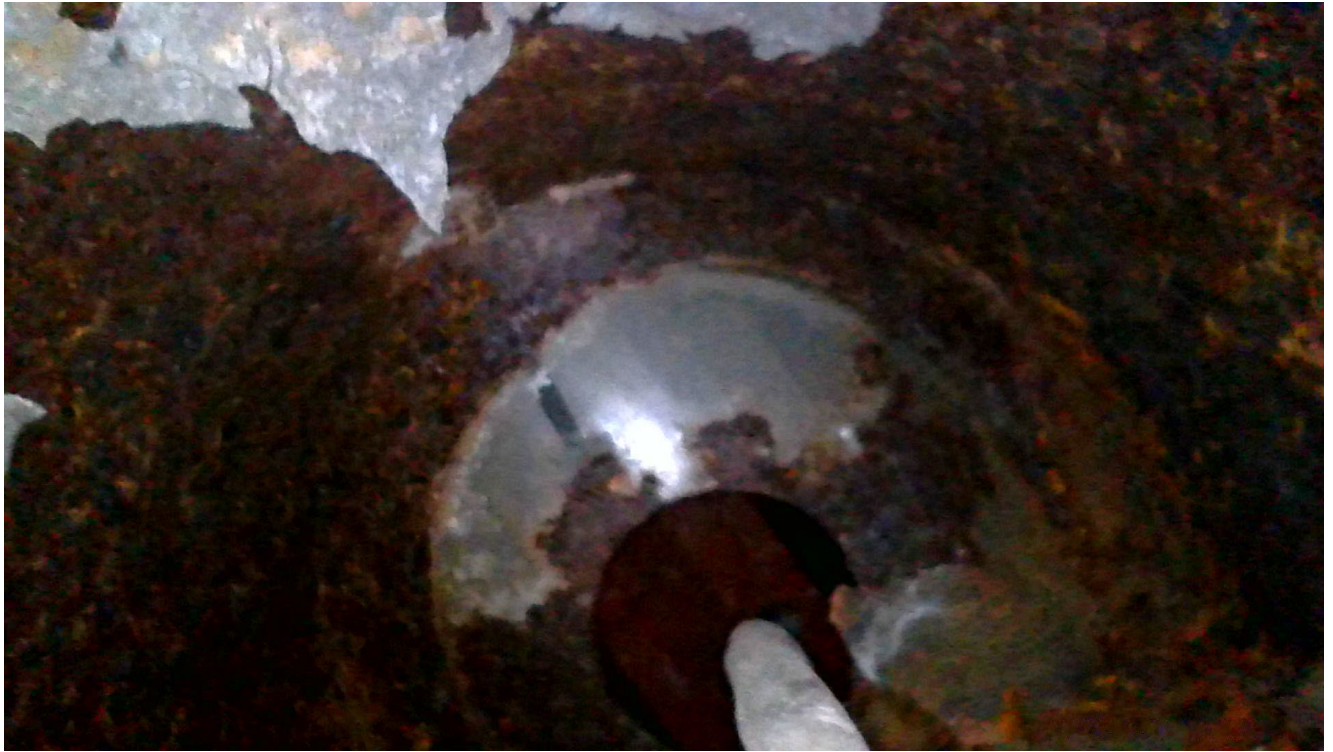
Photo 11: V1/H1 – Borescope view of corrosion on arm interior
