## PAVEMENT SURVEY AND EVALUATION REPORT

FINANCIAL PROJECT NUMBER: 433605-1

**STATE ROAD 501 (Clearlake Road)**

From Michigan Avenue to Industry Road

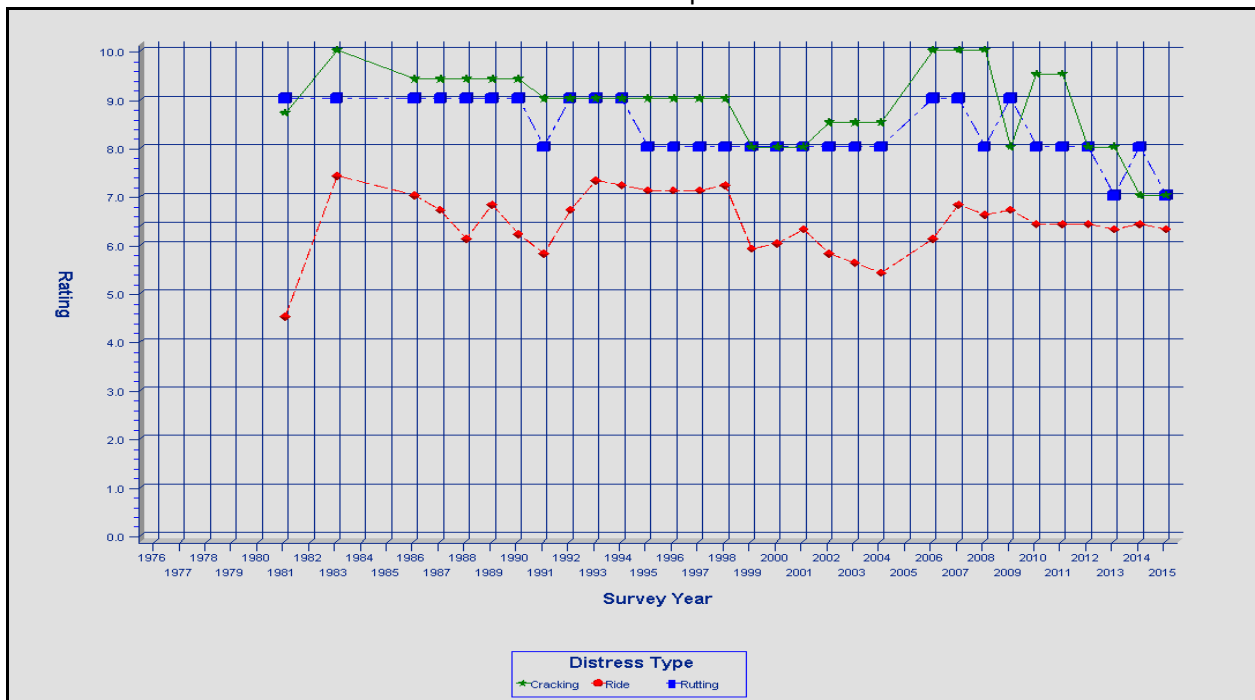
SR 501 in Section 70011 from MP 2.372 to MP 2.856 Composite

Currently, the 2015 Pavement Condition Survey (PCS) notes no deficiencies in cracking. However, the roadway has low ratings for ride and rut from MP 2.372 to MP 2.856. In this segment, the ride rating is a 6.3, while the rut rating is a 7.0. Graphs of the 2015 PCS ratings are in the Appendix for review.

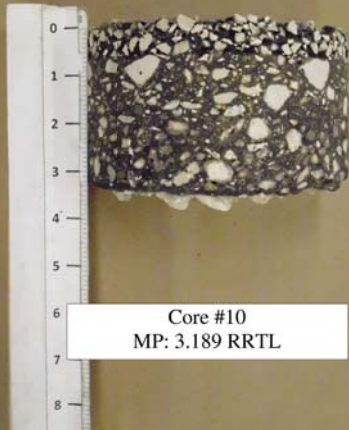
Core #10  
MP: 3.189 RRTL

5) Cores #10 (MP 3.189/RRTL) and #29 (MP 3.320/RLTL) have FC-2 friction course instead of FC-9.5 as a friction course.

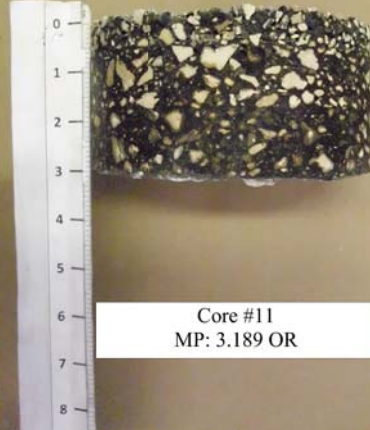
Core #11  
MP: 3.189 OR

6) Core #11 (MP 3.189/OR) has an FC-2 friction course instead of FC-9.5 friction course.

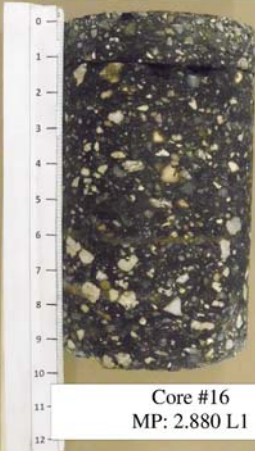
Core #16  
MP: 2.880 L1

2) Cores #16 (MP 2.880/L1) #32 (MP 2.880/LLTL) and #30 (MP 3.260/L1) were noted to have a very thick layer of Type S/SP in their compositions. They are considered to be outliers and are not included in statistical calculations.

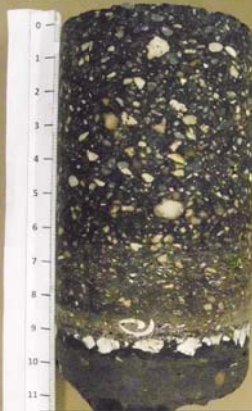
Core #22  
MP: 2.471 R1

1) From approximately MP 2.460 to MP 2.600, a portion of SR 501 was noted to have Sand Bituminous Roadway Mix (SBRM) as a base course. Refer to Cores #22, #23, #24, and #44 for details and these were not included in the statistical calculations for the above box.

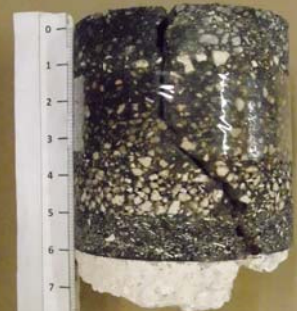
Core #34  
MP: 2.690 LLTL OWP

4) Cores #33 (MP 2.690/LLTL (IWP)), #34 (MP 2.690/LLTL (OWP)) #42 (MP 2.690/L1 (IWP)) have a layer of Type II below the Type S layer. These are not included in the statistical calculations for the above box.

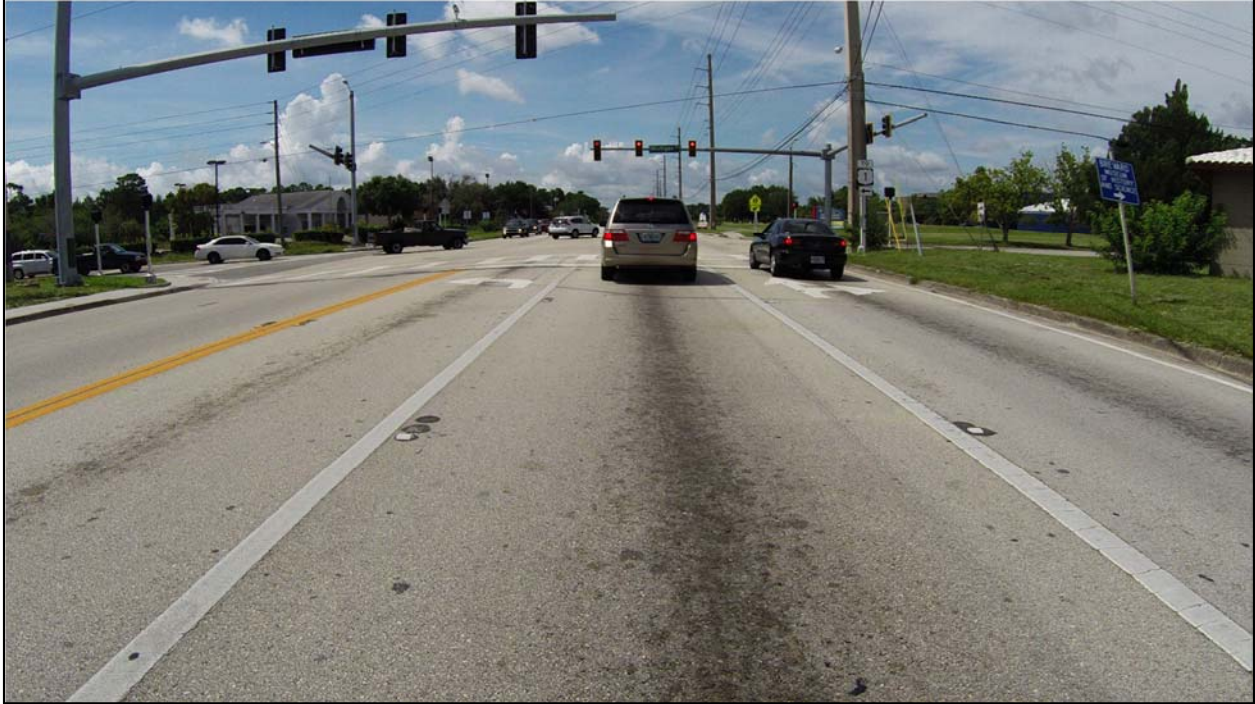
Photo 1: SR 501 southbound near MP 2.283. The pavement surface at the beginning of the project is an older friction course. It is in fair condition with minor cracking distress.

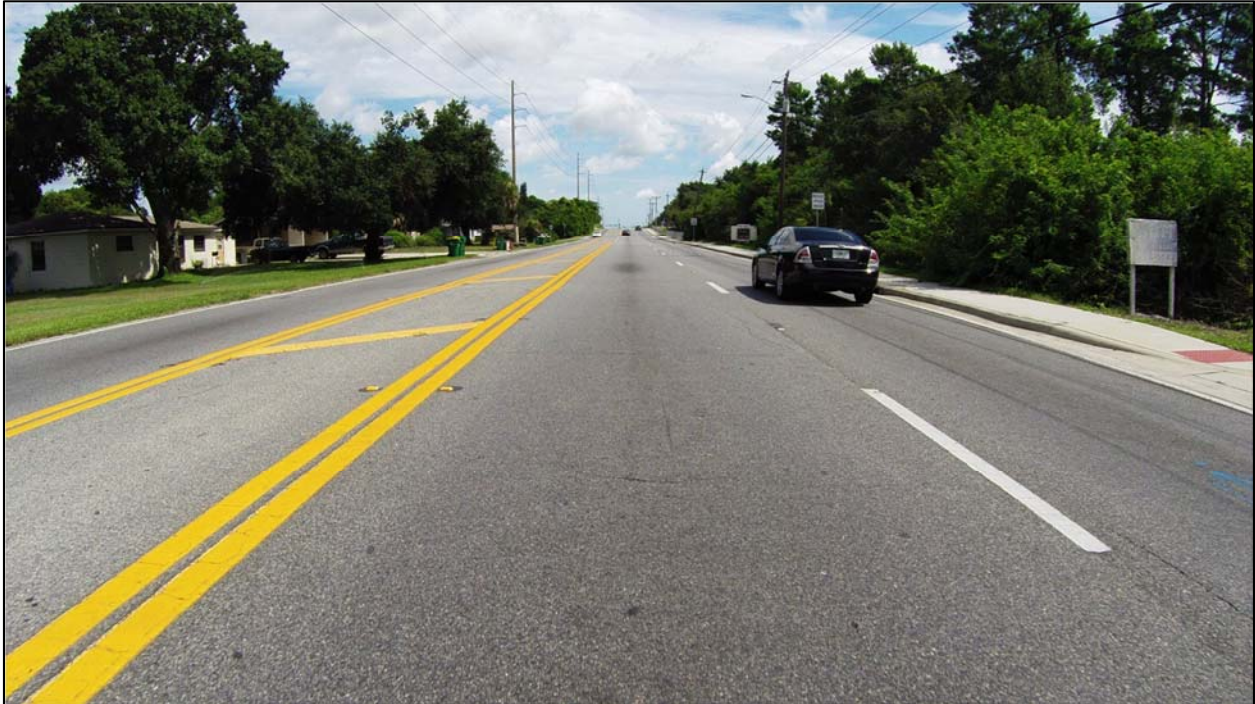
Photo 2: SR 501 northbound near MP 2.395. The pavement from MP 2.355 to MP 3.115 in the northbound lane was performed under a permit when the Walmart shopping center at MP 2.708 was constructed in 2005.

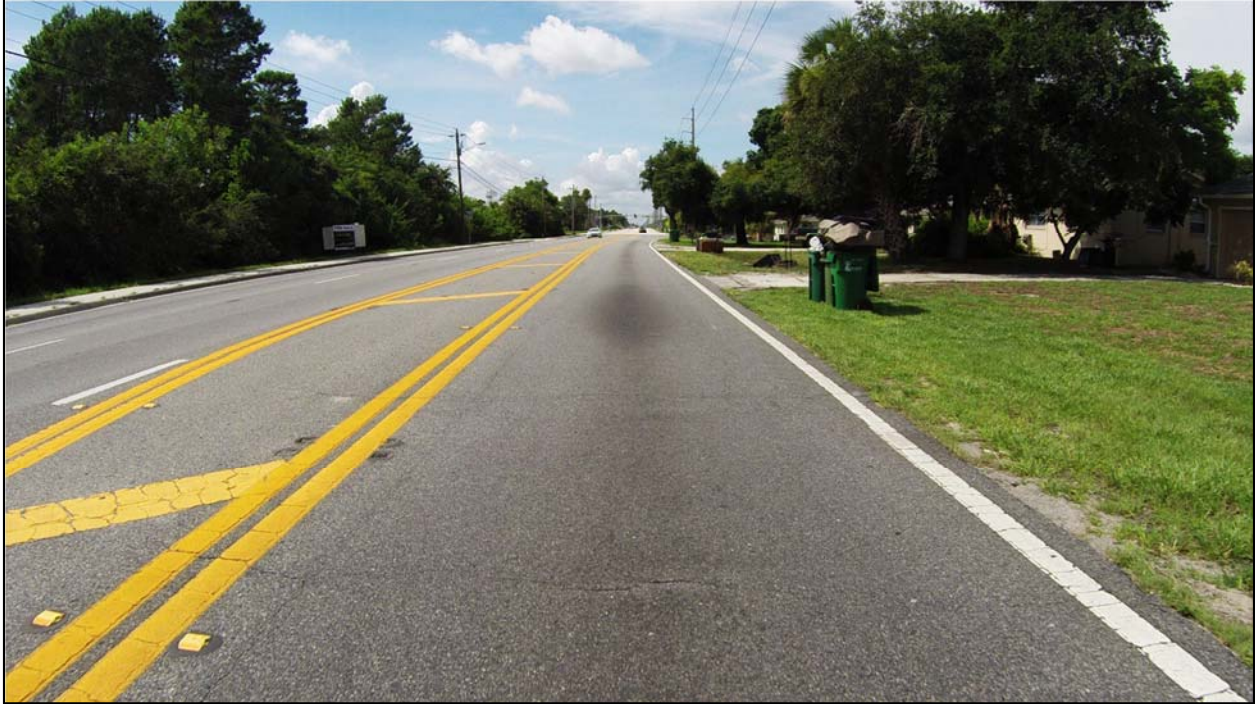
Photo 3: SR 501 southbound near MP 2.468. The center turn lane and southbound L1 travel lane is the original alignment with Sand Bituminous Roadway Mix (SBRM) as a base instead of Limerock.

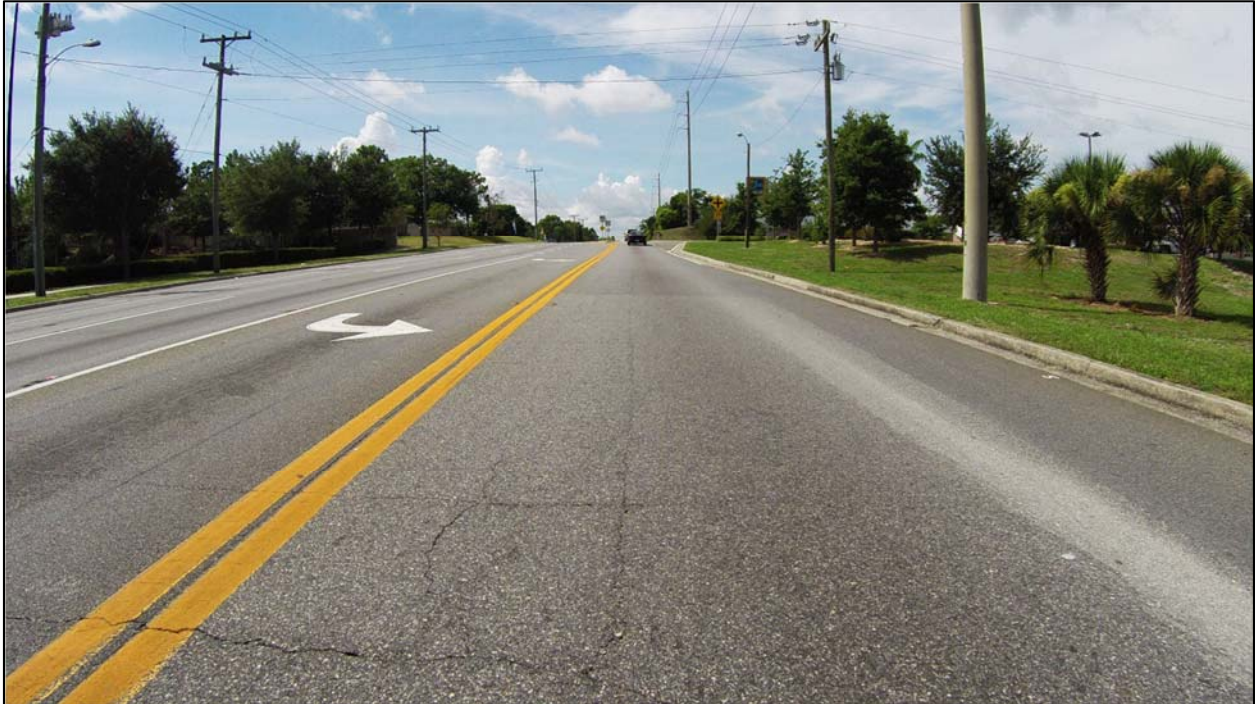
Photo 4: SR 501 southbound near MP 2.650. This is an example of the reflective cracking from the SBRM base of the original roadway base coming to the surface. The outside portion of the lane is widening and has a Limerock base.

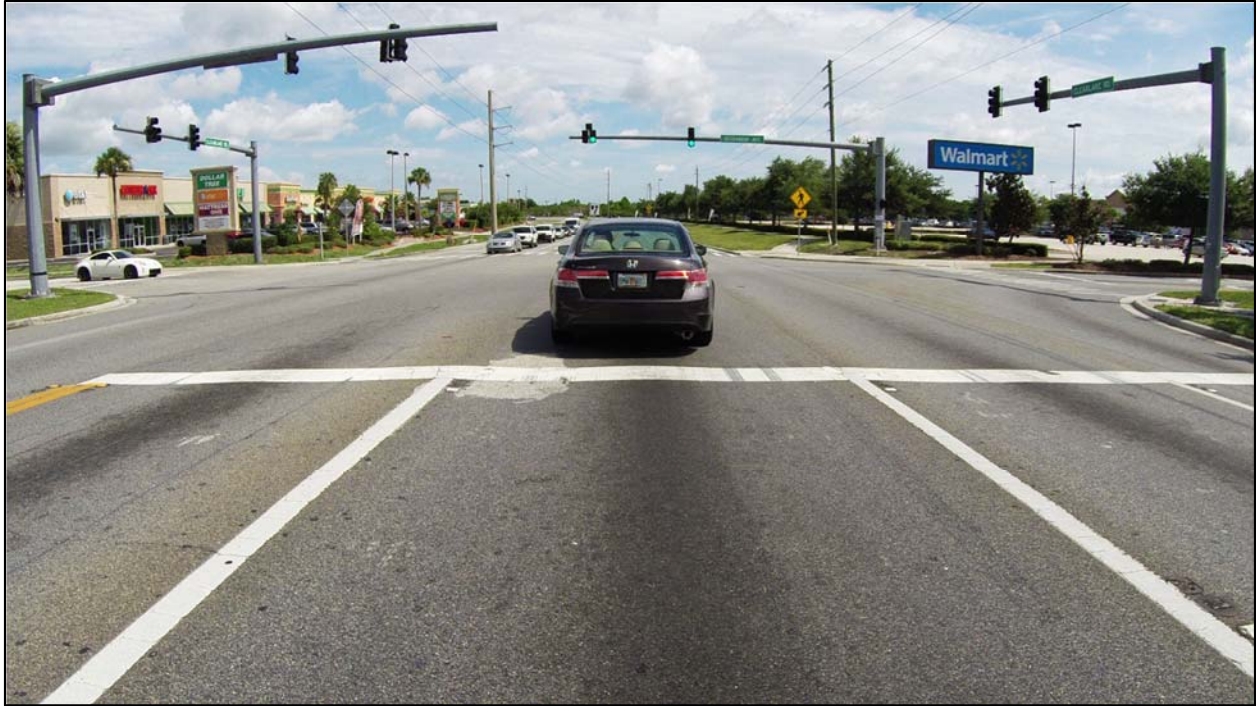
Photo 5: SR 501 northbound near MP 2.655. This is an area of visible rutting in the roadway. Note the asphalt patch at the stop bar. This is at the intersection of Otterbein Avenue.

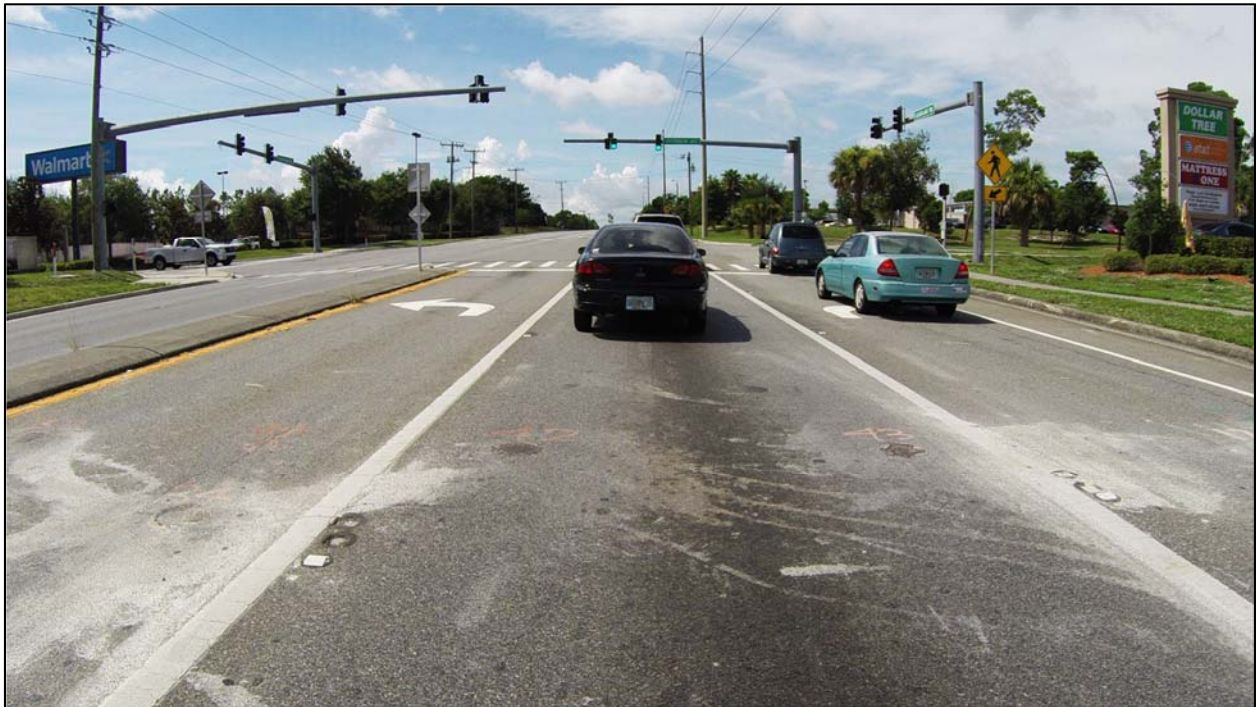
Photo 6: SR 501 southbound near MP 2.708. This was at a location where profile coring was performed to determine cross-slope, composition of the asphalt and base thickness.

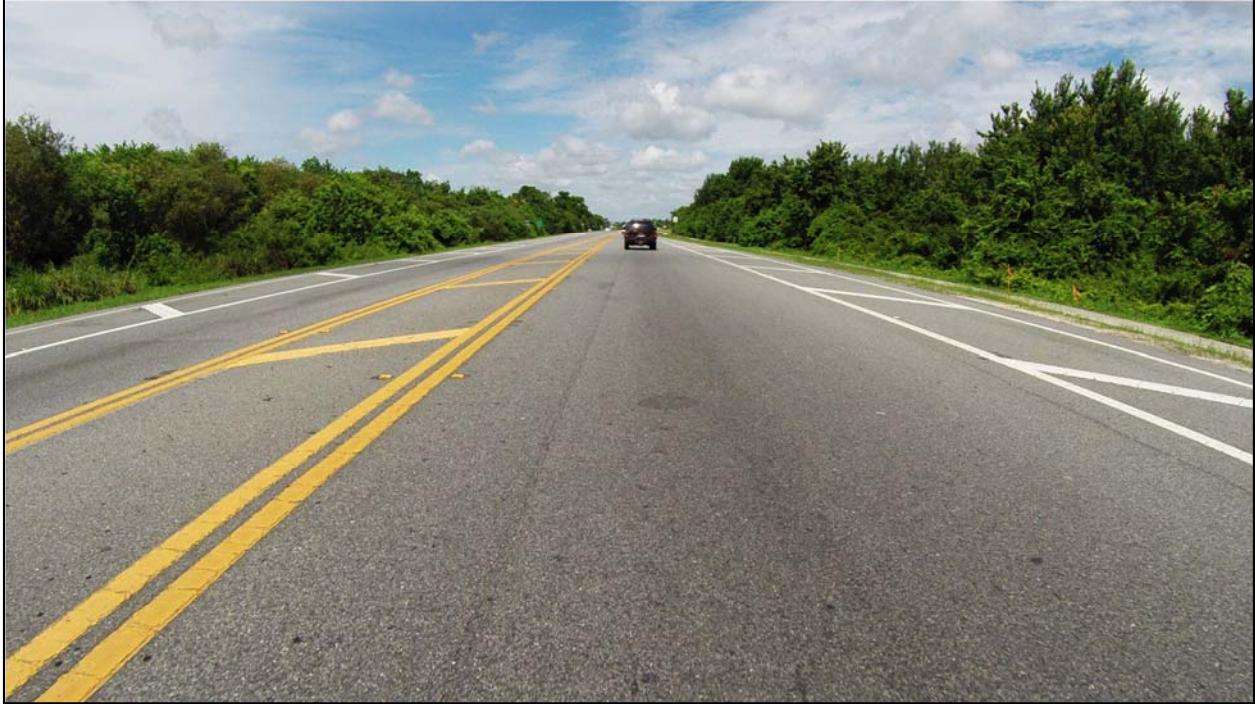
Photo 7: SR 501 northbound near MP 2.970. This is in the merge area where the roadway narrows from a four lane divided roadway to a two lane roadway.

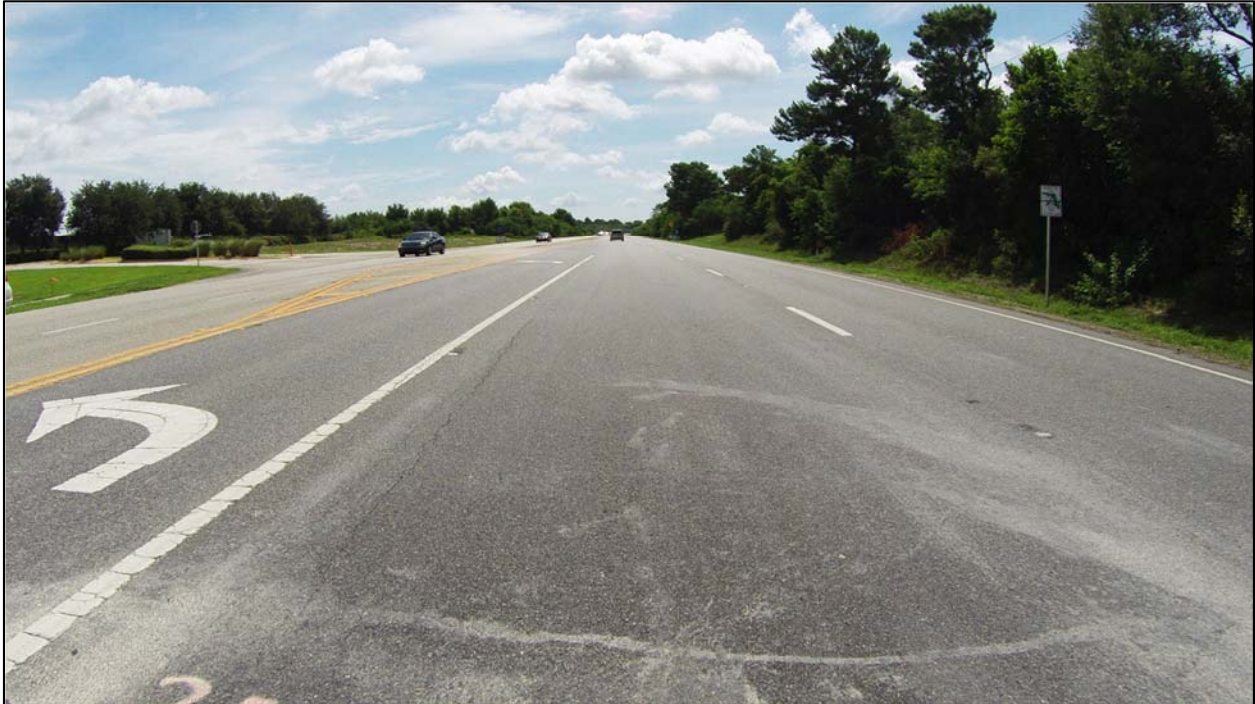
Photo 8: SR 501 southbound near MP 3.263. There are continuous minor longitudinal cracks where pavement joints exist from the last asphalt work on the roadway in 2005.

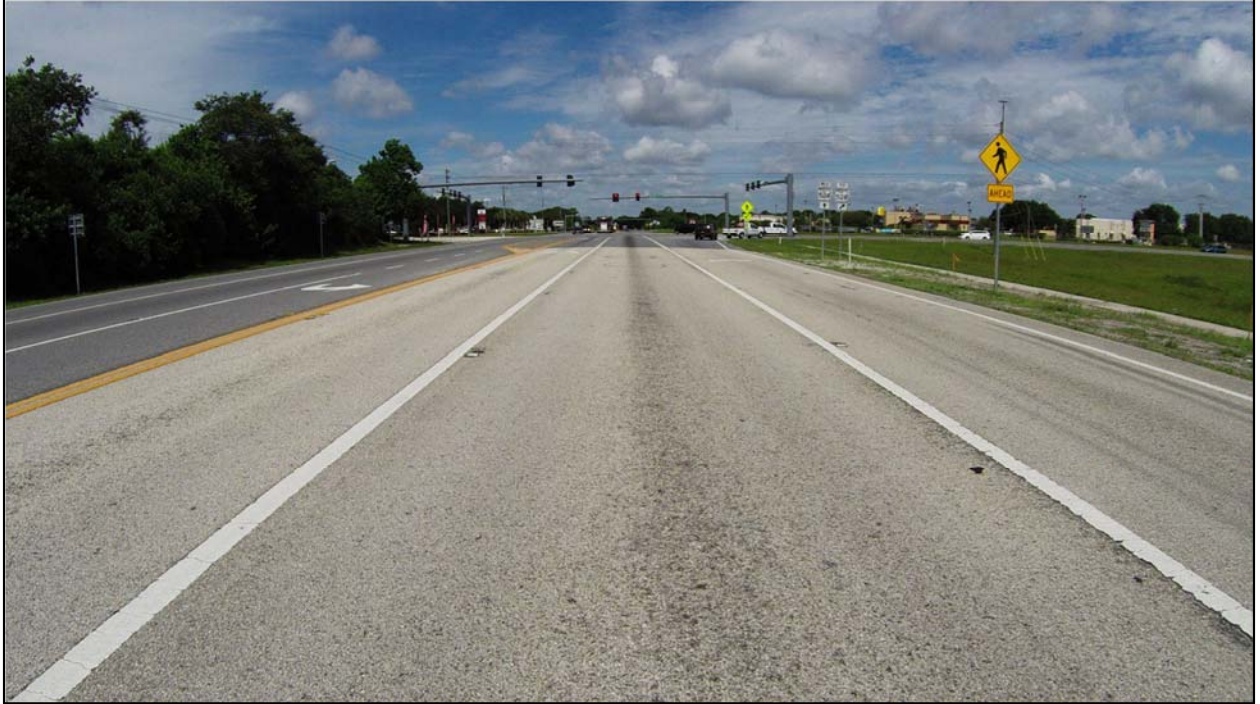
Photo 9: SR 501 northbound near MP 3.295. From MP 3.115 to MP 3.358, the surface course of the northbound R1 lane, outside right turn lane and outside paved shoulder has an open-graded friction course (OGFC) of FC-2 instead of the dense-graded friction found elsewhere on the project.
