Existing Conditions

2.1 Introduction

Roadway data for SR 40 (Granada Boulevard), from Cassen Park to SR A1A, was collected to assist the Department in determining the most viable route for the St. Johns River-to-Sea Loop Trail.

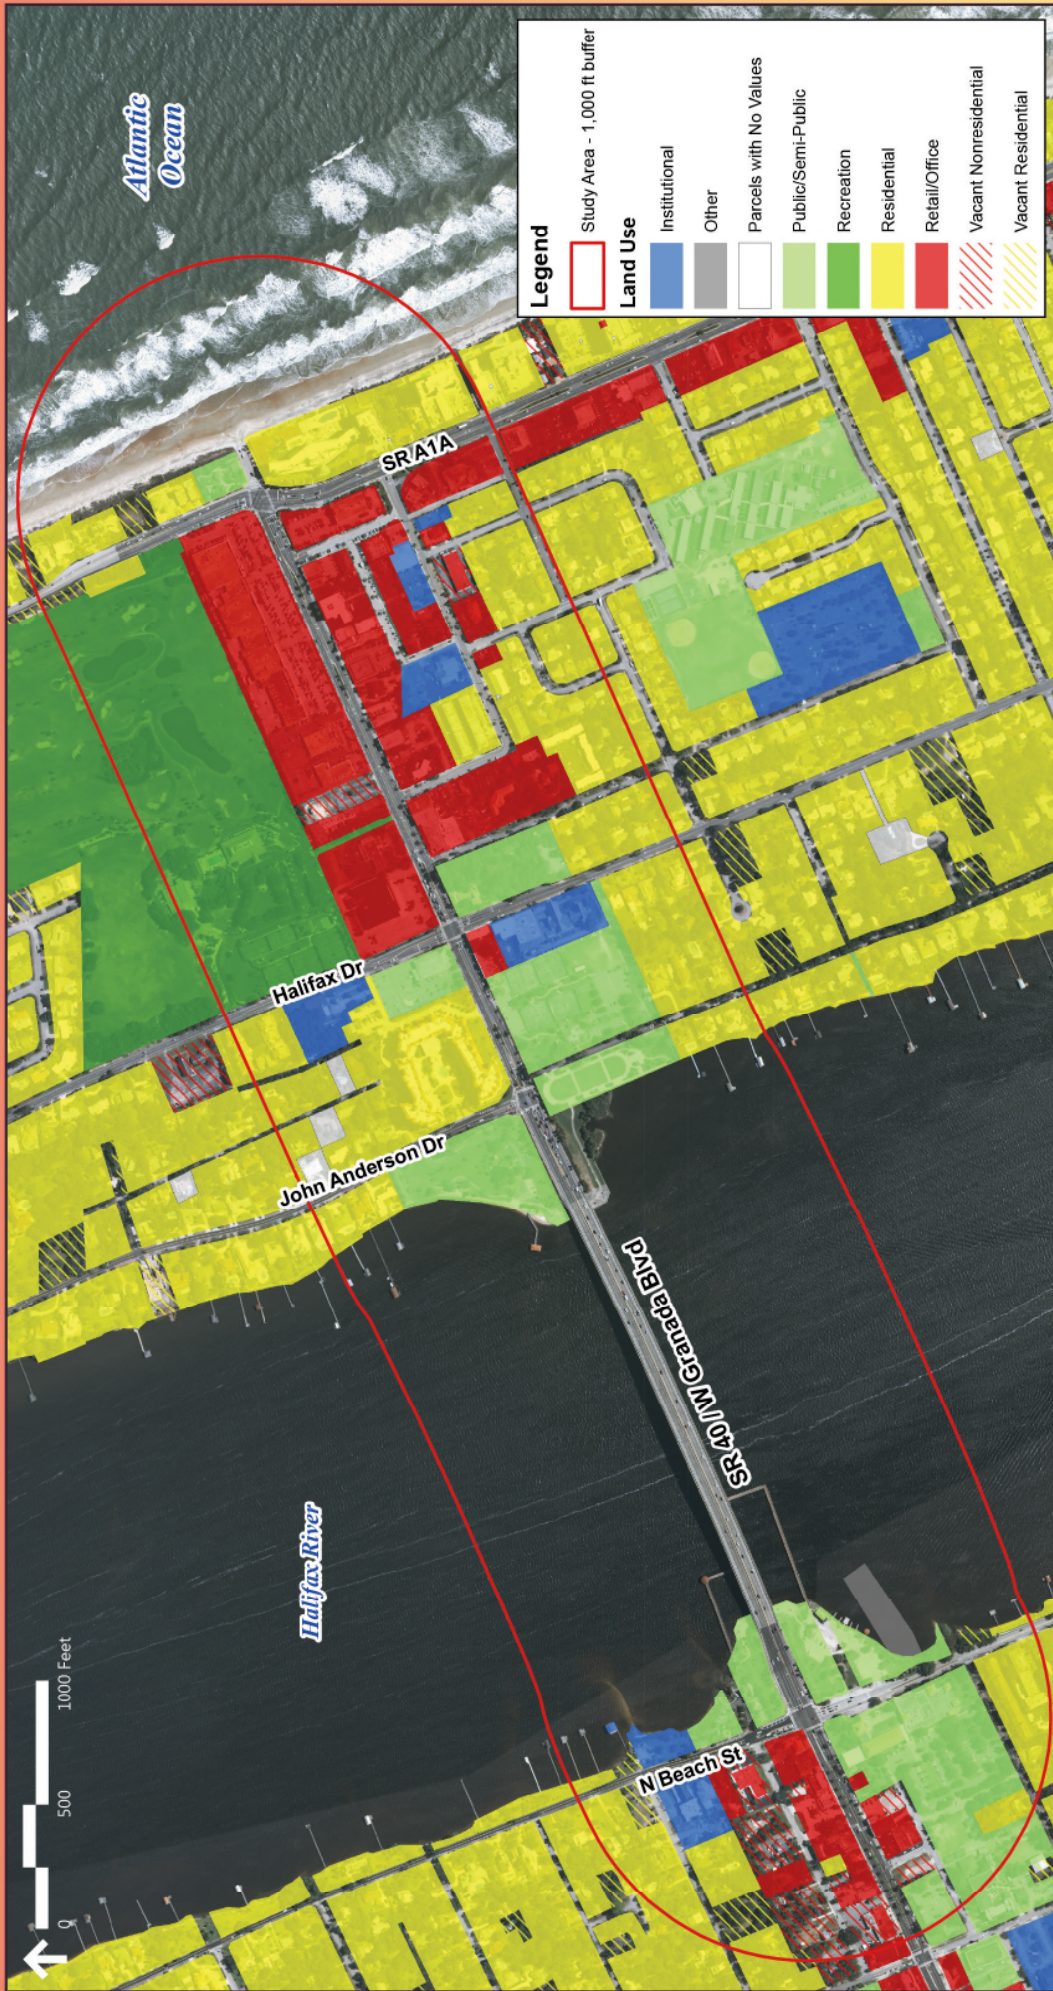
Figure 2
Existing Land Use Map

West of Halifax Drive, the existing land use is primarily a combination of public and residential uses. East of Halifax Drive, land use along the SR 40 corridor is primarily retail and office. **Figure 2** provides a map of the existing land use designations.

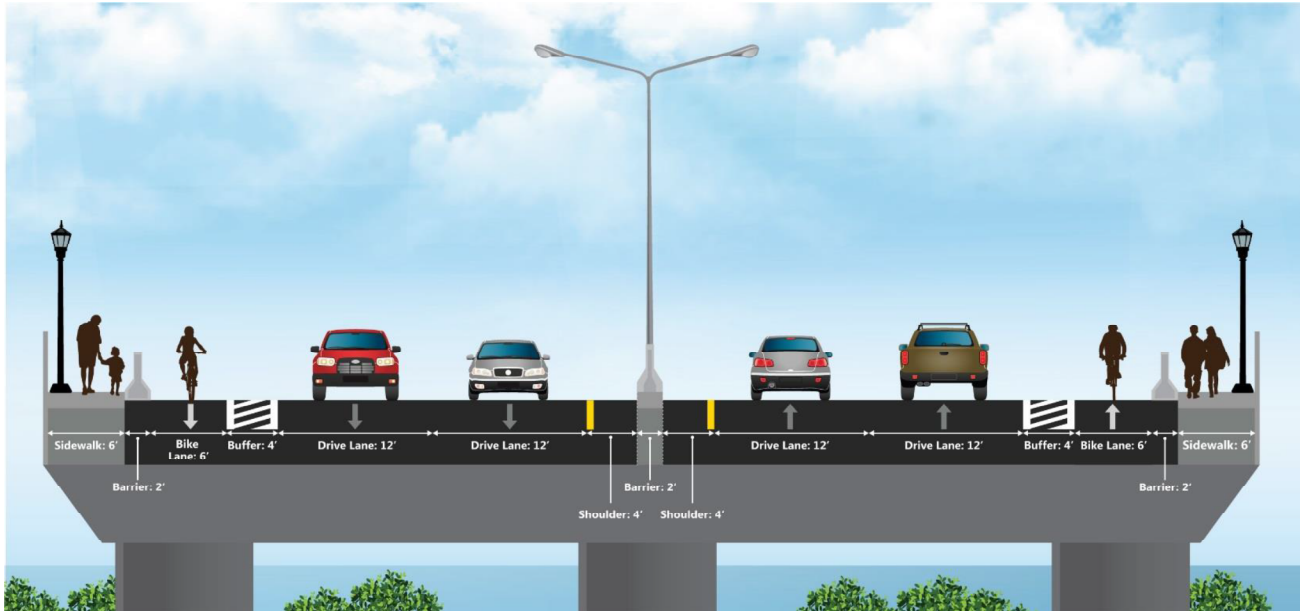
Figure 4: SR 40 from Cassen Park to John Anderson Drive Typical Section (Bridge)

The SR 40 (Granada Boulevard) bridge over Halifax River is a four-lane divided bridge. There are six foot sidewalks provided on both sides of the roadway which are separated from the roadway by a traffic barrier. There are also bicycle lanes provided on both sides of the roadway which are separated by a four-foot chevron buffer. The typical section for SR 40 bridge over Halifax River is illustrated in **Figure 4**.

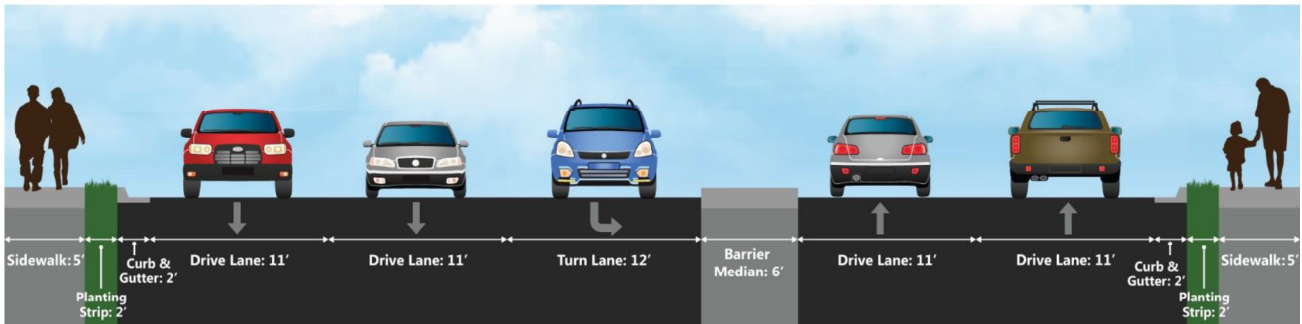
Figure 5: SR 40 from John Anderson Drive to Halifax Drive Typical Section

SR 40 from John Anderson Drive to Halifax Drive, shown in **Figure 5**, is a four-lane divided roadway. Five foot sidewalks are provided on both sides, with planting strips where possible. The roadway is divided by an 18-foot raised median, which is narrower when westbound left-turn lanes are provided. At the east end of this segment, there are five on-street parking spots provided on the south side of SR 40. No bicycle lanes are provided for this segment.

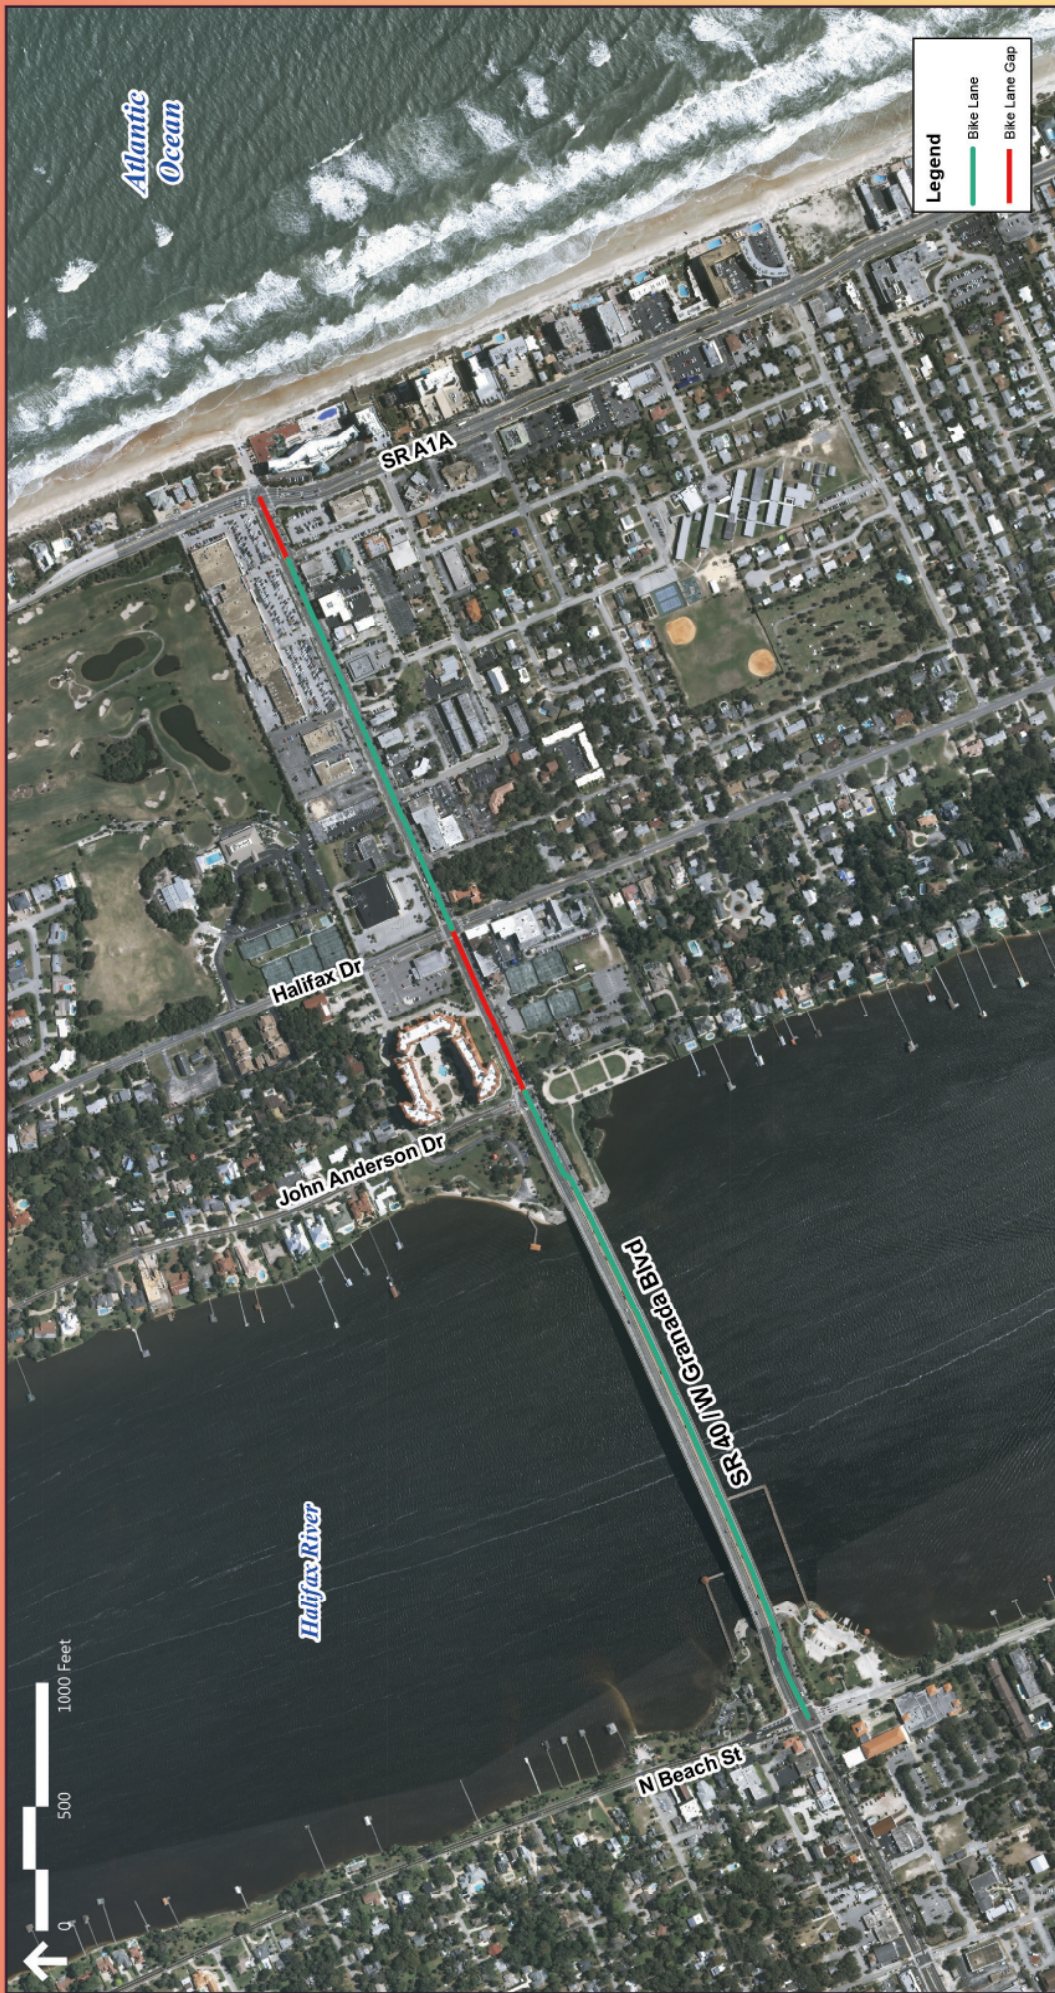
Figure 7
SR 40 Bike Lane Gaps

Sidewalks are provided on both sides of SR 40 for the entire length of the study area. There are no gaps in sidewalk coverage. Marked crosswalks with pedestrian signals are provided at all approaches of the three signalized intersections of the study area. There are no midblock crosswalks located along the study corridor. Bicycle lanes are provided along SR 40 with the exception of segments between John Anderson Drive and Halifax Drive and between Bovard Avenue and SR A1A. The bike lane gaps along SR 40 are displayed in **Figure 7**.

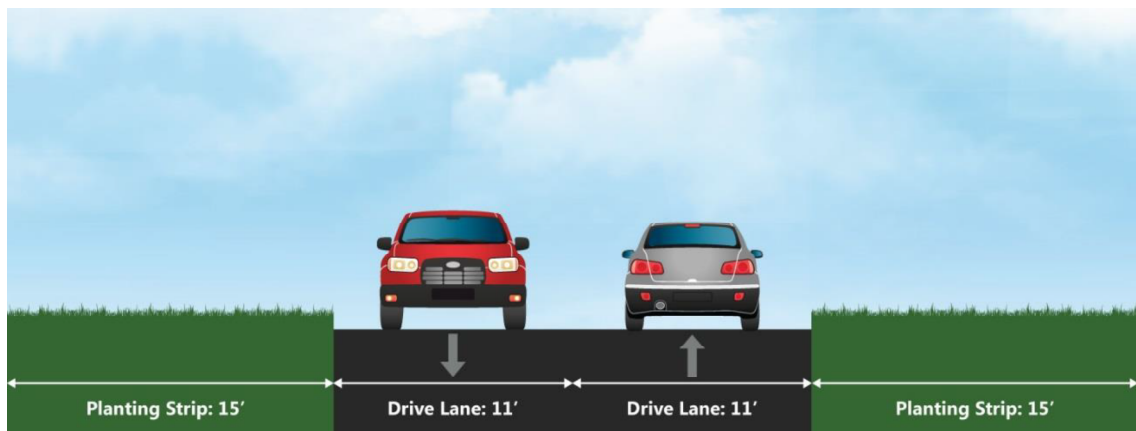
Figure 9: John Anderson Drive Typical Section (From SR 40 to Royal Palm Avenue)

The typical section of John Anderson Drive from SR 40 to Royal Palm Avenue is a two-lane undivided roadway. This is a residential road, with multiple driveways located along both sides of the road. There are no sidewalks, bicycle lanes, or street lighting along either side of the corridor. The typical section for John Anderson Drive is displayed in **Figure 9**.

According to right-of-way maps provided by the City of Ormond Beach, the right-of-way within this segment of John Anderson Drive is approximately 52 feet. The city's right-of-way maps are included in **Appendix D**. There are overhead utilities that run along the west side of the roadway.

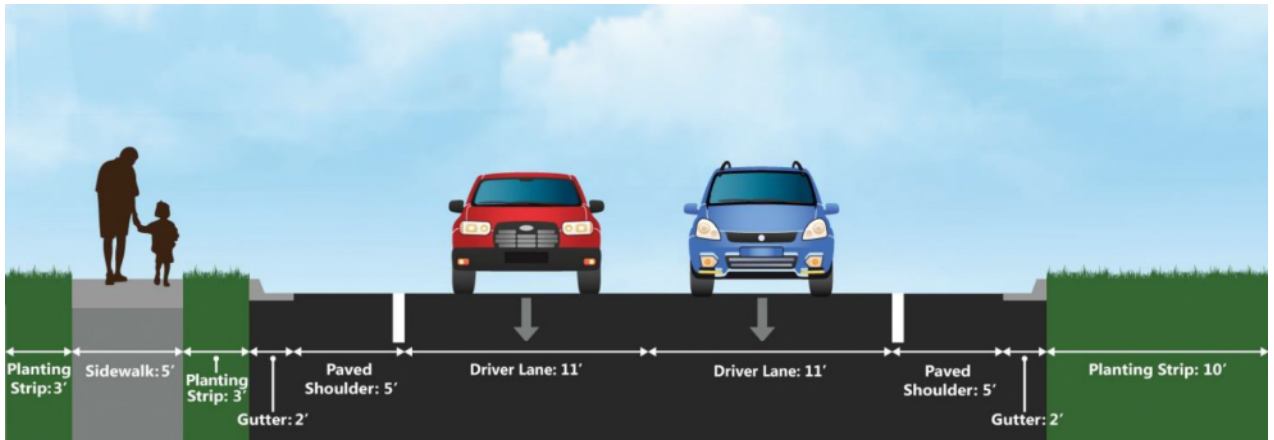
Figure 11: Halifax Drive Typical Section (From Royal Palm Avenue to Bosarvey Circle)

Halifax Drive from SR 40 to Royal Palm Avenue is a two-lane undivided roadway. A five-foot sidewalk is provided along the west side of the roadway, with a planter strip serving as a buffer. Although there is no bicycle lane along either side of Halifax Drive, there are five foot paved shoulders on both sides of the road. A typical section for Halifax Drive between SR 40 and Royal Palm Avenue is presented in **Figure 11**.

According to the Volusia County Property Appraiser, the existing right-of-way on Halifax Drive is approximately 55 feet wide. Overhead utilities are provided along the west side of the roadway, with the poles located in the buffer between the sidewalk and road.

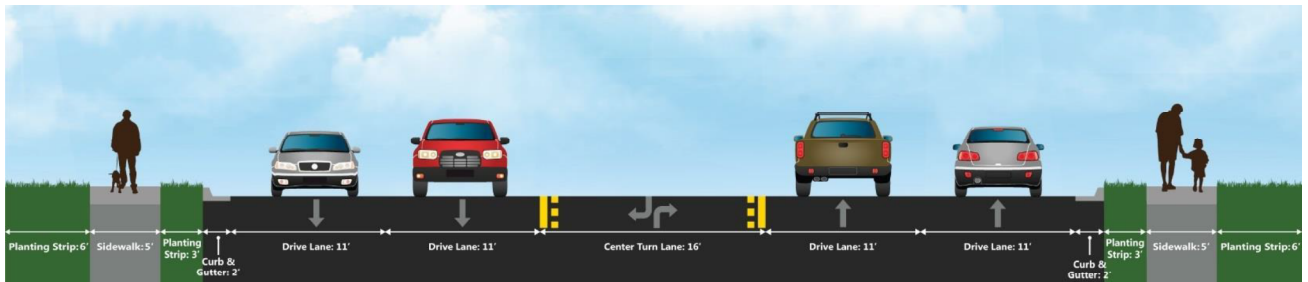
Figure 12: SR A1A Typical Section (From Vining Court to SR 40)

SR A1A from Vining Court to SR 40 is four lanes with sidewalks separated by grass strips on both sides. There are no bicycle lanes provided within this segment of SR A1A. A typical section for SR A1A from Vining Court to SR 40 is presented in **Figure 12**.

According to the roadway as-built plans, the existing right-of-way on SR A1A from Vining Court to SR 40 is approximately 92 feet wide. Overhead utilities are provided along the west side of the roadway, and lighting is provided on both sides. The right-of-way is limited on both sides by businesses and a resort condominium adjacent to SR A1A.

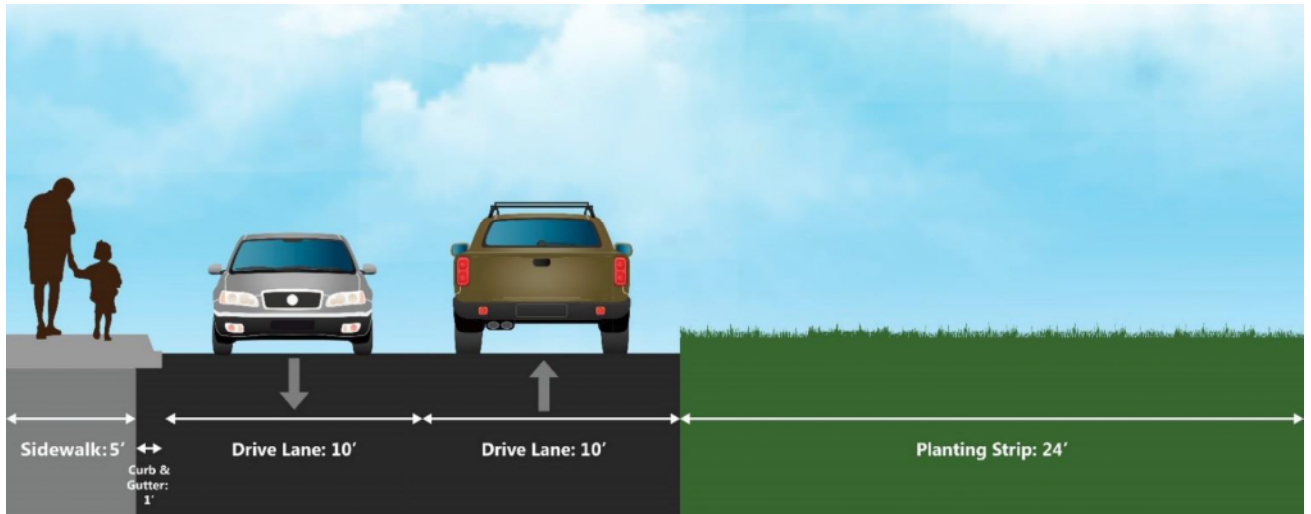
Figure 13: Casements Drive Typical Section

Casements Drive is a local residential road that is a two-way undivided roadway. There is a sidewalk provided along the north side of the roadway, which is separated by a planter strip for most of the segment. There are marked crosswalks at driveways as well as at the intersection with Riverside Drive. However, there is no crosswalk at the intersection with Halifax Drive. There are no bicycle lanes along this road. The typical section for Casements Drive is provided in **Figure 13**.

According to right-of-way maps provided by the City of Ormond Beach, the existing right-of-way on Casements Drive is approximately 50 feet. The city's right-of-way maps are included in **Appendix D**. The only overhead utilities observed were located at the intersection with Halifax Drive. There are trees located between the roadway and sidewalk; however, the right-of-way is not restricted north of Casements.

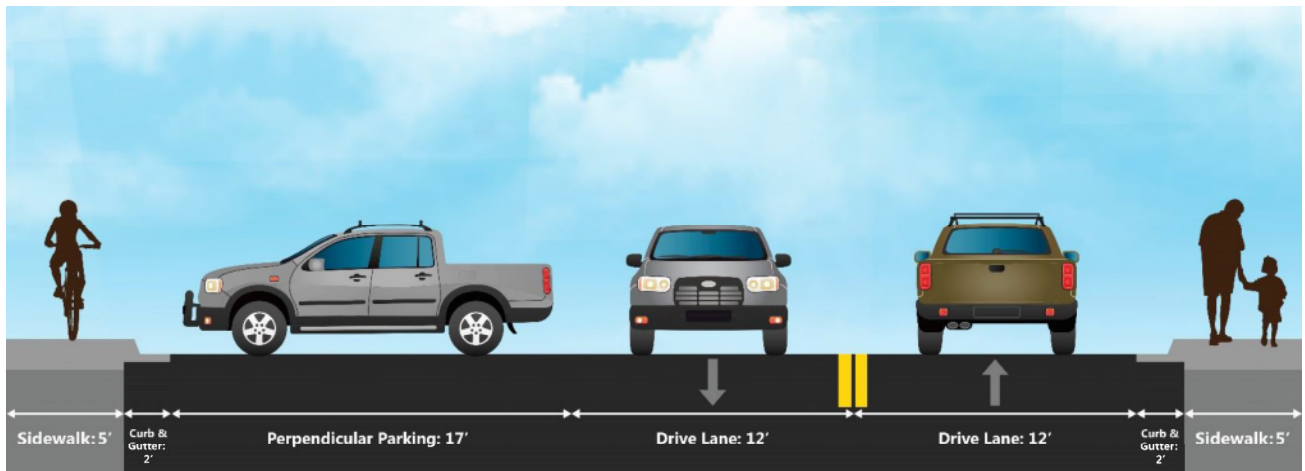
Figure 15: Bovard Avenue from Vining Court to SR 40 Typical Section

Bovard Avenue, connecting Vining Court and SR 40, is a short two-way undivided roadway segment, with perpendicular on-street parking along the west side. Sidewalks are provided along both sides of the roadway; however, no bicycle lanes are present. The typical section for Bovard Avenue is provided in **Figure 15**.

According to right-of-way maps provided by the City of Ormond Beach, the existing right-of-way on Bovard Avenue is approximately 55 feet wide. The city's right-of-way maps are included in **Appendix D**. There are no overhead utilities along the segment, but there is lighting along both sides. The right-of-way is constrained by businesses on both sides of Bovard Avenue, however there is some existing perpendicular on-street parking that represents an opportunity for being repurposed to accommodate a trail improvement.

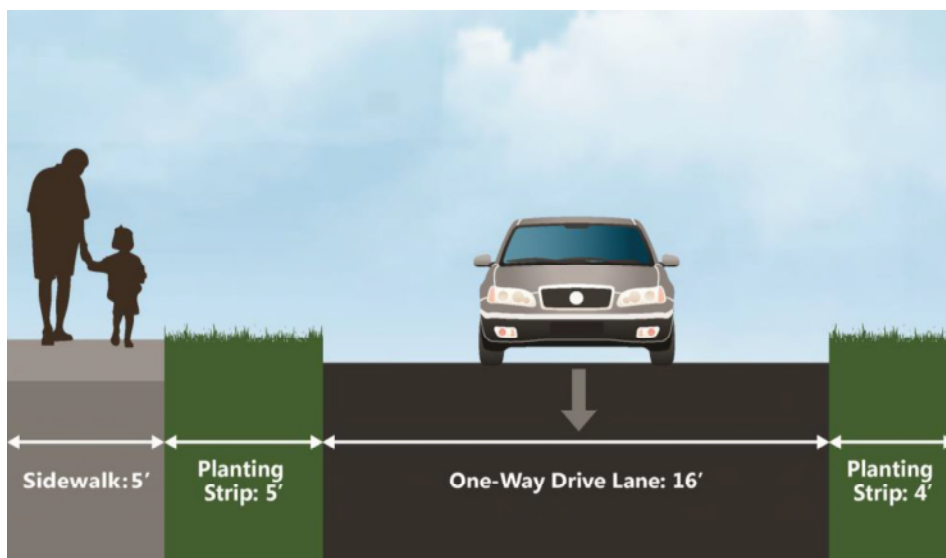
Figure 17: Riverside Drive from Casements Drive to SR 40 Typical Section

Riverside Drive, connecting Casements Drive and SR 40, is a short southbound one-way segment. The typical section for Riverside Drive is provided in **Figure 17**.

According to right-of-way maps provided by the City of Ormond Beach, the existing right-of-way on Riverside Drive between Casements Drive and SR 40 is approximately 30 feet wide. The right-of-way is constrained by The Casements cultural center, a Florida Heritage Site, on the east side of the roadway and Rockefeller Gardens on

the west side, which are both city-owned properties. The city’s right-of-way maps are included in **Appendix D**. There are no overhead utilities along the segment, and there is some pedestrian-oriented overhead lighting along The Casements fence and within the Rockefeller Gardens park. The east side of the roadway has a sidewalk from SR 40 to the main entrance of The Casements. The west side has a sidewalk for the entire segment from SR 40 to Casements Drive.

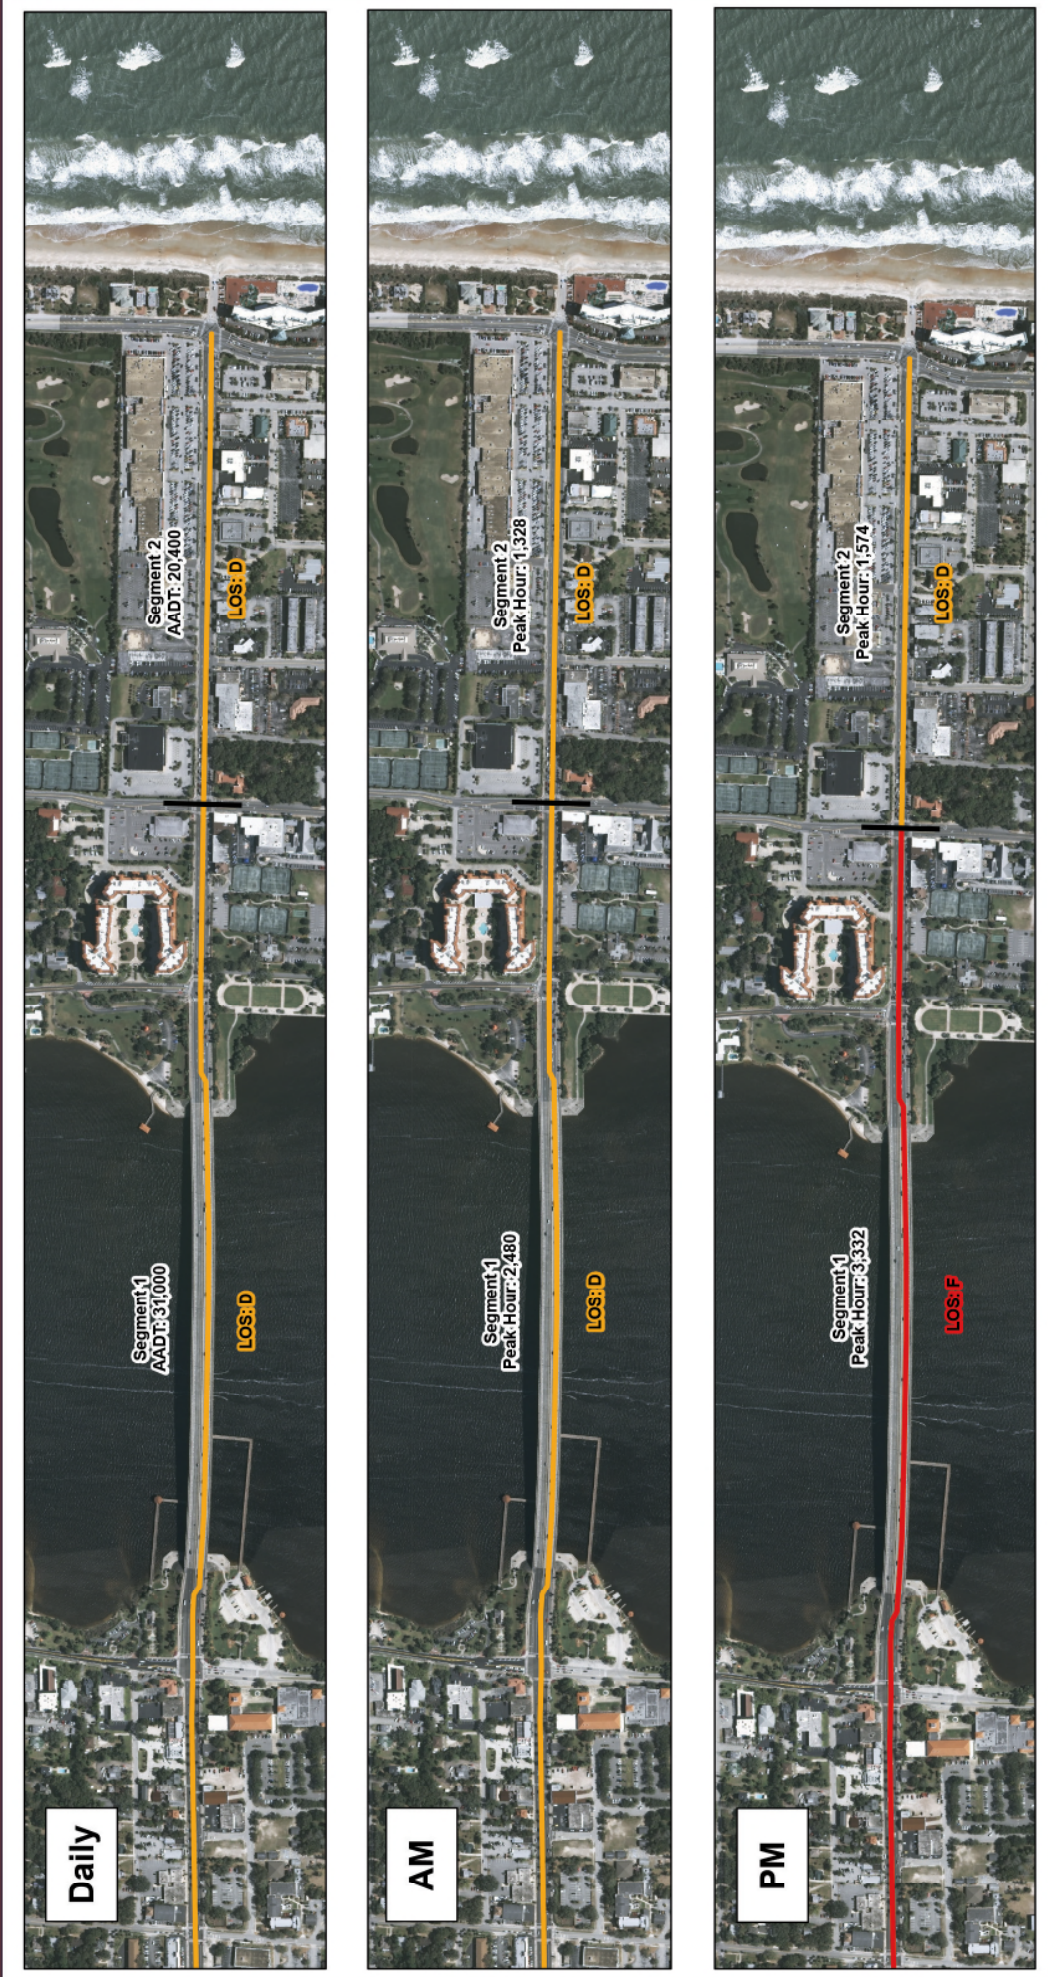
Figure 18
Existing Roadway Traffic Volumes

The existing AADT was adjusted utilizing the latest (2015) FDOT axle (where applicable) and seasonal adjustment factors for Volusia County, to provide average conditions. The AADT data reports and seasonal factors are provided in **Appendix E**. Existing volumes are illustrated in **Figure 18**.

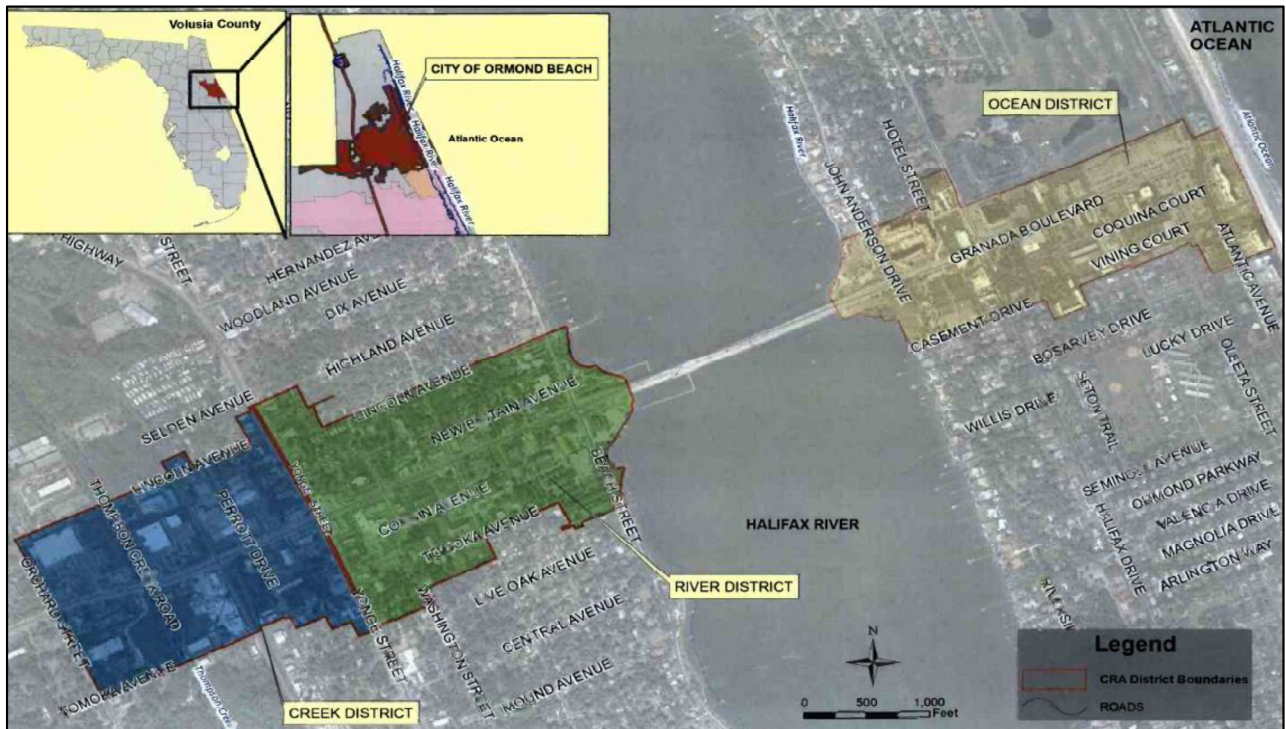
Figure 20: Community Redevelopment Agency Master Plan Districts

The CRA Master Plan divides the district into three areas: Ocean District, River District, and Creek District as seen in Figure 20.

The proposed improvements are located within the Ocean District and the River District. Each area is divided into multiple sub-basins. Given the nature of the proposed project, it is anticipated that a modification to the conceptual ERP will be required. The improvements may qualify for a permit exemption. Should the permit exemption not be granted, a permit modification will need to be submitted and approved.

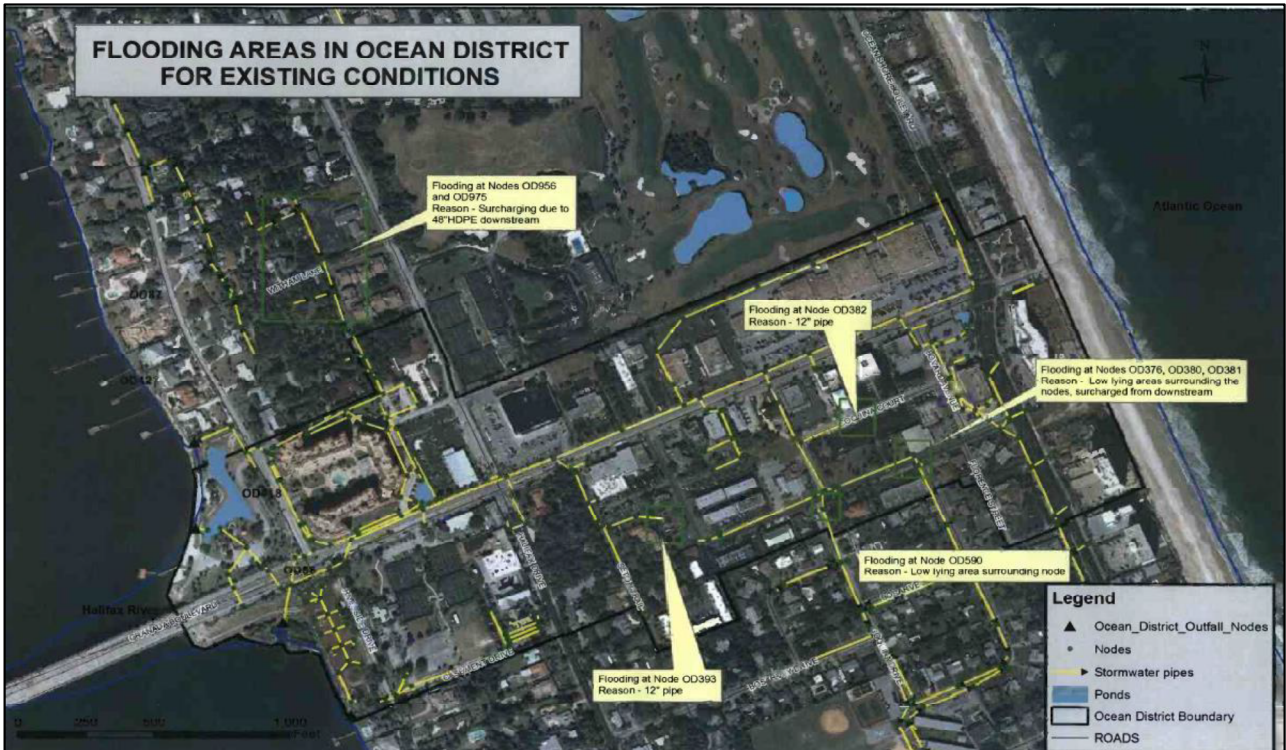
Figure 21: Flooding Areas

Flooding conditions within the limits of the project site were evaluated using FEMA’s FIRM Map 12127C0216J and the site’s conceptual ERP. Based on the FIRM map, no portion of the project lies within an identified 100-year flood plain; however, based on the stormwater report from the above-referenced CRA ERP, portions of the proposed project would potentially be subject to flooding for the 25-year storm event. As shown in **Figure 21**, obtained from the permit’s stormwater report, flooding exists along Vining Court due to this being a low-lying area, which could potentially impact Alternative 3.

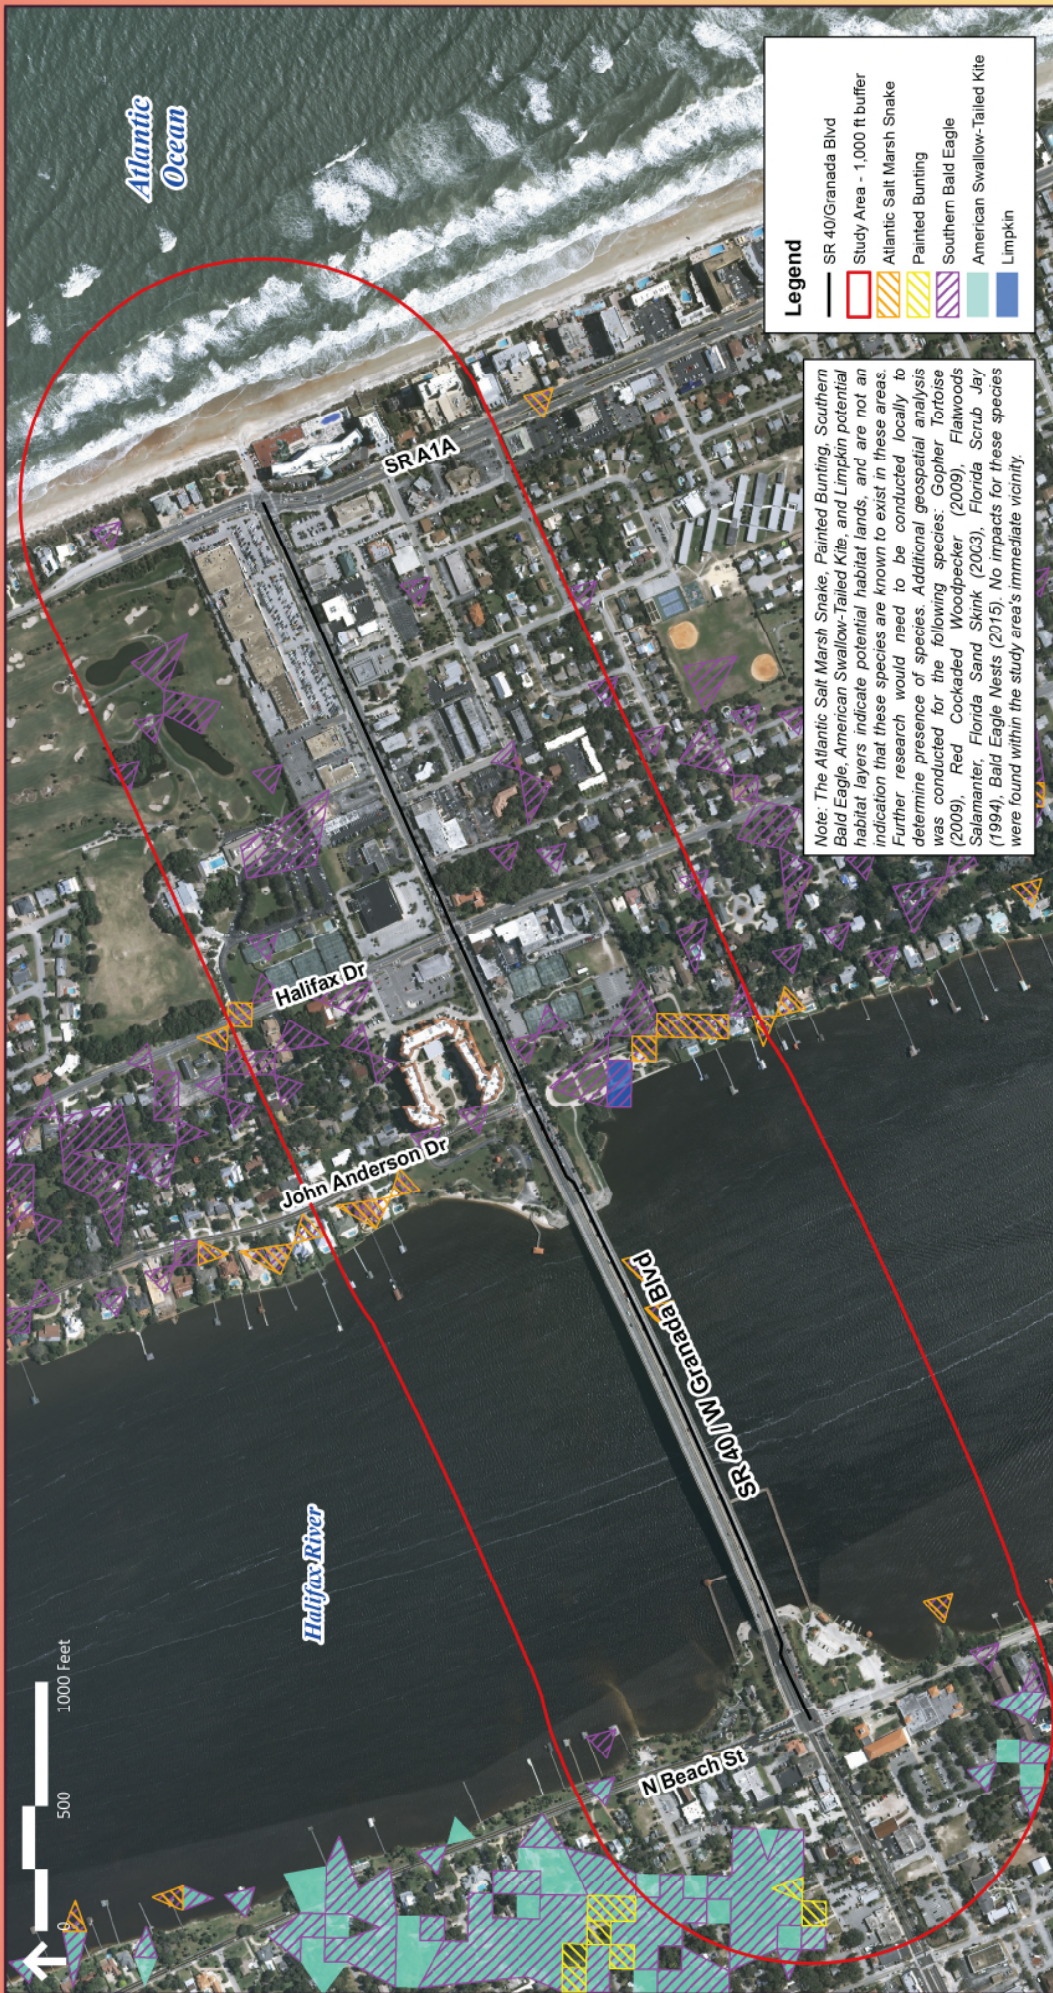
Figure 23
Threatened and Endangered Species
Habitat Map

After review of the U.S. Fish and Wildlife Conservation Commission's threatened and endangered species habitat maps, there were several locations where threatened or endangered species could potentially exist. These species included the Atlantic Salt Marsh Snake, the Painted Bunting, the Southern Bald Eagle, the American Swallow-tailed Kite, and Limpkins. The potential locations for threatened and endangered species and/or critical habitats are shown in **Figure 23**.

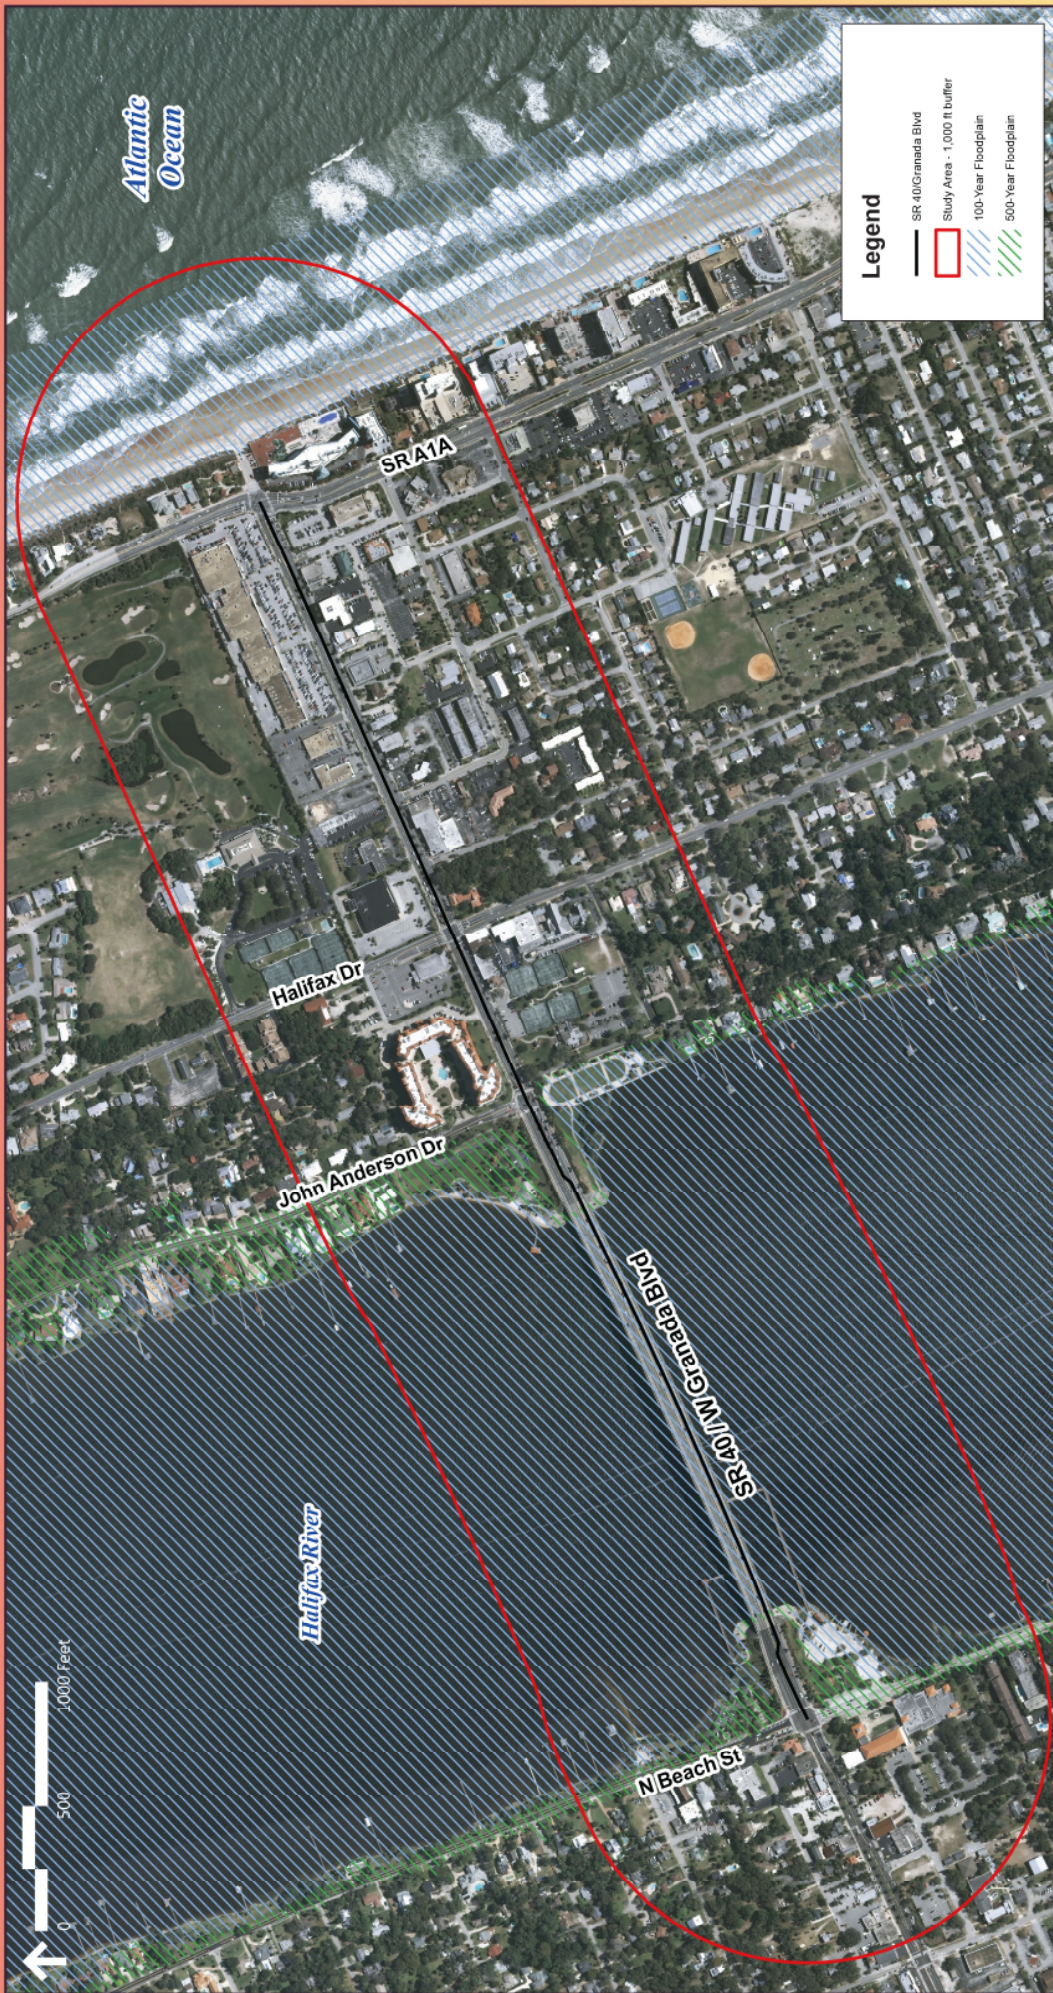
Figure 24
Floodplains Map

Since the study area is located in close proximity to the ocean and runs over the Halifax River, floodplains in the area are important for planning purposes. Special Flood Hazard Areas are located on both sides of the Halifax River, and on the east side of the corridor closest to the Atlantic Ocean. Both the Halifax River and the beach bordering the Atlantic Ocean are a part of the 100-Year Floodplain. The land on both sides of the Halifax River is a part of the 500-Year Floodplain. This area includes Cassen Park, Bailey Riverbridge Gardens, Fortunado Park, and Rockefeller Gardens. The floodplains found within the study area can be seen in **Figure 24**.

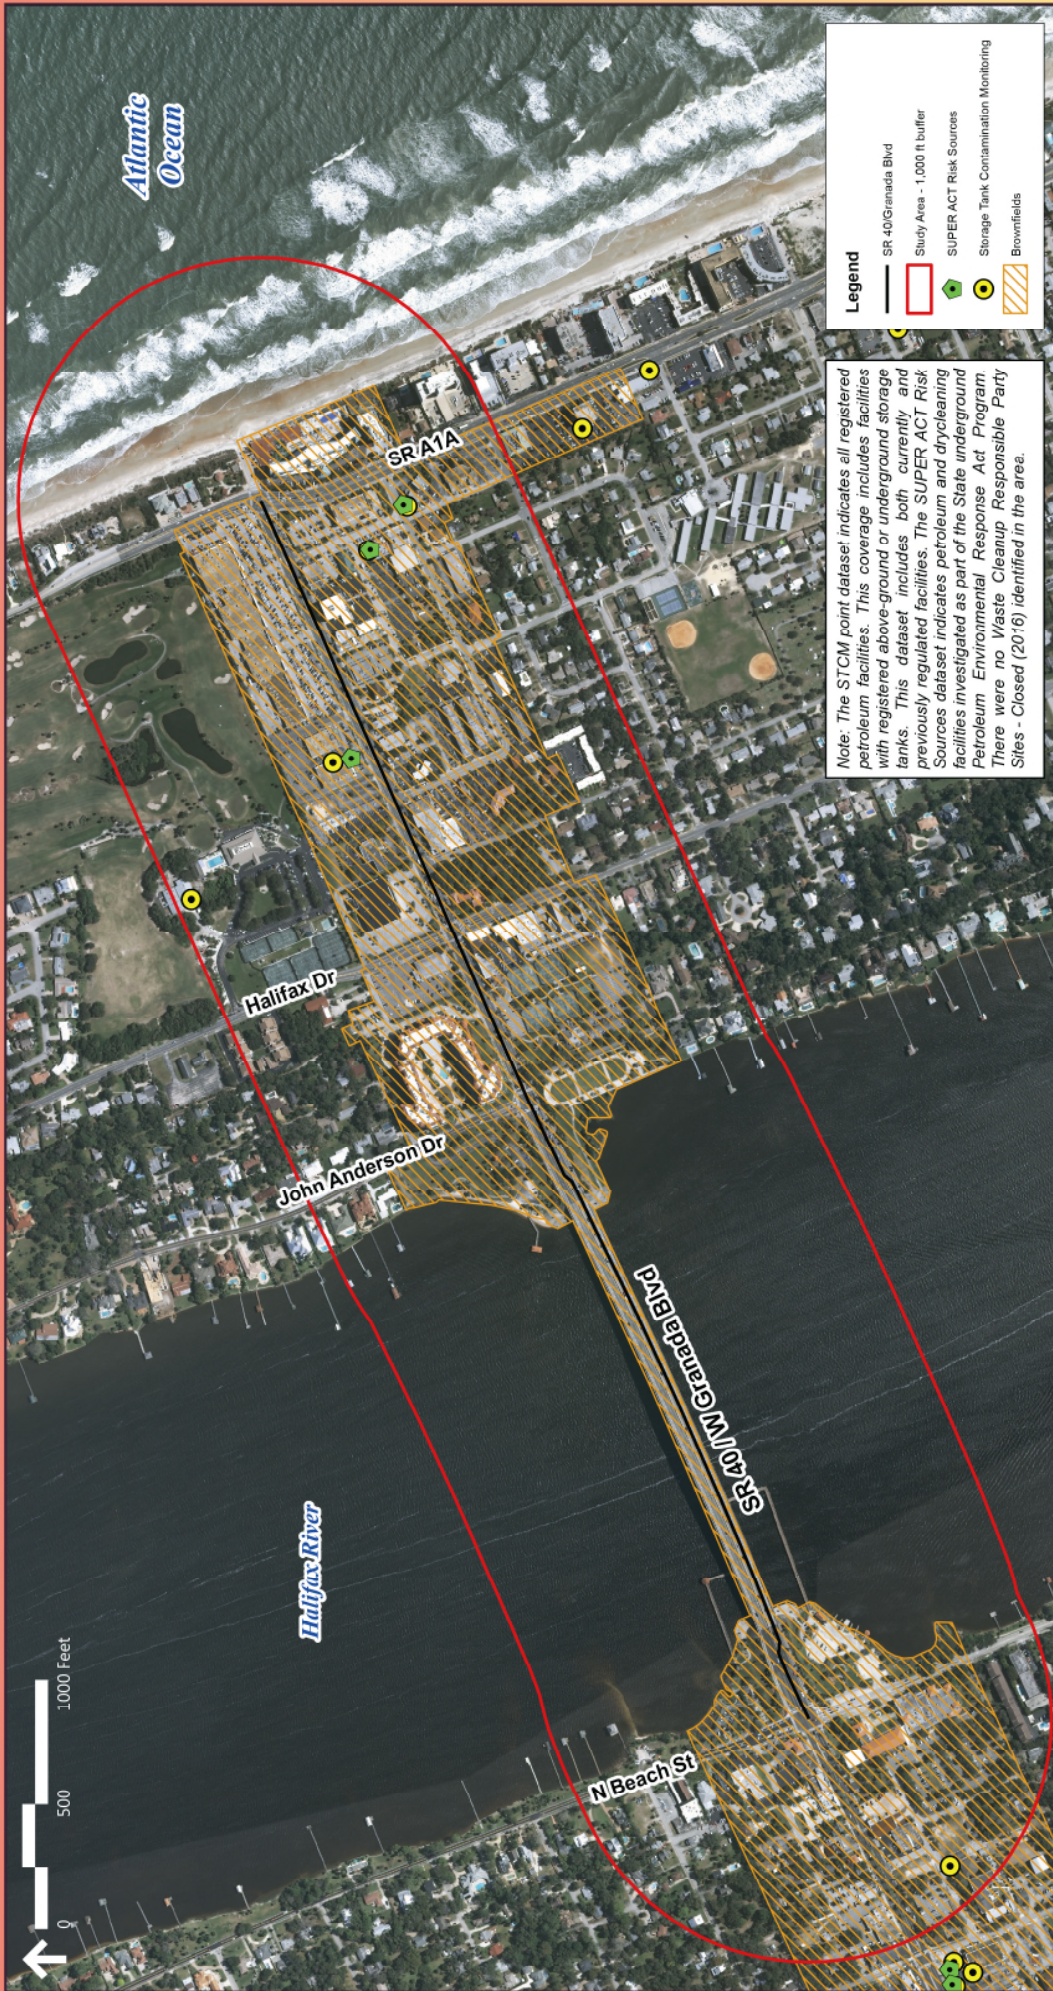
In addition to the brownfield area, three FDEP cleanup sites (2017) were identified within the study area. One petroleum cleanup site was noted at the intersection of Bovard Avenue and Coquina Court. Two dry-cleaning cleanup sites were identified: one at the intersection of Vining Court and Florence Street, and the other along SR 40, west of the Granada Plaza.

In May 2013, Ormond Beach Resolution Number 2013-90 was adopted to establish the brownfield area located within the SR 40 study area. The resolution establishes certain financial incentives and local incentives for redevelopment within the brownfield area.
