# CONTAMINATION SCREENING EVALUATION REPORT

**I-95 INTERCHANGE AT PIONEER TRAIL**

**PD&E STUDY**

Volusia County, Florida

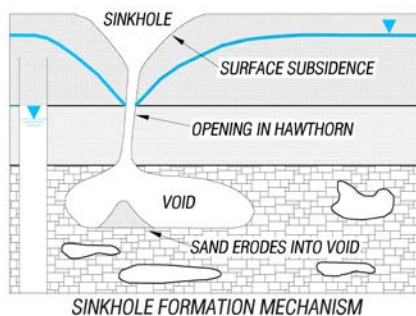
The water table aquifer is comprised of Recent and Pleistocene sands and is separated from the Eocene limestone of the Floridan aquifer by the Miocene sands, clays and limestone of the Hawthorn. Since the thickness and consistency of the Hawthorn is variable across Central Florida, the likelihood of groundwater flow from the upper to the lower aquifer (known as aquifer recharge) will also vary by geographical location.

In areas where the Hawthorn is absent, water table groundwater (and associated sands) can flow downward to cavities within the limestone aquifer, like sand through an hourglass, recharging the Floridan aquifer, and sometimes causing the formation of surface sinkholes. This process of subsurface erosion associated with recharging the Floridan aquifer is known as raveling. Thus, in Central Florida, areas of effective groundwater recharge to the Floridan aquifer have a higher potential for the formation of surface sinkholes.

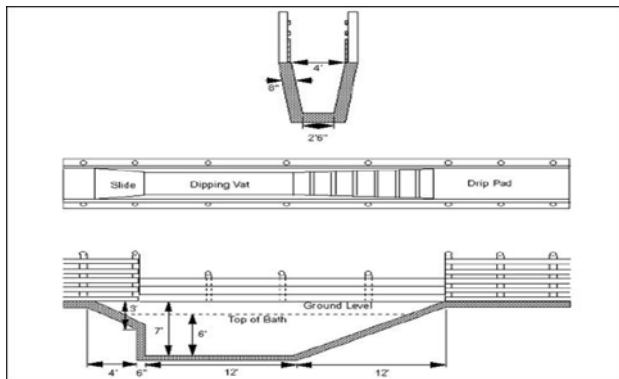
Cattle dip vats were used until the 1960s and many vats have not been located, or documented. Cattle dip vats were used to apply pesticides to cattle and other livestock, kill ticks, and thereby eliminate tick-borne diseases. The vats were typically constructed of concrete. They consisted of four sections; the entrance slide, dipping vat, exit stairs and drip pad. Cattle were funneled into a chute leading to the entrance slide, then slide down

into the pesticide-filled vat, swim or walk across the vat and walk up the exit stairs to the drip pad. The vats were roughly four feet wide, seven feet deep, and 40 feet long as shown on the following diagram.

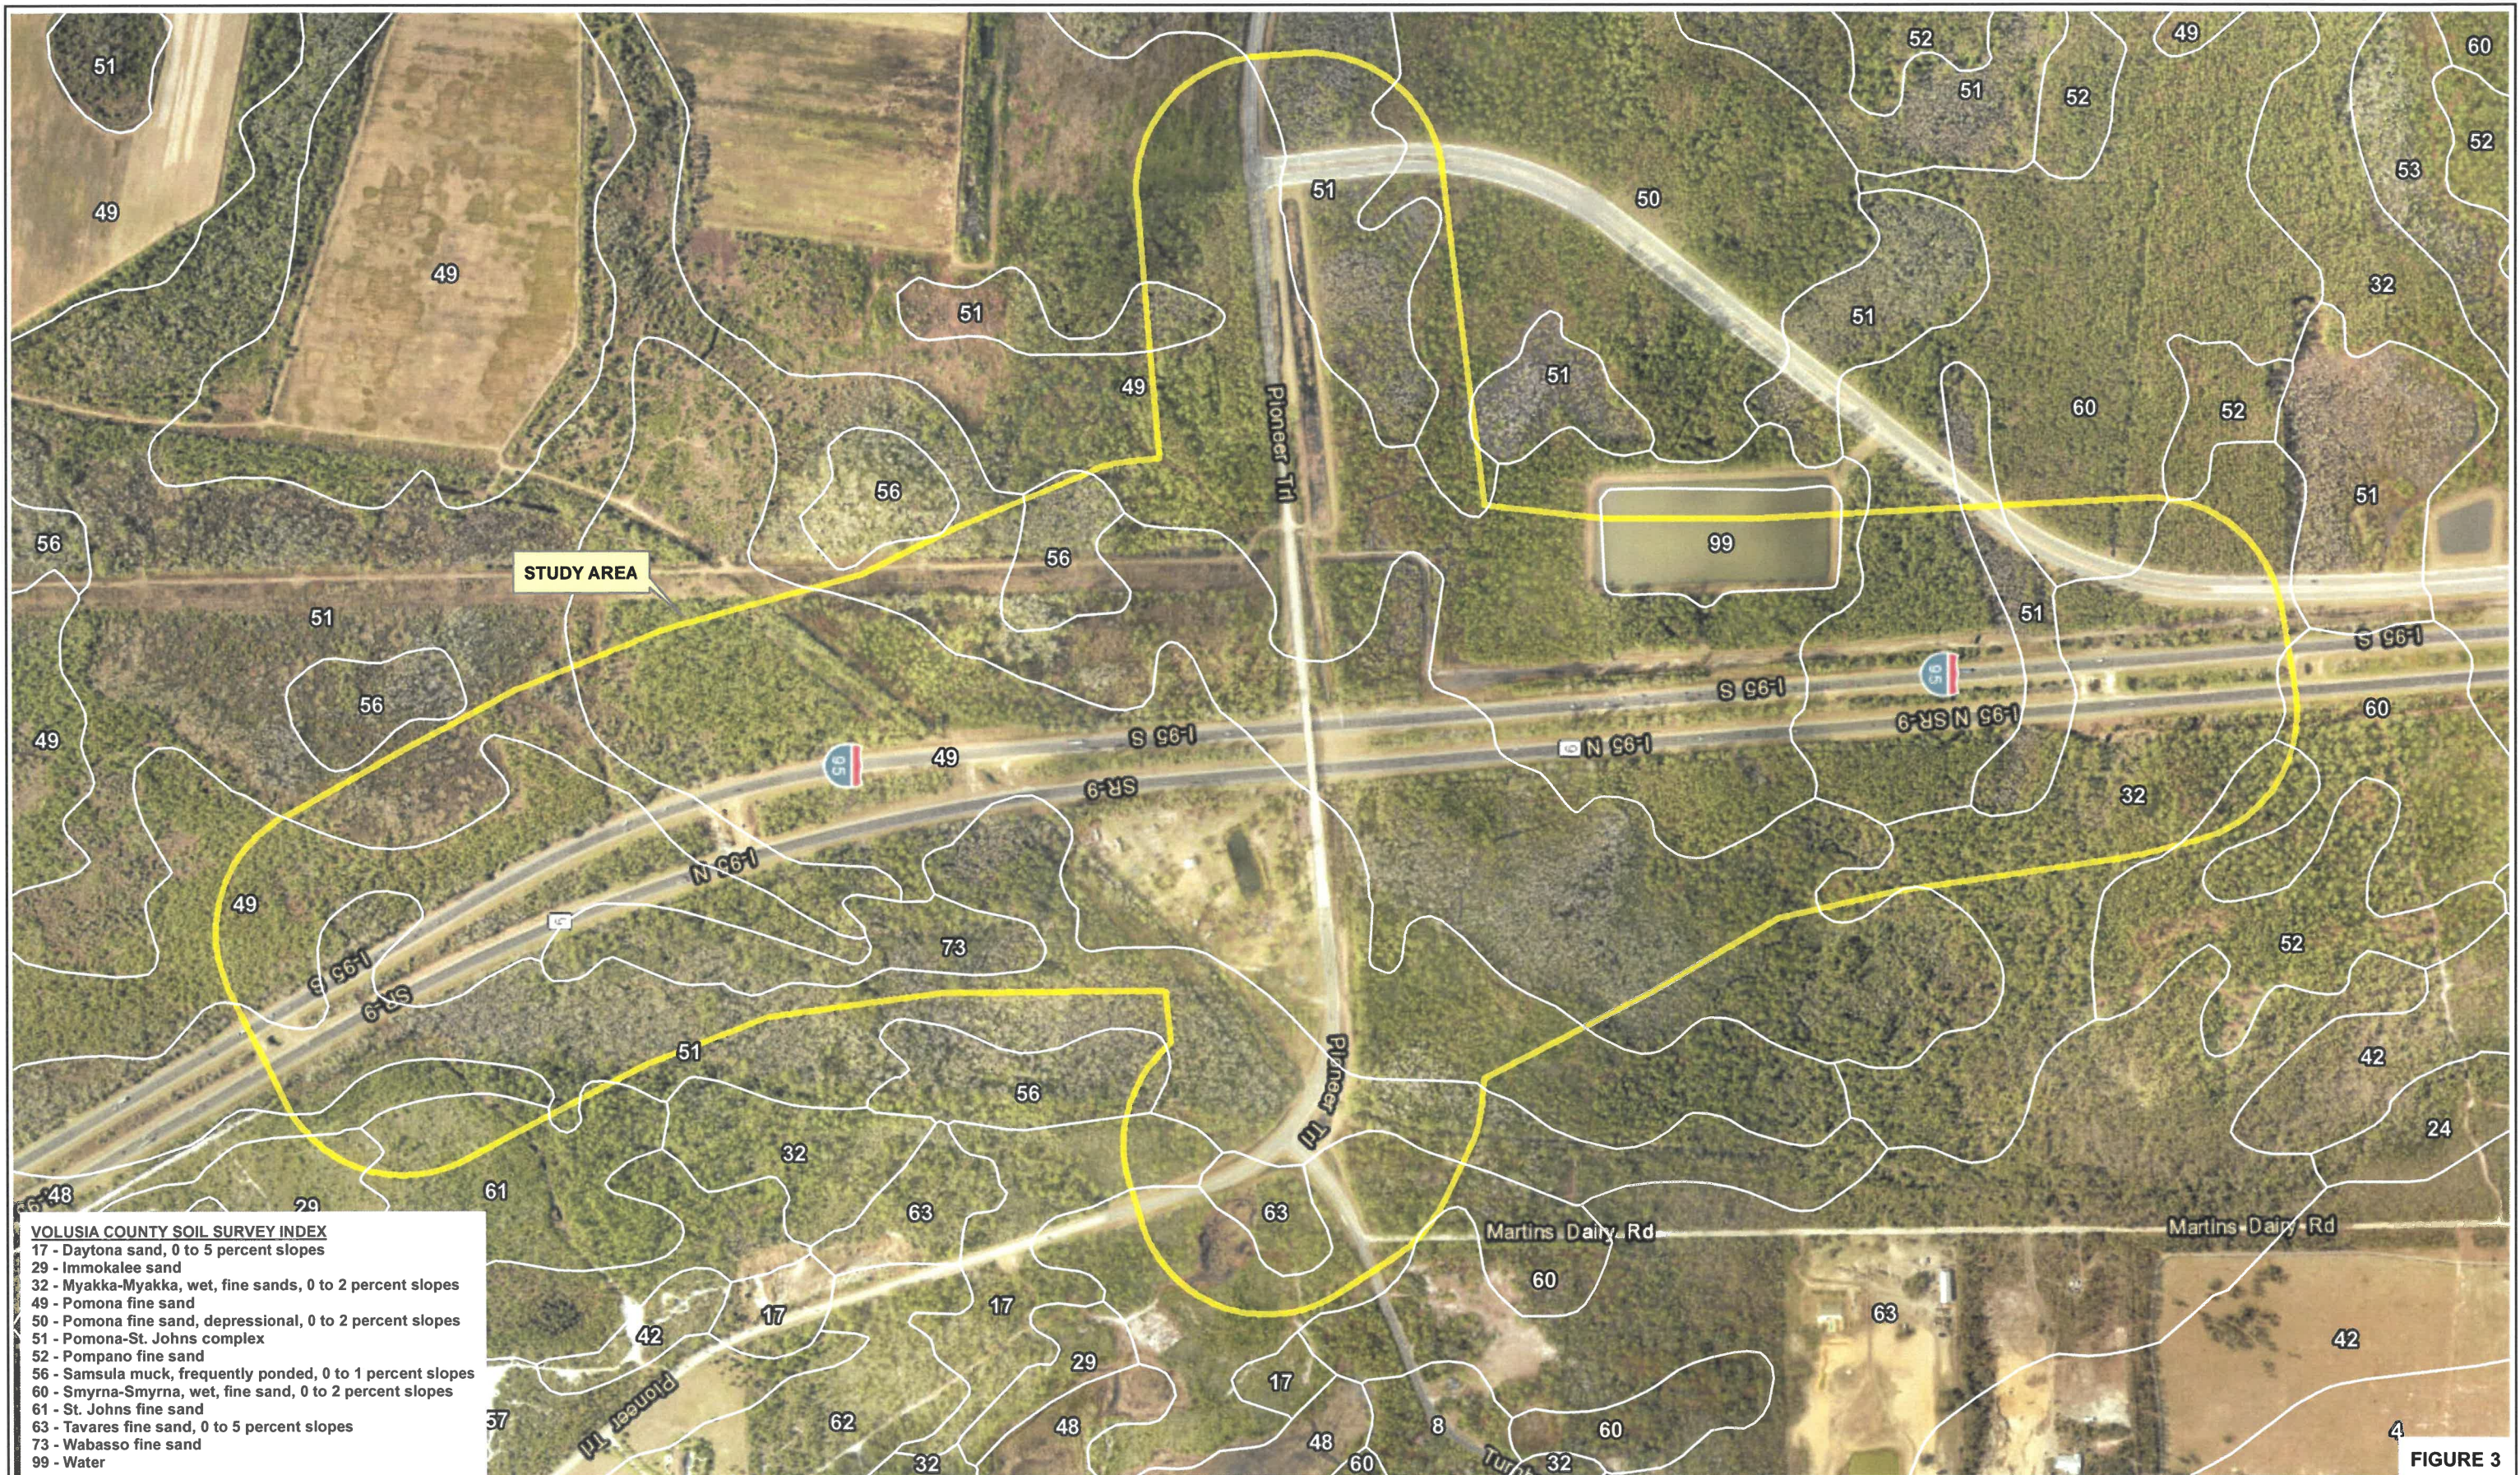
*SJRWMD LAND USE MAP*

The current land uses within the study area are shown on the Saint Johns Water Management District (SJRWMD) Map on **Figure 2** and are summarized as follows:

No other landfills, borrow pits, or quarries are depicted that would represent potential contamination concerns on, or in the immediate vicinity of, the study area. **Figure 2** depicts land use in the project area.

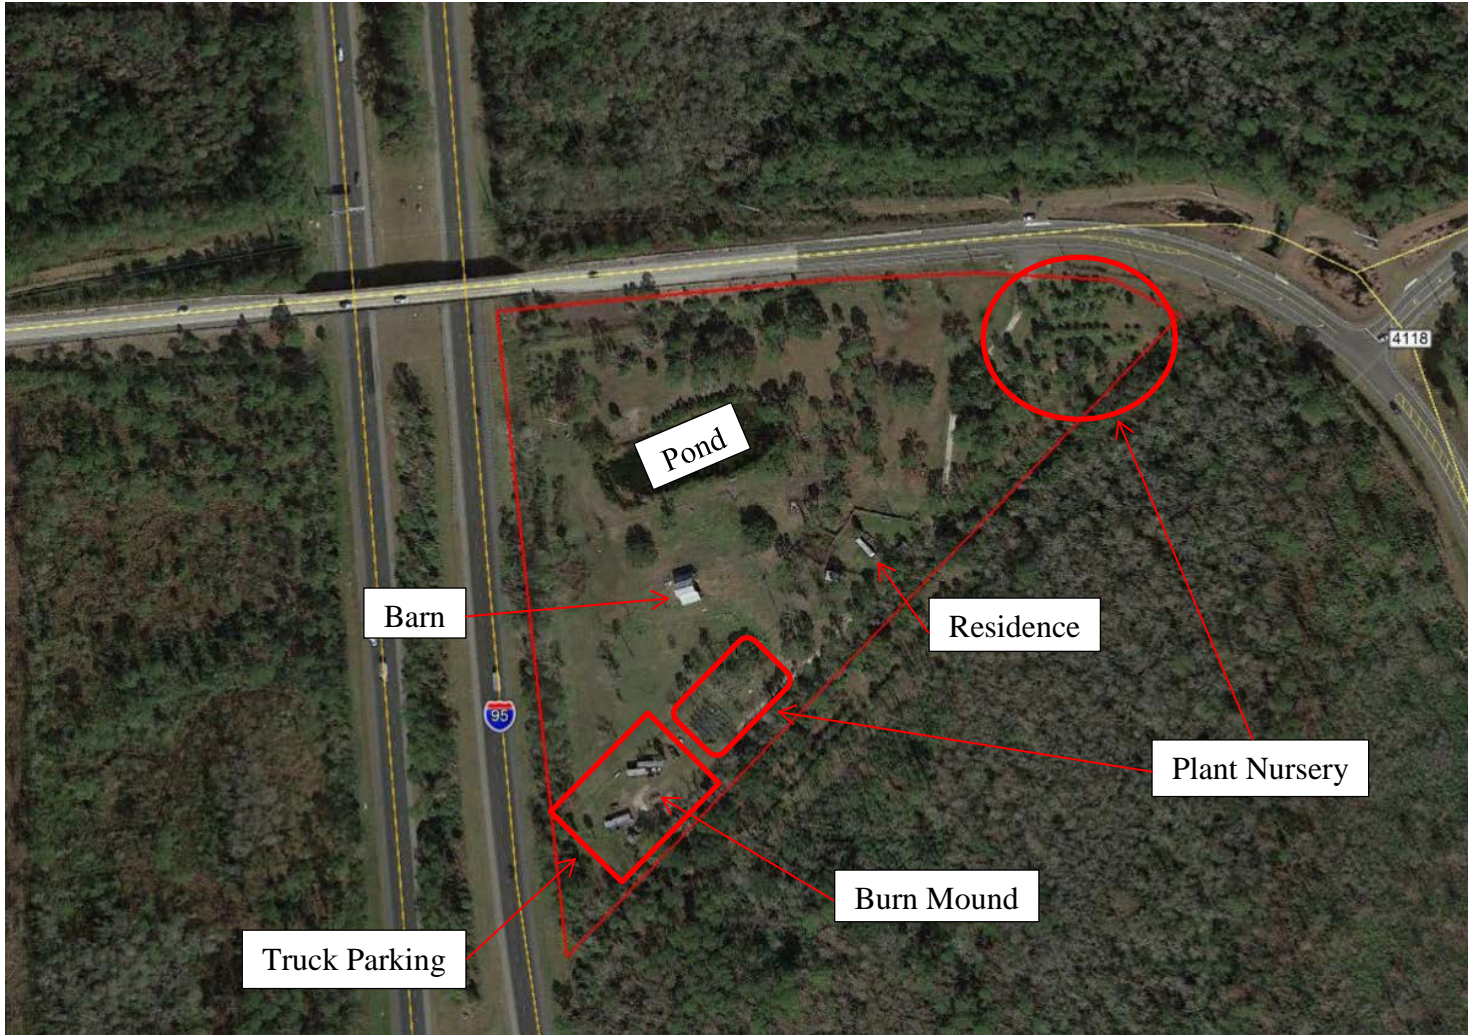
Site No.:	<b>1</b>	Site Name:	Tornelli Property	Risk Rating:	<b>MED</b>
-----------	----------	------------	-------------------	--------------	------------

Site No.:	<b>1</b>	Site Name:	Tornelli Property		Risk Rating:	<b>MED</b>
Street Address:		3160 Pioneer Trail				
Location:		Southeast corner of the I-95 and Pioneer Trail intersection				
Distance from Right of Way:		Adjacent				
Current Land Use:		Residence, farm, plant nursery, tractor-trailer truck parking				
Historical Land Use:		Vacant Land				
Database Listings / Sources:		Aerial Photographs				
Facility ID Nos.:		N/A				
Storage Tank Description:		N/A				
Discharge Date:		<b>N/A</b>	SRCO/NFA:		<b>N/A</b>	
Hazardous Materials:		<b>Yes</b>	Petroleum Products:		<b>Yes</b>	
Soil Concern:		<b>Yes</b>	Groundwater Concern:		<b>Yes</b>	
Public Record Findings:		<p>This property was developed between 1999 and 2004 with an excavated pond, residence and vehicle parking. In later years, a barn, plant nursery, tractor-trailer truck parking, and a burn mound are visible.</p> <p>No documented violations or releases of hazardous materials or petroleum products have been reported for this property.</p>

Interview Information:		No one was available for an interview at the time of the site reconnaissance.				
Site Observations:		The site is currently operating as a small farm, plant nursery, and tractor-trailer truck parking facility.				
Conclusions:		Based on the presence of the plant nursery, burn mound, truck parking, and heavy equipment on-site, and the potential for the proposed northbound exit ramp to encompass this facility, this site has been assigned a <b>Medium Risk</b> .

Photo Description: Tornelli Property as seen on the 2019 Google Earth imagery.

- ICAs are recommended for Site 1, the Tornelli Property in the SE quadrant of the project; the two plant nursery locations, burn mound, and the truck parking area should be assessed for chemicals of concern.
- The USGS well(s) in this quadrant should be investigated to determine if they still exist and if they will need to be protected or accommodated during construction activities.

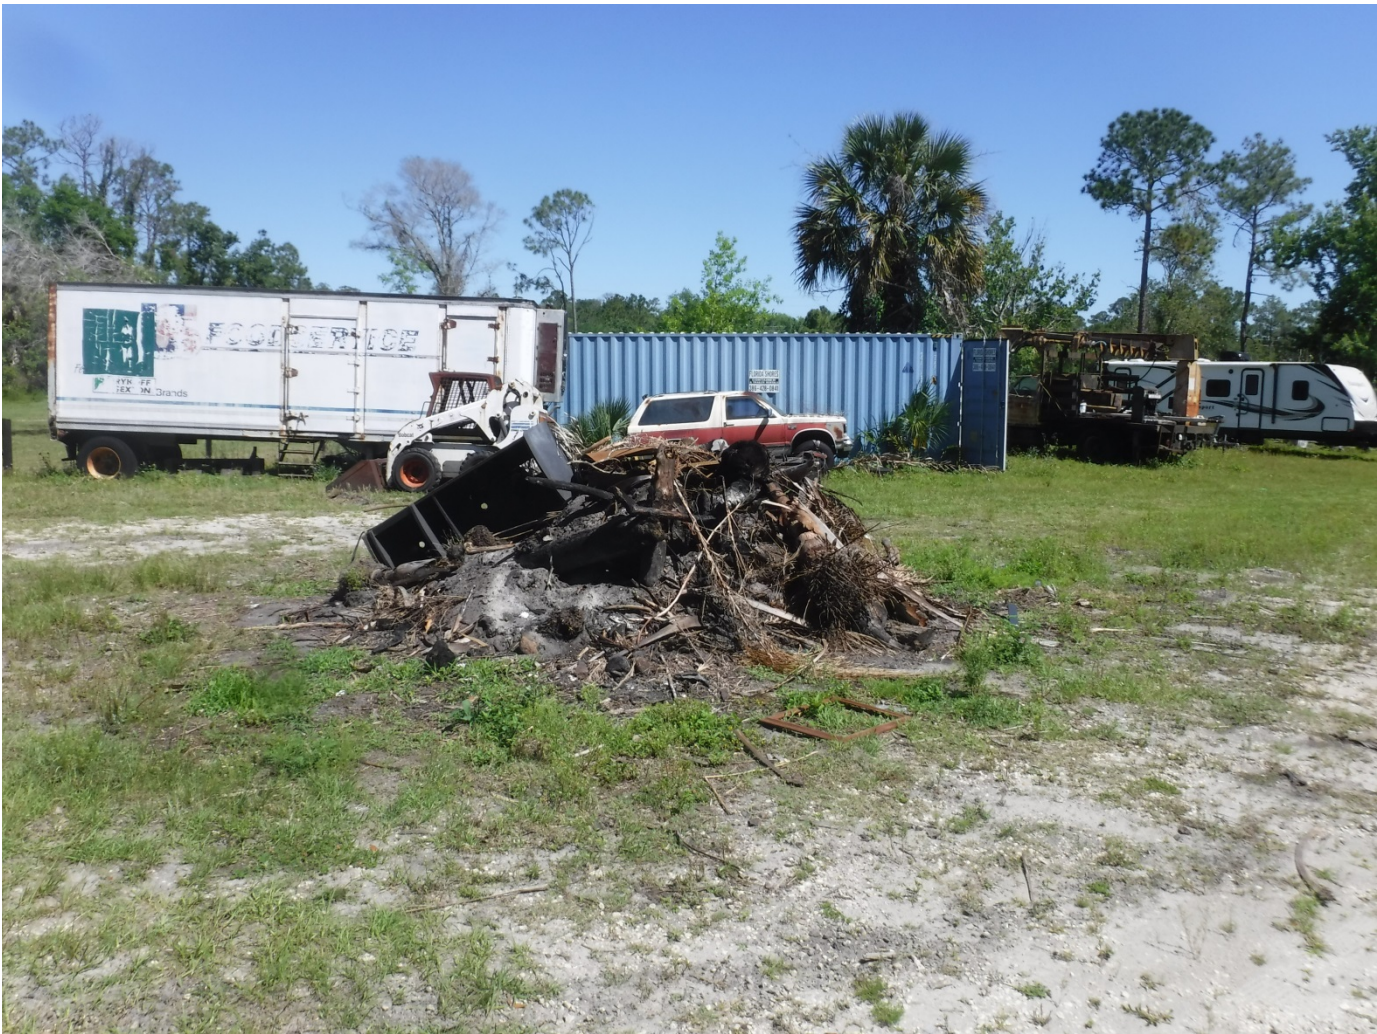
Site No.:	1	Site Name:	Tornelli Property	Risk Rating:	MED
-----------	---	------------	-------------------	--------------	-----

The 2014 and 2019 aerial photographs show a plant nursery area located northeast of the tractor-trailer truck parking area. Debris and the burn pile are visible in the truck parking area.

Photo Description:	Truck parking and burn mound on-site.
--------------------	---------------------------------------

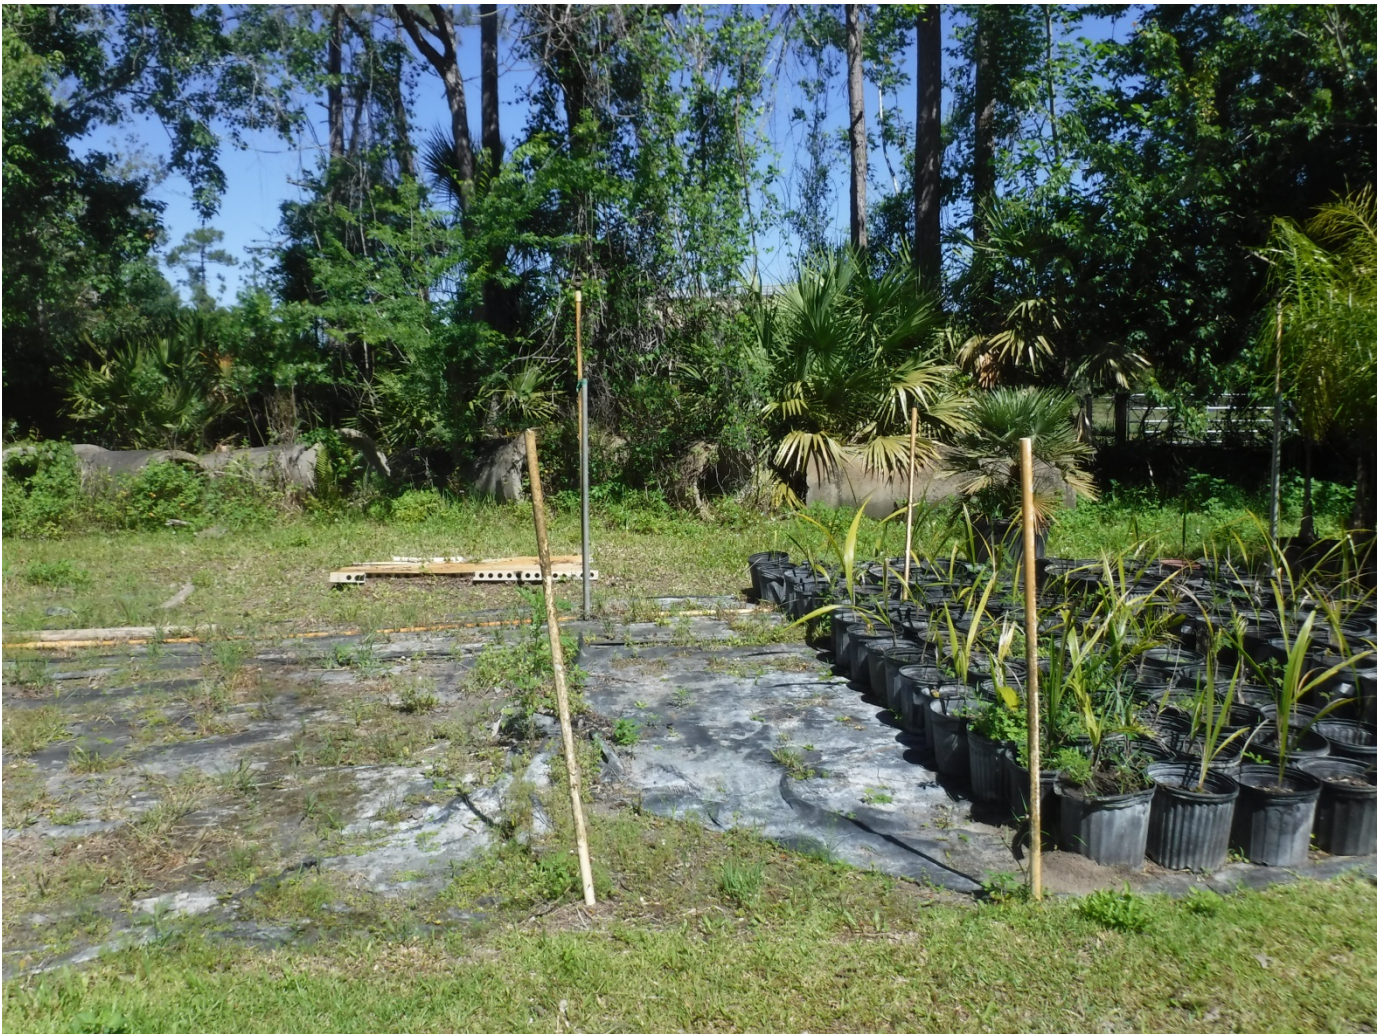
Site No.:	<b>1</b>	Site Name:	Tornelli Property	Risk Rating:	<b>MED</b>
-----------	----------	------------	-------------------	--------------	------------

Photo Description:	Plant nursery area on-site.
--------------------	-----------------------------

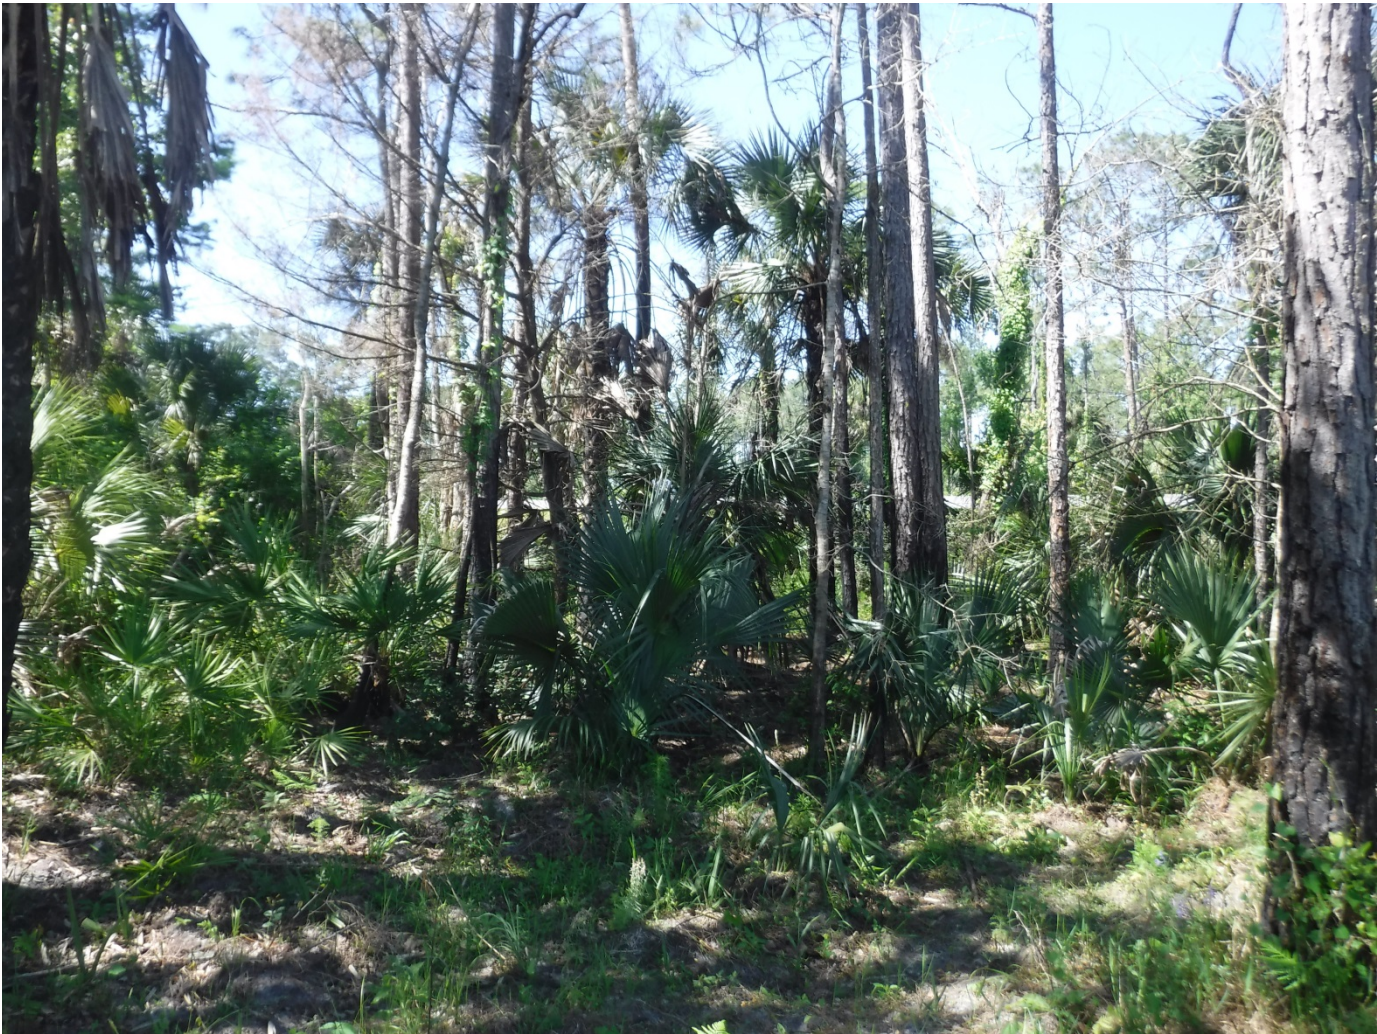
Site No.:	<b>3</b>	Site Name:	Sampling Station #27080085	Risk Rating:	<b>LOW</b>
-----------	----------	------------	----------------------------	--------------	------------

Site Observations:	The sampling location was found to contain water and did not have a formal sampling station or water gauging equipment.				
Conclusions:	Based on the sampling station being used to evaluate the overall health of the habitat and not to monitor contamination impacts, this site has been assigned a <b>Low Risk</b> .

Photo Description:	Apparent location of Sampling Station #27080085 (I-95 northbound in background).
--------------------	--

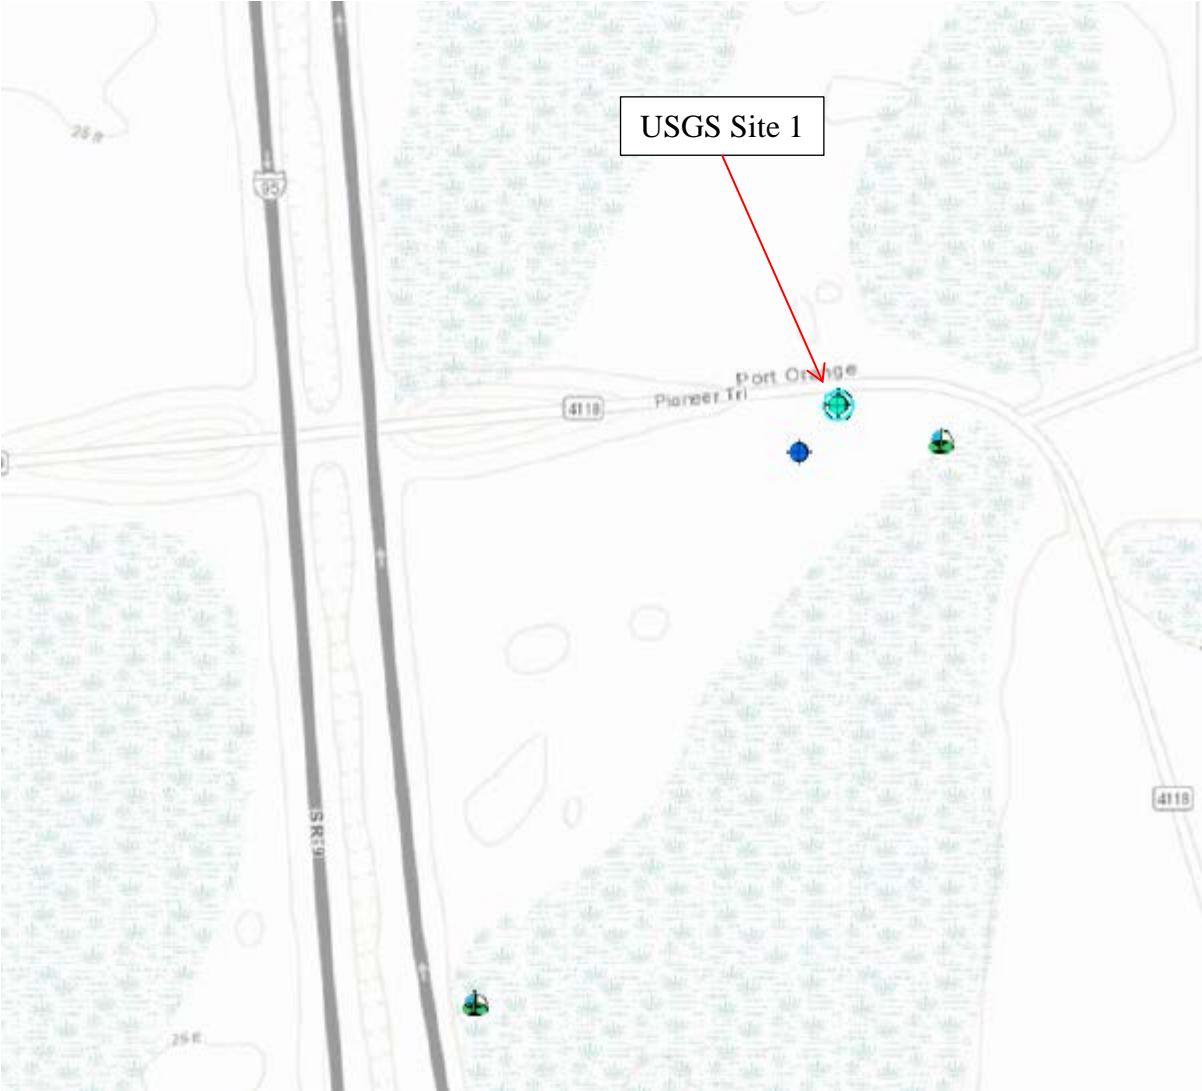
Site No.:	4	Site Name:	USGS Site 1	Risk Rating:	LOW
-----------	---	------------	-------------	--------------	-----

Site No.:	<b>4</b>	Site Name:	USGS Site 1	Risk Rating:	<b>LOW</b>
Street Address:	Pioneer Trail				
Location:	Southeastern quadrant of I-95 and Pioneer Trail intersection				
Distance from Right of Way:	Adjacent to right of way				
Current Land Use:	Pioneer Trail right of way				
Historical Land Use:	Vacant Land				
Database Listings / Sources:	FDEP Map Direct				
Facility ID Nos.:	N/A				
Storage Tank Description:	N/A				
Discharge Date:	<b>N/A</b>	<b>SRCO/NFA:</b>	<b>N/A</b>		
Hazardous Materials:	<b>No</b>	<b>Petroleum Products:</b>	<b>No</b>		
Soil Concern:	<b>No</b>	<b>Groundwater Concern:</b>	<b>No</b>		
Public Record Findings:	This site is called USGS Site 1. It is a 700-foot deep exploratory soil boring that was logged for geophysical information.				
Interview Information:	N/A				
Site Observations:	USGS Site 1 was not observed in the field.				
Conclusions:	Based on the geophysical nature of this boring, this site has been assigned a <b>Low Risk</b> .

Photo Description:	FDEP Map Direct Image showing this site.
--------------------	--

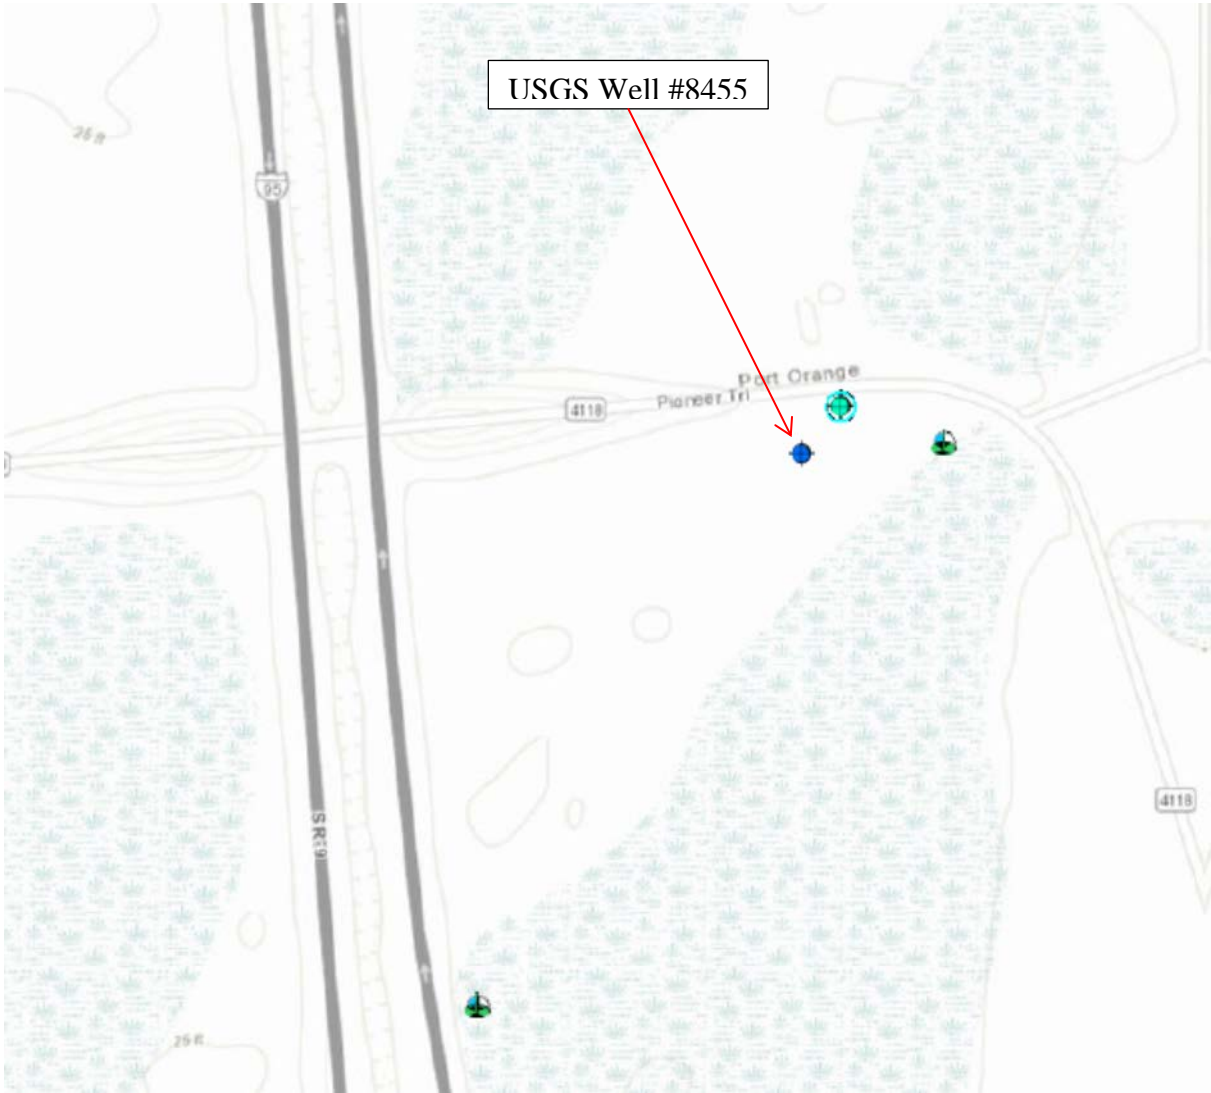
Site No.:	5	Site Name:	USGS Well #8455	Risk Rating:	LOW
-----------	---	------------	-----------------	--------------	-----

Site No.:	<b>5</b>	Site Name:	USGS Well #8455	Risk Rating:	<b>LOW</b>
Street Address:	Pioneer Trail				
Location:	Southeastern quadrant of I-95 and Pioneer Trail intersection				
Distance from Right of Way:	Adjacent to right of way				
Current Land Use:	Pioneer Trail right of way				
Historical Land Use:	Vacant Land				
Database Listings / Sources:	FDEP Map Direct				
Facility ID Nos.:	N/A				
Storage Tank Description:	N/A				
Discharge Date:	<b>N/A</b>	<b>SRCO/NFA:</b>	<b>N/A</b>		
Hazardous Materials:	<b>No</b>	<b>Petroleum Products:</b>	<b>No</b>		
Soil Concern:	<b>No</b>	<b>Groundwater Concern:</b>	<b>No</b>		
Public Record Findings:	This site is called USGS Well #8455. It is a 700-foot deep well that is/was used to monitor deep aquifer conditions for the United States Geological Survey.				
Interview Information:	N/A				
Site Observations:	USGS Well #8455 was not observed in the field.				
Conclusions:	Based on the natural conditions monitoring nature of this well, this site has been assigned a <b>Low Risk</b> .

Photo Description:	FDEP Map Direct Image showing this site.
--------------------	--

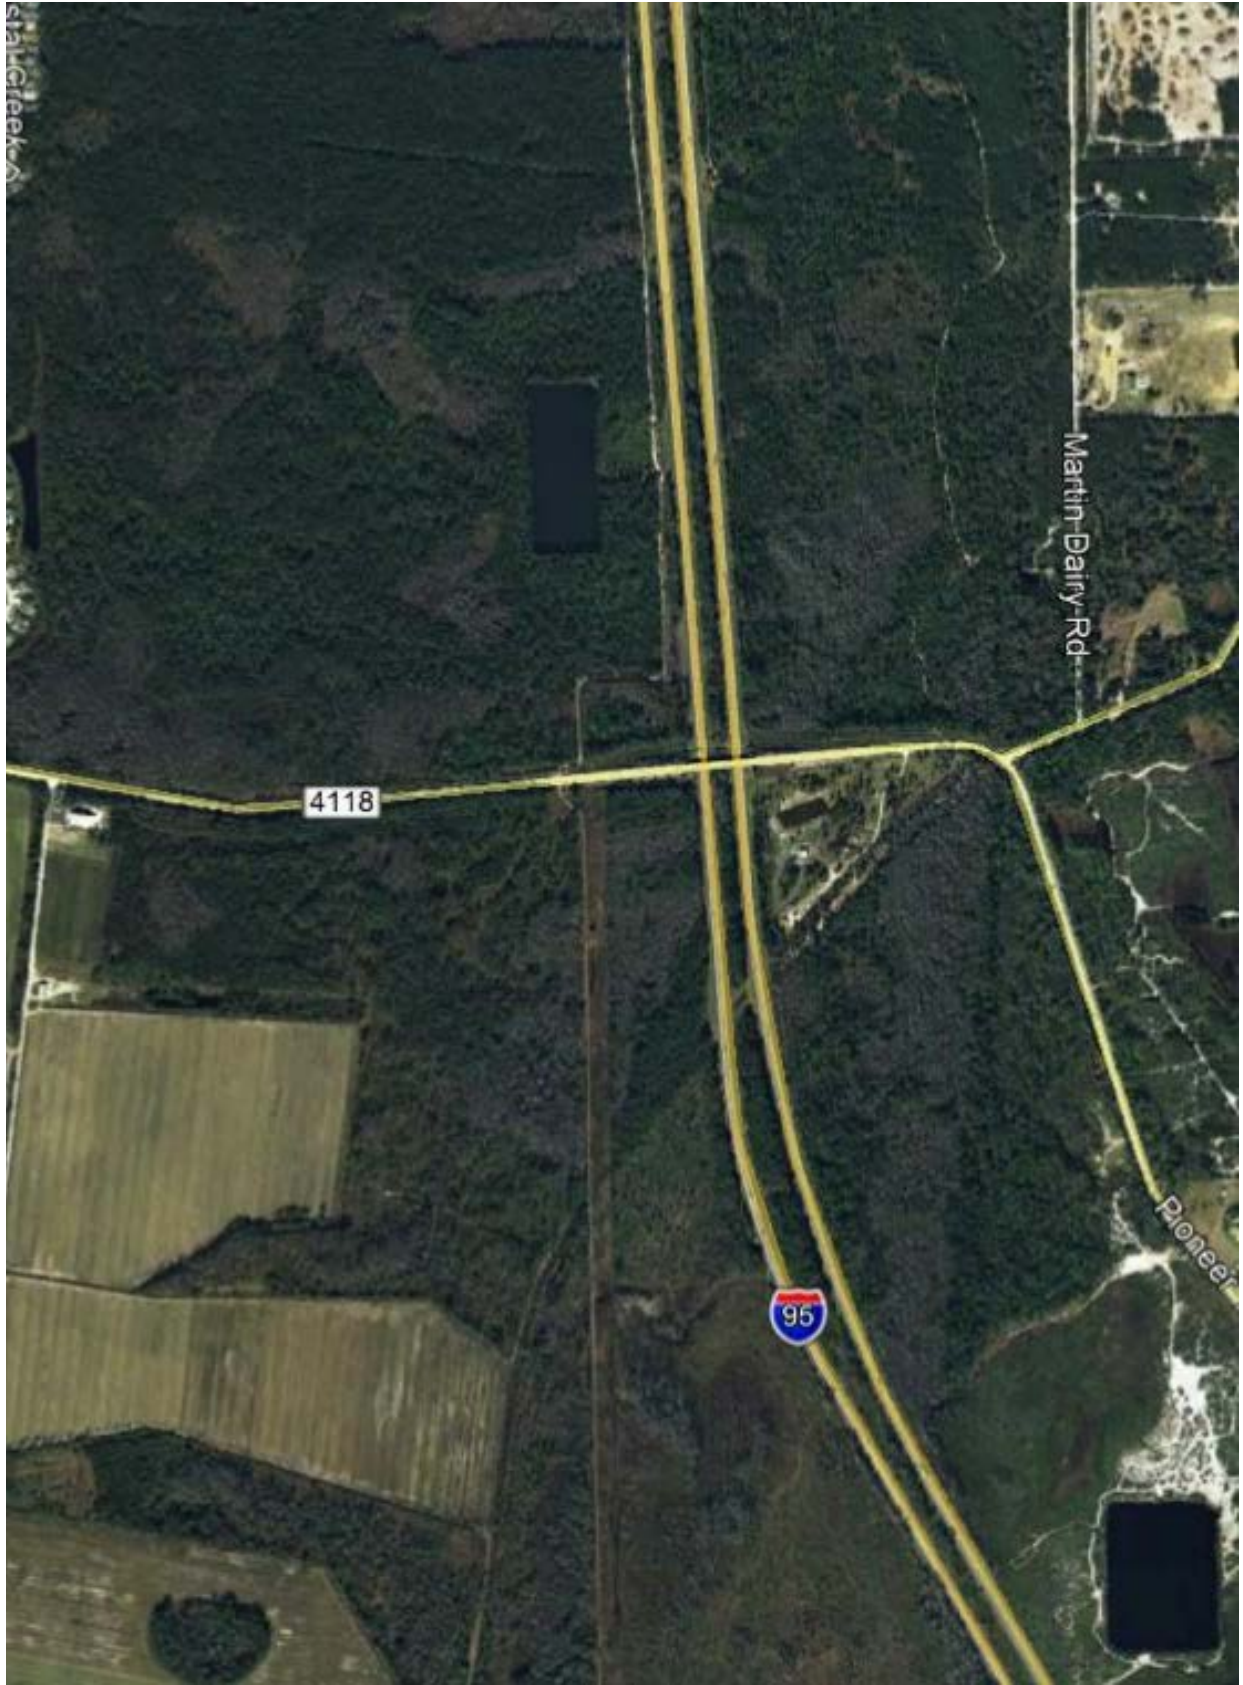
The 2009 aerial photograph shows the construction of a barn and formal truck parking area in the southwestern portion of that site. A burn area is visible within the tractor-trailer truck parking area. Some trees or plants are visible in rows in the northeastern portion of the site, on the east side of the driveway (area of present-day plant nursery).
