ISB Pedestrian Connectivity & Safety Assessment Study Field Evaluation Report

Prepared for:
Florida Department of Transportation District 5, Deland, FL

Prepared by: Ghyabi & Associates, Inc.

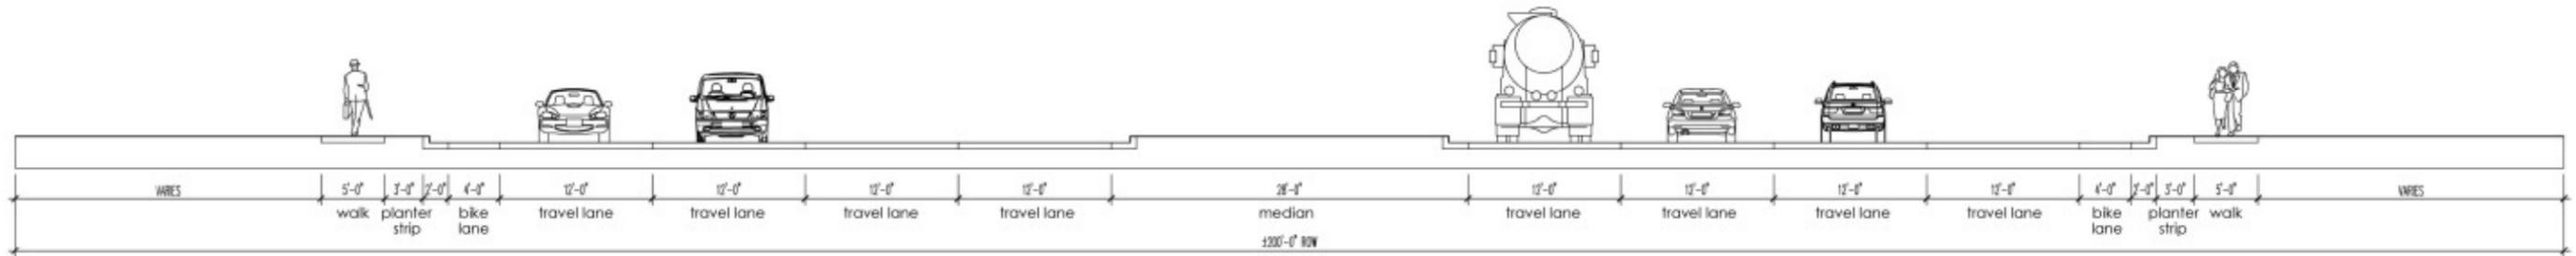
Figure 2: US 92/SR 600 Typical Cross Section (I-95 to Bill France Boulevard)

Figures 2, 3 and 4 depict the typical cross sections for US 92/SR 600/International Speedway Boulevard within the study area. All cross sections include Type F curb and gutter, four-foot bike lanes, and five-foot sidewalks on both sides of the facility throughout the study area.

Between I-95 and SR 483/Clyde Morris Boulevard, US 92/SR 600/International Speedway Boulevard is an eight-lane divided roadway with a 200-foot right of way. This section includes eight, twelve-foot through lanes and a 28-foot grass median. East of SR 483/Clyde Morris Boulevard, the right of way narrows to 120 feet and a reduced roadway cross section of six, twelve-foot wide through lanes and a 22-foot median.

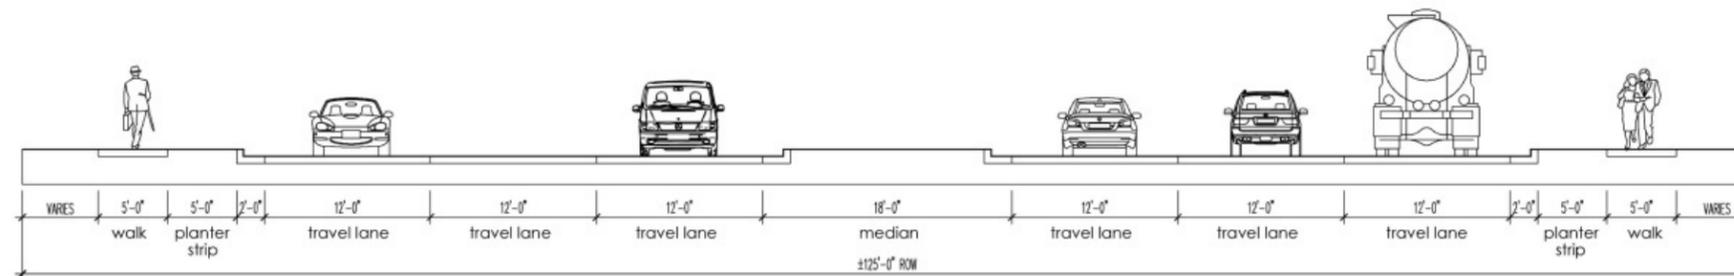
Figure 5: SR 5A/Nova Road Typical Cross Section

The typical cross section SR 5A/Nova Road is depicted in Figure 5. This facility features a six-lane urban section with a grass median. The right of way within the study area varies with a minimum width of 125 feet and has six, twelve-foot through lanes, an 18-foot grass median and Type F curb and gutter on each side. It also includes five-foot sidewalks on both sides of the corridor.

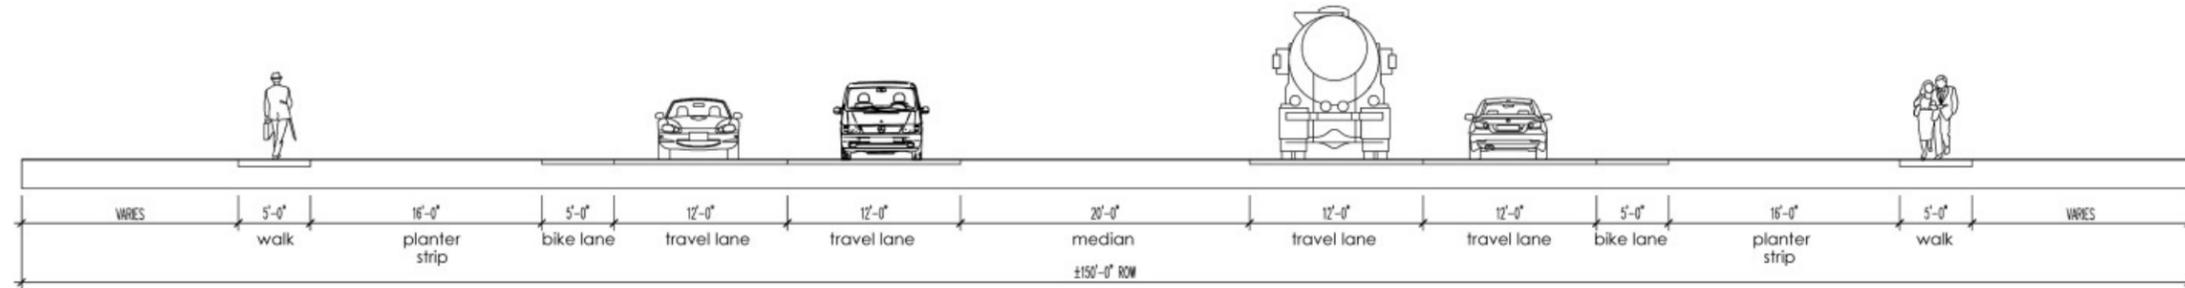
Figure 6: Williamson Boulevard Typical Cross Section

Figure 6 depicts the typical cross section for Williamson Boulevard which is a four-lane urban section with a grass median. The right of way within the study area is 150 feet. This roadway features four, twelve-foot through lanes and a 20-foot grass median. North of US 92/SR 600/International Speedway Boulevard, Williamson Boulevard has Type F curb and gutter, five-foot bike lanes, and five-foot sidewalks on both sides of the corridor.

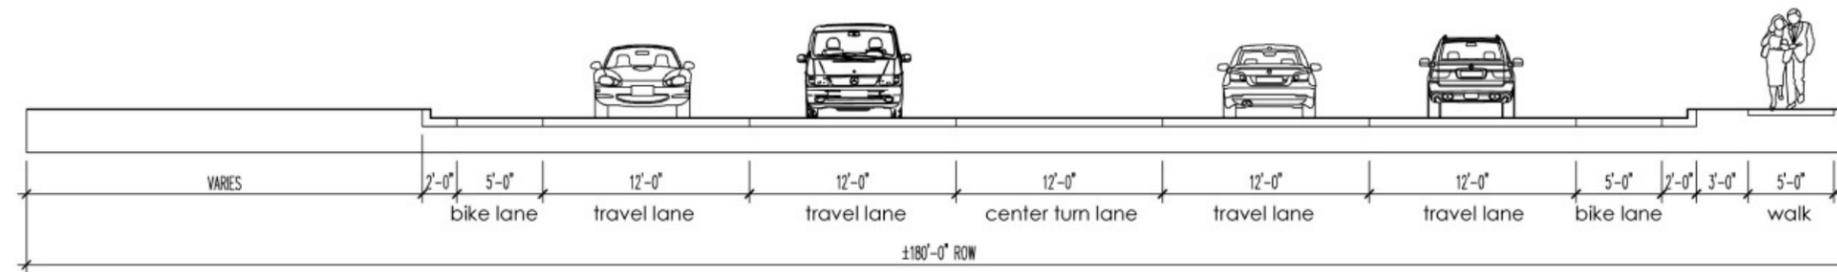
Figure 7: SR 483/Clyde Morris Boulevard Typical Cross Section (South of US 92/SR 600)

As shown in Figure 7, SR 483/Clyde Morris Boulevard, south of US 92/SR 600/International Speedway Boulevard, consists of four through lanes, a continuous center turn lane, Type F curb and gutter, bike lanes and a sidewalk adjacent to the northbound through lanes. The right of way varies but is approximately 180 feet.

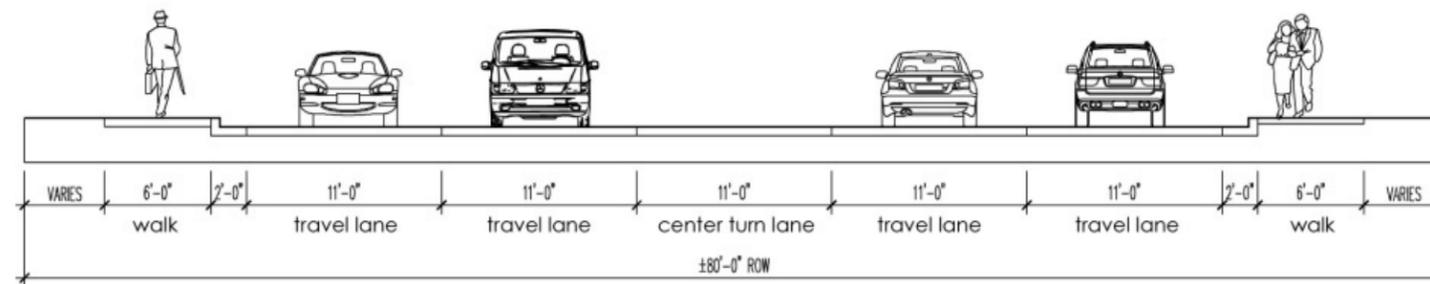
Figure 8: SR 483/Clyde Morris Boulevard Typical Cross Section (North of US 92/SR 600)

SR 483/Clyde Morris Boulevard, north of US 92/SR 600/International Speedway Boulevard, is depicted in Figure 8. It features four through lanes, a continuous center turn lane, Type F curb and gutter and sidewalks on both sides. This segment of the arterial roadway has a right of way of 80 feet.

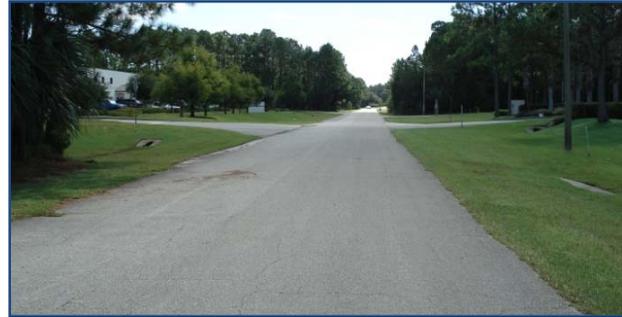
1. There are no sidewalks on Holsonback Drive.

A view of Holsonback Dr, which lacks sidewalks.

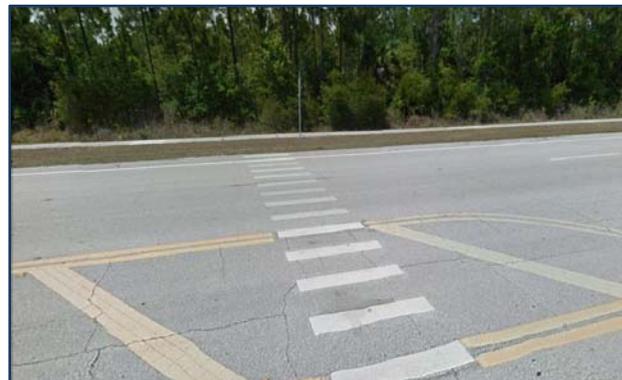
2. At Palm Terrace Elementary School, the sidewalk on the south side of Dunn Avenue terminates at the school's entrance. Pedestrians are directed to a marked crosswalk across Dunn Avenue that does not connect with the sidewalk on the north side of Dunn Avenue. Consideration should be given to providing an ADA compliant connection at this location.

There is a gap between the marked crosswalk and the sidewalk at Palm Terrace Elementary School. Photograph courtesy of Google Streetview taken in June 2011.

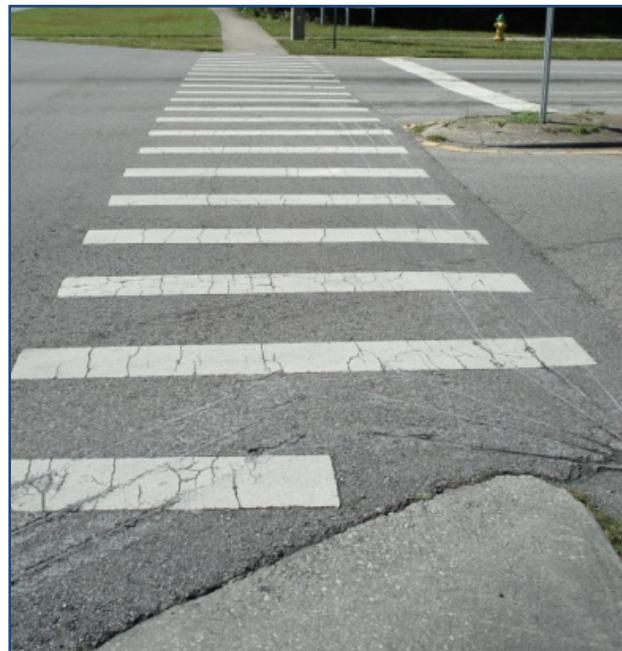
3. Several intersections along Dunn Avenue/George Engram Boulevard are not ADA compliant and lack detection pads. These intersections include: the US Post office driveways, Bill France Boulevard, Par Brook Avenue, Windy Pines Apartment Driveways, Wood Pine Driveway, Jimmy Ann Drive, White Fawn Drive, National Health Care Drive, Health Boulevard, Colfax Drive, Seneca Street, Frederick Avenue, Fletcher Avenue, Jackson Avenue, and Wilson Avenue.

There are no detection pads at Jimmy Anne Dr & Dunn Ave.

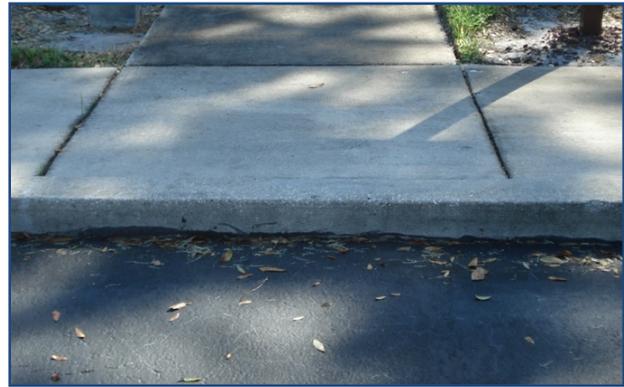
- 4. The eastern sidewalk approach on White Fawn Drive lacks a curb ramp. This should be corrected as required under ADA regulations.

There is no curb ramp at White Fawn Dr.

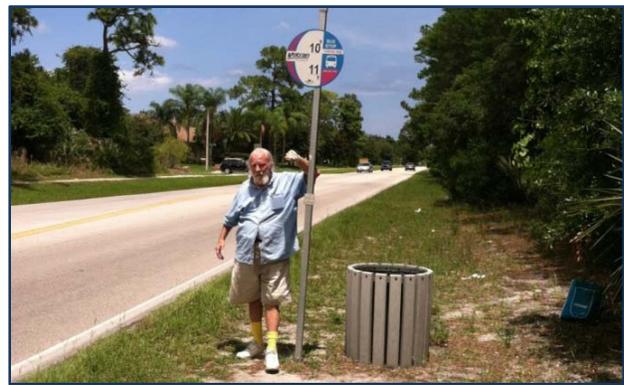
- 5. Several bus stops located along Dunn Avenue, including near Jimmy Ann Drive and National Healthcare Drive, are not ADA compliant or connected to the existing sidewalk network. The relocation of bus stops or addition of ADA compliant sidewalk and stop improvements should be considered at these locations.

A bus stop on Dunn Avenue near National Health Care Dr.

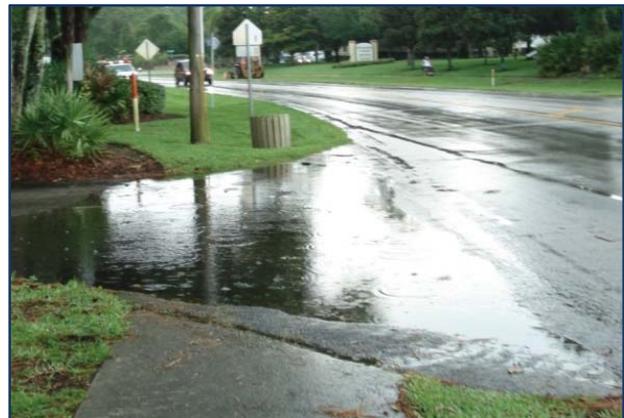
- 6. There is no sidewalk or bicycle lane on the south side of the Dunn Avenue and SR 483/Clyde Morris Boulevard intersection between National Health Care Drive and White Fawn Drive. Adding these features, as well as resolving non-ADA compliant bus stops along this stretch of roadway, should be considered.

The sidewalk on the south side of Dunn Ave ends abruptly just west of SR 483/Clyde Morris Blvd. A bus stop, located in a ditch, can be seen in the background.

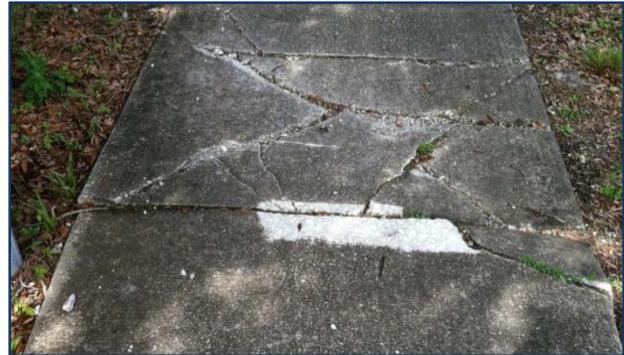
7. Sections of the sidewalks on Dunn Avenue, near SR 5A/Nova Road, are cracked and broken. As this may cause a tripping hazard, they should be repaired as soon as practical.

The sidewalk on Dunn Avenue, near the Nova Rd intersection, has several large cracks.

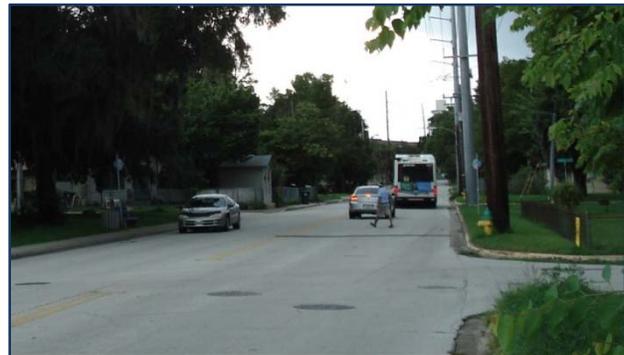
8. There are no sidewalks on the north side of Dr. Mary McLeod Bethune Boulevard. Transit riders must either walk in the grass, in the gutter or cross to the other side of the street to get to the sidewalk.

A transit rider maneuvers between moving automobiles to access the sidewalk on the south side of Bethune Blvd.

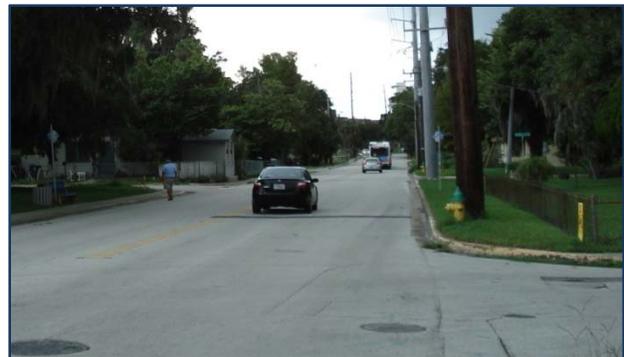
9. Travel lanes on Dr. Mary McLeod Bethune Boulevard are potentially wide enough to incorporate additional bicycle and pedestrian improvements between SR 5A/Nova Road and Daytona State College. Since there is insufficient right of way available on US 92/SR 600/International Speedway Boulevard to accommodate significant changes in the bicycle/pedestrian network, Dr. Mary McLeod Bethune Boulevard, which is a few blocks south, should be considered as a potential alternative corridor to strengthen network connectivity.

The width of Bethune Blvd offers opportunity for the inclusion of bicycle and pedestrian improvements without the need to acquire additional right of way.

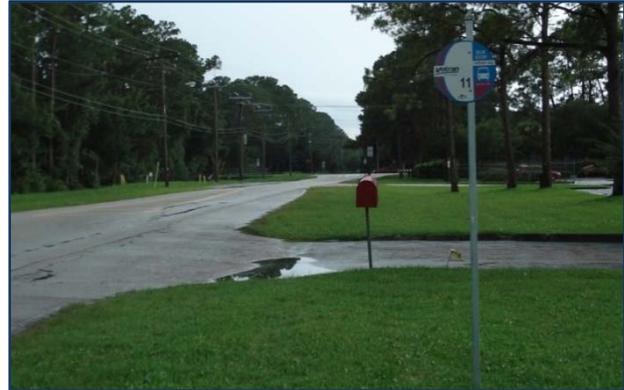
10. There are no sidewalk or bicycle facilities on Bayless Boulevard, despite the presence of transit service. Consideration should be given to the development of an ADA compliant bus stop at the intersection of Bayless Boulevard and Fentress Boulevard.

Looking west at a bus stop, from the intersection of Bayless Blvd and Fentress Blvd.

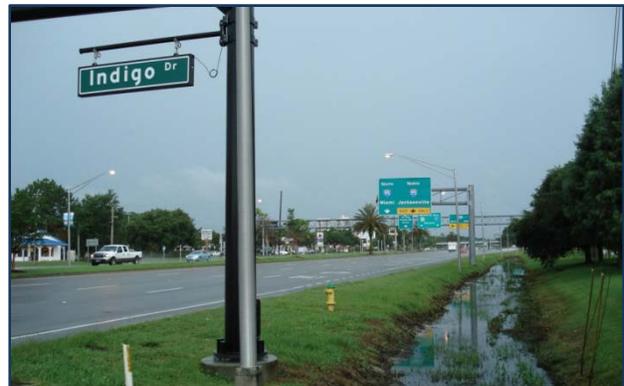
11. There is no sidewalk on the north side of US 92/SR 600/International Speedway Boulevard between I-95 and Indigo Drive. A twelve-foot shared use path is proposed for this area as a part of FDOT's planned widening of the road between I-95 and the I-4 interchange, west of the PCSA study area.

This section of US 92/SR 600/International Speedway Blvd, west of Indigo Dr, lacks sidewalks on the north side.

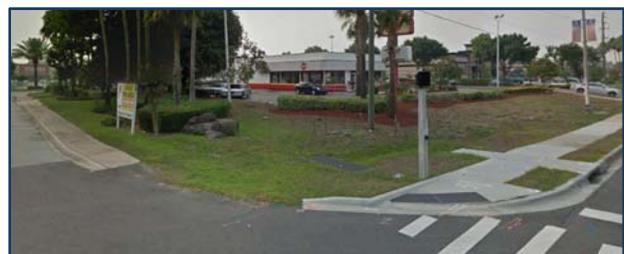
12. The signalized intersection with Indigo Drive is shown in the adjacent photo. On the northeast corner, the sidewalk on Indigo Drive abruptly ends, forcing pedestrians into the street to access the sidewalk along US 92/SR 600/International Speedway Boulevard. Consideration should be given to eliminating this sidewalk network gap.

A gap in the sidewalk network at US 92/SR 600/International Speedway Blvd and Indigo Dr. Photograph courtesy of Google Streetview taken in June 2011.

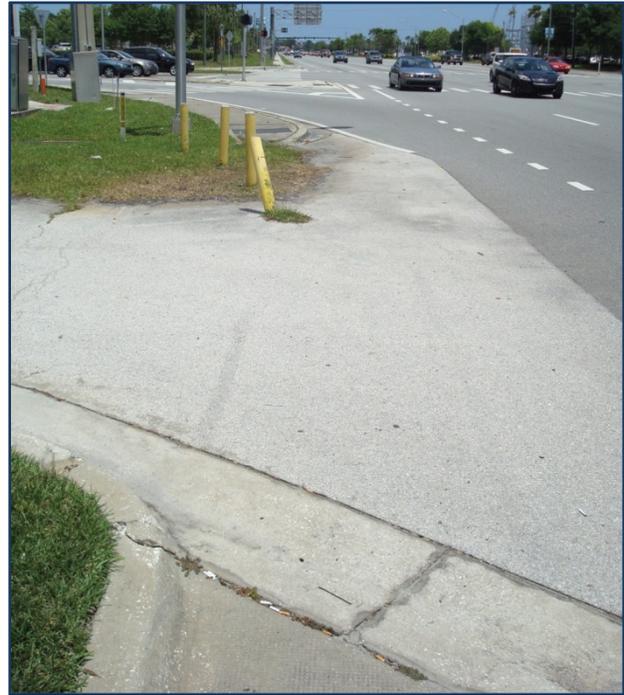
13. At the intersection of US 92/SR 600/International Speedway Boulevard and Williamson Boulevard, there is no direct path across the utility access point. The travelway is also obstructed by grass and concrete bollards on the FDOT right of way.

Unmaintained sidewalk conditions near the Williamson Blvd traffic signal.

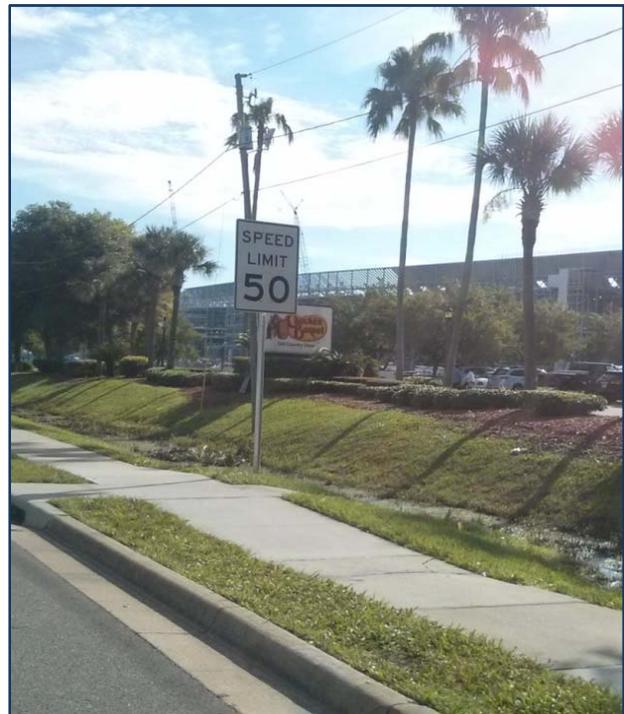
14. The sidewalk on the south side of US 92/SR 600/International Speedway Boulevard, between Thames Road and Midway Avenue, is bounded by adjacent travel lanes, with vehicular speeds of 50 mph, and large ditches containing water and weeds. This situation is a potential safety hazard in an area where major events attract large crowds of pedestrians on a regular basis. The situation will be improved in 2015 as a part of a \$20 million pedestrian safety enhancement project along US 92/SR 600/International Speedway Boulevard between Williamson Boulevard and Midway Avenue. This project will eliminate the existing open ditches on both sides of US 92/SR 600/International Speedway Boulevard and widen, landscape and buffer sidewalks from high speed vehicular traffic.

The eastbound US 92/SR 600/International Speedway Blvd sidewalk conditions between Thames Rd and Midway Ave.

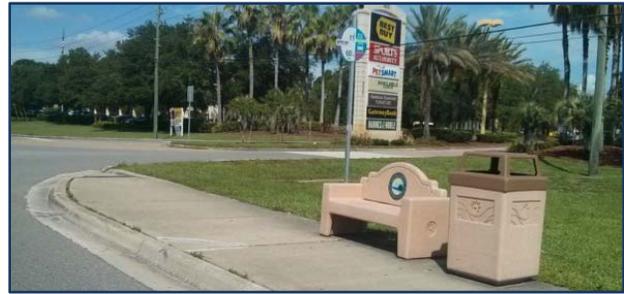
15. Throughout the US 92/SR 600/International Speedway Boulevard corridor, there are multiple examples of bus stops and other amenities obstructing sidewalks, which limits their effective width and ADA accessibility. Examples of this can be found near Best Buy Plaza, the Fentress Boulevard traffic signal, Volusia Square shopping center, Cracker Barrel restaurant, and the intersection of Turn One Drive and International Speedway Boulevard.

Bus stop amenities are located on the sidewalk near the entrance of Best Buy Plaza.

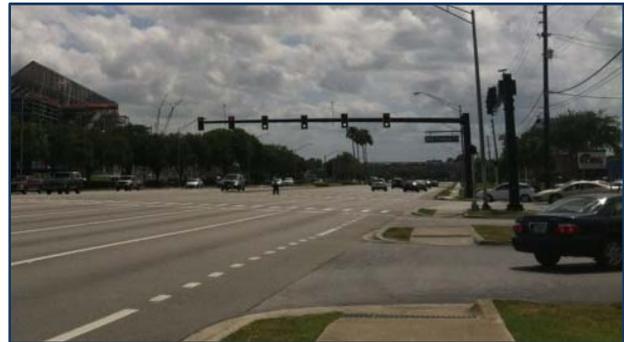
16. Sidewalks along US 92/SR 600/International Speedway Boulevard in the PCSA study area are interrupted by multiple driveways into private properties, creating points of conflict between motorized and non motorized traffic. These crossings are generally unmarked, with the driveway connection holder or Use Permit owner having maintenance responsibility. During the private development approval process, consideration should be given to marking and maintaining obvious conflict points between motorized and non-motorized traffic to limit the situation over time. An example is shown in the adjacent photo.

A sidewalk comes into conflict with a private driveway near Bill France Blvd.

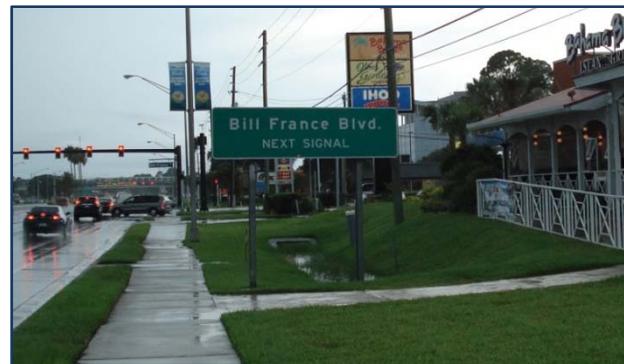
17. Some of the newer establishments have constructed connecting sidewalks to provide pedestrian access from the public sidewalks to their front door. These businesses, which include Olive Garden and Bahama Breeze, serve as a good example of strengthening pedestrian connectivity through better integration of public and private land uses.

A pedestrian entrance to Bahama Breeze ties into US 92/SR 600/International Speedway Blvd's westbound sidewalk. Vehicular traffic is located behind the building, reducing pedestrian and vehicular conflict points along the thoroughfare.

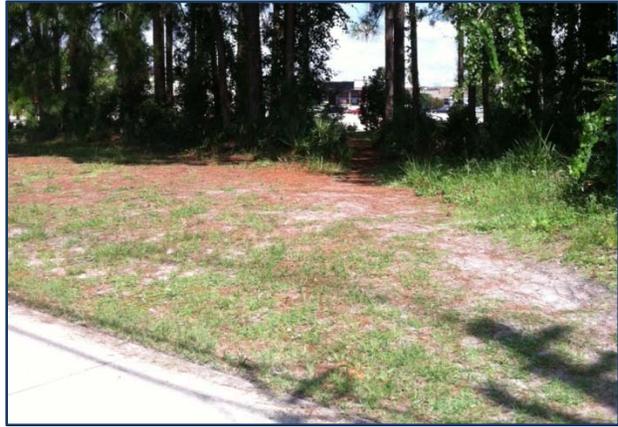
18. Over time, pedestrians have created a “cattle trail,” extending through the shrubbery, to access the east entrance parking lot of the Volusia Mall. This path serves as a pedestrian short cut between the mall’s entrance and the sidewalk on the north side of US 92/SR 600/International Speedway Boulevard.

A “cattle trail” leading from the westbound sidewalk of US 92/SR 600/International Speedway Blvd to Volusia Mall.

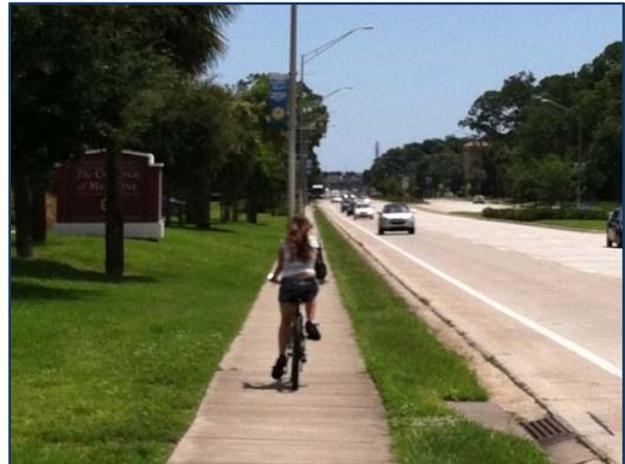
19. Despite the presence of bike lanes, cyclists frequently use the sidewalks to travel, potentially due to the designated maximum speed limit of US 92/SR 600/International Speedway Boulevard varying between 45-50 mph within the PCSA study area. Use of the sidewalk by bicyclists is dangerous to both pedestrians and cyclists

On International Speedway Blvd near the campus of Daytona State College, a cyclist rides on the sidewalk despite the availability of bike lanes.

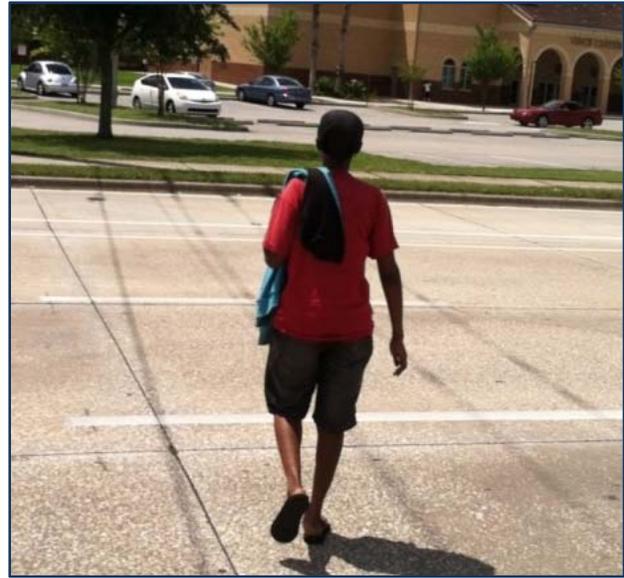
20. US 92/SR 600/International Speedway Boulevard, just east of SR 483/Clyde Morris Boulevard, is bounded on both sides by Daytona State College and Mainland High School. With a number of students enrolled in both campuses and the nearest marked crosswalk at 0.25 mile west, pedestrians tend to cross US 92/SR 600/International Speedway Boulevard mid-block between Highland Avenue and Central Avenue.

A pedestrian crosses US 92/SR 600/International Speedway Blvd to get from a bus stop in front of Daytona State College to Mainland High School.

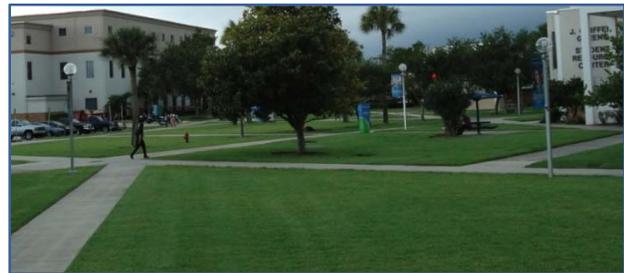
21. Major activities centers within the PCSA study area, such as Daytona State College, are already bicycle and pedestrian oriented. In most cases, there is a lack on direct connectivity of these internal uses with the streets that surround their campuses. Coordinated land use planning between public and private agencies offers the opportunity to tie the heart of existing internal activity centers with improved study area wide multimodal networks.

The heart of Daytona State College caters to pedestrian movement.

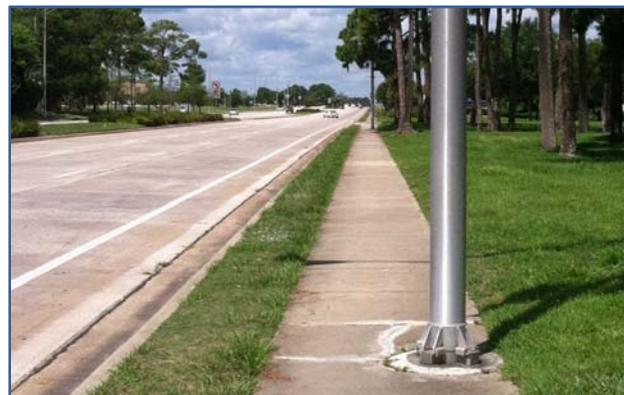
22. On the north side of the street, between SR 483/Clyde Morris Boulevard and White Street, street lights are located within the sidewalk. These protrusions reduce the effective width of the sidewalk and create ADA accessibility challenges. In areas where right of way may be constrained, it may be desirable to expand the sidewalk within the grass planter strip adjacent to the roadway.

A street light reduces the usable width of the sidewalk.

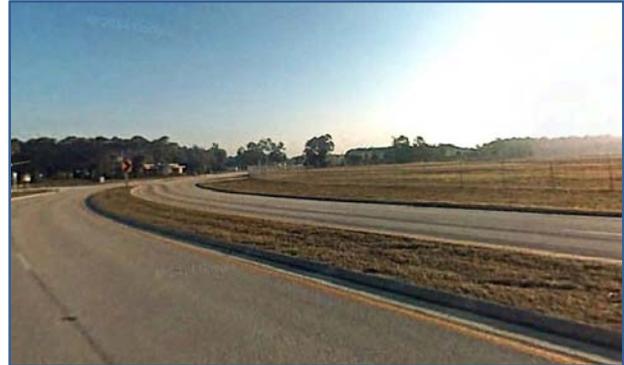
23. Richard Petty Boulevard, an important collector roadway and thoroughfare through the campus of Embry-Riddle Aeronautical University, is depicted in the adjacent photo. The facility lacks sidewalks on both sides for significant distances.

There is no sidewalk on this stretch of Richard Petty Blvd. Photograph courtesy of Google Streetview taken in June 2011.

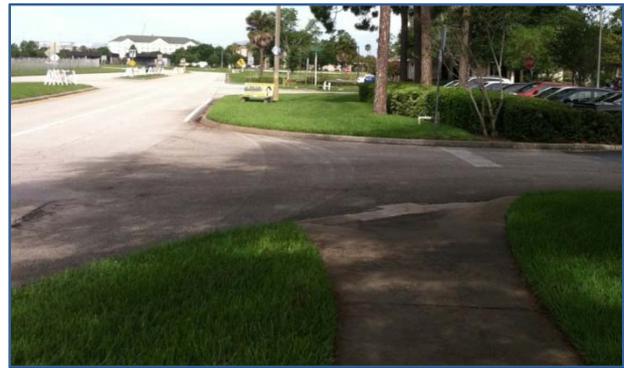
24. The bus stop on Richard Petty Boulevard, east of Corsair Drive, is not ADA compliant.

A non ADA compliant bus stop and sidewalk gap on Richard Petty Blvd at Corsair Dr. The bus stop is located on the utility pole above the bench in the background.

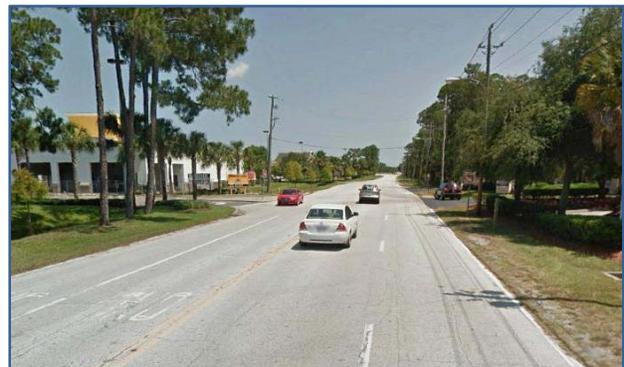
25. Thames Road lacks sidewalks on both sides between US 92/SR 600/ International Speedway Boulevard and Williamson Boulevard. It appears that a pedestrian “cattle trail” has developed along the southbound lanes of Thames Road near area shopping centers.

Due to a lack of sidewalks, a pedestrian “cattle trail” has formed along Thames Rd. Photograph courtesy of Google Streetview taken in June 2011.

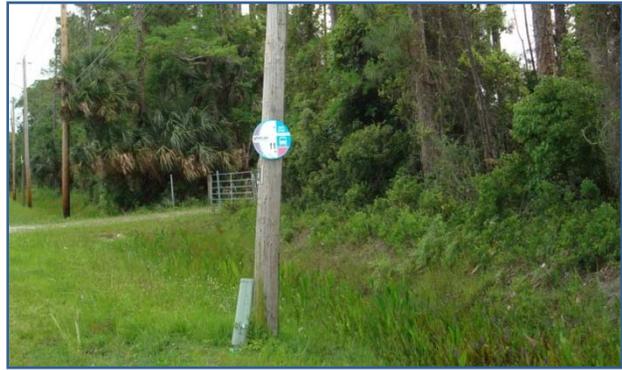
26. A bus stop on Thames Road is disconnected from the sidewalk network and is not ADA compliant.

A bus stop on Thames Rd.

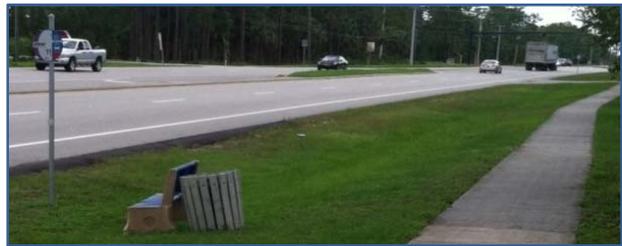
27. Several bus stops located along Williamson Boulevard are not ADA compliant or connected to the existing sidewalk network. The relocation of bus stops or addition of ADA compliant sidewalk and stop improvements should be considered at these locations.

This bus stop on Williamson Blvd near Indigo Dr is located in a ditch.

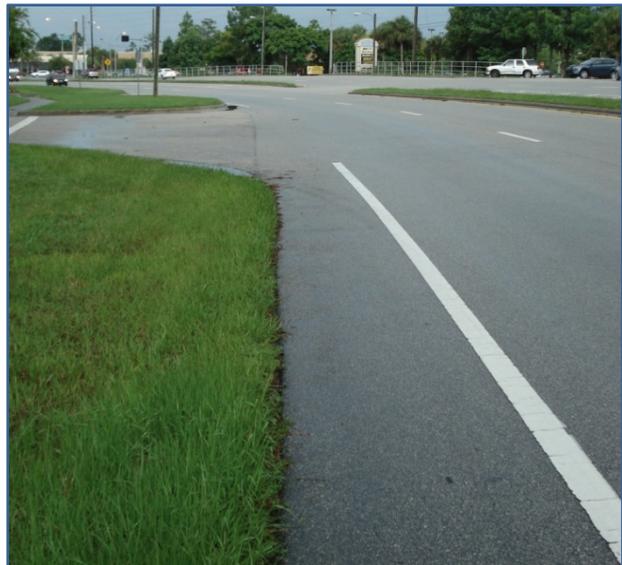
28. There is a 0.15 mile gap in the bike lane network, along Williamson Boulevard, just north of US 92/SR 600/ International Speedway Boulevard.

The Williamson Blvd bicycle lane, north of Target's rear entrance.

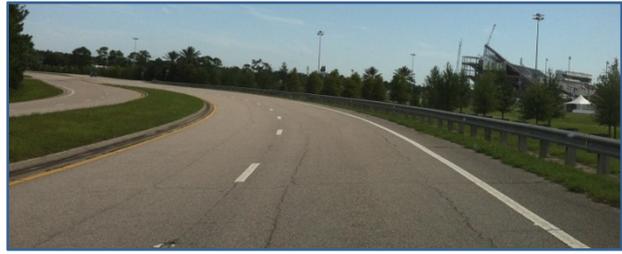
29. There are no sidewalks on either side of Williamson Boulevard, south of US 92/SR 600/International Speedway Boulevard.

Williamson Blvd, just south of US 92/SR 600/International Speedway Blvd.

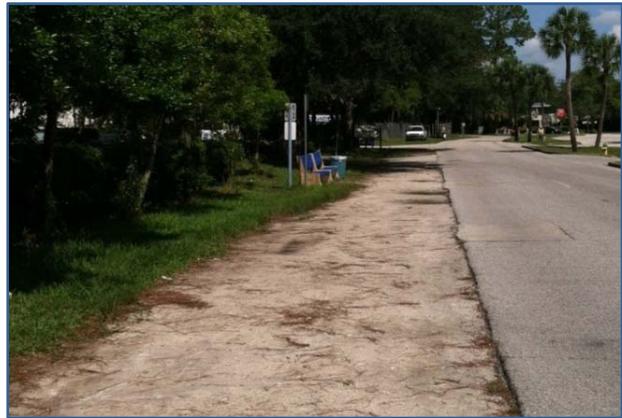
30. Fentress Boulevard connects several office and industrial uses with US 92/SR 600/International Speedway Boulevard. There is also a Votran bus route along Fentress Boulevard between US 92/SR 600/International Speedway Boulevard and Bayless Boulevard. Fentress Boulevard lacks sidewalks on both sides and transit stops along the roadway are non ADA compliant. During field observation, pedestrians were observed walking on the side of the road in gravel and grass to reach their destination.

A bus stop is located in an area without sidewalks on Fentress Blvd.

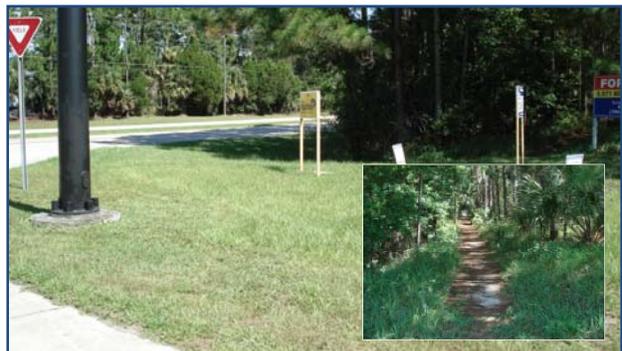
31. The sidewalk at the intersection of Mason Avenue and Bill France Avenue is disconnected from the sidewalk on the east side of Bill France Boulevard. Also, the east side sidewalk is hidden from view and in need of repair. Pedestrians were observed walking on the side of the road because they were unaware that there was a sidewalk.

The east side, disconnected sidewalk is hidden by trees, on the right side of the picture near the signs. The inset picture displays the condition of the sidewalk.

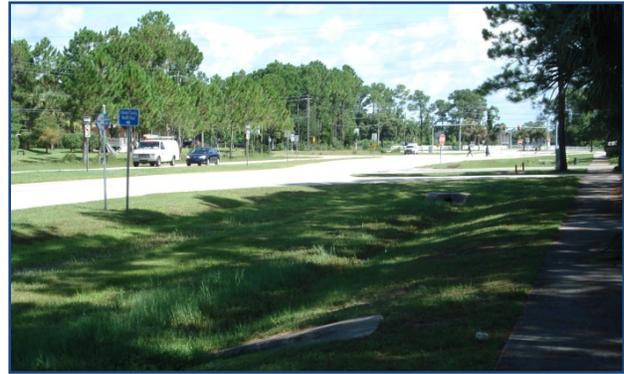
32. Several bus stops located along Bill France Boulevard are not ADA compliant or connected to the existing sidewalk network. The relocation of bus stops or addition of ADA compliant sidewalk and stop improvements should be considered at these locations.

This bus stop on Bill France Blvd near Mason Avenue is located in a ditch.

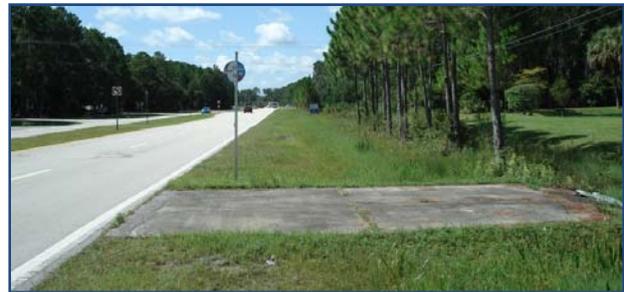
33. As illustrated in the adjacent photo, Bill France Boulevard has significant gaps within the sidewalk network.

A bus stop on Bill France Blvd near Holsonback Dr.

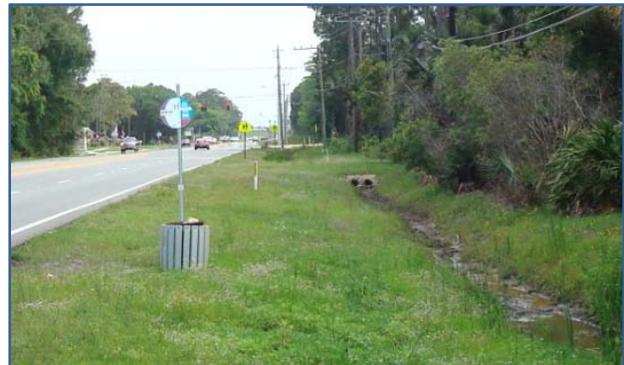
34. Bus stops on Bill France Boulevard are non-ADA compliant and lack sidewalk access.

A bus stop on Bill France Blvd.

ID	Location	Description	Lead Agency	Potential Resolution
34	Bill France Blvd. between Volusia Mall and Dunn Ave.	Bus stops on west side of street lack amenities and aren't ADA accessible.	City of Daytona Beach	Provide ADA accessible bus stops
35	Bill France Blvd north of Dunn Ave	A drop-off exists at the edge of sidewalk.	City of Daytona Beach	Repair grade to make ground flush with sidewalk travel surface
36	Bill France Blvd at southwest corner of Dunn Ave intersection.	No connection between sidewalk and pedestrian crossing button.	City of Daytona Beach	New sidewalk connection
37	Bill France Blvd south of Dunn Ave	Sidewalk on west side of street ends 200' south of Dunn Ave.	City of Daytona Beach	Construct sidewalk or shared use path on west side of street
38	Bill France Blvd north of Volusia Mall	There are no sidewalks on the west side of street north of Volusia Mall.	City of Daytona Beach	Construct sidewalk or shared use path on west side of street

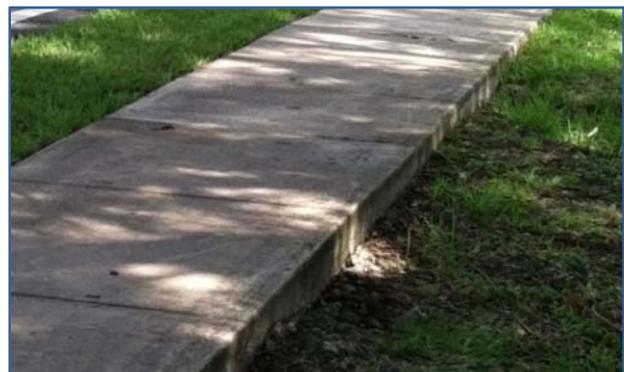
35. Just north of Dunn Avenue, a drop-off exists at the edge of the sidewalk. This creates a potential hazard for pedestrians and could be especially problematic for elderly pedestrians or others with a mobility disadvantage. As with roadways, the ground should be brought up flush with the sidewalk travel surface and maintained at that level.

Edge drop-off north of Dunn Ave.

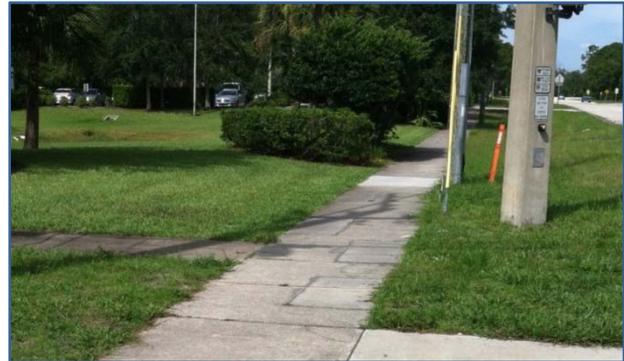
36. There is no connection between the sidewalk and the pedestrian crossing button at the southwest corner of the Bill France Boulevard/Dunn Avenue intersection.

Pedestrian button with no access to sidewalk.

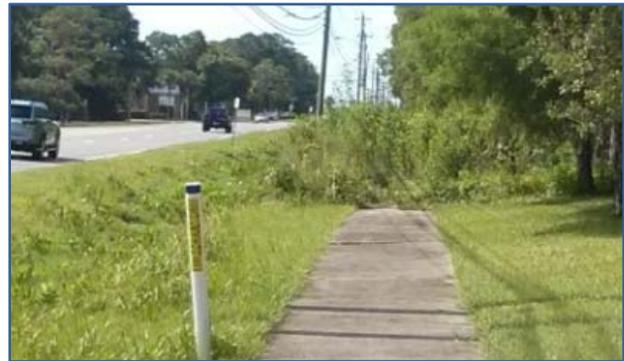
37. The sidewalk on the west side of Bill France Boulevard abruptly ends roughly 200 feet south of Dunn Avenue. Pedestrians using this sidewalk facility must backtrack or attempt to cross a ditch and Bill France Boulevard, mid-block, to access the sidewalk located on the east side of the street. Consideration should be given to eliminating this gap within the sidewalk network.

The sidewalk on the west side of Bill France Blvd, looking south from Dunn Ave.

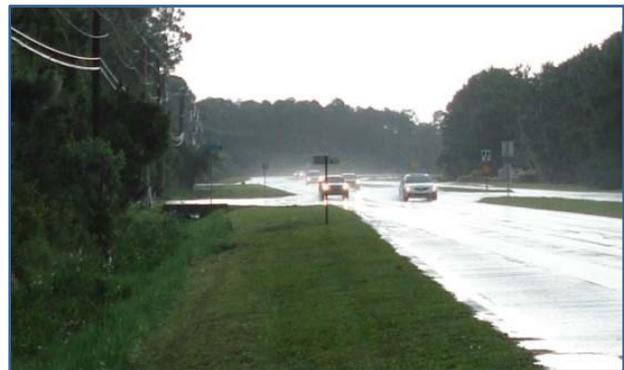
38. There are no sidewalks on the west side of Bill France Boulevard, north of Volusia Mall.

Bill France Blvd north of Volusia Mall.

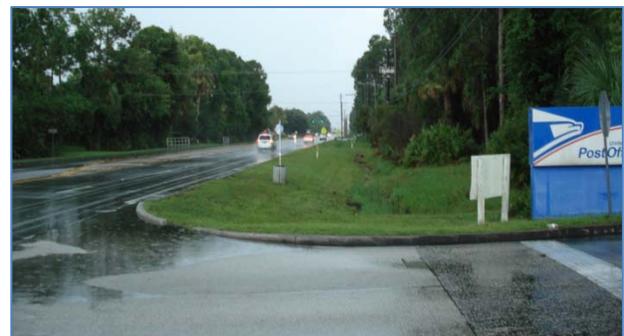
39. There are no sidewalks on the west side of Bill France Boulevard, between Dunn Avenue and SR 483/Clyde Morris Boulevard.

A view of the west side of Bill France Blvd north of Dunn Ave.

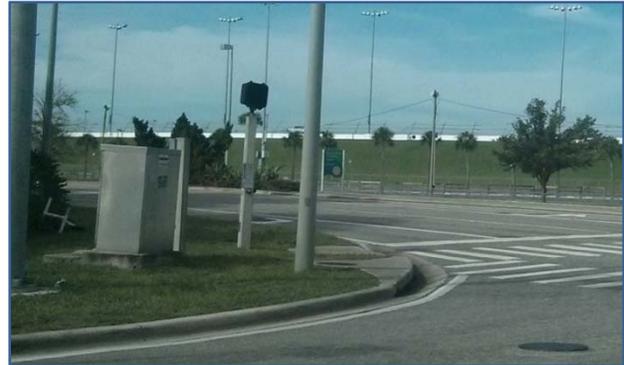
There are no sidewalks on Midway Avenue.

39	Midway Ave	Excluding a short segment on the east side of street, north of Richard Petty Blvd, there are no sidewalks on Midway Ave.	Volusia County	Construct sidewalk
40	Jimmy Ann Dr	There is no sidewalk on the east side of street. A pedestrian "cattle trail" has formed as a result.	City of Daytona Beach	Construct sidewalk
41	SR 483/Clyde Morris Blvd just south of Dunn Ave	Vegetation obstructs the sidewalk on the west side of street near Halifax Health.	FDOT	Maintenance of vegetation
42	SR 483/Clyde Morris Blvd south of Dunn Ave.	Existing condition of sidewalk on east side of street creates obstruction for pedestrians after rain events.	FDOT	Upgrade existing sidewalk conditions
43	SR 483/Clyde Morris Blvd. south of Dunn Ave	Access points in sidewalk on west side of road lack truncated domes. The sidewalk is broken with loose concrete.	FDOT	Upgrade existing sidewalk conditions
44	SR 483/Clyde Morris Blvd south of Dunn Ave	A utility pole is located within the sidewalk on the west side of the road.	FDOT	Verify the clearance meets minimal ADA accessibility requirements

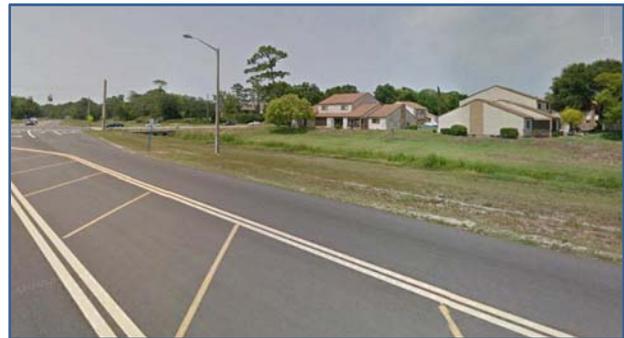
41. There is no sidewalk on the east side of Jimmy Ann Drive. As shown in the photo, a “cattle trail” has formed from pedestrians using the corridor.

Jimmy Ann Dr at Dunn Ave. Photograph courtesy of Google Streetview taken in June 2011.

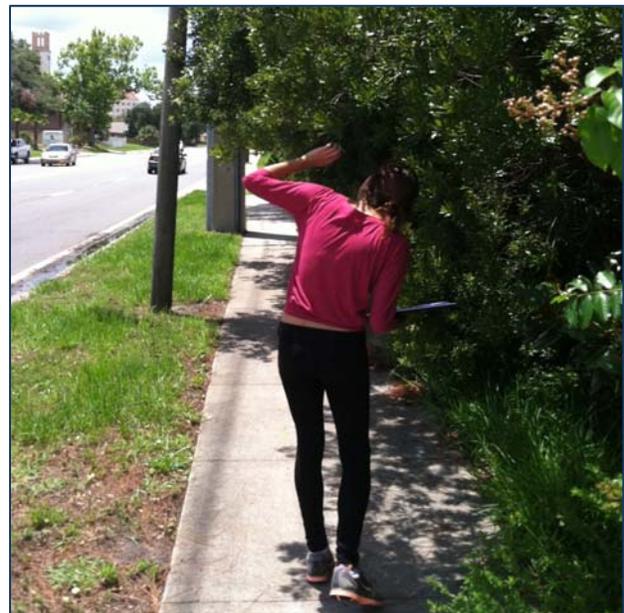
Vegetation obstructs walkway on Clyde Morris Blvd.

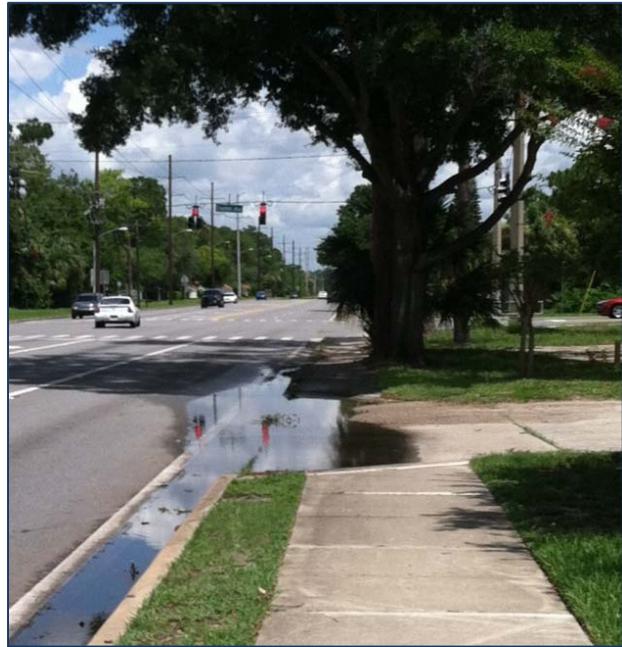
43. The driveway shown in the photo, located just south of Dunn Avenue, is affected by poor drainage after rainfall events. This creates an obstacle for pedestrians.

A driveway just south of the Dunn Ave intersection.

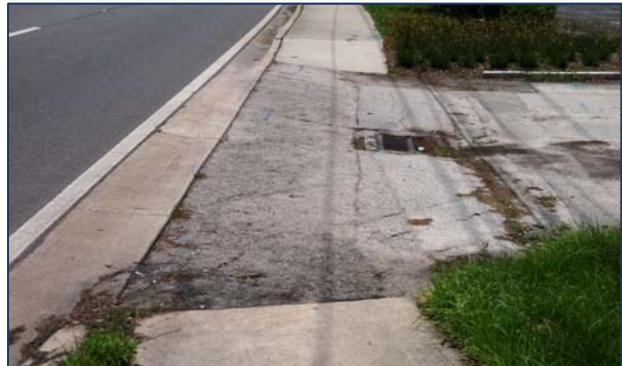
44. On the west side of SR 483/Clyde Morris Boulevard, the sidewalk ramps in the adjacent photo lack truncated domes (handicapped pads) and the driveway has a cracked and uneven surface.

The ramps at this sidewalk lack truncated domes and the driveway has an uneven surface.

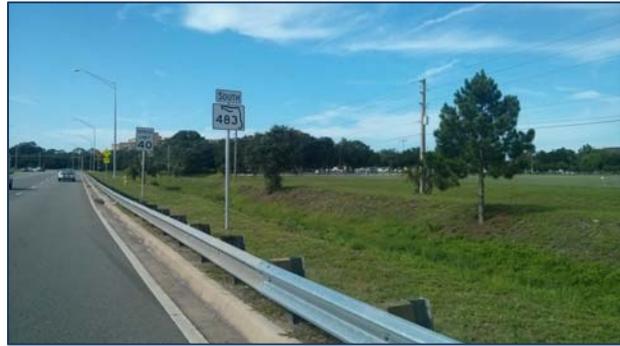
46. There is a gap within the sidewalk and bicycle network on the west side of SR 483/Clyde Morris Boulevard, between US 92/SR 600/International Speedway Boulevard and the campus of Embry-Riddle Aeronautical University.

Driving south on SR 483/Clyde Morris Blvd, between US 92/SR 600/International Speedway Blvd and Richard Petty Blvd.

As per the River to Sea TPO's 2035 Long Range Transportation Plan (LRTP), sidewalks will be installed on SR 483/Clyde Morris Boulevard south of US 92/SR 600/International Speedway Boulevard as a part of FDOT's plans to widen SR 483/Clyde Morris Boulevard from four to six lanes. FDOT anticipates right of way acquisition for this project to begin in 2018.

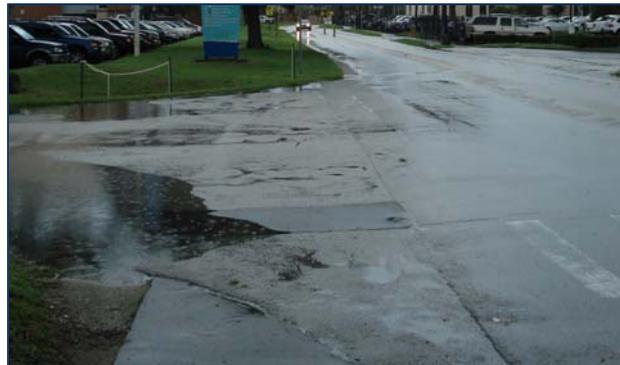
There is no connecting sidewalk from Heineman St into the adjacent parking area. In addition, puddles form following rain events.

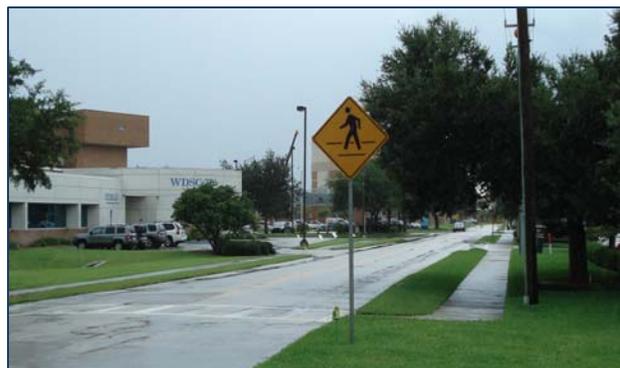
48. There are several sidewalk gaps on the west side of Heineman Street between Dunn Avenue and US 92/SR 600/International Speedway Boulevard. Missing segments include the block between Dunn Avenue and Willis Avenue and Redding Avenue to Bird Avenue/Mayberry Avenue. The last section of sidewalk starts at Pinecrest Avenue and ends 90 feet north of US

The sidewalk on the west side of Heineman St begins just south of Bird Ave/Mayberry Ave.

92/SR 600/International Speedway Boulevard. This stretch of sidewalk is broken in several places and should be repaired as soon as practical.

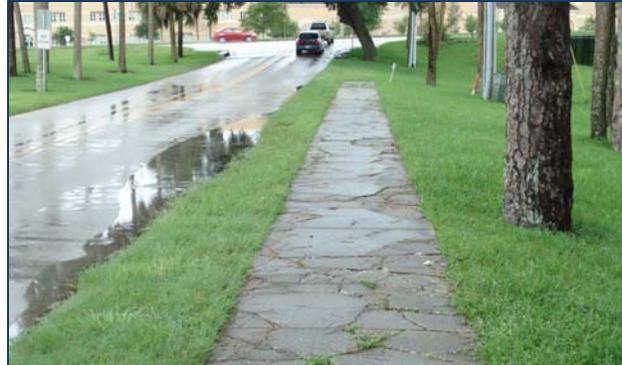
49. The sidewalk on the west side of Highland Avenue is in poor condition and ends abruptly before the intersection with US 92/SR 600/International Speedway Boulevard. To reach the intersection, pedestrians must either walk on the grass or in the street. As shown in the adjacent photo, water ponds along the edge of the roadway.

The sidewalk on the west side of Highland Ave abruptly ends before reaching US 92/SR 600/International Speedway Blvd. It is also in poor condition.

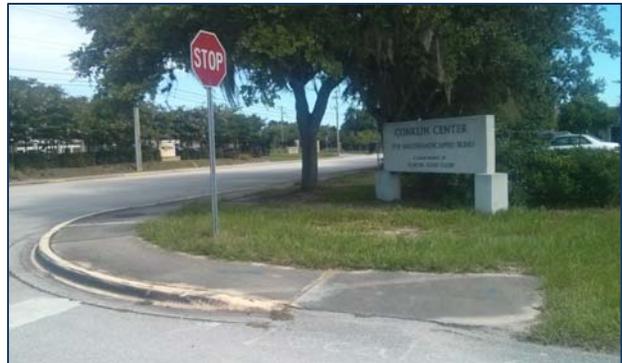
50. With the exception of the White Street/Dr. Mary McLeod Bethune Boulevard intersection, sidewalk ramps at intersections on the east side of White Street lack ADA compliant detection pads.

The intersection of Willis Ave and White Blvd.

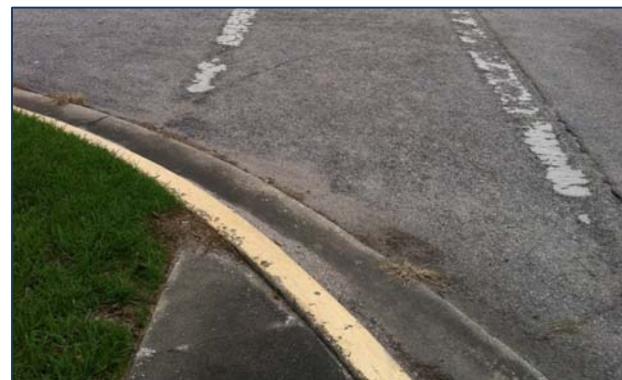
There are no ADA accessible ramps at the intersection of White St and Milligan Ave.

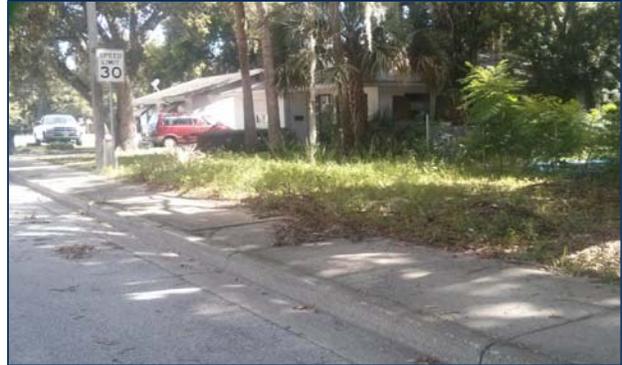
52. Vegetation obstructs the sidewalk on the east side of White Street. Trees, bushes and other vegetation should be maintained such that pedestrian movement is not impeded.

Vegetation obstructs the sidewalk on White St.

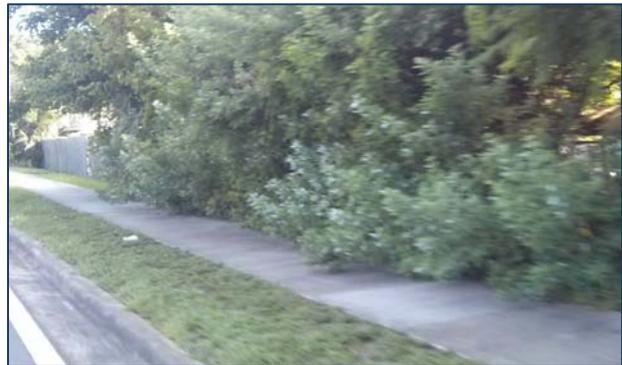
53. On the east side of SR 5A/Nova Road, between George Engram Boulevard and Dr Mary McLeod Bethune Boulevard, vegetation obstructs the sidewalk. Trees, bushes, and other vegetation should be maintained such that pedestrian movement is not impeded.

Vegetation reduces the useable width of sidewalks on SR 5A/Nova Rd.

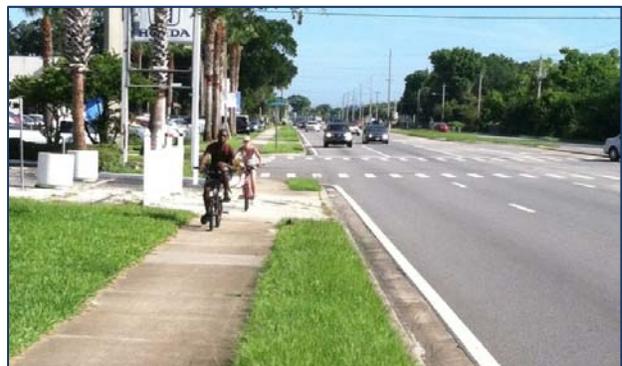
Cyclists ride on the sidewalk along SR 5A/Nova Rd.

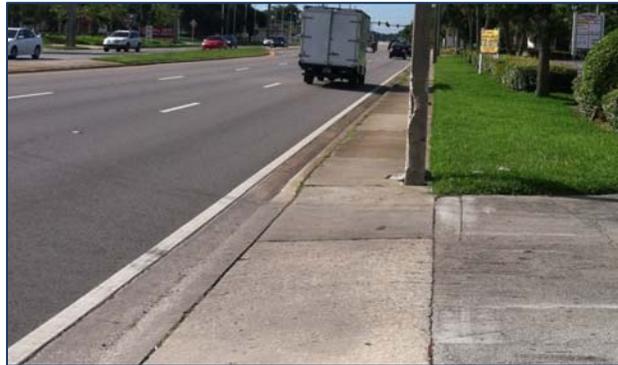
55. Street lights are located within the sidewalks between George Engram Boulevard and Orange Avenue. Although it appears that its location exceeds the ADA minimums, consideration should be given to relocating the pole outside of the sidewalk in the event of a future roadway project.

A utility pole located in the sidewalk at Midtown Plaza on SR 5A/Nova Rd.
