ISB Pedestrian Connectivity & Safety Assessment Study Field Evaluation Report

Prepared for:
Florida Department of Transportation District 5, Deland, FL

Prepared by: Ghyabi & Associates, Inc.

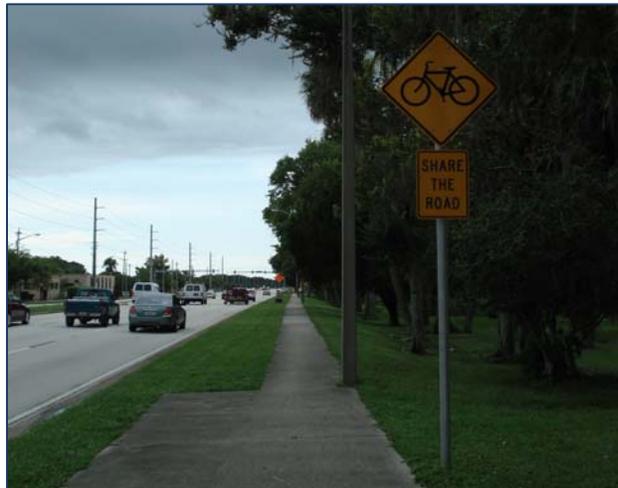
The sidewalk on the west side of SR 5A/Nova Rd varies.

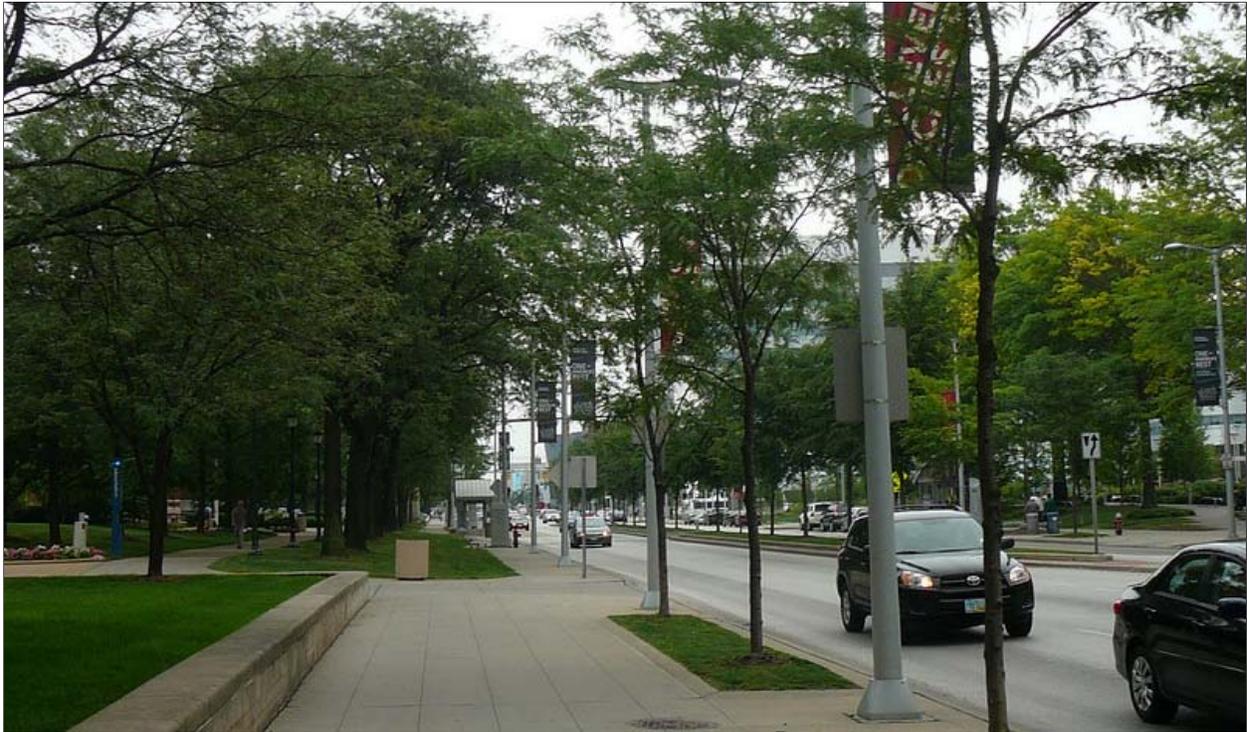
environment. Even with the current context that has relatively large building setbacks, moving or relocating obstacles – such as signs and utility poles while adding lighting, landscaping and street furniture to the edge of the curb – can create a clear pedestrian way to facilitate pedestrian movements. An example of a well defined Streetside Zone is shown below.

US 20/Euclid Avenue in Cleveland, OH is a good example of a walkable street. Photograph courtesy of MetroJacksonville.com taken in June 2013.

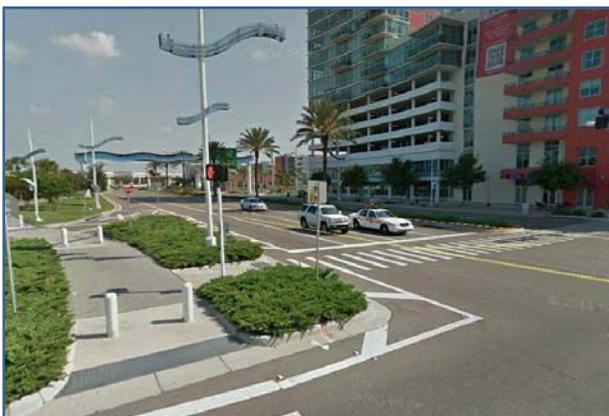
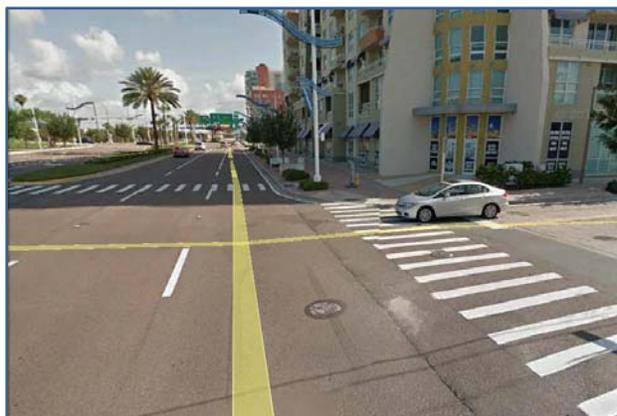
Meridian is a \$17 million six-lane gateway project to downtown Tampa that was completed by the Tampa Hillsborough Expressway Authority (THEA) in 2006. The 0.60 mile "Complete Streets" project connects SR 618A/Lee Roy Selmon Expressway's reversible express lanes (REL) and SR 60 with Channelside Drive. Bicycle and pedestrian features include 20-foot wide ADA compliant sidewalks, a 12-foot wide shared use path, median-based pedestrian refuges, benches, trash cans, sheltered bus stops, and adequately spaced decorative light fixtures and shade trees. There are four signalized intersections and maximum vehicle speed limits are 35 mph. In addition, Meridian Avenue's light fixtures are designed to resemble cranes that pay homage to the Channel District's maritime related past. Prior to its completion, the corridor consisted of a seldom used railroad yard and a two-lane street serving industrial uses within the vicinity.

A shared use path, themed lighting and infill development along SR 60/Meridian Avenue. Photographs courtesy of Google Streetview, taken in March 2013.

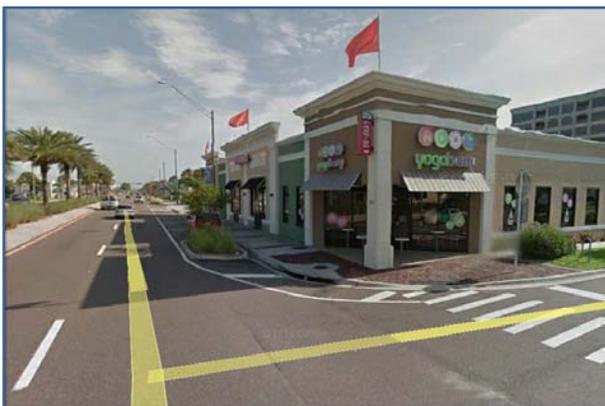
Pedestrian enhancements included new intersection crosswalks, landscaped center medians, parking lane "bulb-out islands," new sidewalks, and ADA compliant ramps at intersections. Pedestrian refuges were added at busy intersections to provide pedestrians and cyclists a safe break in the center of the roadway. Pedestrian countdown timers were also installed at crosswalks at signalized intersections.

Marked crosswalks, a landscaped median, and pedestrian refuge along SR A1A/Third Street. Photographs, courtesy of Google Streetview, taken in July 2013.

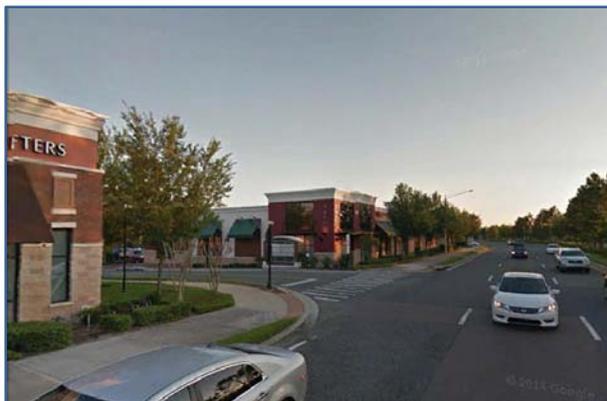
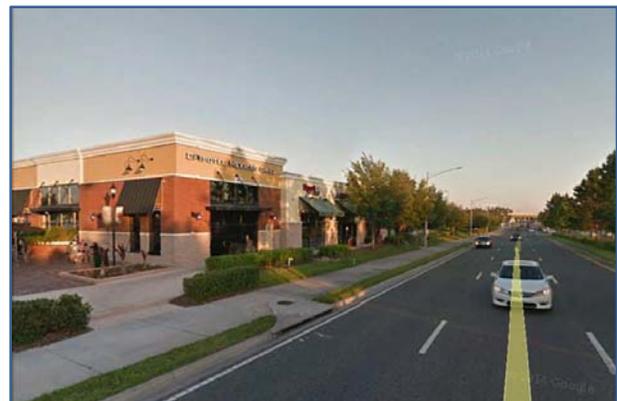
The design of Daniels Road contains a 6-foot wide sidewalk adjacent to southbound lanes and a 12-foot wide concrete path next to northbound lanes. This width is sufficient for bicycle traffic, efficiently reducing conflict points between motorized and non-motorized traffic. While marked crosswalks are typically present at urban signalized intersections, a unique feature of the Daniels Road project is that marked crosswalks are included at all driveways accessing private land uses within the corridor. Furthermore, the land development regulations require adjacent land uses to be designed to integrate with and activate the pedestrian network within the Daniels Road Right-of-Way.

A marked crosswalk and retail buildings tied to the sidewalk along CR 535/Daniels Road. Photographs, courtesy of Google Streetview, taken in April 2014.

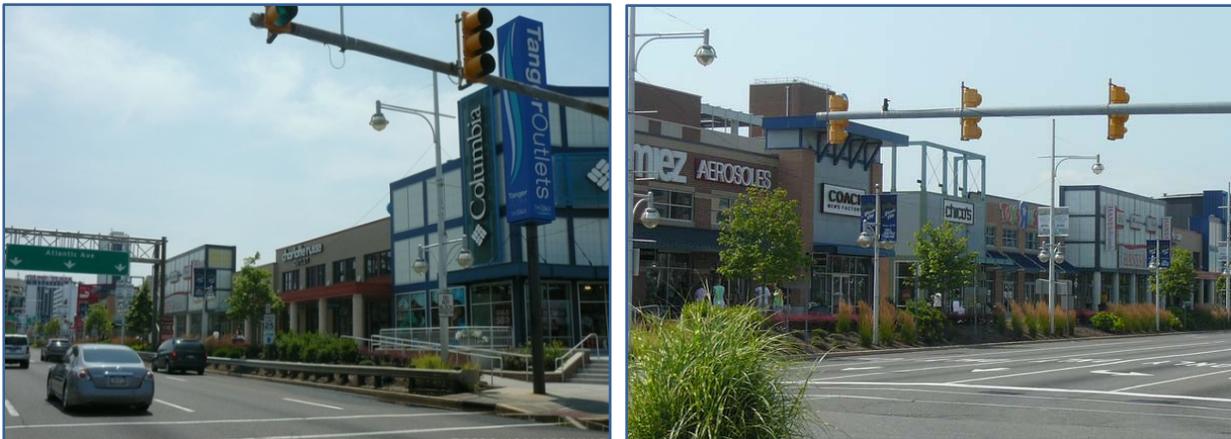
Its unique layout includes a municipal bus terminal, surface parking behind buildings, and retail stores with awnings, and a landscaped buffered sidewalk protecting pedestrians from vehicular traffic. In addition, a large landscaped median separates CR 692 and CR 694, speed limits are restricted to 25 mph and all intersection and driveway entrances have marked crosswalks, creating a safe pedestrian environment.

Tanger Outlets The Walk is infill retail adjacent to CR692/694 in Atlantic City, NJ. Photographs courtesy of MetroJacksonville.com taken in July 2014.
