TECHNICAL MEMORANDUM
CULTURAL RESOURCE ASSESSMENT SURVEY UPDATE
IN SUPPORT OF INTERSTATE 95 INTERCHANGE AT PIONEER TRAIL,
VOLUSIA COUNTY, FLORIDA

CONSULTANT:	SEARCH 700 N. 9 th Avenue, Pensacola, Florida 32501
PRINCIPAL INVESTIGATOR:	Jessica Fish, MSt, RPA
ARCHITECTURAL HISTORIAN:	Jason Newton, MA, MLIS
PROJECT ARCHAEOLOGIST:	Paetyn Milton, BS
CLIENT:	Florida Department of Transportation, District 5
DATE:	August 2020
FM#:	436292-1
SEARCH PROJECT #:	T20102

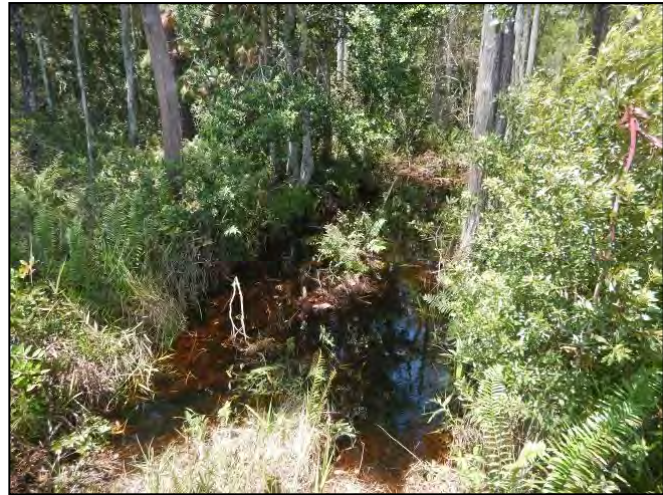
Figure 9. Overview of Pond 1, view north.

Pond 1 is a 9.6-acre pond located along the north side of Pioneer Road, west of I-95. The southern half of the pond was previously tested as part of FMSF Survey No. 26148. The pond is thickly vegetated by palmetto and pines, and standing water was noted (**Figure 9**). Two shovel tests were excavated within the boundaries of Pond 1; in addition, one “no-dig” point was employed at the west end of the pond where standing water was encountered (see **Figure 8**). Stratigraphy in both shovel tests consisted of dark brown or black mucky sand. In one shovel test, the water table was almost immediately encountered. In the second shovel test, the water table was encountered at approximately 40 cmbs (15.7 inches).

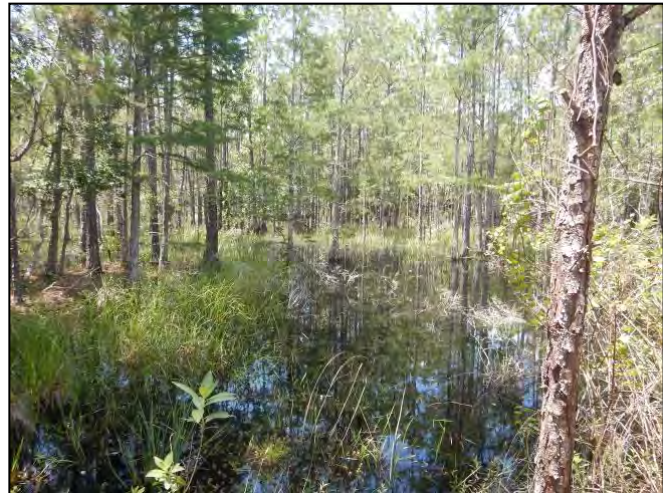
Figure 10. Overview of Pond 2, view north.

Pond 2 is a small, 1.0-acre pond located in the northwest quadrant of the interchange, northeast of Pond 1. Standing water was noted to the south of the pond. Vegetation consisted of palmetto and pines (**Figure 10**). A single, negative shovel test was excavated within Pond 2 (see **Figure 8**). Stratigraphy consisted of black wet sand to 15 cmbs (5.9 inches; Stratum I). At 15 cmbs (5.9 inches), the water table was encountered and excavation terminated.

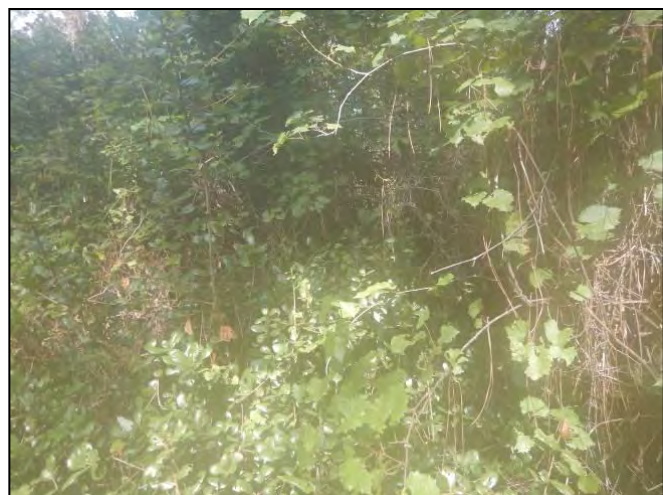
Figure 11. Overview of Pond 3, view west.

Pond 3 is an irregularly-shaped, 7.5-acre pond along the north side of Pioneer Trail, east of the I-95 interchange. The western half of the pond was previously tested during FMSF Survey No. 26148. Vegetation consists of dense palmettos and pines (**Figure 11**). Three shovel tests were

excavated in the untested portion of the pond, all of which were negative for cultural material (see **Figure 8**). Soil stratigraphy typically consisted of dark gray sand to 30 cmbs (11.8 inches; Stratum I), white sand from 30 to 50 cmbs (11.8 to 19.7 inches; Stratum II), and black spodic soils or standing water over 50 cmbs (19.7 inches).

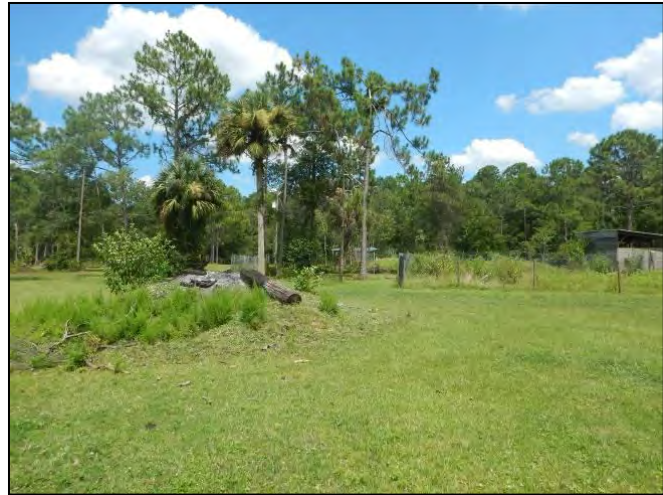
Figure 12. Overview of Pond 4, view east.

Pond 4 is a 5.5-acre triangular pond situated in the southeast corner of the interchange. A small retention pond is already located in the center of this proposed pond site, and the western half of the pond was previously tested as part of the original survey (FMSF Survey No. 26148). This pond is situated adjacent to a horse farm, and a small structure (non-historic) is located within the proposed pond site, according to current aerials. This location is largely clear with scattered mature trees (**Figure 12**).

Due to the presence of an existing pond, the previous testing, and existing structures, only one shovel test was able to be excavated within Pond 4, which was negative for cultural material (see **Figure 8**). The soil profile consisted of black and gray mottled loamy sand to approximately 25 cmbs (9.8 inches; Stratum I), gray loamy sand from 25 to 50 cmbs (9.8 to 19.7 inches; Stratum II), black very compact spodic soils from 50 to 60 cmbs (19.7 to 23.6 inches; Stratum III), and heavily compact, wet black soils over 60 cmbs (23.6 inches; Stratum IV).

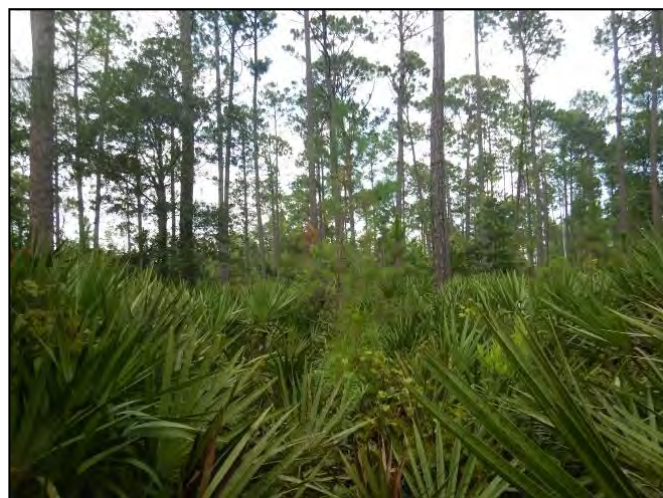
Figure 13. Overview of Pond 5, view north.

Pond 5 is a triangular, 4.3-acre pond located along the west side of I-95, south of Pioneer Trail. The west edge of the pond is bounded by an existing utility corridor, and the pond is vegetated by dense palmetto and wetland vegetation (**Figure 13**). A total of three shovel tests were excavated within the pond footprint, all of which were negative for cultural material (see **Figure 8**). The typical soil stratigraphy consisted of black or dark gray, mucky sand to at least 40 cmbs (15.7 inches; Stratum I), at which point crews encountered the water table and excavation terminated.

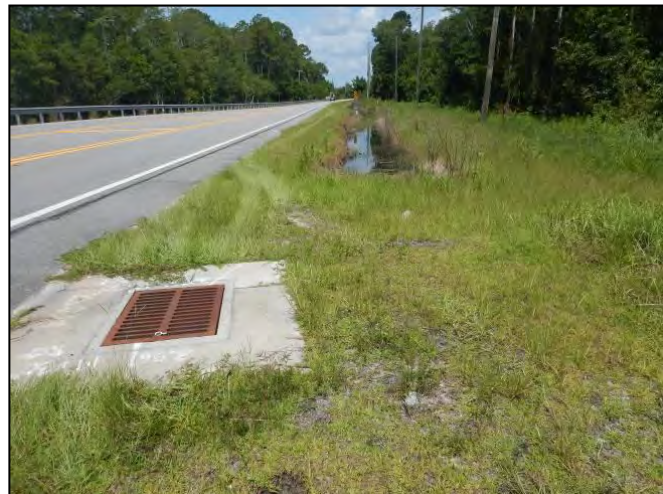
Figure 15. Overview of west end of Pioneer Road, north side, view west.

The current project limits along Pioneer Road extends approximately 1,312.3 feet (400 meters) west of archaeological APE tested as part of the original survey (FMSF Survey No. 26148). Minor widening to the south of the current roadway will necessitate the acquisition of additional right-of-way; as such, the archaeological APE in this area of the project corridor was slightly wider on the southern side of Pioneer Road. Several buried utilities (gas, sewer, etc.) as well as a drainage ditch are located on the north side of the roadway, while the south side was marked with wetland flags (**Figure 15**). Due to buried utilities, no testing could be conducted on the north side; a pedestrian survey was used to inspect the area for evidence of archaeological deposits, and four “no-dig” points were used to document

Due to buried utilities, no testing could be conducted on the north side; a pedestrian survey was used to inspect the area for evidence of archaeological deposits, and four “no-dig” points were used to document

this survey (see **Figure 8**). Three shovel tests were excavated along the south side of Pioneer Road; all three shovel tests revealed black, mucky sand and terminated in standing water at 10 cmbs (3.9 inches).

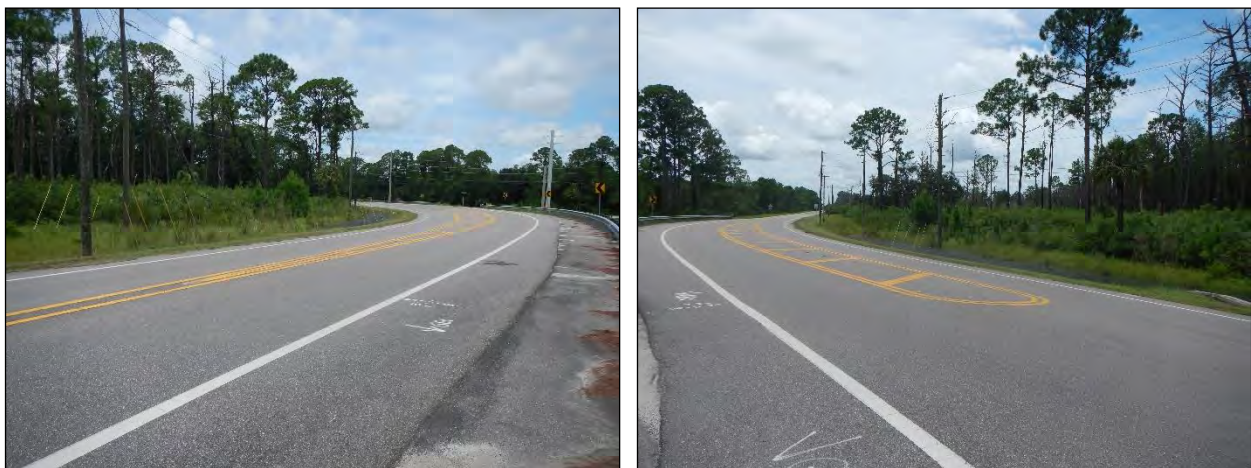
Figure 16. Resources 8VO07656 and 8VO07660 within the I-95 at Pioneer Trail Update APE, facing northwest (left) and southeast (right).

A thorough field check of the project area was undertaken for this CRAS addendum. Based on this field visit, it is the opinion of SEARCH that the conditions of these two linear resources within the project APE has not changed since their previous recordation in 2019, and they remain ineligible for listing in the NRHP. As a result, Resources 8VO07656 and 8VO07660 were not re-evaluated as part of this CRAS addendum. **Figure 16** shows the condition of the modern roadway as observed during the field visit.
