**FLORIDA DEPARTMENT OF TRANSPORTATION**  
**BRIDGE MANAGEMENT SYSTEM**  
**Inspection/CIDR Report**  
(TRAFFIC SIGNAL MAST ARM INSPECTION REPORT)

Structure ID: 70M088

| BY: | Ayres Associates | STRUCTURE NAME: | US-1 (Washington Ave.) NB at SR-406 (Garden St.) |

TYPE OF INSPECTION: Regular NBI

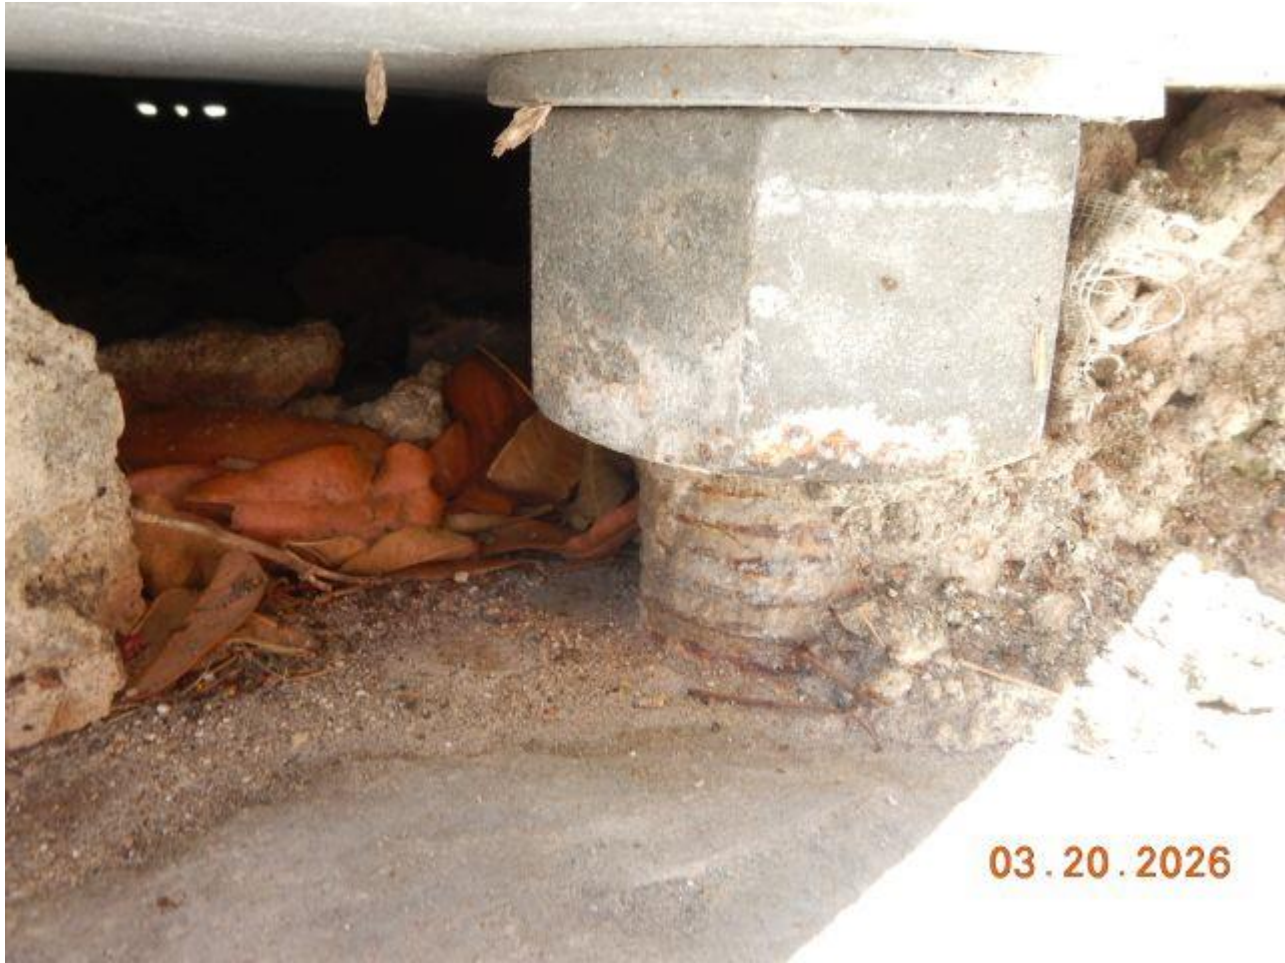
**Photo 1: Element 8480 / Mast Arm Foundation**

F1, F2 and F3 - The anchor bolts and leveling nuts below the base plate have light corrosion viewed thru the spalled grout ring at F1 and thru the hand hole access at F2 & F3 with a borescope. NO CHANGE. Refer to Photos 1 & 2. (3 EA) REPAIR.

F1 - Light anchor bolt thread corrosion below base plate viewed where grout pad was partially removed.

F1, F2 & F3 - Remove remaining grout pad. Clean / paint all corrosion and tighten any loose leveling nuts. Install structural grout pad in accordance with FDOT Spec. 649-7. No repairs have been made since the 2021 Inspection.

F1 F2 & F3 - Remove grout pad, paint anchor bolts & leveling nuts & install wire screen Per Spec. 649-8.

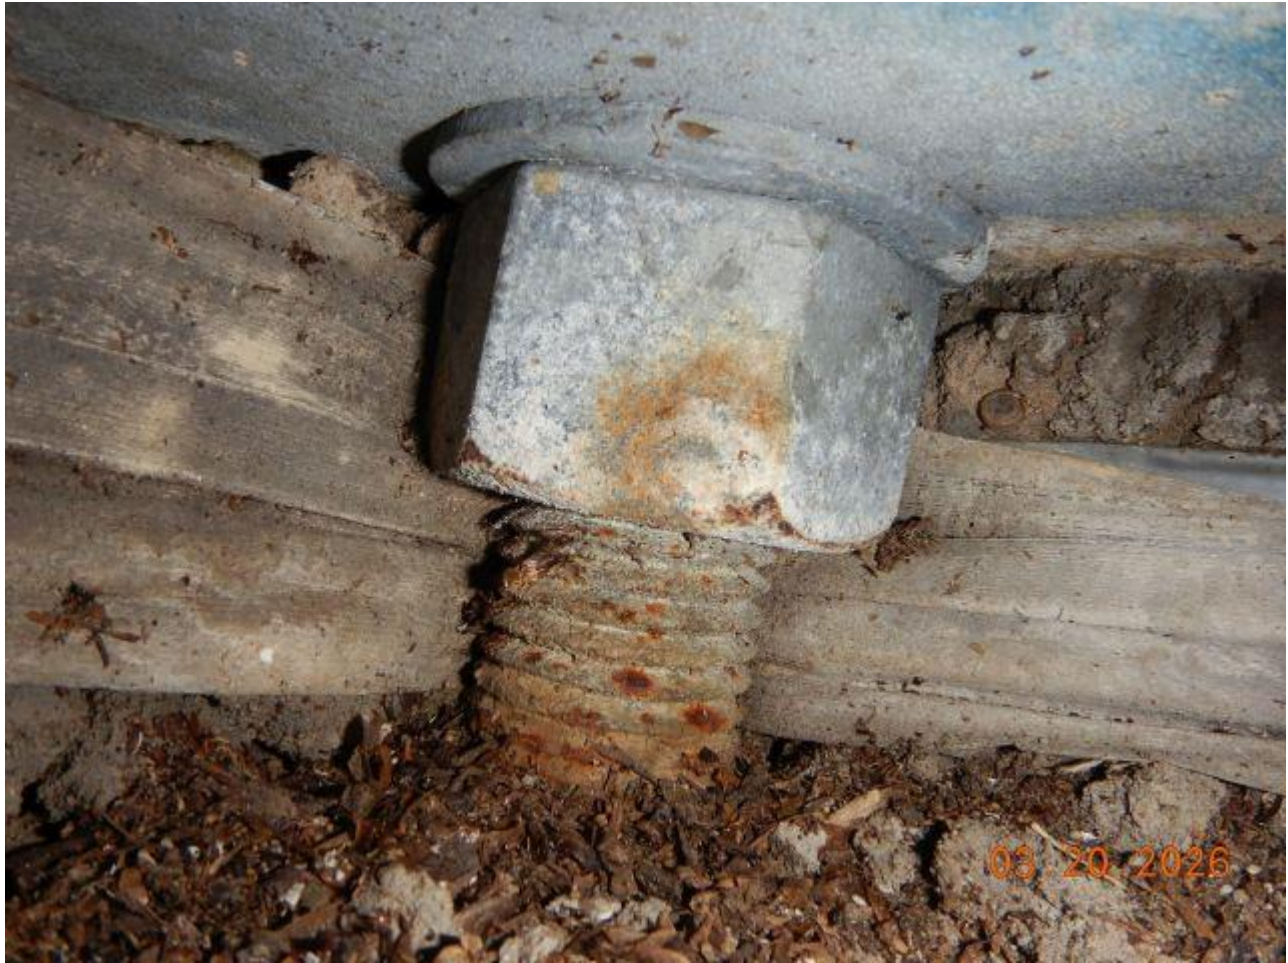
**Photo 2: Element 8480 / Mast Arm Foundation**

F2 & F3 - Typical light anchor bolt thread & leveling nut corrosion below base plate viewed with borescope thru the hand hole access. (F3 shown)

F1 F2 & F3 - Remove grout pad, paint anchor bolts & leveling nuts & install wire screen Per Spec. 649-8.

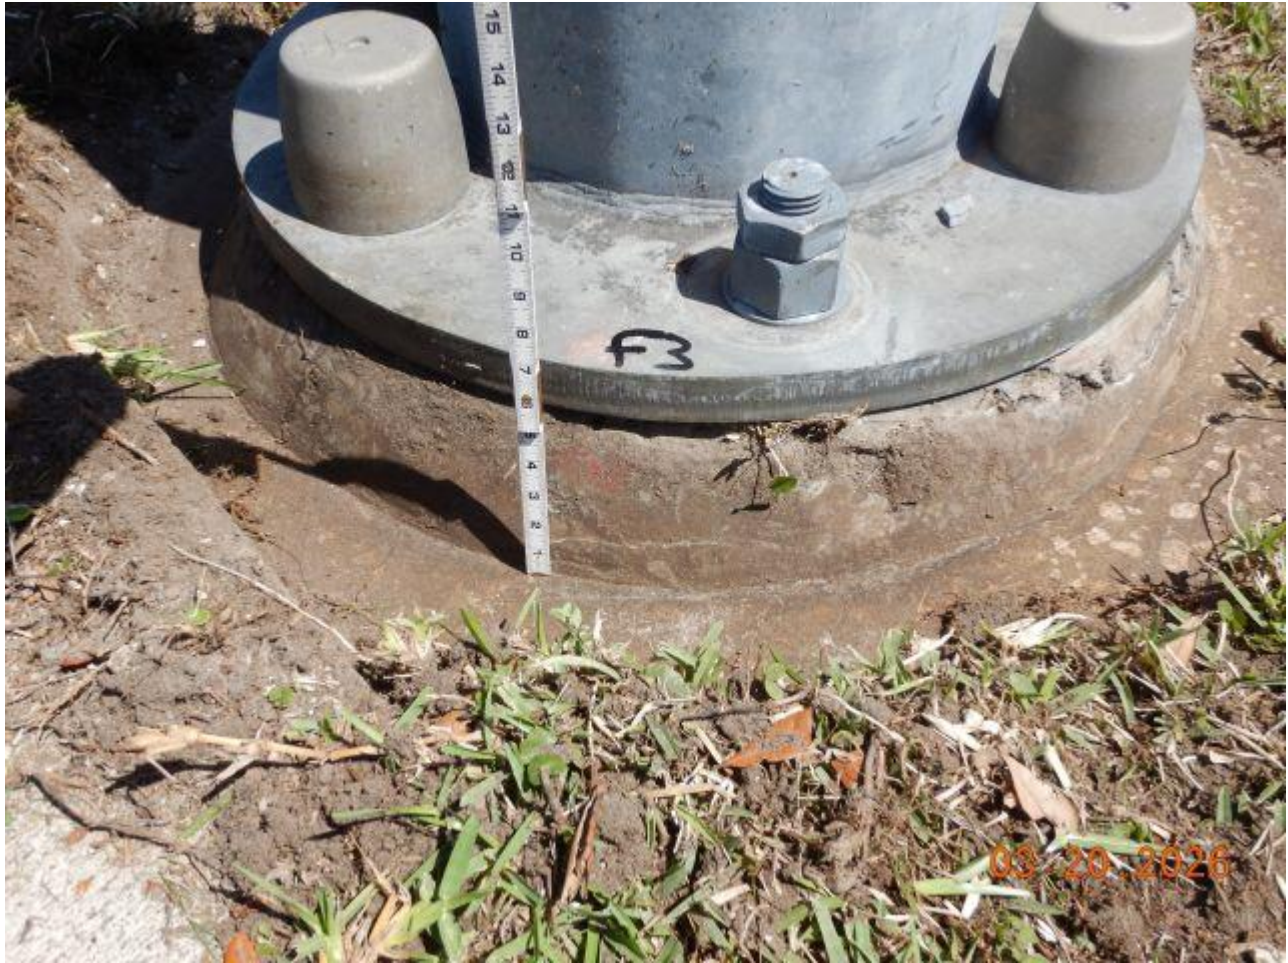
**Photo 3: Element 8480 / Mast Arm Foundation**

F3 - The anchor bolt stand-off distance appears to be greater than the diameter of the anchor bolt. Bolt diameter = 1 3/4 in., average estimated stand-off distance = 2 in. Per DMS Memorandum 15-03, this structure was built before 2008 and has an arm length less than 60 ft., therefore, no repair is necessary at this time. NO CHANGE. Refer to Photo 3.

NBI Item (60) Substructure rating is coded a 5 - Fair due to excessive anchor bolt stand-off distance at Foundation F3.

F3 - Excess anchor bolt stand-off distance.

None.

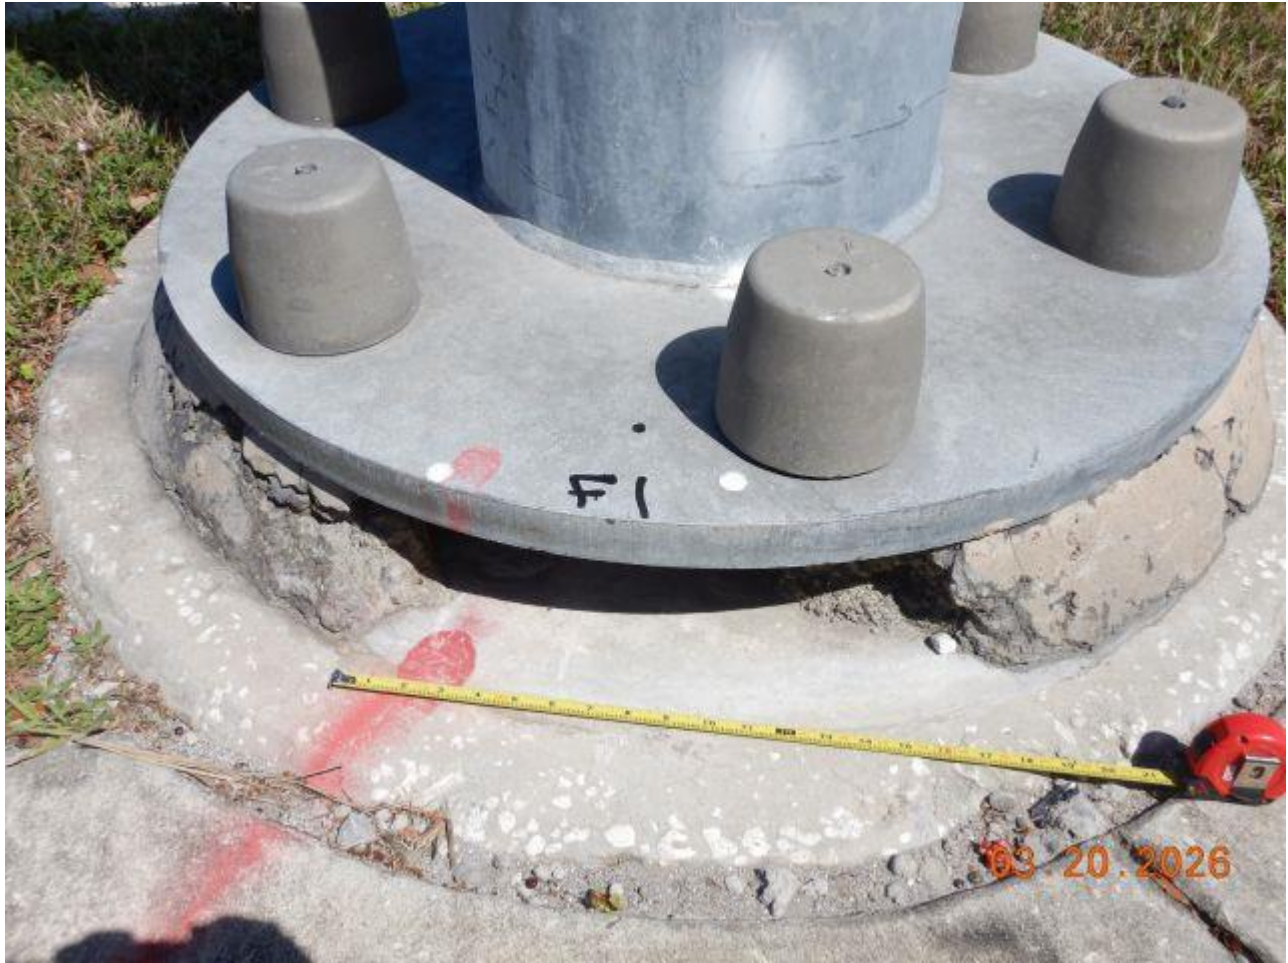
**Photo 4: Element 8480 / Mast Arm Foundation**

F1 - The grout ring is failing / hollow and was previously partially removed by the inspectors between anchor bolts #1 & 2. NO CHANGE. Refer to Photo 4. REPAIR.

F1 - Gout ring failing and previously partially removed between anchor bolts 1 & 2.

F1 F2 & F3 - Remove grout pad, paint anchor bolts & leveling nuts & install wire screen Per Spec. 649-8.

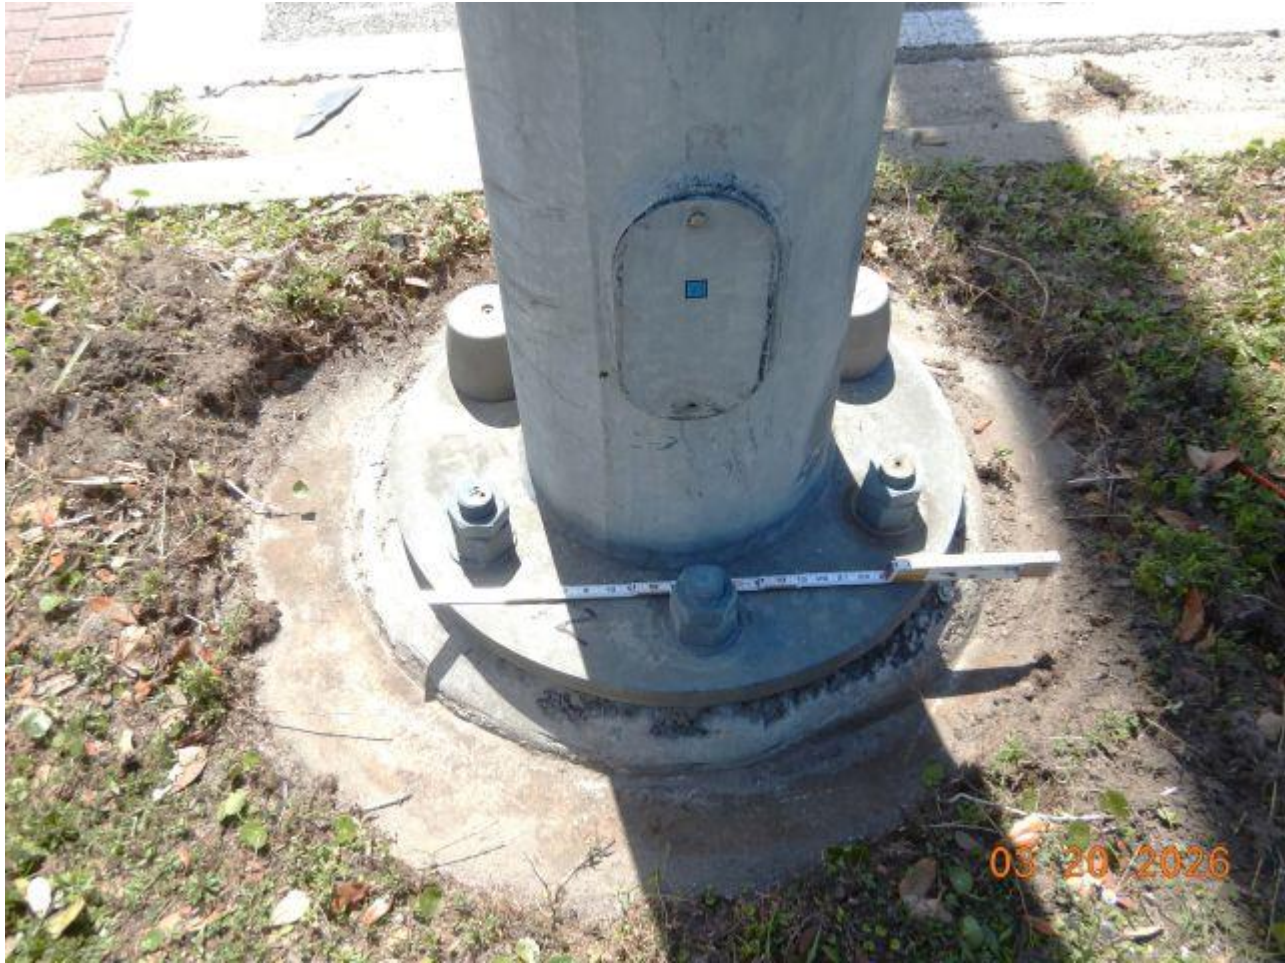
**Photo 5: Element 8480 / Mast Arm Foundation**

F2 - (3) of (6) anchor bolt covers (AB#1, 3 & 4) attachment bolts are broken off inside the anchor bolts, and the covers cannot be secured (previously noted as 2 of 6). INCREASE. Refer to Photo 5. REPAIR.

F2 - (3) of (6) anchor bolt covers (AB#1, 2 & 6) are missing (previously noted as 1 of 6). INCREASE. Refer to Photo 5. REPAIR.

F2 - Overview of broken anchor bolt attachment bolts and missing covers.

F2 & F3 - Repair broken anchor bolt cover attachment bolts & replace missing covers.

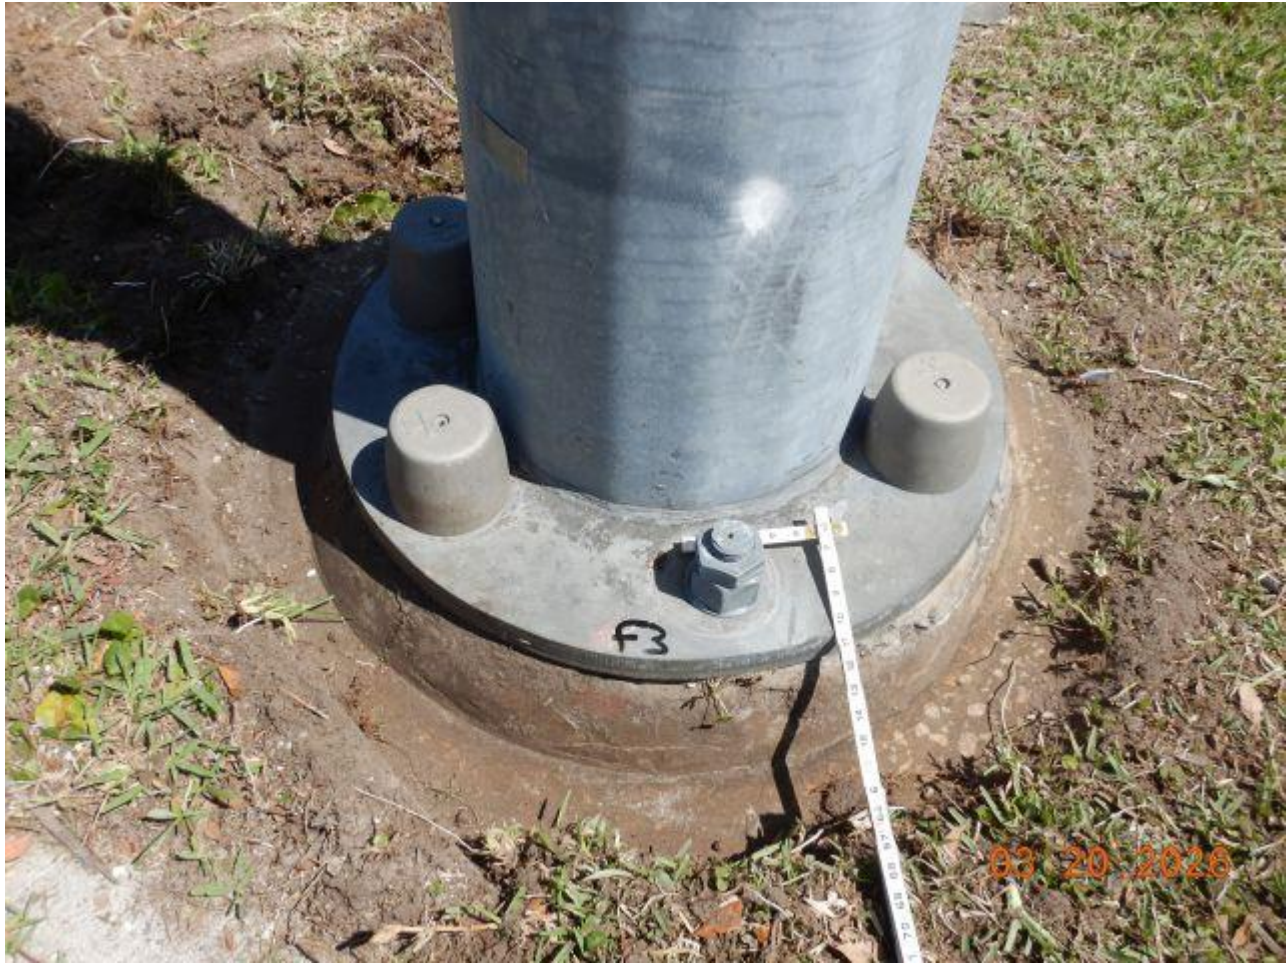
**Photo 6: Element 8480 / Mast Arm Foundation**

F3 - (1) of (6) anchor bolt covers (AB#2) attachment bolt is broken off inside the anchor bolts, and the cover cannot be secured. Refer to Photo 6. REPAIR.

F3 - (1) of (6) anchor bolt cover (AB#3) is missing. NEW. Refer to Photo 6. REPAIR.

F3 - Overview of broken anchor bolt attachment bolt and missing cover.

F2 & F3 - Repair broken anchor bolt cover attachment bolts & replace missing covers.

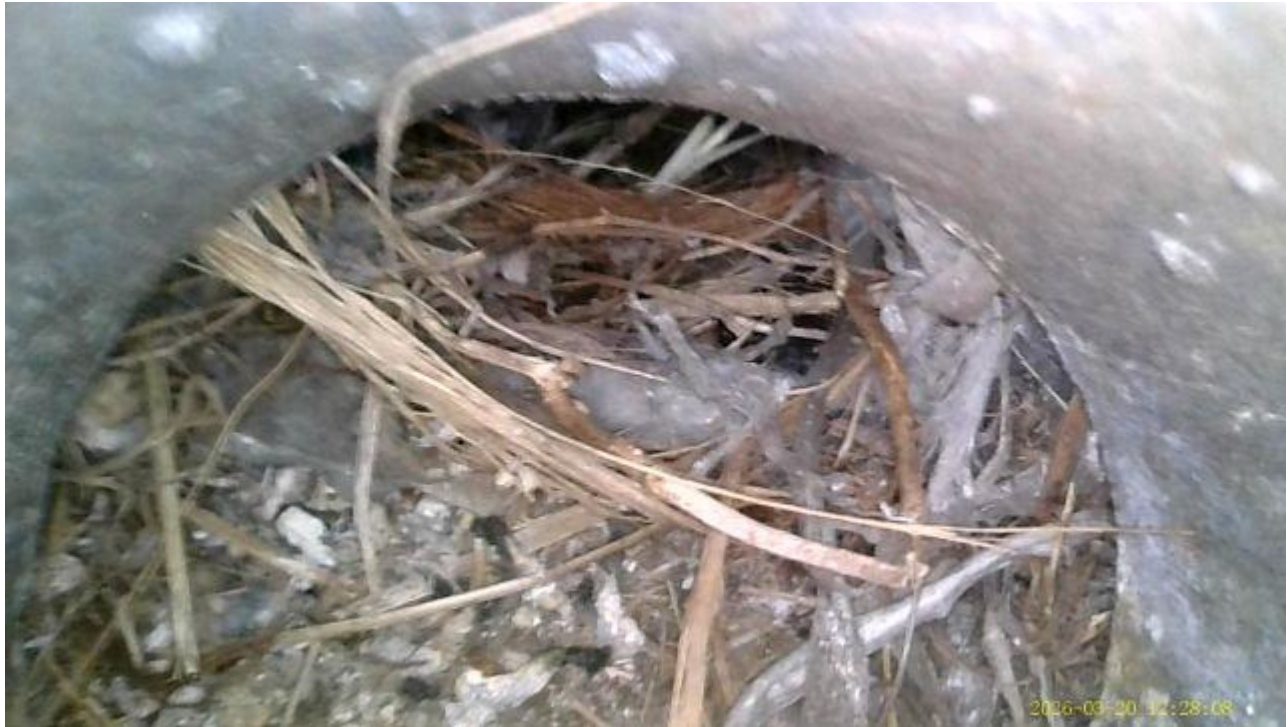
**Photo 7: Element 8484 / Mast Arm Horizontal**

V1/H1, V2/H2 & V3/H3 - The horizontal arm interiors have a heavy accumulation of bird nesting material viewed with a borescope thru the moment connection plate signal wire

holes and the arm drain holes. D-meter readings at 3 in., 12 in. & 24 in. from the moment connection taken at the 5, 6 and 7 o'clock positions did not indicate any reduction in section at this time. NEW. Refer to Photos 7, 8 & 9.

V1/H1 - Bird nesting material completely filling arm interior viewed thru moment connection plate signal wire hole.

V1H1 V2H2 & V3H3 - Remove bird nests from moment connection plates & install screening.

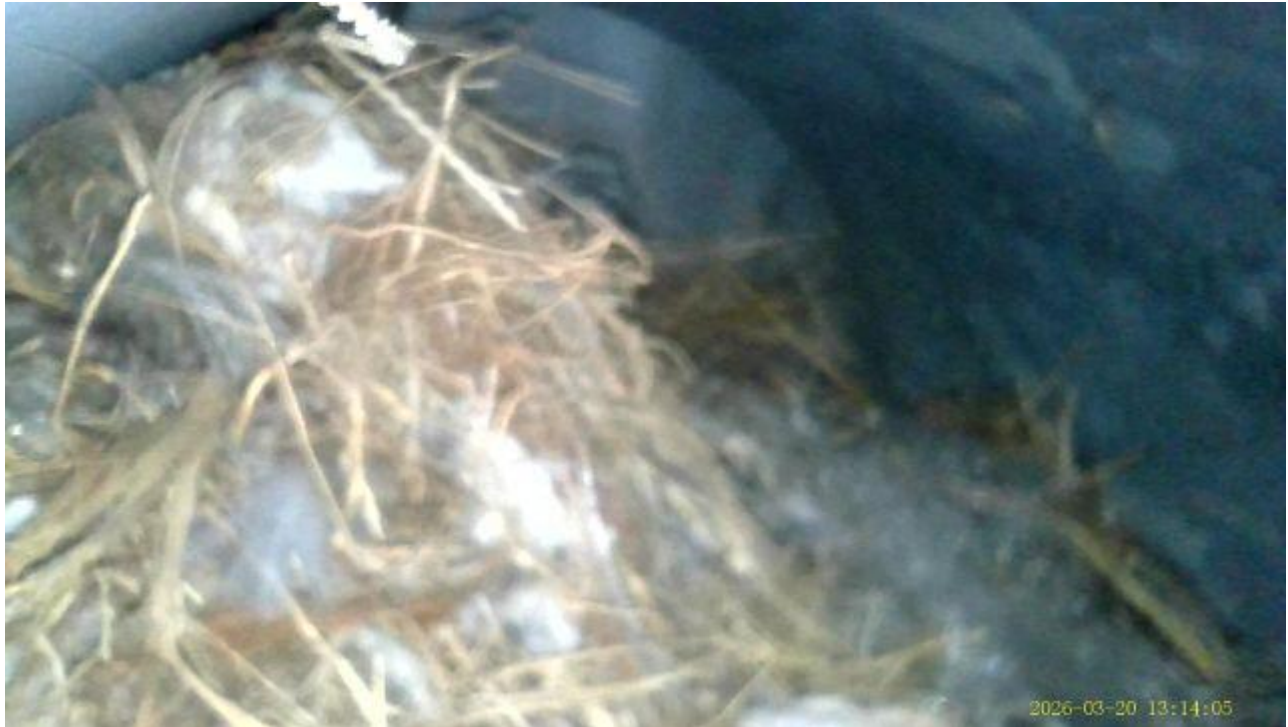
**Photo 8: Element 8484 / Mast Arm Horizontal**

V2/H2 - Bird nesting material completely filling arm interior viewed thru moment connection plate signal wire hole.

V1H1 V2H2 & V3H3 - Remove bird nests from moment connection plates & install screening.

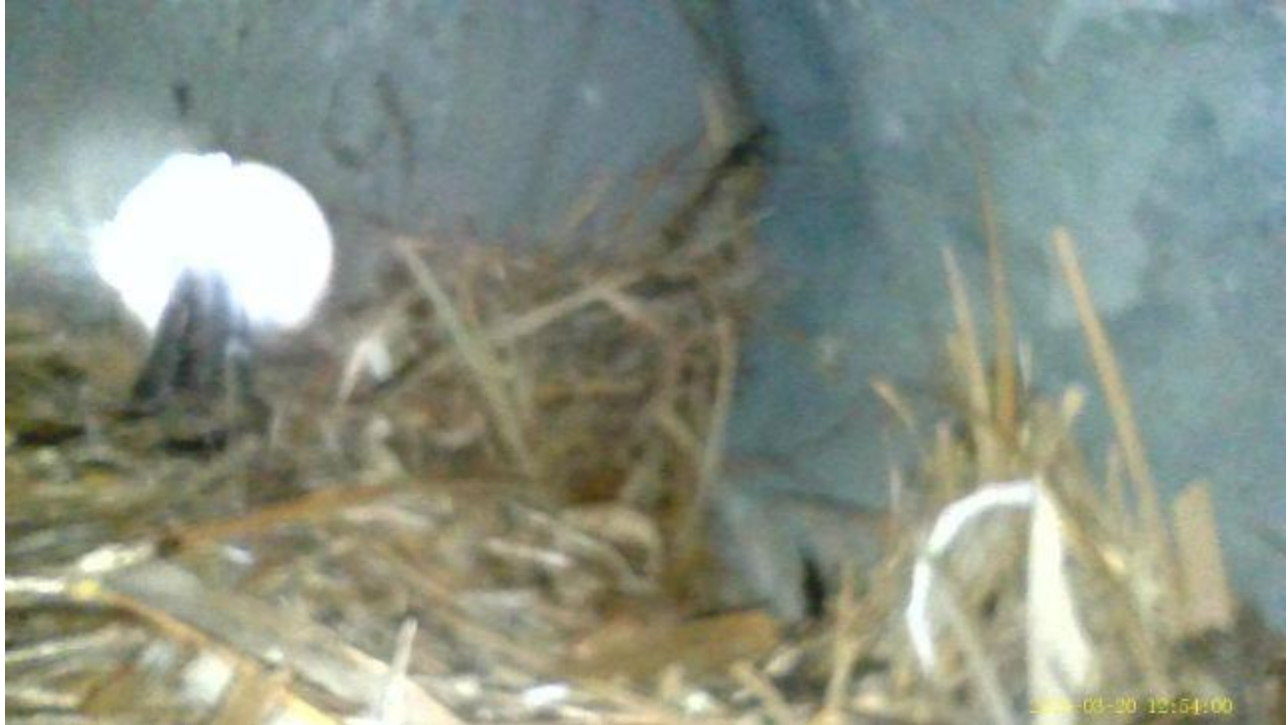
**Photo 9: Element 8484 / Mast Arm Horizontal**

V3/H3 - Bird nesting material completely filling arm interior viewed thru moment connection plate signal wire hole.

V1H1 V2H2 & V3H3 - Remove bird nests from moment connection plates & install screening.

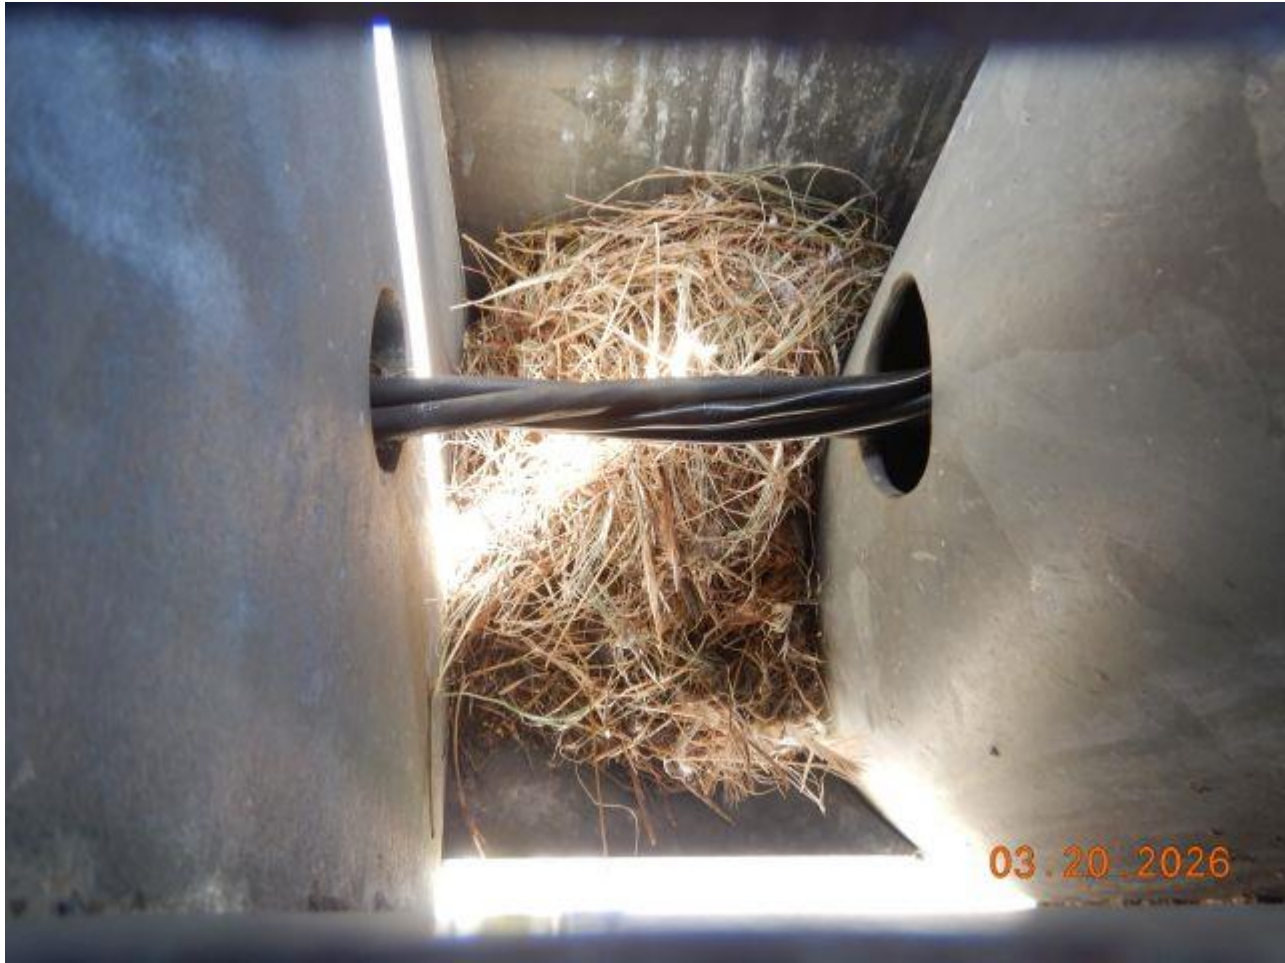
**Photo 10: Element 8484 / Mast Arm Horizontal**

V1/H1 and V2/H2 - There is a bird nest between the moment connection plates. NEW. Refer to Photo 10. REPAIR.

V1/H1 & V2/H2 -Typical bird nest between moment connection plates. (V1/H1 shown)

V1H1 V2H2 & V3H3 - Remove bird nests from moment connection plates & install screening.
