Intersection Analysis

**SR 46 at Richmond Avenue
(Section 77040, M.P. 4.065)**

Seminole County, Florida

July 2023

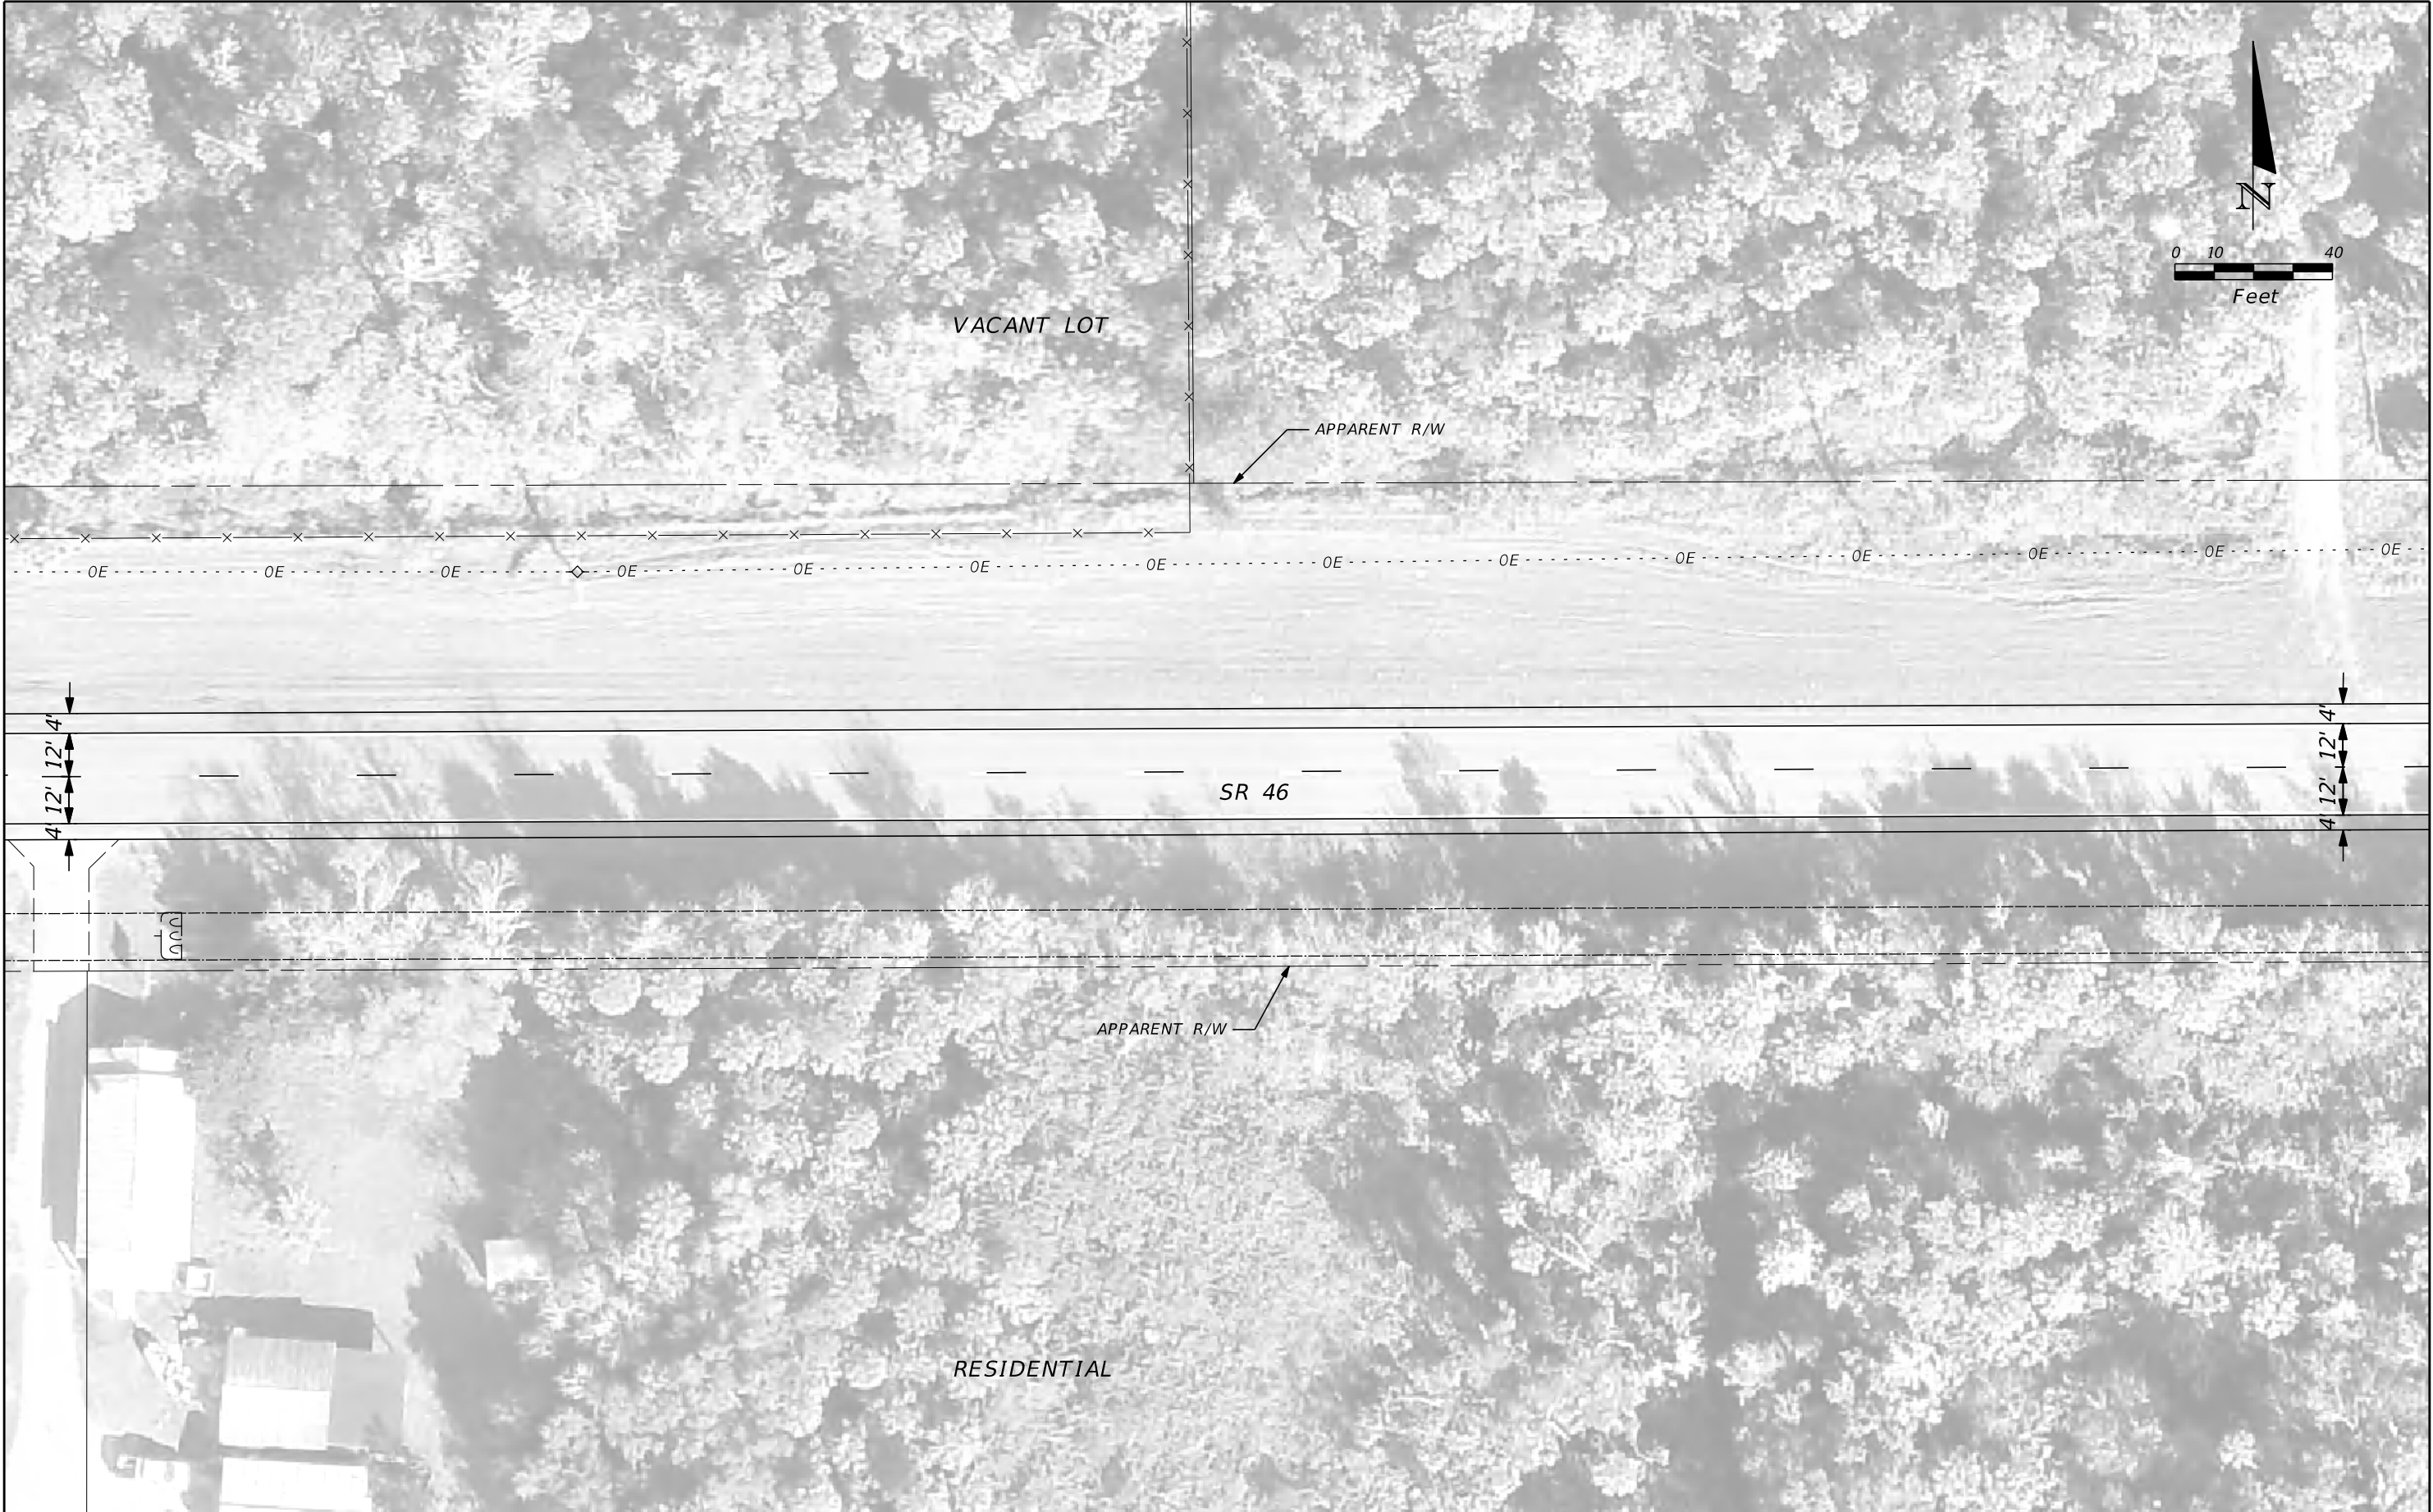
LEGEND			STATE OF FLORIDA DEPARTMENT OF TRANSPORTATION			FIGURE 2-2 CONDITION DIAGRAM		SHEET NO.	
—x—	FENCE	⌒	EXISTING SIGN	ROAD NO.	COUNTY			1 of 4	
- - - -	CANAL	⌒	EXISTING LUMINAIRE	SR 46	SEMINOLE	FINANCIAL PROJECT ID			
⌒	ELECTRICAL CABINET	⌒	UTILITY POLE			237995-1-32-20			
⌒	UTILITY POLE	⌒	UTILITY POLE

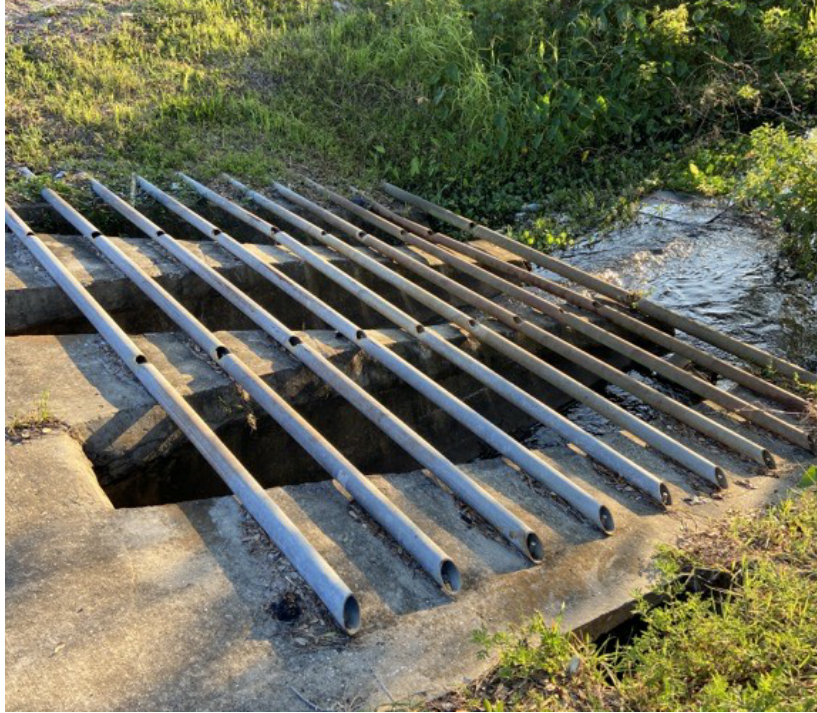
Figure 4-4
Drainage Structure East of Richmond Avenue

West of Richmond Avenue, construction was underway on the adjacent parcel 03-20-31-300-0020-000 with dewatering of the site occurring. This led to the presence of standing water in the mitered end sections adjacent to Richmond Avenue (**Figure 4-4**) but did not indicate poor drainage under normal conditions. During the PM peak hour observation while conditions were wet, drainage appeared sufficient. Mitered end sections are present 120 feet west of the Richmond Avenue edge of pavement and 10 feet east of the Richmond Avenue edge of pavement.

The ditch on the south side of SR 46 east of Richmond Avenue was found to be located within the 36-foot clear zone. The field measured distance from the eastbound edge line to the shoulder break point was approximately 12 feet. The measured slope for the paved and unpaved shoulder appeared to meet slope criteria (6% and 1:4 or flatter, respectively) within this distance. However, the ditch had very steep slopes that would be considered non-traversable.

In the southeast corner of the intersection, the top of the mitered end section is very close to the edge of travel (less than 10 feet) for the northbound Richmond Avenue through lane. It is recommended to wrap the guardrail around the radius using an 8-foot radius CRT System (Standard Index 536-001, sheet 12 of 24), and extend the cross drain 25 feet to the east. Note 2 of Standard

Index 536-001, sheet 12 of 14 requires a minimum clear area of 25 feet behind the CRT to fixed objects and above ground hazards. There are no fixed objects or above ground hazards within that distance. However, these improvements shield the canal and increase the distance from the guardrail to the canal, greatly improving safety over existing conditions. Per FAC 62-330.051(9)(c), this cross drain extension would be exempt from permitting as its impact is less than 0.10 acre.

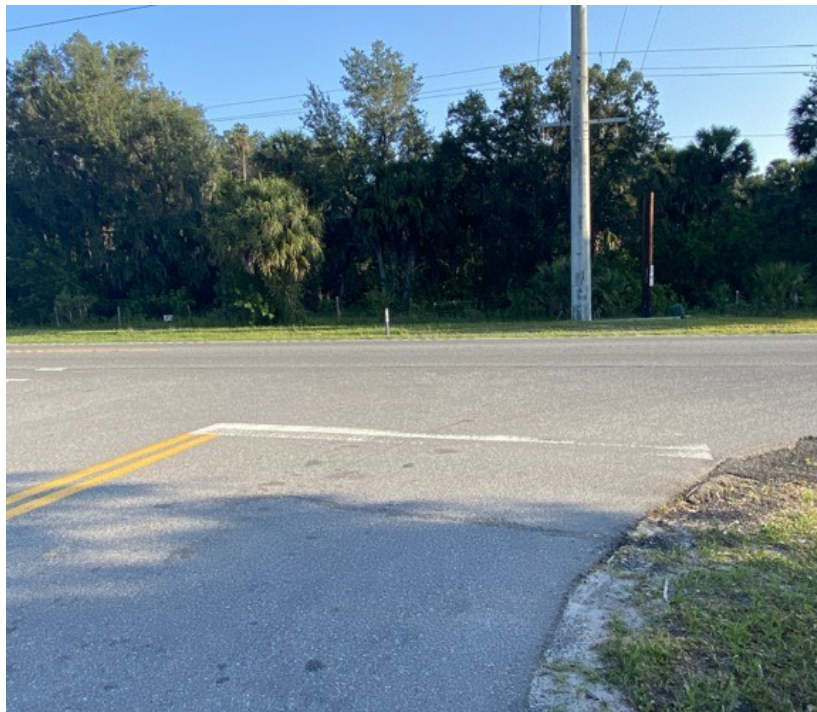
Figure 4-5
Stop Bar at Northbound Richmond Avenue

Pavement markings on the northbound approach to the intersection indicate a need for refreshment due to fading and cracking. This was particularly evident at the stop bar on Richmond Avenue (**Figure 4-5**). Additionally, reflective pavement markers (RPMs) are missing on Richmond Avenue from the stop bar to approximately 45 feet south of the stop bar (**Figure 4-6**). Audible and vibratory treatment is present along the centerline of SR 46 as well as along the edge lines. Passing is permitted in the eastbound direction from Richmond Avenue to approximately 940 feet east of the intersection on SR 46 via a skip gap yellow centerline. A dotted extension line is present at the SR 46 eastbound approach as a keyhole for right turn conflicts with shoulder bicycle use. A double solid yellow centerline is present along Richmond Avenue and no edge lines are present.

- The stop bar at Richmond Avenue needs to be refreshed.
- The missing RPMs should be replaced on Richmond Avenue.
- The stop sign (R1-1) located at Richmond Avenue needs to be replaced.

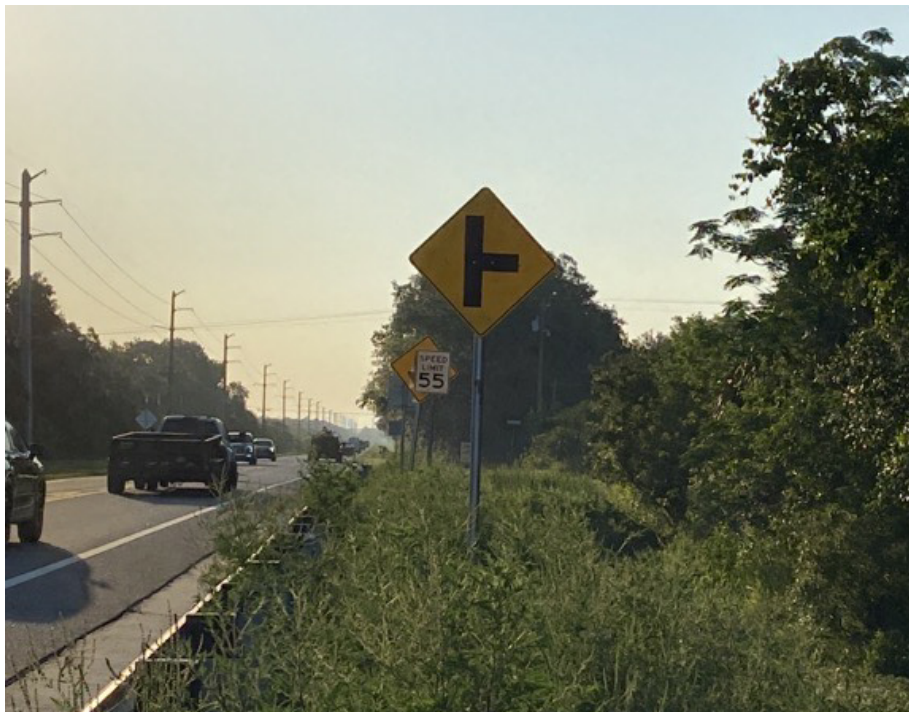
Figure 4-7
Two-way Traffic Sign Obstructed by Speed Limit Sign on Eastbound SR 46

A county-installed stop sign (R1-1) located 20 feet from the stop bar on Richmond Avenue with a June 2005 installation date should be replaced. An eastbound 55 mph posted speed limit sign (R2-1) is located approximately 360 feet west of the intersection, obstructing the view of a two-way

- The eastbound 55-mph posted speed limit sign (R2-1) located approximately 360 feet west of the intersection is a duplicate speed limit sign and is obstructing the view of two-way traffic sign (W6-3). It should be removed.
- The westbound divided highway sign (W6-1) located 60 feet west of the intersection should be rotated 180 degrees due to incorrect installation.
- Street name subplates (W16-8P) are recommended to be added to the intersection warning signs (W2-2) in both directions.
- Install minor street termination signing on the north side of SR 46 to include the two-direction large arrow sign (W1-7) and three object markers (OM1-3)
- The pavement edge failure located on both the west and east edges of pavement of Richmond Avenue at the intersection should be repaired.

- Pavement markings should be refreshed within the project limits, including centerlines and edge lines.
- The eastbound 55-mph posted speed limit sign (R2-1) located approximately 360 feet west of the intersection is a duplicate speed limit sign and is obstructing the view of two-way traffic sign (W6-3). It should be removed.
- The westbound divided highway sign (W6-1) located 60 feet west of the intersection should be rotated 180 degrees due to incorrect installation.
- Street name subplates (W16-8P) are recommended to be added to the intersection warning signs (W2-2) in both directions.
- Install minor street termination signing on the north side of SR 46 to include the two-direction large arrow sign (W1-7) and three object markers (OM1-3)
- The pavement edge failure located on both the west and east edges of pavement of Richmond Avenue at the intersection should be repaired.

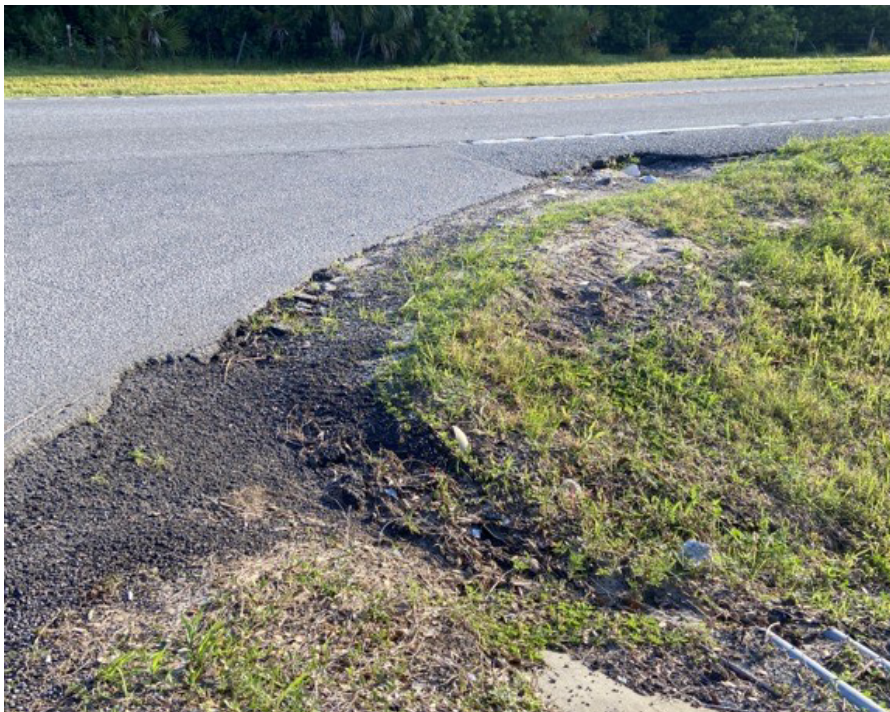
Figure 4-9
Edge Failure on Richmond Avenue East Edge of Pavement

Pavement conditions along SR 46 and Richmond Avenue were adequate. However, pavement edge failure was present along the right turn radii on Richmond Avenue due to erosion and potential over tracking (**Figure 4-9**). Edge failure was also present southbound on Richmond Avenue at the intersection (**Figure 4-10**).

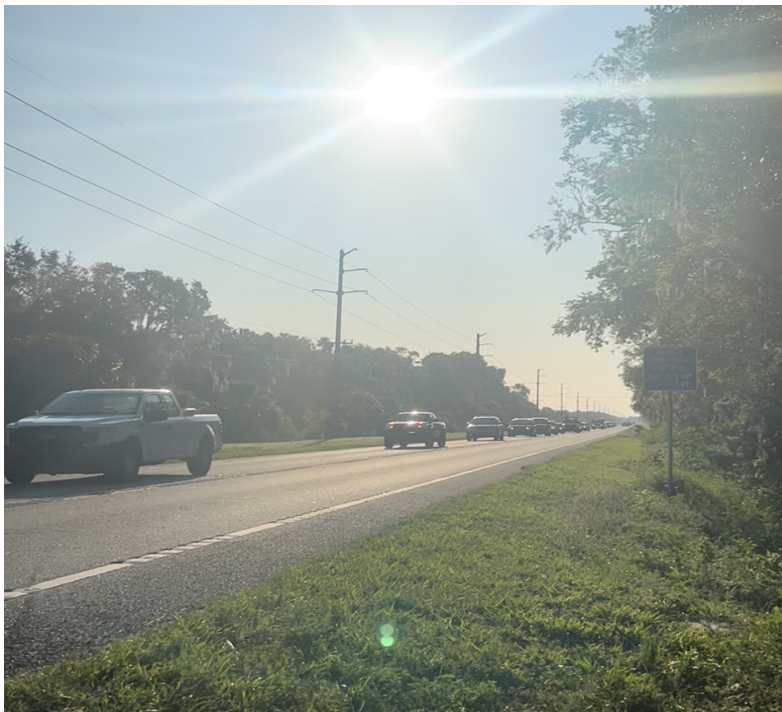
Figure 4-11
Queuing Caused by Westbound Left Movement

The westbound left movement on SR 46 to Richmond Avenue appeared to have sufficient gaps in opposing traffic to accommodate this movement. However, in one instance, it was observed that as a vehicle waited for an appropriate gap to perform the movement, a queue formed with a length of the observable distance from the intersection (**Figure 4-11**). This movement appeared to create a

shockwave event, causing queueing. Another observed instance of the westbound left movement created a queue length of seven vehicles.

Based on the crash history and field observations, the addition of a westbound left turn lane along SR 46 at Richmond Avenue is recommended. Large queues were witnessed when a westbound vehicle attempted to turn left onto Richmond Avenue and some drivers were observed driving off the pavement to go around the left turning vehicle. These conditions can cause left turning drivers to accept insufficient gaps in opposing traffic. The addition of a left turn lane will provide a separation of the westbound left turn movement from the mainline westbound through movement reducing the potential for rear-end crashes. Additional benefits include providing the westbound left turn movement the ability to select an adequate gap in opposing traffic without delaying the westbound through movement, ultimately providing additional capacity and operational benefits, as well as a safer experience for all users at the intersection.

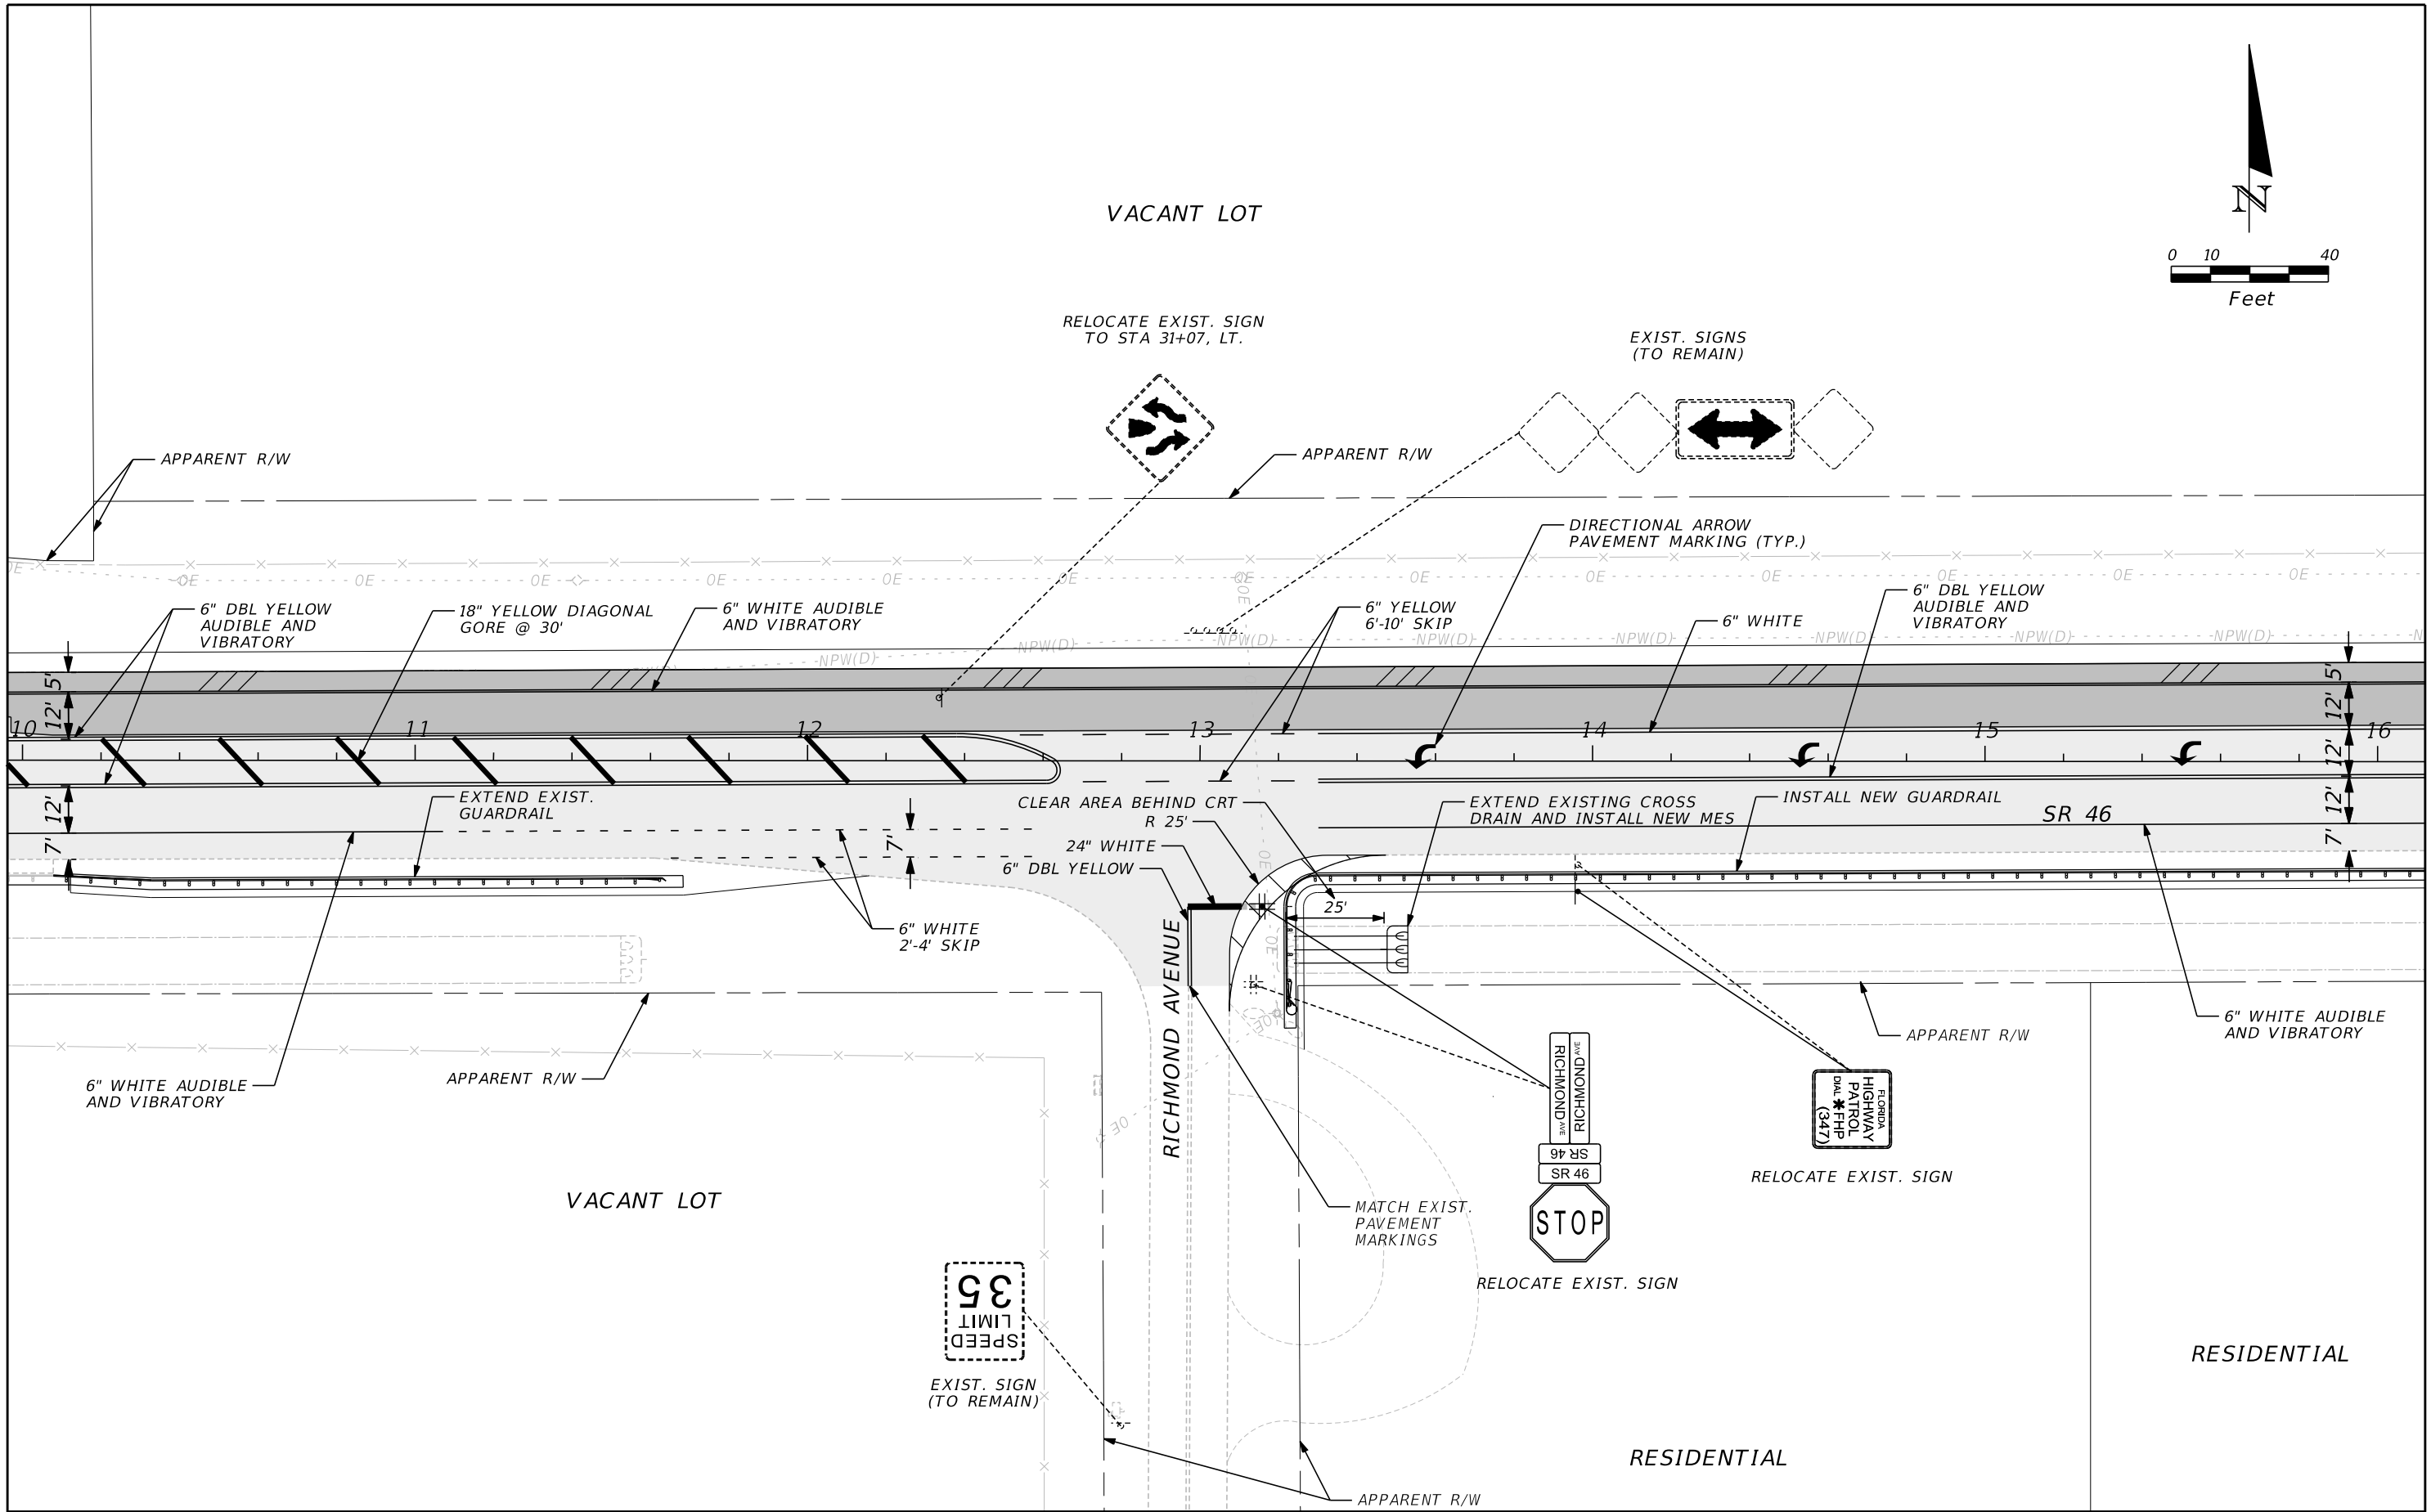
A concept of the proposed improvements is depicted in **Figure 7-2**. Please note, this concept may need to be modified during design based on survey.

FDM Figure 215.4.6 depicts lateral offset to guardrail criteria. For flush shoulder roadways without shoulder gutter, the lateral offset for this project is full shoulder width (10 feet) plus 2 feet, or 12 feet total. Based upon our field review, the existing unpaved shoulder and front slope along the canal was field measured at approximately 1:4. Per the standard plans index 536-001, the recommended miscellaneous asphalt needs to be constructed with a 1:10 max slope to the 2-foot slope break point, followed by a 1:2 slope tying to the existing ground. Leaving the road at the existing location and adding guardrail at the 12-foot offset would result in impacts to the canal. Based on our preliminary analysis, the roadway would need to be shifted 3 feet to the north and a deep post guardrail option utilized to reduce the 2-foot setback to the slope break point, thereby eliminating impacts to the canal. With the additional roadway shift, the need for milling and resurfacing with cross slope correction using overbuild will also be required to shift the existing crown to the new inside travel lane.

It is recommended to reduce the radius in the southeast corner of the intersection to a 25-foot radius. This would both increase the distance between the northbound approach and the guardrail proposed to wrap around the southeast corner of the intersection, as well as improve the line of sight to the stop sign.

- Install guardrail around the radius of the southeast corner of the intersection, extending on the south side of SR 46 east approximately 400 feet along the canal to the first residential driveway, as well as extending guardrail along the canal west of Richmond Avenue from the existing terminus eastward past the mitered end section a minimum of 25 feet
- Extend the cross drain in the southeast corner of the intersection 25 feet to the east to increase separation between the guardrail proposed to wrap around the southeast corner of the intersection and the canal
- Reduce the radius in the southeast corner of the intersection to 25 feet to increase the distance between the northbound approach and the guardrail proposed to wrap around the southeast corner of the intersection, as well as improve the line of sight to the stop sign
