RE: Section 106 Consultation Case Study Report
State Road 5/US 1 Bridge Replacement over Pellicer Creek
Flagler and St. Johns Counties, Florida
Financial Management No.: 447118-1-52-01

SECTION 106 CONSULTATION CASE STUDY REPORT FOR THE STATE ROAD 5/US 1 BRIDGE REPLACEMENT OVER PELLICER CREEK, FLAGLER AND ST. JOHNS COUNTIES, FLORIDA

CONSULTANT: SEARCH
3117 Edgewater Drive, Orlando, FL 32804

DATE: October 2023

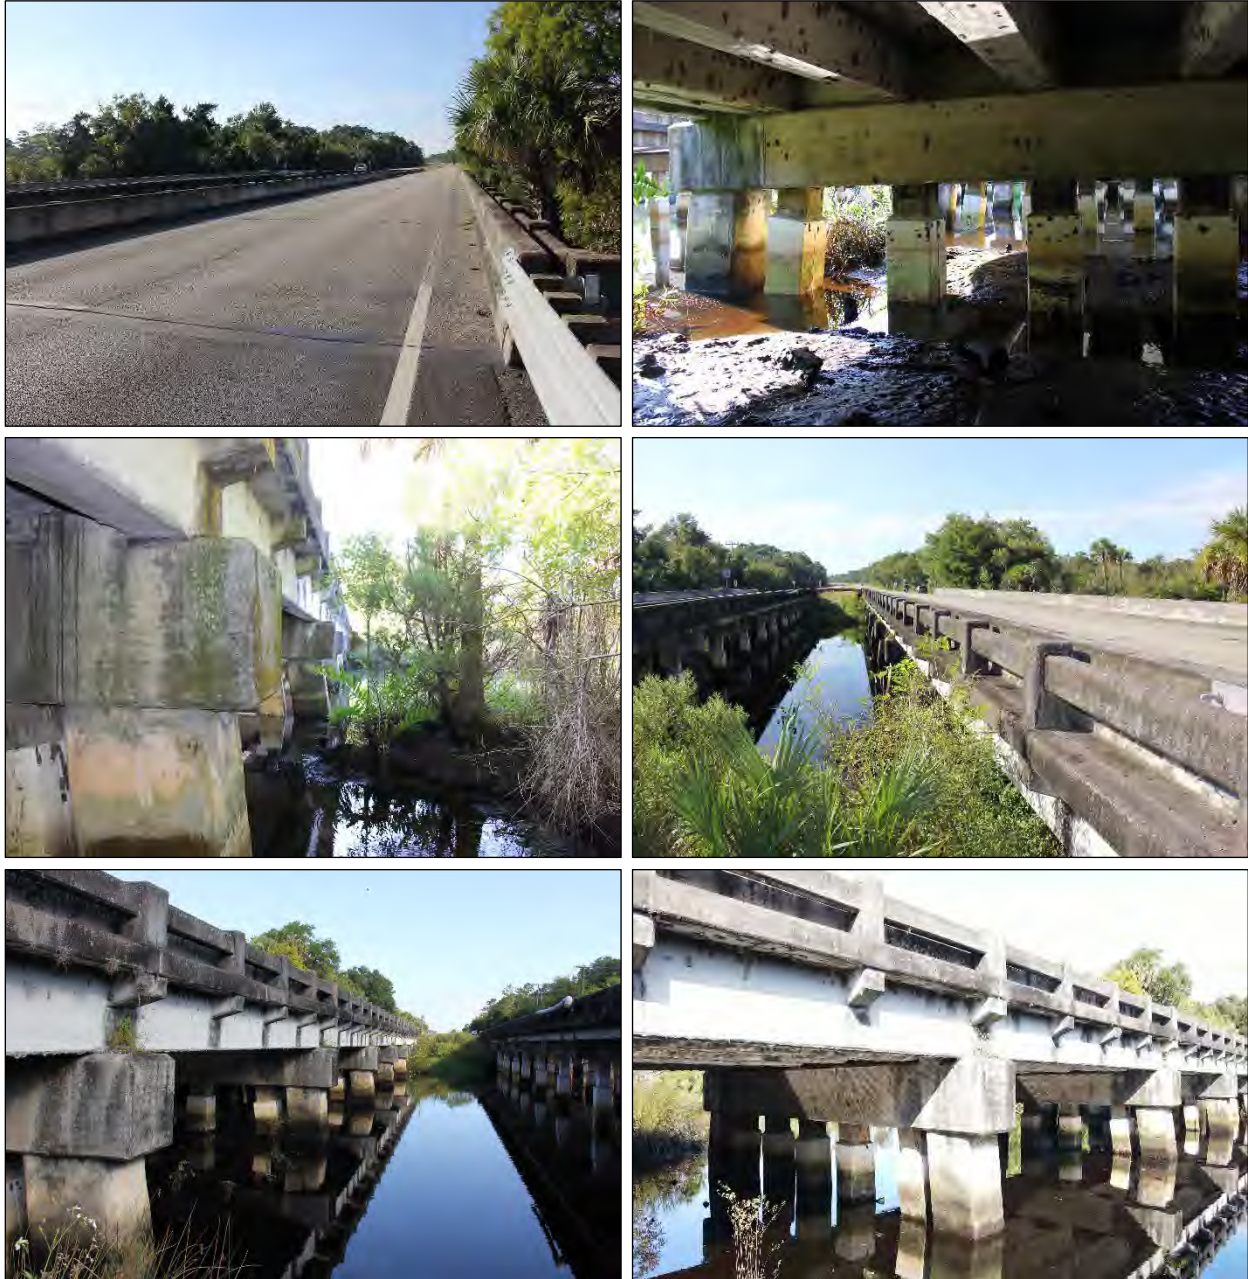
Figure 3. Representative views of Resource 8FL01008/8SJ08262. Deck and roadway, facing southeast (top left); underside with girders and piers, facing southeast (top right); west side of structure, facing south (middle left); railing along east side, facing south (middle right); railing and east side, facing north (bottom left); east side and piers, facing northwest (bottom right).

At present, FDOT Bridge No. 730008 is 96 years old, which is well beyond the 75-year design life for the bridge. Structurally, the bridge has had pile jackets installed as a repair procedure and as a preventative measure to keep the existing piles from deteriorating further. The pile jackets themselves have spalls, voids, and exposed rebar per the most recent inspection reports. Further, the bridge has been labeled as “functionally obsolete,” which means it does not meet current

road design standards due to narrow shoulder width (the current shoulder width is 2.0 ft [0.7 m], and the standard is 6.0 ft [1.8 m] for the inside shoulder and 10.0 ft [3.0 m] for the outside shoulders).

Repairing the bridge is not recommended since the structure is beyond its design life. Replacing the pile jackets would require extensive work while trying to avoid damage to the original piles, while adding more width to the existing pile jackets would affect the hydraulic opening of the bridge over the creek. Even if repairs were to occur, the substandard shoulders would remain, which would pose a safety hazard per today's standards. For these reasons, the rehabilitation and no-build alternatives were dismissed from consideration for not meeting the purpose and need for the undertaking, and the bridge is recommended for replacement.

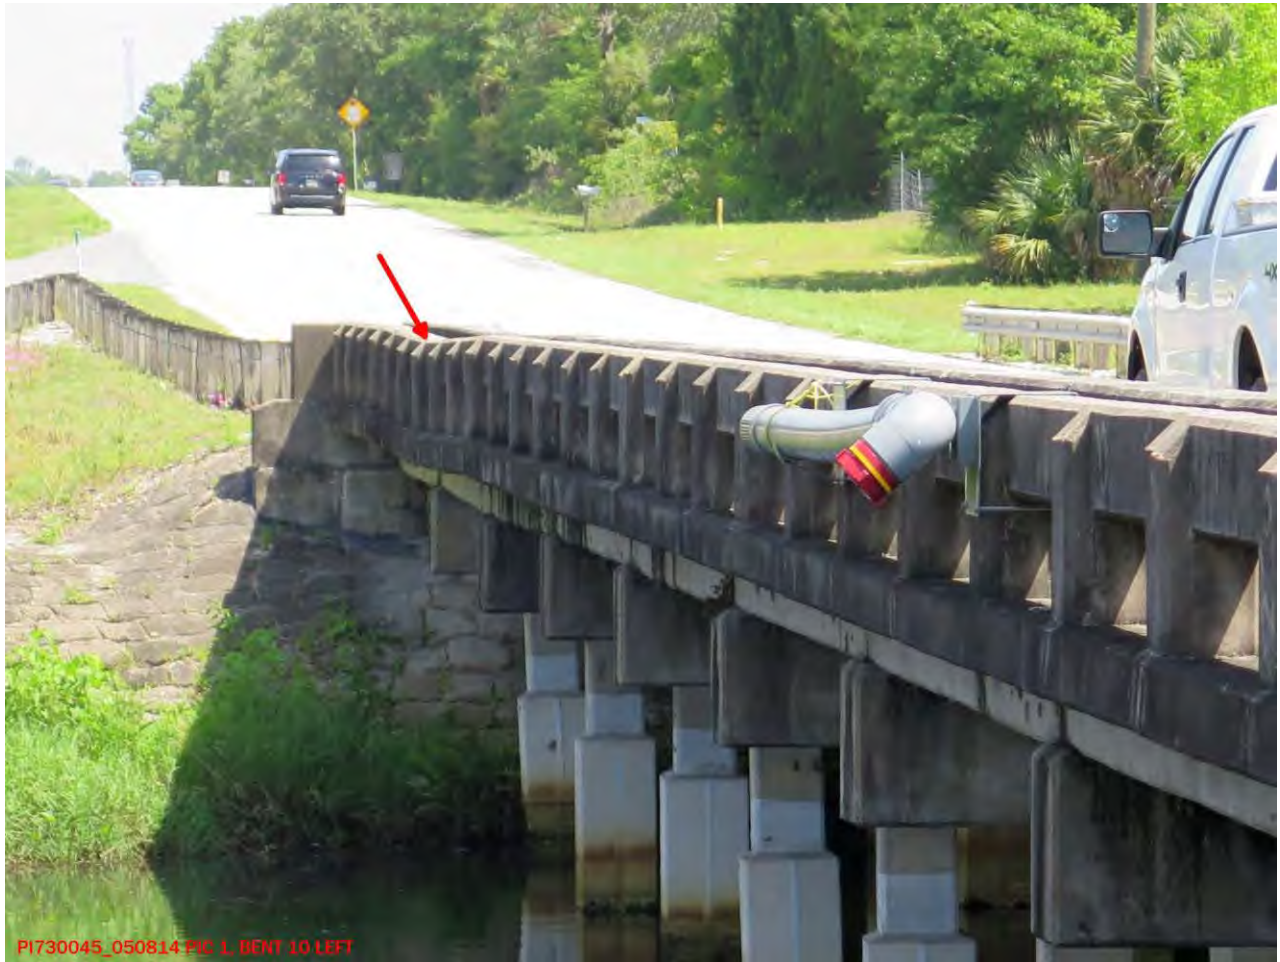
Photo 1: Settlement of bridge no. 730045 – US-1 Northbound over Pellicer Creek

Additionally, this bridge has a history of settlement affecting the ride quality and potentially impacting the effectiveness of any proposed rehabilitation. A monitoring program was instituted to measure the amount of settlement and track progression. Through that monitoring program, Structures Maintenance determined that the bridge settlement had stabilized and was no longer settling. However, should rehabilitation efforts take place on either northbound or southbound bridges, the work may cause settlement to reinitiate leading to additional rehabilitation scope and cost.
