CULTURAL RESOURCE ASSESSMENT SURVEY LPGA BOULEVARD FROM US 92 (SR 600) TO WILLIAMSON BOULEVARD PROJECT DEVELOPMENT & ENVIRONMENT STUDY

PONDS ADDENDUM

FPID: 448456-1-22-01

Volusia County, Florida

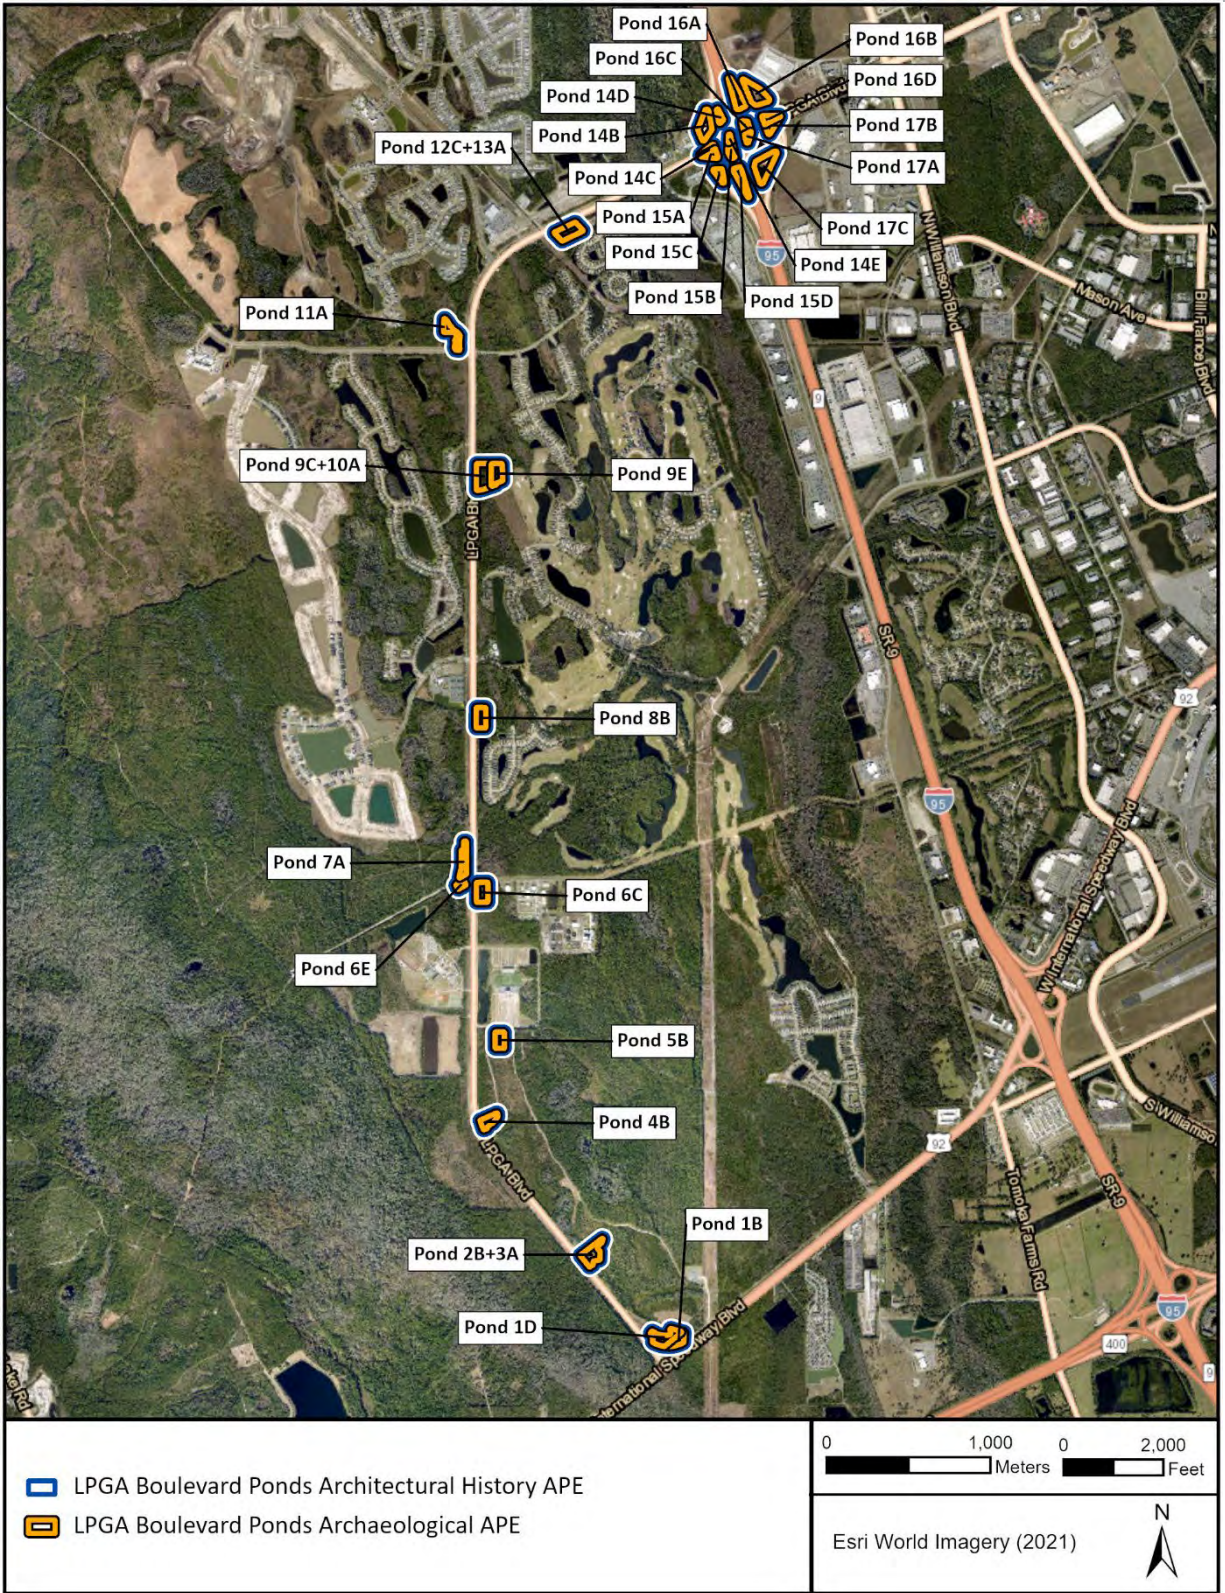
Figure 2. The LPGA Boulevard ponds archaeological APE and architectural history APE in Volusia County, Florida.

The archaeological area of potential effects (APE) was limited to the proposed pond footprints. The architectural history APE included the proposed pond footprints and was extended to no more than 100.0 feet (30.5 meters) from the proposed footprint to consider viewshed effects to aboveground resources. For the purposes of this report, “APE” refers to the combined archaeological APE and architectural history APE.

The area of potential effects (APE) was developed to consider visual, audible, and atmospheric effects that the project may have on historic resources. The archaeological APE was defined as the proposed pond footprints, while the architectural history APE included the pond footprints in addition to a 100.0-foot (ft) (30.5-meter [m]) buffer (**Figure 2**). For the purposes of this report, “APE” refers to the combined archaeological APE and architectural history APE.

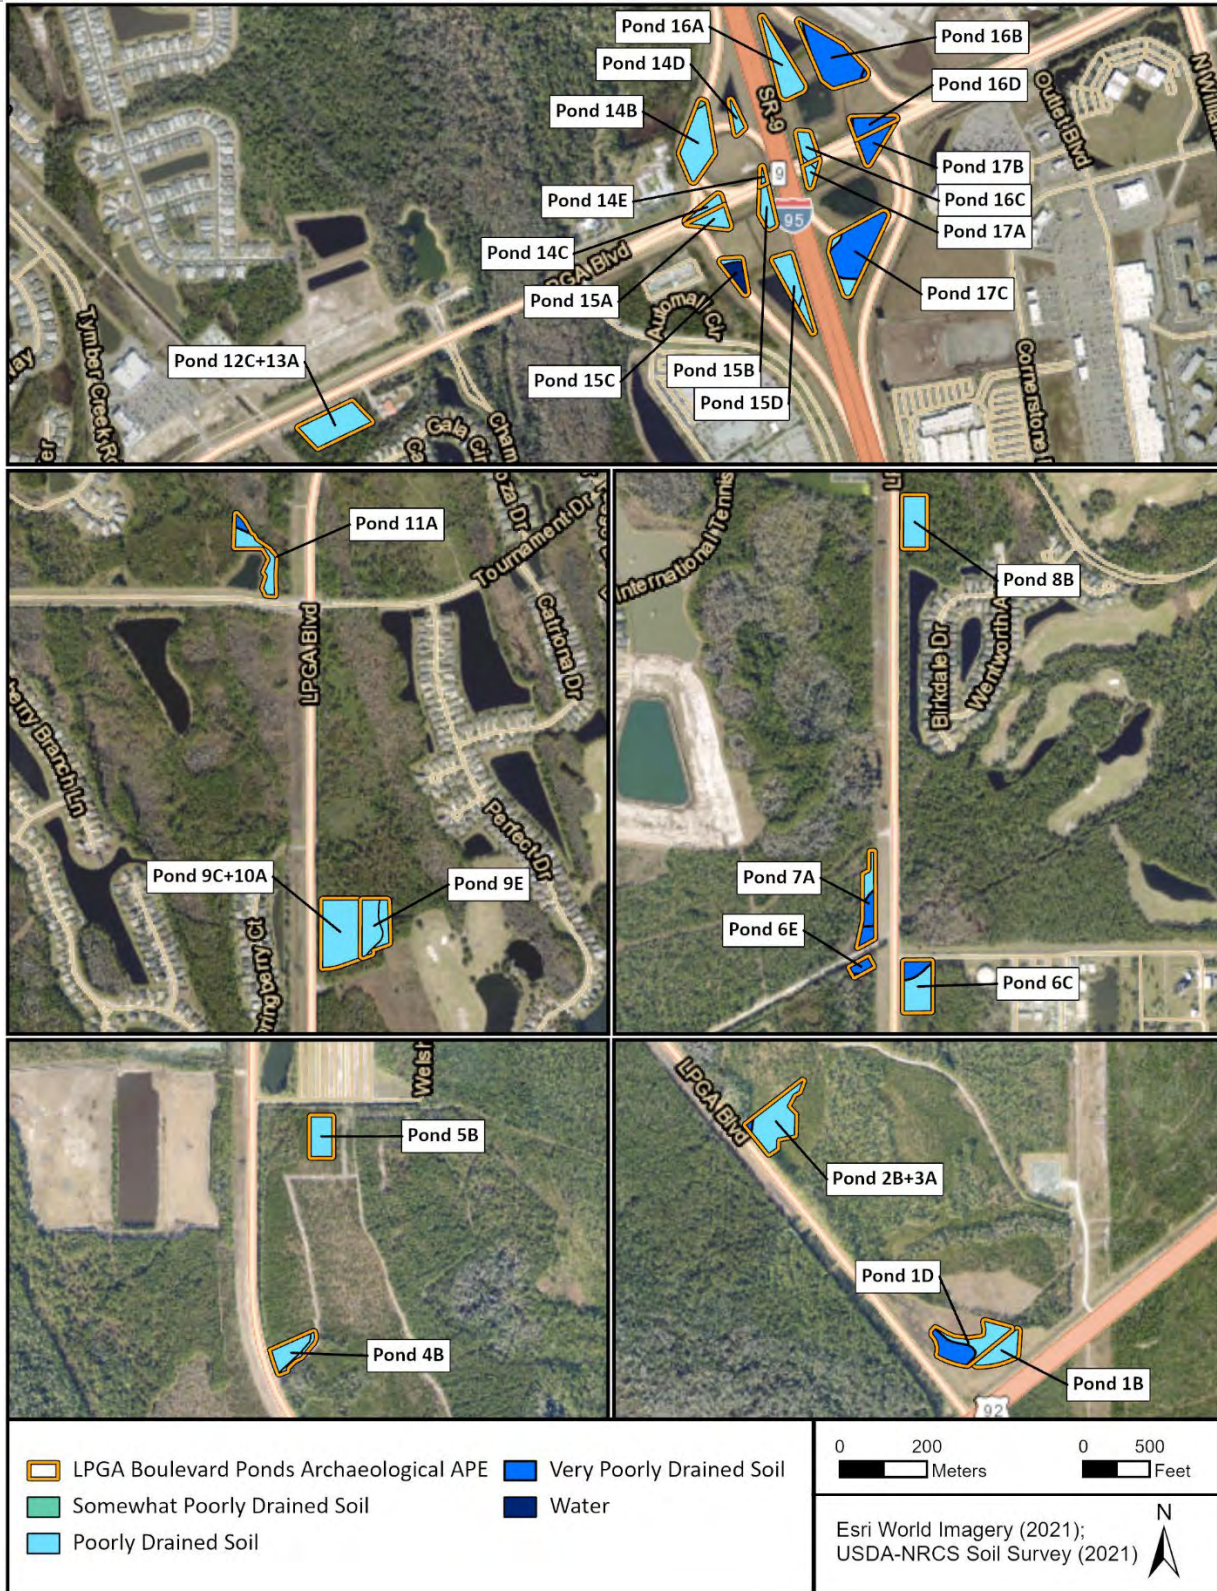
Figure 3. Soil drainage within the LPGA Boulevard Ponds archaeological APE.

Based on an examination of environmental variables (soil drainage, access to wetlands and marine resources, and relative elevation) and the results of previously conducted surveys (FMSF Survey Nos. 2791, 3214, and Kinchen et al. 2023), the potential for Native American archaeological sites to be within the APE was generally low. While the previously conducted surveys have identified Native American sites in proximity to the APE, the soils within the proposed pond footprints are generally poorly drained with relatively low elevations. Additionally, much of the LPGA Boulevard right-of-way, such as the I-95 interchange, has undergone extensive disturbance due to road construction and maintenance and is unlikely to contain intact archaeological deposits.

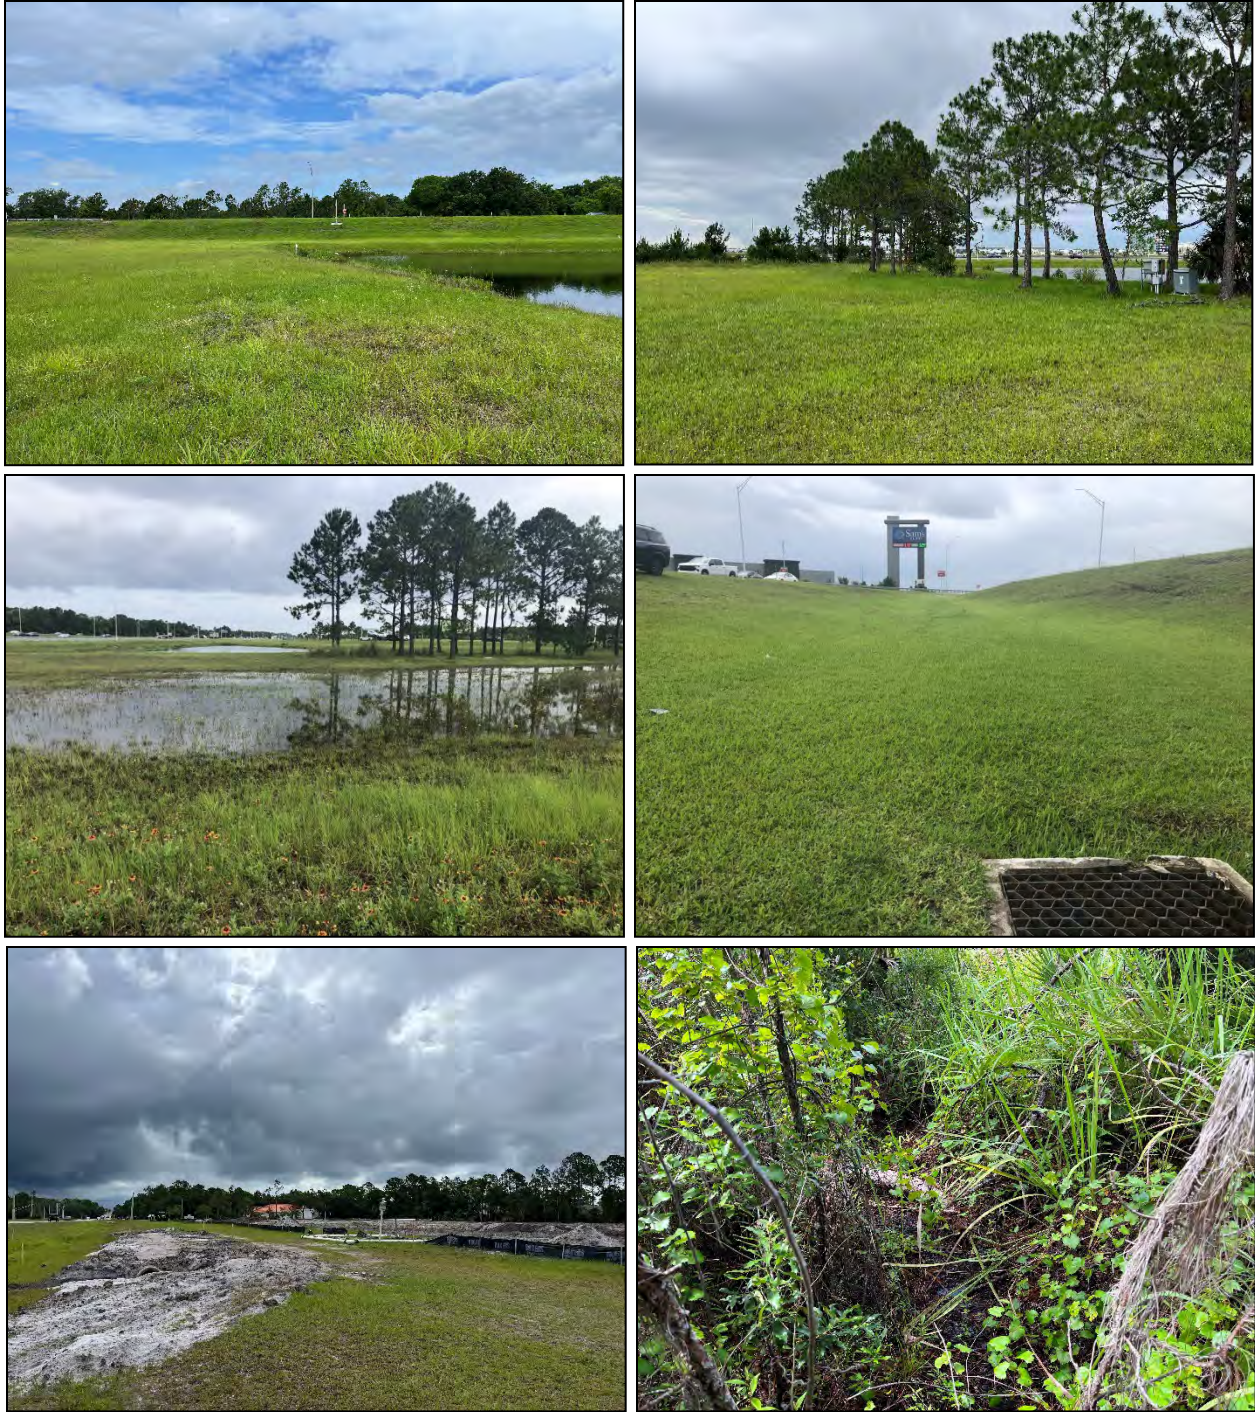
Figure 6. Representative views precluding excavation within the APE. Top left: slope and inundation within Pond 14D, view south. Top right: utilities and inundation within Pond 15C, view east. Center left: heavily disturbed landform with inundation within Pond 16A, view north. Center right: ditch with slope within Ponds 16D and 17B, view south. Bottom left: active construction within the footprint of Ponds 12C and 13A, view east. Bottom right: environment and standing water on surface within the footprint of Pond 11A, view south.

Table 3 provides a summary of the archaeological results within each pond location. The field visit confirmed the artificial and disturbed nature of the soils within the northern end of the APE at the interchange with I-95. Excavation was not possible at Ponds 14B, 14C, 14D, 14E, 15A, 15B, 15C, 15D, 16A, 16B, 16C, 16D, 17A, 17B, and 17C due to inundation, ditches, buried utilities, slope, and disturbance (**Figure 6**). Additionally, evidence of active construction was observed at the location of Pond 12C/13A, and Pond 11A was inundated (**Figure 6**). In total, 20 shovel tests were excavated in the archaeological APE for the current field effort, and all were negative for cultural material (**Figure 7**). Marked field maps showing the location of shovel tests, buried utilities, and other disturbances identified in the current survey are included in **Appendix A**. An FDHR survey log sheet is provided in **Appendix B**. Further discussion of archaeological testing within the pond footprints is continued below.

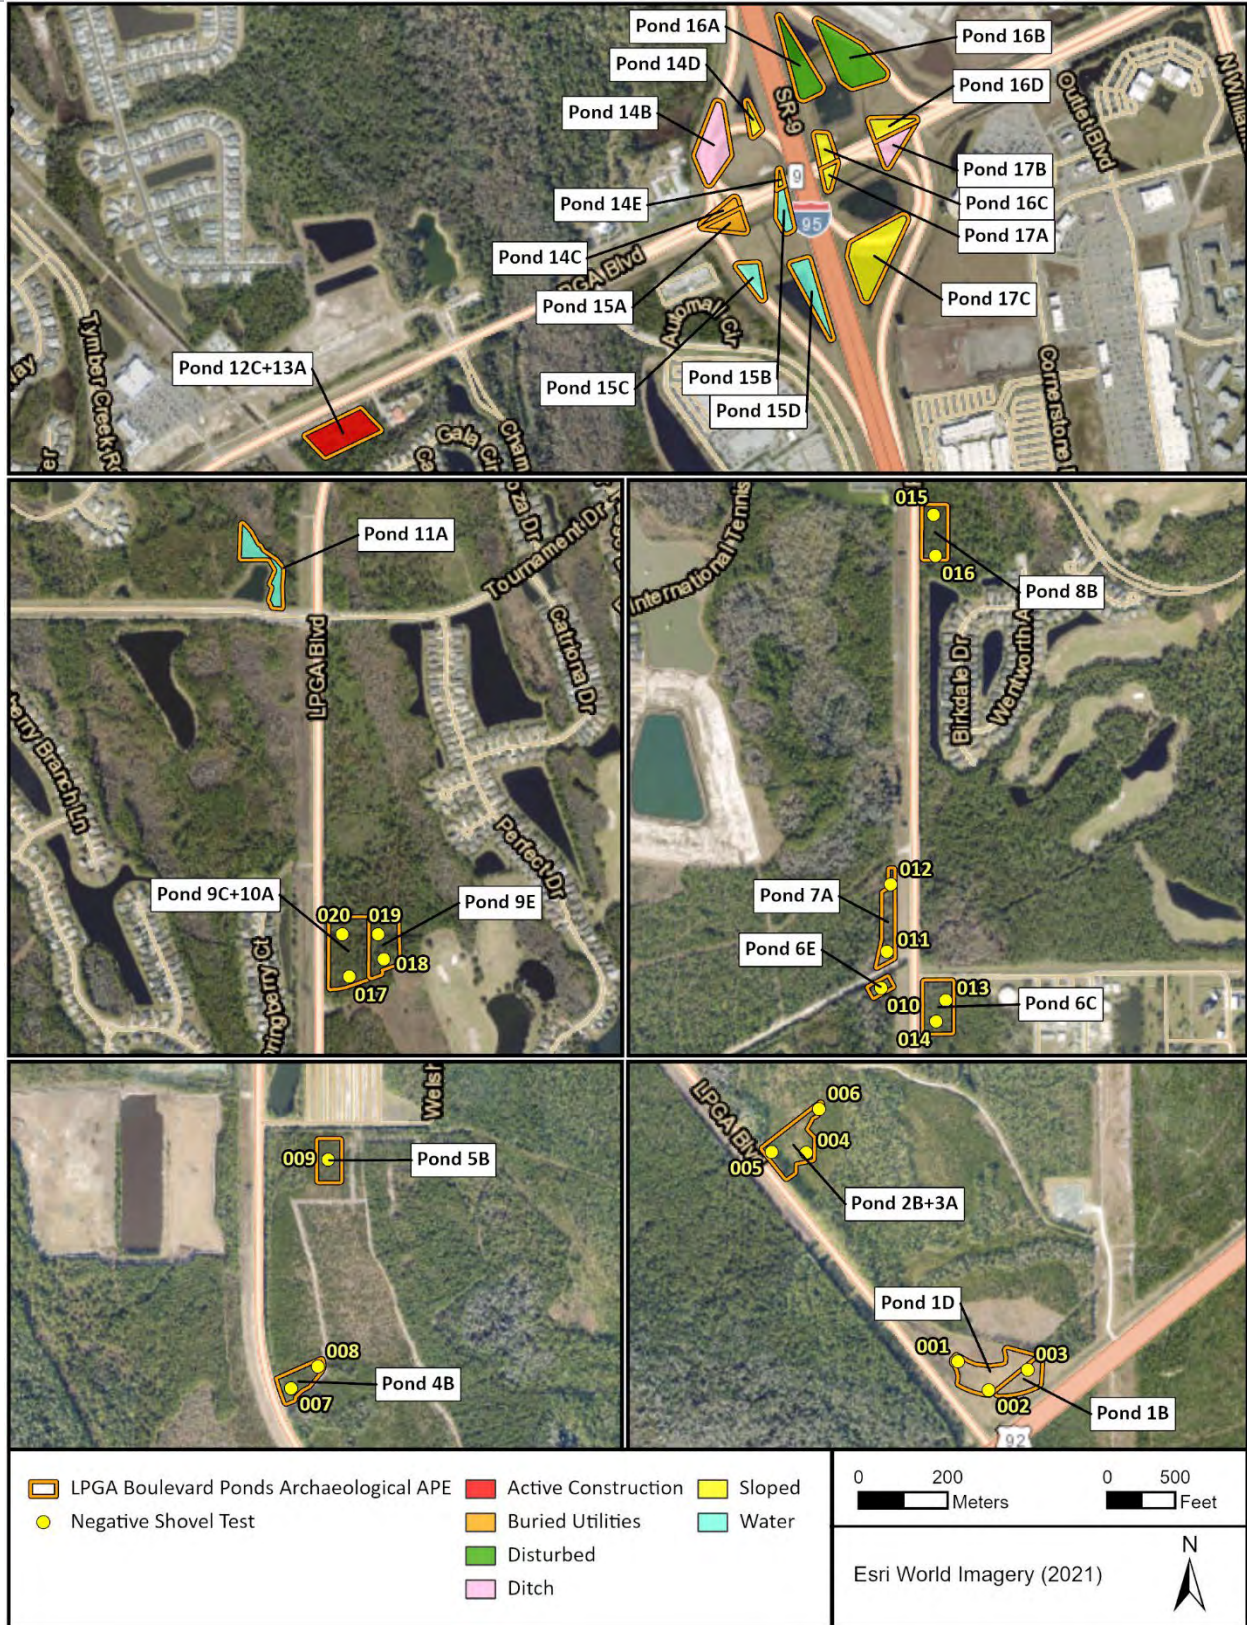
Figure 7. Results of testing within the LPGA Boulevard ponds archaeological APE.

Twenty shovel tests were excavated within these pond footprints (see **Figure 7**). None of these tests contained cultural materials, and no archaeological sites or occurrences were identified within Ponds 1B, 1D, 2B/3A, 4B, 5B, 6C, 6E, 7A, 8B, 9C/10A, or 9E.

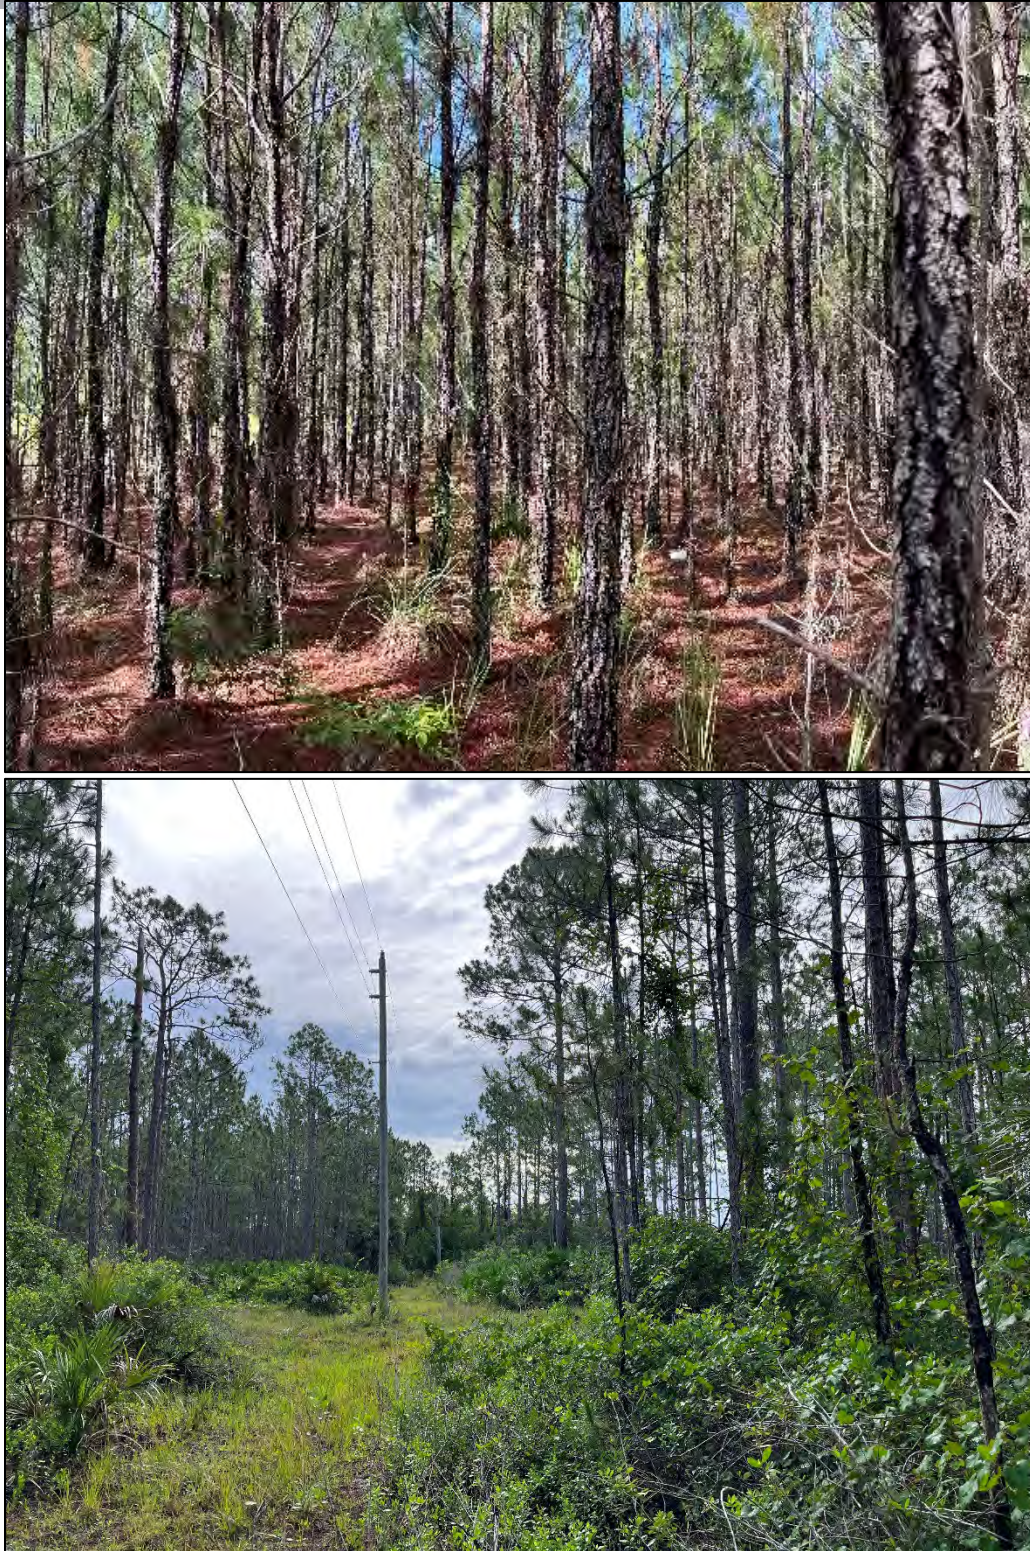
Figure 8. Example of environmental conditions within Ponds 1B, 1D, 2B/3A, 4B, 5B, 6C, 6E, 7A, 8B, 9C/10A, and 9E. Top: environmental overview of Pond 4B, view south. Bottom: environmental overview of Pond 9E, view east.

The footprints of Ponds 1B, 1D, 2B/3A, 4B, 5B, 6C, 6E, 7A, 8B, 9C/10A, and 9E cover 19.19 ac (9.50 ha). Shovel testing was conducted at low-probability intervals (328 ft [100 m]) in each footprint with the exception of the western portion of Pond 4B, which was tested at moderate-probability intervals (164 ft [50 m]) within 328 ft (100 m) of site 8VO10481 and at a low-probability throughout the remainder of the footprint. Vegetation within these footprints consisted predominately of sparsely wooded areas with planted pine (**Figure 8**); however, Ponds 1B and 1D were within open, grassy areas, and an electrical line corridor ran through the footprint of Pond 9C/10A.

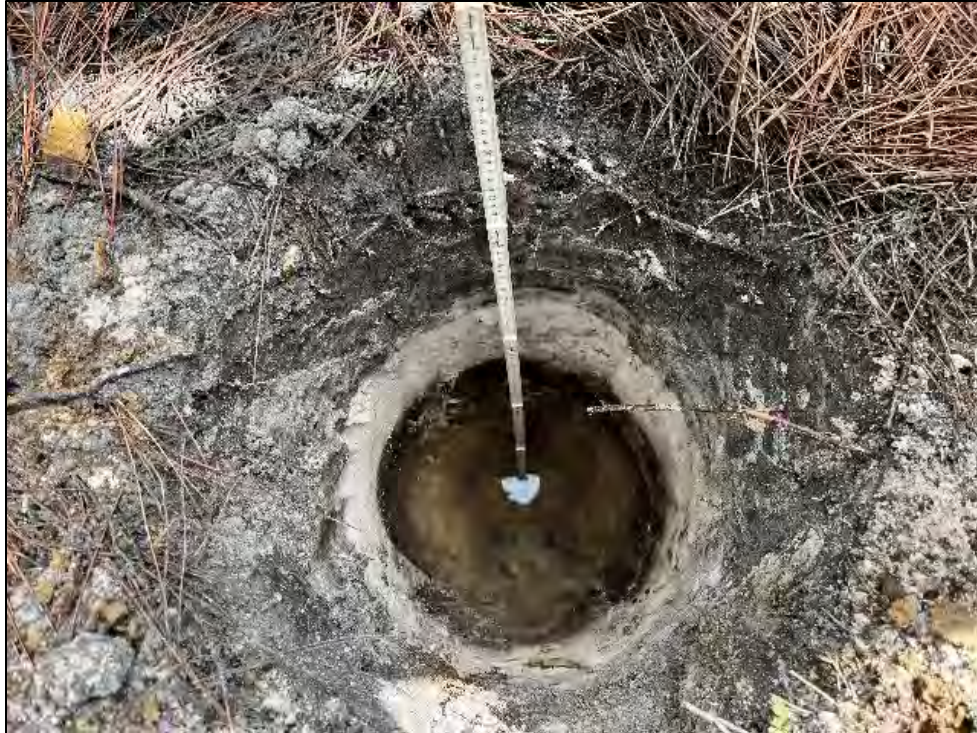
Figure 9. Typical shovel test profile, view north.

Soils within these pond footprints generally consisted of gray (10YR 6/1) sand from 0 to 25 centimeters below surface (cmbs) (0 to 10 inches below surface [inbs]; Stratum I), light gray (10YR 7/1) sand from 25 to 44 cmbs (10 to 17 inbs; Stratum II), and black (10YR 2/1) sand from 53 to 93 cmbs (17 to 37 inbs; Stratum III) (**Figure 9**). Shovel tests terminated due to inundation between 40 and 93 cmbs (16 to 37 inbs) (n=5), sterile substratum between 50 and 95 cmbs (20 to 37 inbs) (n=2), compaction impasse at spodic soils between 50 and 70 cmbs (20 to 28 inbs) (n=8), or upon reaching a maximum depth of 100 cmbs (39 inbs) (n=5).
