**Contamination Screening Evaluation Report  
Proposed State Road 46 Widening  
From State Road 415 to County Road 426  
Seminole County, Florida**

**Financial ID Number: 240216-4-28-01**

November 11, 2011

Ardaman & Associates, Inc.  
8008 South Orange Avenue  
Orlando, Florida 32809

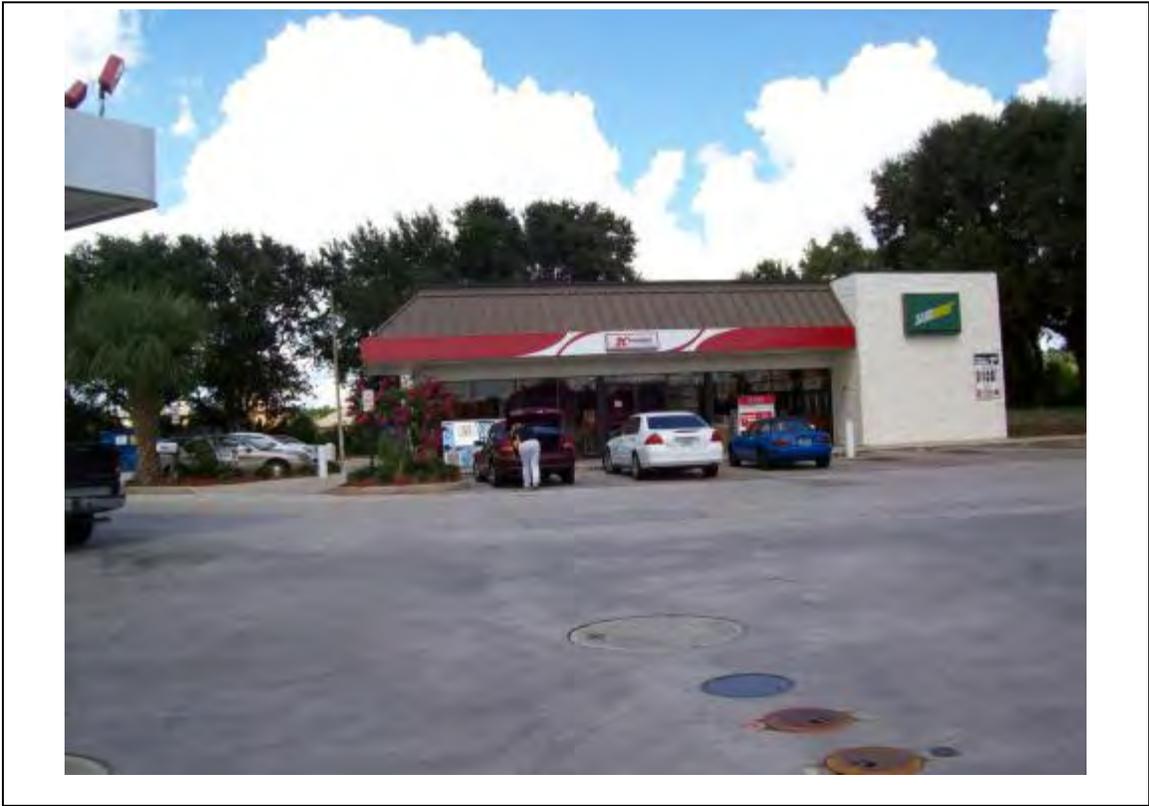
The Pantry, Map ID No. 2.

A July, 1997 discharge was reported at The Pantry (Kangaroo Express) facility; however, no assessment data was available due to the low cleanup ranking score. The November 17, 2010 annual tank compliance inspection report found the facility to be in compliance. However, based on proximity of the facility to the alignment, the lack of assessment data from the 1997 discharge, there is a potential that contamination from this facility may have adversely impacted the proposed roadway alignment.

- Map I.D. 2, The Pantry, has been assigned a contamination risk potential rating of "High". No assessment information was available regarding the reported petroleum discharge.
- Map I.D. 16, Former Trombley's Auto Body, has been assigned a contamination risk potential rating of "High". Evidence of excavation and landfilling of possible hazardous materials was observed on this facility's property, approximately 75 feet north of State Road 46, during the April, 2000 FDEP inspection. No soil or groundwater assessment information was available for the facility. Based on proximity of the Trombley's Auto Body and Used Cars facility to the alignment, the Trombley's Auto Body and Used Cars facility may have adversely impacted the proposed project alignment.

Preliminary Contamination Assessments consisting of soil and groundwater sampling in the right-of-way are recommended relative to the sites identified with a "High" contamination risk potential rating.

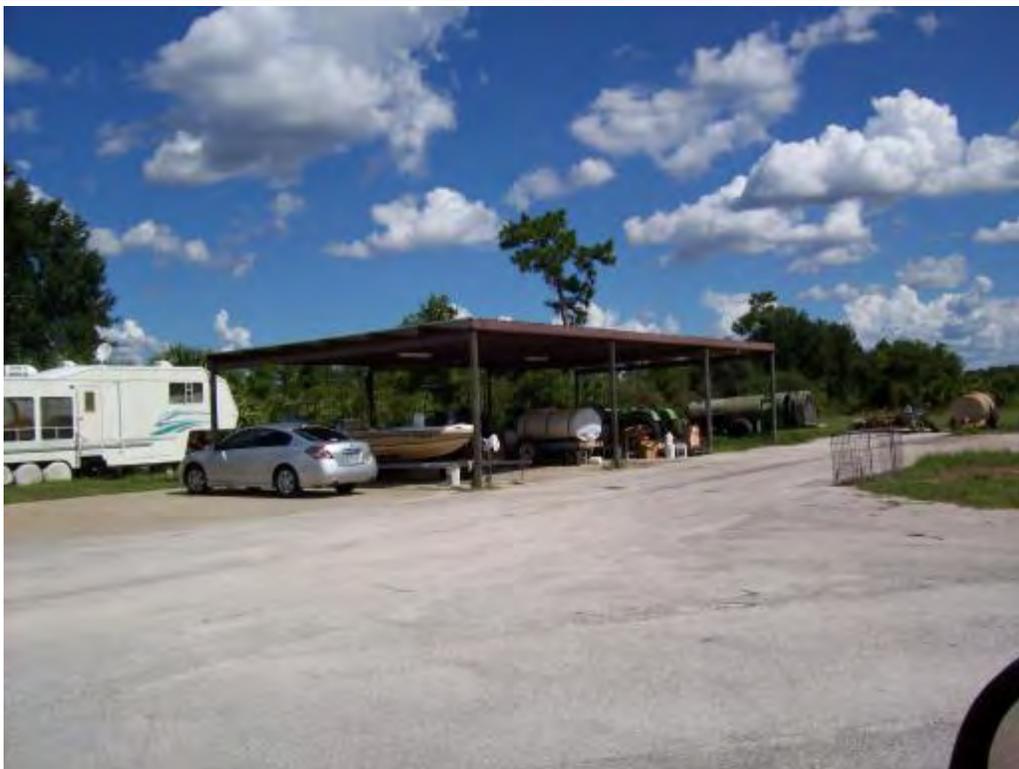
Lake Jessup Groves grove care equipment storage area, Map ID 21.

- Map I.D. number 21, Lake Jessup Groves – Grove Maintenance Area is an operating grove care equipment, chemical and fuel storage area, and has been assigned a contamination risk potential rating of "Medium." No evidence of obvious contamination, stressed vegetation or stained soils was observed during the site reconnaissance; however, the potential for contamination from chemical mixing, chemical storage and aboveground storage tank storage in this area exists.
- Map I.D. number 38, Geneva Food Store/MJM Food Store is an operating gas station, and has been assigned a contamination risk potential rating of "Medium". Groundwater has been reported to flow away from the proposed project alignment. However, a discharge has been reported and no assessment data was available. A discharge

Dewatering may be needed for the project construction near the site rated as "Medium". Dewatering may cause migration of groundwater contaminants from these facilities towards the proposed project alignment. If contaminants are detected in the groundwater and dewatering is conducted, the withdrawn water must be treated before being discharged off-site, directed to a sanitary sewer with treatment possibly being required by the local utility, or re-infiltrated on-site after being treated.

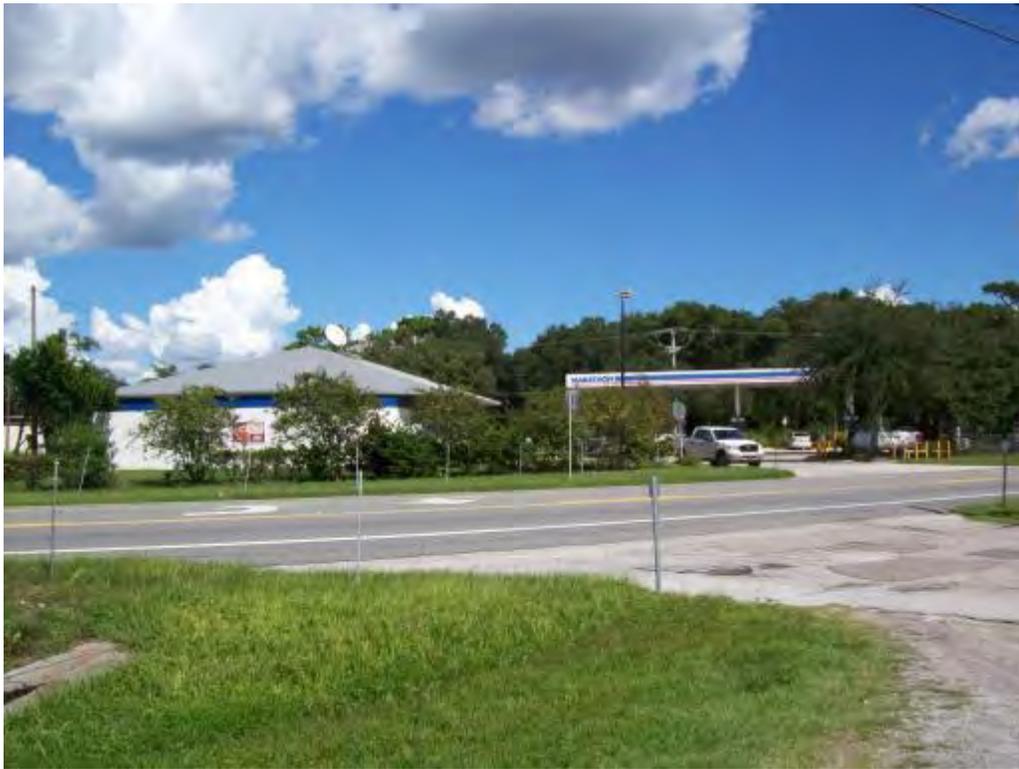
Geneva Food Store / MJM Food Store, Map ID 38.

The Geneva Food Store/MJM Food Store (currently Marathon Gas) facility is located adjacent to the north of the proposed alignment. Based on a December 4, 2003 Fill Pipe Closure Assessment and Source Removal Report conducted by FER, Inc., contamination was reported due to cracks in two fill port buckets at the facility. A total of 30.49 tons of petroleum contaminated soil was excavated and disposed of. Groundwater was reported to be greater than 20 feet below land surface and the maximum depth of source removal excavation was 4 feet bls. Therefore, groundwater samples were not obtained. The Source Removal Report recommended No Further Action.

An additional discharge reporting form was submitted on January 4, 2011 when a split was observed in another spill bucket during an annual inspection. Based on a March 22, 2011 FDEP Inspection Report, the spill bucket was replaced on March 14, 2011. Soil screening results indicated OVA readings above 10 parts per million. No additional assessment information was available on OCULUS. Based on depth to groundwater and reported easterly to northeasterly groundwater flow in the area of this facility, contamination emanating from the Geneva Food Store/MJM Food Store, if any, is not likely to be currently impacting the proposed roadway alignment.

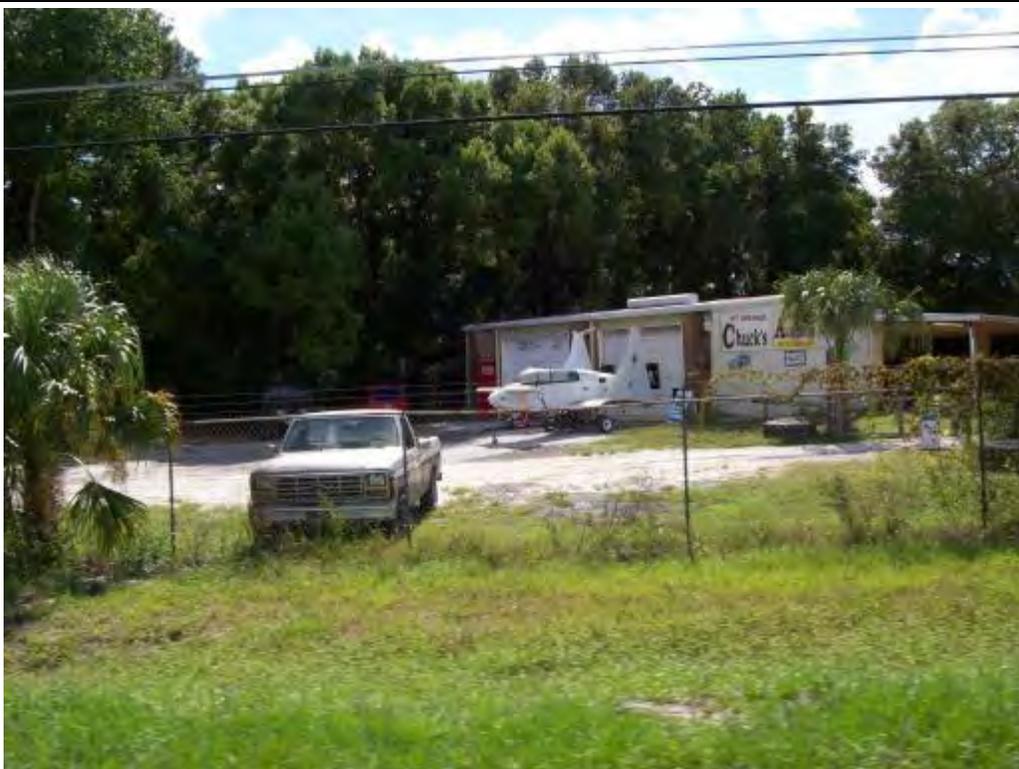
Chuck's Automotive repair, Map ID 41.

- Map I.D. 41, Chuck's Automotive Repair, has been assigned a contamination risk potential rating of "Low". No contamination has been reported at this facility. A northeasterly groundwater flow direction, away from the proposed project alignment, has been reported in the vicinity of this facility. The site was assigned a "low" risk rating based on the availability of assessment data.

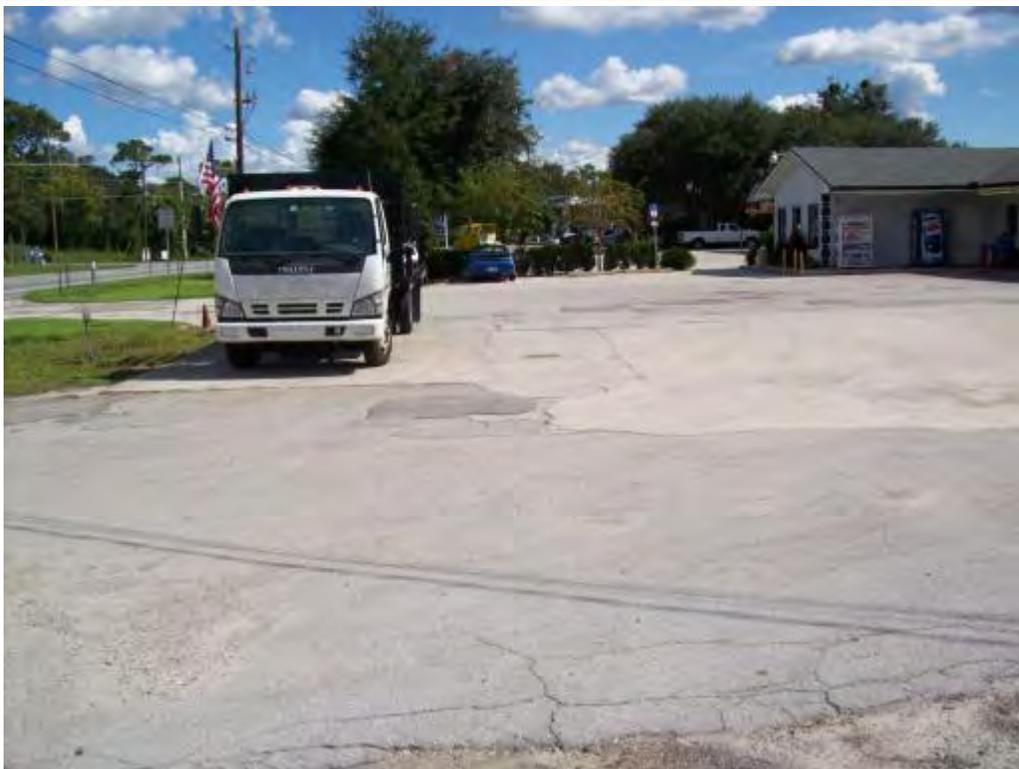
Geneva General Store former UST location.

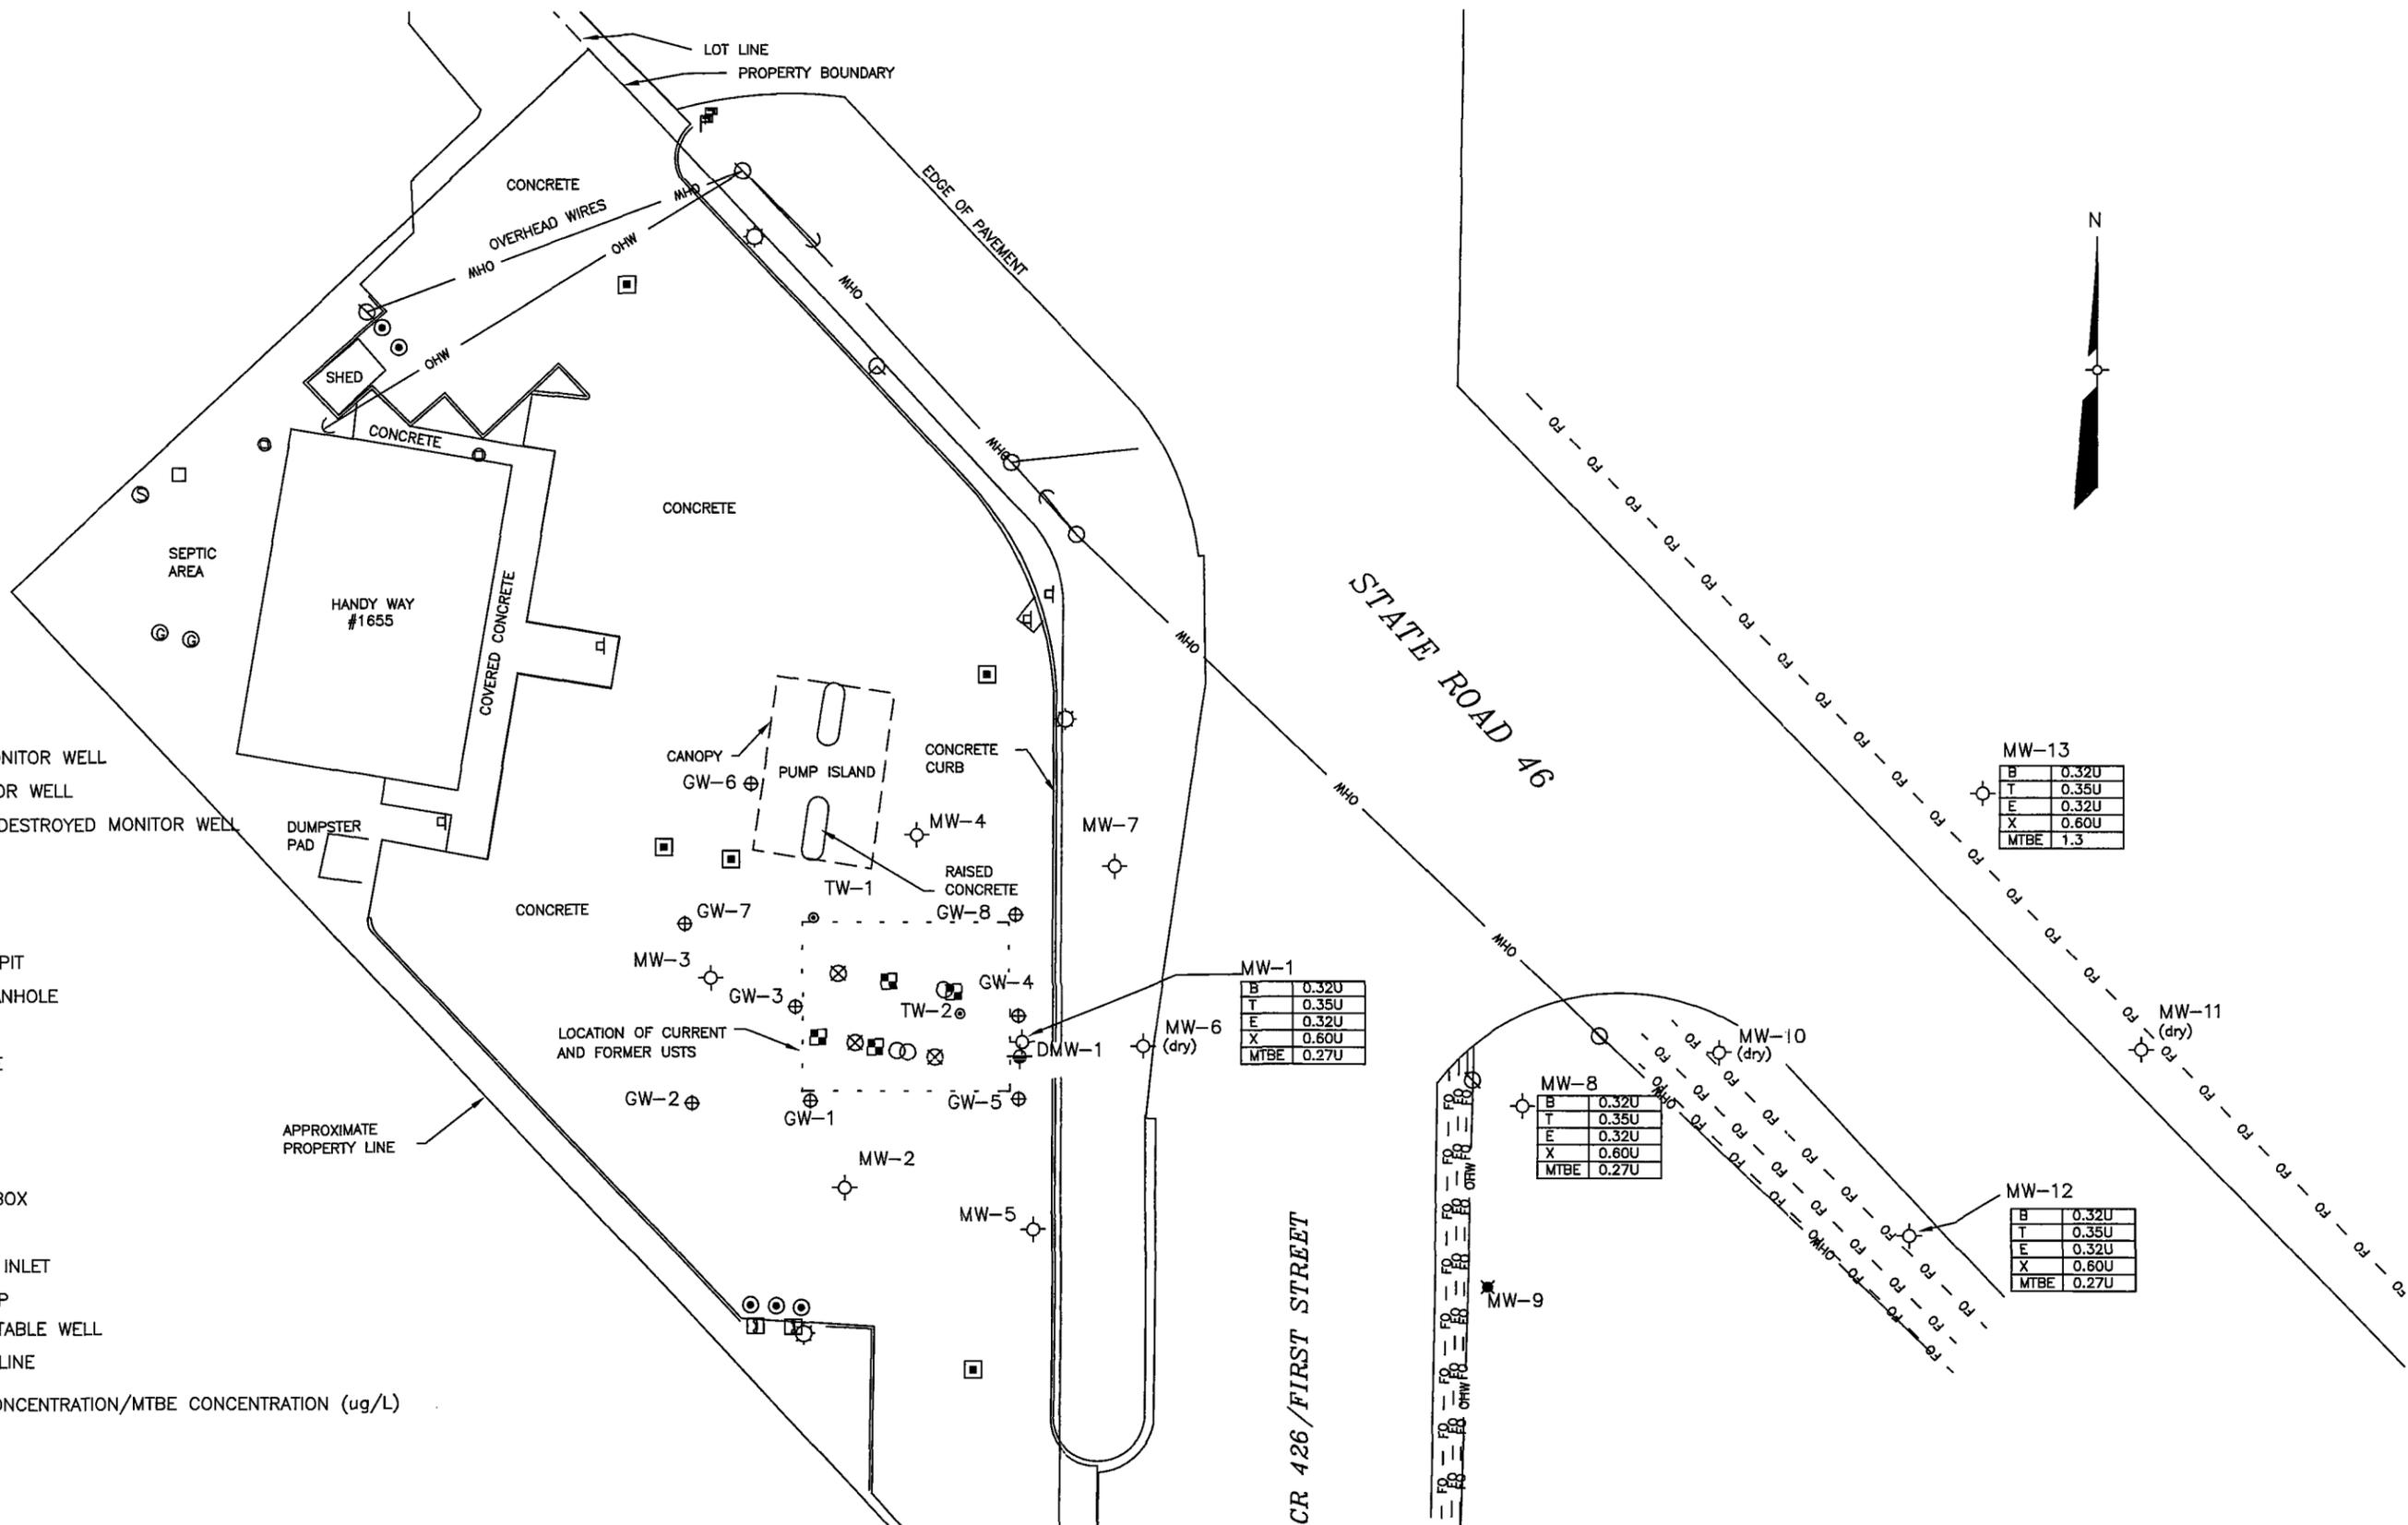
**FIGURE 3**  
**GROUNDWATER QUALITY MAP**  
 July 25, 2007  
 HANDY WAY #2655  
 GENEVA, FL  
 FDEP FAC. ID NO.: 598631252

(22/185) BENZENE CONCENTRATION/MTBE CONCENTRATION (ug/L)
