## SR 524 PD&E Study

Friday Road to Industry Road in Brevard County, Florida

## Cultural Resource Assessment Survey Report

**CULTURAL RESOURCE ASSESSMENT SURVEY FOR THE  
STATE ROAD 524 IMPROVEMENTS  
PROJECT DEVELOPMENT AND ENVIRONMENT STUDY FROM  
NORTH FRIDAY ROAD TO INDUSTRY ROAD,  
BREVARD COUNTY, FLORIDA**

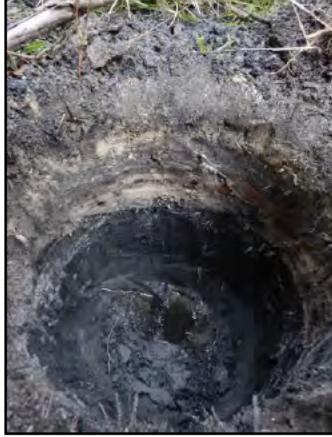
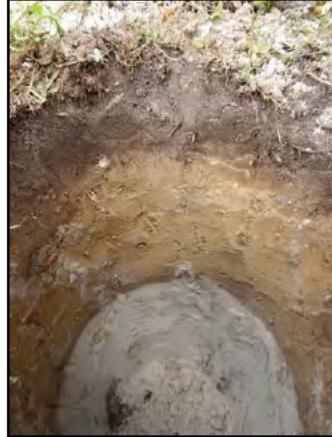
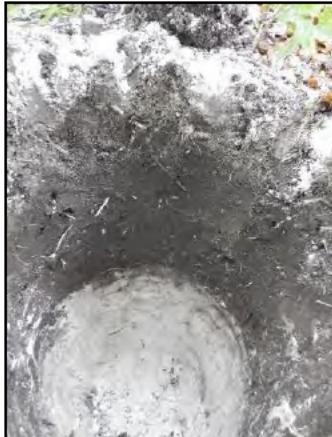
**Table 5. Examples of Negative Shovel Test Data.**

Shovel Test	Strata	Depth (cmbs)	Matrix Description	Photo
15 Located on south side of SR 524 east of Thien Thai Lane within right-of-way	I	0-10	Grayish-brown loamy sand with gravel

II	10-30	Stratum I with light gray sand and pale brown clay striations	
	III	30-60	Very dark grayish-brown compact sand (wet)	
	IV	60-70	Gray sand (wet)	
		70+	Water	
52 Located on north side of SR 524 just east of London Boulevard	I	0-15	Dark grayish-brown loamy sand

II	15-40	Yellowish-brown clay loamy sand with shell fragment inclusions	
	III	40-45	Strong brown sandy silt	
	IV	45-100	Light gray coarse and wet sand	
70 Located within Regional Pond A at northwestern corner	I	0-45	Very dark grayish-brown clayish loam with gravel inclusions

II	45-100	White sand

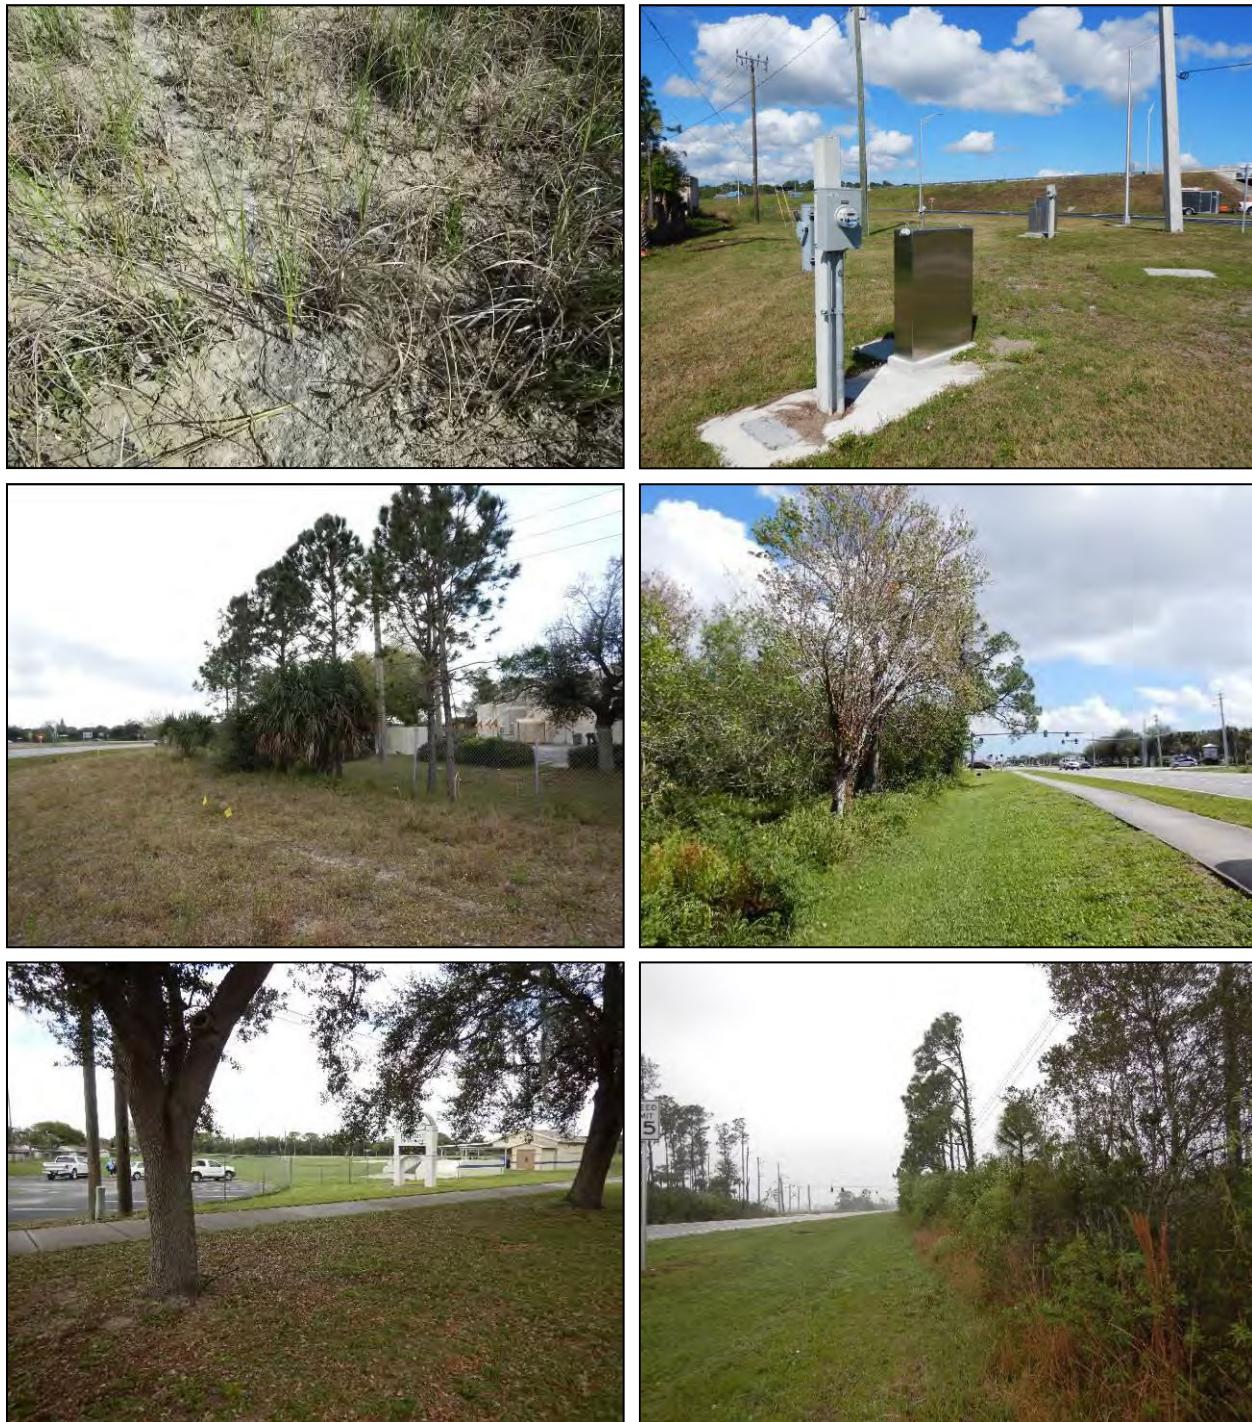
**Figure 13. Environmental photographs of “no dig” shovel test locations. Top left: View of clayish, wetland within western portion of Pond 1A. Top right: View north/northwest from shovel test located on north side of SR 524 and just west of I-95. Middle left: View south from shovel test at north end of right-of-way west of East Industry Road. Middle right: View east from shovel test north of SR 524 and west of Pond 3A. Bottom left: View north from shovel test north of SR 524 and south of the Fred Gay Golf Academy. Bottom right: View southwest from shovel test north of SR 524 and east of entrance to Walmart.**

Soils within the project right-of-way and ponds were found to be of variable composition and recorded as combinations of sand, loam, and/or silt. Within the 23 shovel tests that were excavated to the target depth, the majority (n=18) consisted of three or four strata. Representative examples of negative shovel test data are presented in **Table 5**. Representative environmental photographs of the 20 “no dig” shovel tests are provided in **Figure 13**.

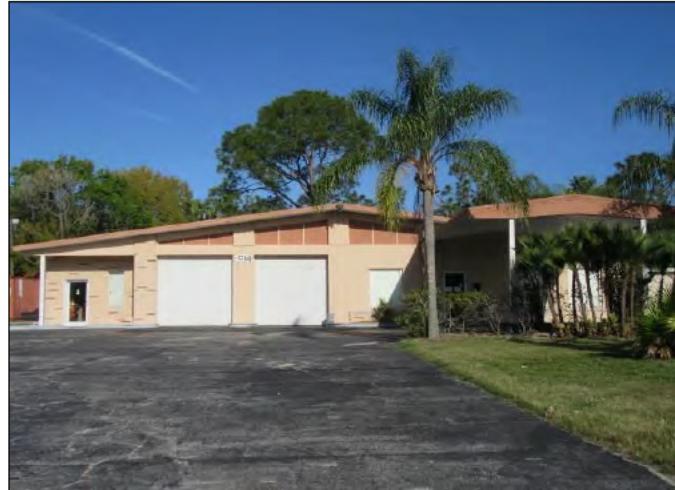
**Figure 24.** Resource 8BR04196 provides an example of the Masonry Vernacular style within the SR 524 Improvements APE. Photograph facing northwest.

There are five Masonry Vernacular building within the SR 524 Improvements APE (Figure 24). Masonry Vernacular buildings were designed on a basis of local need, material availability, and tradition. Materials of this style include brick, cement block, oolitic limestone, Ocala block, hollow clay tile, stucco, and stone, amongst others. Decoration is often sparse. However, examples of Masonry Vernacular may be influenced by a variety of high styles.

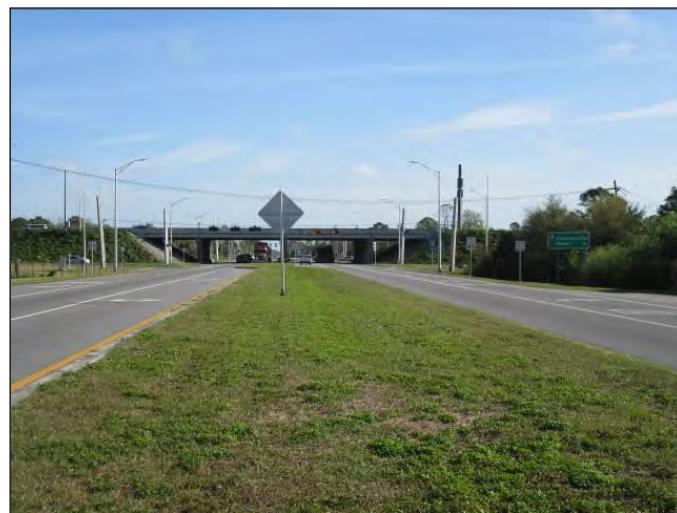
**Figure 25.** Representative view of Resource 8BR04195, facing northeast.

SR 524 (8BR04195) is a newly recorded linear resource in Brevard County (see **Figures 18-23**). Within the SR 524 Improvements APE and SR 524 Improvements Ponds APE, 8BR04195 is situated in Sections 13, 23, 24, and 27 of Township 24 South, Range 35 East and Section 18 of Township 24 South, Range 36 East, as shown on the 2018 *Lake Poinsett, Fla. and Sharpes, Fla.* USGS quadrangle maps. The road is oriented southwest-northeast and runs approximately 3.3 miles (5.3 kilometers) within the APE. It begins at the southwestern terminus of the SR 524 Improvements APE, approximately 0.3 miles (0.5 kilometers) southwest of I-95, and travels northeast, terminating at its intersection with East Industry Road. Within the APE, 8BR04195 is an asphalt-paved highway that consists of two travel lanes, central and outside turning lanes, and occasional grassy and concrete medians. In the southwestern half of the APE, 8BR04195 has grassy boundaries and with minimal development immediately adjacent. In the northeastern half of the APE, it is bordered by residential development on its northwestern side, with commercial development located at the eastern terminus of the SR 524 Improvements APE near East Industry Road (**Figure 25**).

SR 524 was constructed by 1970 (USDA 1970) to connect SR 520 to the Bennett Causeway (SR A1A) and Cape Canaveral. Upon completion of the Martin B. Anderson Beachline Expressway, formerly known as the Bee Line, in 1974, the road was renamed SR 524 and the Bee Line became SR 528 (AARoads 2018; Shofner 2001:46). The original SR 524 connection to US 1 and the Bennett Causeway was retained as the SR 528 on-ramp from Industry Road, but was disconnected from SR 524. The easternmost end of SR 524 was realigned to the south (FDOT 1972, 1980, 1986, 1993) (**Figure 26**). A review of aerial imagery from 1972 to 2018 shows that it has remained relatively unaltered since its realignment (FDOT 1972, 1980, 1983, 1986, 1993, 2005, 2012, 2015, 2018).

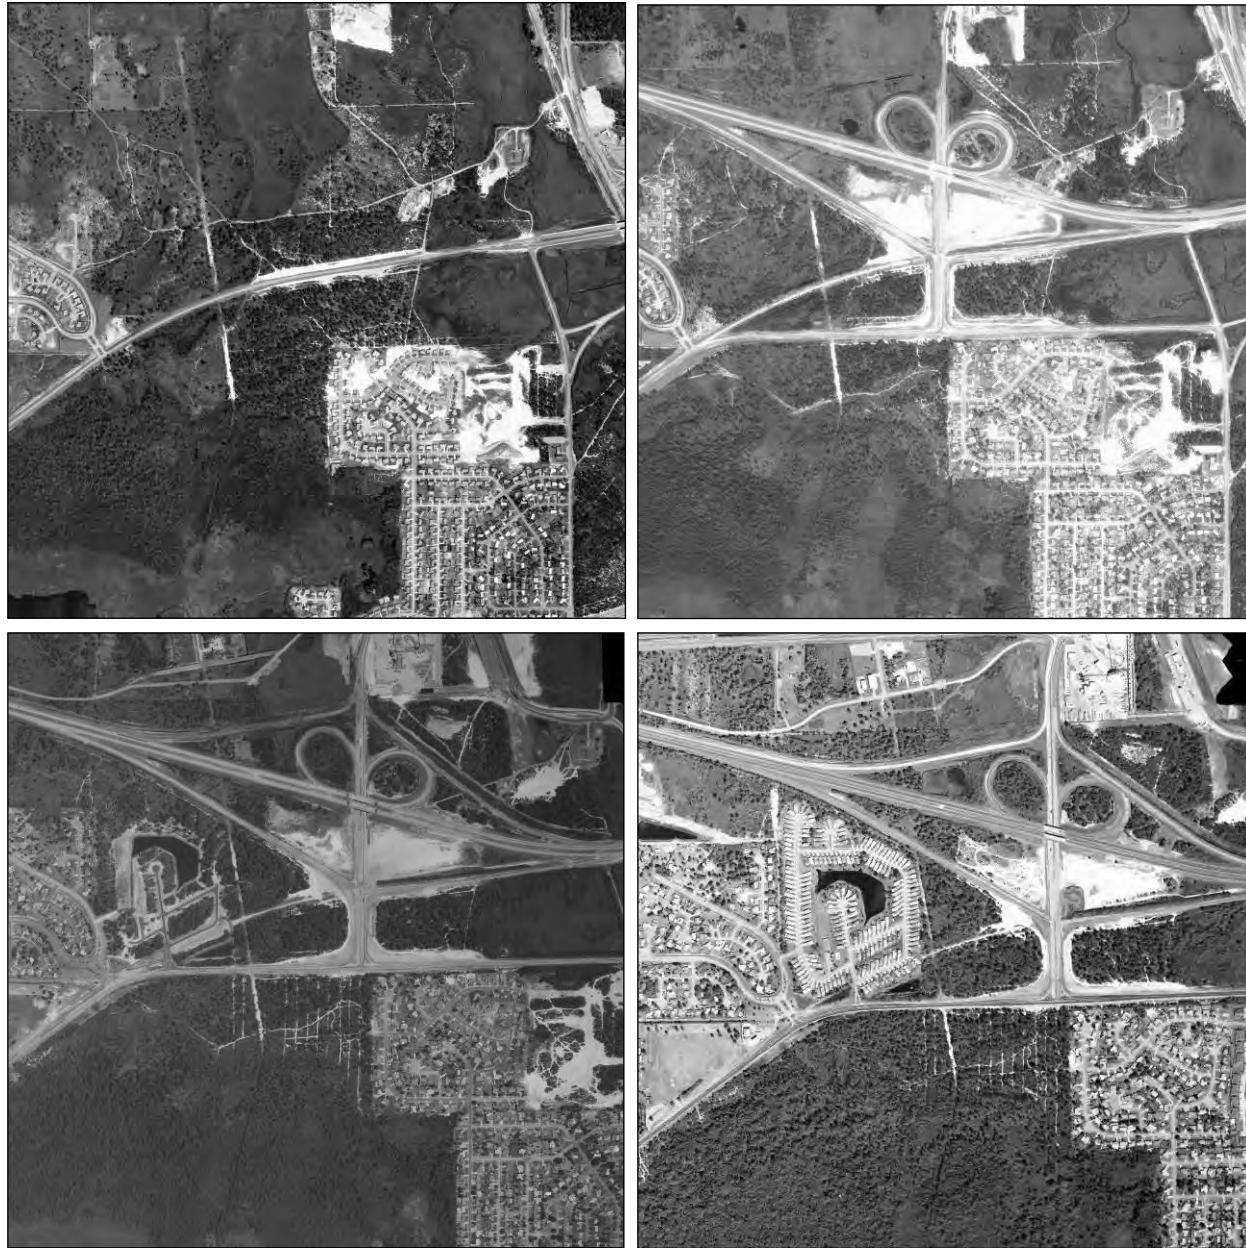
**Figure 26. Historic aerials showing realignment of the eastern end of SR 524. Top left, FDOT 1972; top right, FDOT 1980; bottom left, FDOT 1986; bottom right, FDOT 1993.**

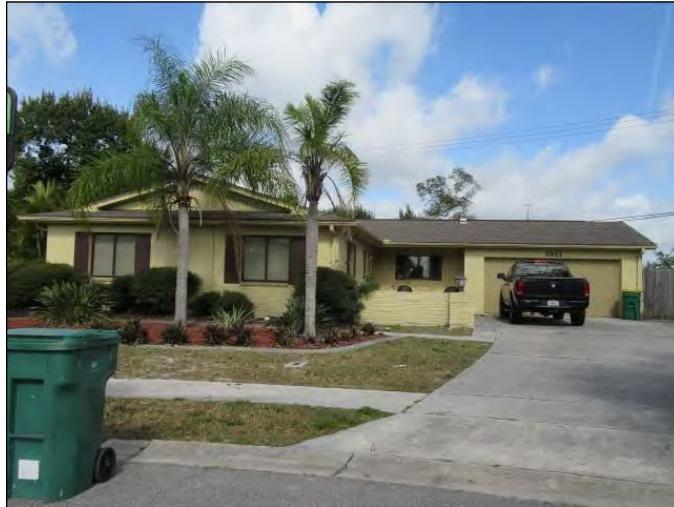
**Figure 27. Resource 8BR03331, facing northwest.**

Masonry Vernacular structure set on a continuous concrete block foundation (**Figure 27**). The gable roof intersects a gable-on-hip roof; both are clad with composition shingles. The windows consist of sliding, two-light aluminum windows with faux shutters. The exterior material consists of painted concrete block. There is a metal chimney near the northwestern corner of the roof. The main entrance is located on the northeast façade at its intersection with the southeast façade. It features a single door obscured by a metal and screen storm door. There is a partial-width incised porch on the southeast façade, which intersects the northeast façade where the main entry is situated. The porch features a brick platform sheltered by the structure's main gable roof. A concrete block kneewall is located to the southeast of the structure extending from the northeast façade, and a paved concrete driveway is located to the southeast.

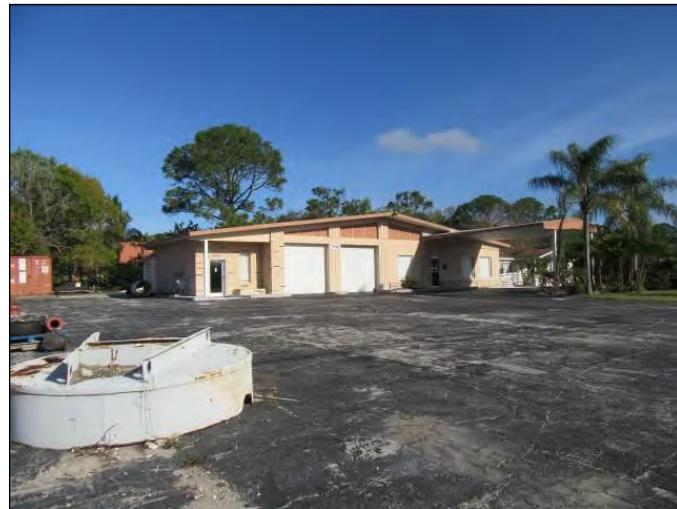
**Figure 28. Resource 8BR04196, facing north.**

Resource 8BR04196, 5580 State Road 524, is a newly recorded resource within Brevard County (see **Figure 18**). Resource 8BR04196 is situated in Section 27 of Township 24 South, Range 35 East, as shown on the 2018 *Lake Poinsett, Fla.* USGS quadrangle map. The structure is located on an irregular parcel, bounded to the southeast by SR 524, to the east by Friday Road, and to the southwest and northwest by private parcels. The ca. 1967 commercial structure is a one-story, irregular-plan Masonry Vernacular building set on a concrete slab foundation (**Figure 28**). The gable roof is clad with composition roll. The windows consist of fixed, vinyl-framed, individual, one-light windows. The exterior material consists of painted concrete block, brick, and fluted and flat decorative plywood panels. The main entrances are located on the south and east ends of the southeast façade and feature two single vinyl-framed doors with central glass panels. A porte-cochère is attached to the southeast façade east of center and is composed of a gable roof supported by wood posts over asphalt decking. An additional incised porch is located on the south end of the southeast façade and is composed of concrete decking sheltered by the main gable roof and supported by a wood post. An asphalt-paved lot is located to the south and east of the structure. Resource 8BR04196 is located southwest of and shares a tax parcel with a non-historic prefabricated house.

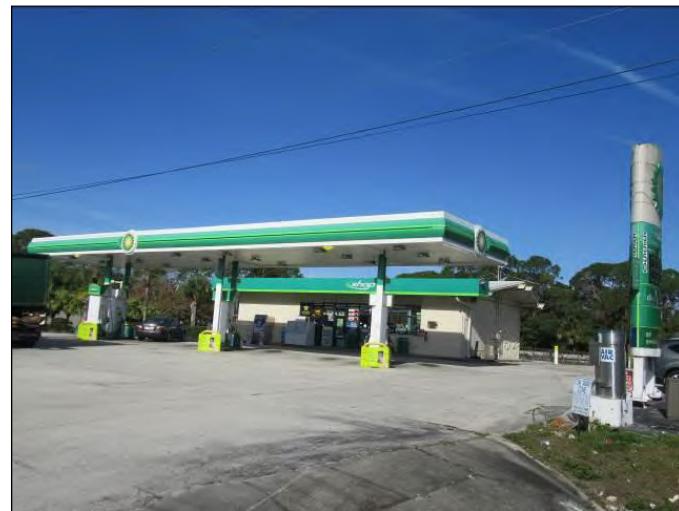
**Figure 29. Resource 8BR04197, facing west.**

Resource 8BR04197, 5550 State Road 524, is a newly recorded resource within Brevard County (see **Figure 18**). Resource 8BR04196 is situated in Section 27 of Township 24 South, Range 35 East, as shown on the 2018 *Lake Poinsett, Fla.* USGS quadrangle map. The structure is a gas station, located on a rectangular parcel, bounded to the southeast by SR 524, to the southwest by Friday Road, and to the northwest and northeast by private parcels. The ca. 1967 gas station is a one-story, rectangular-plan Masonry Vernacular building set on a concrete slab foundation (**Figure 29**). The gable roof is clad with composition roll. The windows consist of fixed and transom continuous single-light metal windows. The exterior material consists of concrete block and artstone. The main entrance is located east of center on the southeast façade and features double metal-framed doors with central glass panels. There are transoms above the doors. An open porch across the full width of the southeastern façade is formed of a concrete platform sheltered by a metal commercial-style block parapet. An artstone kneewall extends from the southeast structure façade to the southwest of the structure, and a gas shelter is located to the southeast of the building. A metal sign also is located to the east of the building, and a concrete lot fills the parcel.

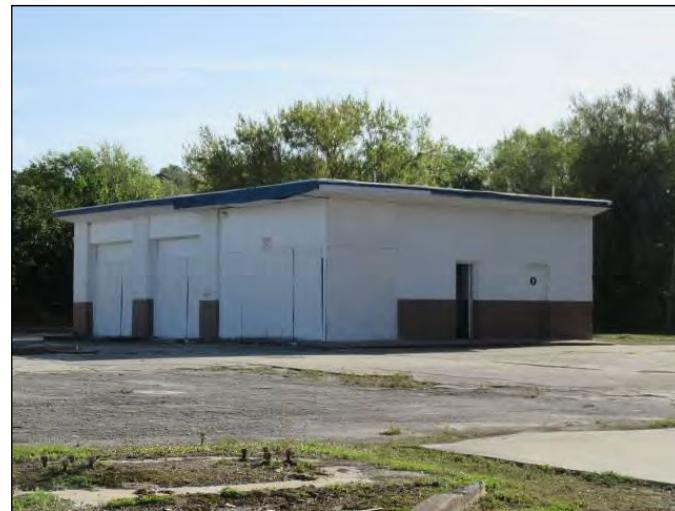
Figure 30. Resource 8BR04198, facing east.

Resource 8BR04198, 5555 State Road 524, is a newly recorded resource within Brevard County (see **Figure 18**). Resource 8BR04198 is situated in Section 27 of Township 24 South, Range 35 East, as shown on the 2018 *Lake Poinsett, Fla.* USGS quadrangle map. The structure is located on a rectangular parcel, bounded to the northwest by SR 524, to the southwest by Friday Road, and to the northeast and southeast by private parcels. The ca. 1966 commercial structure is a one-story, rectangular-plan Masonry Vernacular structure set on a continuous brick foundation (**Figure 30**).

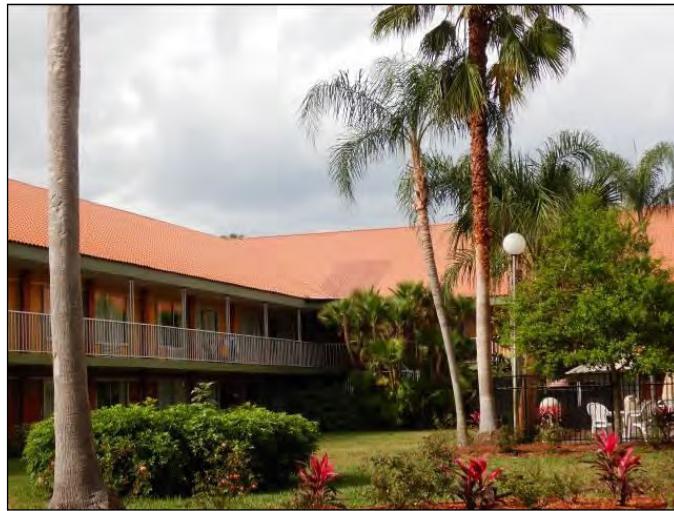
Figure 31. Resource 8BR04214, facing northwest.

private parcels, and to the north and west by private parcels. The ca. 1973 hotel is a two-story, L-shaped Masonry Vernacular structure set on a concrete slab foundation (**Figure 31**). Corrugated sheet metal covers the steeply pitched hip roof. The windows consist of two-light, metal-framed, individual sliding windows, with roughly one window per hotel room unit. The exterior material consists of stucco-clad concrete block. Each unit is entered via a single wood door with a wood doorframe. There is a full-width porch on the north, east, and south façades of the first story with a concrete walkway sheltered by the second story balconies. The second stories on the north, east, and south façades also contain full-width balconies with concrete platforms, metal railings, and metal posts sheltered by the main hip roof. A paved asphalt parking lot is located to the north and west of the structure.

The second stories on the north, east, and south façades also contain full-width balconies with concrete platforms, metal railings, and metal posts sheltered by the main hip roof. A paved asphalt parking lot is located to the north and west of the structure.

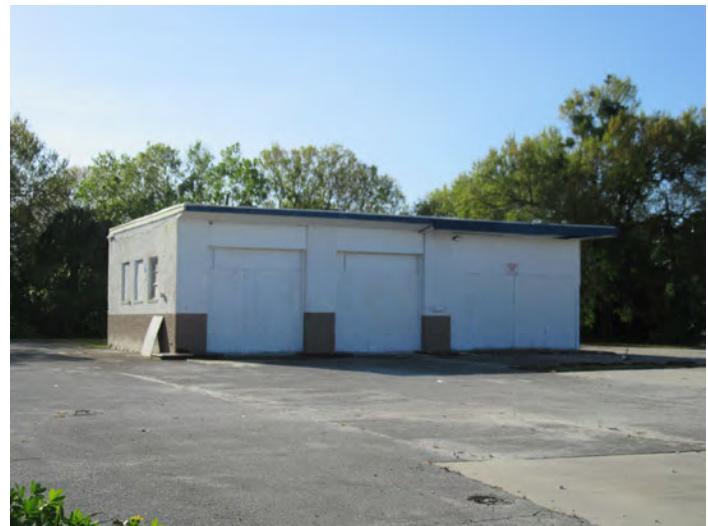
8BR04198\_a Facing Southeast

Resource 8BR04198 is a 1-story, Masonry Vernacular commercial structure with a rectangular plan set at grade on a continuous brick foundation. The flat roof is built-up, and the walls are brick. It is abandoned, and plywood covers most doors and windows.

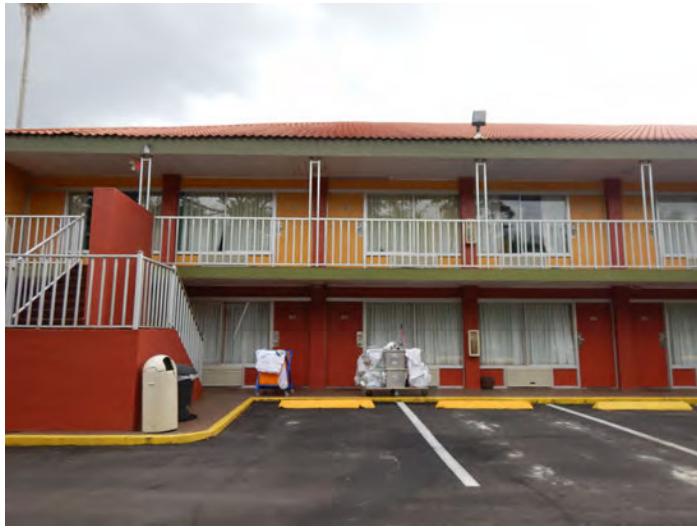
8BR04214\_a Facing West

Resource 8BR04214 is a 2-story Masonry Vernacular hotel with an L-shaped plan set at grade on a concrete slab foundation. Corrugated sheet metal covers the steeply pitched hip roof, and stucco clads the walls. External metal stairs access the 2nd story.Archaeological Remains \_\_\_\_\_  Check if Archaeological Form Completed**RESEARCH METHODS (select all that apply)**
