**FLORIDA DEPARTMENT OF TRANSPORTATION**  
**BRIDGE MANAGEMENT SYSTEM**  
**Inspection/CIDR Report with PDF attachment(s)**  
(TRAFFIC SIGNAL MAST ARM INSPECTION REPORT)

Structure ID: 70M131

INSPECTION DATE: 11/1/2021 BBLN

| BY: FIT Engineering | STRUCTURE NAME: US-1 at Olmstead Drive |

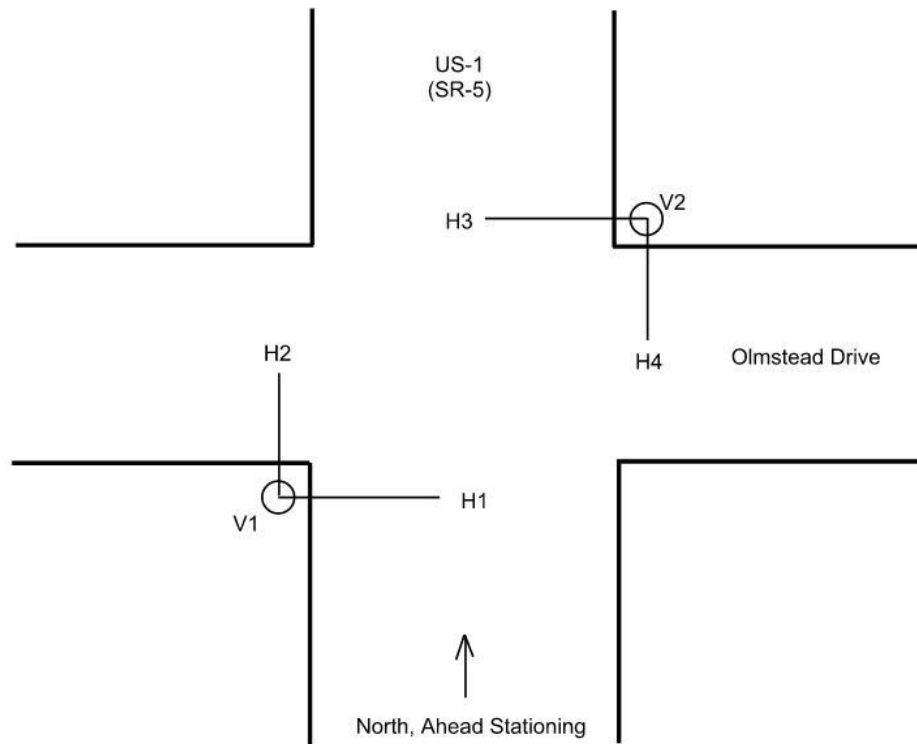
Deficiency Location Photo

F2 - The leveling nuts for Anchor Bolts 1 and 2 are loose, as indicated by washer movement when struck with a hammer. Refer to Photo 1. (1 EA)

The NBI rating for Item 60 Substructure was lowered from an 8 - Very Good to a 5 - Fair due to loose leveling nuts at F2.

F2 –  
Loose leveling nuts

F2 - Tighten the loose leveling nuts for Anchor Bolts 1 and 2. P=3
