**FLORIDA DEPARTMENT OF TRANSPORTATION**  
**BRIDGE MANAGEMENT SYSTEM**  
**Inspection/CIDR Report**  
(TRAFFIC SIGNAL MAST ARM INSPECTION REPORT)

Structure ID: 70M085

| BY: | Ayres Associates | STRUCTURE NAME: | US-1 SB at SR-405 |

TYPE OF INSPECTION: Regular NBI

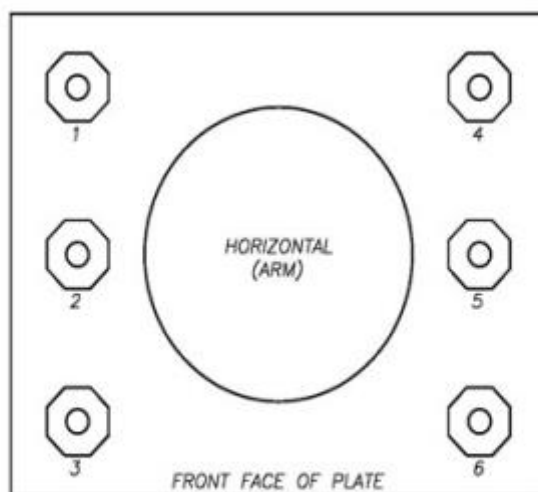
TSMA MOMENT CONNECTION BOLT NUMBERING SCHEME

V1/H1 - Moment Connection Bolts #5 & #6 are loose. NO CHANGE. Refer to Photos 4 & 5. (1 EA) REPAIR.

V1/H1 - The moment connection has a gap up to 1/16 in. wide between the plates at Bolts #5 and #6 (previously Bolt #6 only). INCREASE. Refer to Photo 5. REPAIR.

V1/H2 - The moment connection has a gap up to 1/16 in. wide between the plates at Bolts #1 and #2 (previously noted at Bolt #1 only), but all bolts are tight. INCREASE. Refer to Photo 6. (1 EA)

V1H1 - properly tighten the loose moment connection bolts 5 & 6 per FDOT Spec 649-7. No repairs have been made since the 01/2026 Accident Inspection.

V1H2 - close the gap between moment connection plates at Bolt 1 per FDOT Spec 649-7. No repairs have been made since the 01/2026 Accident Inspection.

| CONDITION<br>STATE | | | PRIORITY |
|---|---|---|---|
| V1H1 - Replace moment connection bolts #5 & 6 with new A325 bolts 7 in. L x 1.0 in. Dia. | | | |
