**FLORIDA DEPARTMENT OF TRANSPORTATION**  
**BRIDGE MANAGEMENT SYSTEM**  
**Inspection/CIDR Report**  
(TRAFFIC SIGNAL MAST ARM INSPECTION REPORT)

**Structure ID: 70M094**  
**DISTRICT: D5 - Deland**

| BY: Ayres Associates | STRUCTURE NAME: US-1 (Hopkins Ave.) SB at Main St |

TYPE OF INSPECTION: Regular NBI

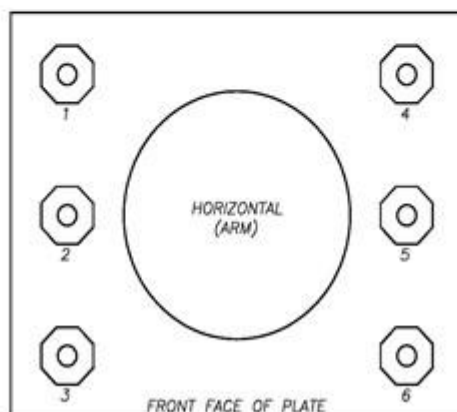
TSM MOMENT CONNECTION BOLT NUMBERING SCHEME

V1/H2 - Moment connection bolt #6 (bottom right) is loose. NEW. Refer to Photos 3. (1 EA) REPAIR.

| CONDITION<br>STATE | | | PRIORITY |
|---|---|---|---|
| V1H2 - Replace moment connection bolt 6 with new Galv. A325 bolt 6in L x 1in. dia. | | | |
