**FLORIDA DEPARTMENT OF TRANSPORTATION
BRIDGE MANAGEMENT SYSTEM
Inspection/CIDR Report with PDF attachment(s)
(INTERIM INSPECTION REPORT)**

Structure ID: 75M125

BY: Ayres Associates	STRUCTURE NAME: SR-526 at Paramore Ave
OWNER: 1 State Highway Agency	YEAR BUILT: 1900
MAINTAINED BY: 4 City/Municipal Hwy Agy	SECTION NO.: 75 030 000
STRUCTURE TYPE: 3 Steel - Traffic Signal Mast Arm	MP: 0.500
LOCATION: 0.40 Mi. West of I-4	ROUTE: 00526
SERV. TYPE ON: Traffic Signal Mast Arm	FACILITY CARRIED: SR526 (Washington)
SERV. TYPE UNDER: 1 Highway	FEATURE INTERSECTED: Paramore Ave
MAST ARM CODE: 4	MAST ARM DESCRIPTION: Mast arm is outside the mast arm boundary area

TYPE OF INSPECTION: Interim

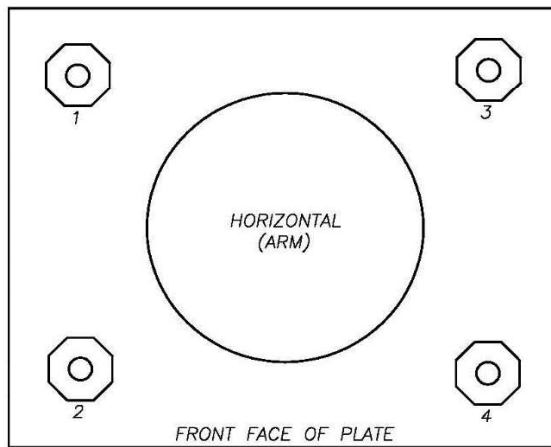
TSMa MOMENT CONNECTION BOLT NUMBERING SCHEME

V2/H2 - Moment Connection Bolt #4 is loose. Refer to Photo 6.

V2/H2 - Replace loose Moment Connection Bolt #4 with new 1 1/4 in. diameter x 8 1/2 in. long galvanized A325 bolt and properly tighten per FDOT Spec. 460-5. P=3
