Level 1 Contamination Screening Evaluation Report

FDOT Office
District Five

Certificate of Quality Compliance Contamination Screening Evaluation Report US 301 Project Development and Environment Study FM No. 430132-1-22-01

US 301 PD&E Study CR 470 E to State Road 44 in Sumter County FM No. 430132-1-22-01

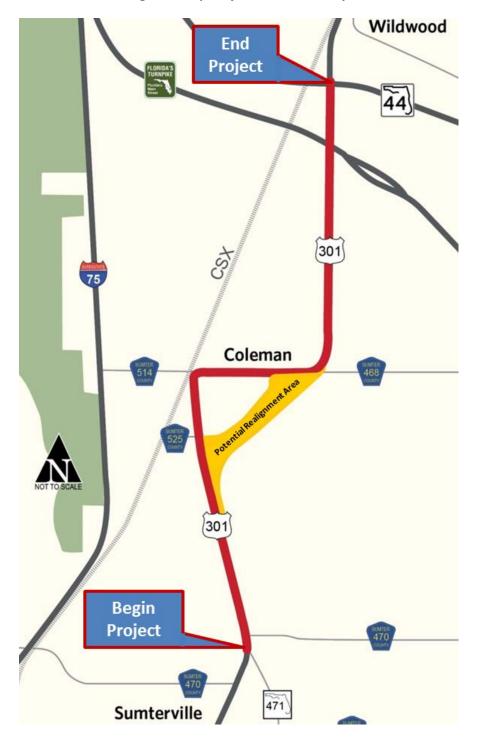
Figure 1-1 | Project Location Map

This study will evaluate all viable alternatives to widen US 301 on the existing project corridor as well as a potential realignment for US 301 from near CR 525 to CR 468 to minimize potential environmental impacts to the City of Coleman. Figure 1-1 shows the study corridor and potential realignment (Realignment Alternatives) area.

A total of ten (10) sites of potential contamination concern were identified to be located within the Potential Realignment Area (as illustrated on Figure 1-1) during the preliminary investigation. Each site was investigated for current or past land uses that may present the potential for finding petroleum contamination or hazardous materials, and therefore may impact the proposed project. The following table summarizes the risk rankings for potential contamination concern from each of the 10 sites in relation to each alignment. The three (3) Realignment Alternatives and the Preferred Alignment (a combination of Alternative B and Alternative C) are presented in **Appendix B, Sheets B-6 and B-7**.
