# PEDESTRIAN SAFETY STUDY

For  
State Road 423 from Wymore Road to U.S. 17/92  
Section 75190  
M.P. 8.655 to M.P. 9.864  
Orange County

June 2024

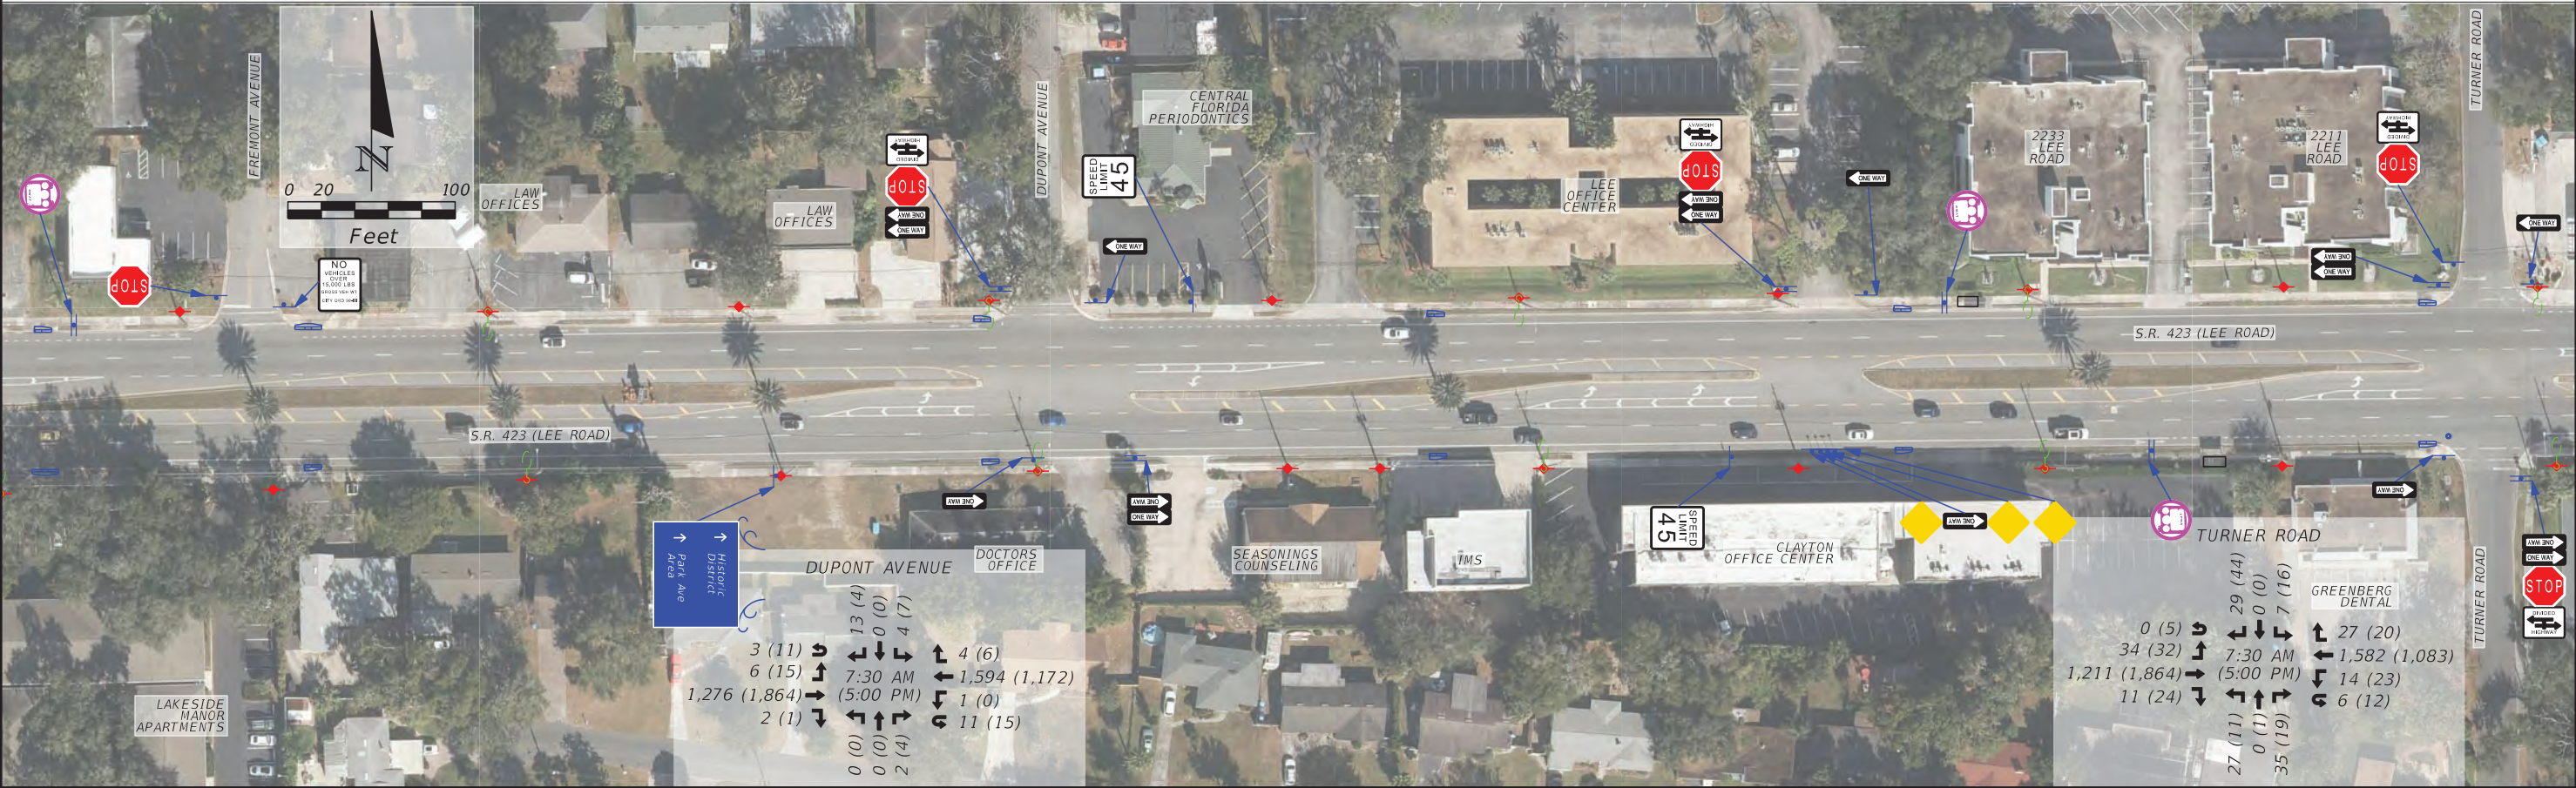
FIGURE 2  
EXISTING CONDITIONS DIAGRAM  
SHEET 1/3

An aerial photograph showing the existing conditions of the study corridor and the surrounding area is depicted in **Figure 2**. The morning and afternoon peak-hour turning movement counts are also included in **Figure 2**. Existing conditions for S.R. 423 are shown in **Table 1**. A straight-line diagram is attached in the **Appendix A**.

The peak-hour volumes at the intersections listed above are shown on the Existing Conditions Diagrams in **Figure 2**. Based on the eight-hour TMCs, the a.m. peak hour ranged from 7:30 to 8:30 a.m. and 7:45 to 8:45 a.m., and the p.m. peak hour ranged from 4:45 to 5:45 p.m. and 5:00 to 6:00 p.m.

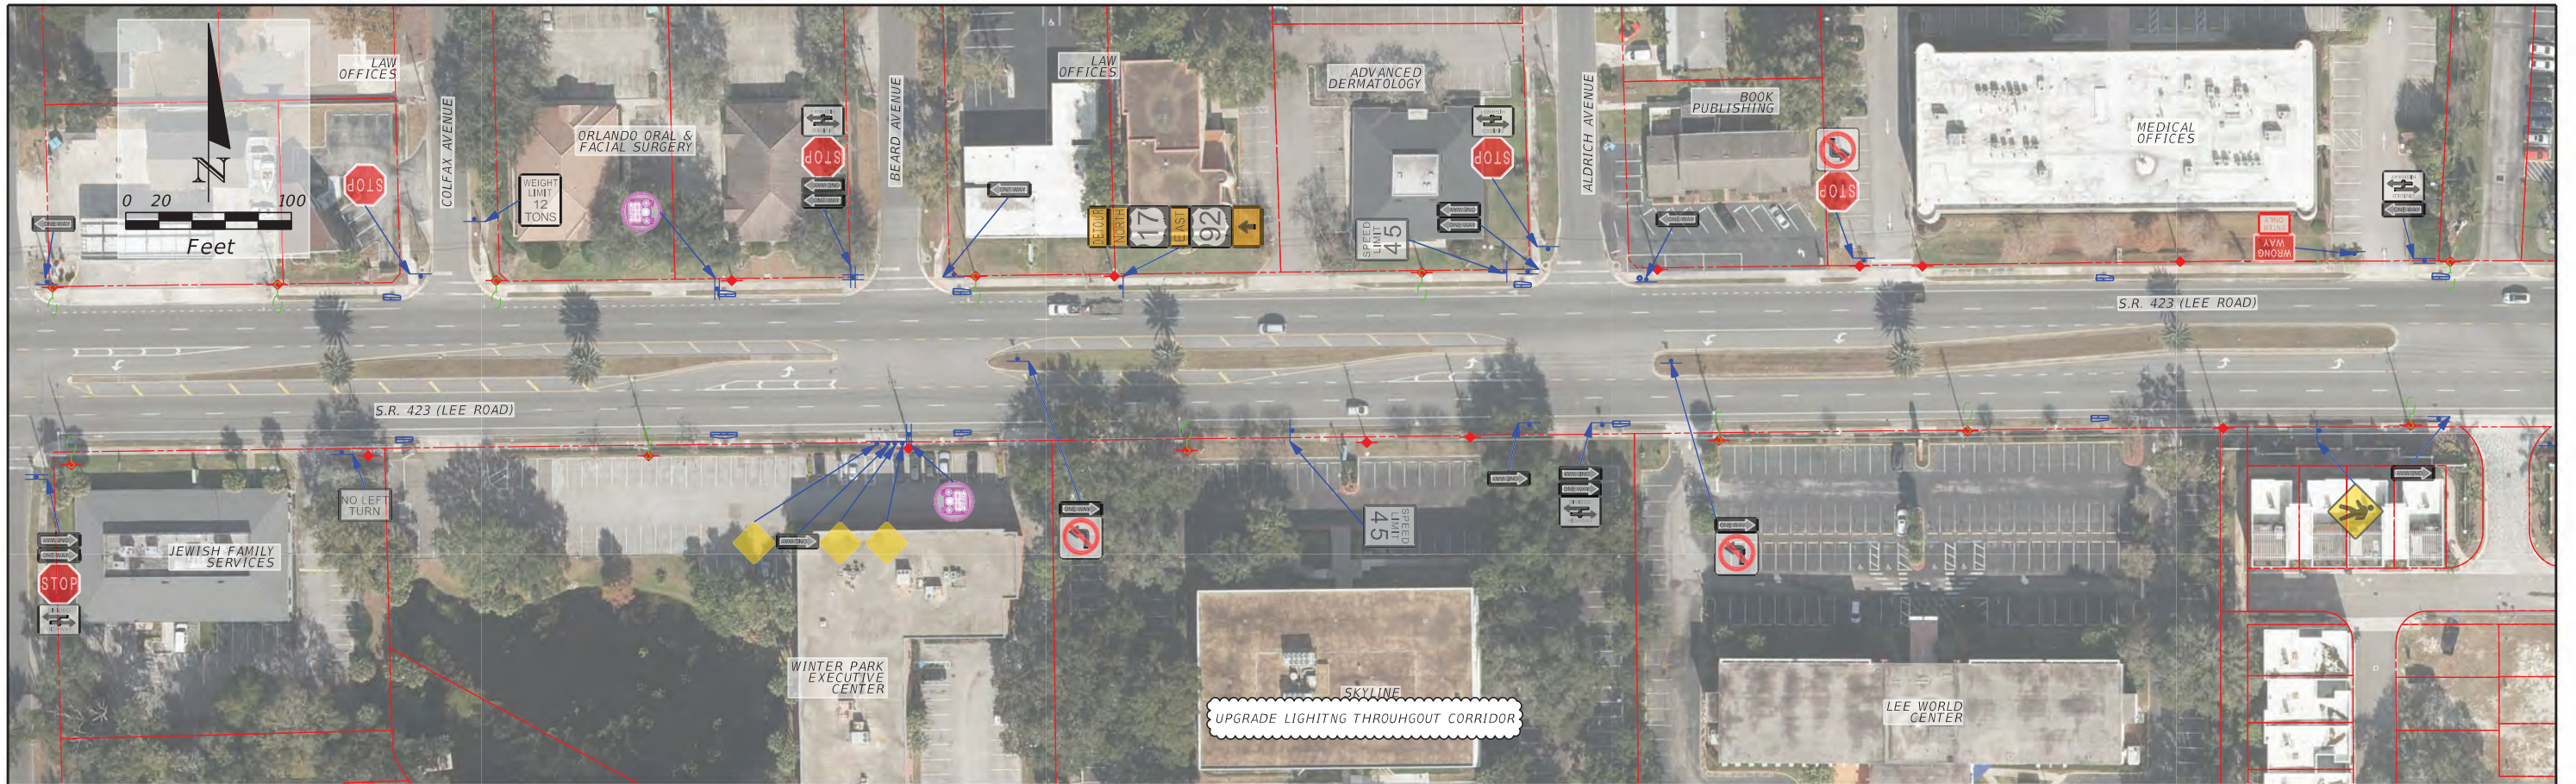
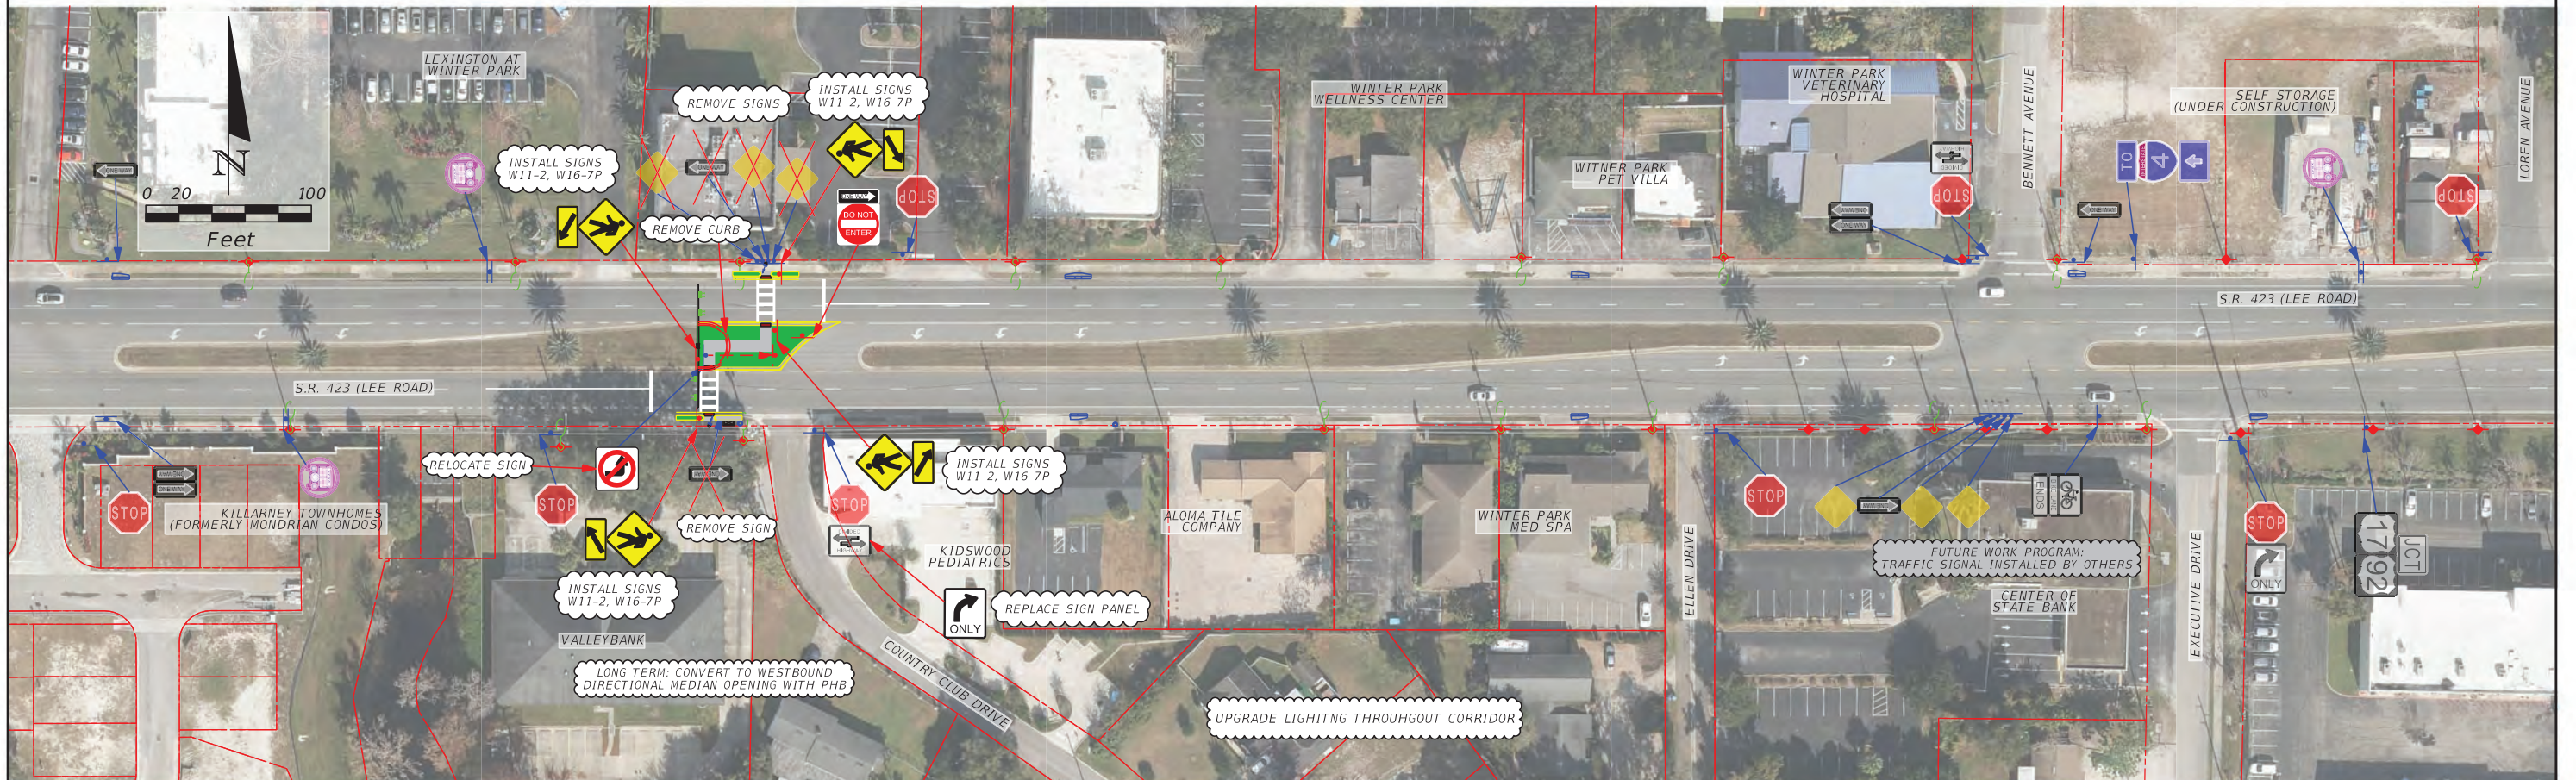
FIGURE 3  
LONG-TERM IMPROVEMENTS DIAGRAM  
(PAGE 2 OF 3)

- Symbols:
- Utility Pole
  - Traffic Sign
  - Luminaire
  - Traffic Controller Cabinet
  - Existing Inlet
  - Proposed Elements
  - Long Term Improvements
  - Future Work Program

With the updated recommended improvements and using the FDOT's 12-Month moving average prices from January 1, 2023 to December 31, 2023, the updated estimated cost for the short and long-term improvements shown in **Figure 3** is \$1,543,435 as shown in the "Engineer's Opinion of Probable Costs" table in **Appendix E**.
