## **CONTAMINATION SCREENING EVALUATION REPORT**

**Florida Department of Transportation  
District 5**

### **US 17/92 PROJECT DEVELOPMENT & ENVIRONMENTAL (PD&E) STUDY** FROM IVY MIST LANE TO AVENUE A Osceola County, Florida

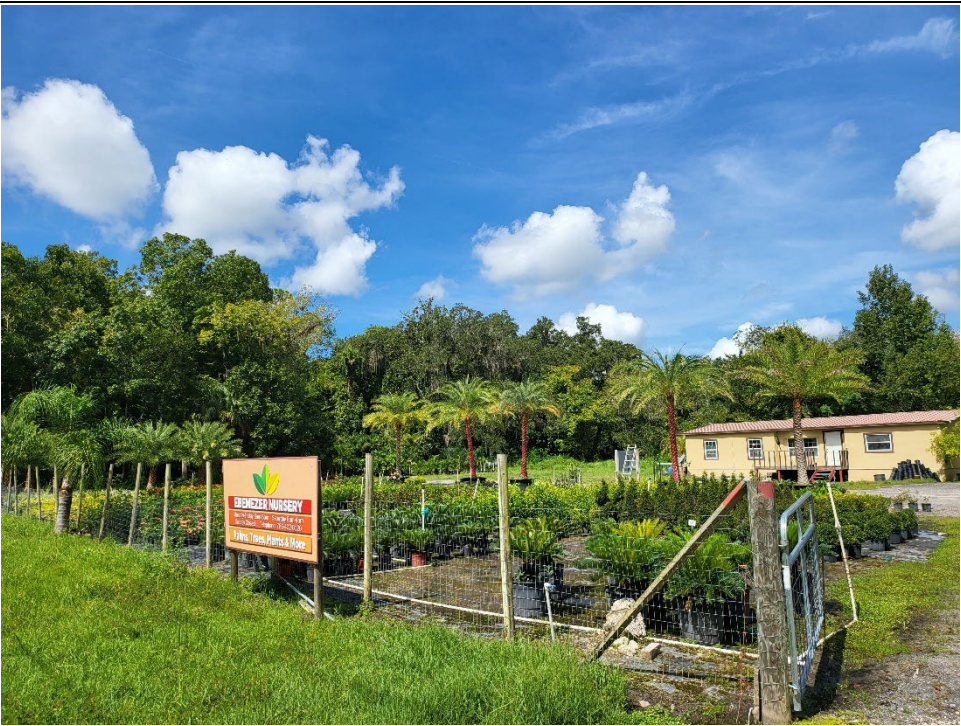
**CONCLUSIONS:** Due to the potential for roadway improvements being on the south side of US 17/92 across from this site, the nursery facility has been assigned a CRR of **Low**.

Looking west at the entrance of the plant nursery.

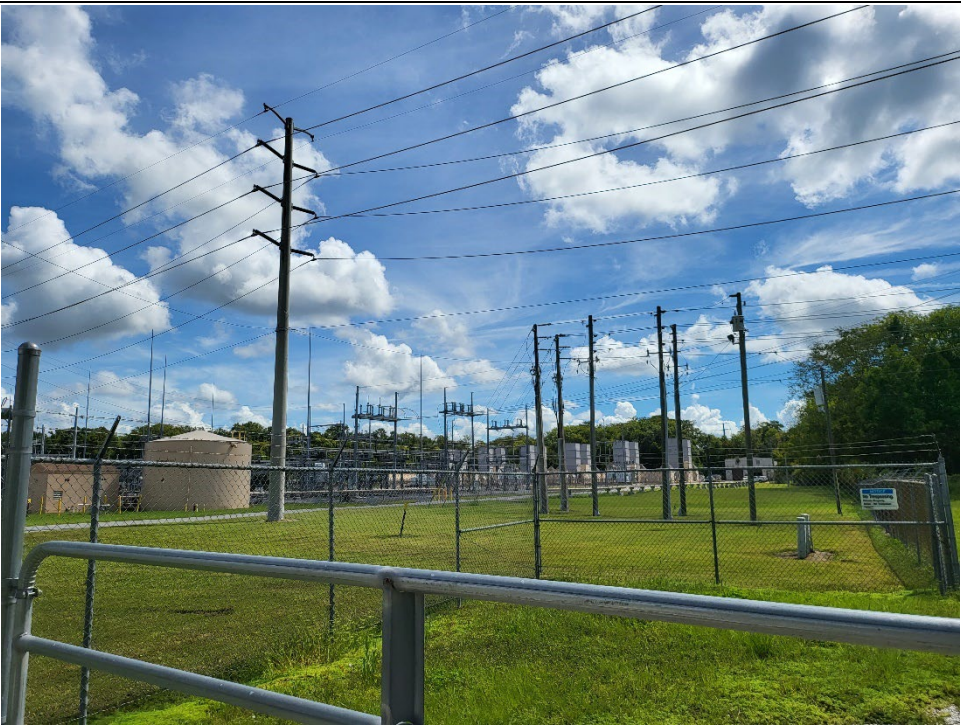
**CONCLUSIONS:** Based on the distance from the soil and groundwater impacts to the proposed construction, land use restriction, and currently being in compliance this site is assigned a Contamination Risk Rating (CRR) of **Low**.

View of the eastern portion of the power plant from the southern border.

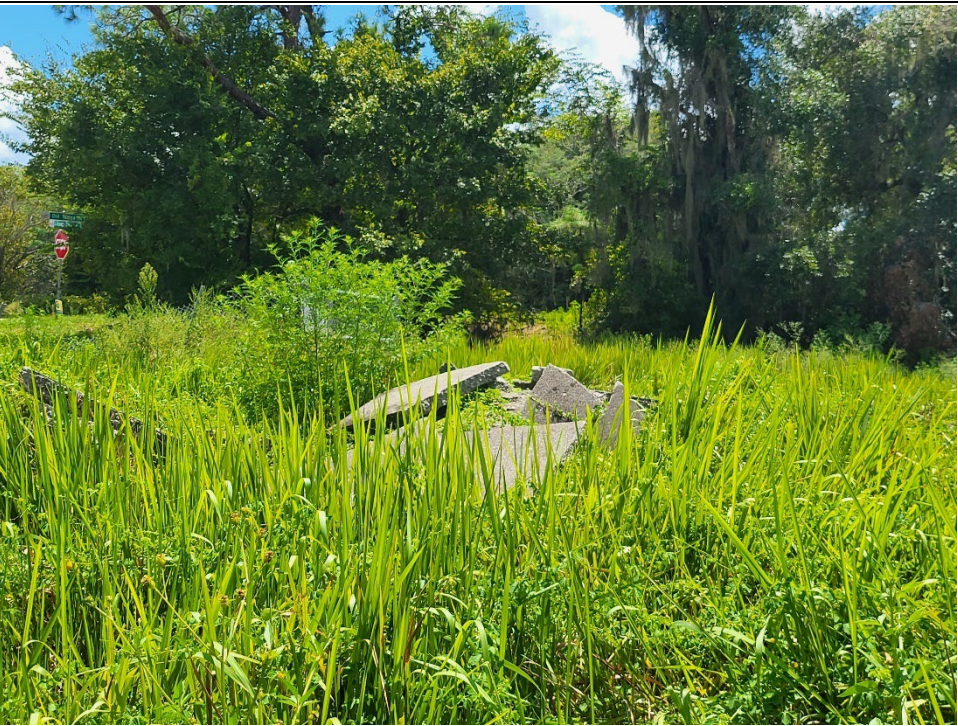
**SITE OBSERVATIONS:** The site contained piles of concrete rubble at the time of the site visit. The piles did not appear to contain hazardous materials.

**CONCLUSIONS:** Based on the debris removal and lack of pollutant releases, the disaster debris management site has been assigned a CRR of **Low**.

View of concrete rubble in debris management site.

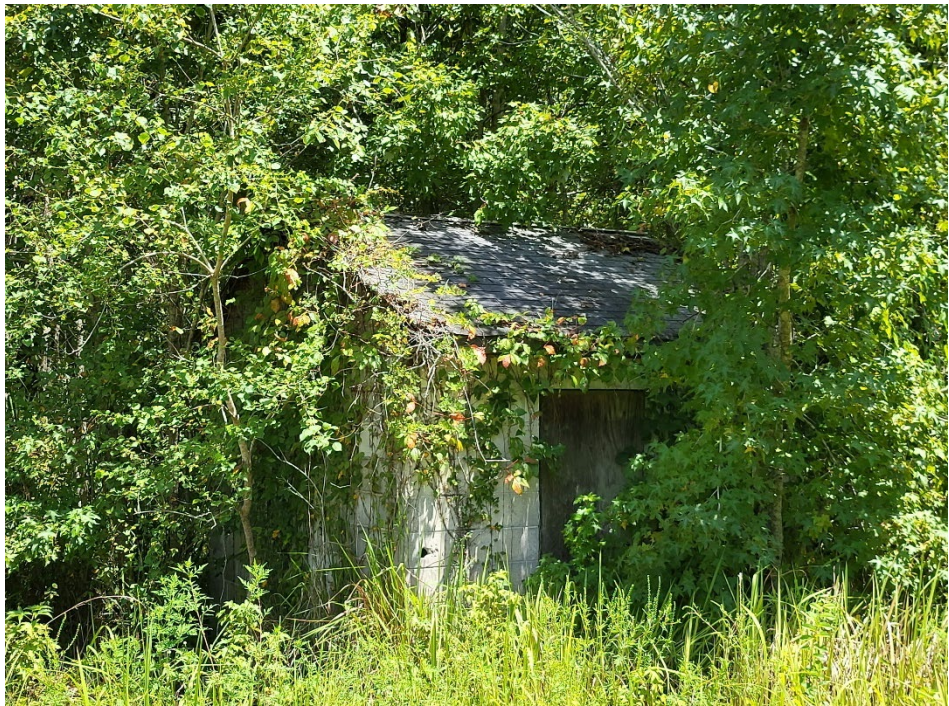
**CONCLUSIONS:** Based on the potential for lead or asbestos clad telephone lines to exist related to this building, and it being located within the footprint of Pond 3.1, the repeater station has been assigned a CRR of **Medium**.

View of the abandoned telephone repeater station.

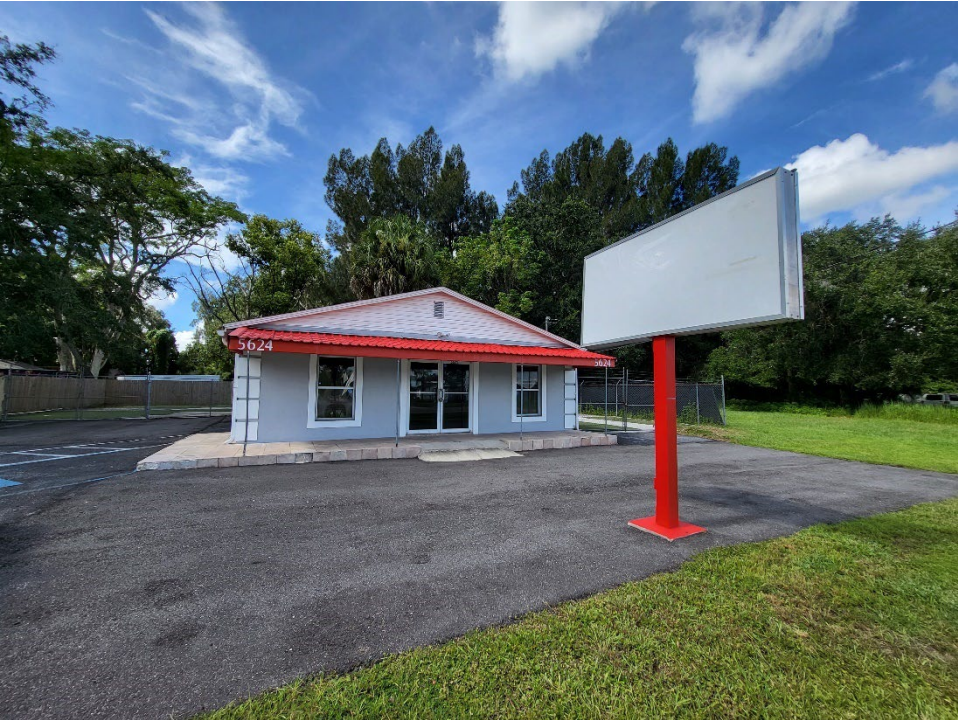
**CONCLUSIONS:** Due to the lack of recorded contamination impacts and its abandoned nature, the facility has been assigned a CRR of **Low**.

Looking south at the vacant building.

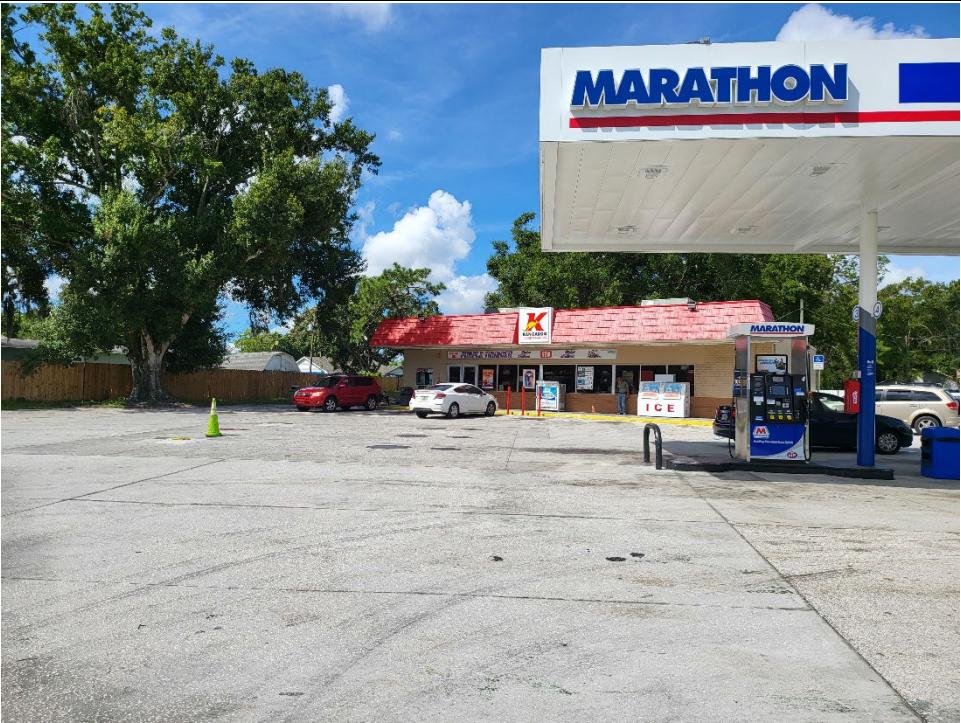
**CONCLUSIONS:** Due to the proposed right of way taking along the south side of US 17/92, the gas station has been assigned a CRR of **Medium**.

View of the Circle K gas station. A fuel pump can be seen on the right.

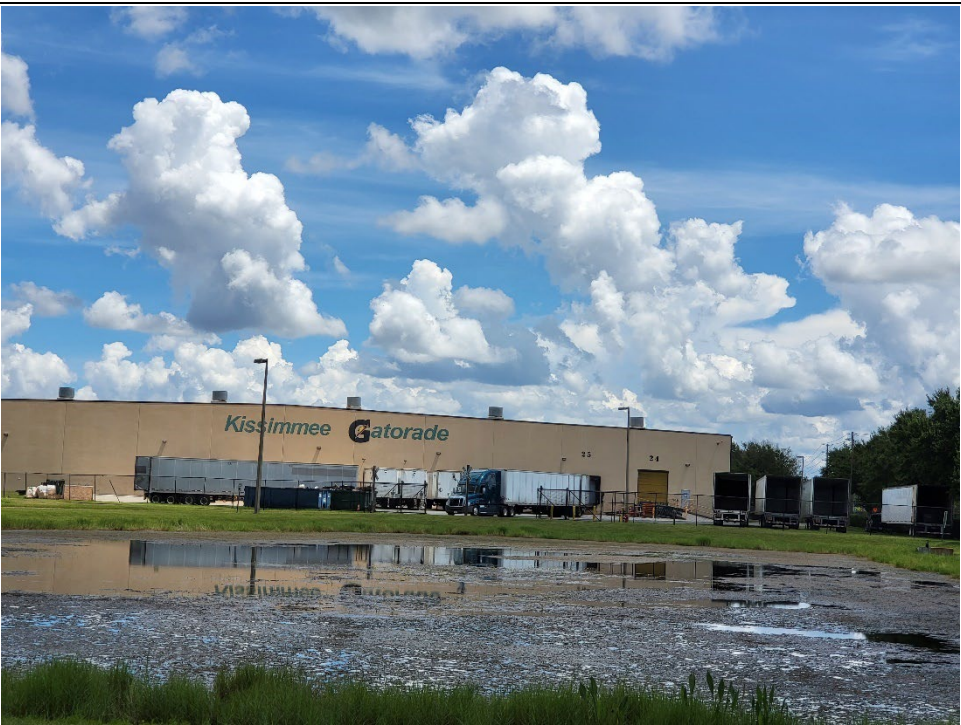
**CONCLUSIONS:** Due to the bulk of this facility falling outside the 500-foot search radius, the lack of recorded contamination, and the business currently being in compliance, the facility has been assigned a CRR of **Low**.

Looking west at the eastern side of the manufacturing facility.

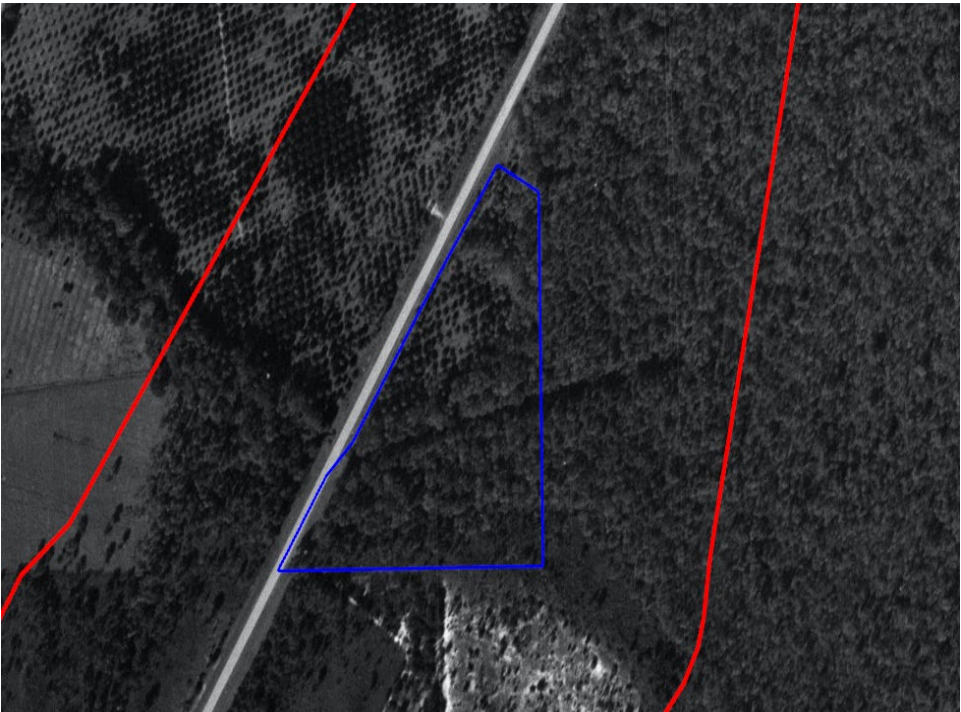
**CONCLUSIONS:** Due to the potential for pesticide and herbicide contamination to exist from the historical citrus groves within the US 17/92 widening and the adjacent **Joint Use Pond 1**, the land use has been assigned a CRR of **Medium**.

View of citrus groves on the west side of US 17/92 and within the footprint of **Joint Use Pond 1** on the 1969 aerial photograph.

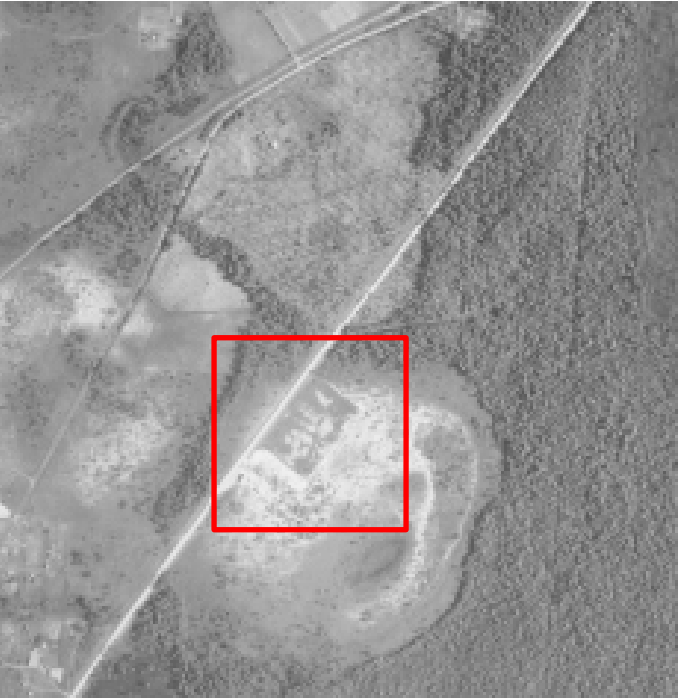
**CONCLUSIONS:** Based on the location of the “Area of Pits” being just outside the study area and having a potential for historical material burial within the rectangular property boundaries, it has been assigned a CRR of **Medium**.

Area of Pits is visible as rectangle on the 1941 aerial photograph.

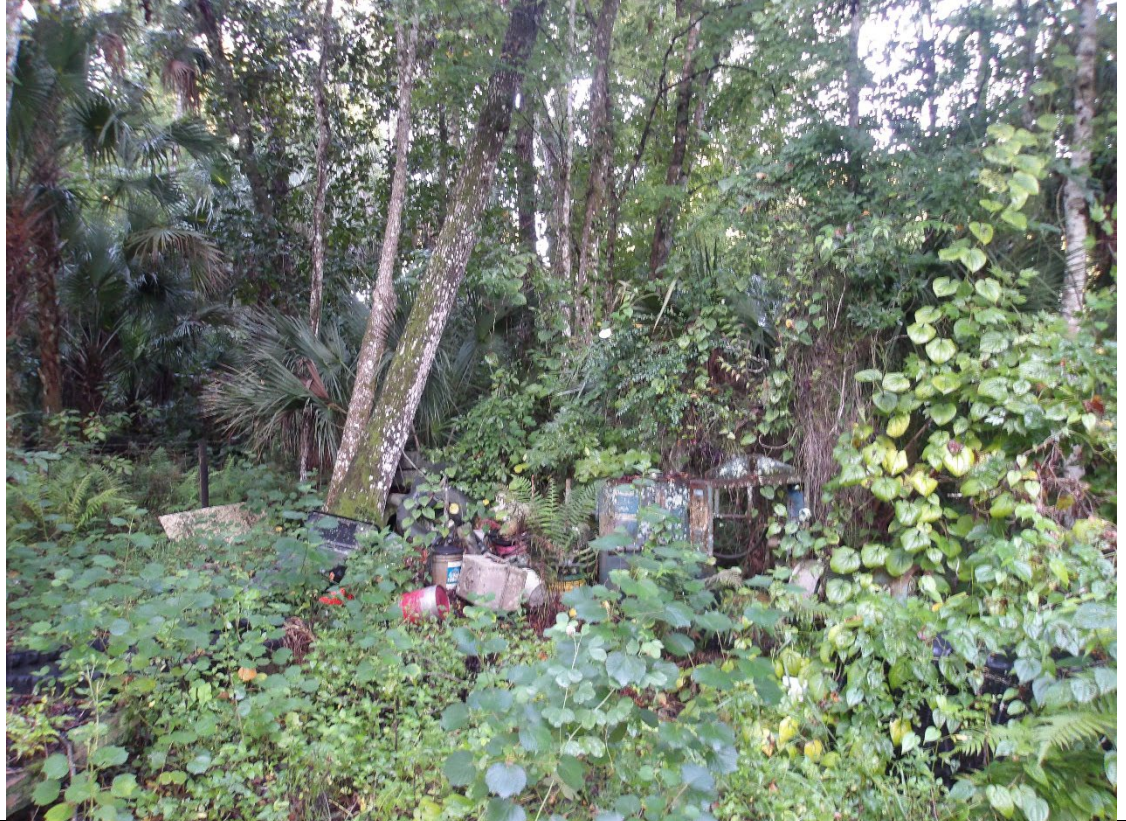
- **Joint Use Pond 1** is located on the east side of US 17/92 and contains two mobile home residences, two storage containers and two sheds. Two areas of dumping were observed, associated with the residences. Gas containers, 5-gallon buckets, dumped tires, and a plastic 55-gallon drum were observed in the areas of dumping.
- **Joint Use Pond 2A** is a wooded area on the west side of US 17/92. The majority of the land contained water at the time of the site reconnaissance.

View of dumping in  
**Joint Use Pond 1.**

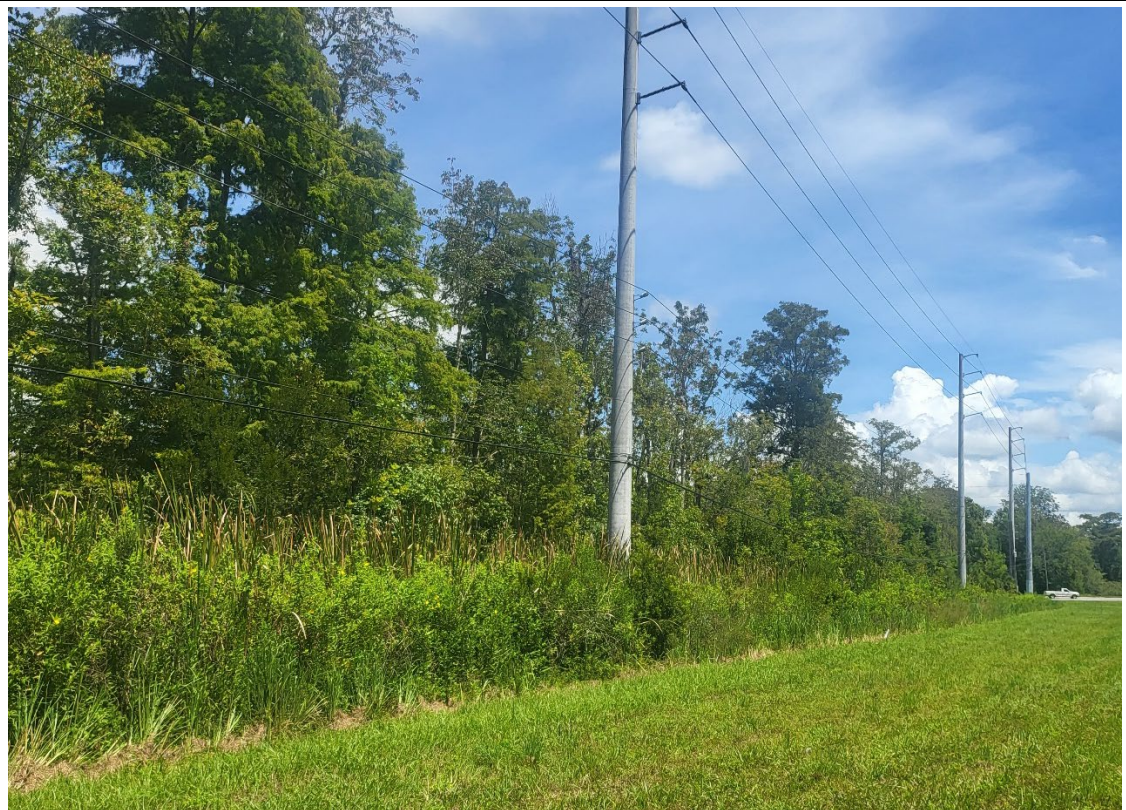
Looking northwest at  
the eastern border of  
**Joint Use Pond 2A.**

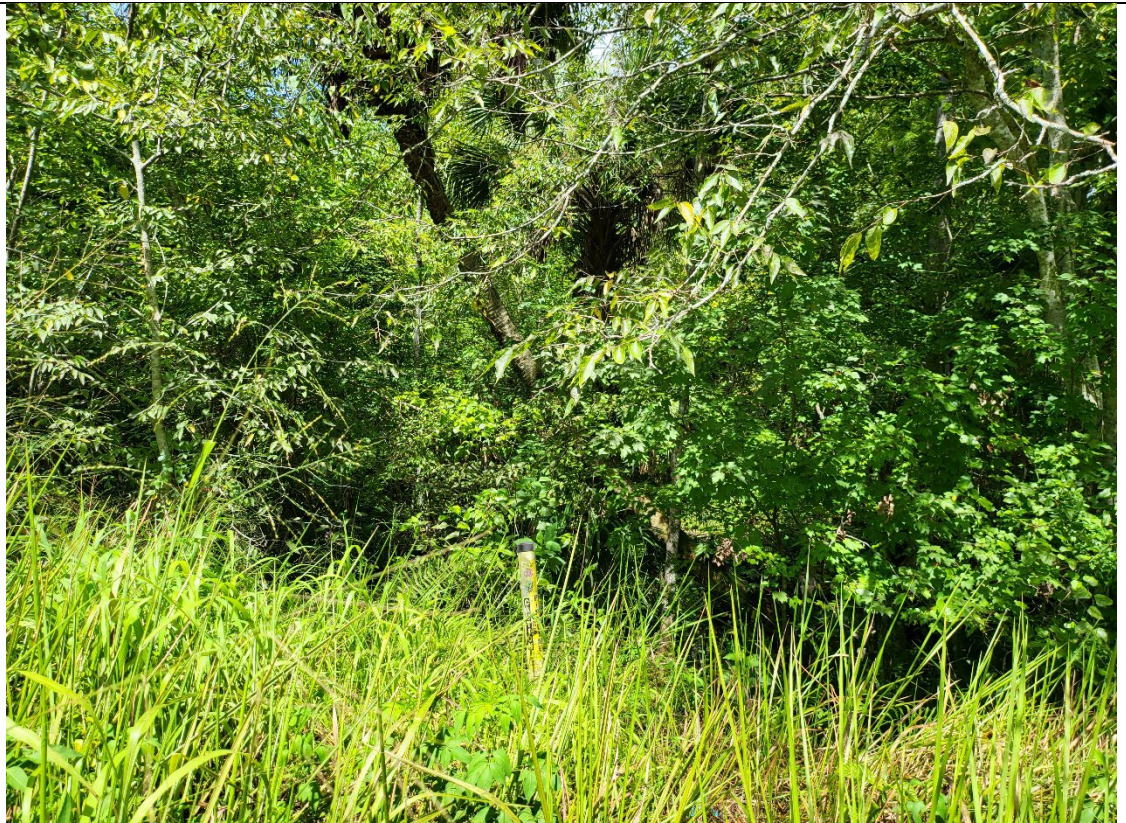
- **Pond 2B** contained water at the time of the site reconnaissance. A buried gas utility pipeline was observed in the southern portion of the pond site.
- **Pond 3.1** is a mostly wooded area and contains a historical telephone repeater station (**Site No. 5**). The western portion of the area contains a pond, and the northeast corner is grassed land. Two soil mounds were observed in the southern portion.
- **Pond 4.1** is a mostly wooded area of land. No obvious signs of contamination were observed in the pond site.
- **Floodplain Compensation Pond.** The floodplain is a former cow pasture. The northern and eastern borders contain trees. A dumped boat was observed to the adjacent south of the floodplain. A gas pipeline and railroad tracks were observed south of the floodplain.

View of the eastern border of **Pond 2B**. A gas pipeline is in the foreground.

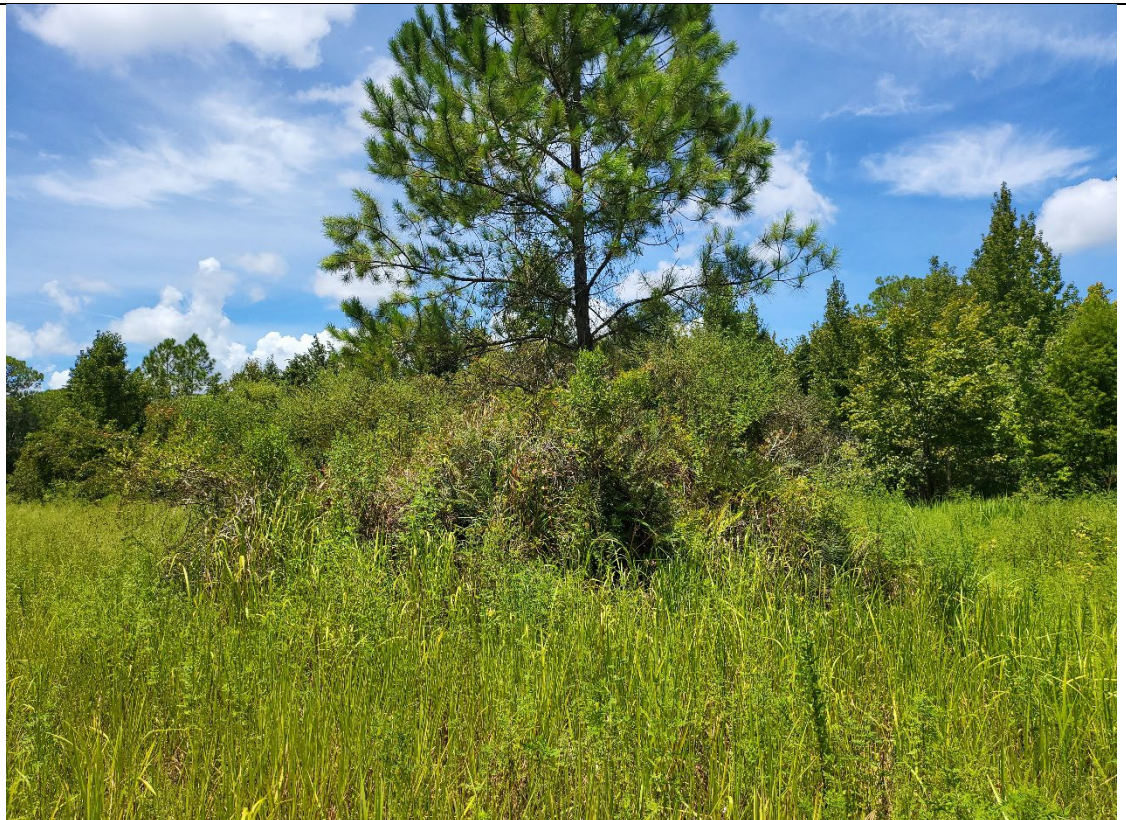
A soil mound located within **Pond 3.1**.

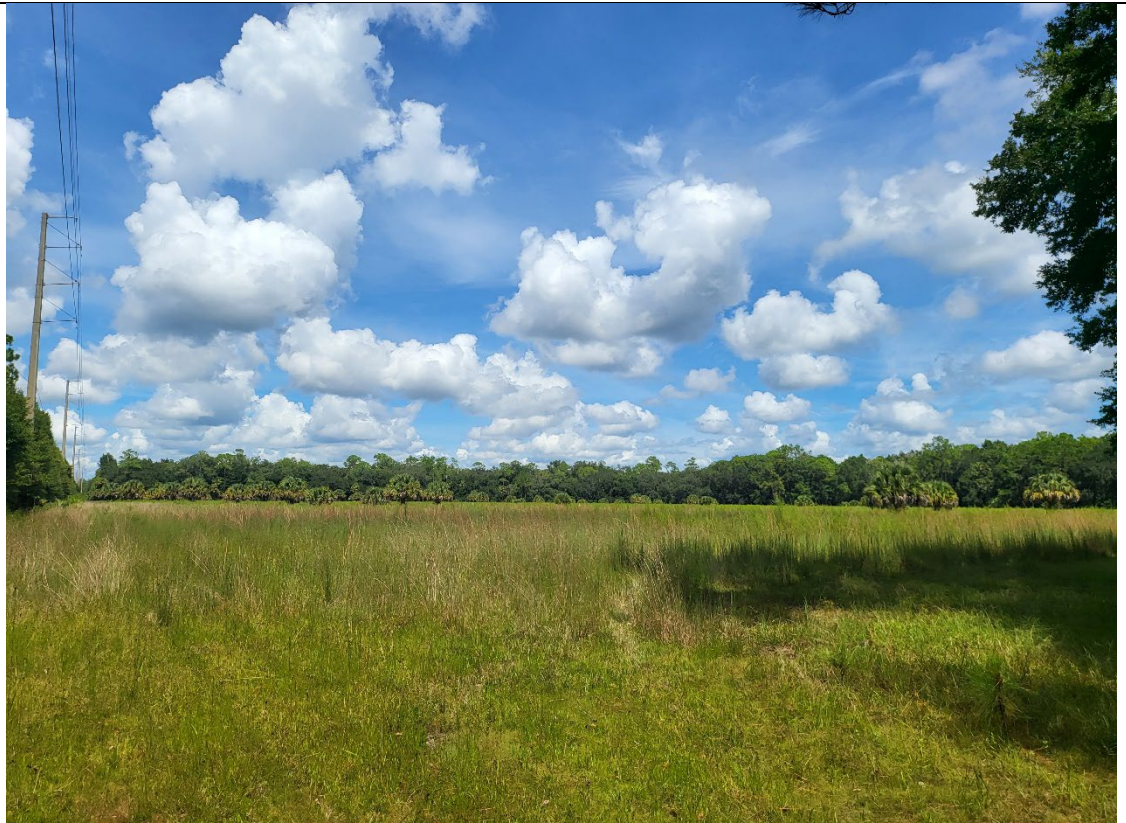
Looking west across  
the **Floodplain  
Compensation Pond.**

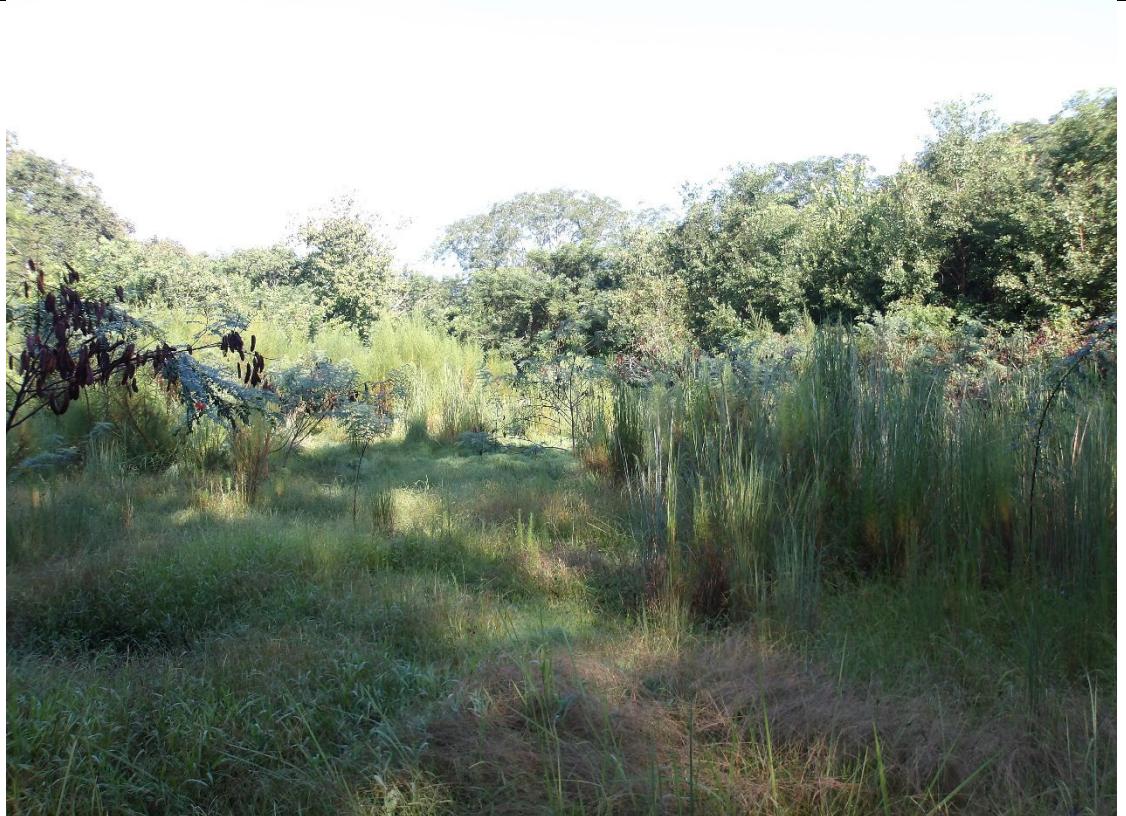
The western portion of  
**Pond 4.1.**
