US 301 (SR 35) PD&E Study

CR 470 E to State Road 44 in Sumter County, FL

Cultural Resource Assessment Survey of US 301 (SR 35)

May 2017

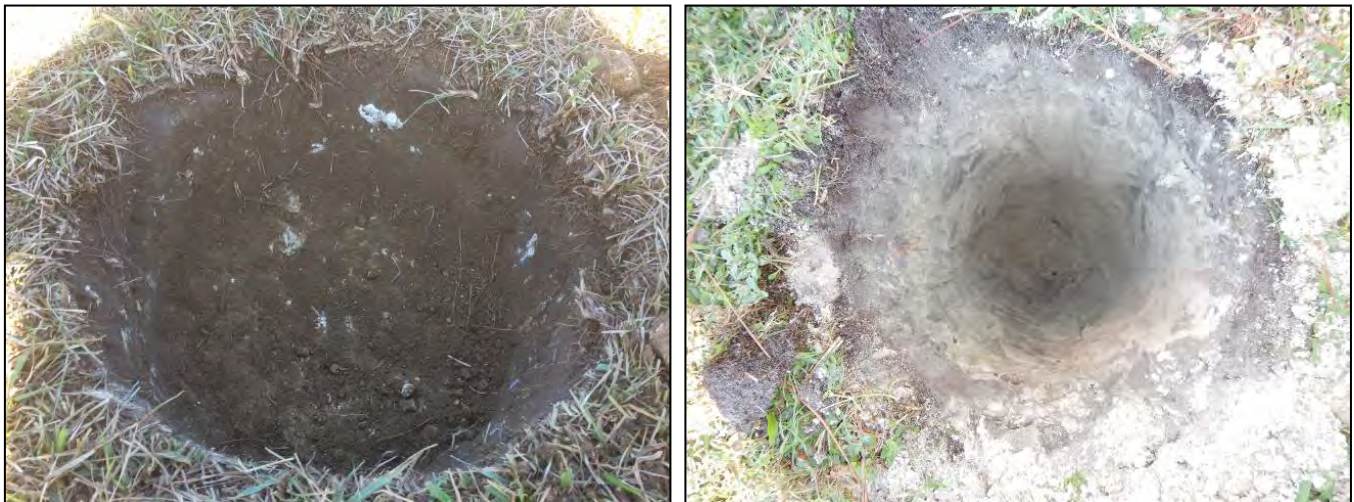
FIGURE 16 | Typical soil stratigraphy in the US 301 PD&E APE. Left: Typical saturated soil stratigraphy in the northern end of the project area. Right: typical soil profile in the southern end of the project area.

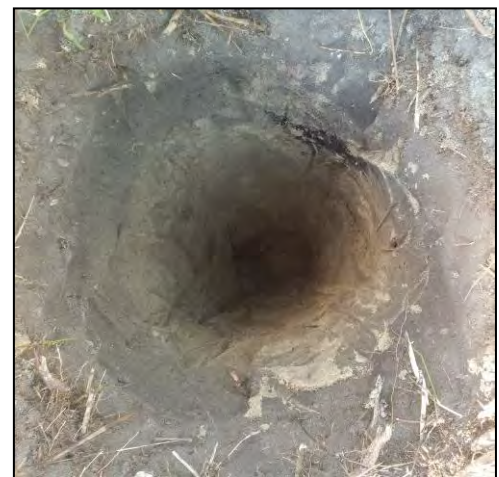
FIGURE 24 | Typical soil profile in 8SM00929.

Soil stratigraphy in 8SM00929 began with an uppermost stratum of grayish brown fine sand which reached a depth of 30 cmbs (11.8 inches) (**Figure 24**). All cultural material in this site was recovered from this uppermost soil layer. Stratum II consisted of yellowish brown loamy sand, which was excavated to 100 cmbs (39.3 inches). Excavation terminated at Stratum II.

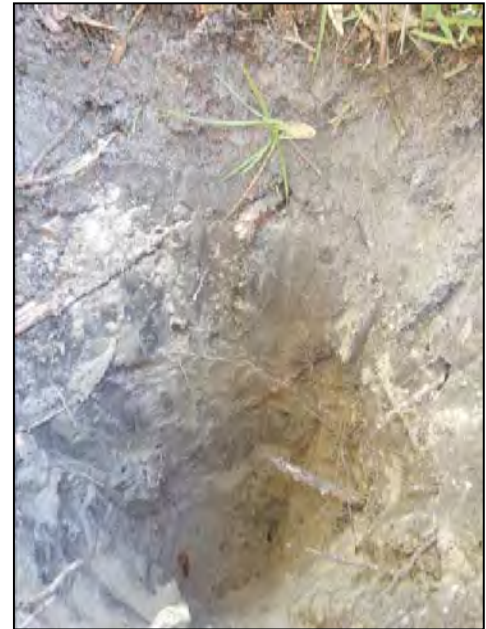
FIGURE 28 | Typical soil profile in 8SM00930.

Stratum I in the Anderson Road Scatter consisted of grayish brown fine sand to approximately 40 cmbs (15.7 inches) (**Figure 28**). The only artifact recorded from Shovel Test (ST) 726, a fragment of clear, machine-made bottle glass, was recovered from this stratum. Stratum II consisted of light gray or pale brown sand to a depth of approximately 80 to 100 cmbs (31.5 inches to 39.3 inches). The majority of artifacts (n=38) were recorded in Stratum II of ST 501. In ST 726, a third stratum of pale yellowish brown sand was recorded below 80 cmbs (31.5 inches). Excavation terminated in both shovel tests at 100 cmbs (39.3 inches).

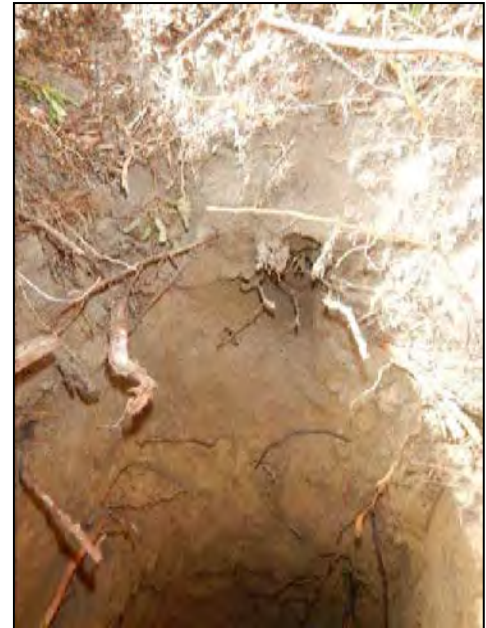
FIGURE 45 | Typical soil profile in 8SM00935.

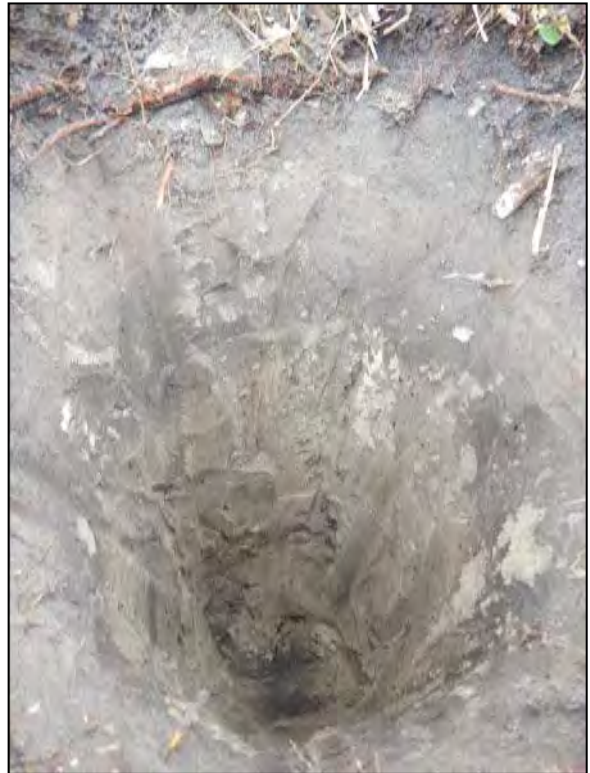
FIGURE 49 | Typical soil profile in 8SM00936.

Stratum I in the Sunoco Scatter site typically began with a layer of mottled grayish brown fine sand to approximately 50 cmbs (19.7 inches) (**Figure 49**). In ST 648, Stratum I became lighter colored with depth. Stratum II varied between all three shovel tests, appearing as undisturbed yellowish brown very fine sand in ST 647 and pale brown sand in ST 648; in ST 597, soil stratigraphy was disturbed throughout, with Stratum II described as mottled brownish gray fine sand. Excavation of all shovel tests stopped at 100 cmbs (39.3 inches).
