**TECHNICAL MEMORANDUM**  
**CULTURAL RESOURCE ASSESSMENT SURVEY OF THE I-75 (SR 93)**  
**AT NW 49<sup>TH</sup> STREET POND SITES,**  
**MARION COUNTY, FLORIDA**

<b>CONSULTANT:</b>	SEARCH 700 N. 9 <sup>th</sup> Avenue, Pensacola, Florida 32501
<b>PRINCIPAL INVESTIGATOR:</b>	Steven RabbySmith, MA, RPA
<b>CLIENT:</b>	Metric Engineering
<b>DATE:</b>	October 2020
<b>FPID#:</b>	435209-1
<b>SEARCH PROJECT #:</b>	3954-17098

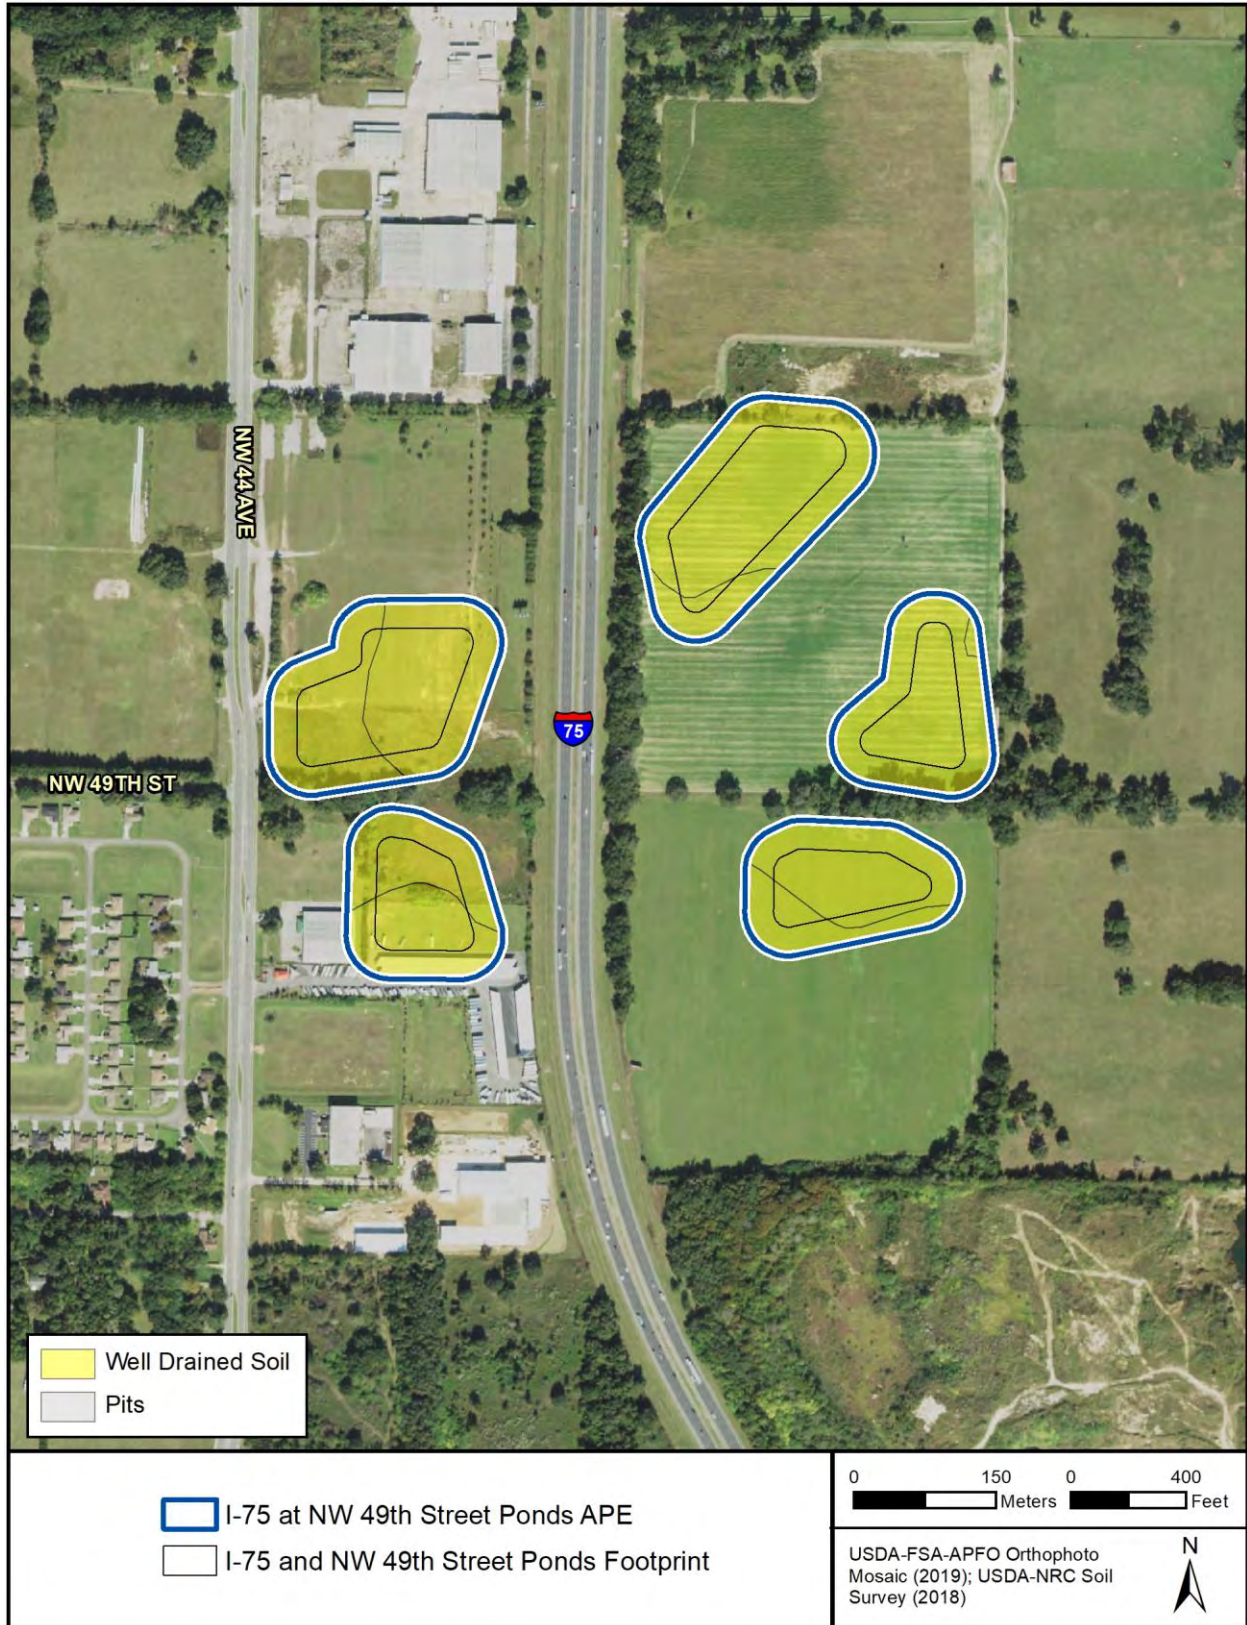
Figure 4. Soil drainage characteristics within the I-75 at NW 49th Street Ponds APE.

Based on an examination of environmental variables (soil drainage, access to wetlands and freshwater resources, and relative elevation), as well as the results of previously conducted surveys, the potential for prehistoric archaeological sites to be present within the project area was considered to be moderate to low in the two unsurveyed pond locations. The soils in these ponds are well drained (**Figure 4**); however, no viable freshwater sources are present in the vicinity (see **Figure 2**). The absence of significant freshwater sources tends to indicate a low probability for prehistoric sites. Because a historic structure, 8MR01660, once stood near the edge of the Pond E-3 footprint, Ponds E-1 and E-3 were considered to have a moderate probability for historic archaeological resources.

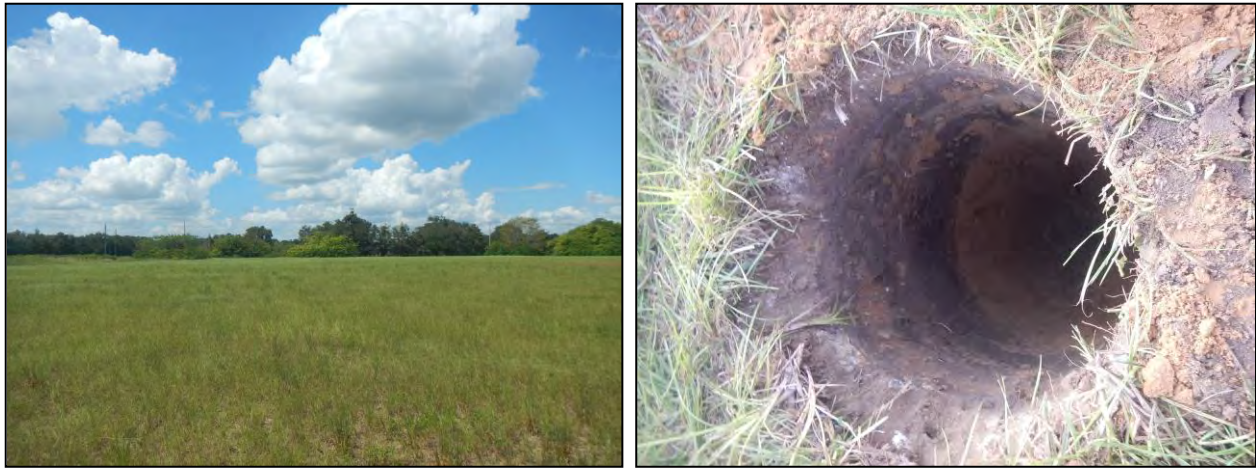
Pond E-1 is located approximately 295 feet (90 meters) west of I-75, southeast of the intersection of NW 49<sup>th</sup> Street and NW 44<sup>th</sup> Avenue. The proposed pond footprint is situated within a regularly maintained grassy field with a few stands of oaks and pine (**Figure 6**). A total of five shovel tests were excavated within the Pond E-1 footprint at 50-meter (164-foot) intervals; none of these tests were positive for cultural material, including artifacts or other evidence of the previously recorded, currently demolished, structure 8MR01660 (see **Figure 5**). A typical soil profile observed in shovel tests excavated within Pond E-1 consisted of dark yellowish-brown (10YR 4/4) sand with dense limestone gravel from 0 to 15 cmbs (0 to 5.9 inches) above dark grayish-brown (10YR 3/2) sand mottled with strong brown (7.5YR 4/6) fine sand from 15 to 50 cmbs (5.9 to 19.7 inches) above yellowish-brown (10YR 5/6) sand from 50 cmbs (19.7 inches) to the base of the excavation at 100 cmbs (39.4 inches) (see **Figure 6**). No artifacts or cultural features were encountered in subsurface tests or on the surface, and no further archaeological survey is recommended.

**Figure 6. Left: Terrain and vegetation within the Pond E-1 footprint, view to the west. Right: Typical soil profile observed in the Pond E-1 footprint.**

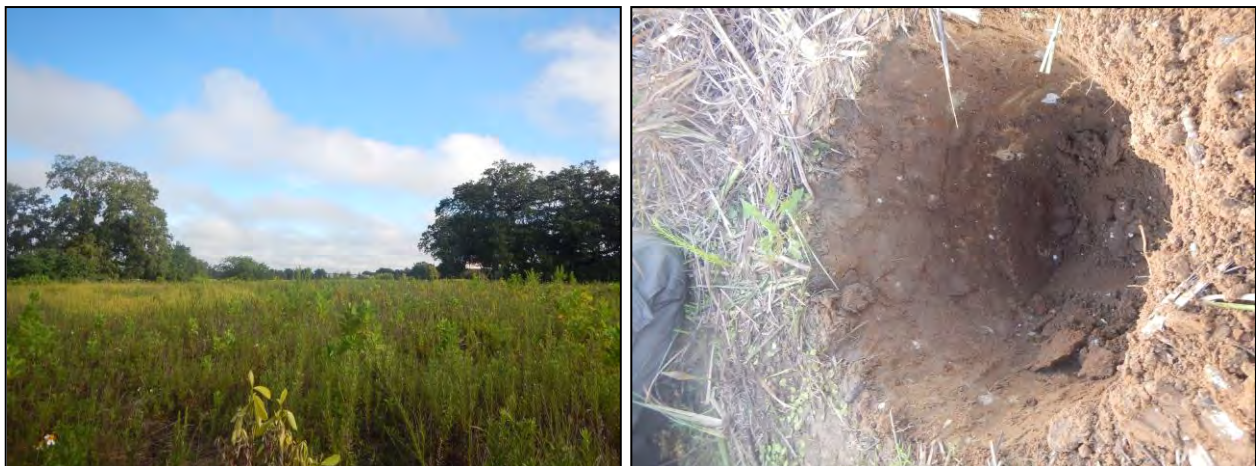
Pond E-3 is located approximately 328 feet (100 meters) west of I-75, northeast of the intersection of NW 49<sup>th</sup> Street and NW 44<sup>th</sup> Avenue. The proposed pond footprint is situated in an open field covered with grasses and other low-lying vegetation (**Figure 7**). A total of eight shovel tests were excavated within the Pond E-3 footprint at 50-meter (164-foot) intervals;

none of these tests were positive for cultural material (see **Figure 5**). A typical soil profile observed in shovel tests within the pond site consisted of dark grayish-brown (10YR 4/2) sand from 0 to 33 cmbs (0 to 13 inches) above dark yellowish-brown (10YR 4/6) fine sand from 33 cmbs (13 inches) to the base of the excavation at 100 cmbs (39.4 inches) (see **Figure 7**). No artifacts or cultural features were encountered in subsurface tests or on the surface, and no further archaeological survey is recommended.

**Figure 7. Left: Terrain and vegetation in the Pond E-3 footprint, view to the north. Right: Typical shovel test profile observed in the Pond E-3 footprint.**
